**CAROLINA POWER & LIGHT  
MAYO ELECTRIC GENERATING PLANT**

**MAYO CREEK DAM  
ASH POND DAM  
PERSON COUNTY, NORTH CAROLINA**

**FIVE-YEAR INDEPENDENT CONSULTANT INSPECTION  
AS REQUIRED BY  
NORTH CAROLINA UTILITIES COMMISSION**

**December 22, 1999**

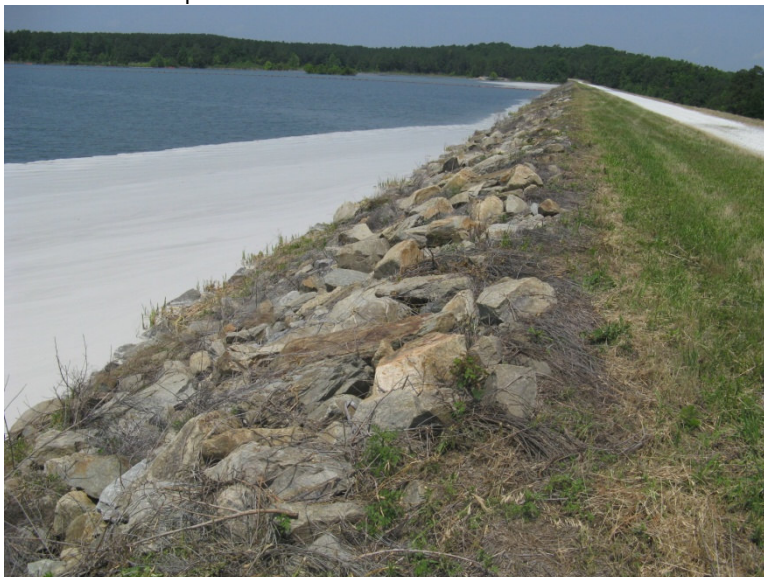
Photo 1: Upstream Embankment, Crest, Photo: 042, 6/3/09

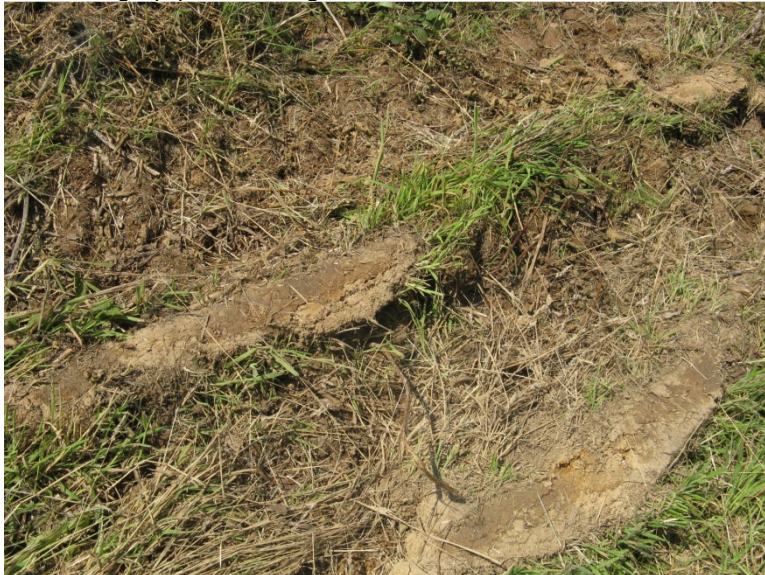
Photo 4: Mowing Equipment Rutting, Downstream Embankment, Photo: 007, 6/3/09

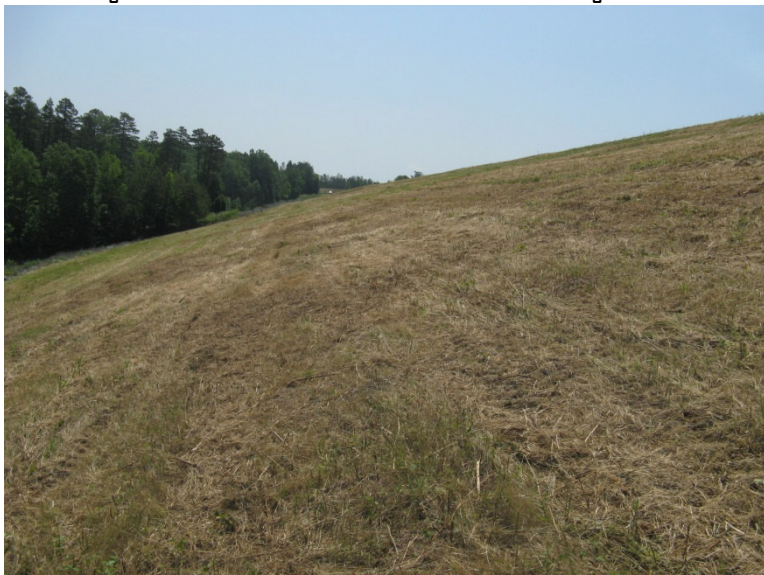
Photo 5: Embankment Looking to Right Abutment, Downstream Embankment, Photo: 036, 6/3/09  
(Note right and left are referenced from observer facing downstream)

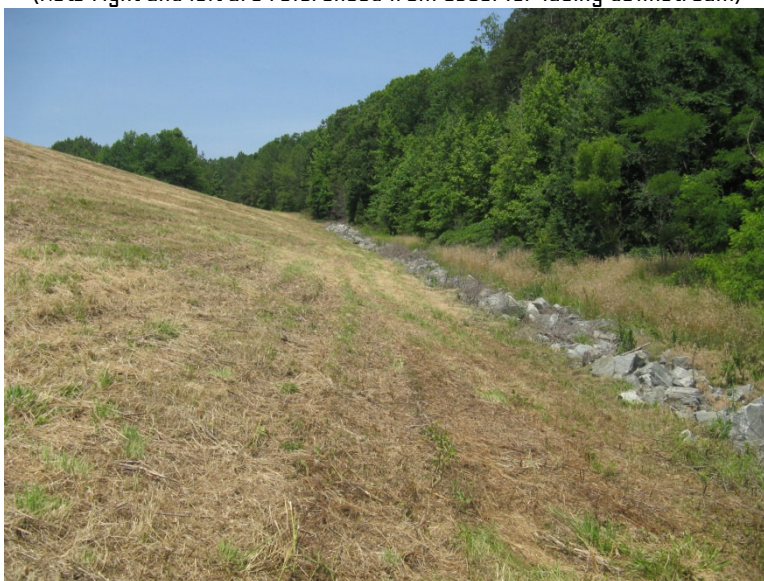
Photo 6: View of Left Groin and Embankment, Left Groin, Photo: 032, 6/3/09  
(Note right and left are referenced from observer facing downstream)

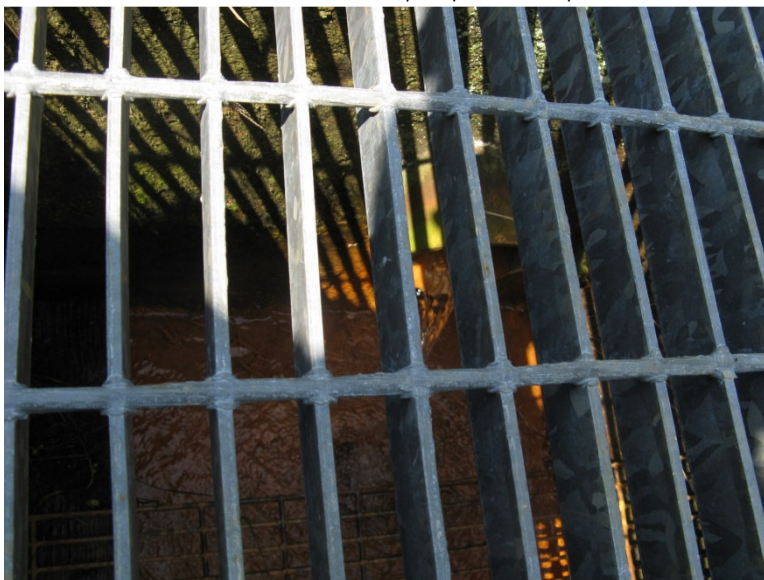
Photo 7: Internal Drain Outlet, Toe, Photo: 019, 6/3/09

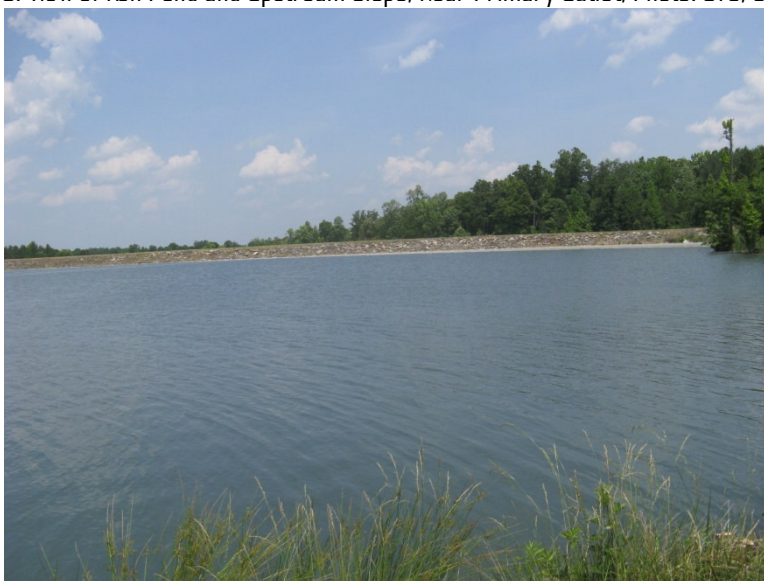
Photo 8: View of Ash Pond and Upstream Slope, Near Primary Outlet, Photo: 075, 6/3/09

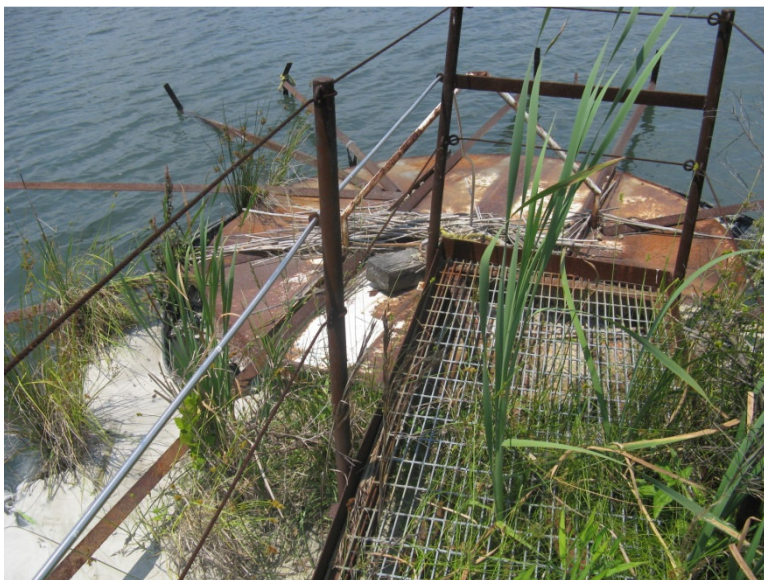
Photo 9: riser and skimmer at stilling pool, Photo: 079, 6/3/09

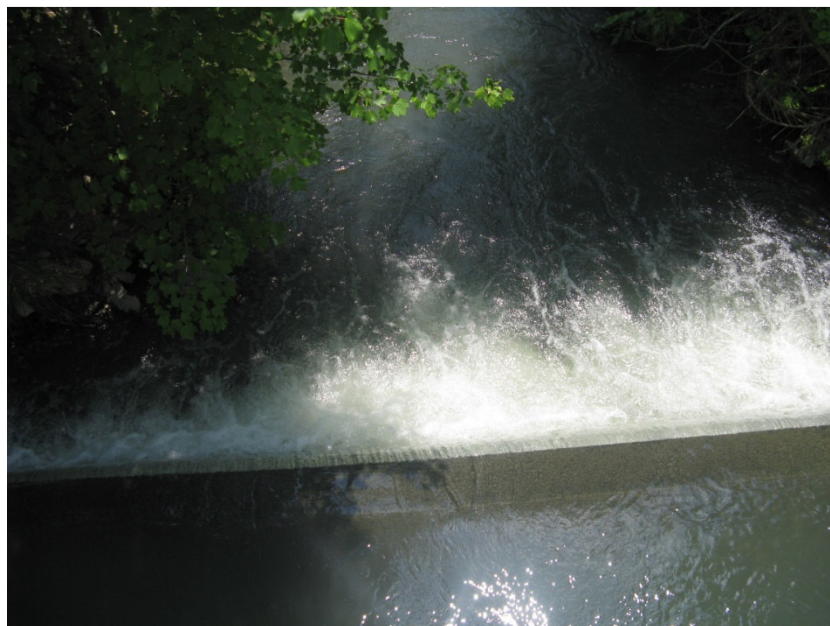
Photo 11 concrete overflow weir spillway, Photo: 068, 6/3/09

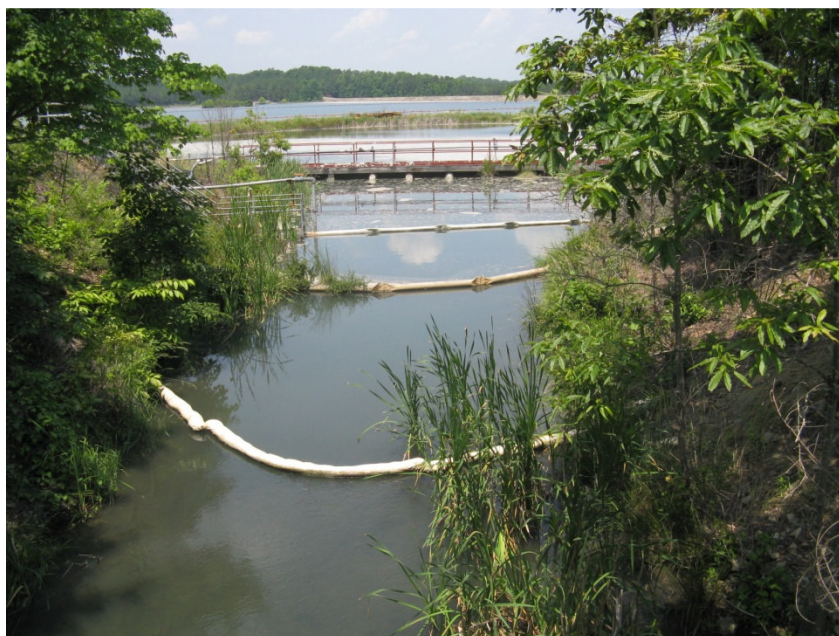
Photo 12: Downstream channel looking upstream at stilling pool with embankment dam in background, Photo: 069, 6/3/09
