**CAROLINA POWER & LIGHT  
MAYO ELECTRIC GENERATING PLANT**

**MAYO CREEK DAM  
ASH POND DAM  
PERSON COUNTY, NORTH CAROLINA**

**FIVE-YEAR INDEPENDENT CONSULTANT INSPECTION  
AS REQUIRED BY  
NORTH CAROLINA UTILITIES COMMISSION**

**December 22, 1999**

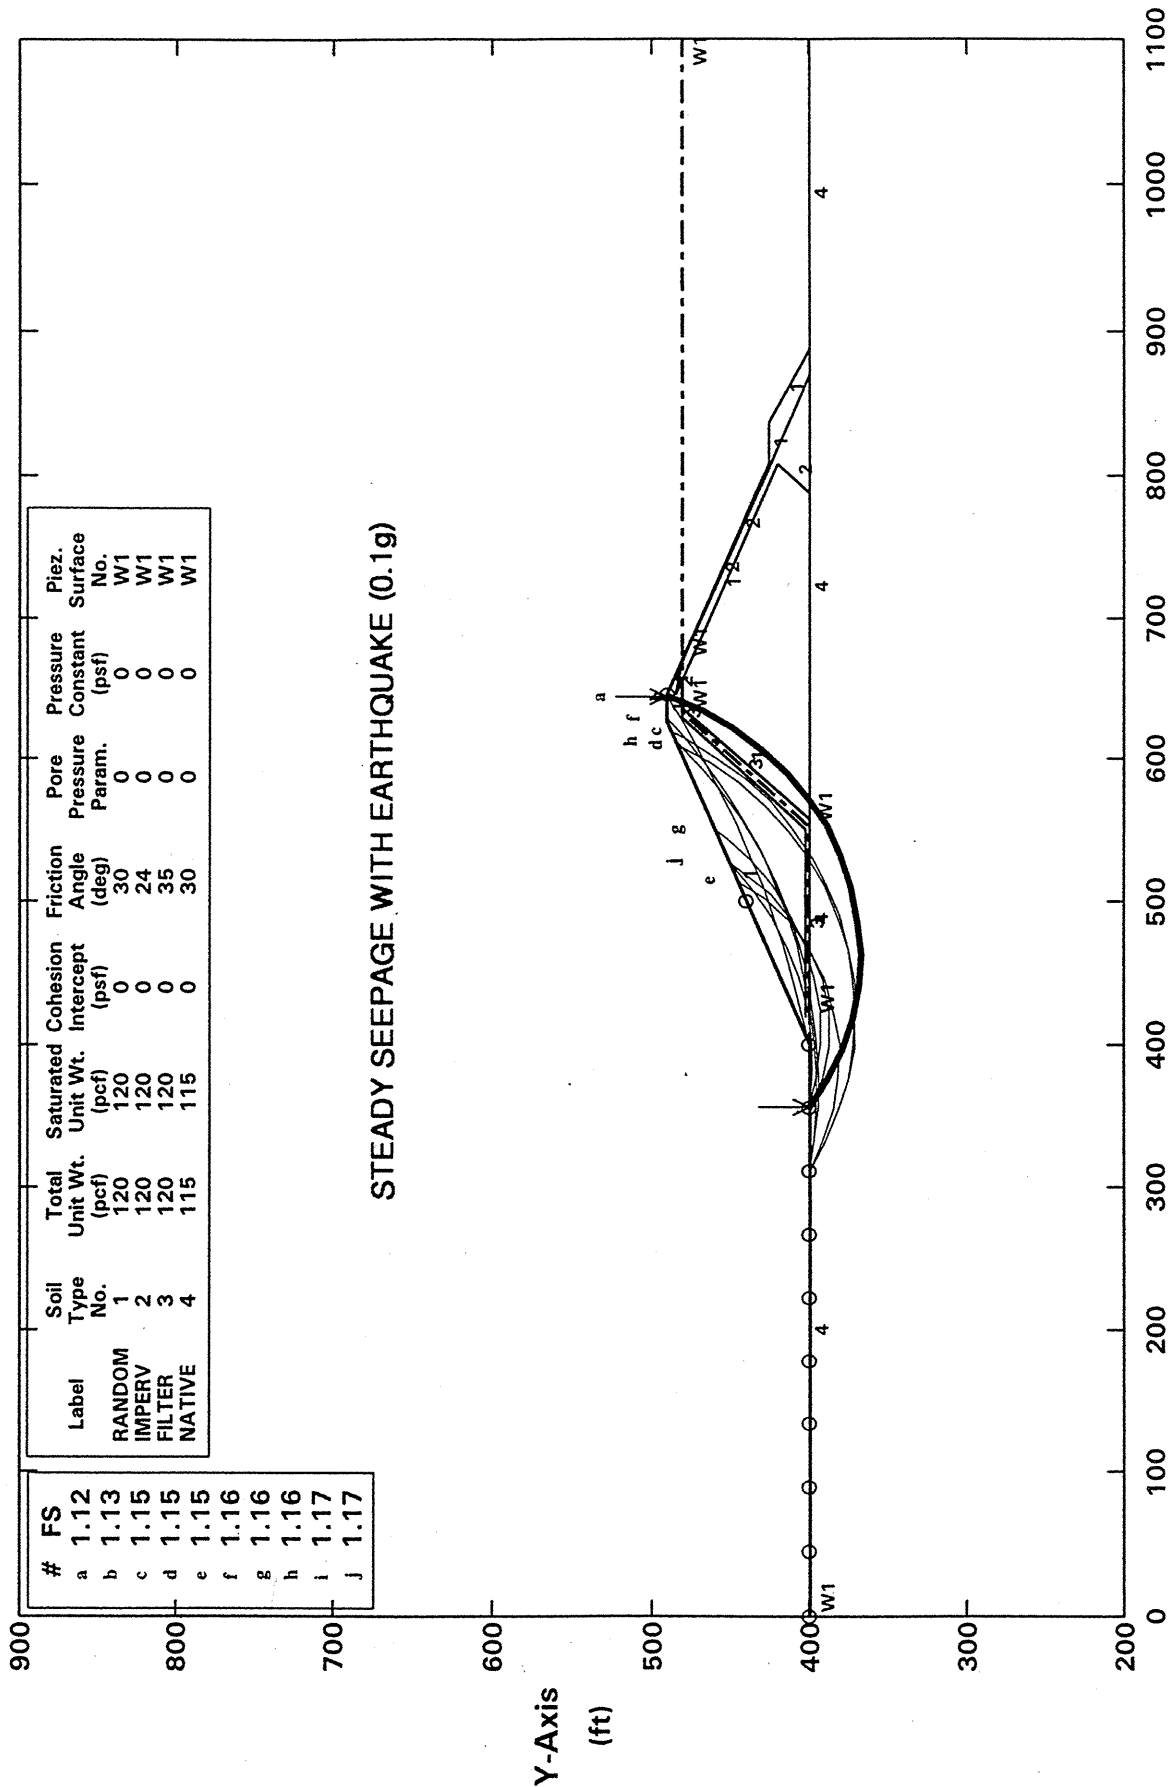
STABL6H FSmin = 1.12 X-Axis (ft)  
Factors Of Safety Calculated By The Modified Bishop Method

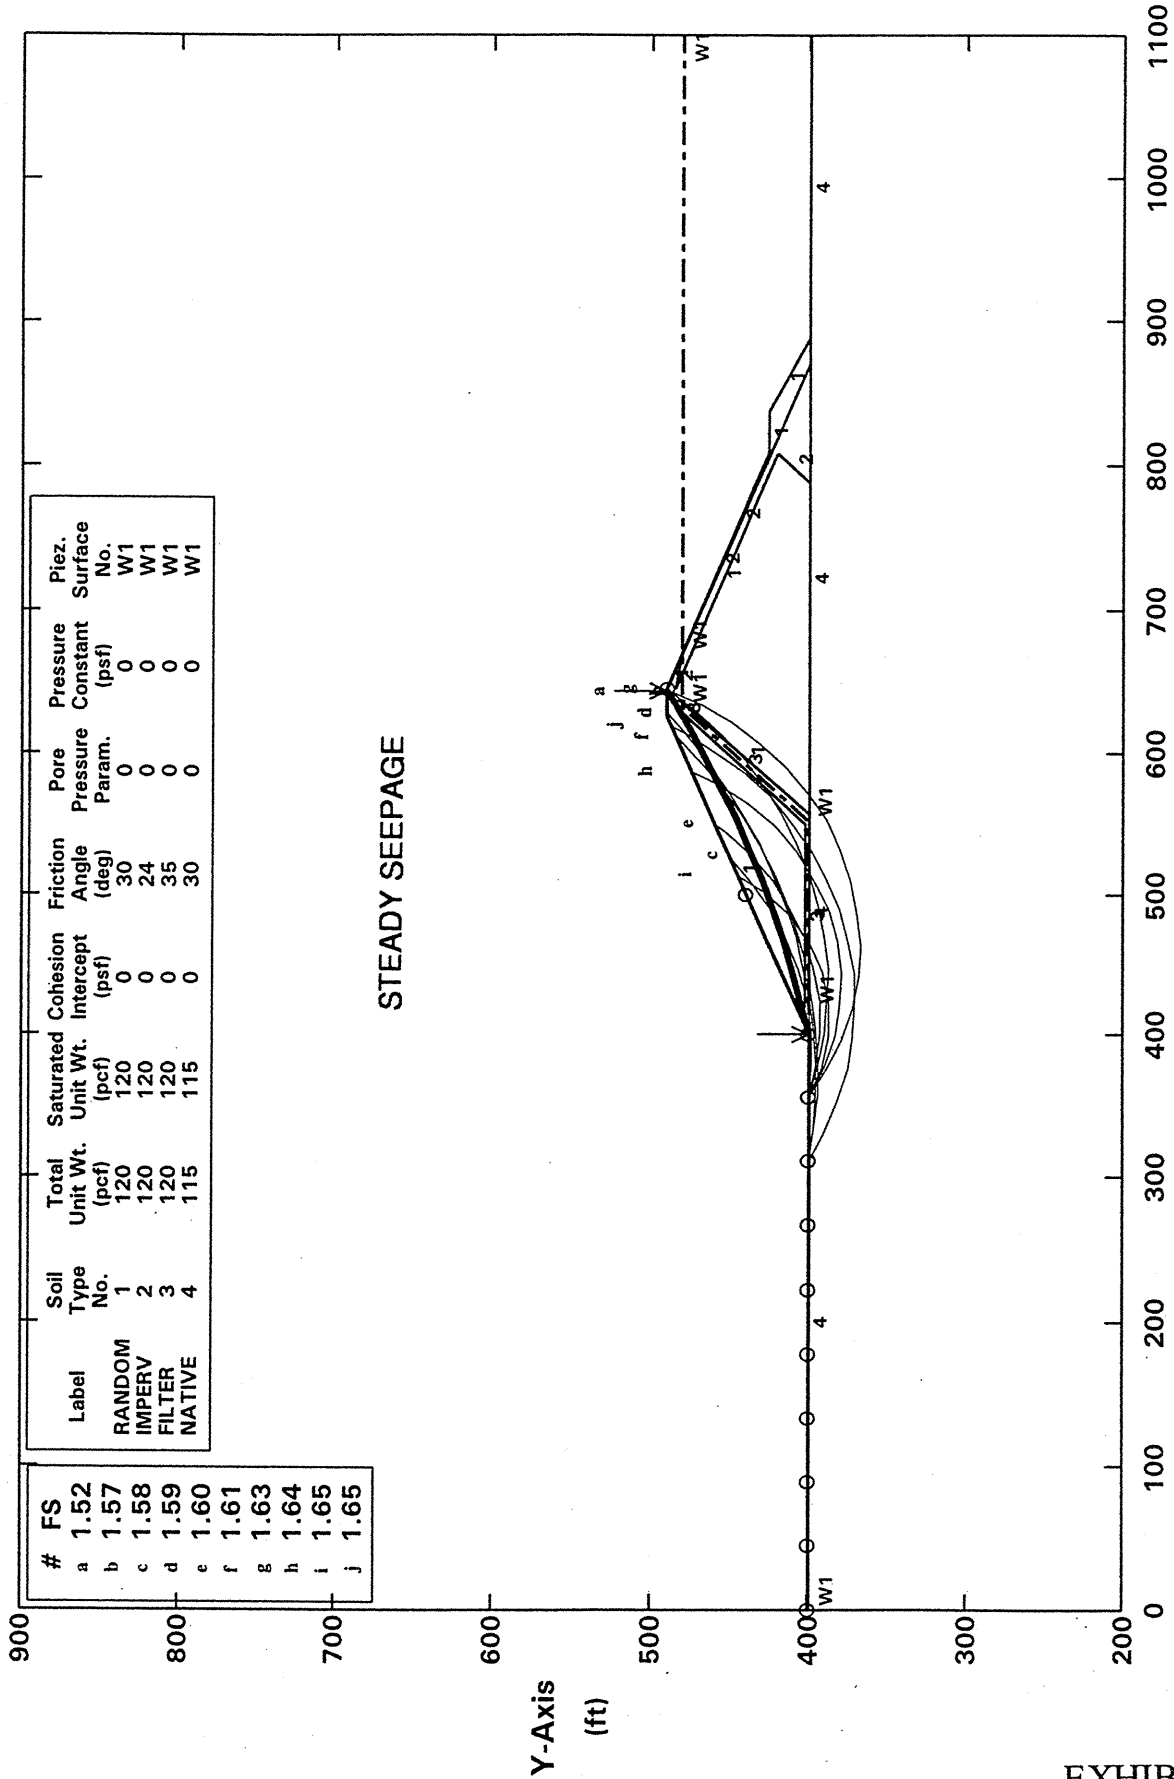
STABL6H FSmin = 1.52 X-Axis (ft)

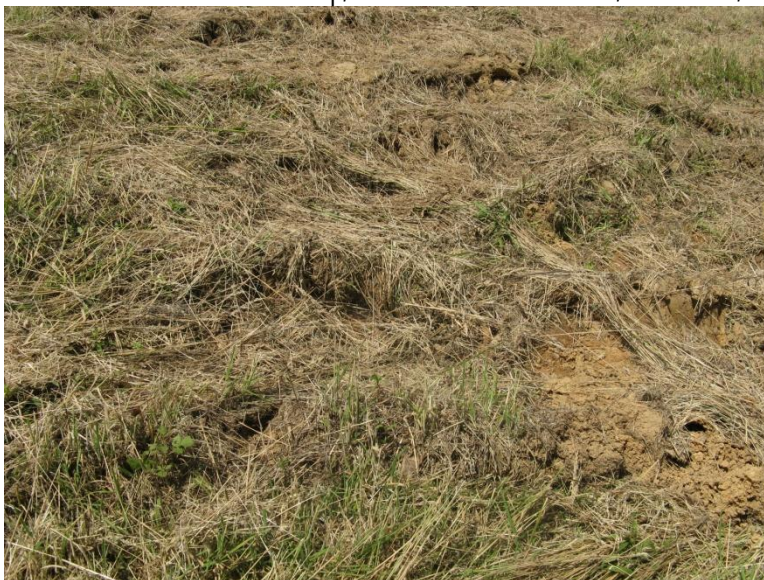
Photo 3: Bare Areas and Straw Build Up, Downstream Embankment, Photo: 004, 6/3/09

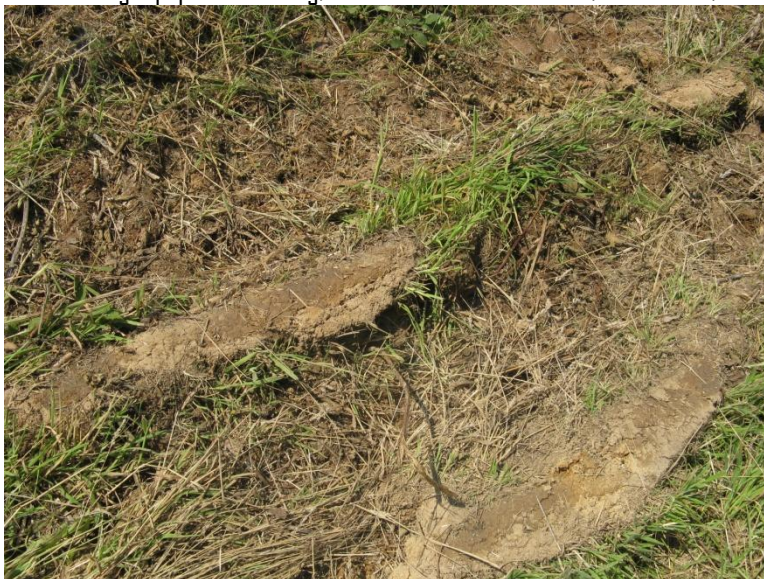
Photo 4: Mowing Equipment Rutting, Downstream Embankment, Photo: 007, 6/3/09
