**Coal Combustion Waste Impoundment  
Dam Assessment Report**

*Site 9  
Mayo Ash Pond  
Progress Energy  
Roxboro, North Carolina*

**Project # 0-381**  
**Assessment of Dam Safety**  
**Coal Combustion Surface Impoundments**  
**For the REAC Program**

**June 2009**  
Revised Final September 11, 2009

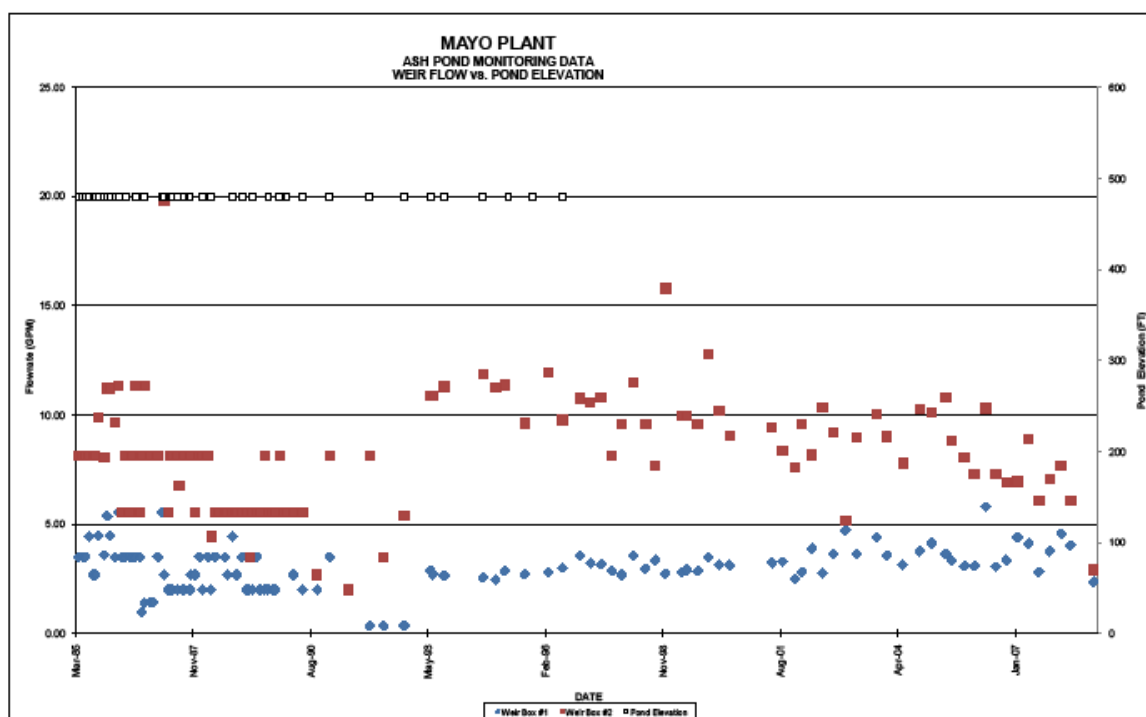
Data is recorded on a standard inspection report for Progress Energy. A copy is given to the manager of the Mayo Electric Generating Plant, and one additional copy is maintained in Progress Energy's files. Please refer to Appendix A, for sample reports. Piezometer readings recorded from March 1985 to May 2009 indicate a steady and consistent trend and are consistent with the design assumptions (see Section 7.1.3). The following chart represents seepage readings recorded from March 1985 to May 2009, for the east and west outlets of the internal drainage system, and indicate a consistent trend.

The historical data indicates that the embankment dam is performing adequately.
