DRAFT
Specific Site Assessment for
Coal Combustion Waste
Impoundments at Minnkota
Power Cooperative
Milton R. Young Station

Center, North Dakota

December 2010
Project 092884

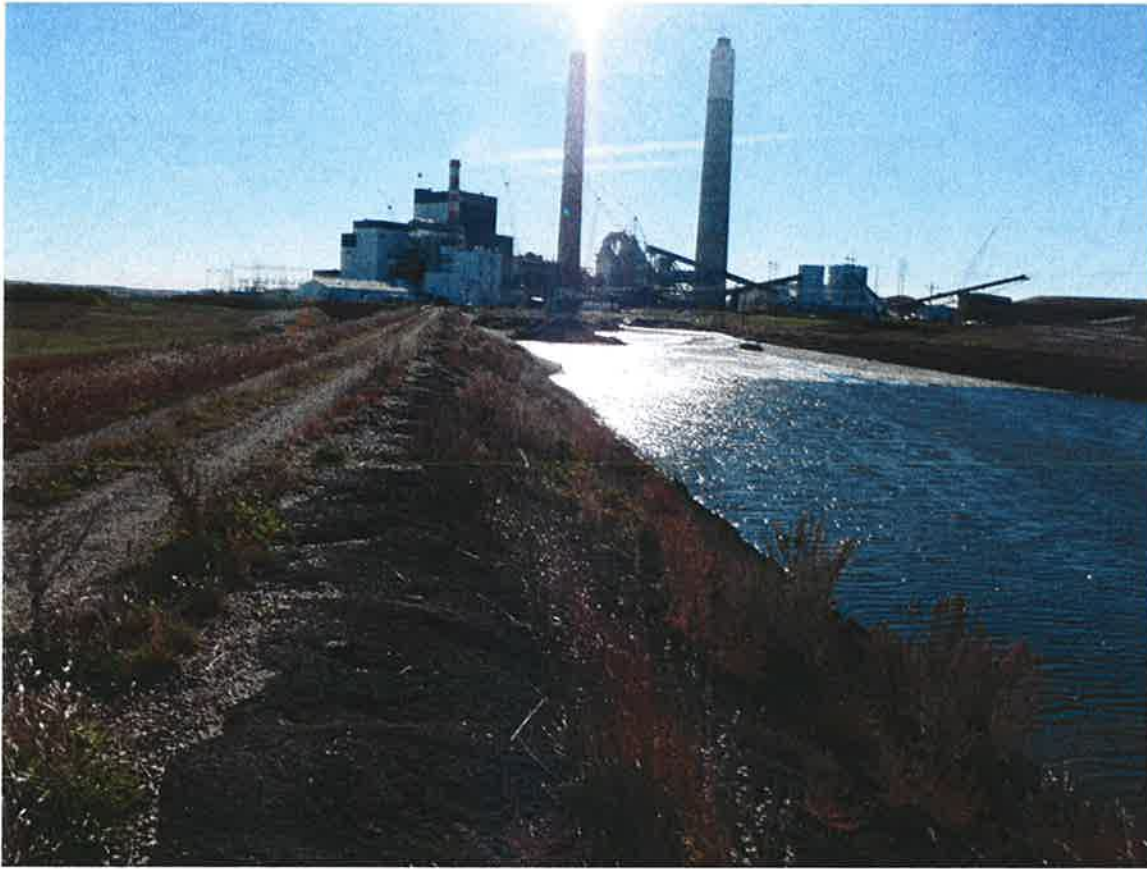
Photo 1: Alternate Bottom Ash Pond – North dike upstream slope, looking east

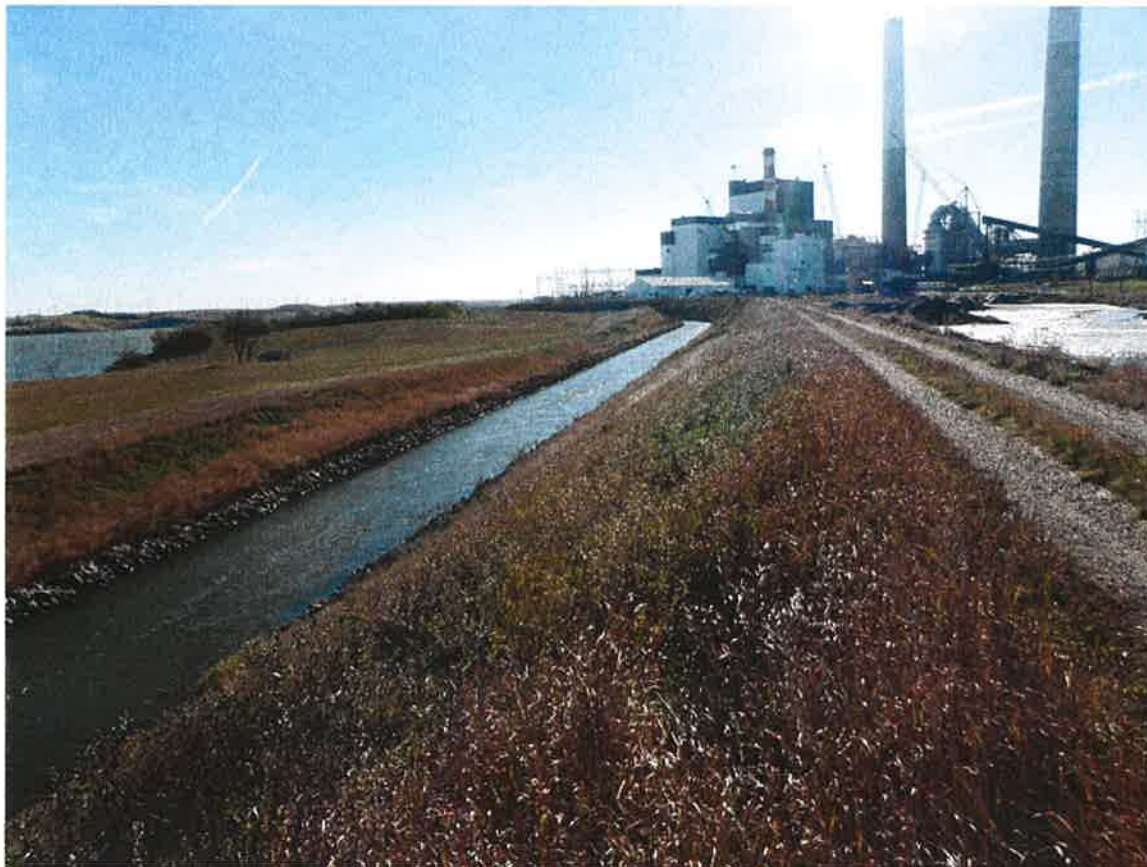
Photo 2: Alternate Bottom Ash Pond – North dike downstream slope and cooling canal, looking east

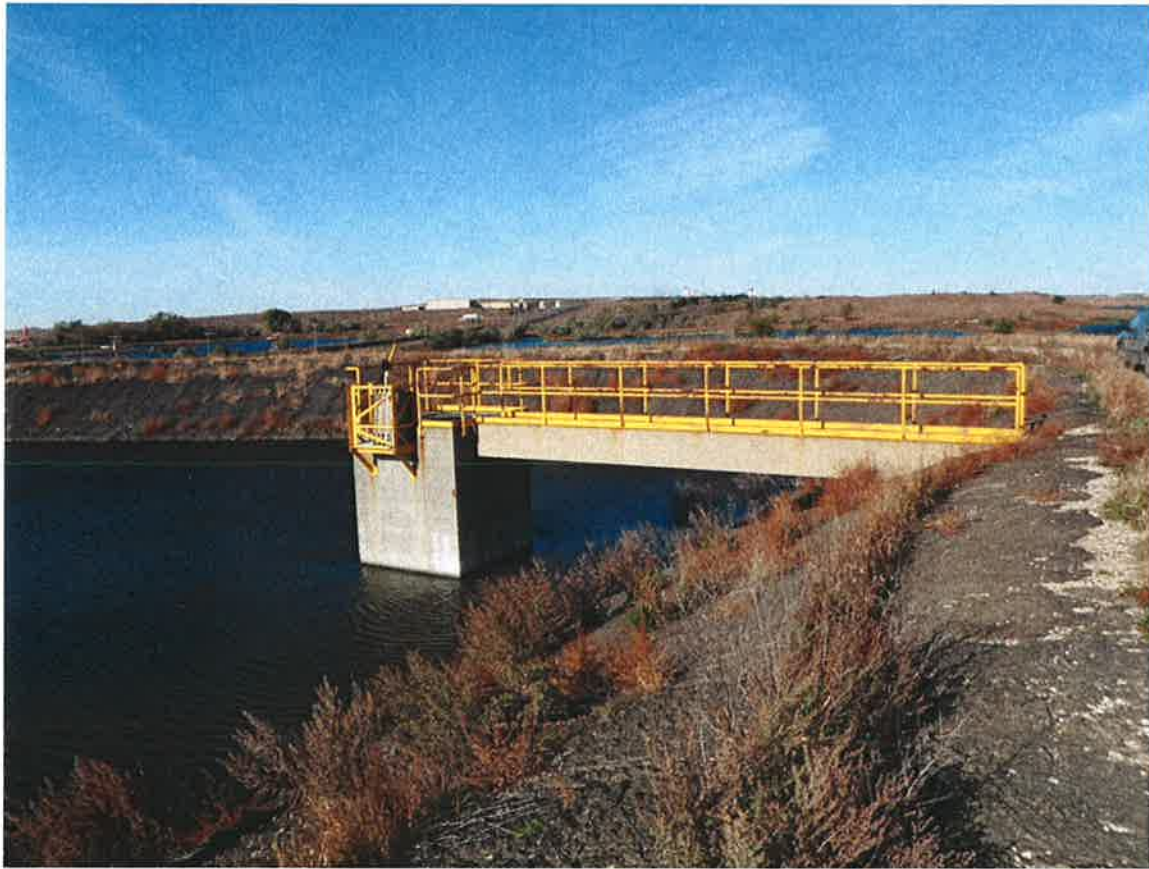
Photo 3: Alternate Bottom Ash Pond – Stop log structure on north dike, looking west

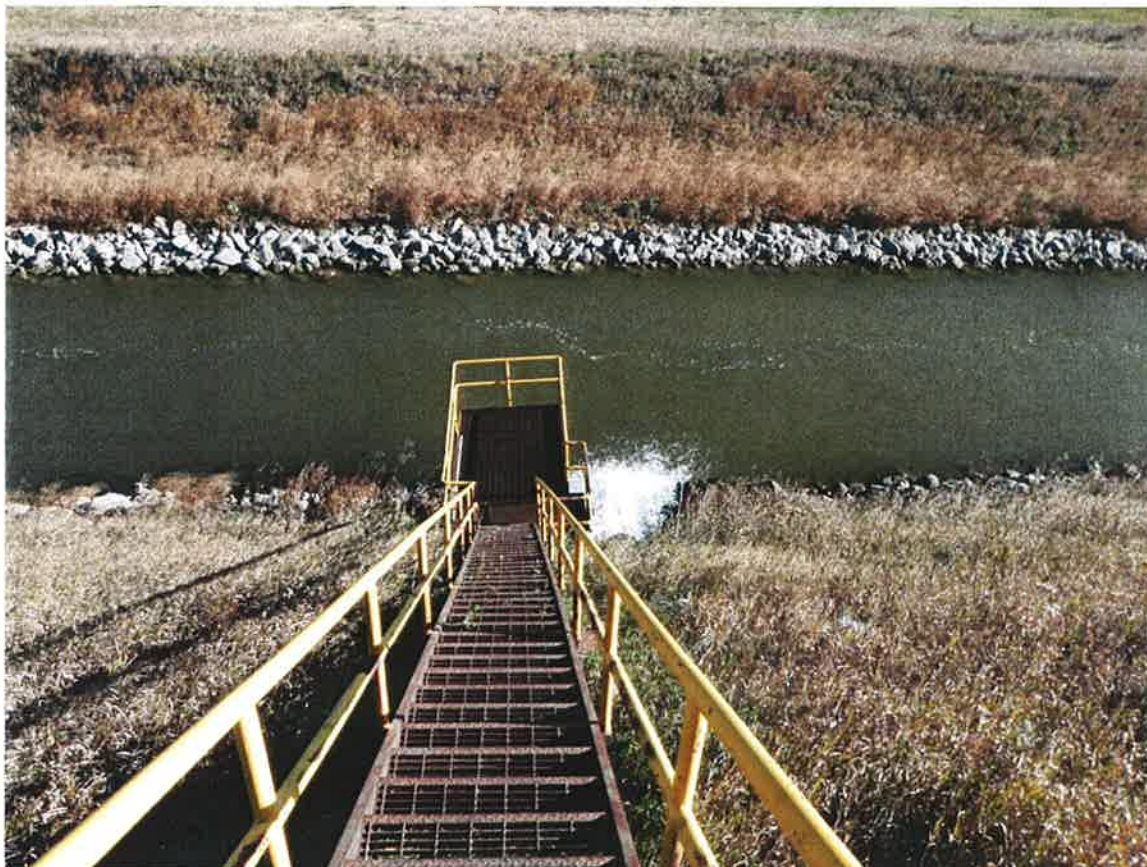
Photo 4: Alternate Bottom Ash Pond – Outlet to cooling canal, looking north

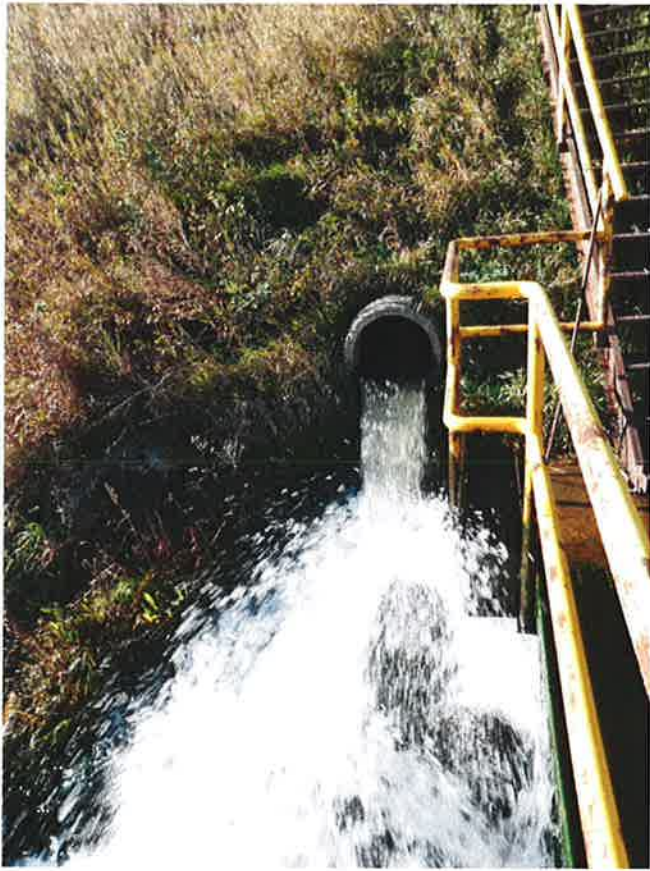
Photo 5: Alternate Bottom Ash Pond – 18" diameter RCP discharge to cooling canal, looking south

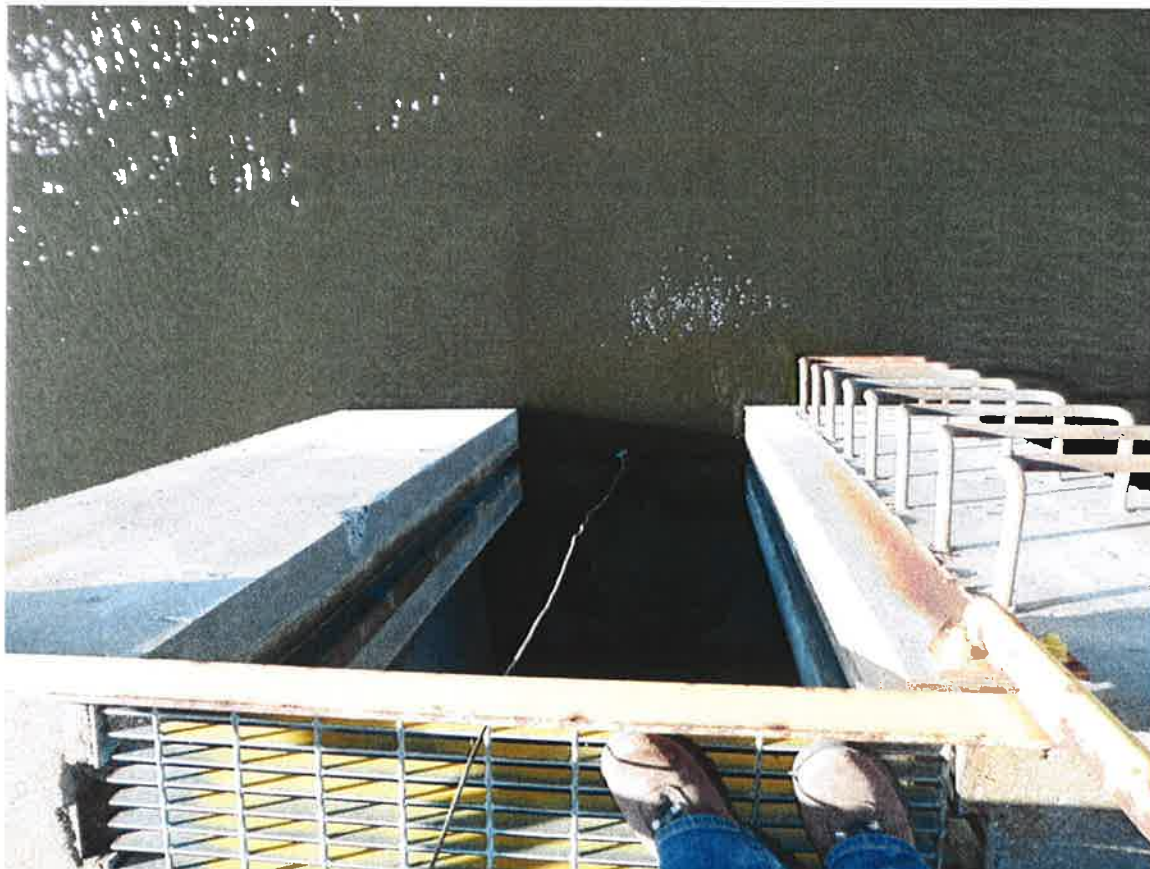
Photo 6: Alternate Bottom Ash Pond – Stop log structure inlet

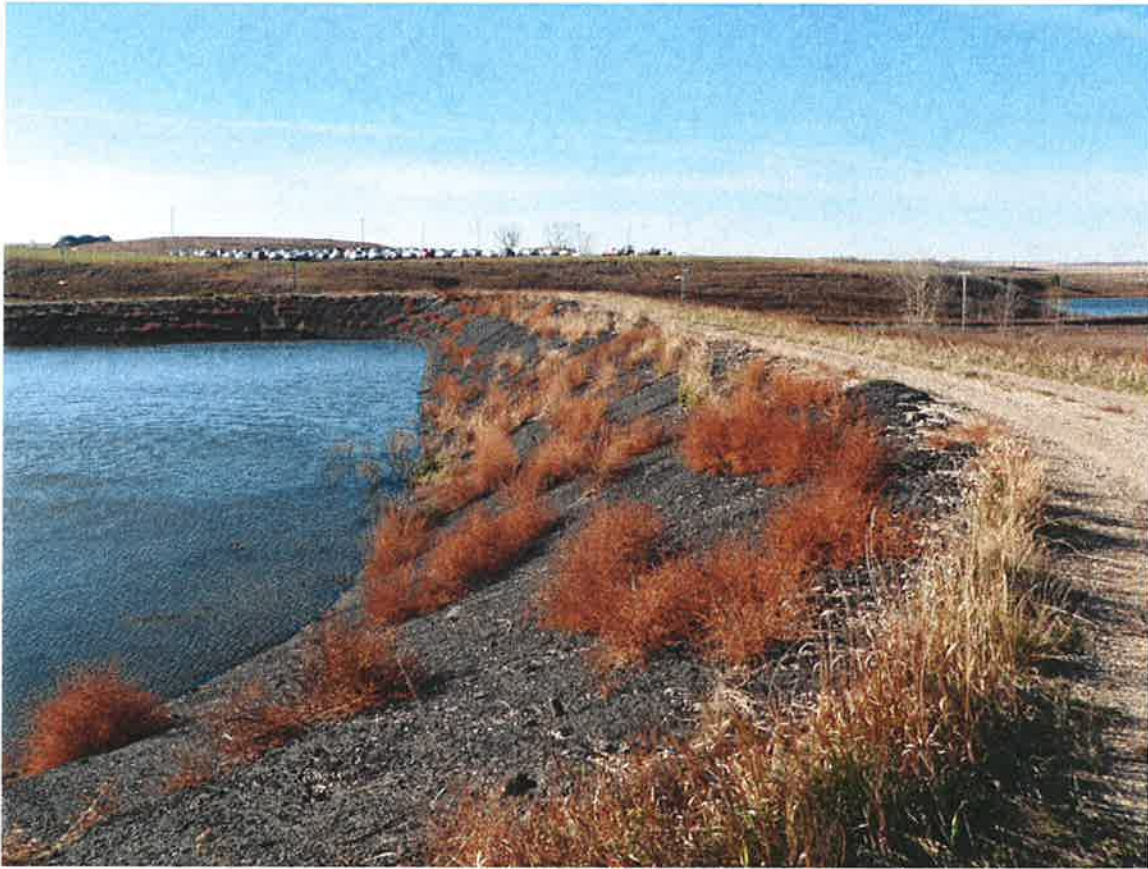
Photo 7: Alternate Bottom Ash Pond – West dike upstream slope, looking south

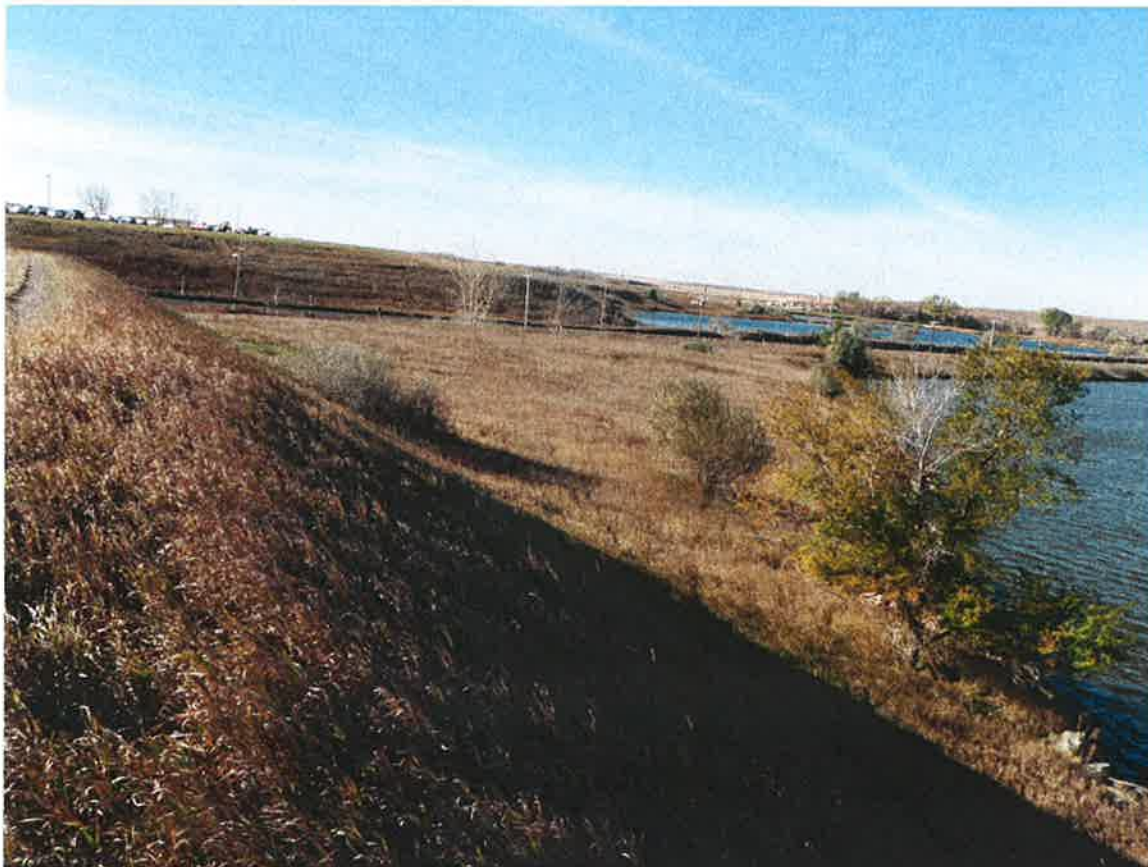
Photo 8: Alternate Bottom Ash Pond – West dike downstream slope, looking south

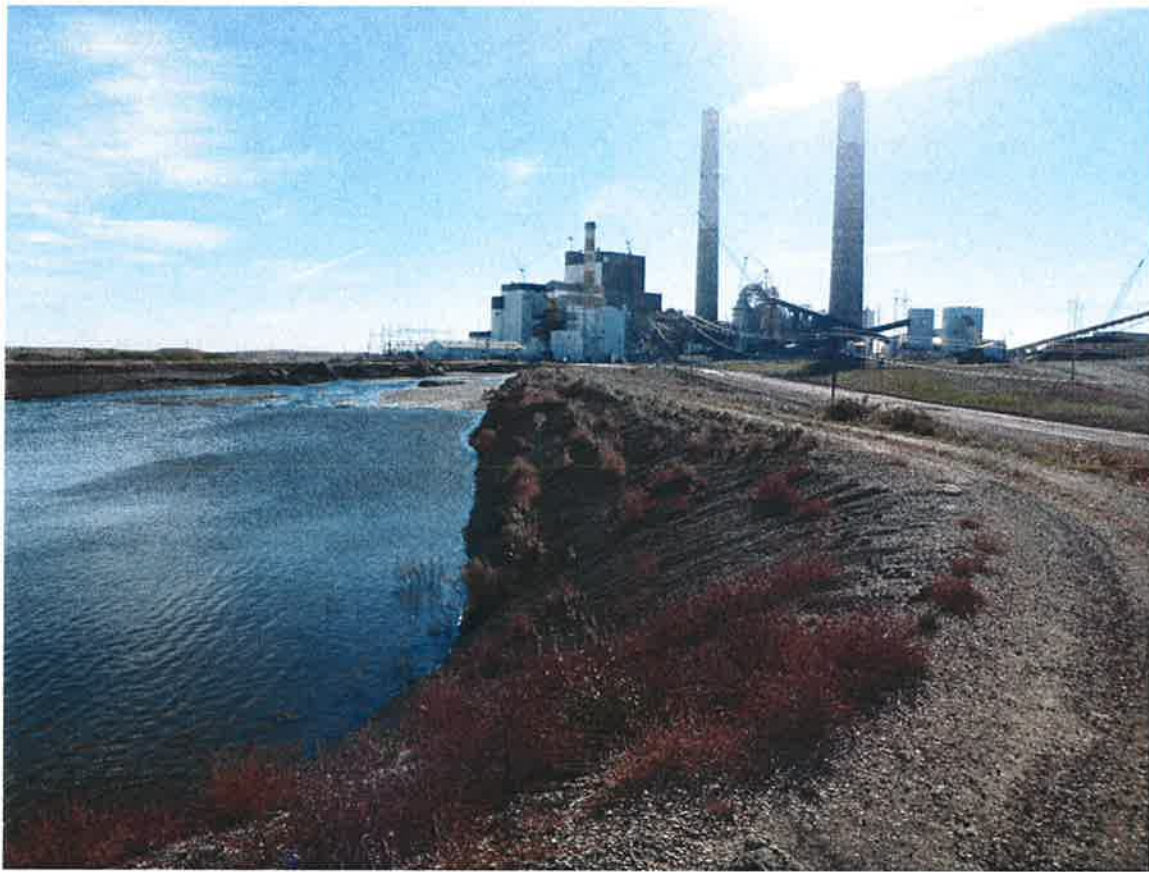
Photo 9: Alternate Bottom Ash Pond – South dike upstream slope, looking east

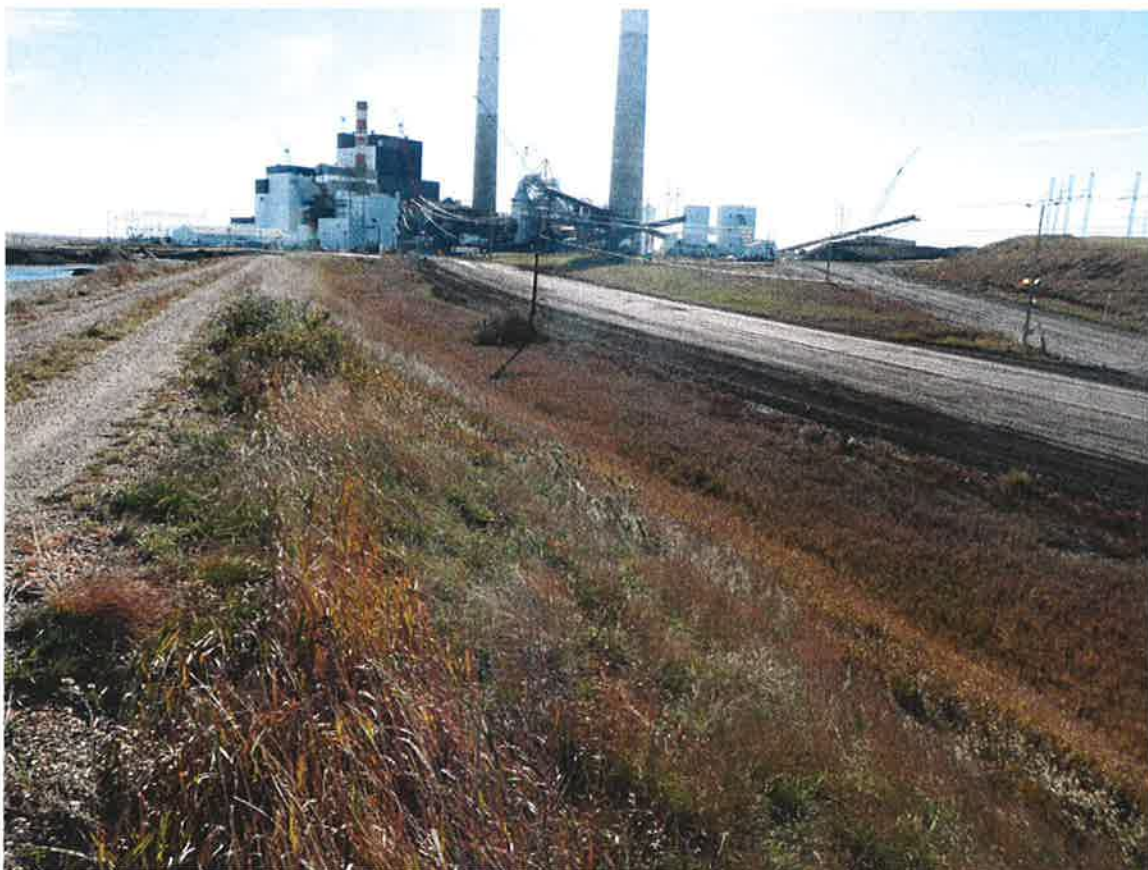
Photo 10: Alternate Bottom Ash Pond – South dike downstream slope, looking east

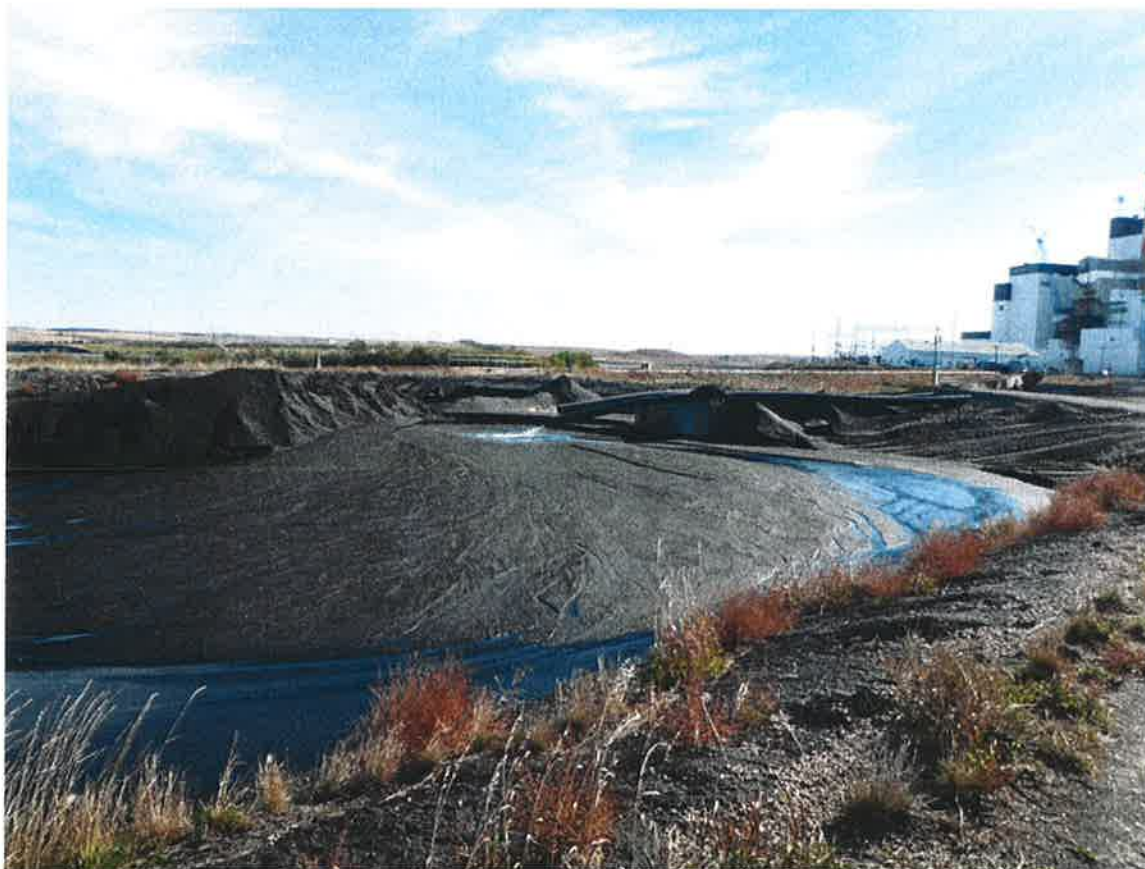
Photo 11: Alternate Bottom Ash Pond – East dike upstream slope and temporary inlet pipes, looking northeast

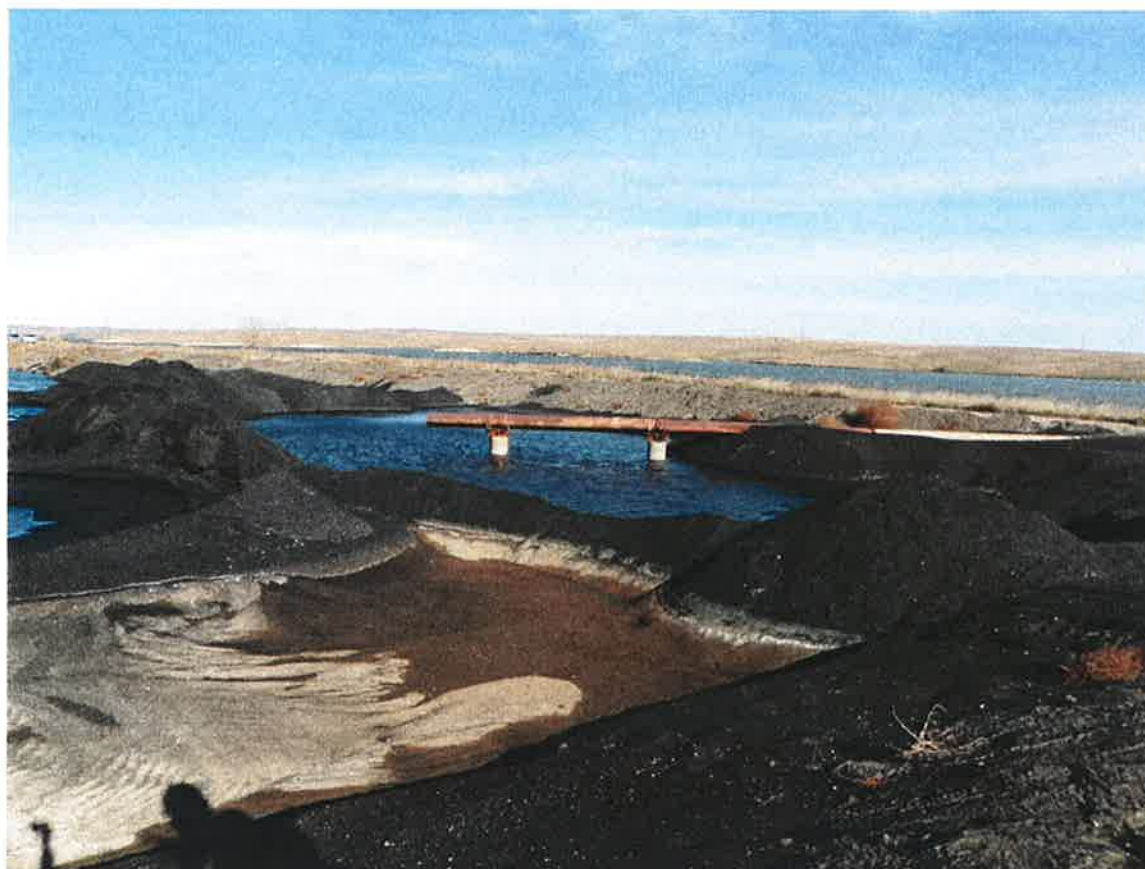
Photo 12: Alternate Bottom Ash Pond – North dike upstream slope and permanent inlet pipes, looking northwest

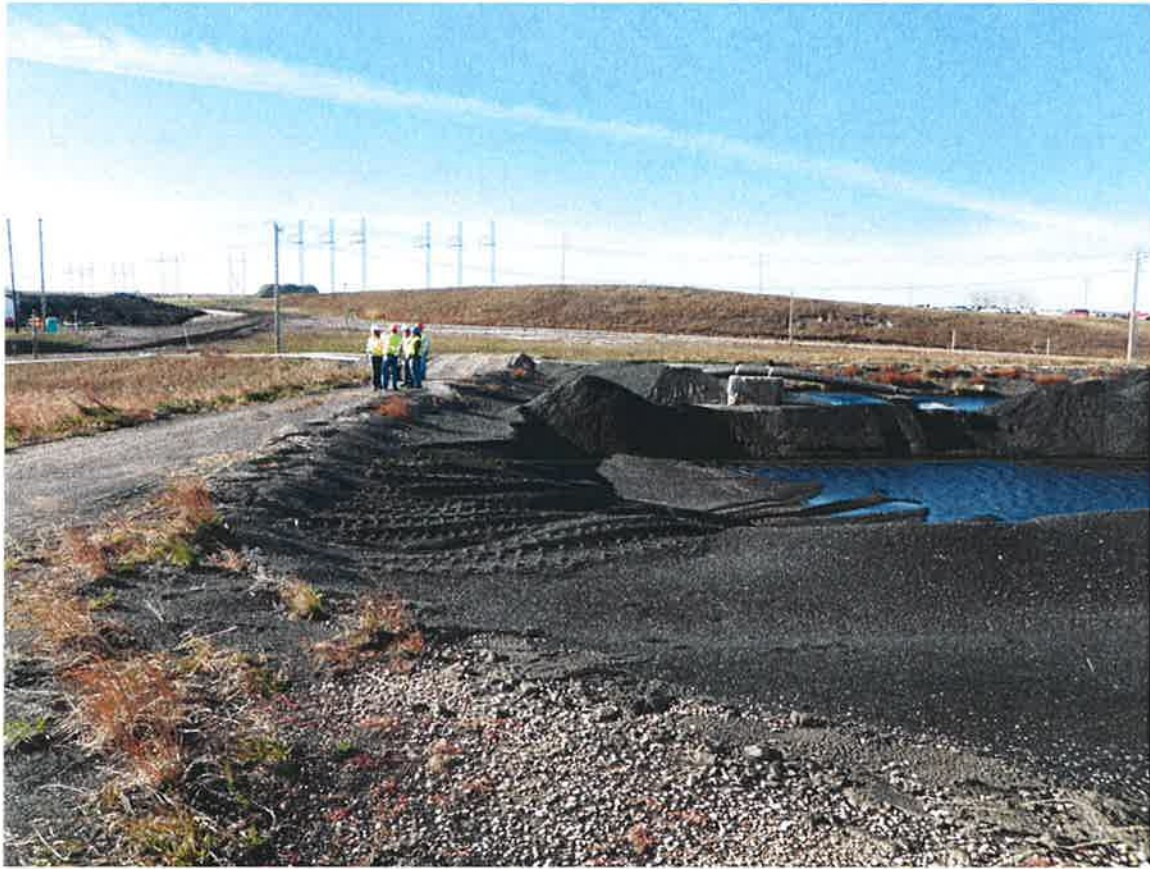
Photo 13: Alternate Bottom Ash Pond – East dike upstream slope, looking south

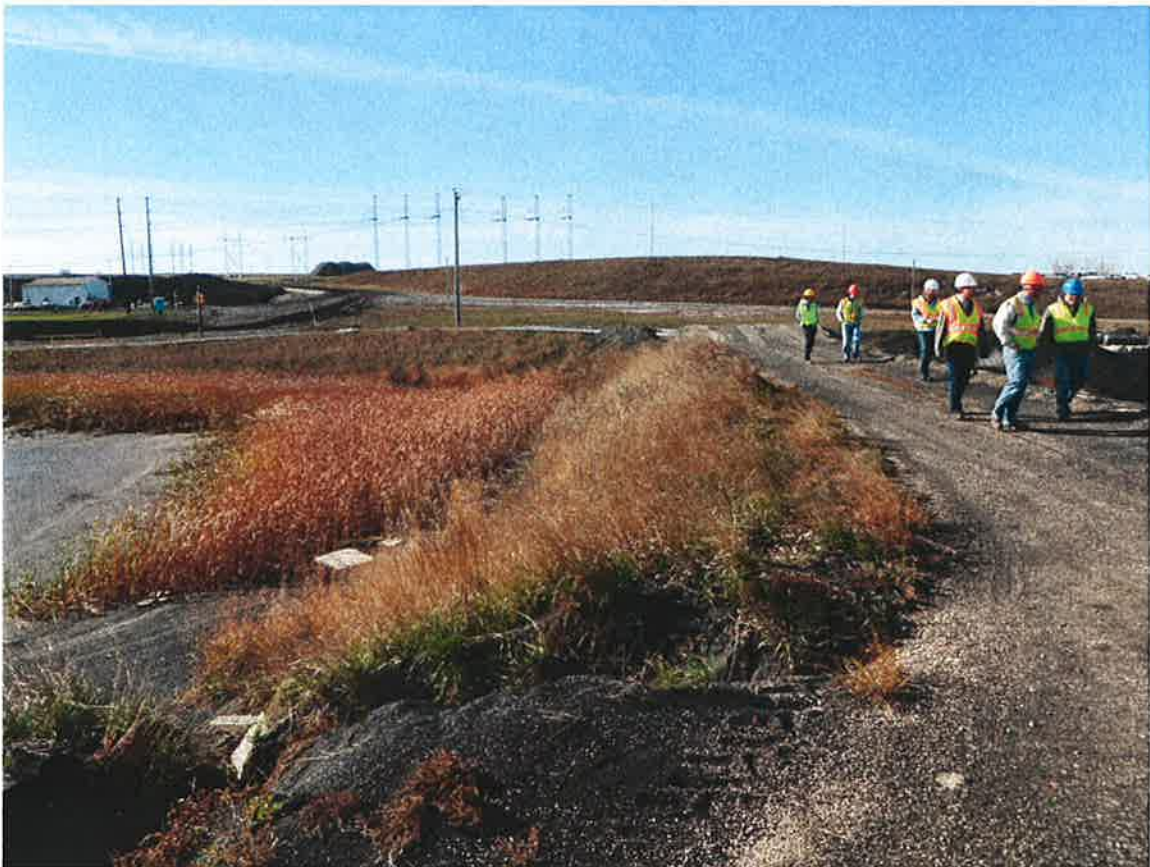
Photo 14: Alternate Bottom Ash Pond – East dike downstream slope, looking south

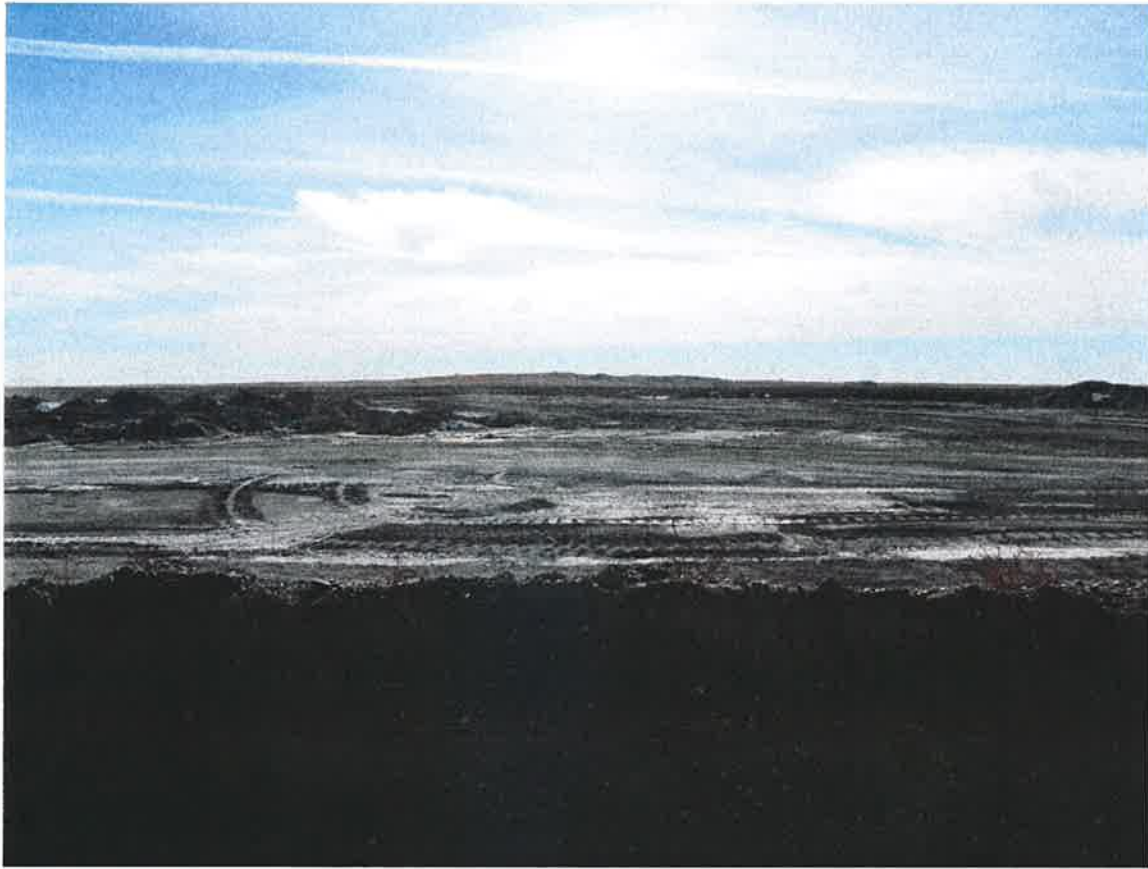
Photo 15: Cell 1 – Looking south across Cell 1

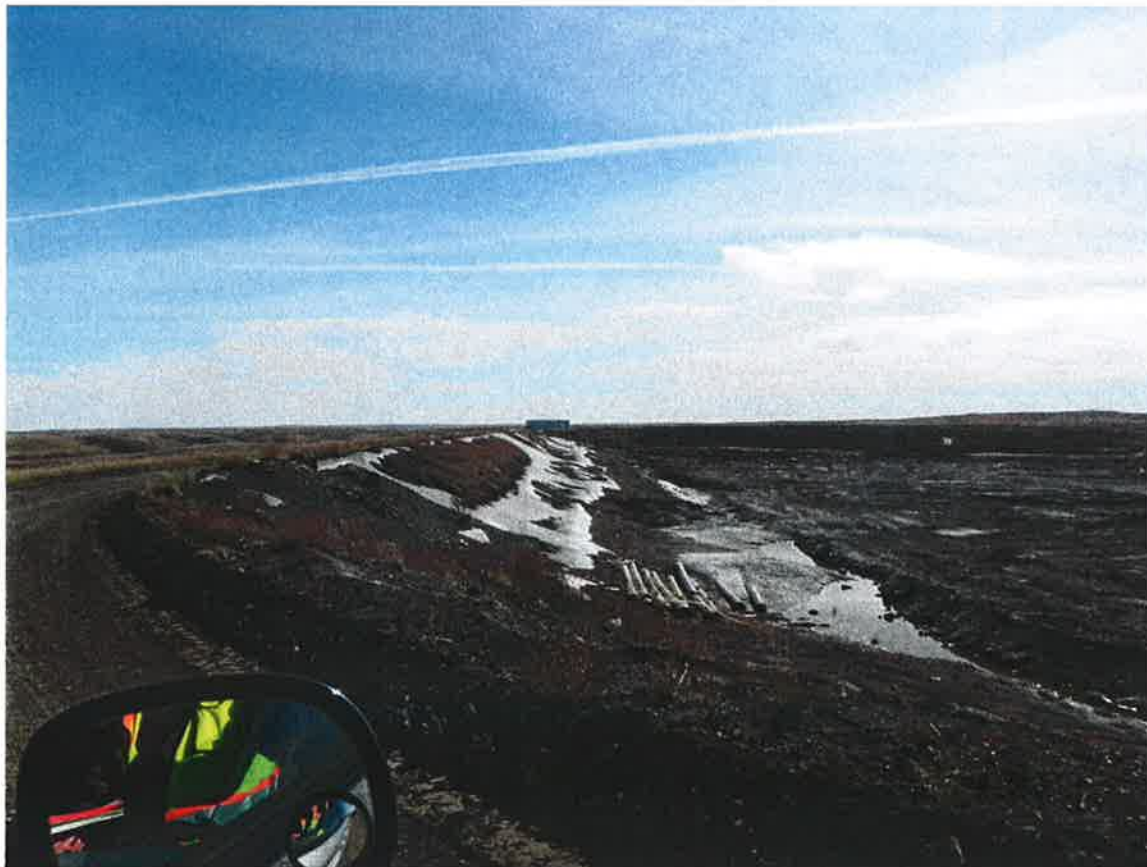
Photo 16: Cell 1 – East dike upstream slope, looking south

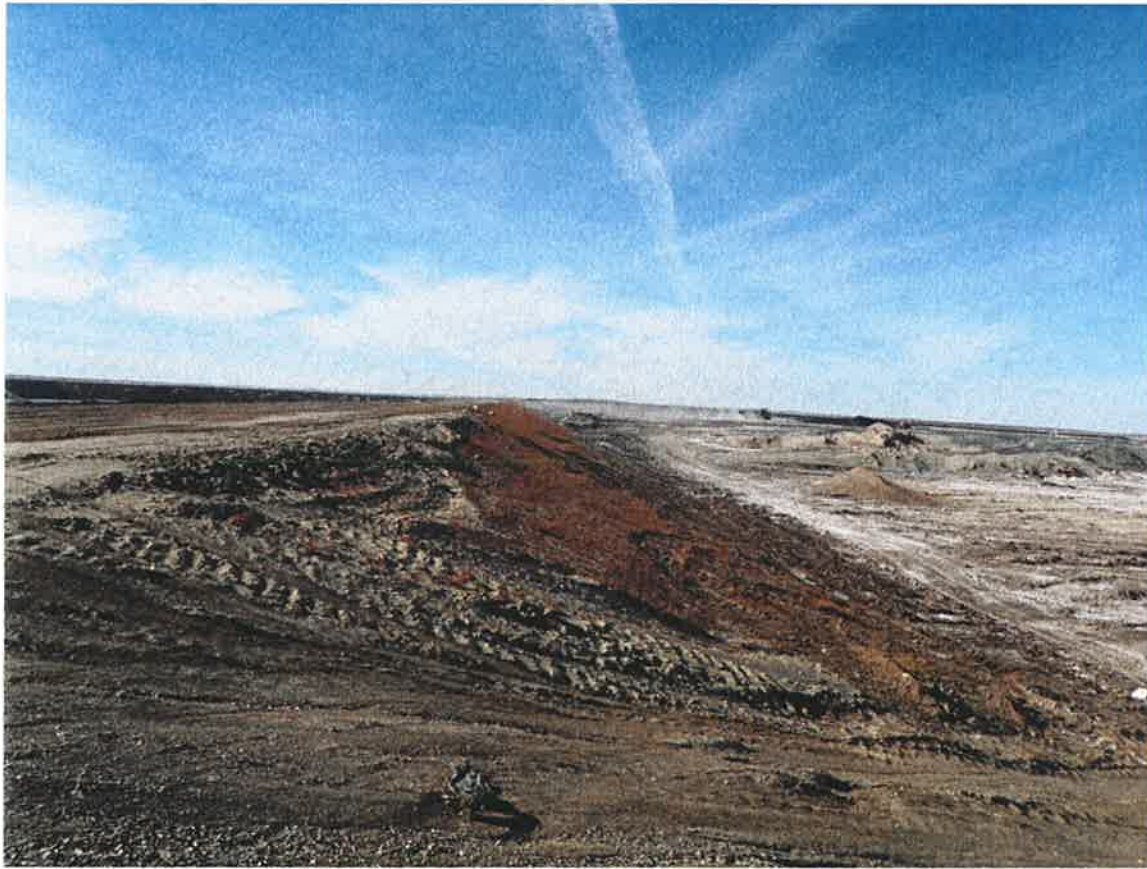
Photo 17: Cell 1 – South dike upstream slope, looking west, divider dike with Cell 2

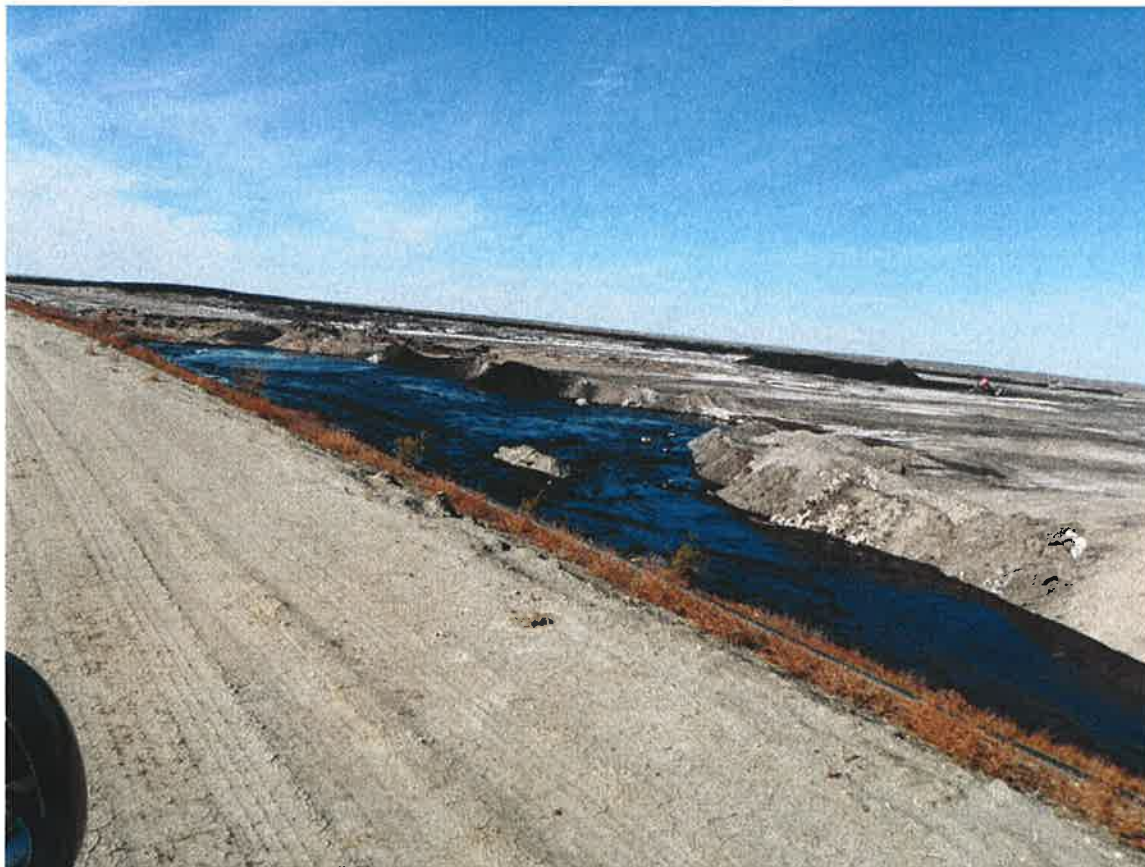
Photo 18: Cell 1 – Looking northwest across Cell 1

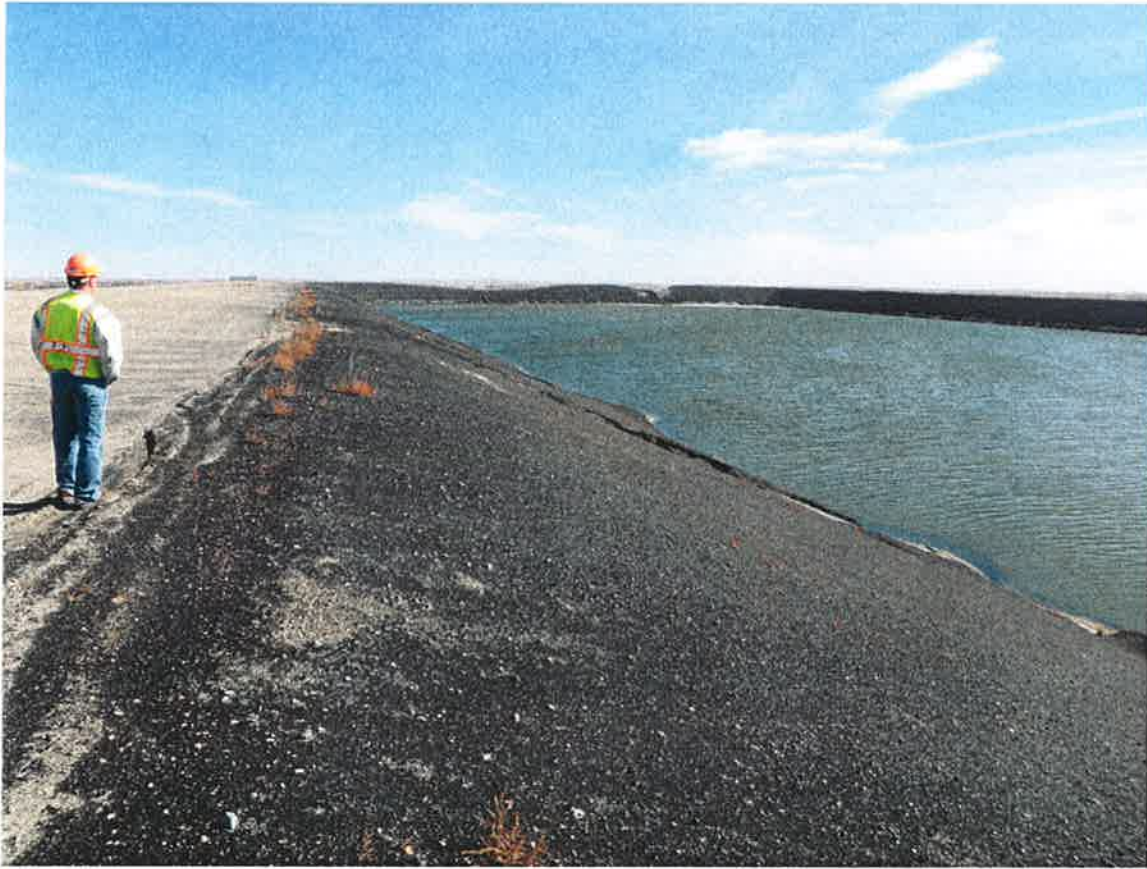
Photo 19: Cell 2 – North dike upstream slope, looking east, divider dike with Cell 1

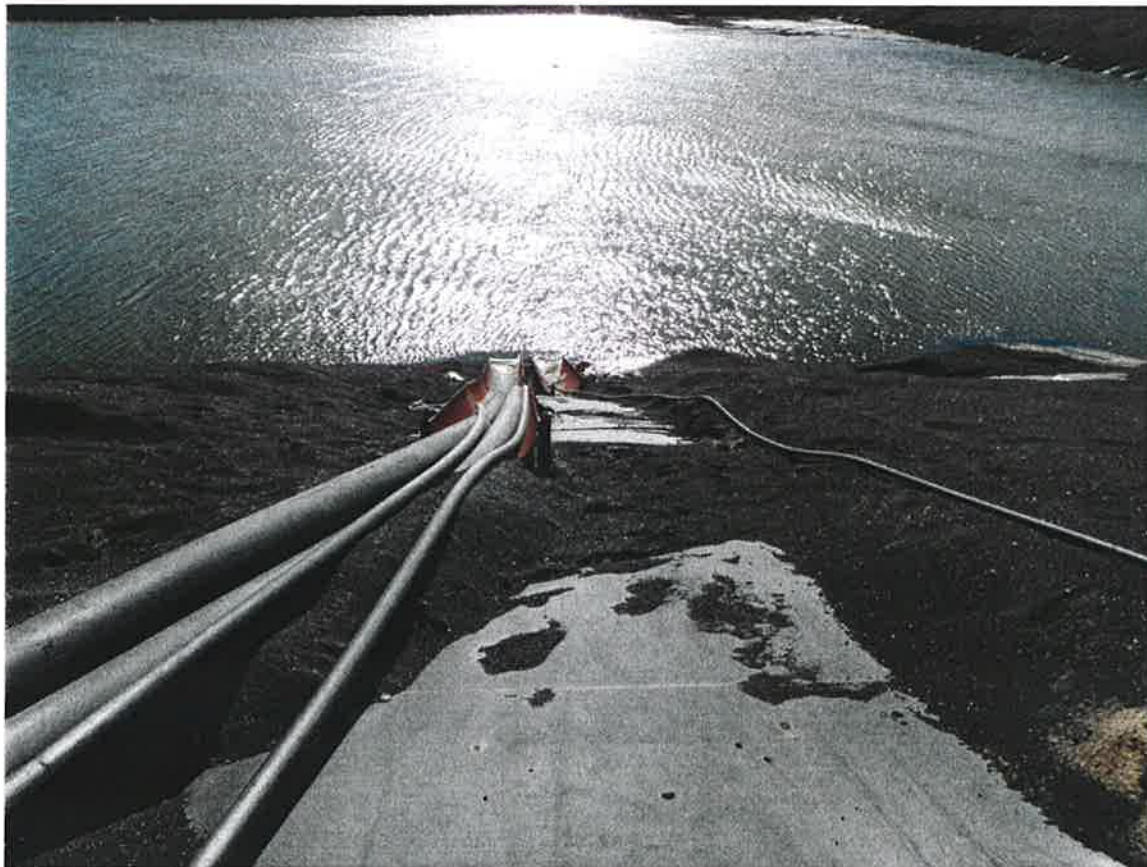
Photo 20: Cell 2 – North dike upstream slope, looking south, inlet pipes from Unit 1 and leachate collection from Butterfly Pond and Cell 1

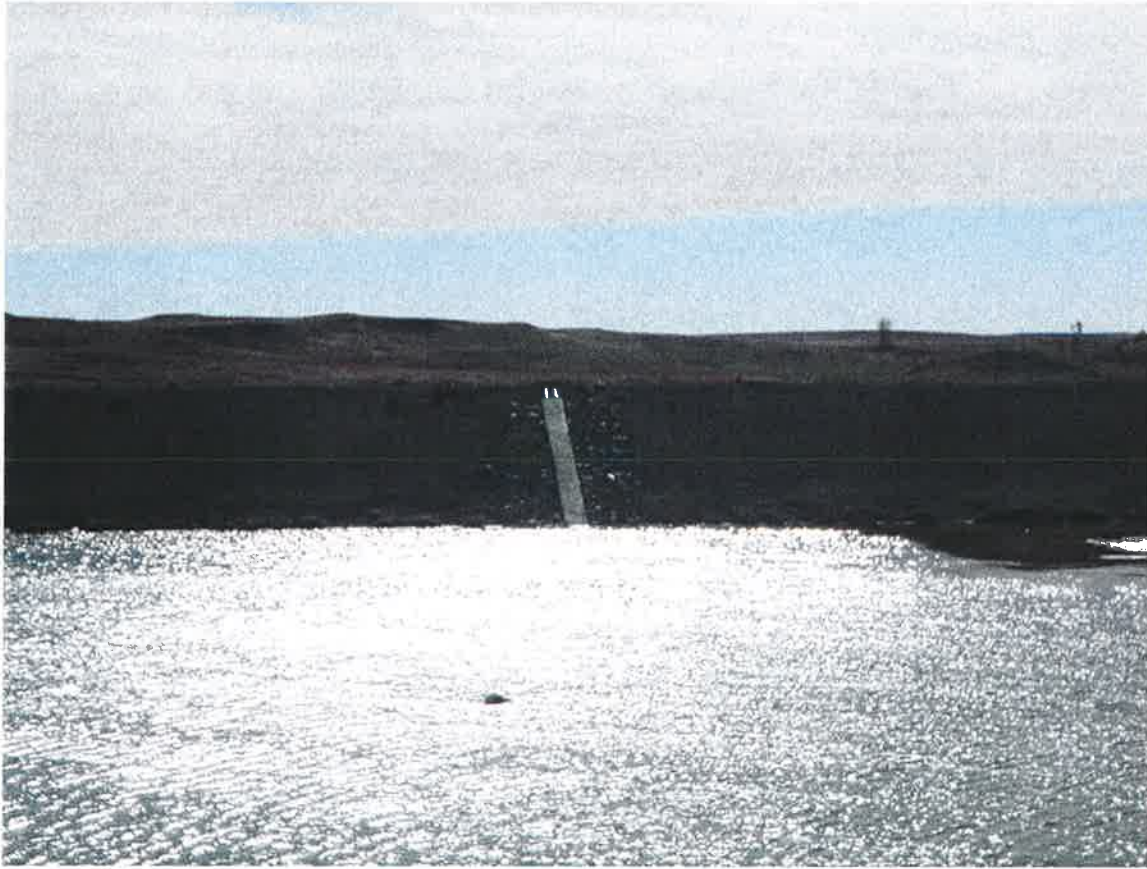
Photo 21: Cell 2 – South dike upstream slope, looking south, underdrain/leachate pipes for Cell 2

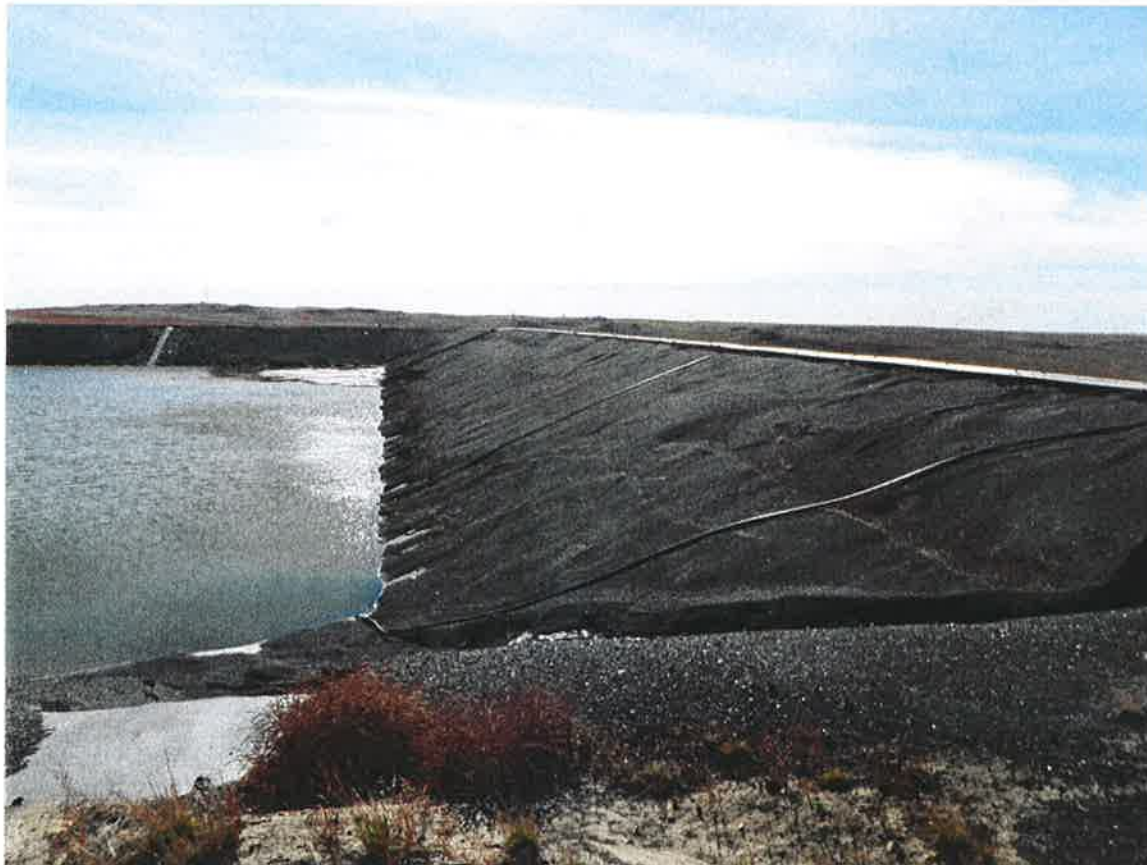
Photo 22: Cell 2 – West dike upstream slope, looking south, inlet pipes from Unit 2

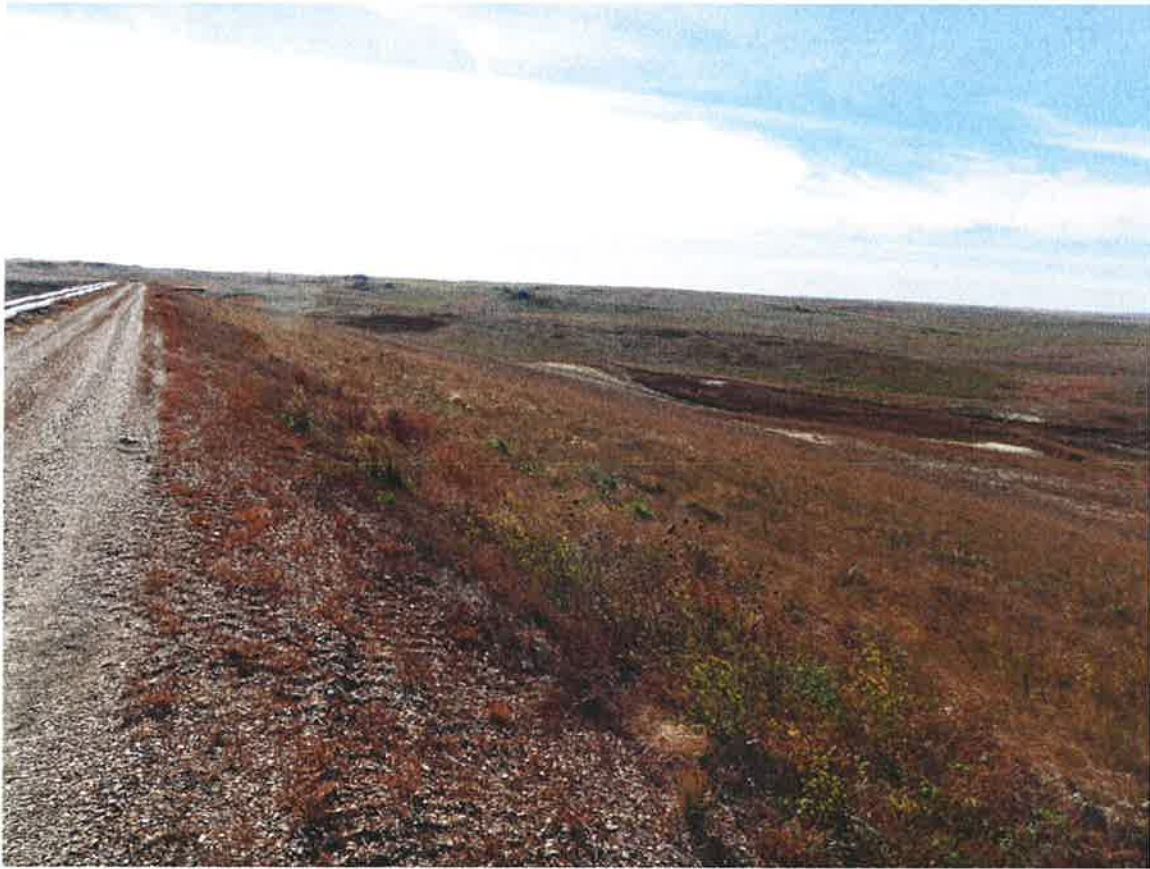
Photo 23: Cell 2 – West dike downstream slope, looking south
