DRAFT
Specific Site Assessment for
Coal Combustion Waste
Impoundments at Minnkota
Power Cooperative
Milton R. Young Station

Center, North Dakota

December 2010
Project 092884

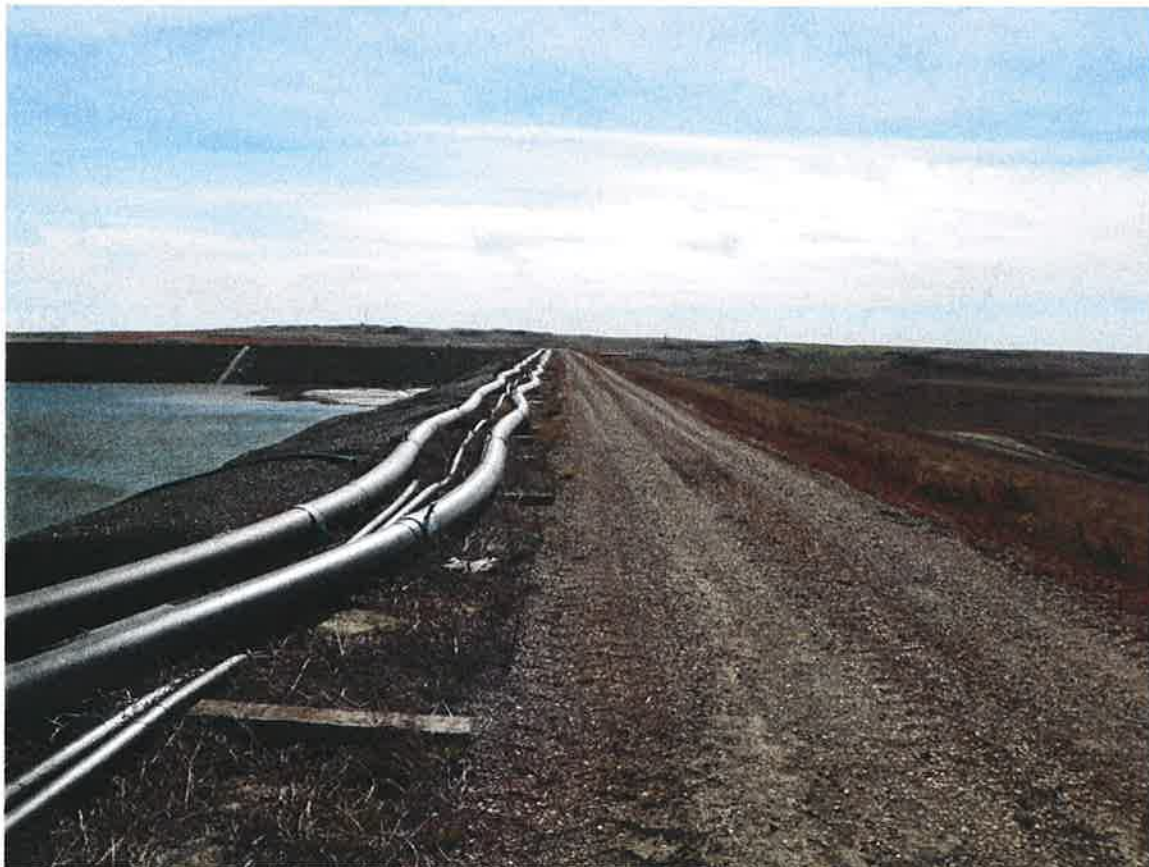
Photo 24: Cell 2 – West dike crest, looking south, inlet pipes from Unit 2

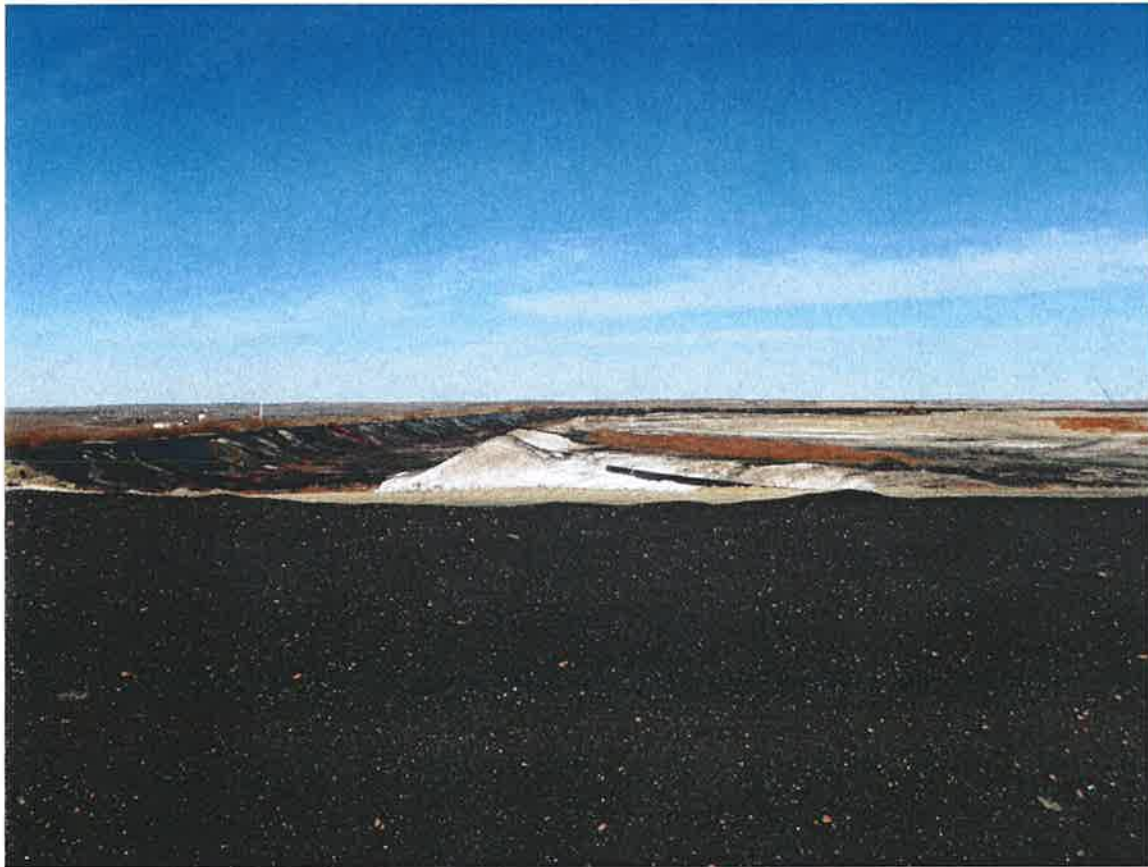
Photo 25: Cell 1 – West dike upstream slope, looking north

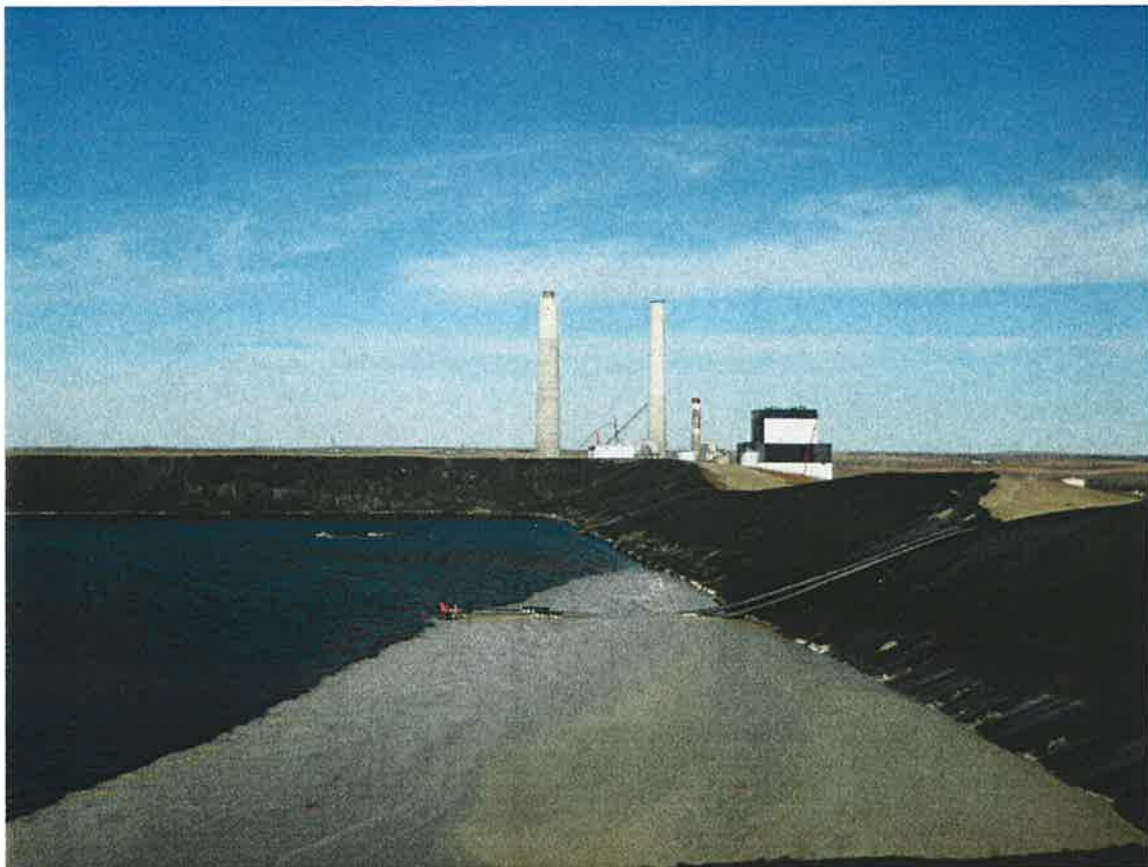
Photo 26: Cell 2 – East dike upstream slope, looking north, note siphon outlet pipes

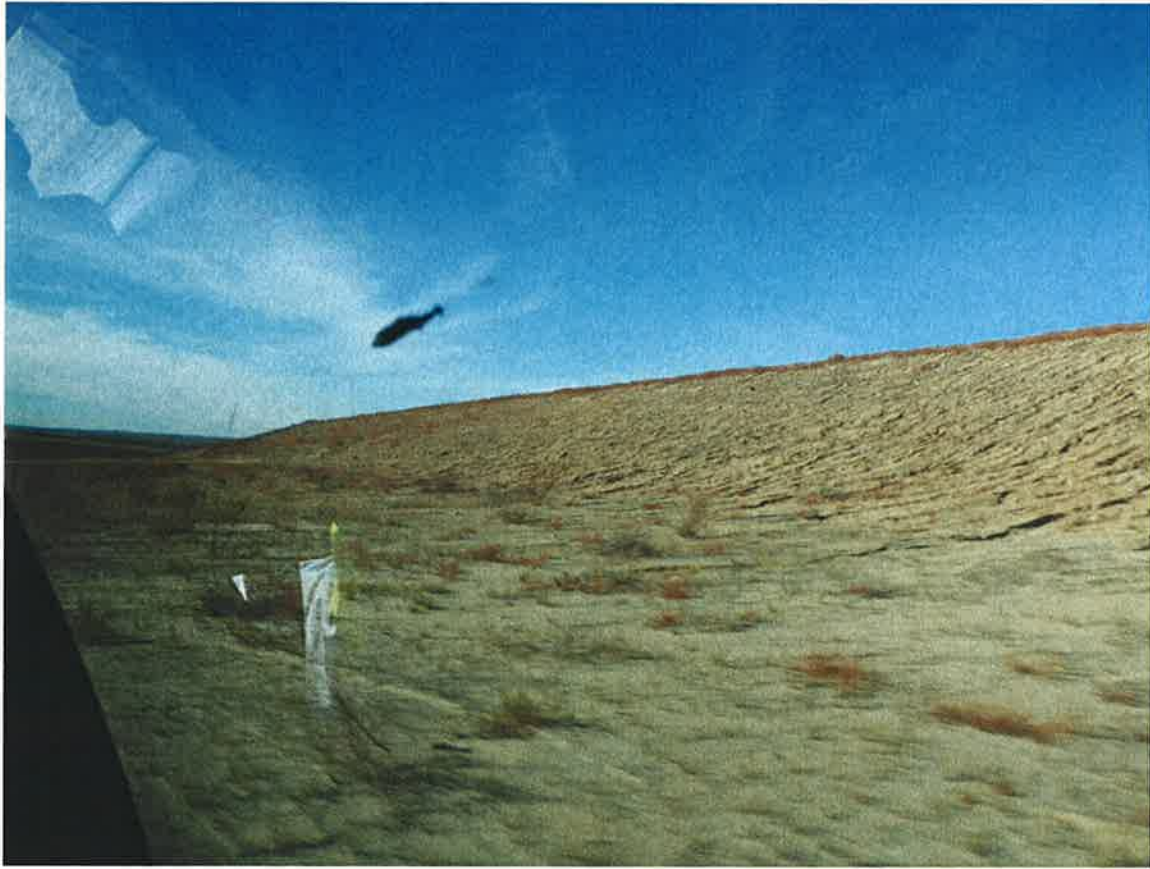
Photo 27: Cell 2 – South dike downstream slope, looking northwest

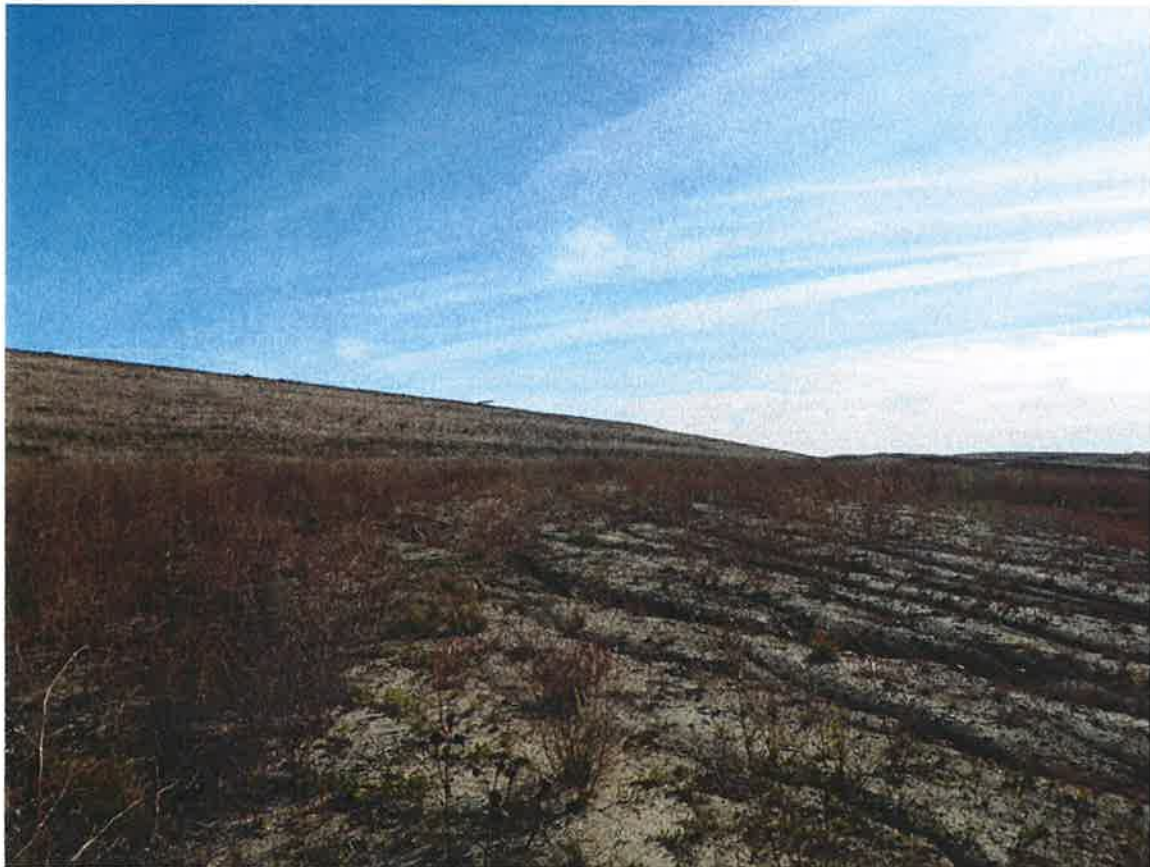
Photo 28: Cell 2 – West dike downstream slope, looking south

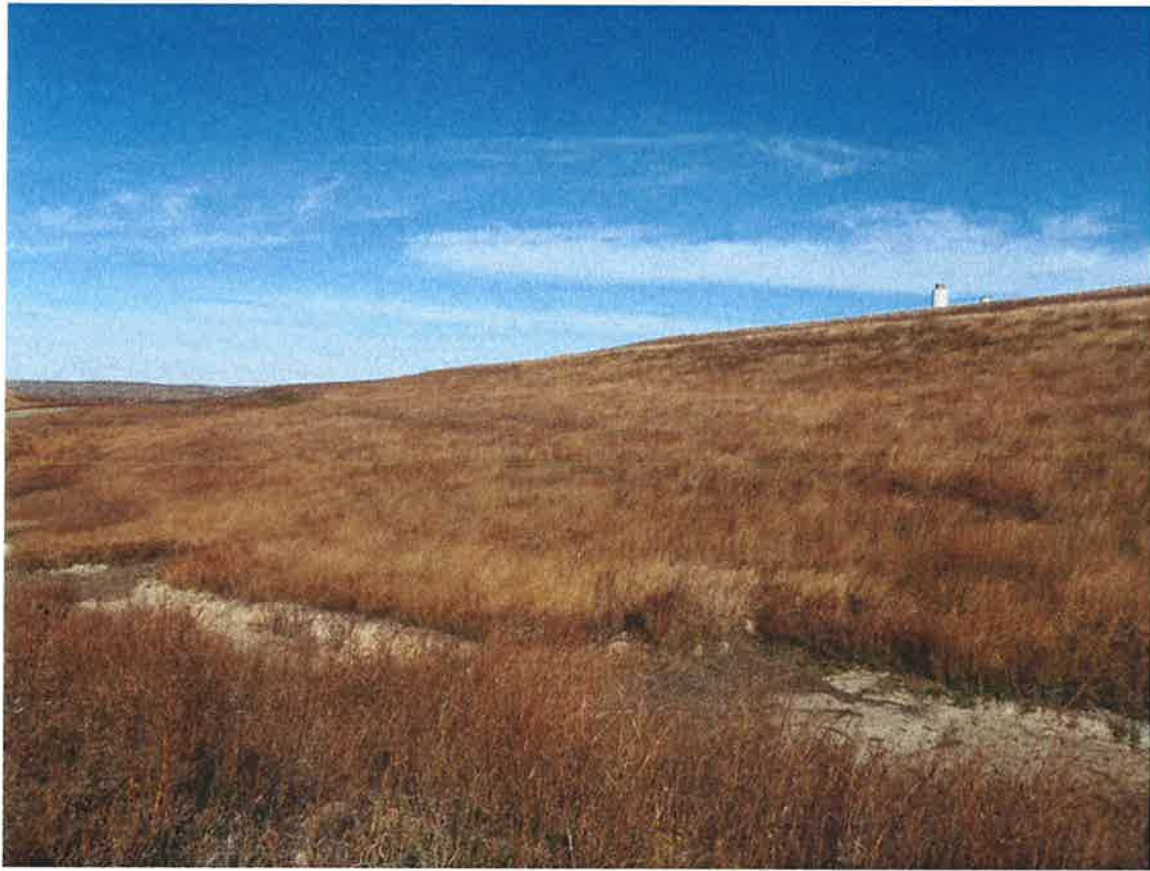
Photo 29: Cell 1 – West dike downstream slope, looking north

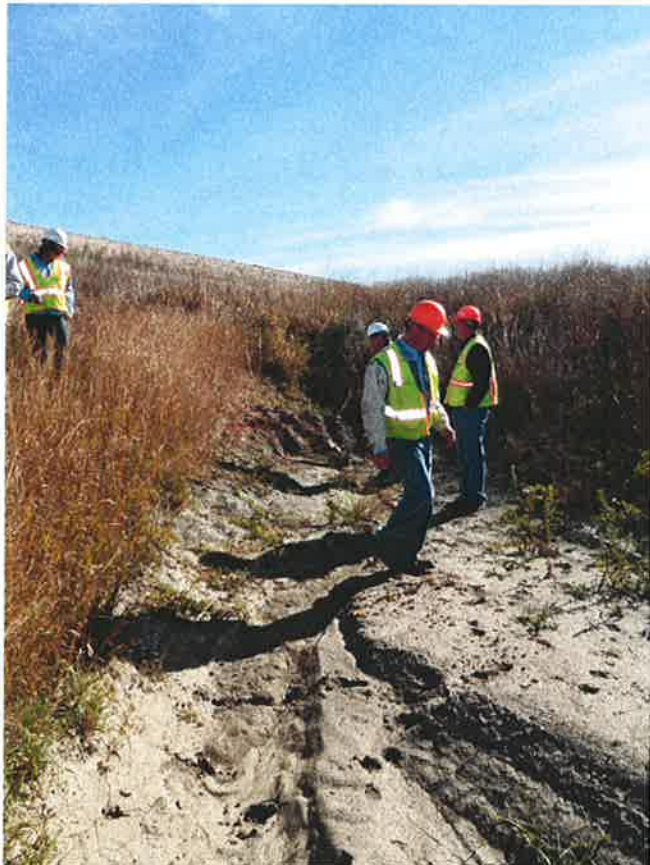
channel was observed near the west embankment downstream toe of Cell 1. The channel appears to have eroded due to surface runoff (see Photo 30) and is not significant enough at this time to impact Cell 1.

No visual signs of instability, movement or seepage were observed. Adequate erosion protection was observed on the embankment slopes of the ash ponds. An erosion channel was observed near the west embankment downstream toe of Cell 1 and minor erosion was observed on the upstream slope protection of the Alternate Bottom Ash Pond and Cell 2. The erosion channel near Cell 1 appears to have eroded due to surface runoff. Minnkota personnel should monitor the channel for continued erosion that could encroach on the west embankment downstream slope of Cell 1.

Photo 30: Cell 1 – Erosion channel near west dike downstream toe, looking south

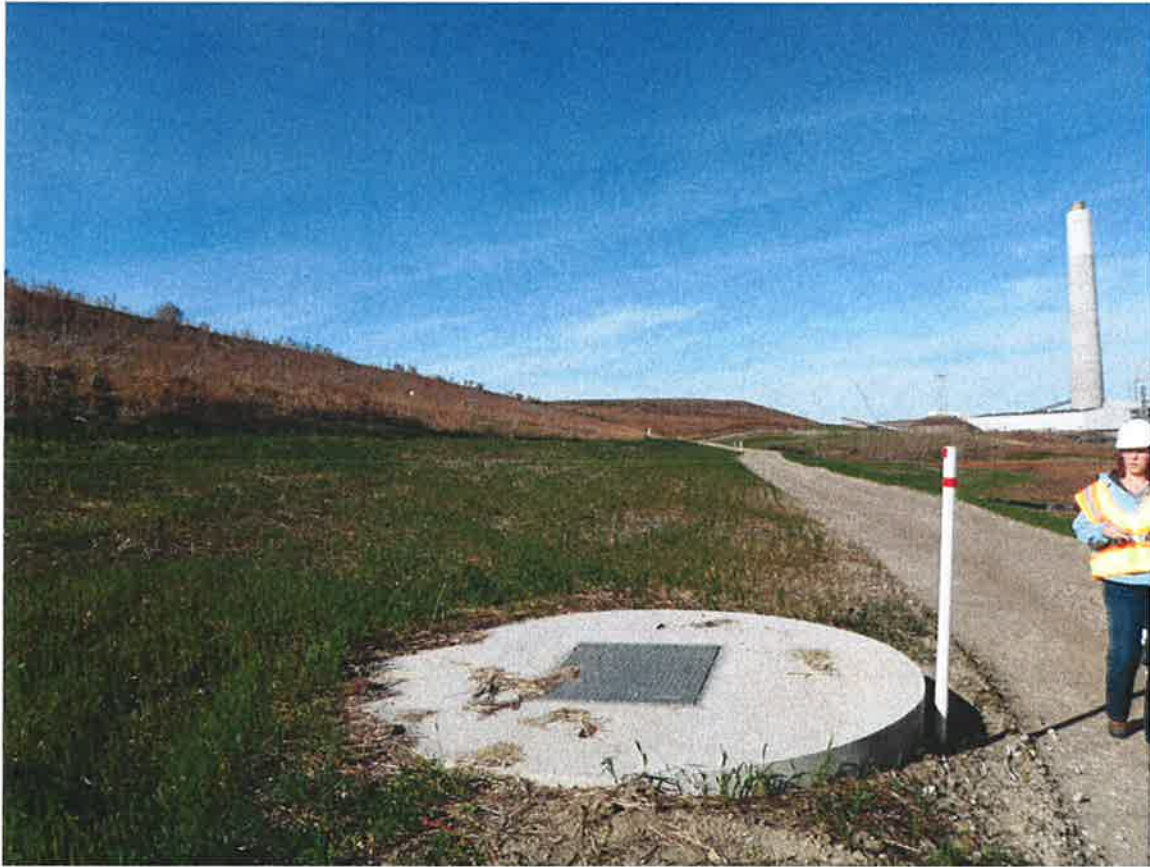
Photo 31: Cell 1 – East dike downstream slope and manhole for outlet pipes from Cell 2 returning to plant, looking north

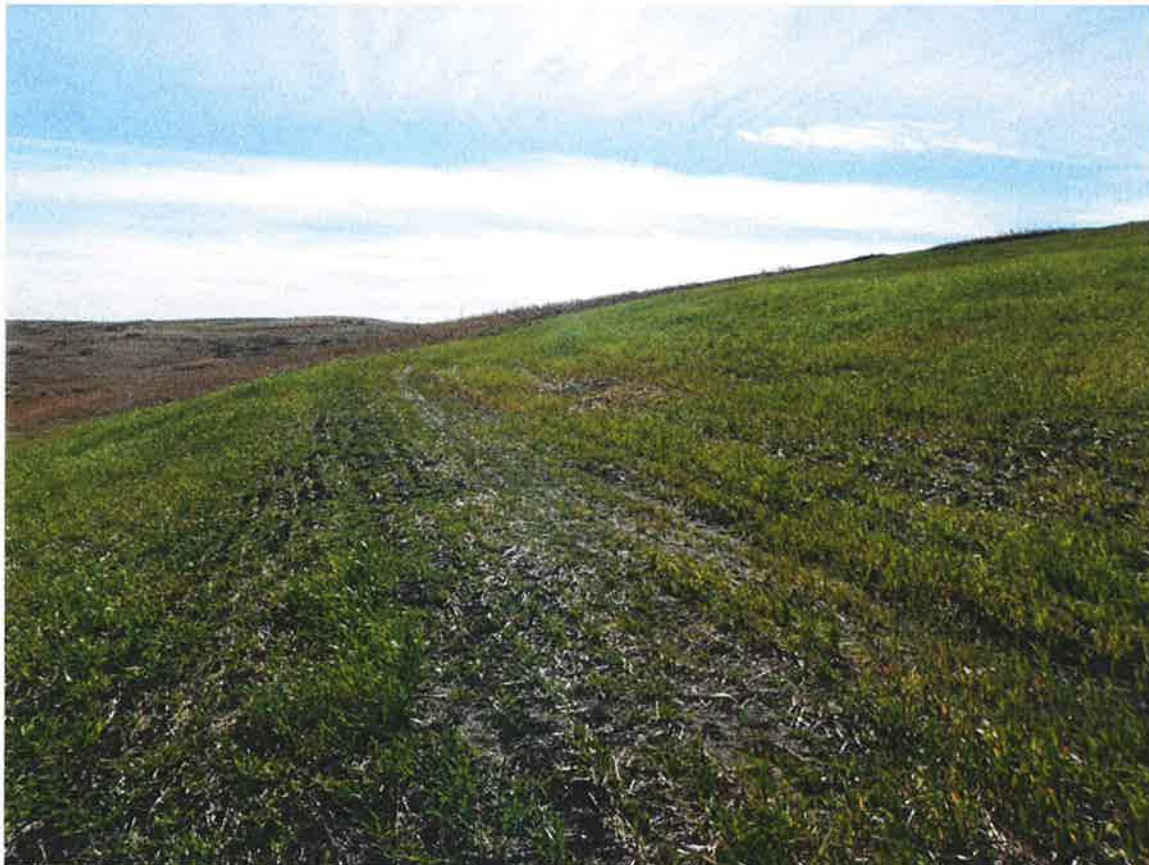
Photo 32: Cell 2 – East dike downstream slope, looking south
