SUBJECT: EPA Comments on "Assessment of Dam Safety of Coal Combustion Surface  
Impoundments: Luminant Generation Co., LLC – Monticello Steam Electric Station,  
Mount Pleasant, TX

DATE: April 7, 2014

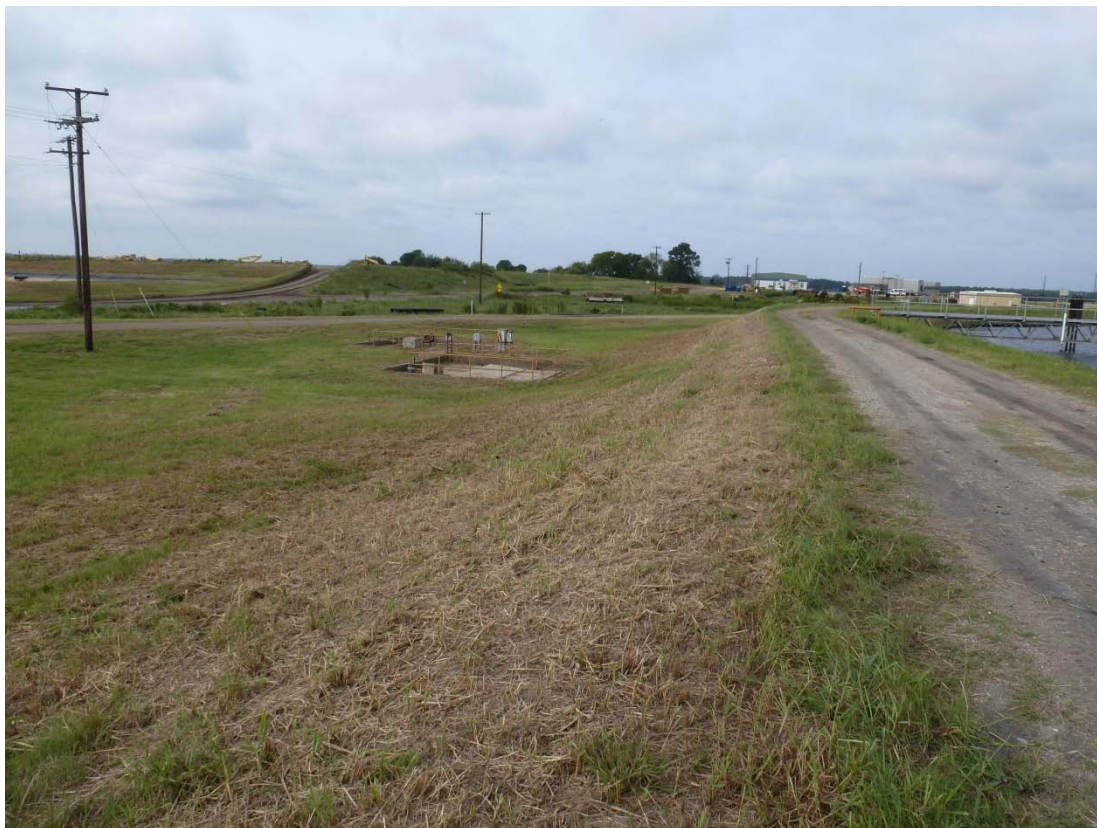
Southern  
embankment of  
the South Pond.

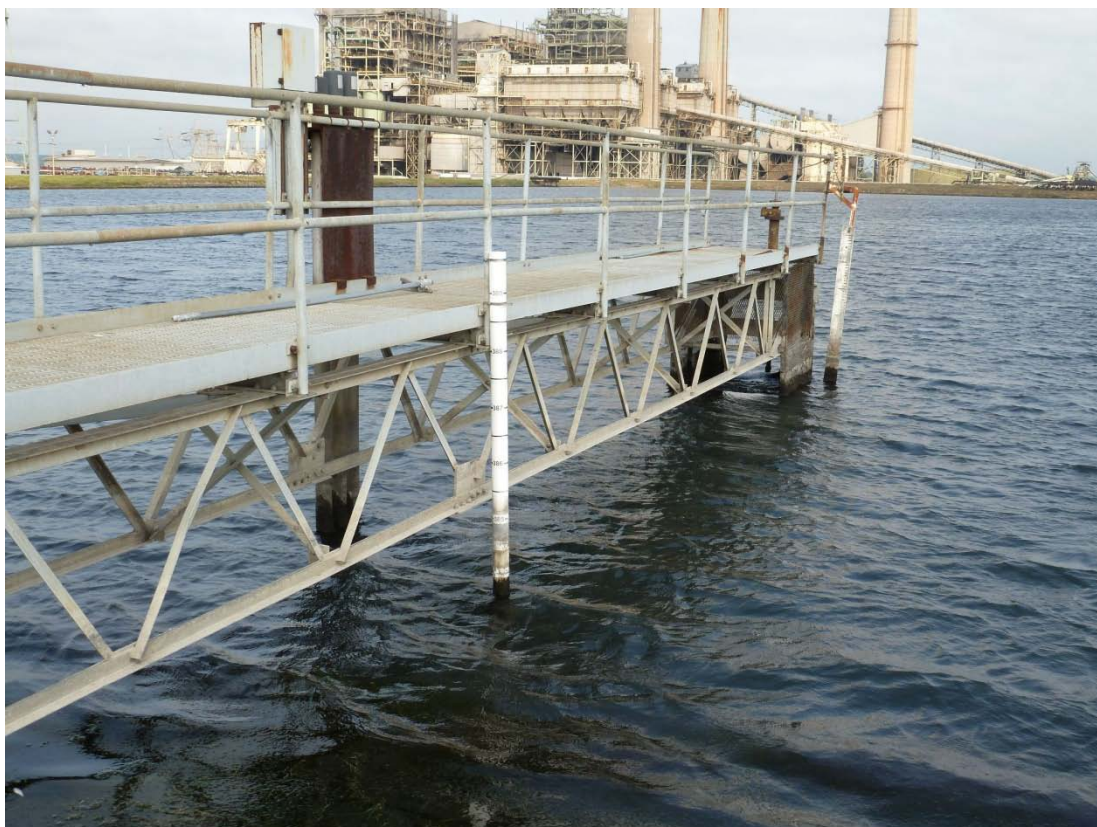
- A gate operator is located at the north end of the access platform. The gate is reportedly inoperable.
- Some rutting was observed on the roadway on the embankment crest. The rutting is minor and has been noted in previous inspection reports.

Access walkway  
to gate  
operator in the  
South Pond.  
Note staff  
gages.

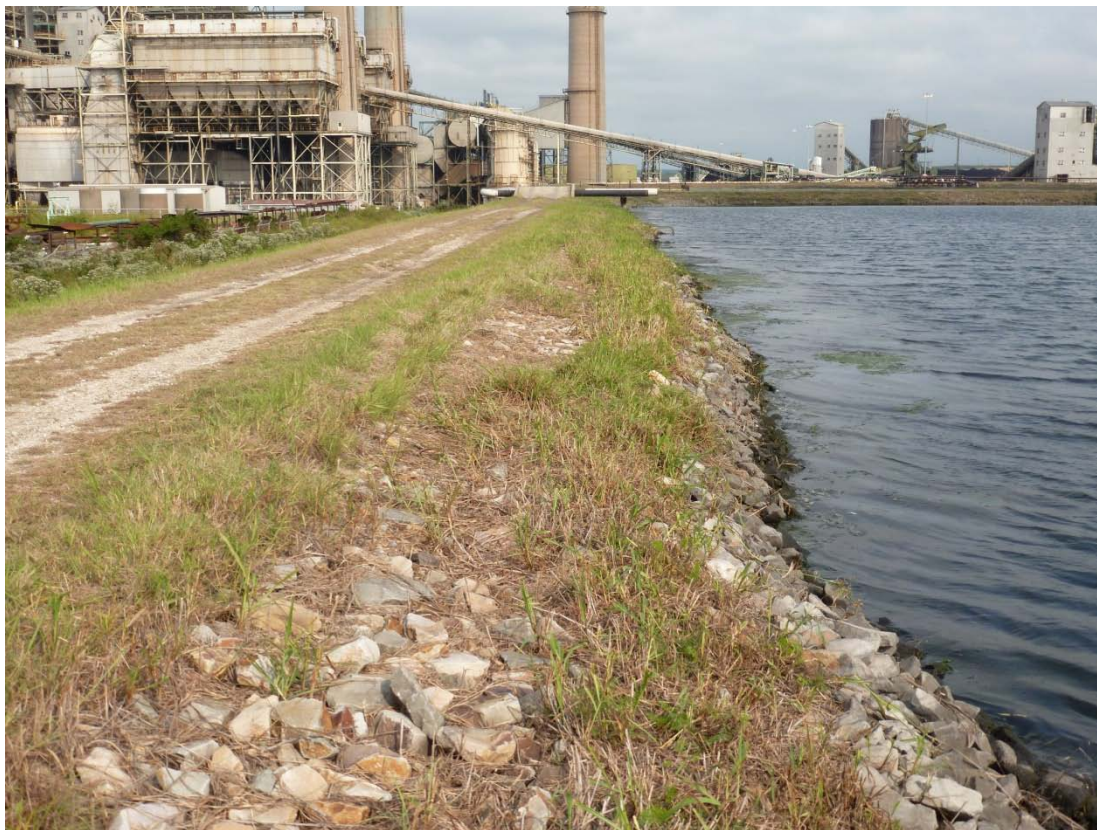
Inboard face of the eastern embankment of the South Pond. Note riprap facing.

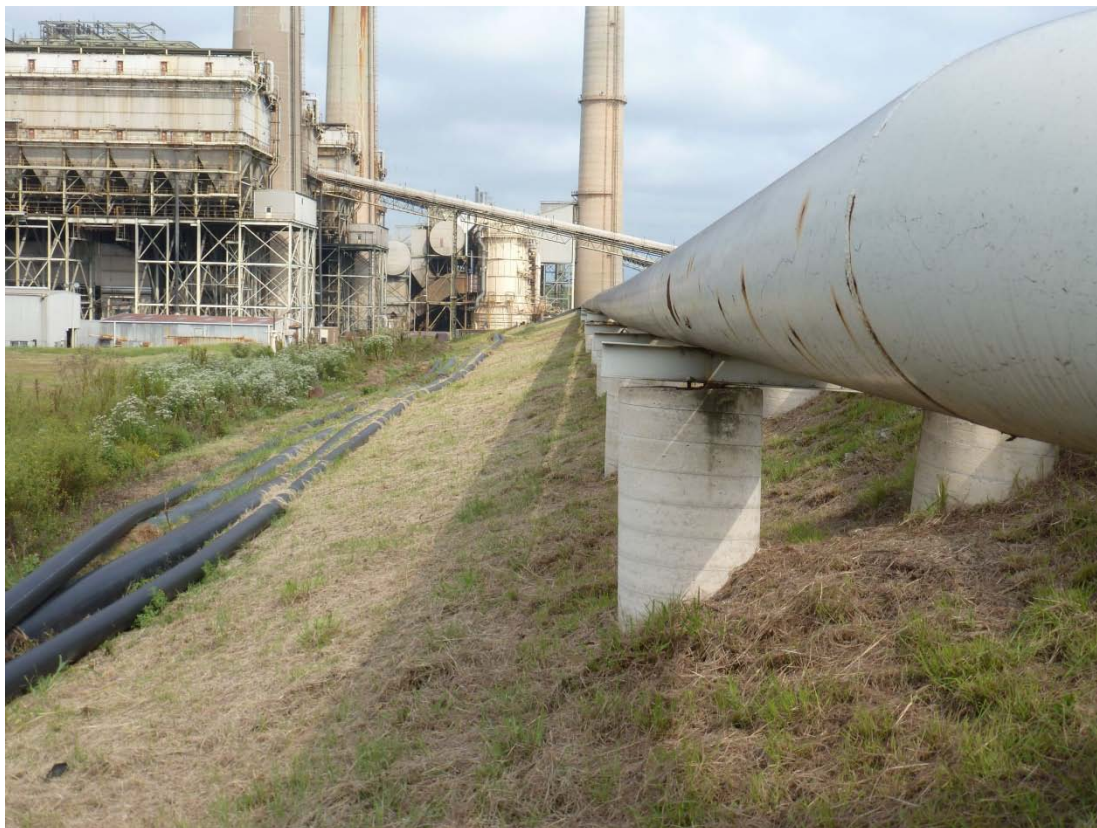
- Some erosion was observed beneath the pipes located on the west side of the western embankment. This erosion has been noted previously.
- Minor sloughing/sliding was observed near the toe of the western embankment.

Western embankment of South Pond. Minor rutting observed below pipes.

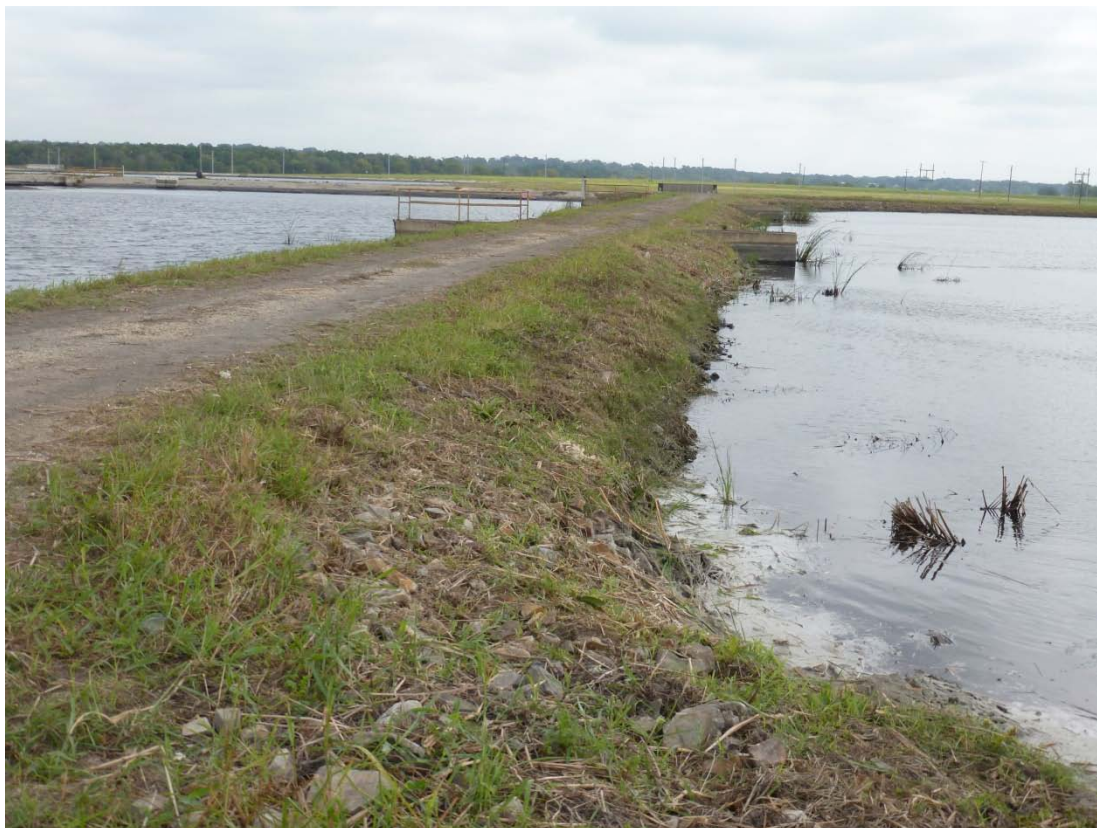
Dividing dike between the North and South Ponds. Note equalizing channel.

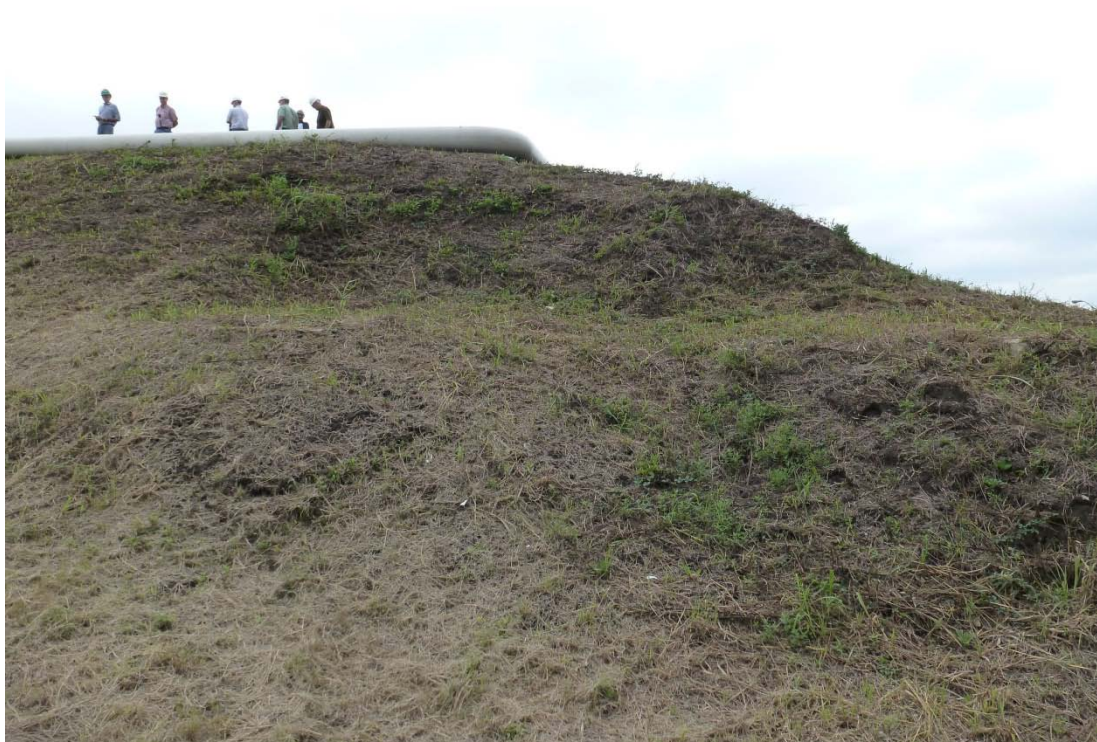
- The outboard slope of the northwest corner of the northern embankment appears to be steeper than the design slope of 2.5H:1V. Additionally, sliding, sloughing or possibly excavation of the embankment material was observed. Luminant representatives noted that additional fill may have been placed against the original embankment along the north side of the North and Settling Ponds and the material movement could be within the additional fill, not the embankment. The slide/slough was noted in the previous inspection reports.

Northwest  
corner of the  
North Pond.  
Some erosion  
and slides.  
Owner noted  
that the  
material is  
additional fill  
placed against  
the original  
embankment.  
Slides have also  
been noted in  
previous  
inspection  
reports

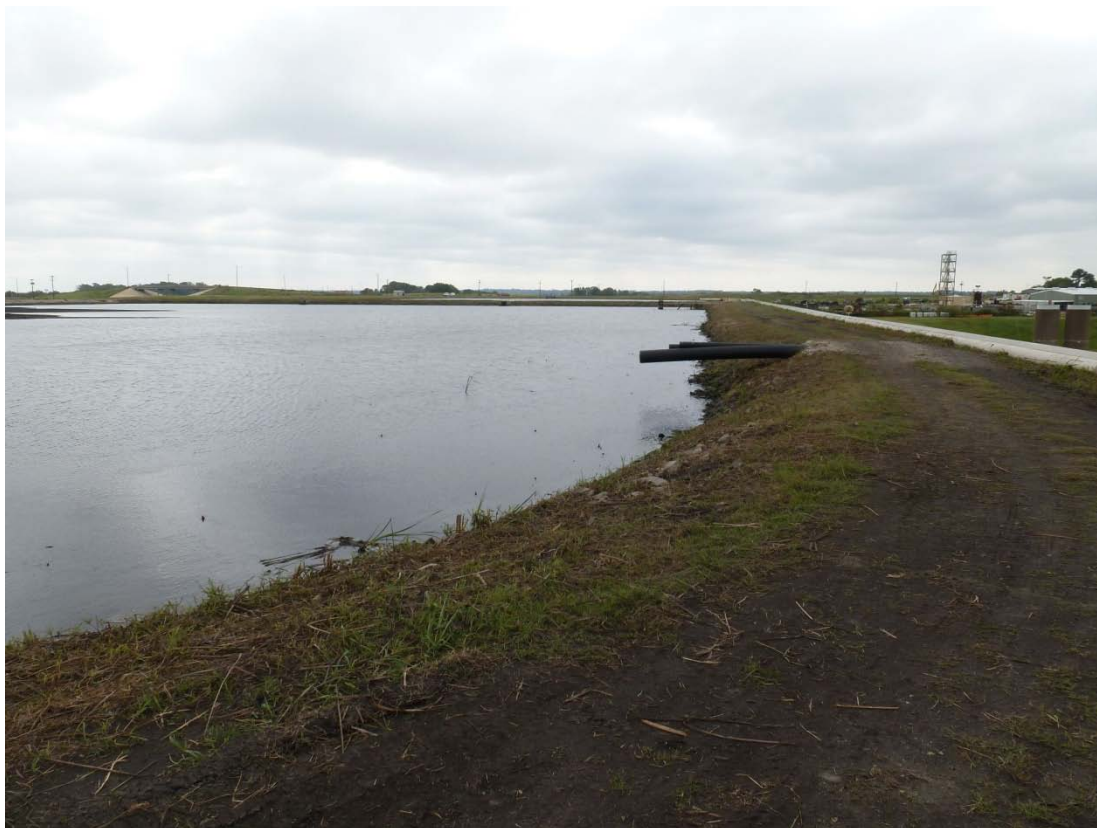
Interior of  
North Pond.  
Note discharge  
piping,  
currently not in  
use.

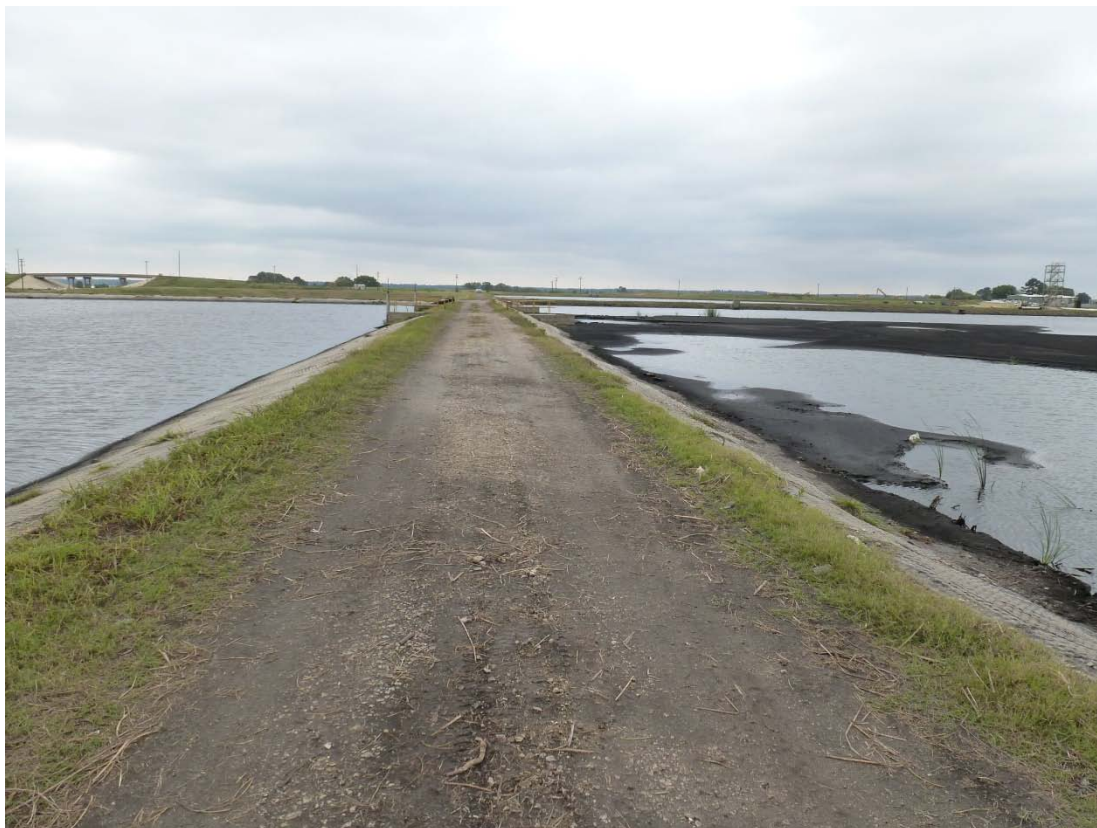
Dividing dike between the North Pond and the Settling Pond. Note the "concrete revetment" (grout-filled bags) on the faces of the dike.

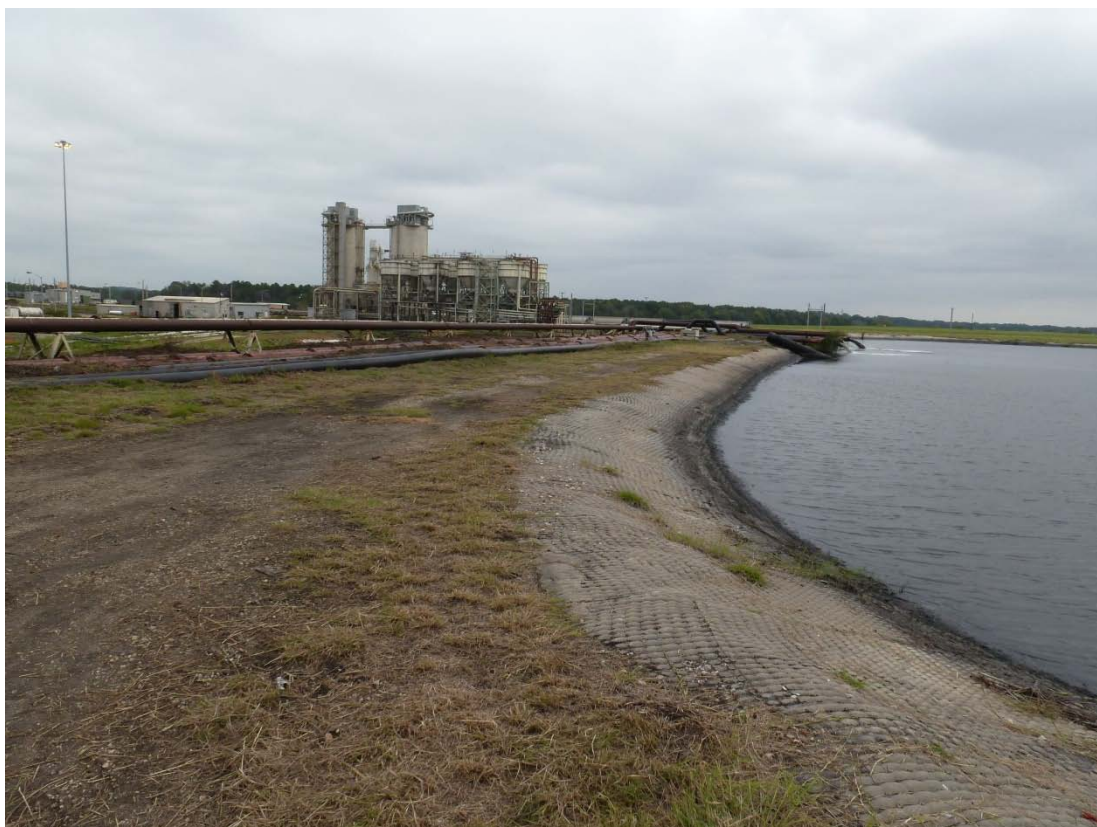
Northwest corner of the Settling Pond. Note concrete revetment. Inflow piping in background.

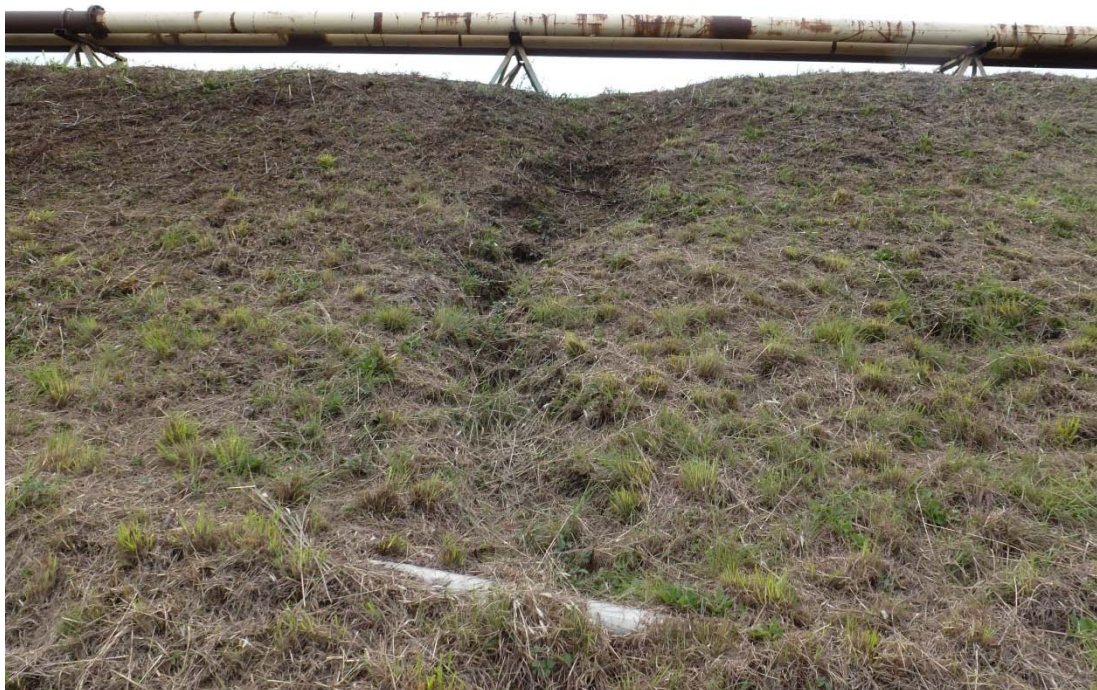
- Sluice water enters the pond through inflow pipes located above the water line on the northern embankment.
- Erosion gullies were observed on the northern embankment.
- The concrete revetment on the inside slopes of the pond has cracked in the southeast corner.
- Some water is retained in the Runoff Collection Pond located to the south of the Settling Pond at the toe of the southern embankment.
- Evidence of prior releases, failures or patchwork of the impoundment was not observed.

Small erosion gully at the crest of the Settling Pond.

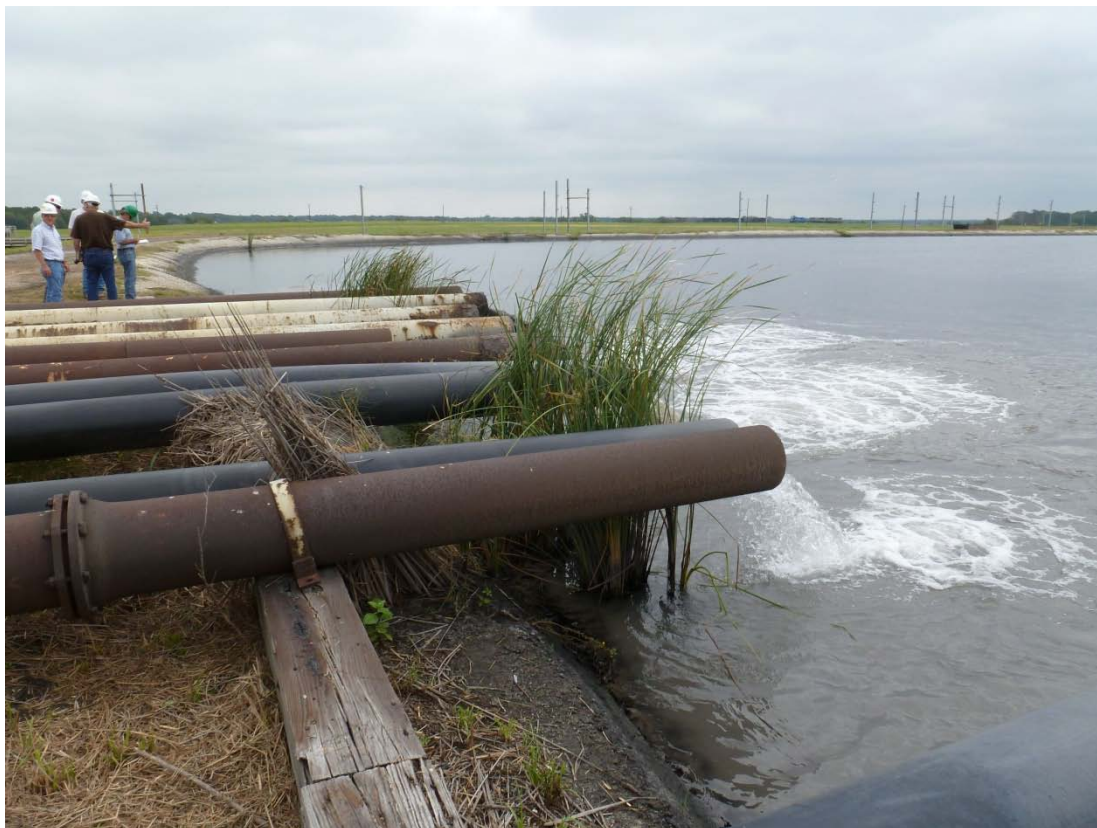
Inflow of  
wastewater into  
the Settling  
Pond.

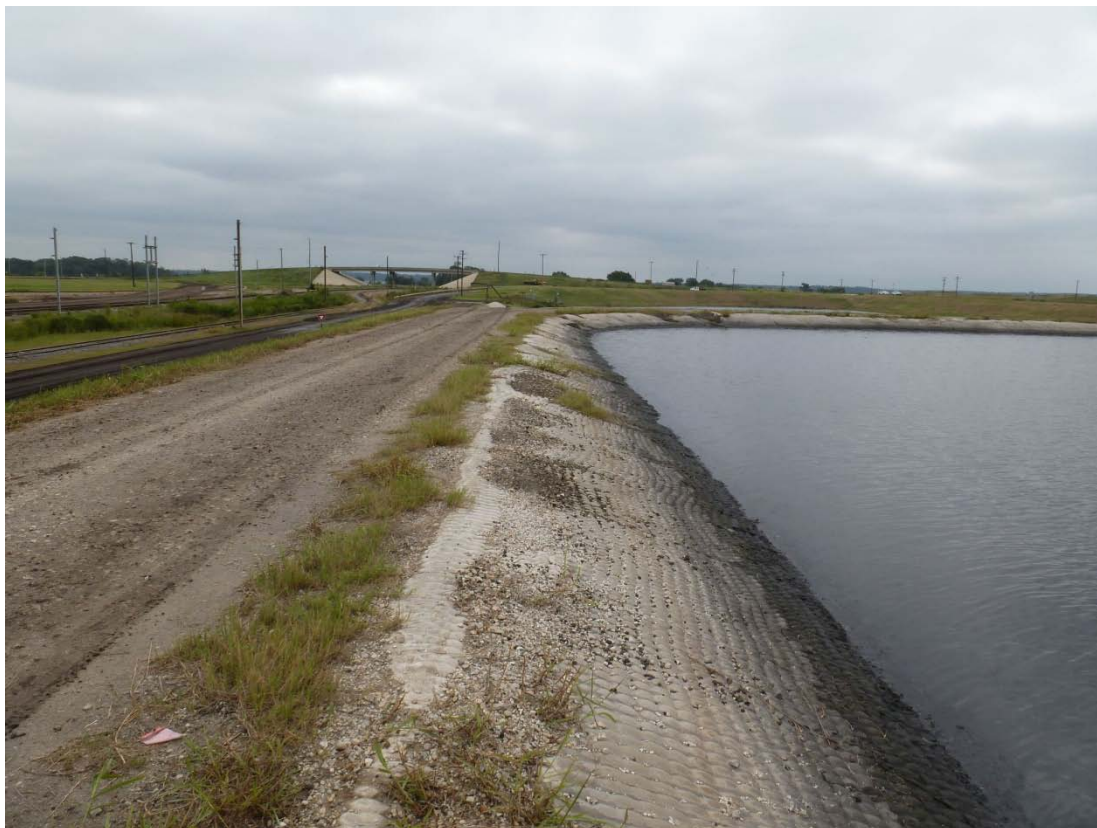
Photo Number:  
17

Description:  
Inboard face of  
the eastern  
embankment of  
the Settling  
Pond.

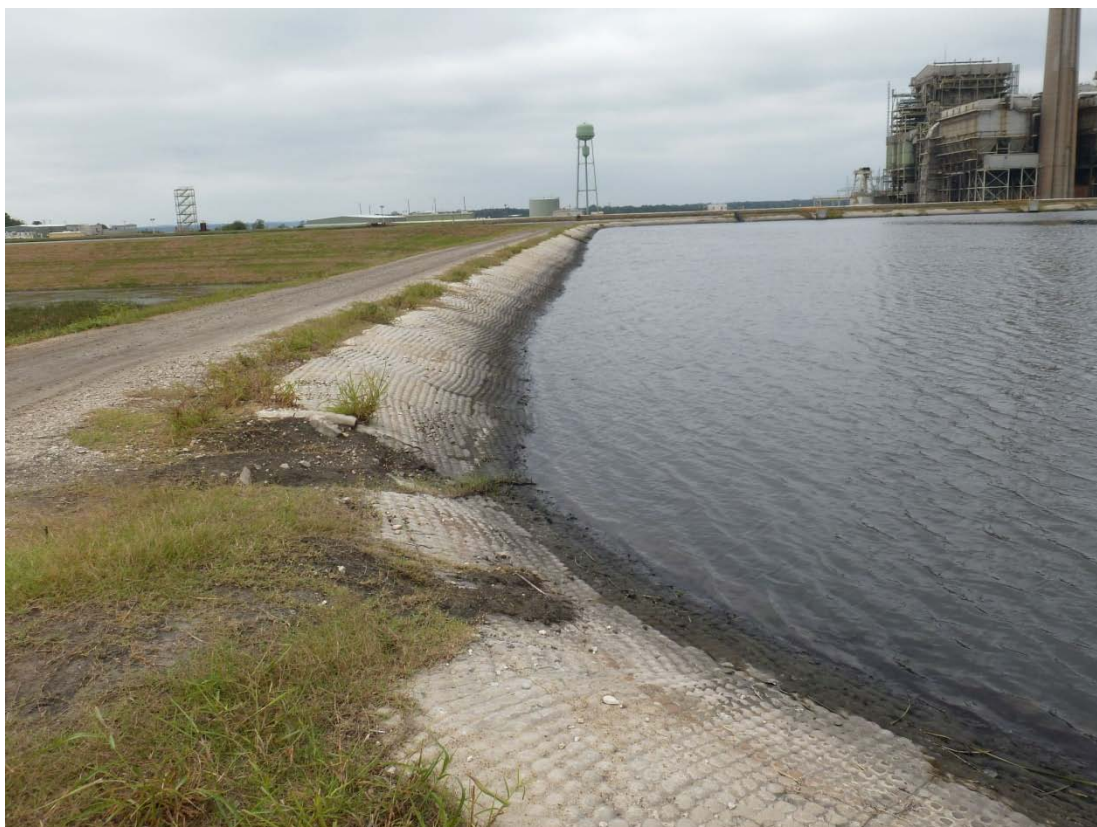
Photo Number:  
18

Description:  
Inboard face of  
the southern  
embankment of  
the Settling  
Pond. Runoff  
Collection Pond  
is visible to the  
left (south).

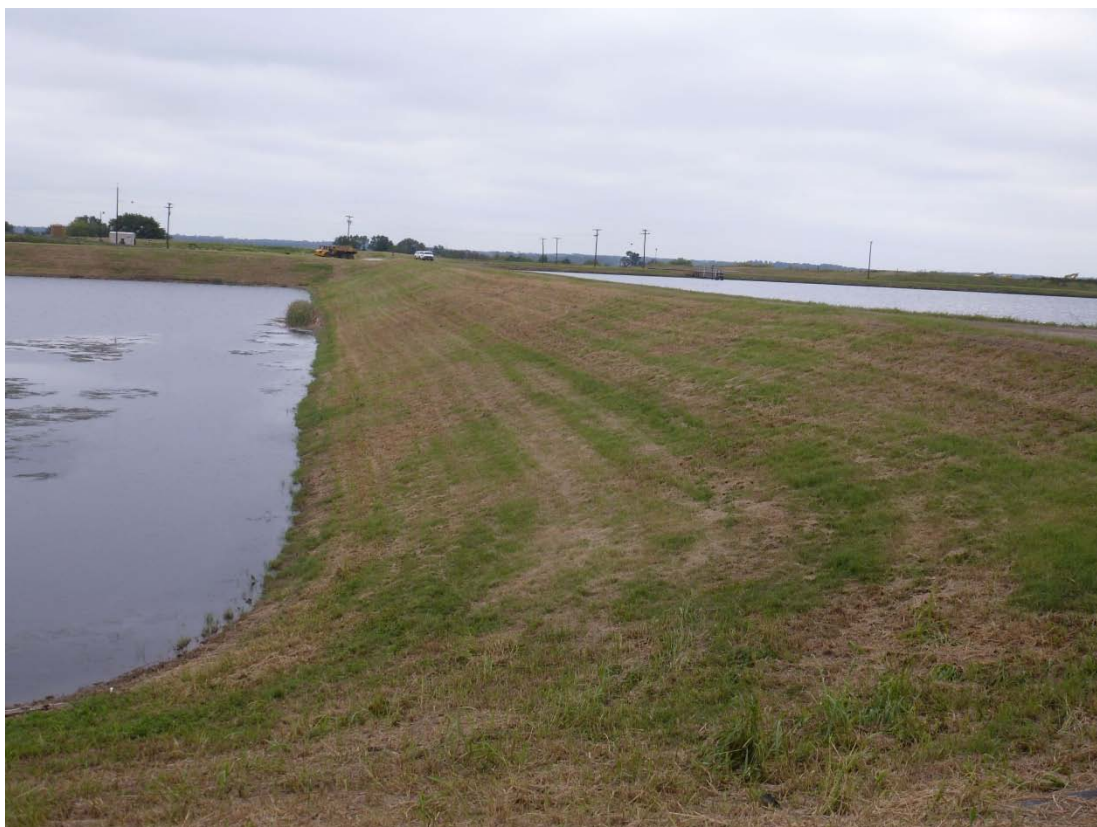
Photo Number:  
22

- Minor erosion was observed on the outboard slope. This erosion has also been noted during previous inspections.
- Some water is retained in the Runoff Collection Pond located to the east of the South Pond at the toe of the eastern embankment.

Description:  
Outboard face of the eastern embankment of the South Pond and the interior of the Runoff Collection Pond.

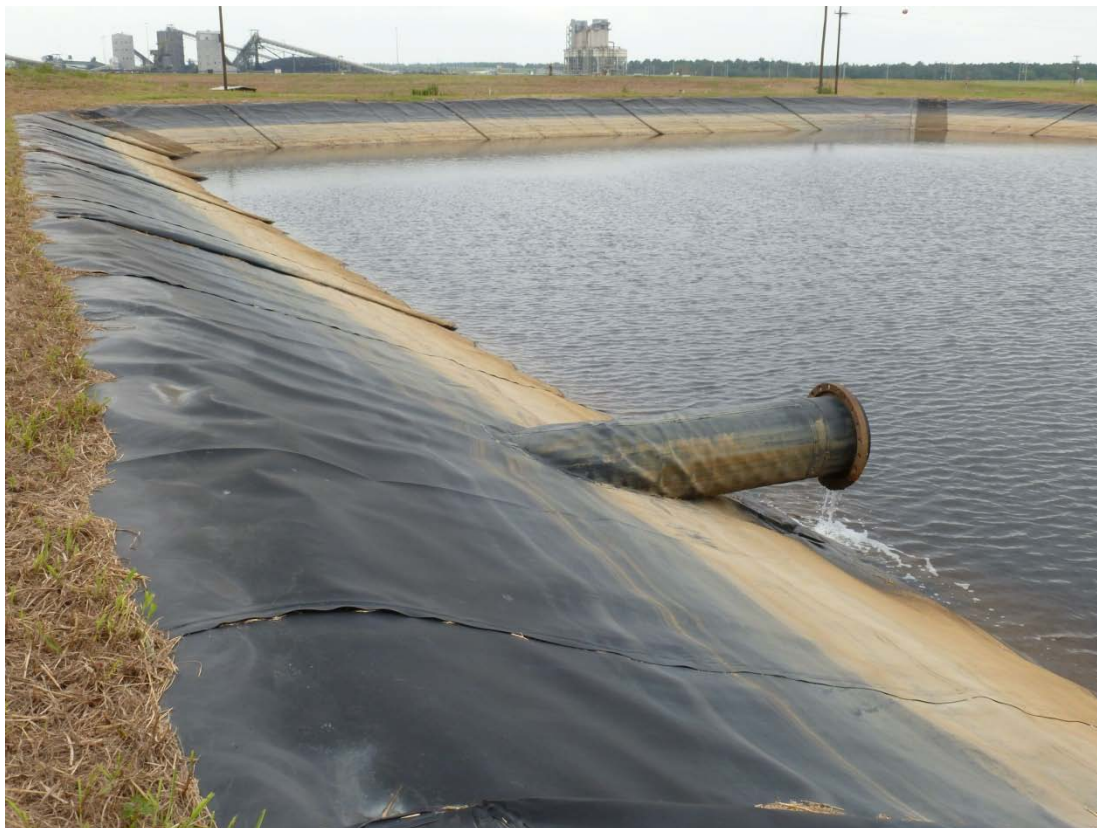
- A small amount of overflow from the decant basins enters the pond through a pipe in the western embankment.
- The HDPE liner appeared to be in good condition, with no signs of cracking observed.
- Evidence of prior releases, failures or patchwork of the impoundment was not observed.

Eastern inboard face of Scrubber Pond and inflow pipe.

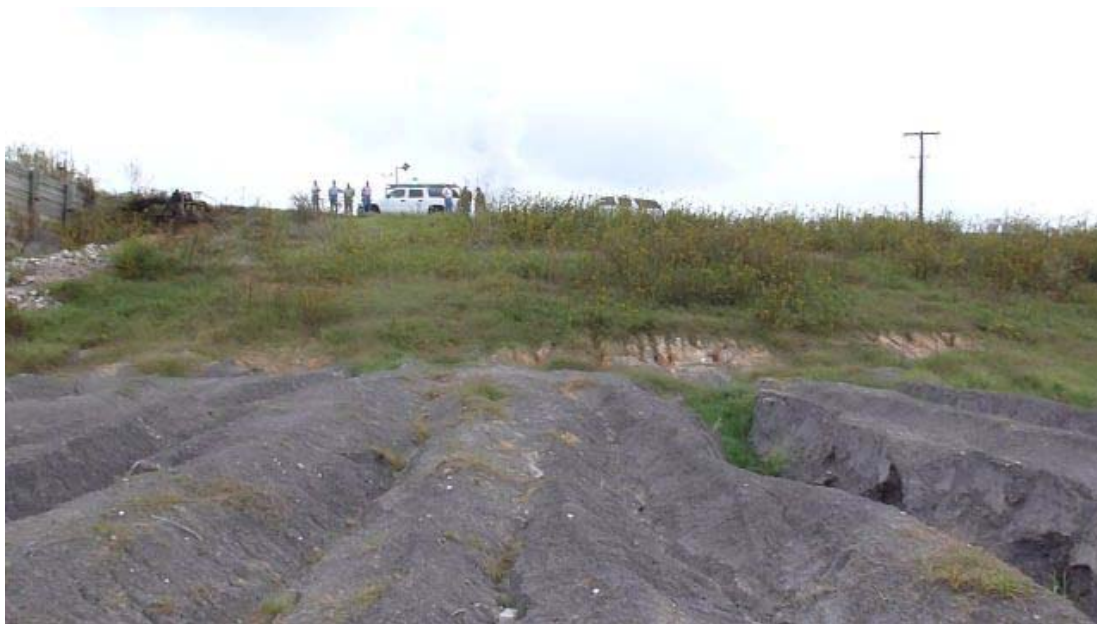
Photo Number:  
28

Description:  
Interior of  
abandoned  
Scrubber Pond  
and southern  
embankment of  
the "New"  
Scrubber Pond.
