# **Dam Safety Assessment of CCW Impoundments**

**Plant Jack Watson**

**United States Environmental Protection Agency  
Washington, DC**

July 30, 2010

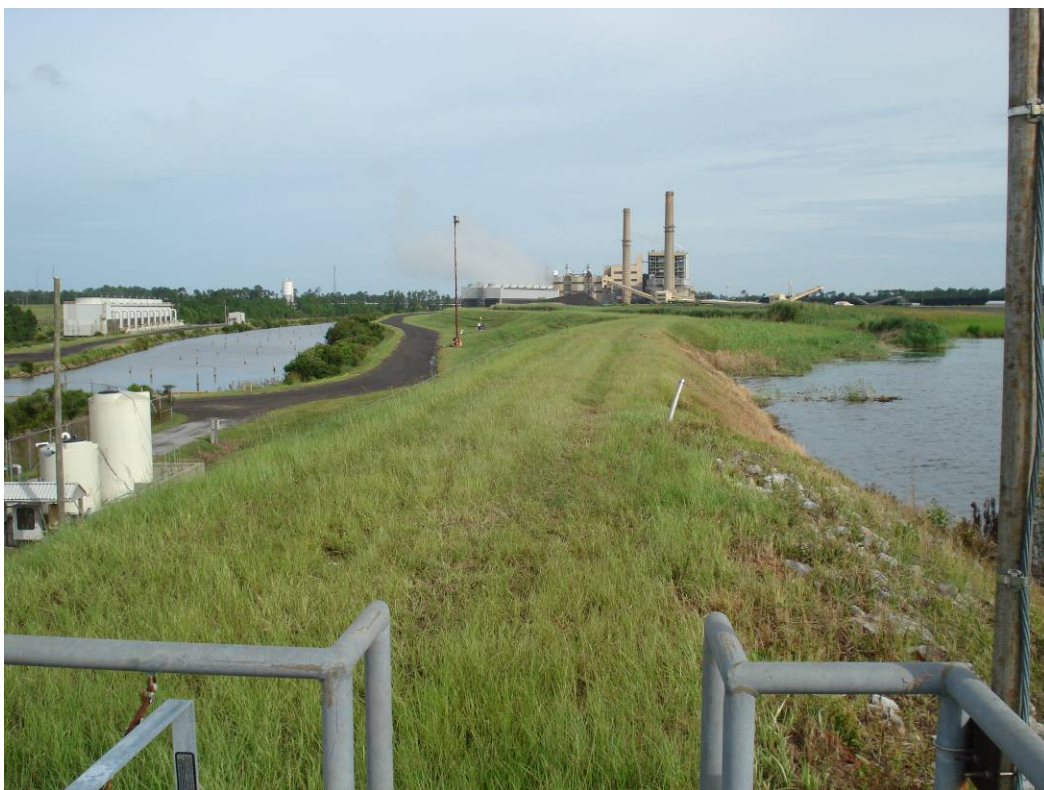
Photo Number:  
1

Overview of northwest section of embankment from outlet structure showing typical condition of crest & inboard slope.

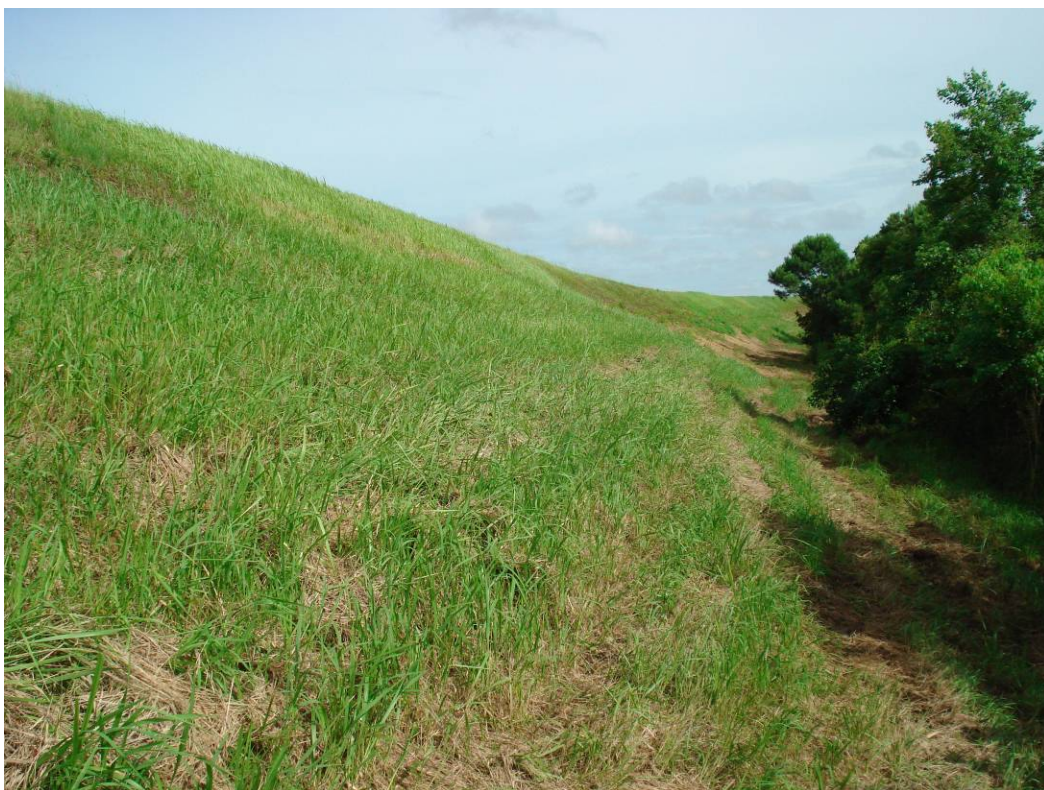
Photo Number:  
2

- Four piezometers were noted at the toe and within the outboard dike slope.
- Small trees and brush cover most of the bench's short outboard slope which meets the bayou (Appendix B – Photo 2). Intermittent forays into this area did not reveal evidence of seepage or instability.

Typical condition of outboard slope. Note vegetation on lower berm slope.

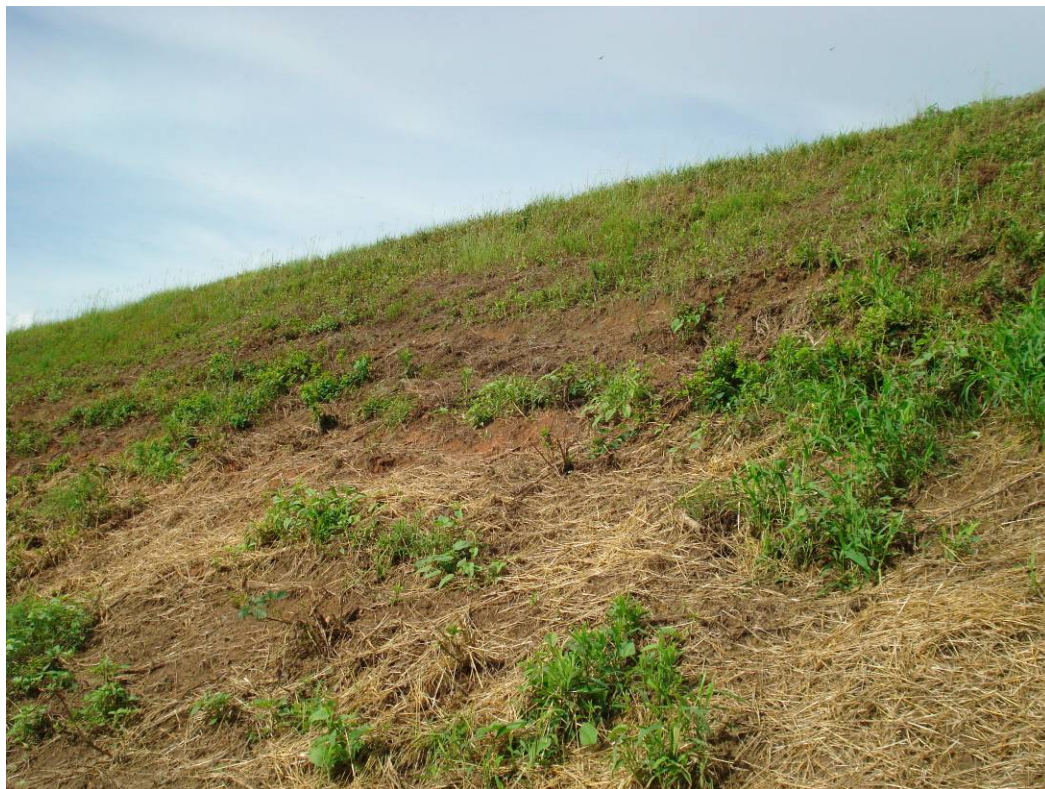
- The outboard slope is covered with well-maintained grass with a few areas of rutting from the mowing equipment. A few bare areas had been seeded and covered with straw mulch (Appendix B – Photo 3). A few minor surface sloughs in the upper 1H;1V outboard slope were evident as noted by Southern Company's inspectors earlier in the year.

Outboard slope  
re-vegetation  
repairs.

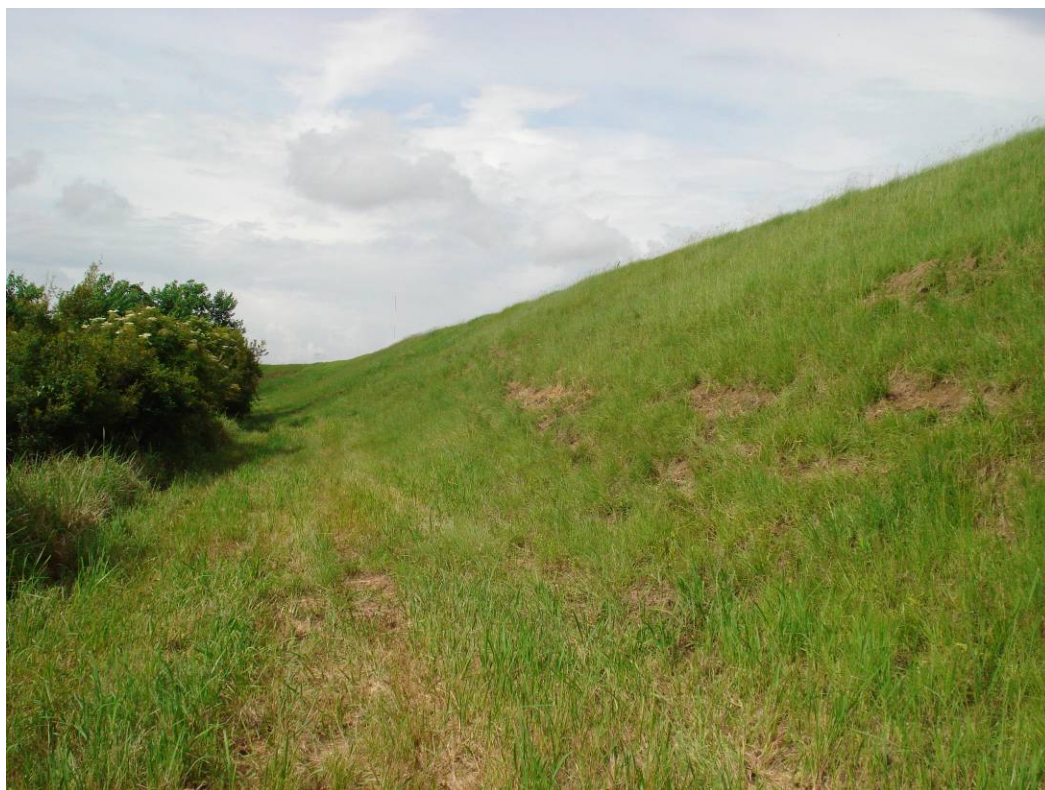
- The shallow surface sloughs on the outboard slope may be a combination of the 1H:1V outboard slope inclination combined with sliding on the underlying geotextile after precipitation.
- The intermittent seeps may be due to drainage of recent precipitation. Southern Company engineers noted that their previous two inspections, which noted similar conditions, were also after rains.
- Rutting is occurring along the toe of the outboard slopes due to mower traffic over soft, wet areas described above.
- Trees and brush are growing on the slope of the outboard bench.

Outboard slope  
& lower berm.  
Note small trees  
& brush on  
berm slope.  
Also minor  
rutting from  
mowing  
machines.

Based on the findings of our visual inspection and review of the available records for the Plant Jack Watson Ash Pond, O'Brien & Gere recommends that additional maintenance of the embankments be performed to correct the overgrowth and other miscellaneous deficiencies cited above.

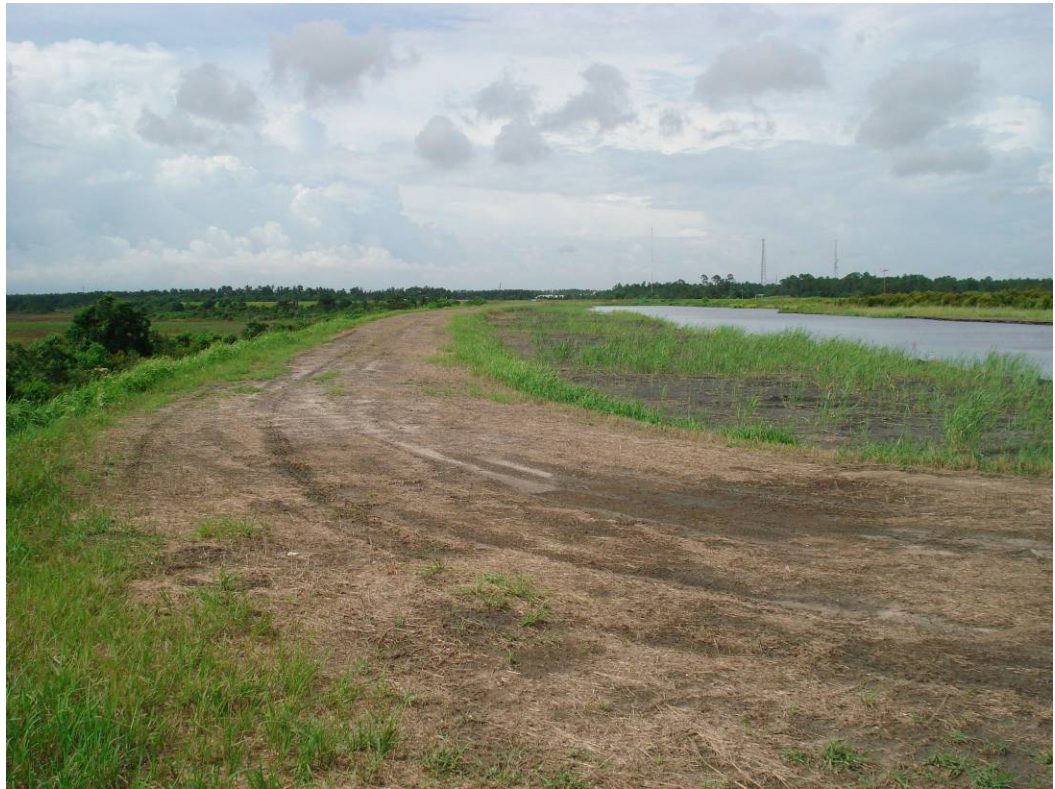
Photo Number:  
5

Embankment  
crest & CCW  
accumulation

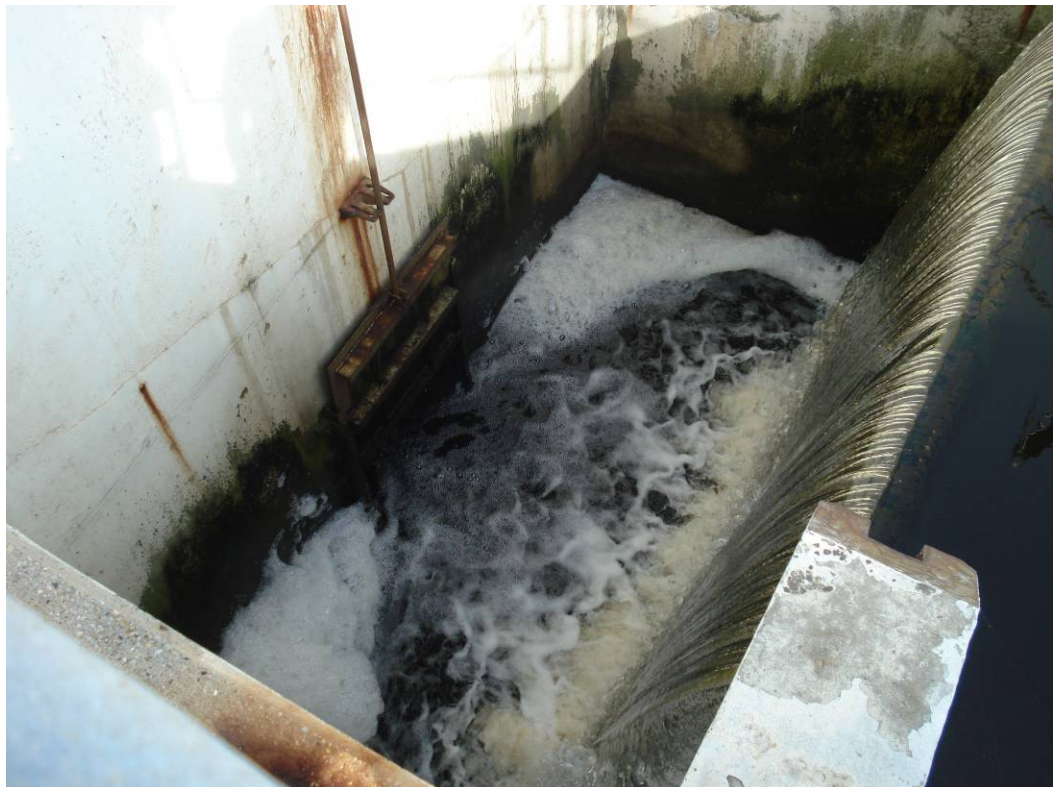
Photo Number:  
6

- The outlet structure appeared to be in good condition and functioning normally (Appendix B – Photo 6).

Outlet weir &  
conduit sluice  
gate.

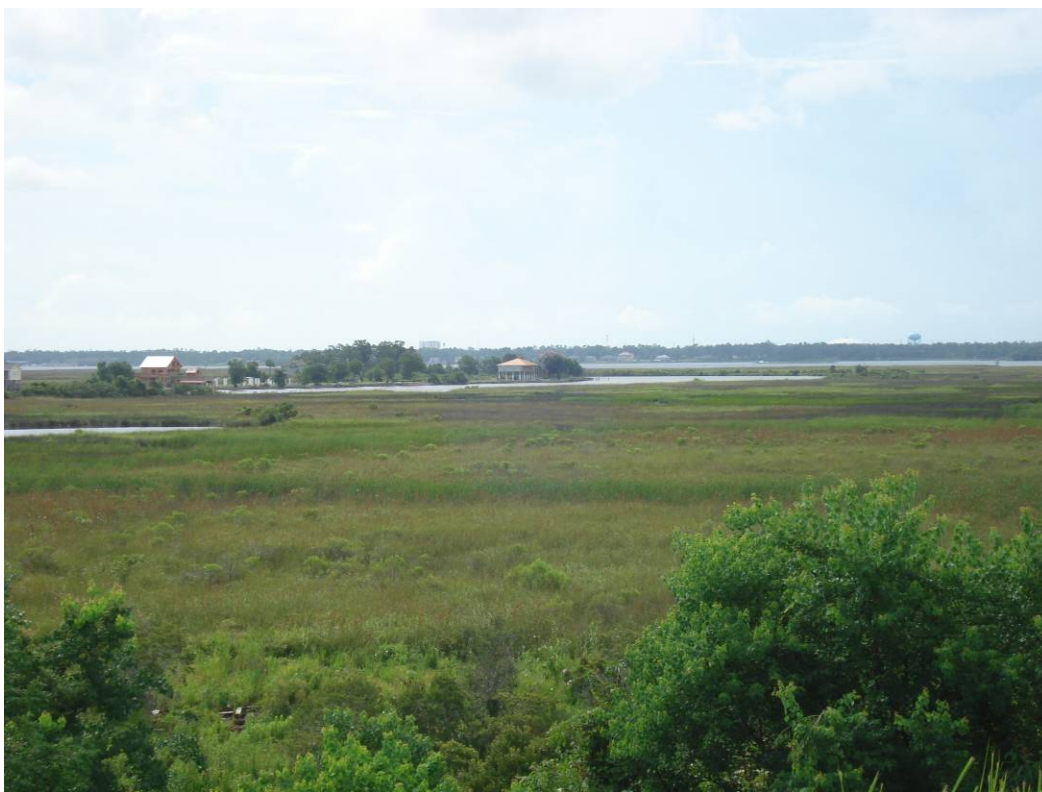
Photo Number:  
7

Downstream hazard area from embankment crest. Bayou in foreground and Gulfport MS on horizon.

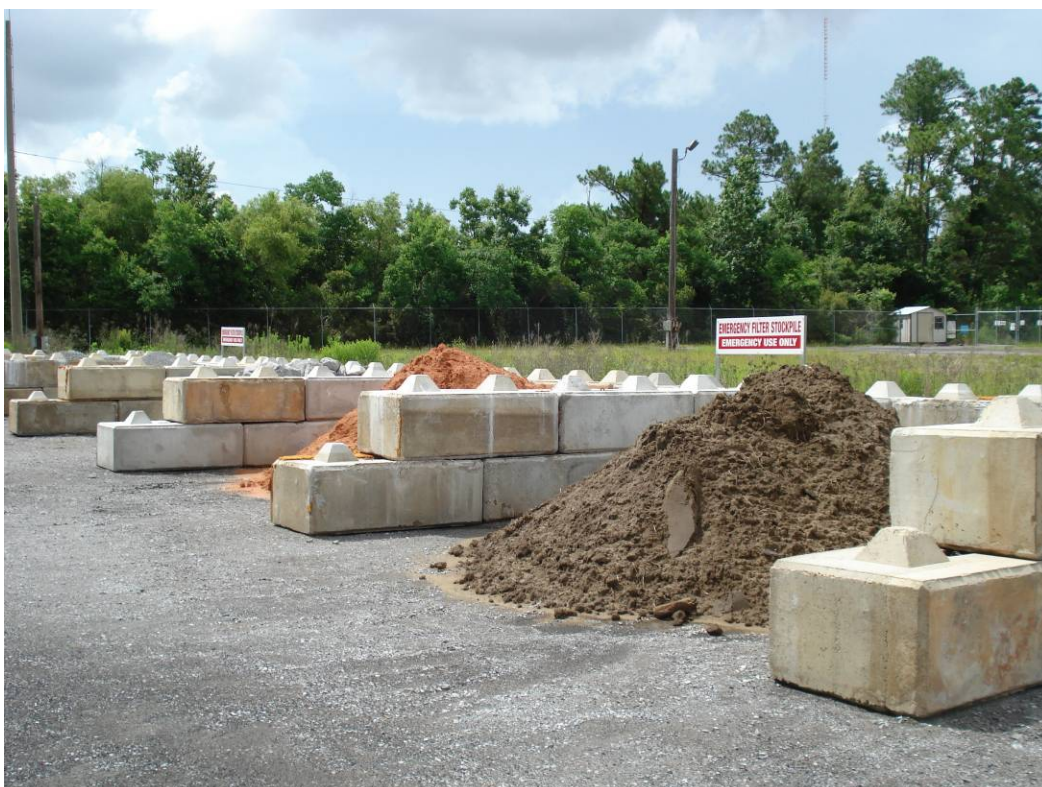
Photo Number:  
8

- No animal burrows were observed as seen by previous inspectors.
- The Plant has stockpiled materials for emergency use near the northwest corner of the impoundment (Appendix B- Photo 7).

Stockpiled emergency fill materials.
