# Dam Safety Assessment of CCW Impoundments

## Plant Jack Watson

December 7, 2010

**O'BRIEN & GERE**  
[www.obg.com](http://www.obg.com)

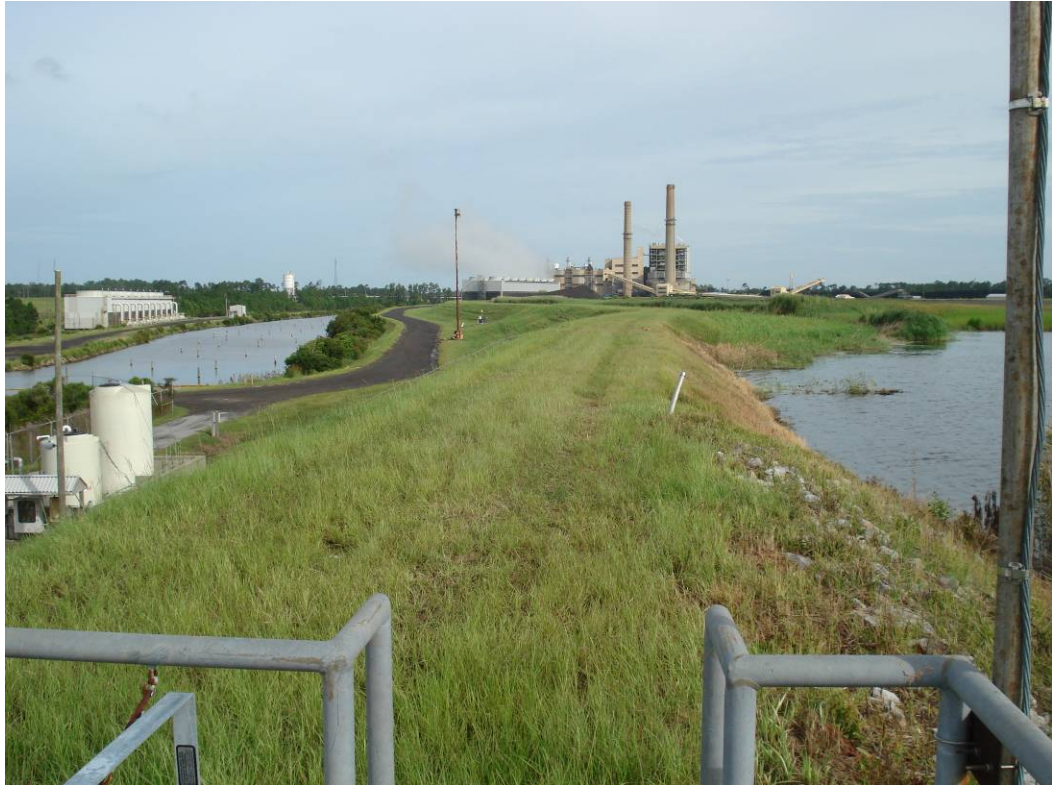
Photo Number:  
1

Overview of northwest section of embankment from outlet structure showing typical condition of crest & inboard slope.

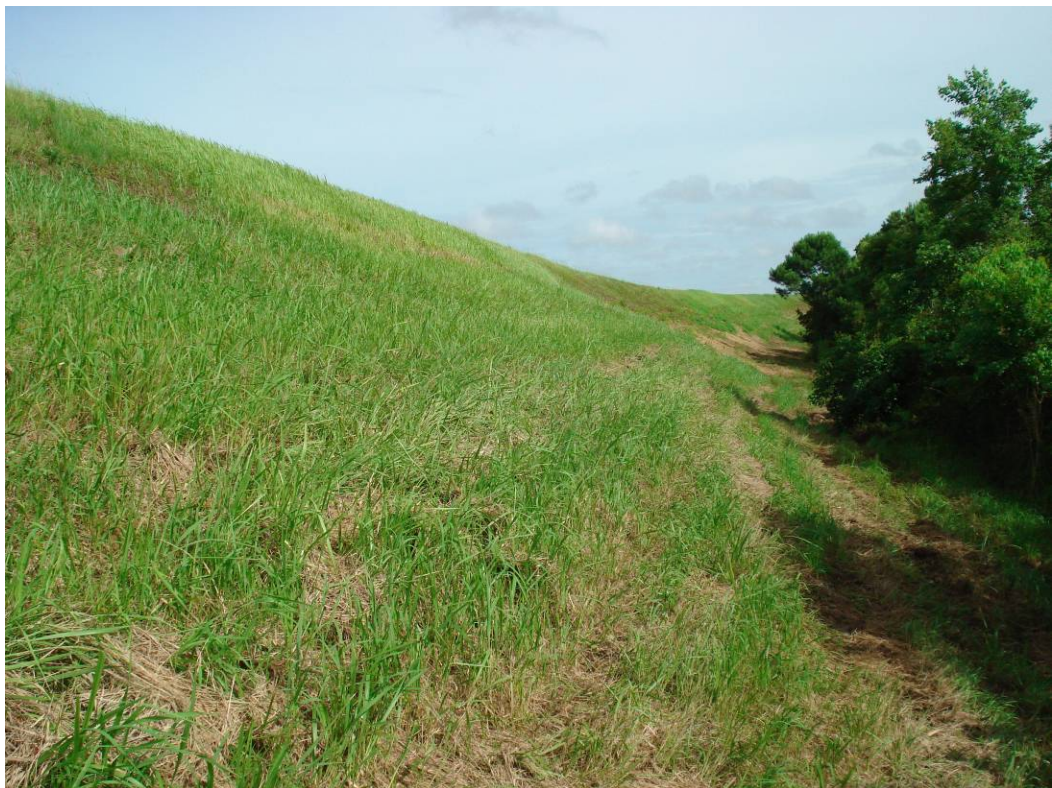
Photo Number:  
2

- Four piezometers were noted at the toe and within the outboard dike slope.
- Small trees and brush cover most of the bench's short outboard slope which meets the bayou (Appendix B – Photo 2). Intermittent forays into this area did not reveal evidence of seepage or instability.

Typical condition of outboard slope. Note vegetation on lower berm slope.

- The brush and trees growing on the outboard slope of the outboard bench should be cut and the slope surface turfed. This action will assist in detection of seepage during future inspections and high pool elevations. It is noted that Mississippi Power initiated the removal of this vegetation following receipt of the draft of this report.

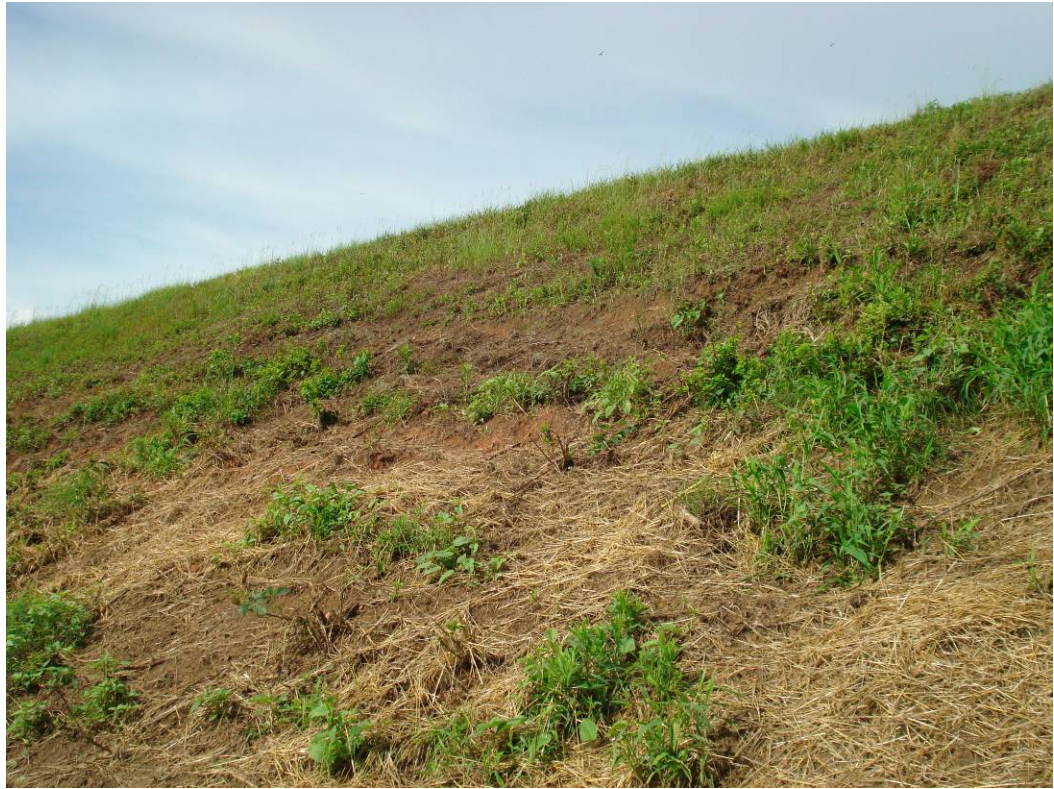
- The outboard slope is covered with well-maintained grass with a few areas of rutting from the mowing equipment. A few bare areas had been seeded and covered with straw mulch (Appendix B – Photo 3). A few minor surface sloughs in the upper 1H;1V outboard slope were evident as noted by Southern Company's inspectors earlier in the year.

Outboard slope  
re-vegetation  
repairs.

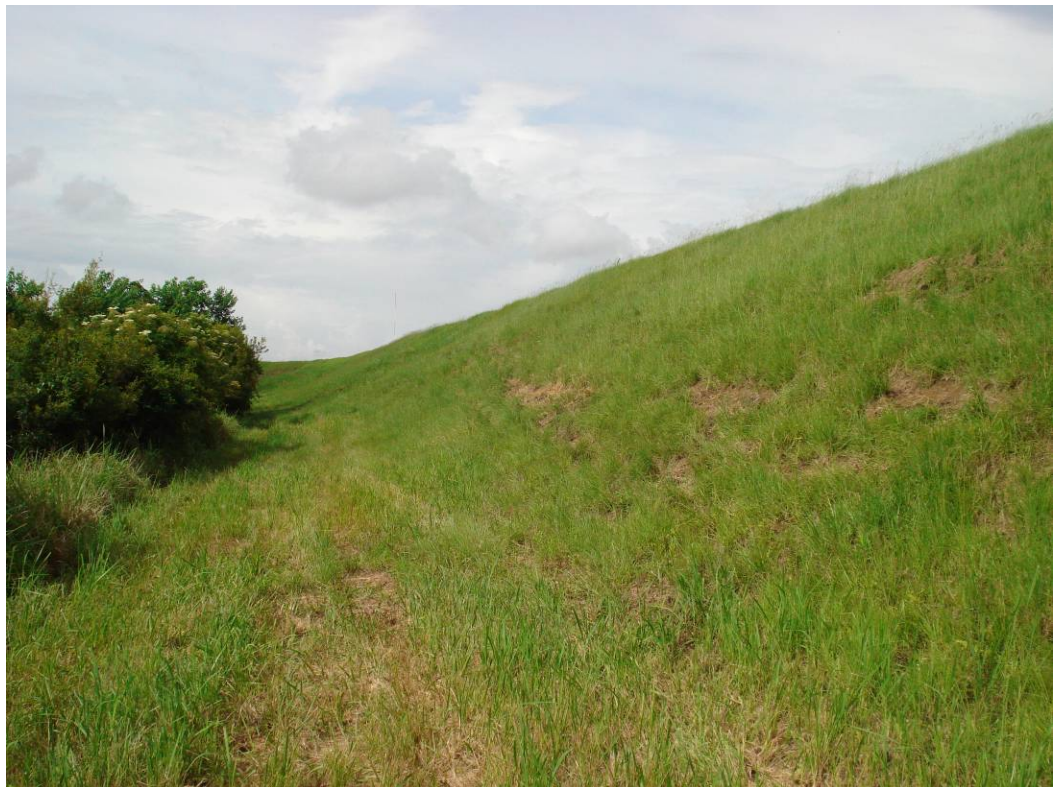
Outboard slope  
& lower berm.  
Note small trees  
& brush on  
berm slope.  
Also minor  
rutting from  
mowing  
machines.

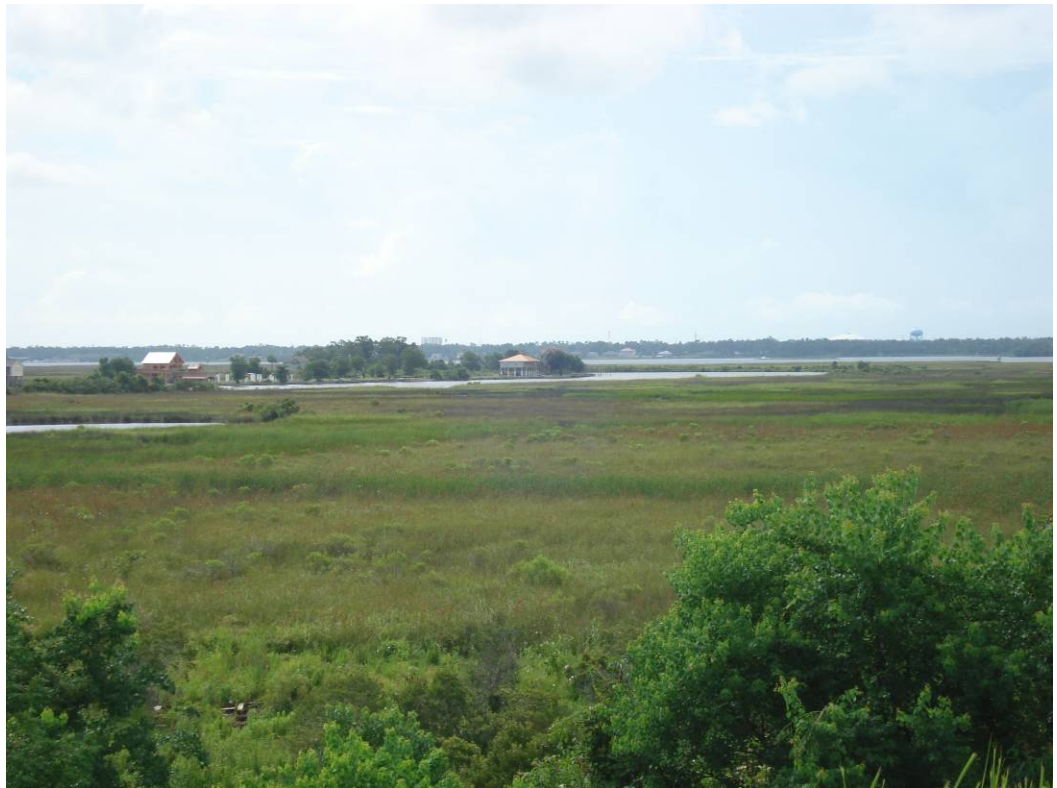
Photo Number:  
7

Downstream hazard area from embankment crest. Bayou in foreground and Gulfport MS on horizon.

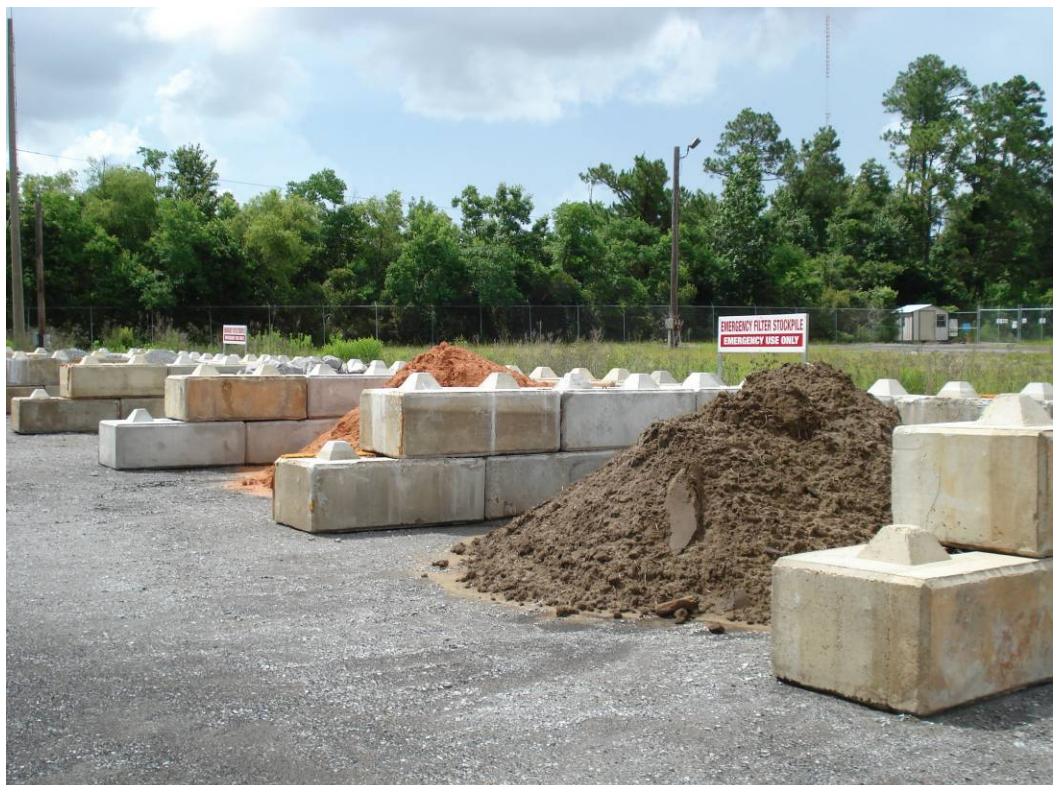
Photo Number:  
8

- No animal burrows were observed as seen by previous inspectors.
- The Plant has stockpiled materials for emergency use near the northwest corner of the impoundment (Appendix B- Photo 7).

Stockpiled emergency fill materials.
