**DRAFT ROUND 10 DAM ASSESSMENT REPORT
NIPSCO MICHIGAN CITY GENERATING STATION
COAL ASH IMPOUNDMENTS**

MARCH 29, 2012

Re: Round 10 Dam Assessment - Draft Report
EPA Contract No. EP10W001313
NIPSCO – Michigan City Generating Station Coal Ash Impoundments
Michigan City, Indiana

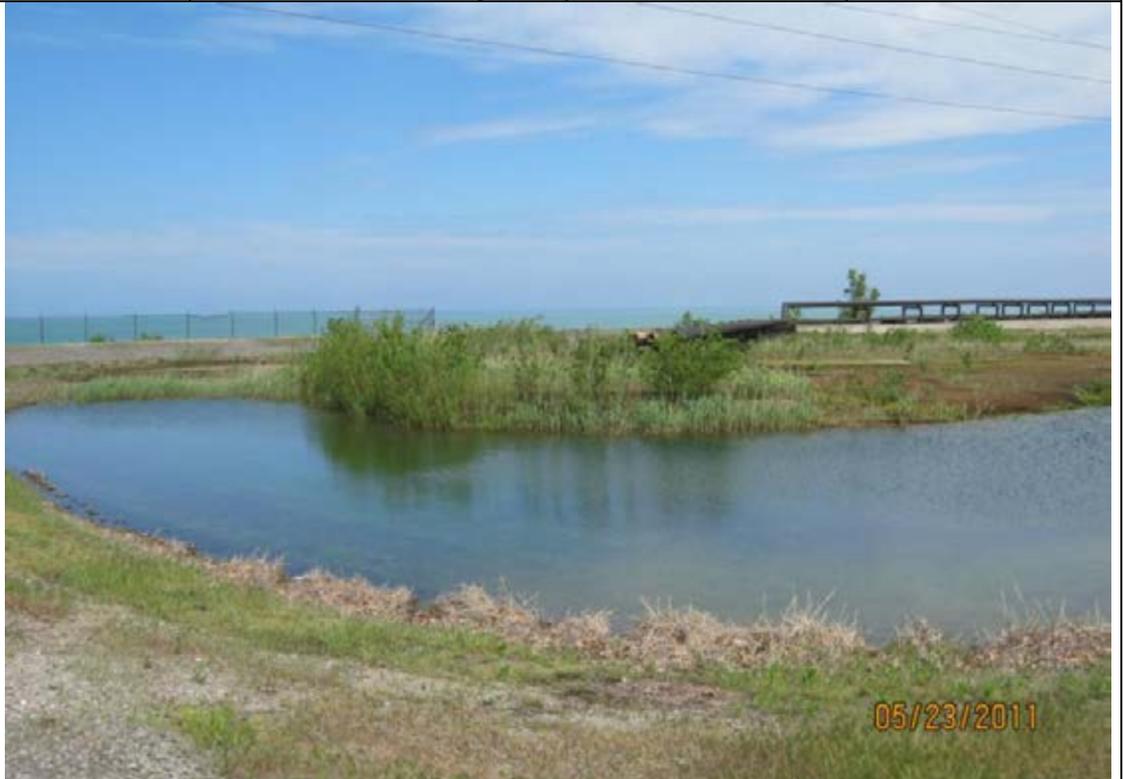
Description: Primary Settling Basin No. 1 influent discharge area.

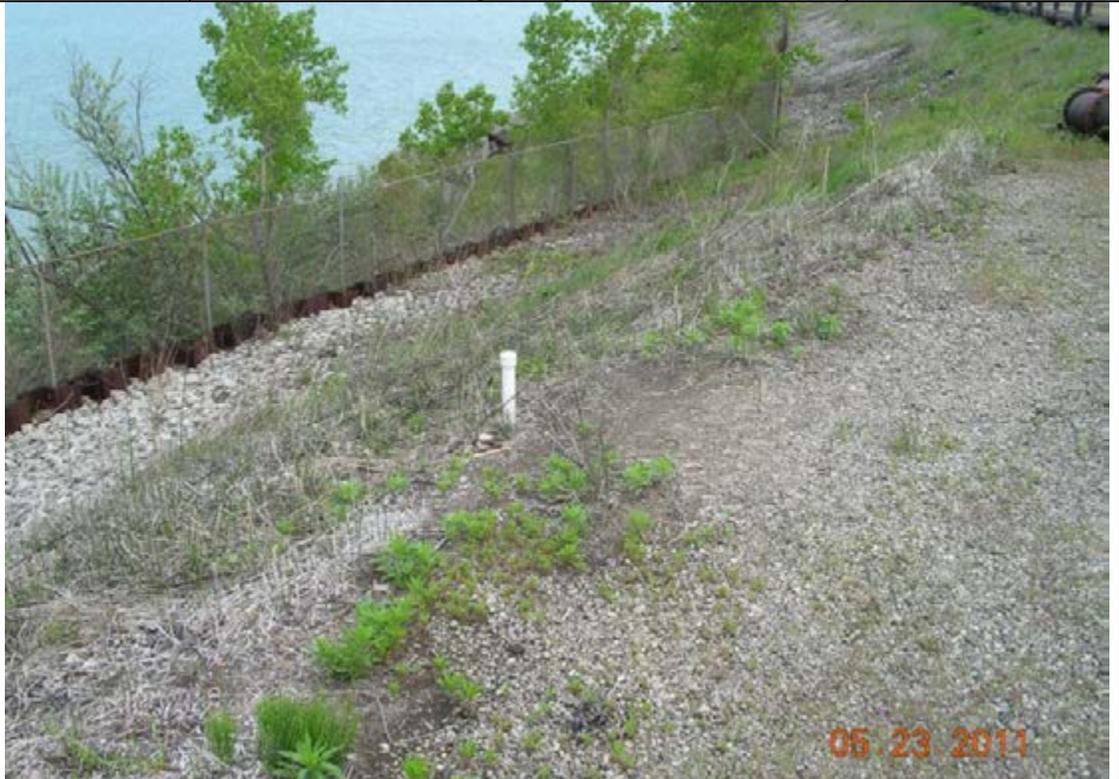
Description: Piezometer near the crest of the Primary Settling Basin No. 1.

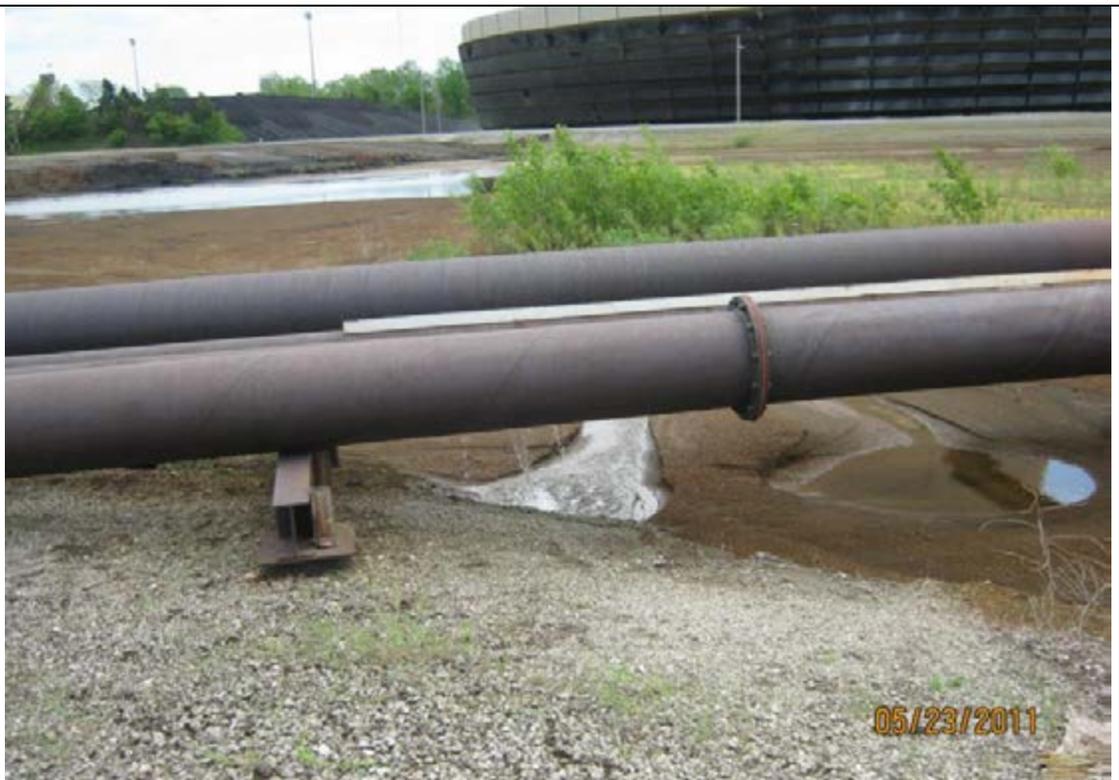
Photo No. 4

Description: Discharge pipes leaking waste water into the Primary Settling Basin No. 1.

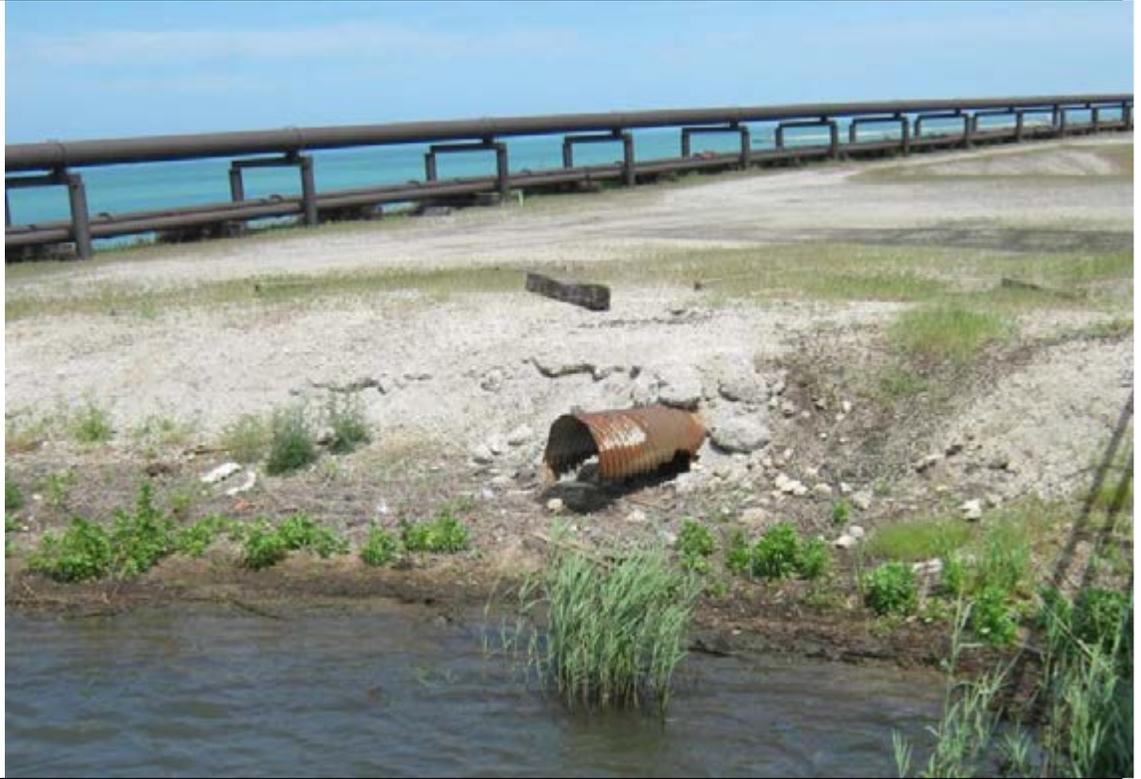
Most of the interior slope could not be observed due to the water elevation within Primary No. 1. The parts of the interior slope that could be observed appeared to be in good condition. Some minor erosion channels were observed (Photo 8) and some minor sloughing was noted near the emergency overflow pipe (Photo 7).

The overflow pipe in the Primary Settling Basin No. 1 that discharges into the Secondary Settling Basin No. 1.

1. Repair the bent trash rack in Primary No. 2 before this Impoundment is put back in service;
2. Repair sloughs and scarps on the embankments and provide future erosion protection as necessary and,
3. Evaluate the function and necessity of the unknown pipe found on the northeast side of the FSP and remove the pipe if it is not needed.

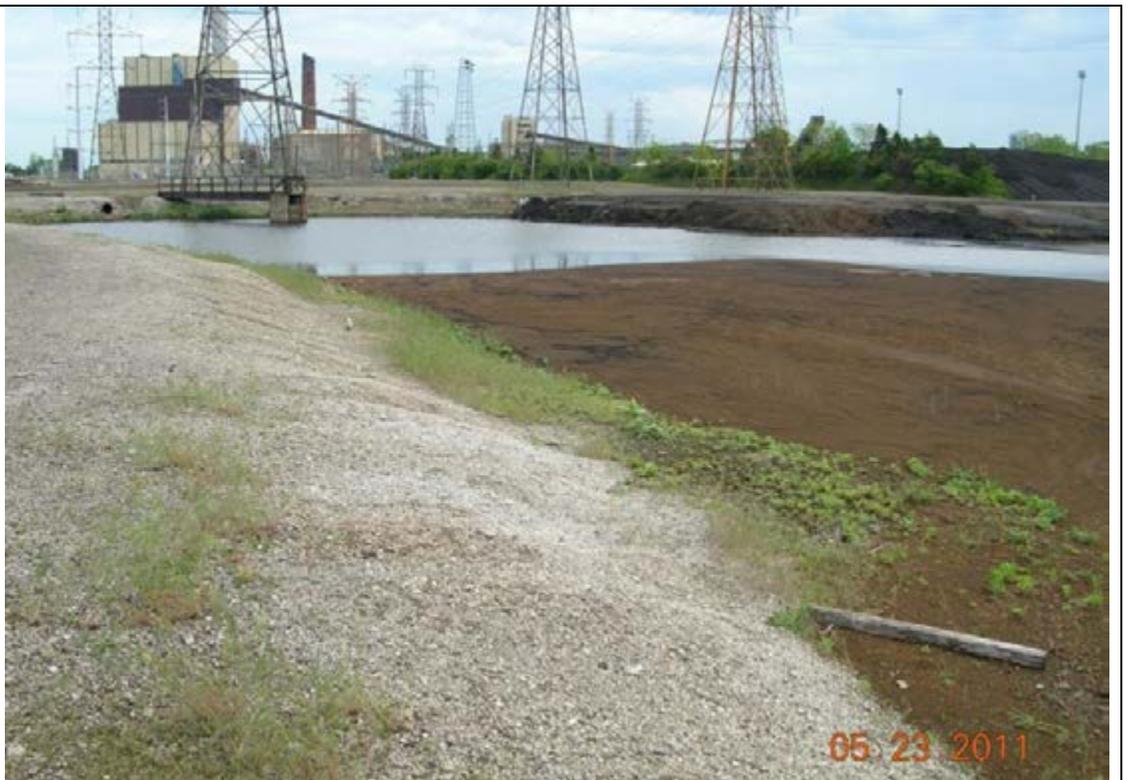
Photo No. 8

Inner slope of the Primary Settling Basin No. 1 embankment and discharge structure. Note minor erosion channeling.

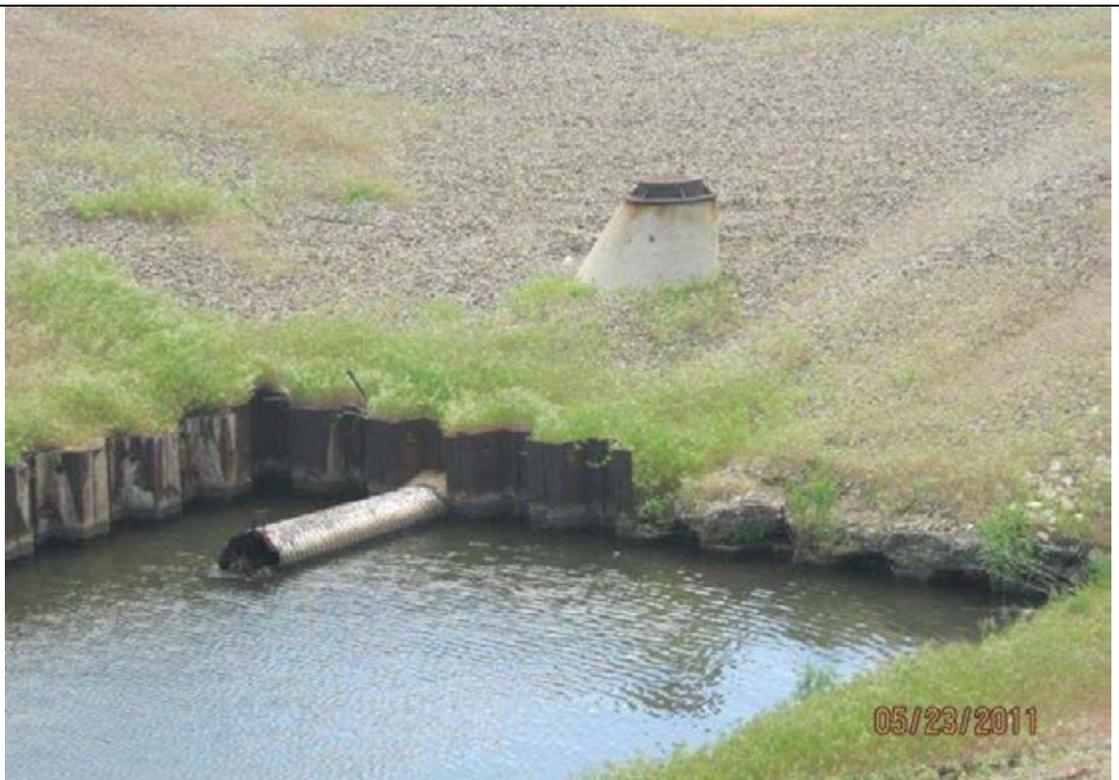
Photo No. 10

Decant structure in Secondary Settling Pond No. 1. The sheet piling to the right of the photograph appears to be at a lower elevation than the rest of the sheet piling in Secondary Settling Pond No. 2.

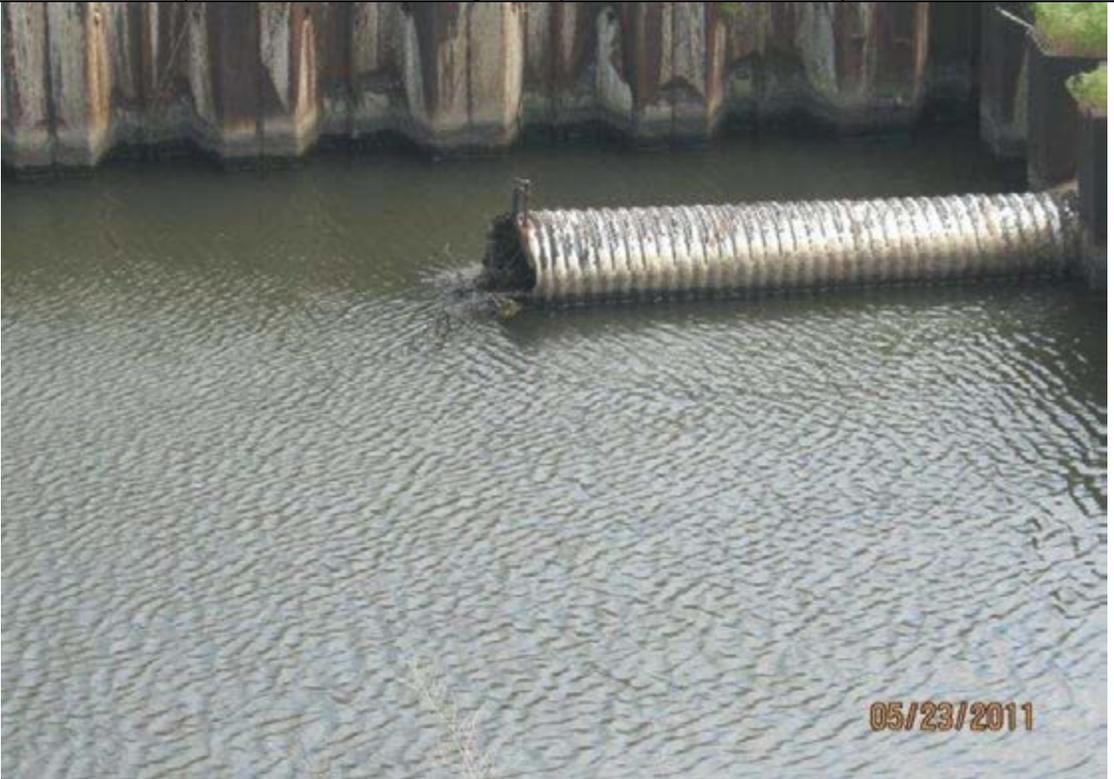
Description:
Debris in the Secondary Settling Pond No. 1 outlet structure.

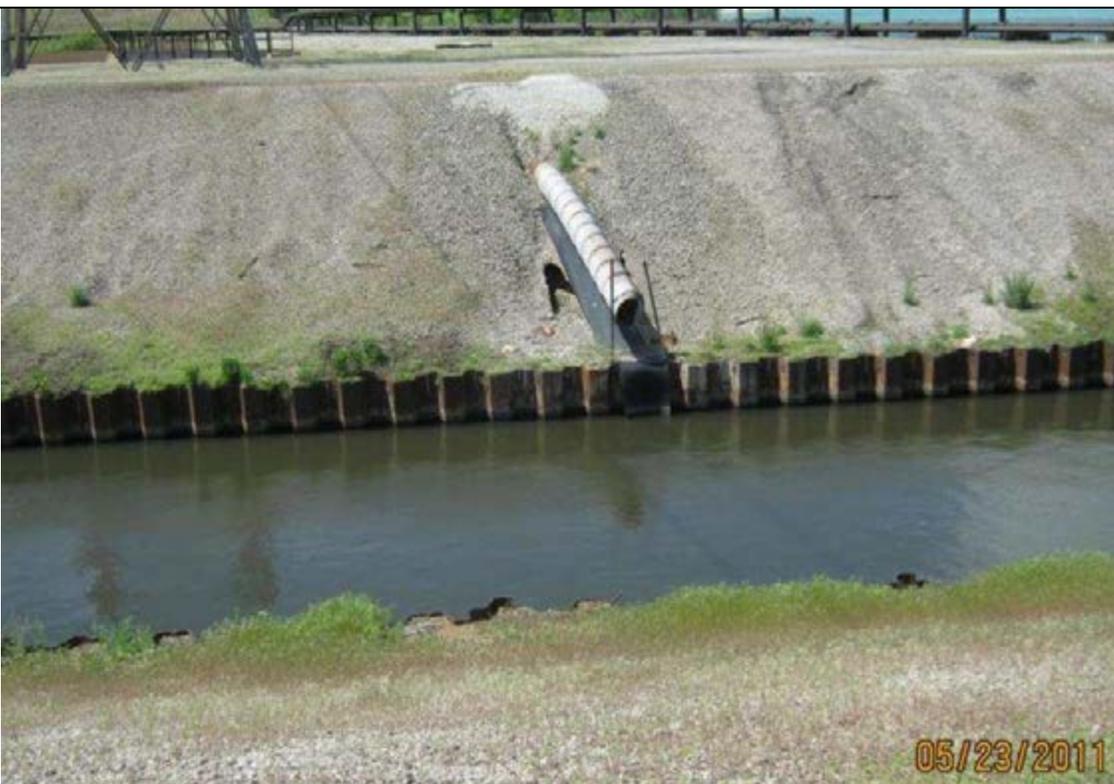
Photo No. 12	Date: 05/23/11
------------------------	--------------------------

Description:
Overflow structure outlet from Primary Settling Pond No. 1 into Secondary Settling Pond No. 1. Note the minor erosion channels and minor sloughing on the slope.

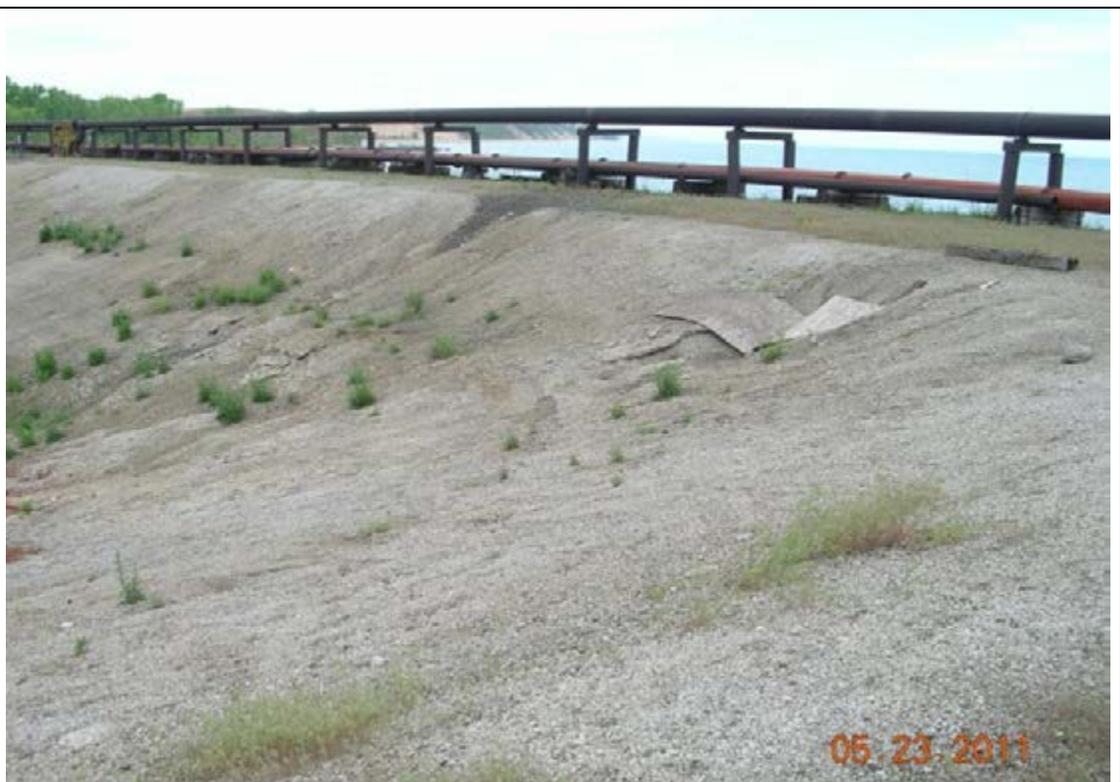
Photo No. 16	Date: 05/23/11
Direction Photo Taken: West

Description:
Erosion channels and sloughing in Primary Settling Pond No. 2.

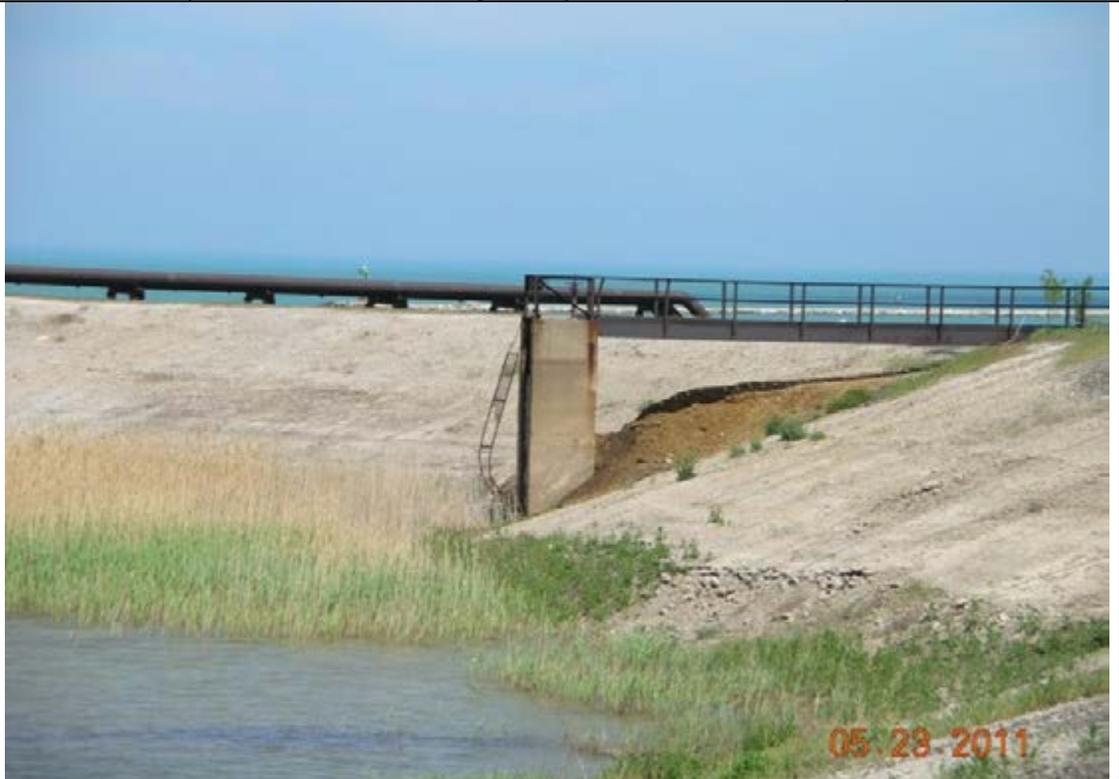
Description: Decant structure in Primary Settling Pond No. 2. Note the decant trashrack is bent.

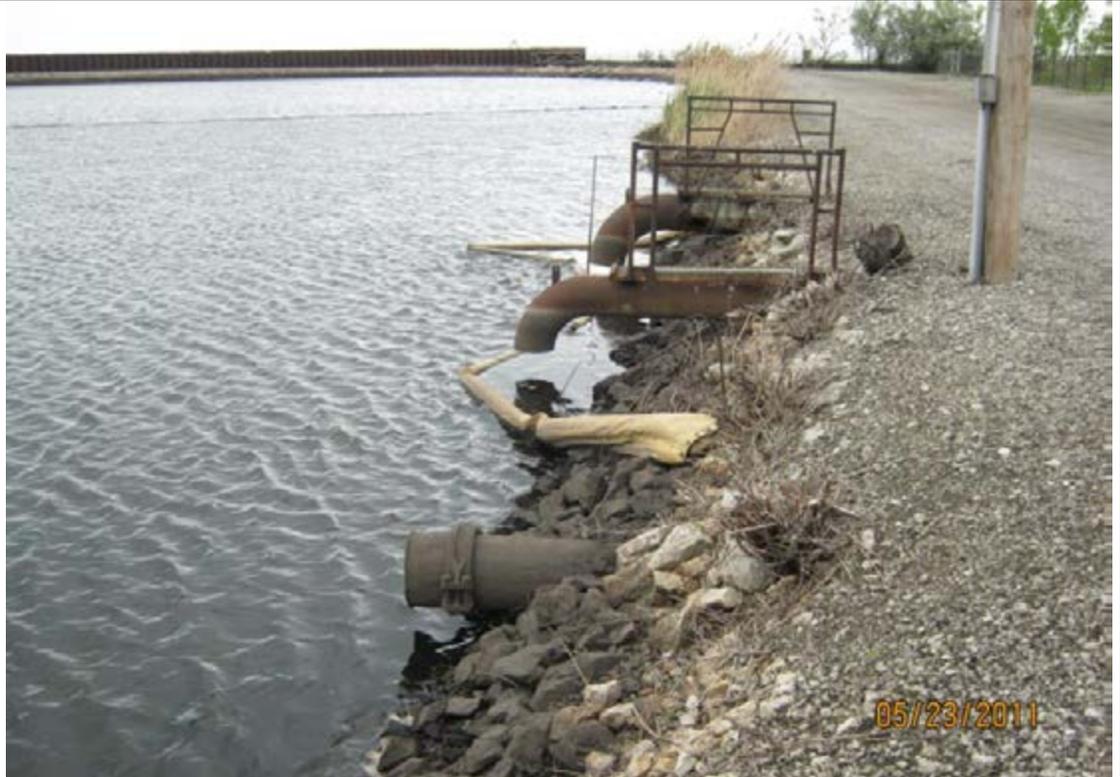
Final Settling Pond interior slope. The purpose of the black pipe in the foreground in unknown. The two pipes with 90 degree bends shown in the background are overflow pipes.

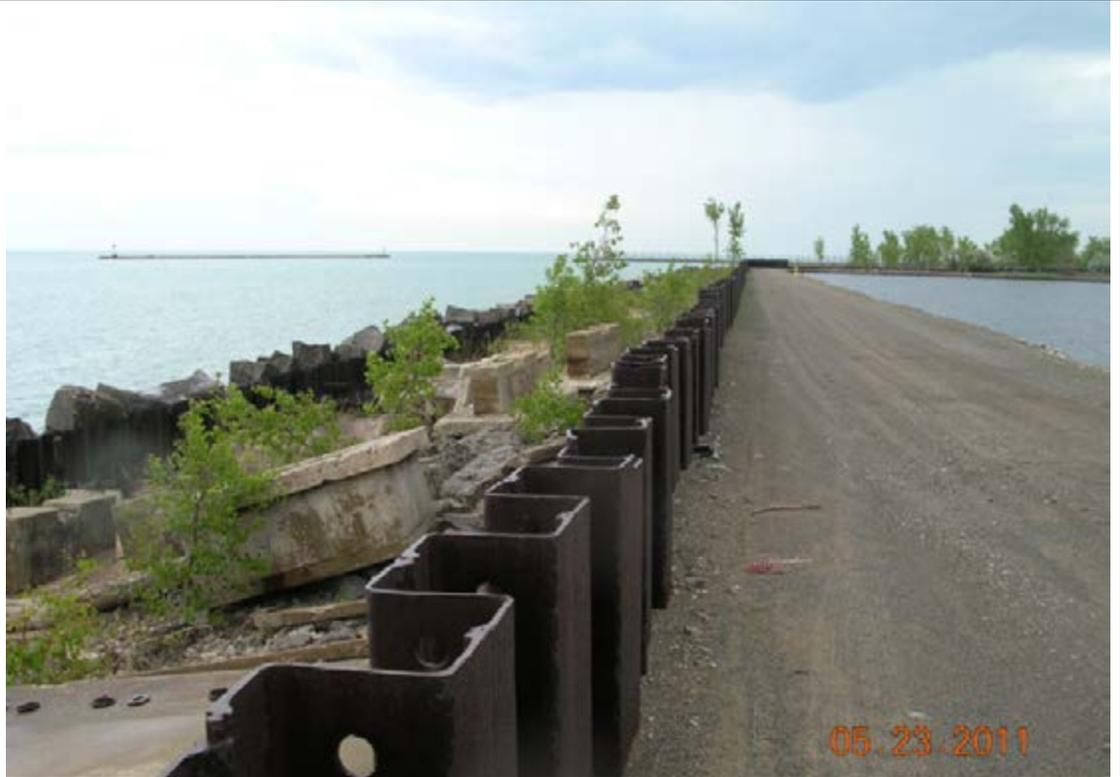
Description: Two rows of sheet piling along the Final Settling Pond. Note the heavy rip rap between the rows of sheet piling.

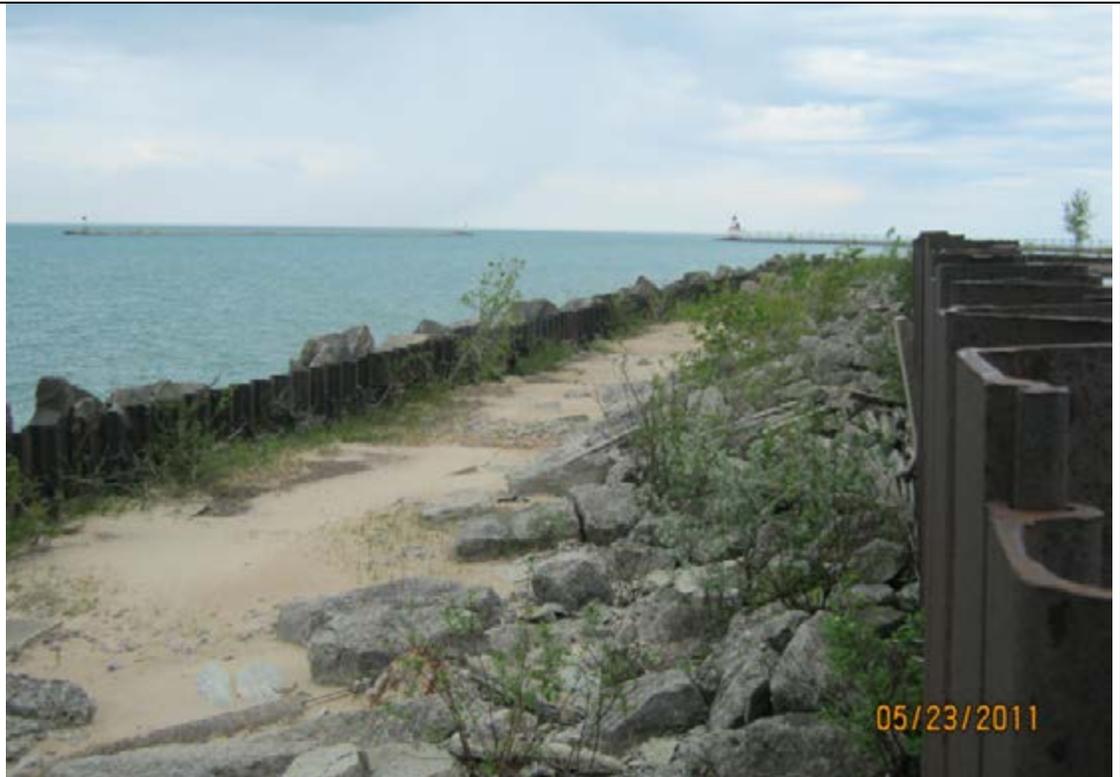
Photo No. 46

Description: Two rows of sheet piling along the Final Settling Pond. Note the heavy rip rap between the rows of sheet piling.
