**Assessment of Dam Safety of Coal Combustion  
Surface Impoundments**

**Northern Indiana Public Service Company**

**R.M. Schahfer Generating Station**

*Draft Report*

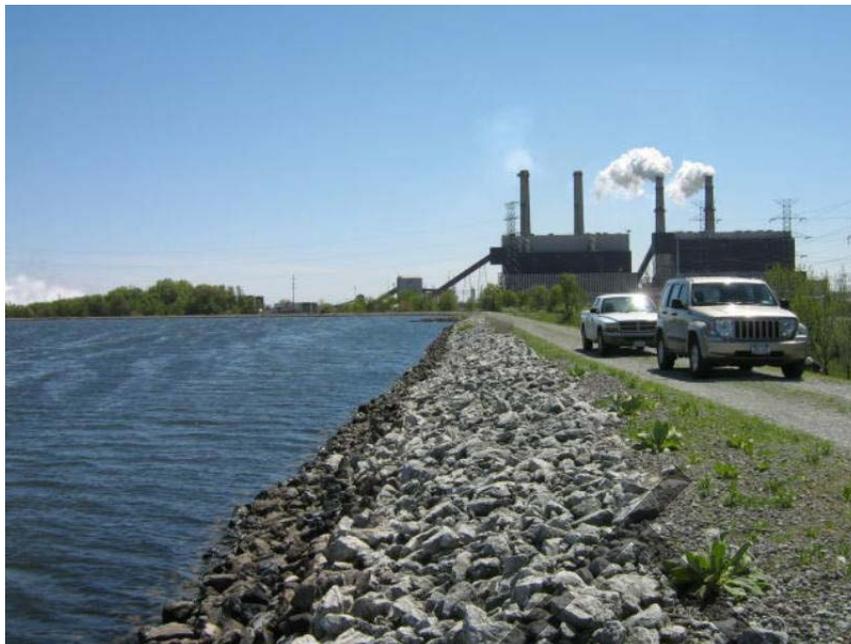
The interior slopes appear to be in fair condition. In general, the embankment's interior slope is armored with riprap (Photograph 3, 7, 16, 21, 23, 34, 35 and 39) and has a slope of approximately 3H: 1V. Riprap has been eroded near the waterline along the majority of the interior slope (Photograph 16 and 39 are typical). Riprap located on the east embankment interior slope has eroded from the top of the slope (Photograph 21).

3. Final Settling Basin - West embankment interior slope, looking south, armoring of the slope is observed

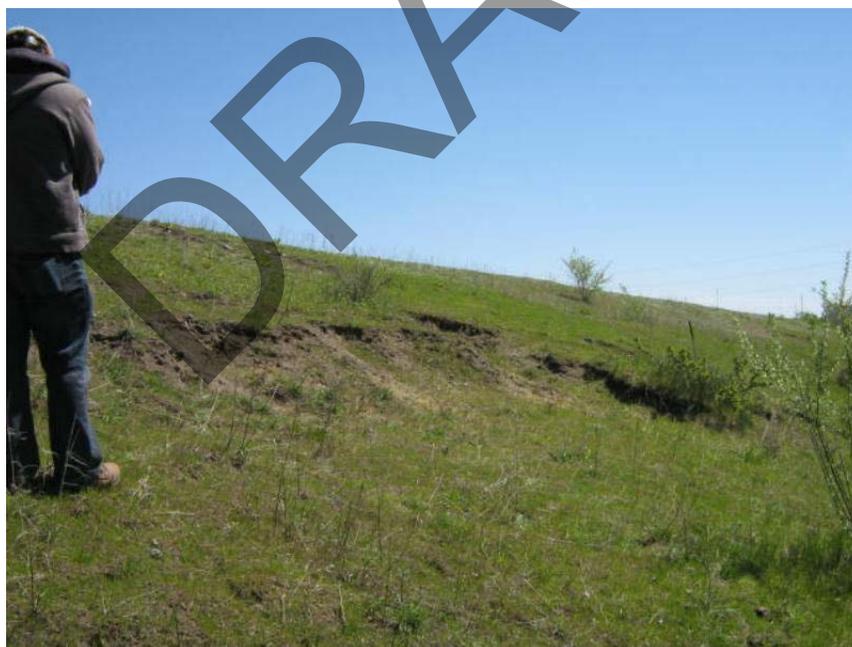
4. Final Settling Basin - West embankment exterior slope scarp  
(Approximately 36 feet Long)

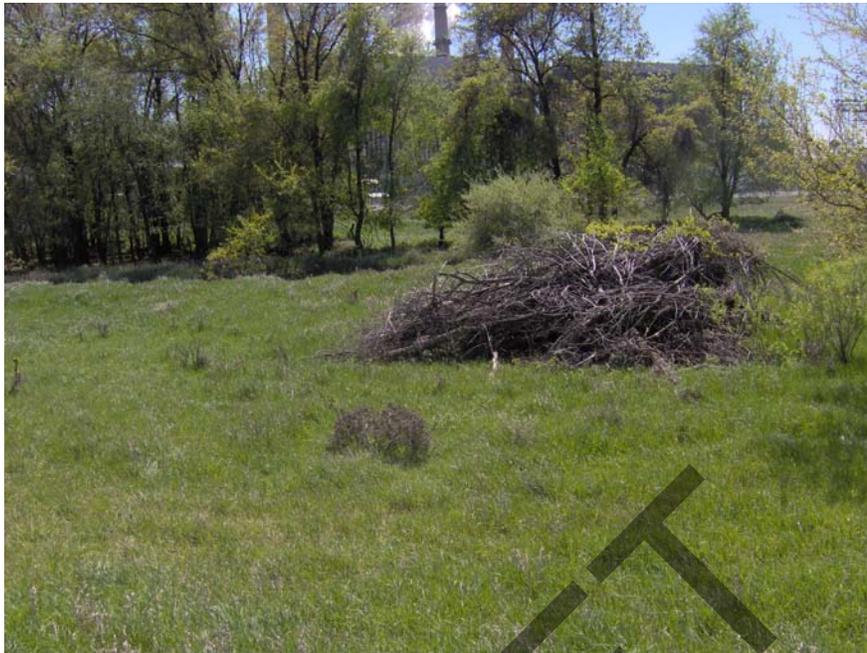
11. Final Settling Basin - Brush pile located on south embankment

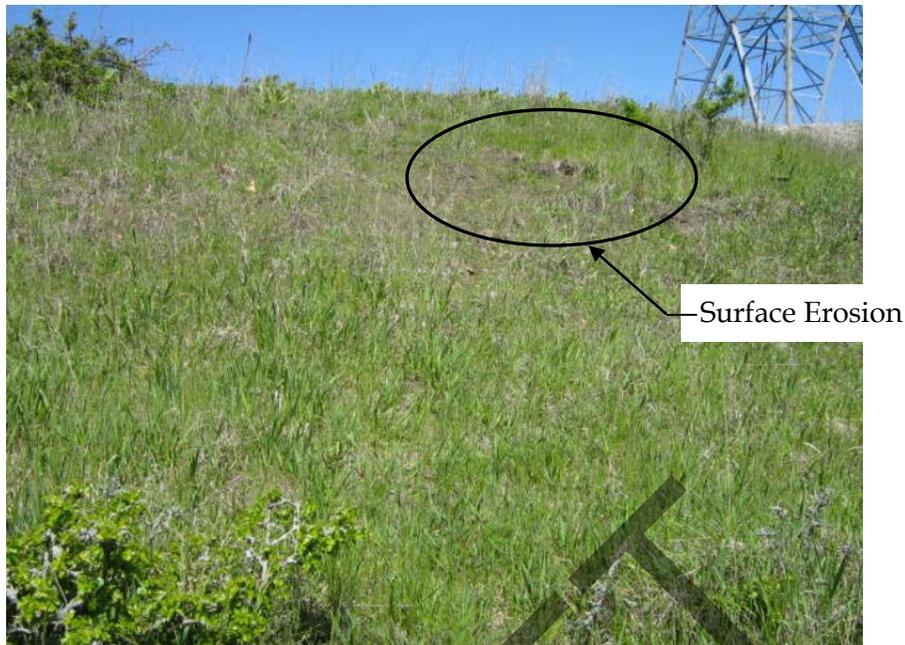
13. Final Settling Basin - Surface erosion on south embankment exterior slope

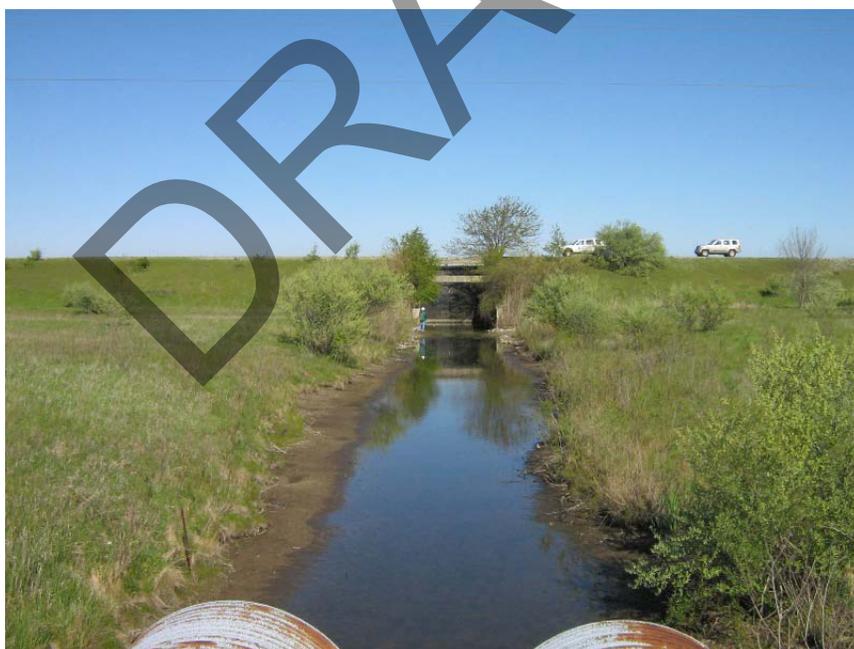
Water is discharged from the Final Settling Basin pump station into the Kankakee River. An overflow weir located on the west embankment appears to be in good condition (Photographs 1 and 40). The outlet channel is free of debris. Woody brush (approximately 2-inches in diameter) was growing along and overhanging the channel walls (Photographs 2 and 40).

40. Final Settling Basin - Drainage ditch

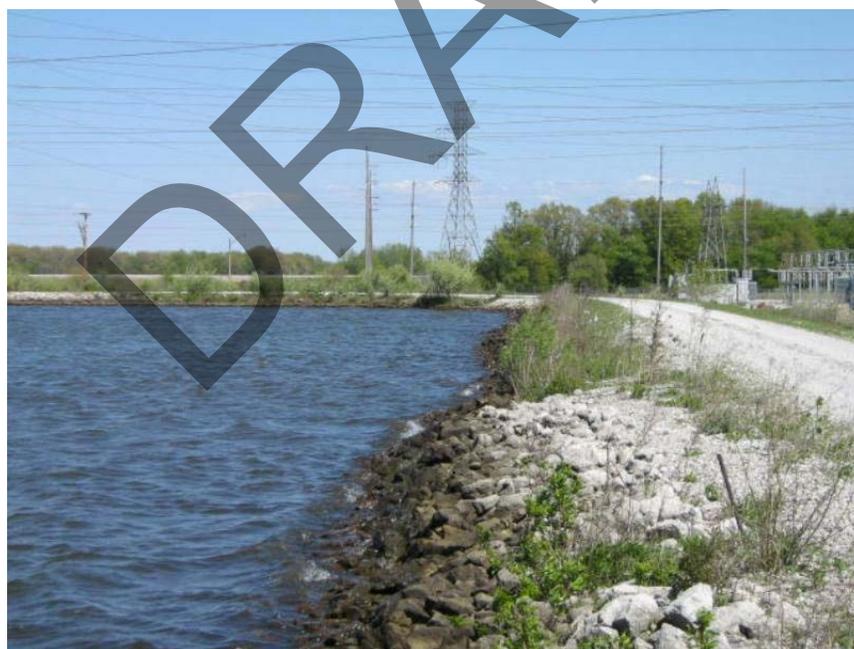
42. Intake Settling Basin - South embankment interior slope

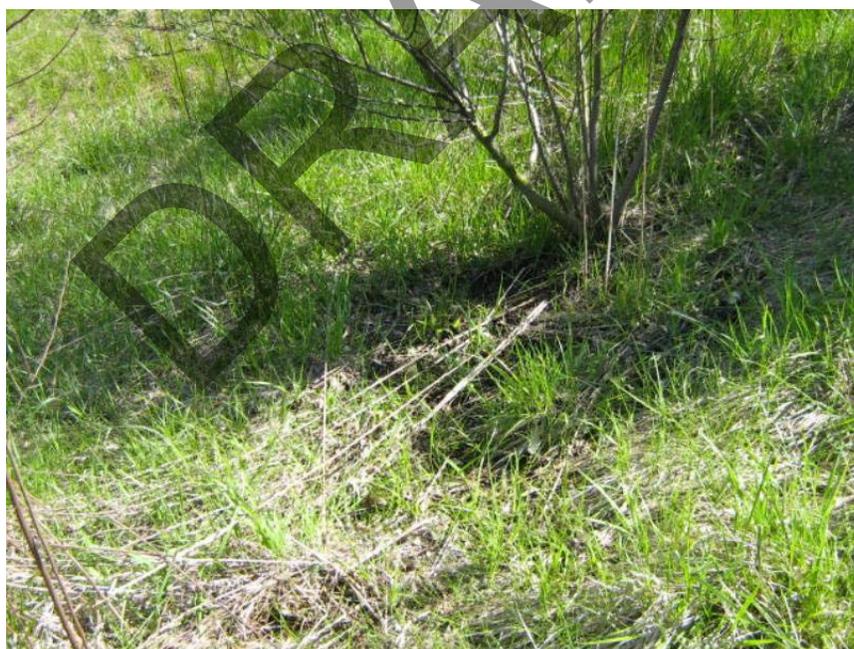
Areas of possible seepage were observed on the east, north, and west embankment exterior slopes (Photographs 47, 48, 49, 51, 52, 55, 60, 61, and 71). Standing water was also observed along the toe of the east and north embankment exterior slopes (Photograph 55 and 61). Due to the significant recent rainfall the observed standing water could not be clearly identified as seepage.

52. Intake Settling Basin - Saturated area in brush on east embankment exterior slope

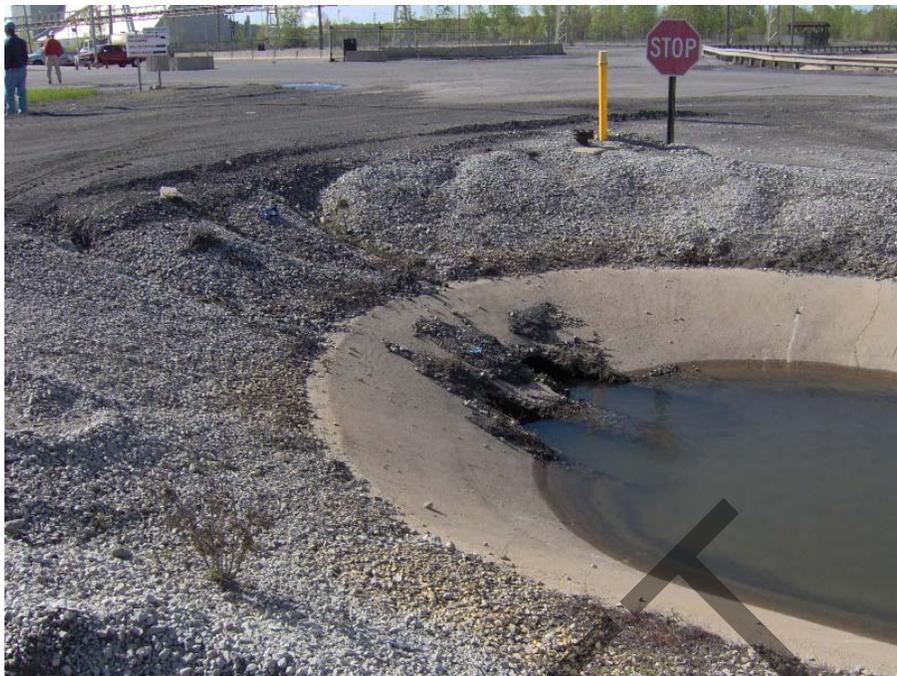
80. Retention Pond – inlets

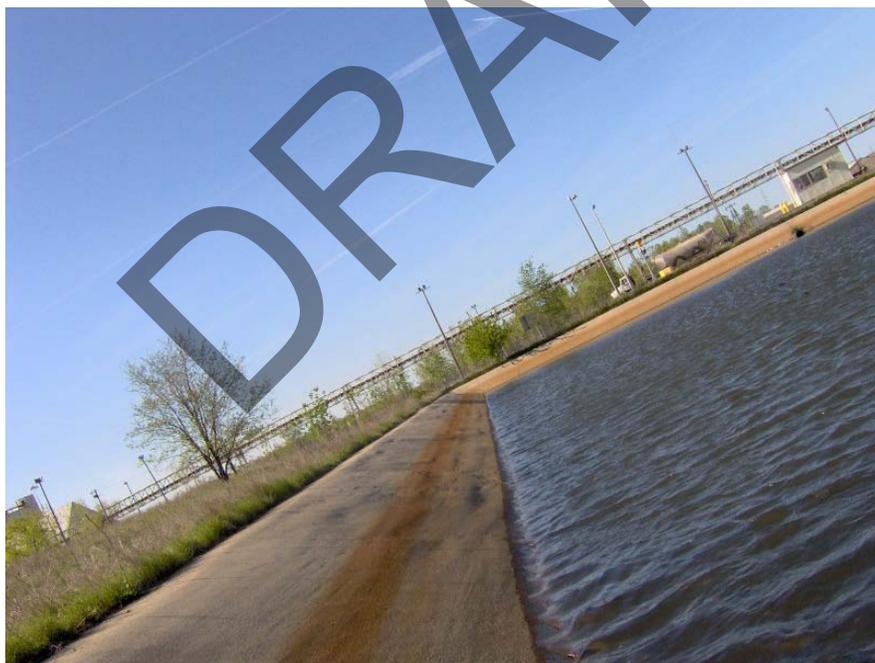
The interior slope of the concrete incised pond appears to be in good condition (Photograph 81 and 82). A surface crack in the concrete was observed at the top of the slope near the pipe inlets (Photograph 79). Construction joints have been sealed with an apparently elastic caulk.

81. Retention Pond – West interior wall

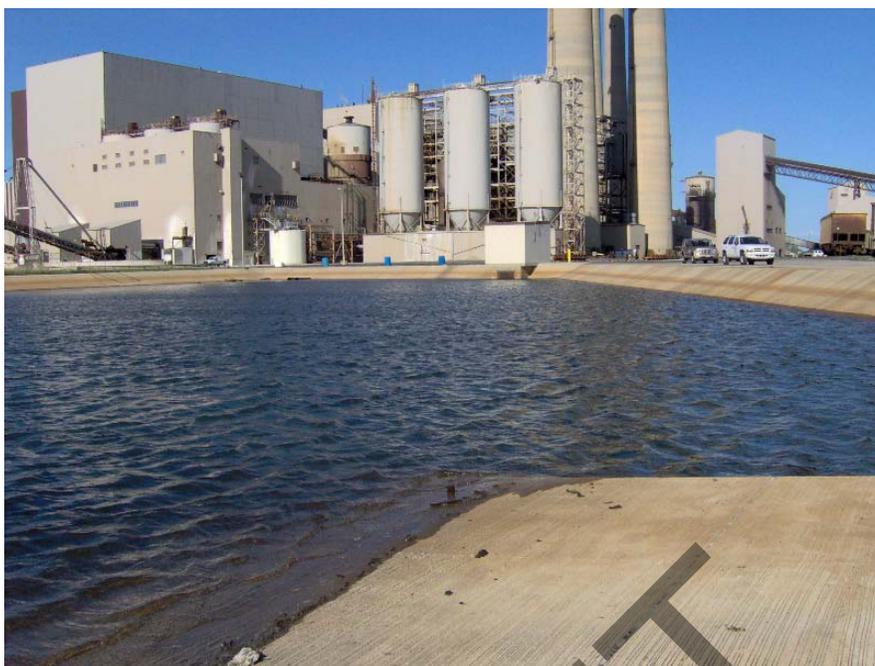
82. Retention Pond - Ramp on south wall

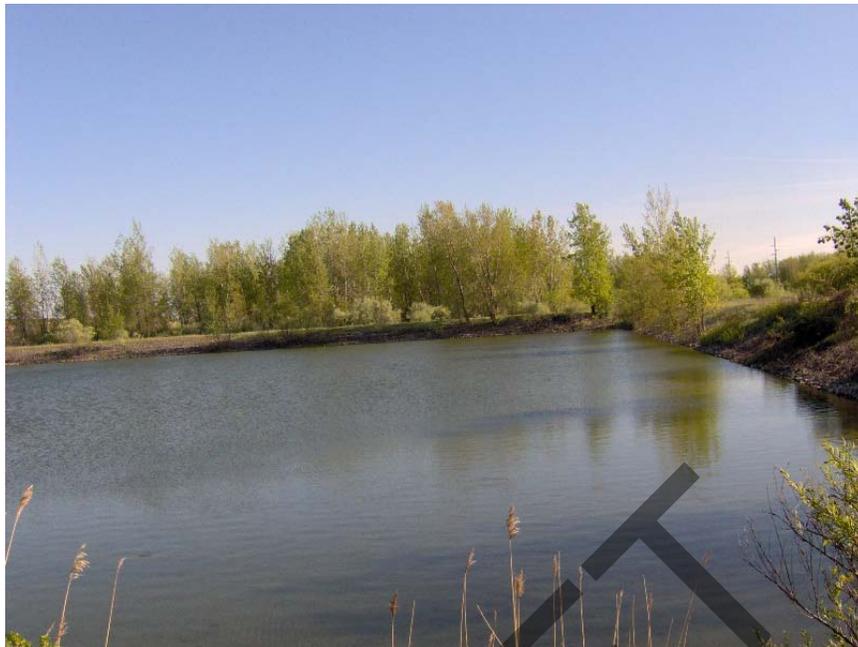
83. FGD Landfill Runoff Pond - West embankment interior slope, looking south

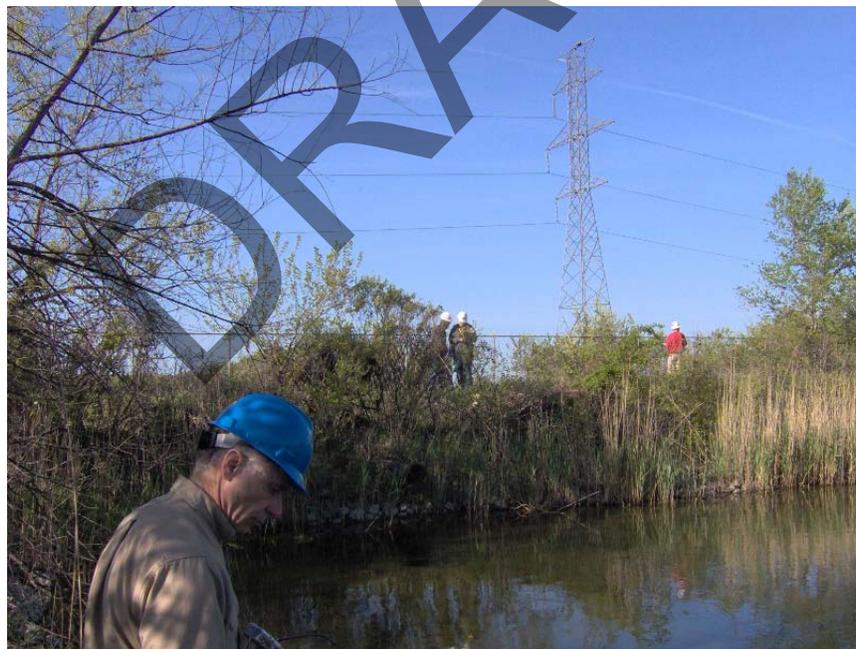
The interior slopes appear to be in poor condition. The embankments' interior slopes are armored with riprap and have a slope of approximately 3H: 1V. Heavy vegetation is prevalent on all interior slopes (Photographs 84, 88, and 90). Trees, up to 24 inches in diameter, were observed on all of the interior slopes (Photographs 85, 86, 87, 88, 90, 91, and 93). The largest trees were observed on the east embankment interior slope (Photographs 88 and 93). An approximate 12 inch diameter tree was growing on the south embankment exterior slope (Photograph 92).

84. FGD Landfill Runoff Pond - North embankment interior slope, heavy vegetation

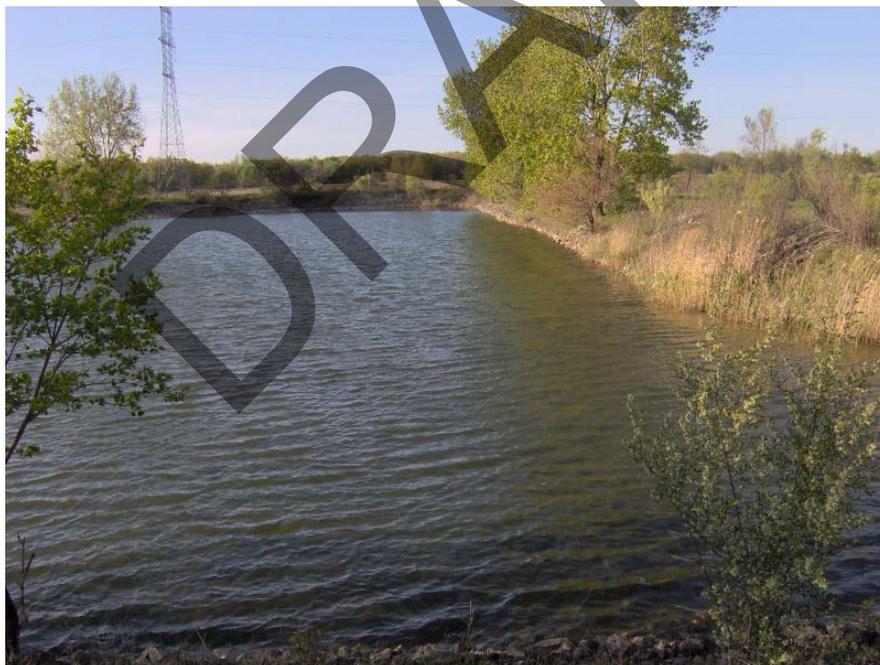
90. FGD Landfill Runoff Pond - East embankment interior slope, vegetation

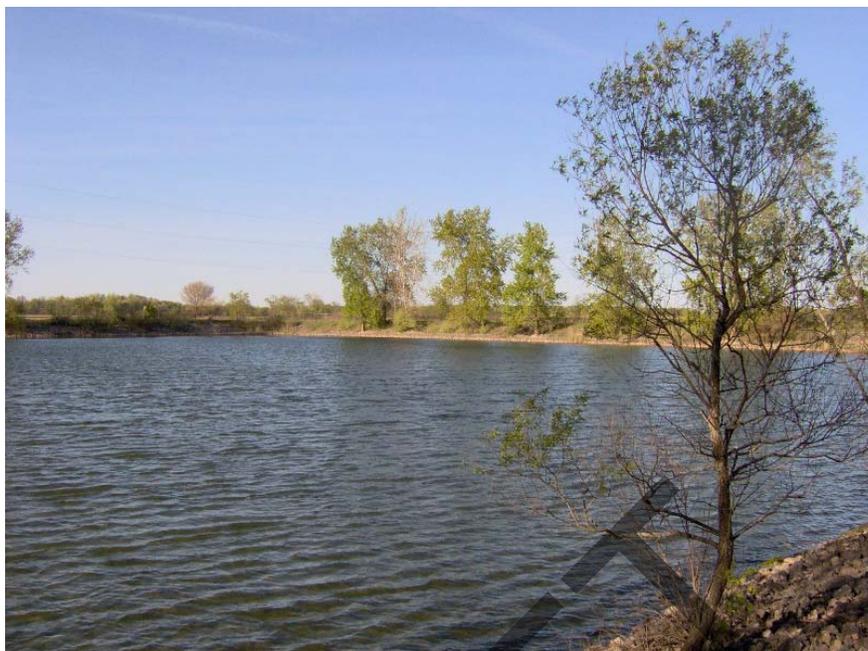
93. FGD Landfill Runoff Pond - Trees at base of east embankment interior slope

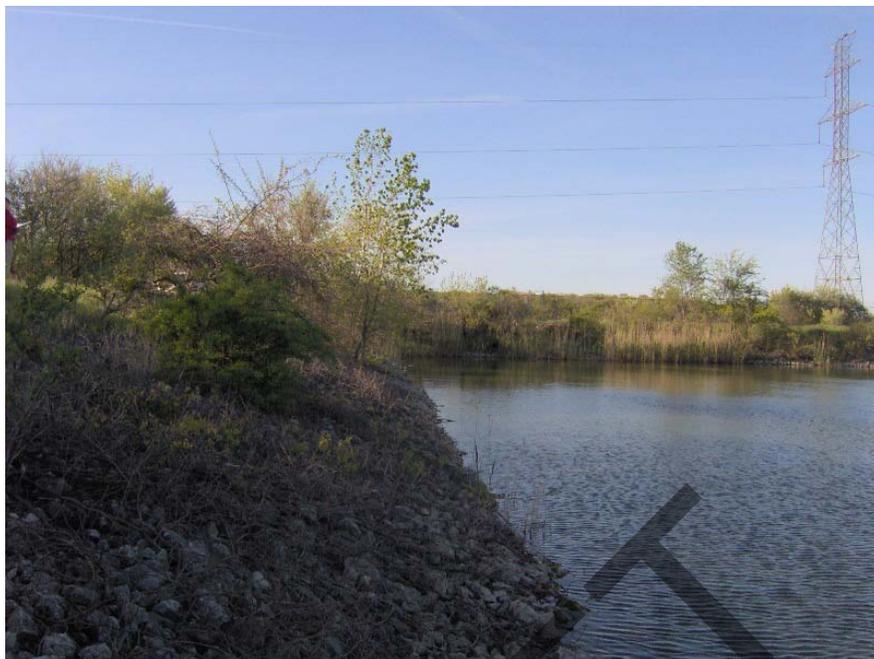
95. FGD Landfill Runoff Pond - West embankment interior slope

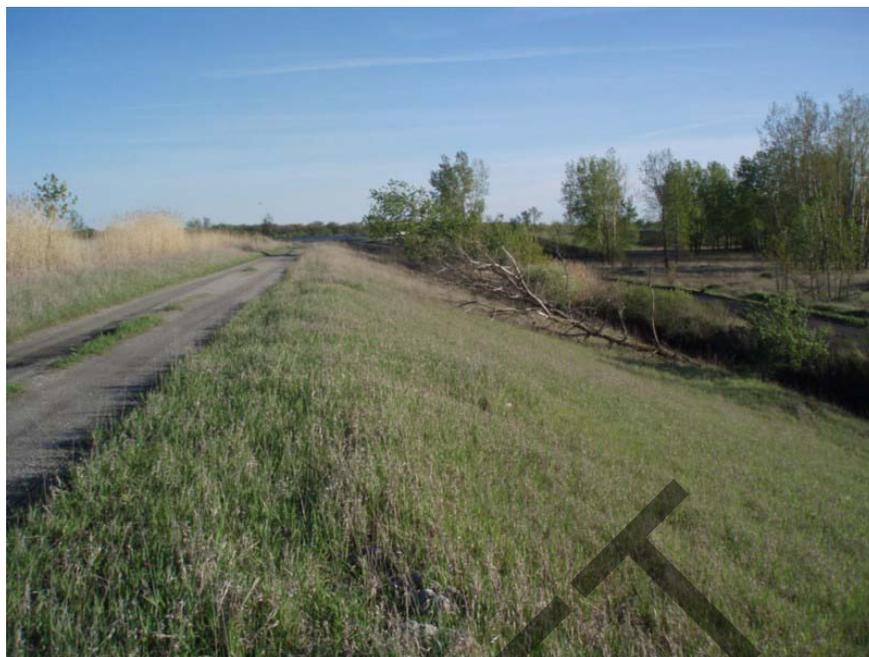
96. Gypsum Storage Area (Units 14&15) A - West embankment exterior slope

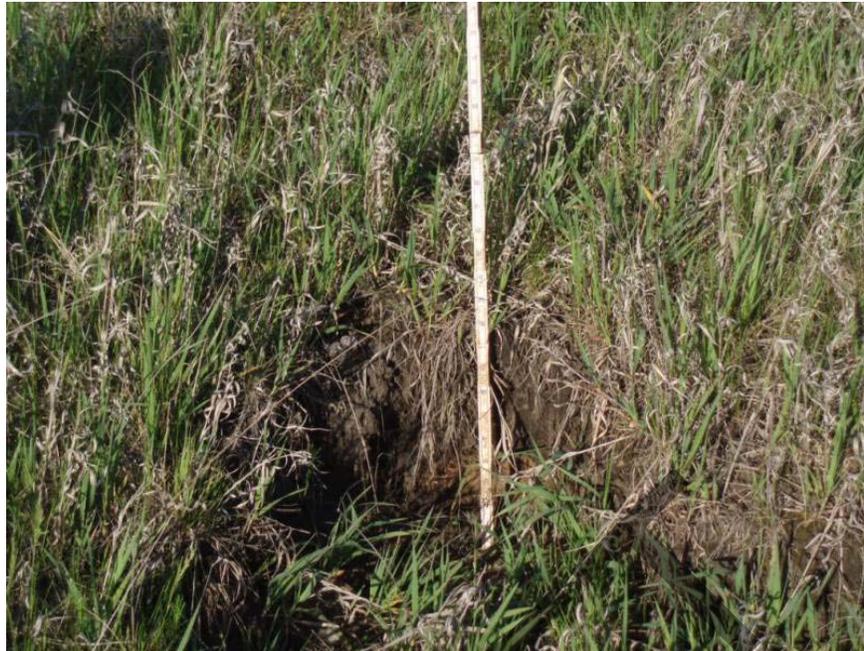
98. Gypsum Storage Area (Units 14&15) A - Rodent burrow on west embankment exterior slope

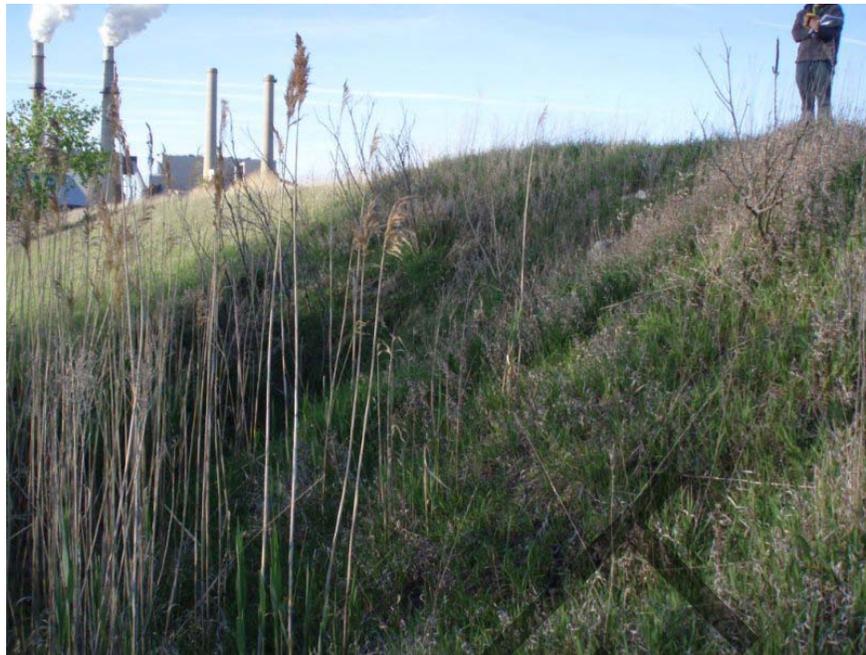
102. Gypsum Storage Area (Units 14&15) A - West embankment exterior slope, erosion Rills

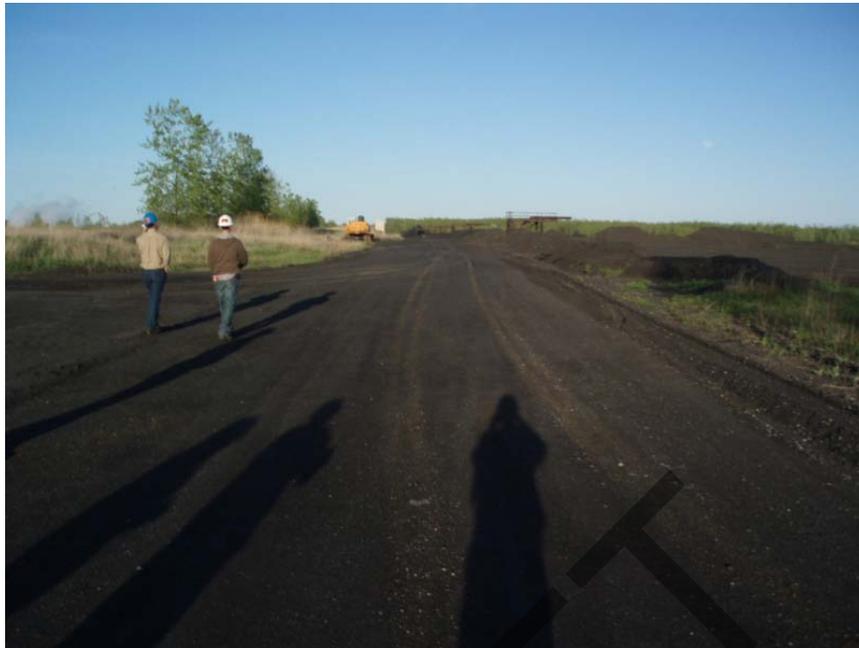
104. Gypsum Storage Area (Units 14&15) A - South embankment crest

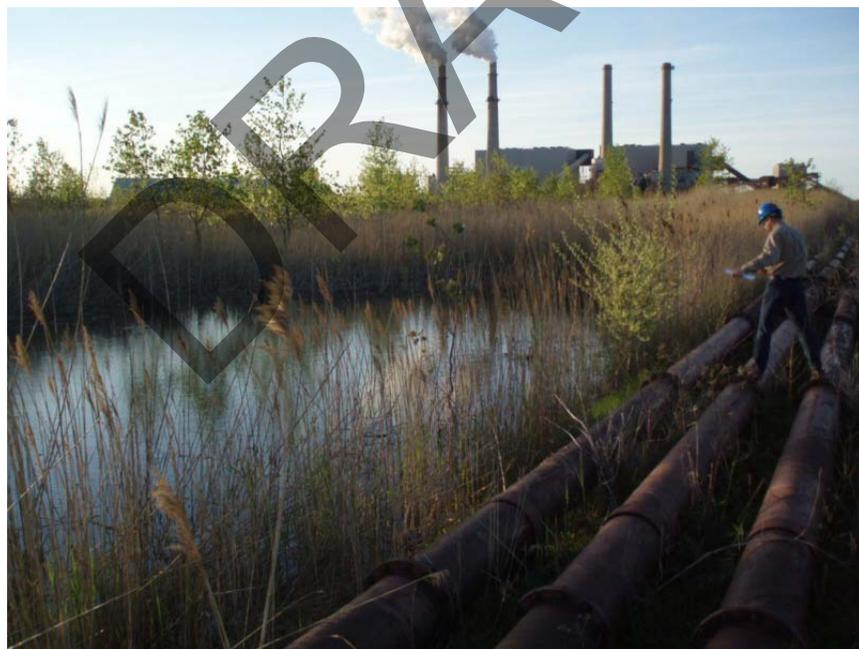
105. Gypsum Storage Area (Units 14&15) A - East embankment crest, sluice lines on crest, vegetation

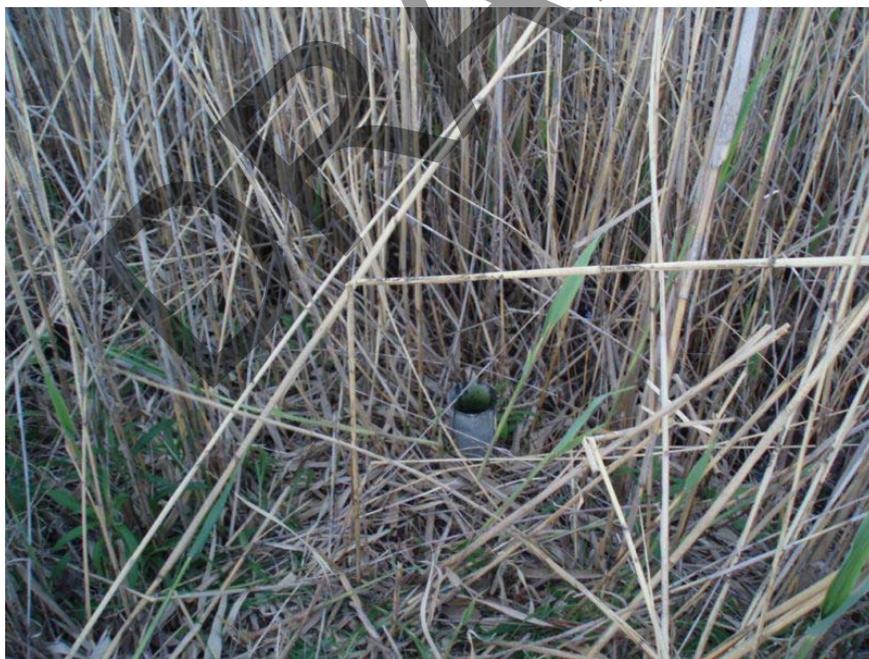
Grassy vegetation and brush were observed on the north, east and west embankment exterior slopes. The vegetation was approximately 6 to 12 inches tall. Trees (up to 12 inches in diameter) were observed near the toe of the exterior slopes of the north and west embankments (Photographs 96 and 112). Rodent burrows were observed on the west and north embankment exterior slopes (Photographs 98 and 109). A possible abandoned monitoring well was located on the east embankment exterior slope (Photograph 107).

107. Gypsum Storage Area (Units 14&15) A - East embankment exterior slope, heavy vegetation and possible abandoned monitoring well

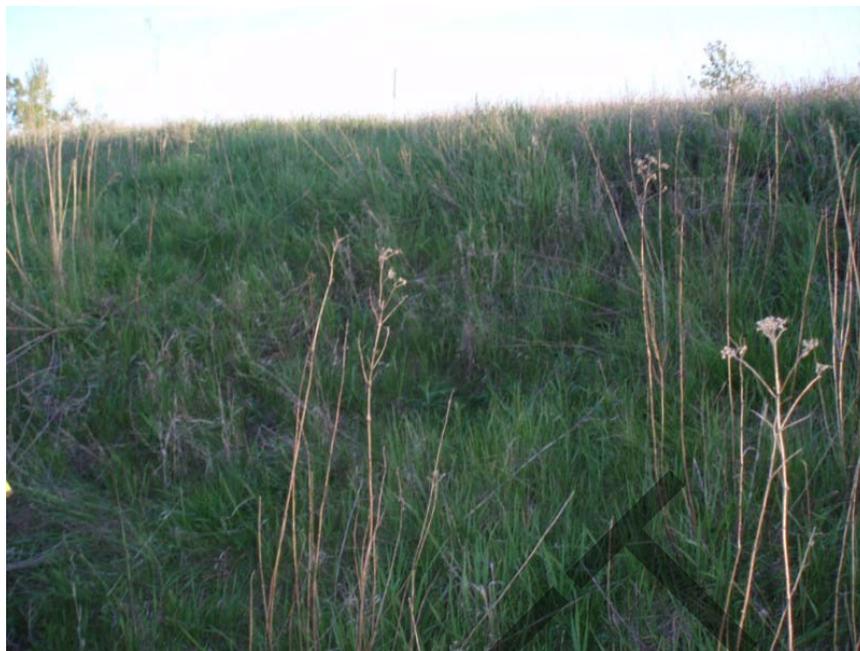
108. Gypsum Storage Area (Units 14&15) A - North embankment exterior slope, surface erosion

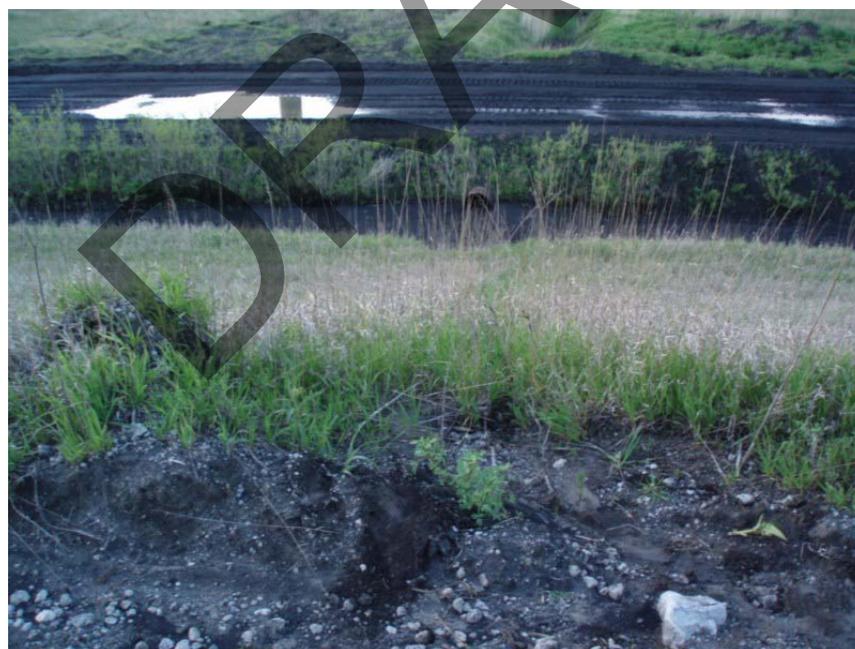
111. Gypsum Storage Area (Units 14&15) A - Active erosion rill channel on north embankment exterior slope

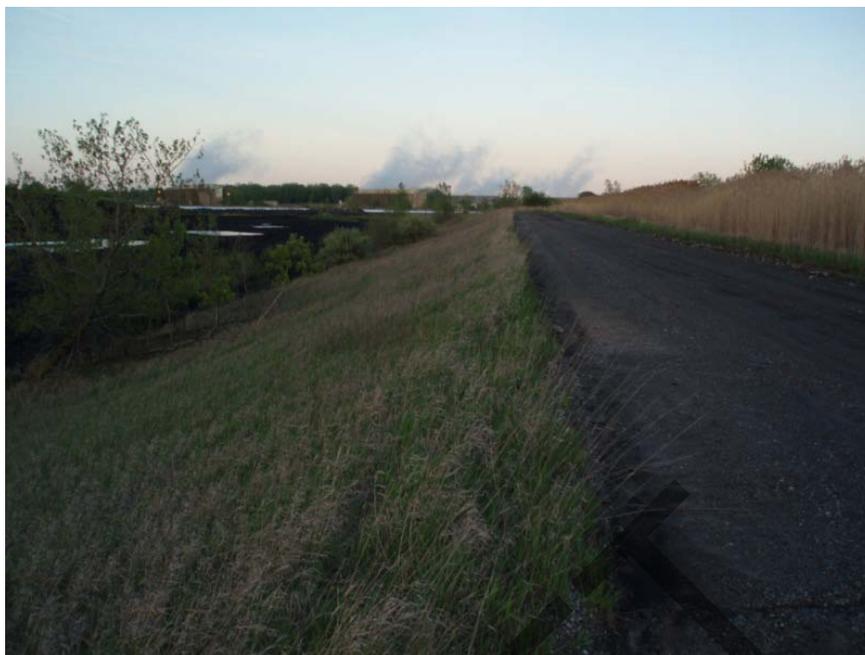
112. Gypsum Storage Area (Units 14&15) A - North embankment crest and exterior slope

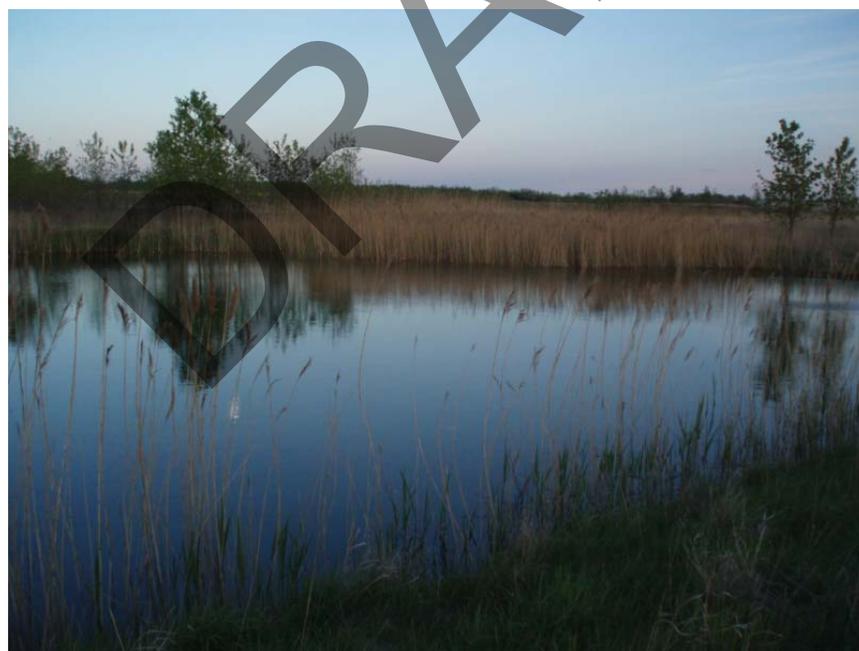
113. Gypsum Storage Area (Units 14&15) A - Standing water at northwestern corner of filled-in pond, note heavy vegetation on south embankment interior slope in background

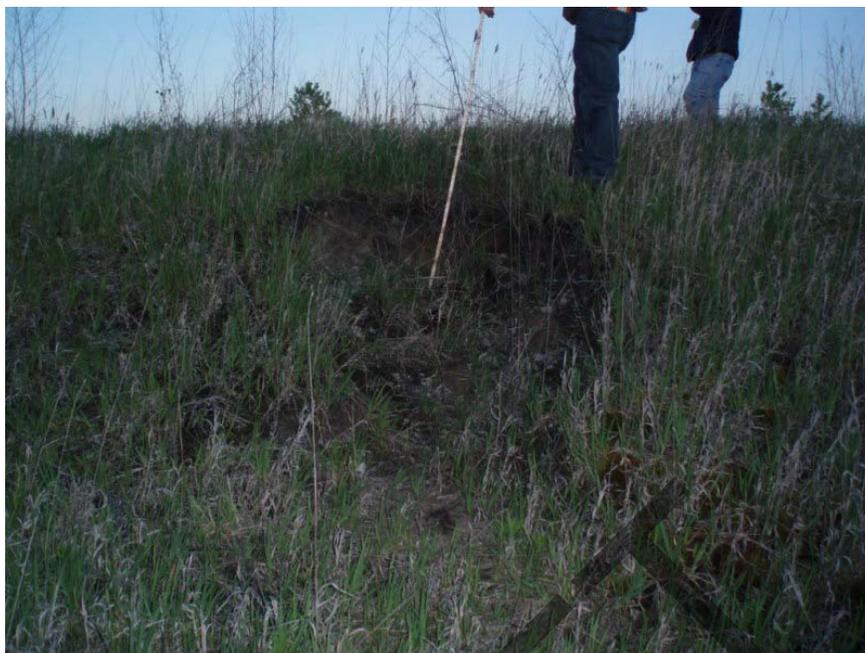
114. Gypsum Storage Area (Units 14&15) A - Slough on north embankment exterior slope

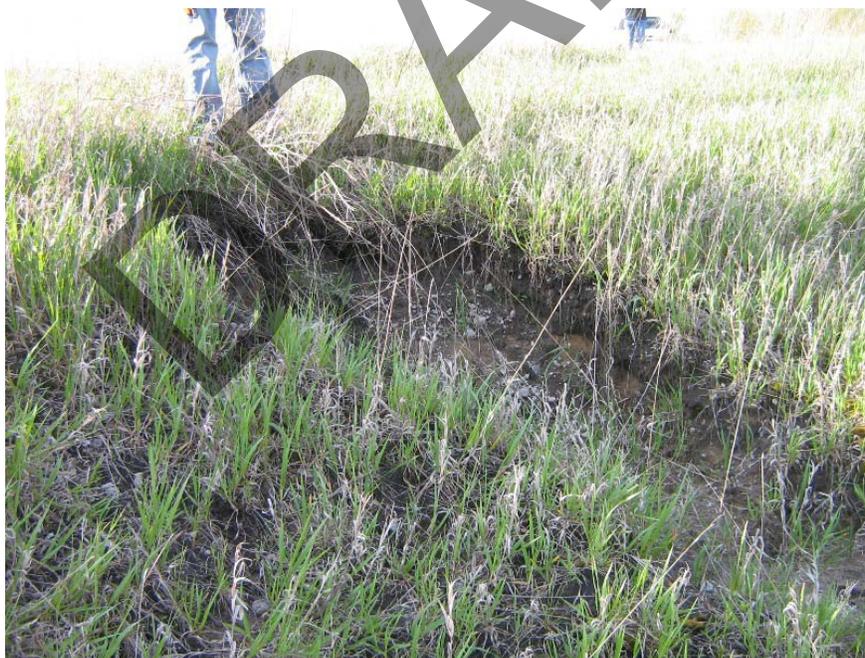
115. Gypsum Storage Area (Units 14&15) A - North embankment exterior slope, erosion rill

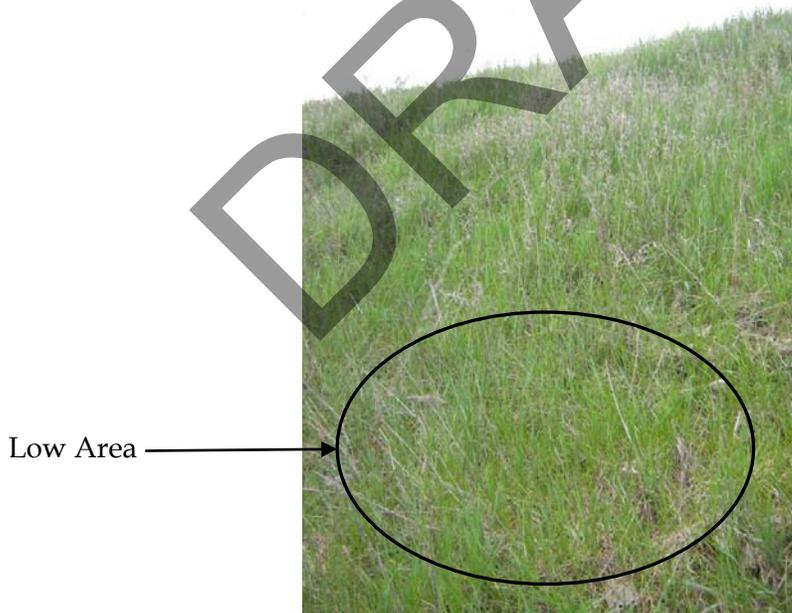
149. Waste Disposal Area - Low area noted on west embankment exterior slope

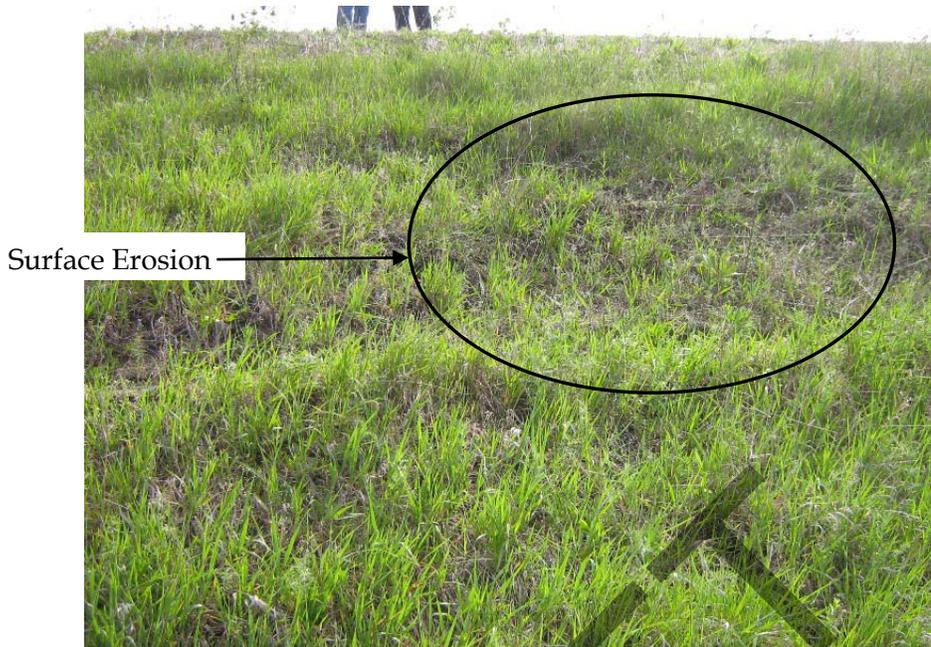
158. Waste Disposal Area - Surface erosion on west embankment exterior slope

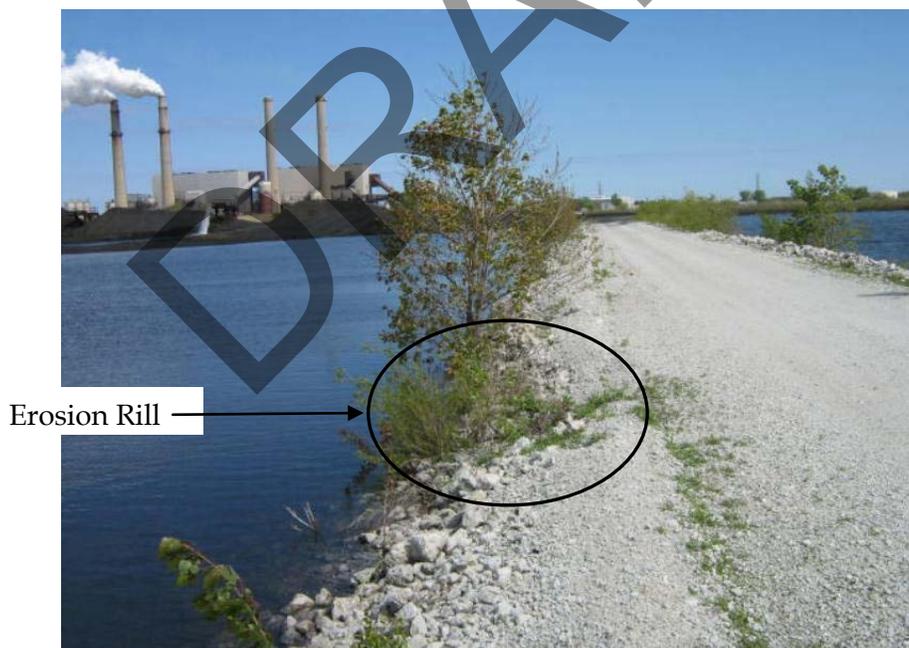
167. Waste Disposal Area - East embankment interior slope, erosion rill
