Assessment of Dam Safety of Coal Combustion Surface Impoundments

Northern Indiana Public Service Company

R.M. Schahfer Generating Station

November 19, 2010

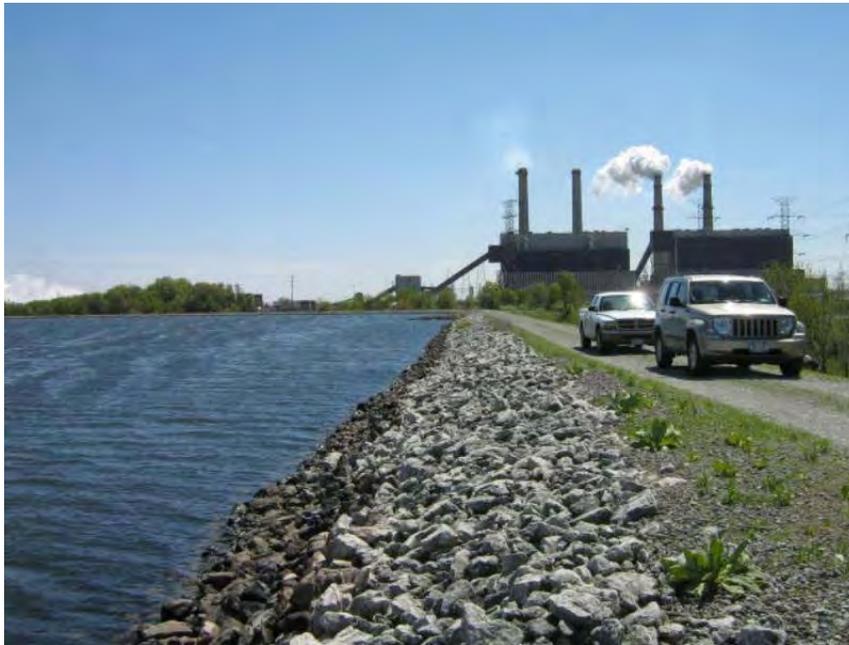
The interior slopes appear to be in fair condition. In general, the embankment's interior slope is armored with riprap (Photograph 3, 7, 16, 21, 23, 34, 35 and 39) and has a slope of approximately 3H: 1V. Riprap has been eroded near the waterline along the majority of the interior slope (Photograph 16 and 39 are typical). Riprap located on the east embankment interior slope has eroded from the top of the slope (Photograph 21).

3. Final Settling Basin - Embankment Interior Slope, Looking South, Armoring of the Slope is Observed

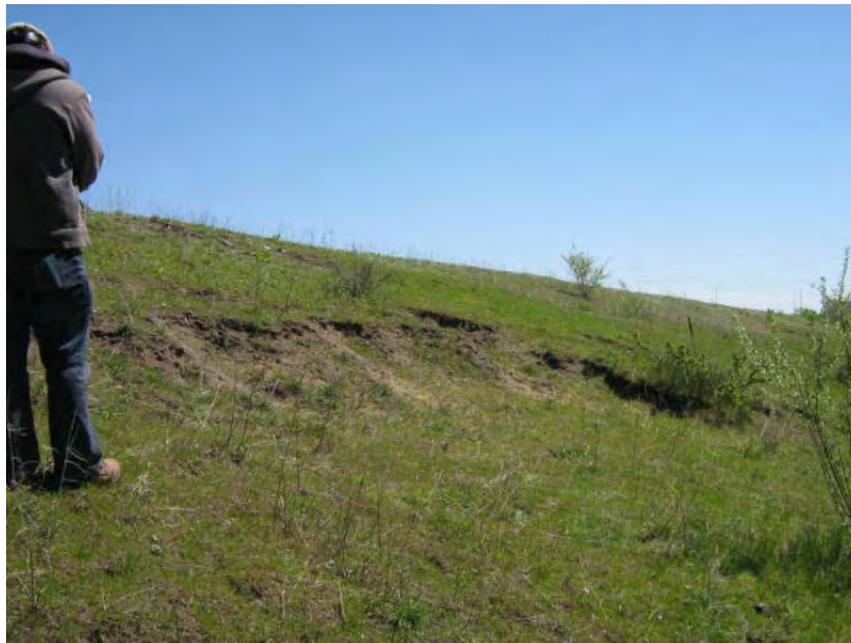
The exterior slopes appear to be in fair condition. The exterior slopes of the Final Settling Basin are approximately 3H: 1V. Several areas of minor surface erosion, erosion rills, and localized surface failures were observed along the exterior slopes (Photographs 4, 6, 8, 12, 13, 15, 32, and 38). A localized slope failure (approximately 32 feet in length) was observed along the west embankment (Photograph 36). Riprap has been placed on the southwest embankment exterior slope apparently to mitigate areas of erosion (Photograph 8 and 10). Little to no vegetation is growing along the top of the south and west embankment exterior slopes. In these areas, stone access road (crest) surfacing has been displaced onto the upper portions of the embankment exterior slope (Photographs 5, 6 and 15).

4. Final Settling Basin - West Embankment Exterior Slope Scarp (Approximately 36 feet Long)

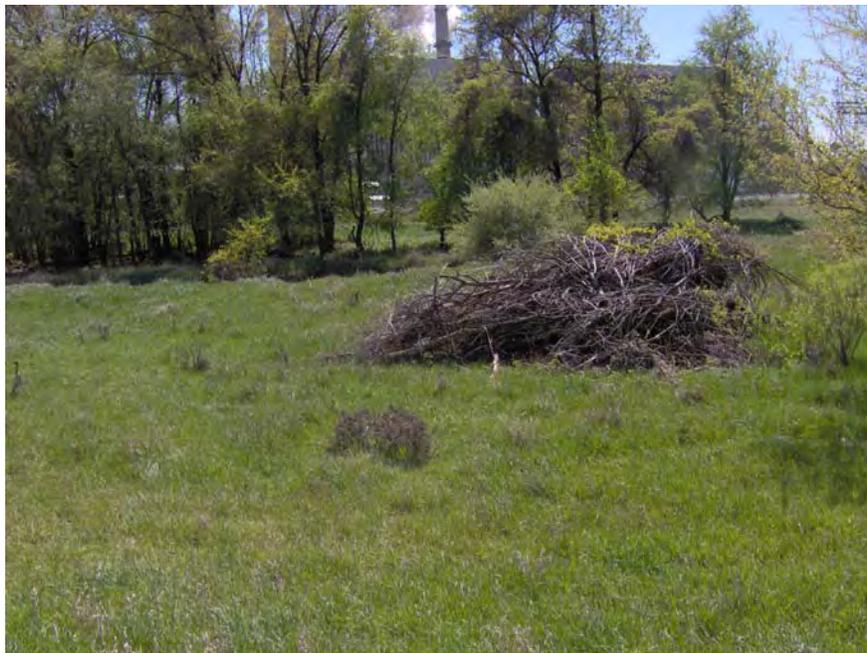
The east embankment was covered with multiple species of grass, which was generally 10 to 16 inches high. Grasses, shrubs, and small trees (up to 3 inches in diameter) were observed near the toe of the west, southwest, and north embankments exterior slopes (Photograph 5, 6, 8, 10, 14, 24, and 26). Several brush piles were observed in the open field at the toe of the slope, south of the Final Settling Basin (Photograph 11). The piles were identified by NIPSCO personnel as debris from previous embankment maintenance.

11. Final Settling Basin - Brush Pile Located on South Embankment

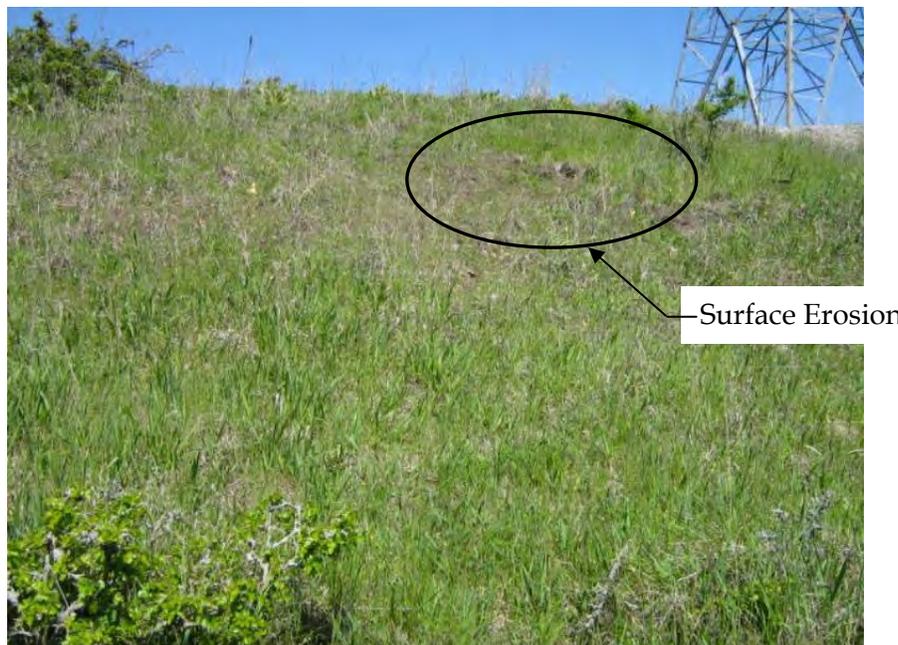
13. Final Settling Basin - Surface Erosion on South Embankment Exterior Slope

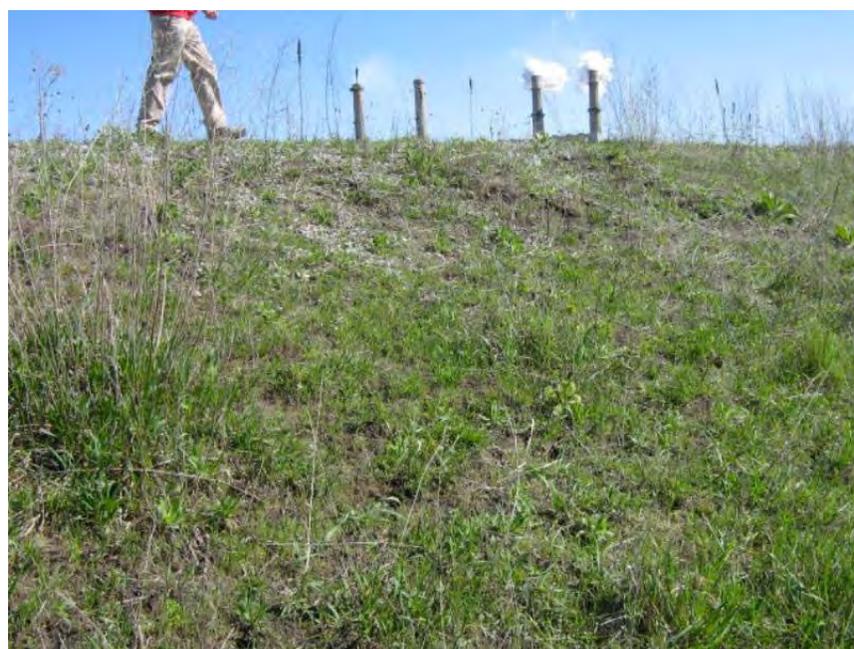
66. Intake Settling Basin - Erosion Rills on West Embankment
Exterior Slope

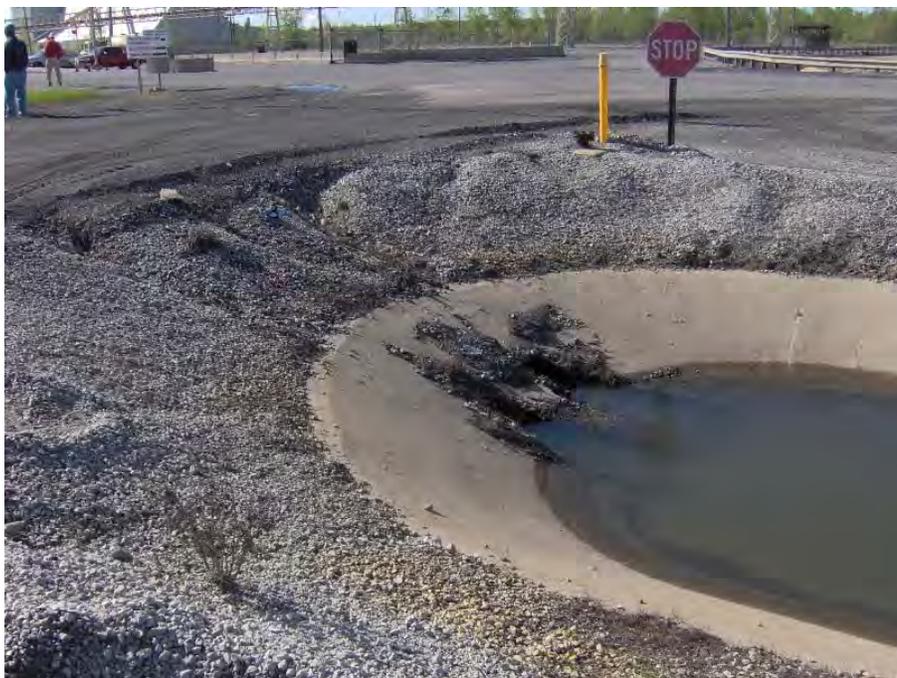
80. Retention Pond - Inlets

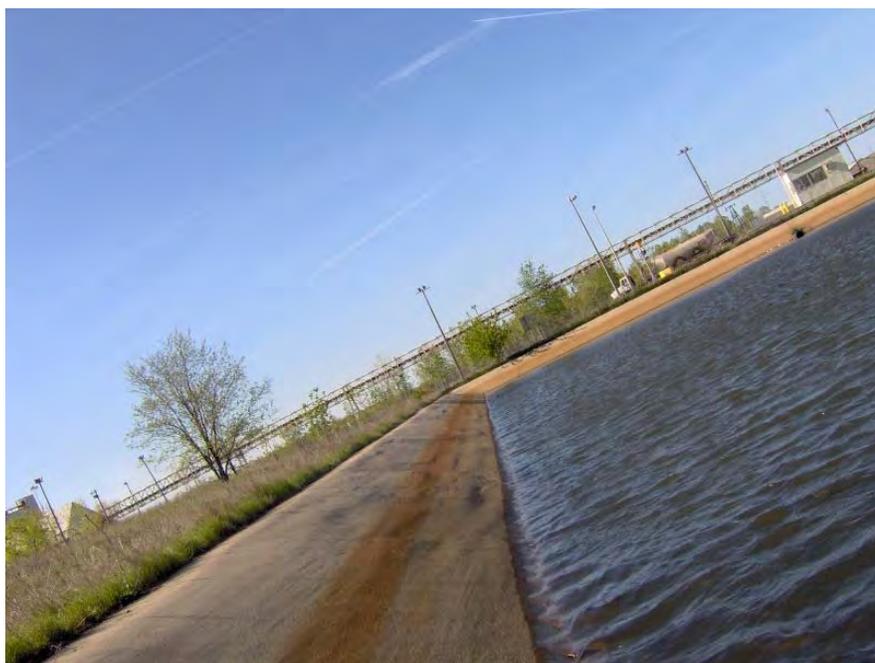
The interior slope of the concrete incised pond appears to be in satisfactory condition (Photograph 81 and 82). A surface crack in the concrete was observed at the top of the slope near the pipe inlets (Photograph 79). Construction joints have been sealed with an apparently elastic caulk.

81. Retention Pond - West Interior Wall

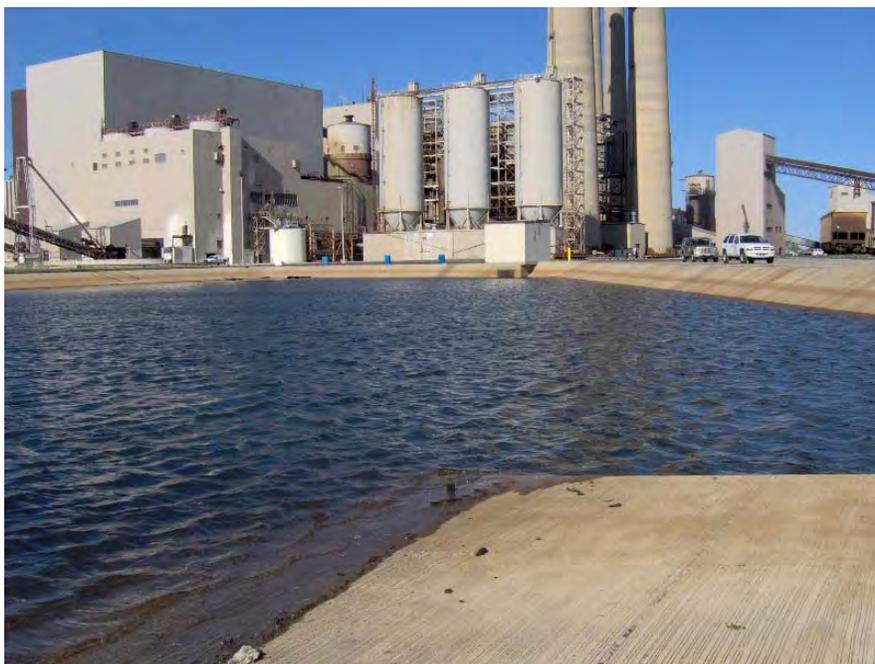
82. Retention Pond - Ramp on South Wall

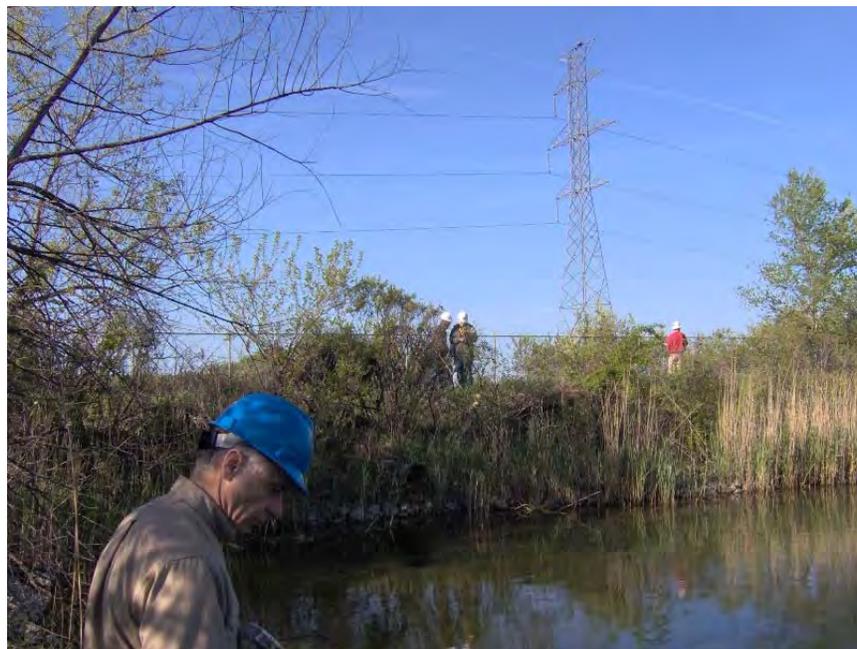
The interior slopes appear to be in poor condition. The embankments' interior slopes are armored with riprap and have a slope of approximately 3H: 1V. Heavy vegetation is prevalent on all interior slopes (Photographs 84, 88, and 90). Trees, up to 24 inches in diameter, were observed on all of the interior slopes (Photographs 85, 86, 87, 88, 90, 91, and 93). The largest trees were observed on the east embankment interior slope (Photographs 88 and 93). An approximate 12-inch-diameter tree was growing on the south embankment exterior slope (Photograph 92).

84. FGD Landfill Runoff Pond - North Embankment Interior Slope,
Heavy Vegetation

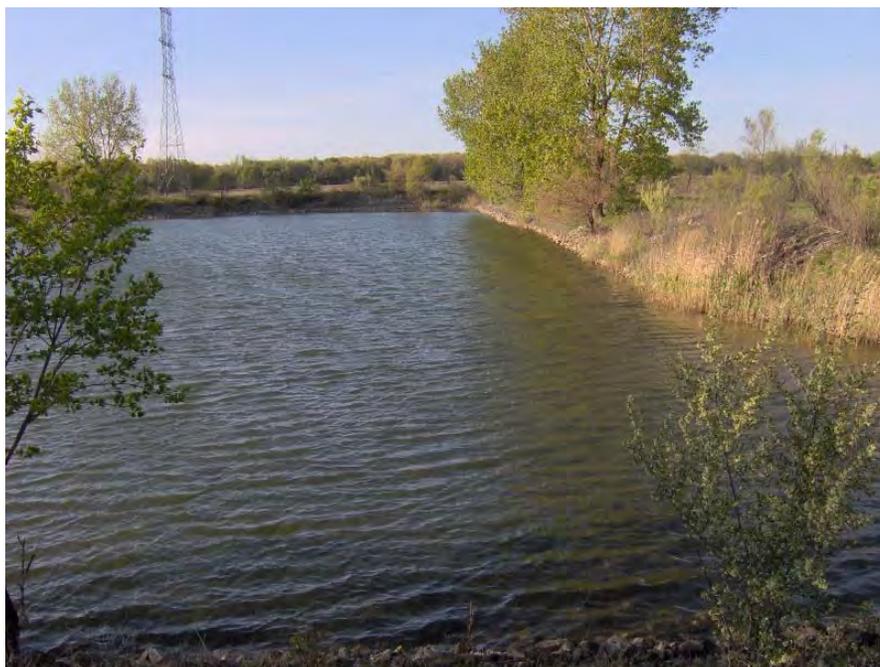
90. FGD Landfill Runoff Pond - East Embankment Interior Slope, Vegetation

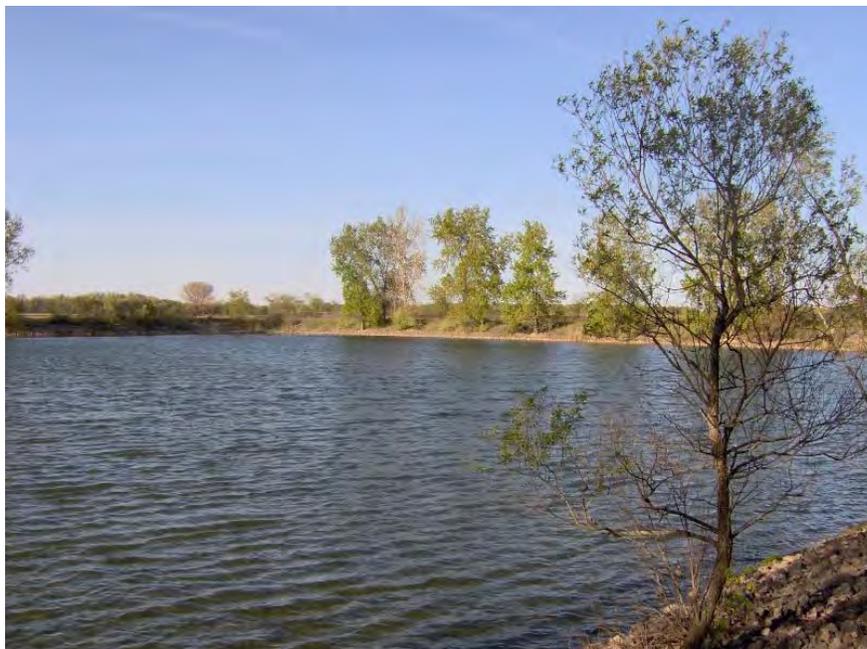
93. FGD Landfill Runoff Pond - Trees at Base of East Embankment
Interior Slope

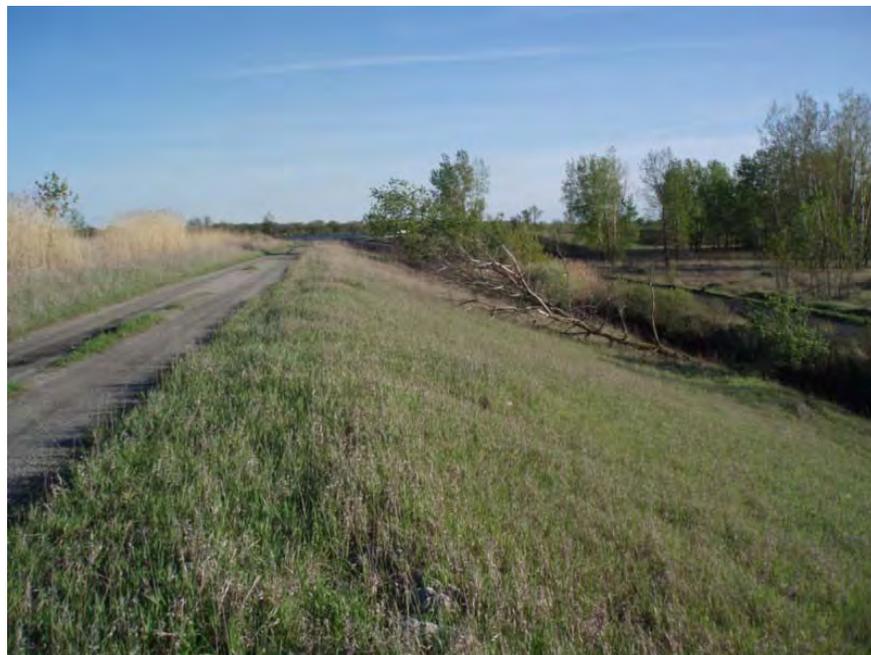
The crest appeared to be in satisfactory condition (Photograph 96, 97, 104, 112, 120 and 121). The crest is surfaced with compacted gravel and serves as an access road around the perimeter of the impoundment. Light vegetation was present along the centerline of the west embankment crest (Photographs 96 and 97). Some rutting was observed on the east embankment crest (Photograph 120). The crests appear to consist of compacted ash materials.

96. Retired Waste Disposal Area - West Embankment Exterior Slope

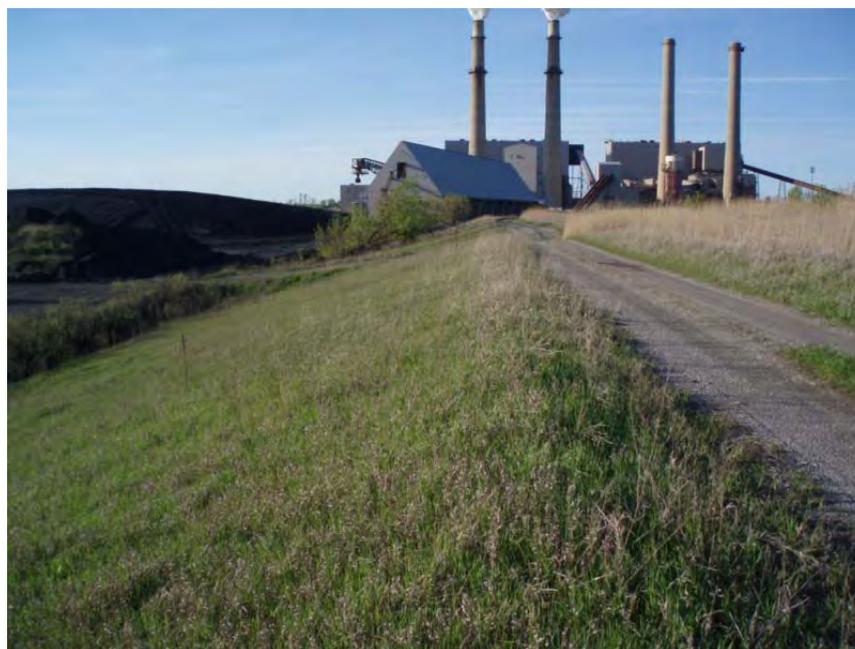
97. Retired Waste Disposal Area - West Embankment Exterior Slope

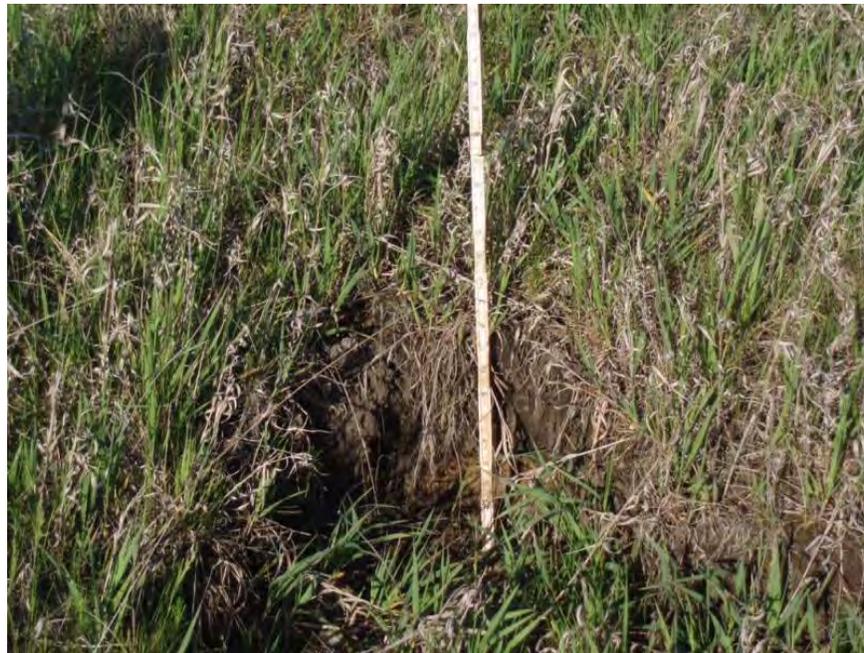
98. Retired Waste Disposal Area - Rodent Burrow on West Embankment Exterior Slope

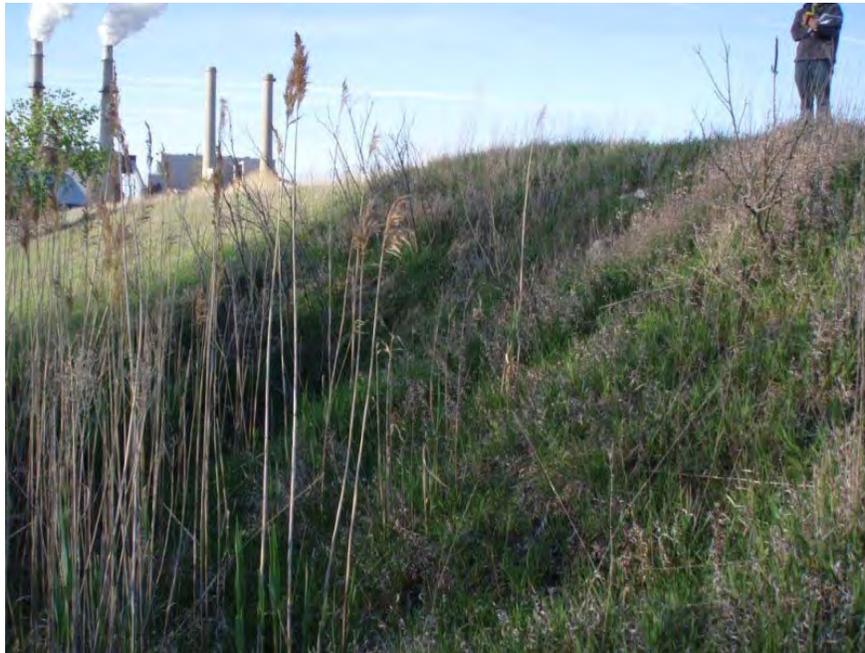
102. Retired Waste Disposal Area - West Embankment Exterior Slope, Erosion Rills

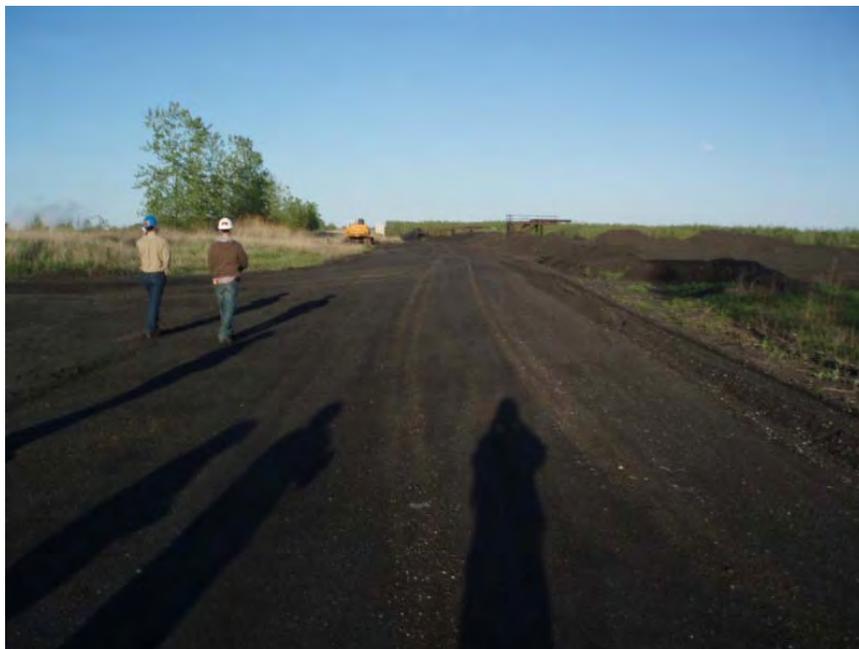
104. Retired Waste Disposal Area - South Embankment Crest

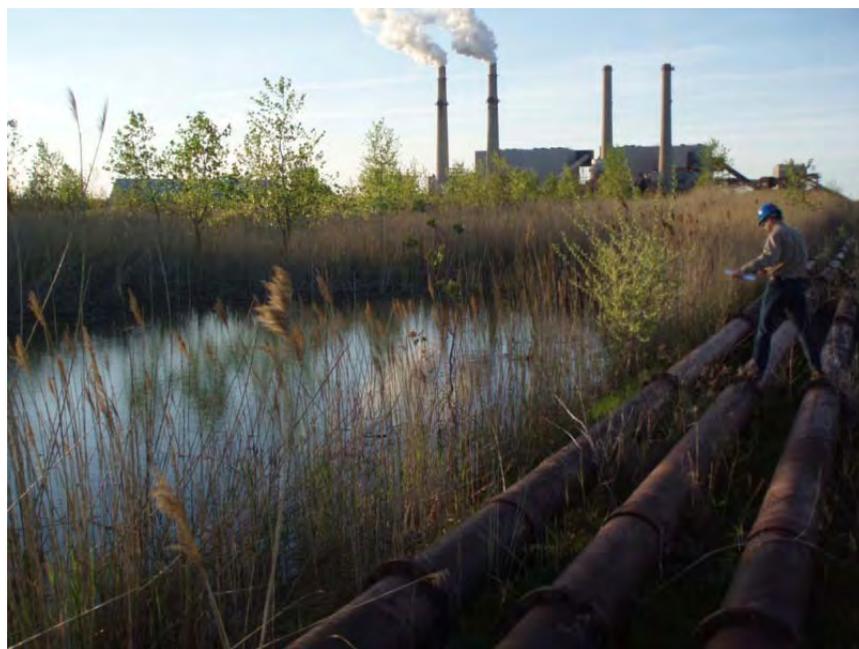
105. Retired Waste Disposal Area - East Embankment Crest, Sluice Lines on Crest, Vegetation

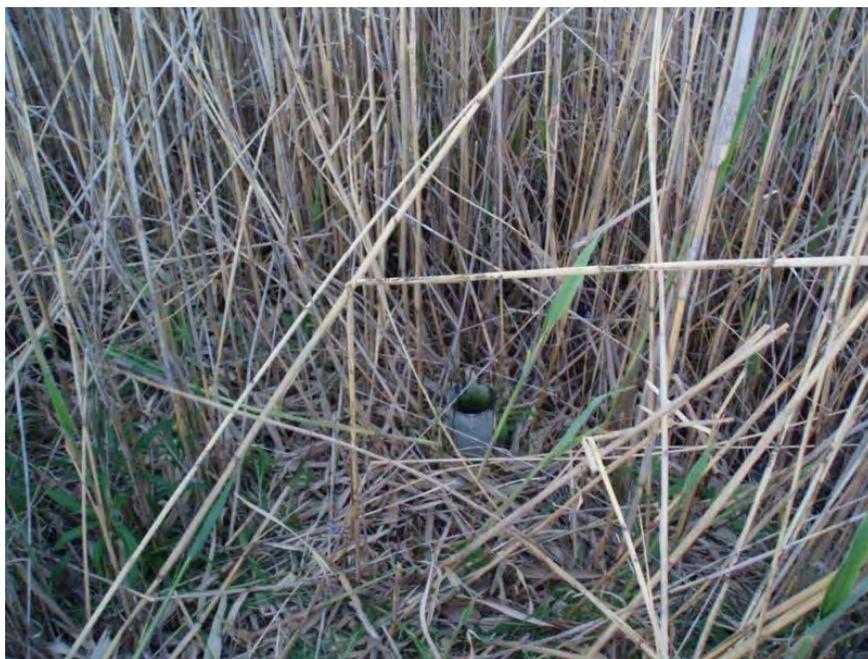
Grassy vegetation and brush were observed on the north, east and west embankment exterior slopes. The vegetation was approximately 6 to 12 inches tall. Trees (up to 12 inches in diameter) were observed near the toe of the exterior slopes of the north and west embankments (Photographs 96 and 112). Rodent burrows were observed on the west and north embankment exterior slopes (Photographs 98 and 109). A possible abandoned monitoring well was located on the east embankment exterior slope (Photograph 107).

107. Retired Waste Disposal Area - East Embankment Exterior Slope, Heavy Vegetation and Possible Abandoned Monitoring Well

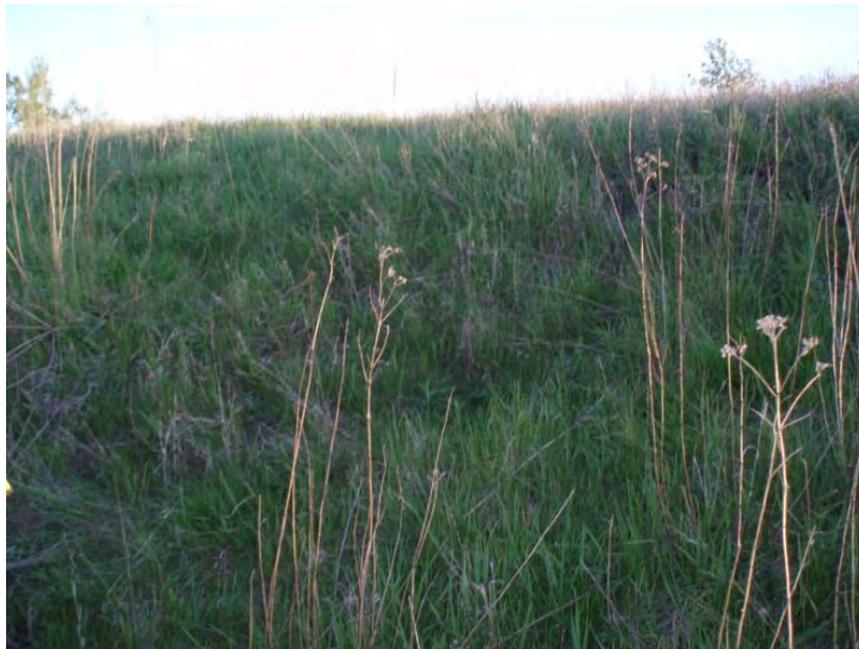
108. Retired Waste Disposal Area - North Embankment Exterior Slope, Surface Erosion

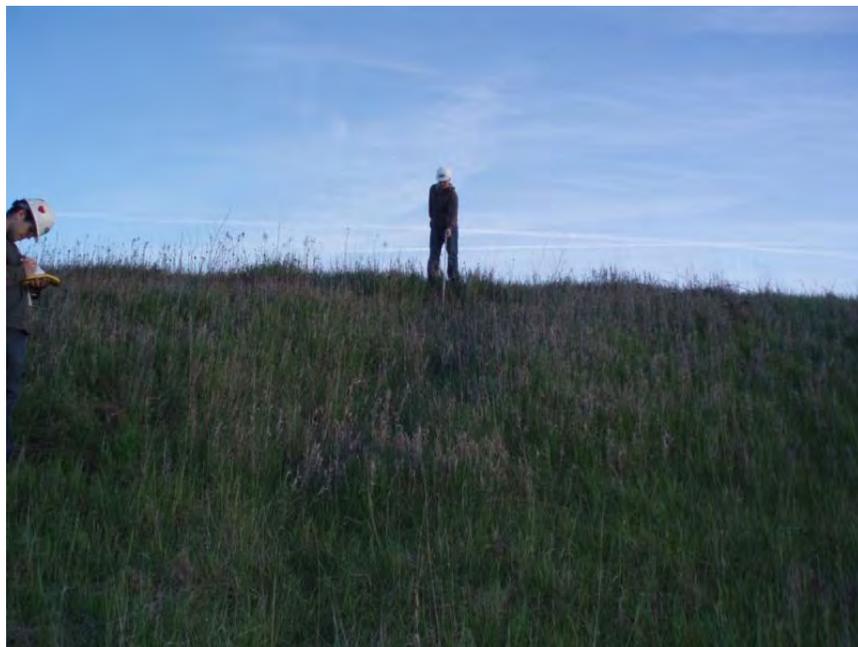
110. Retired Waste Disposal Area - Erosion Rill Down North Embankment Exterior Slope

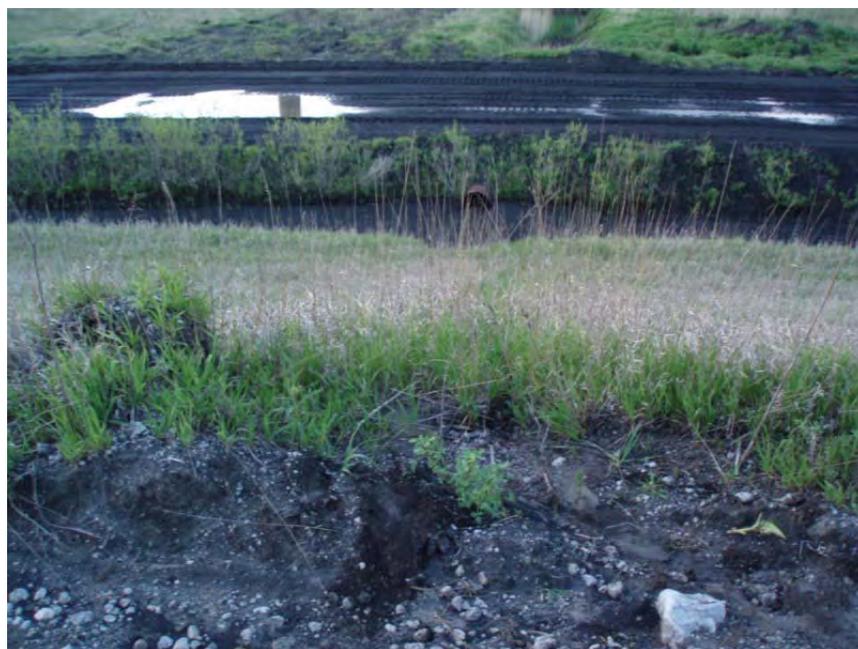
111. Retired Waste Disposal Area - Active Erosion Rill Channel on North Embankment Exterior Slope

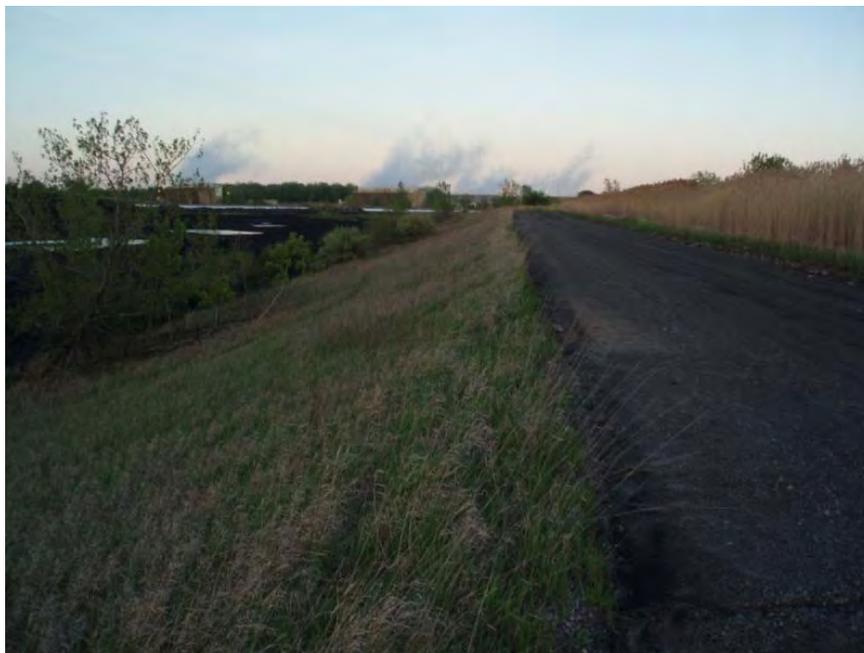
112. Retired Waste Disposal Area - North Embankment Crest and Exterior Slope

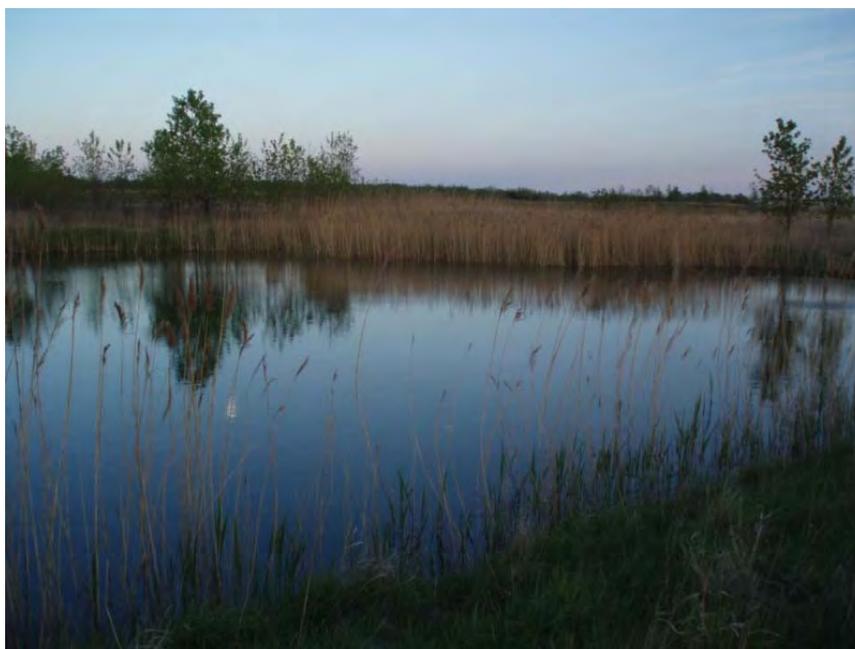
113. Retired Waste Disposal Area - Standing Water at Northwestern Corner of Filled-in Pond, Note Heavy Vegetation on South Embankment Interior Slope in Background

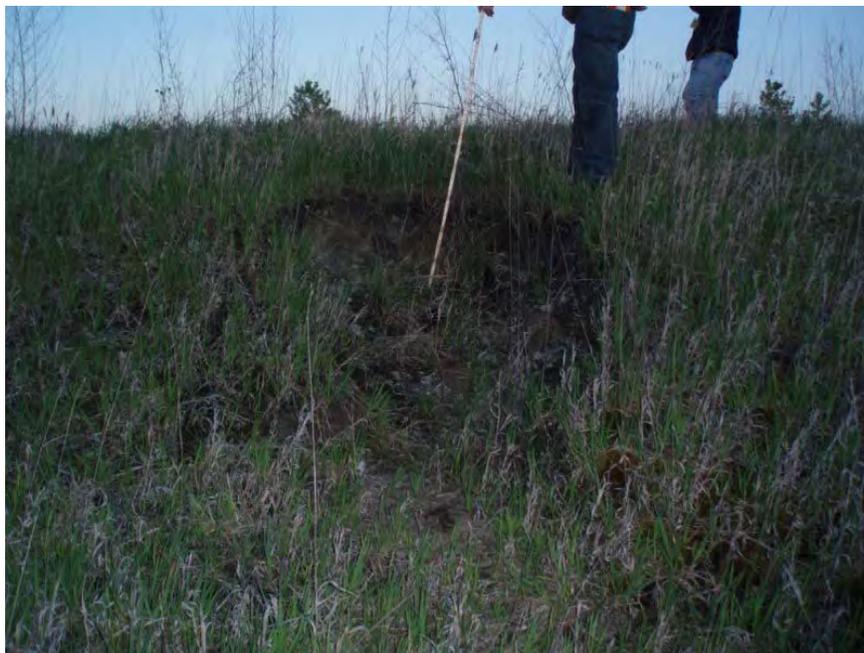
114. Retired Waste Disposal Area - Slough on North Embankment Exterior Slope

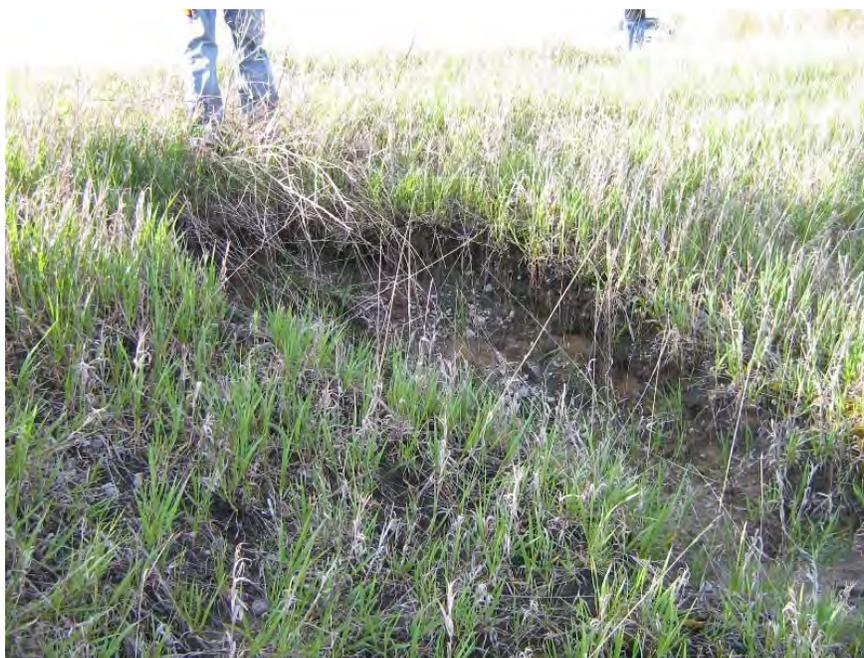
115. Retired Waste Disposal Area - North Embankment Exterior Slope, Erosion Rill

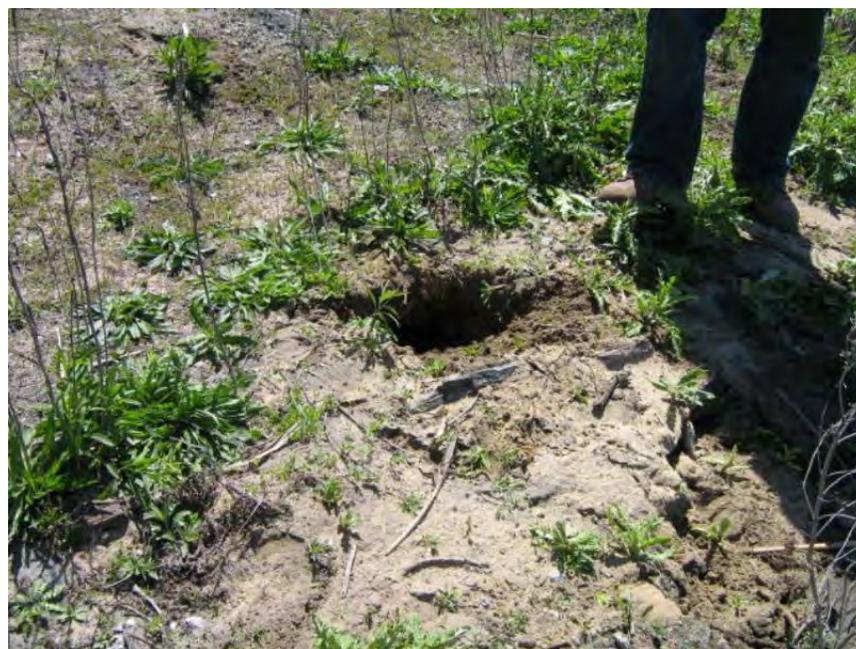
140. Metal Cleaning Waste Basin - East Embankment Interior Slope, Possible Start of Rodent Burrow (Approximately 2 feet in Length, 1 foot Deep)

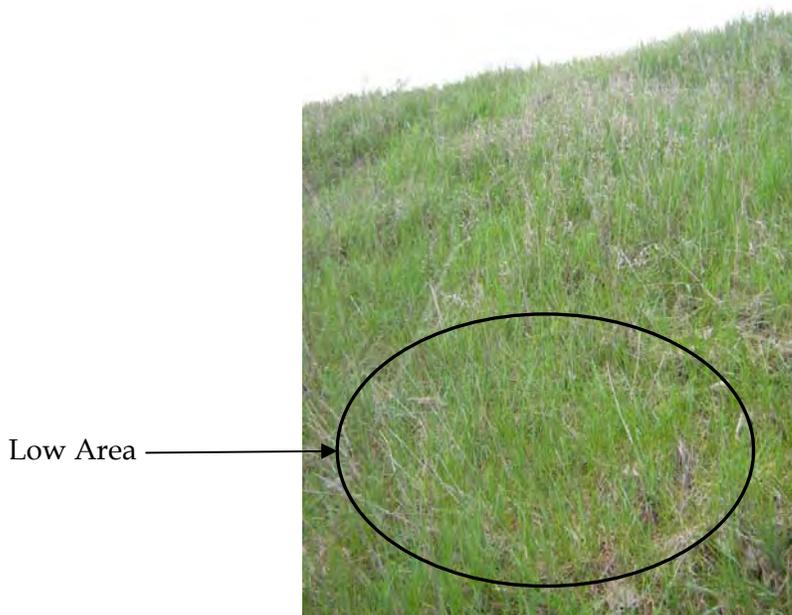
149. Waste Disposal Area - Low Area Noted on West Embankment Exterior Slope

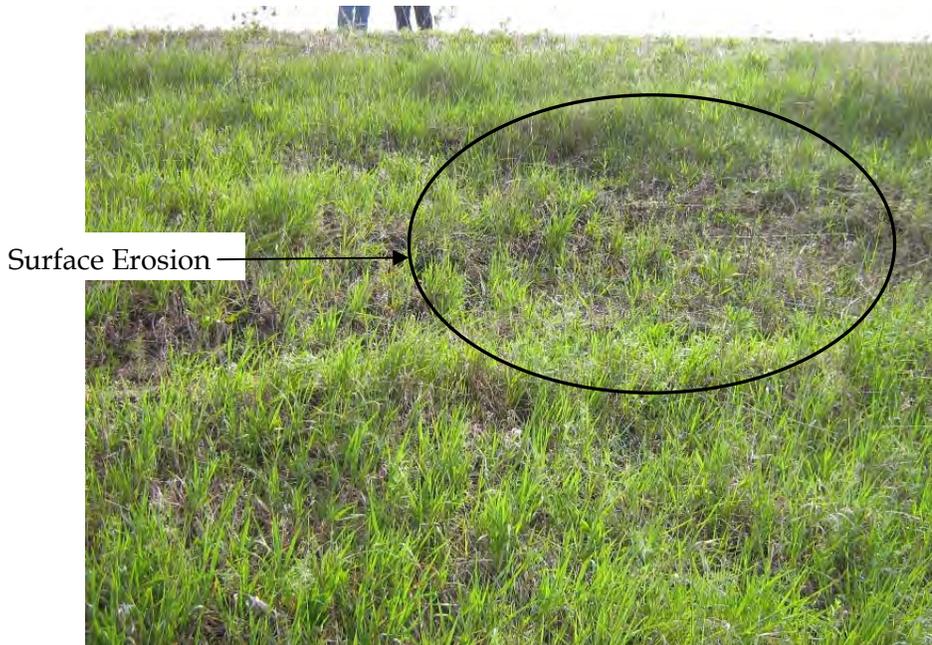
158. Waste Disposal Area - Surface Erosion on West Embankment Exterior Slope

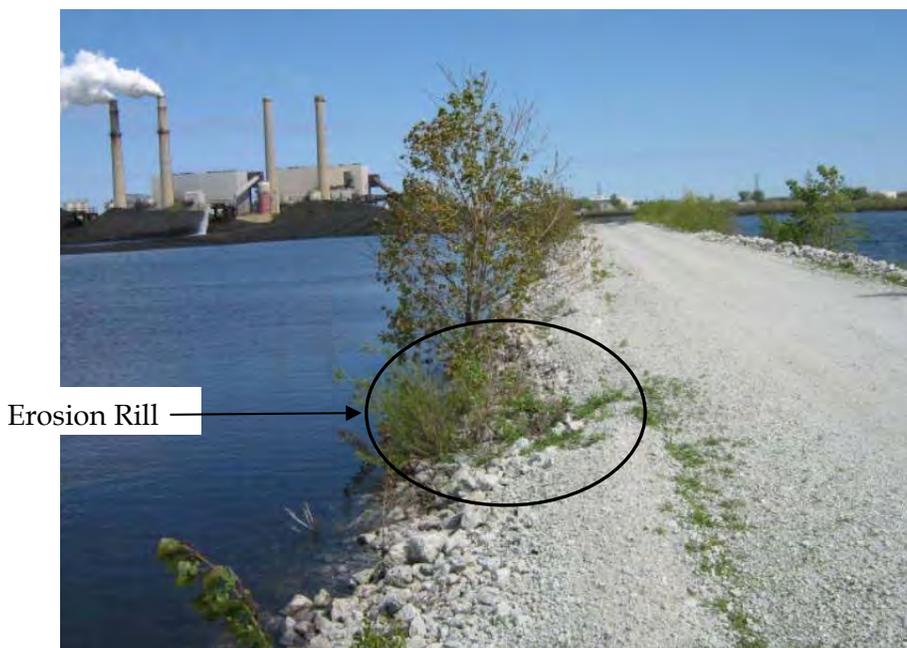
167. Waste Disposal Area - East Embankment Interior Slope,
Erosion Rill
