# Dam Safety Assessment of CCW Impoundments

## NRG CHESWICK POWER STATION

United States Environmental Protection Agency  
Washington, DC

January 2014

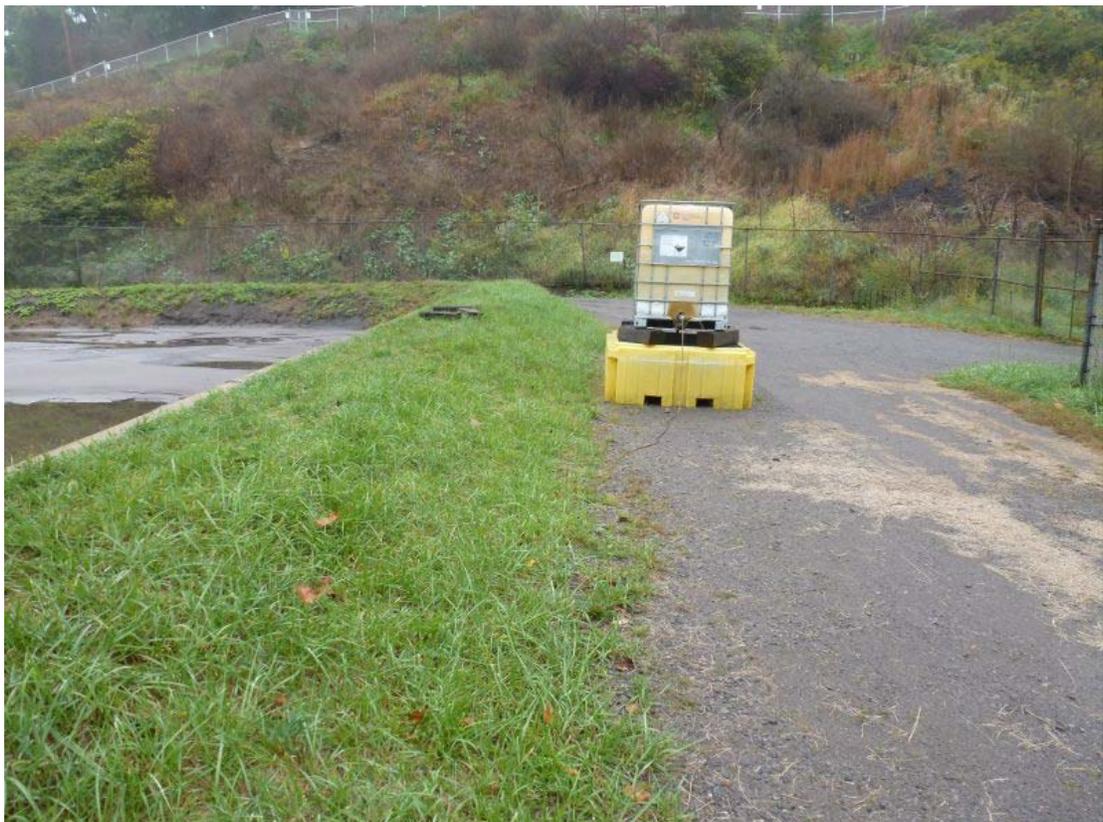
Date:  
9/27/12Photo Number:  
6Photographer:  
DDW

Date:  
9/27/12Photo Number:  
5Photographer:  
DDWOrientation:  
WestDescription:  
Bottom Ash  
Recycle Pond  
north  
embankment.  
Lack of  
vegetation on  
west inboard  
slope visible in  
background.  
Natural hill on  
west side of ash  
ponds in  
background.

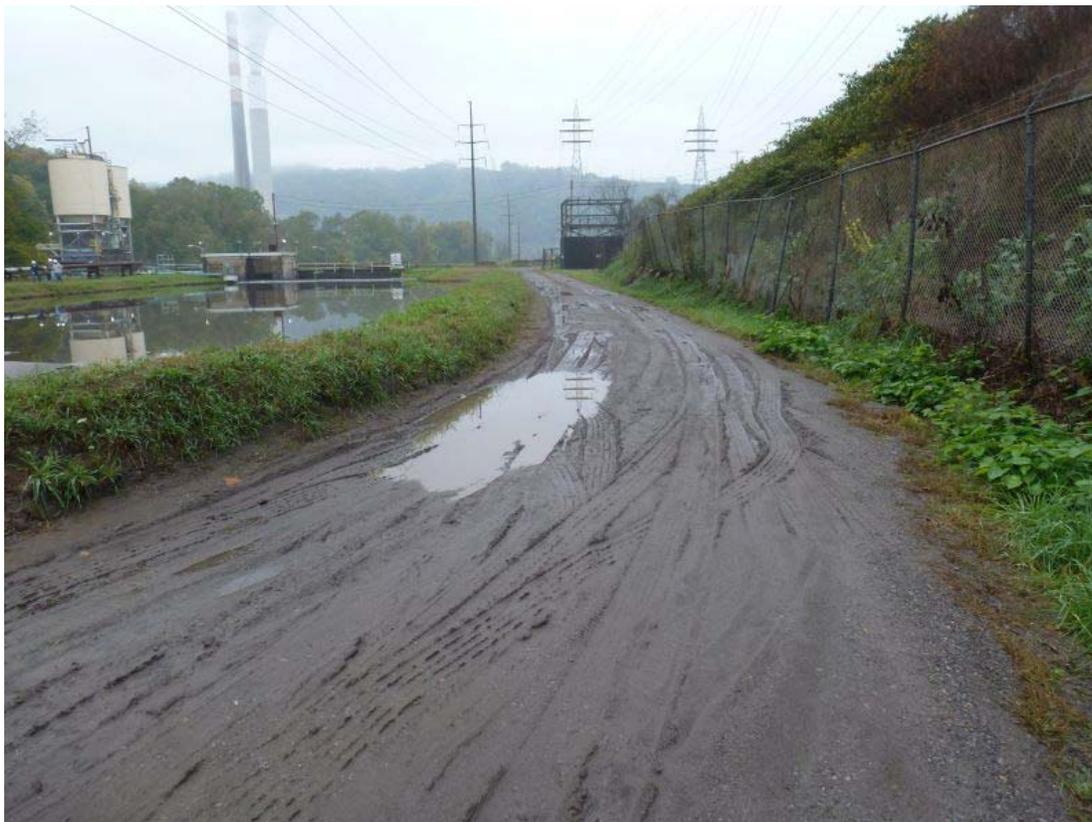
Photo Number:  
9

Description:  
Bottom Ash  
Recycle Pond  
western  
embankment  
and access  
road. Note  
some ponding  
on access road  
and natural  
hillside west of  
ash ponds.

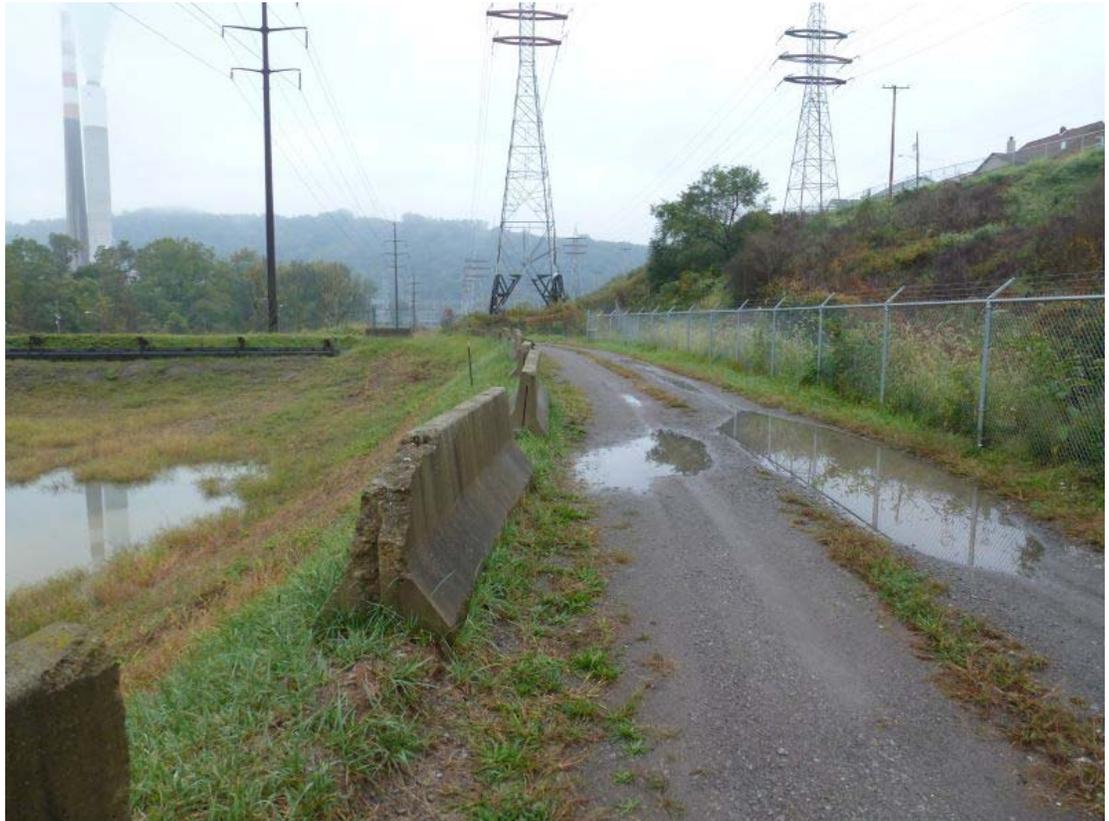
Date:  
9/27/12Photo Number:  
11Photographer:  
DDWOrientation:  
EastDescription:  
Emergency Ash Pond outflow structure, southwest corner inboard slope, and south crest/access road. Hydrobins in background.

Orientation:  
SouthDescription:  
Emergency Ash Pond western and southern inboard slopes, western access road with ponding, and natural hillside on west side of ash ponds.

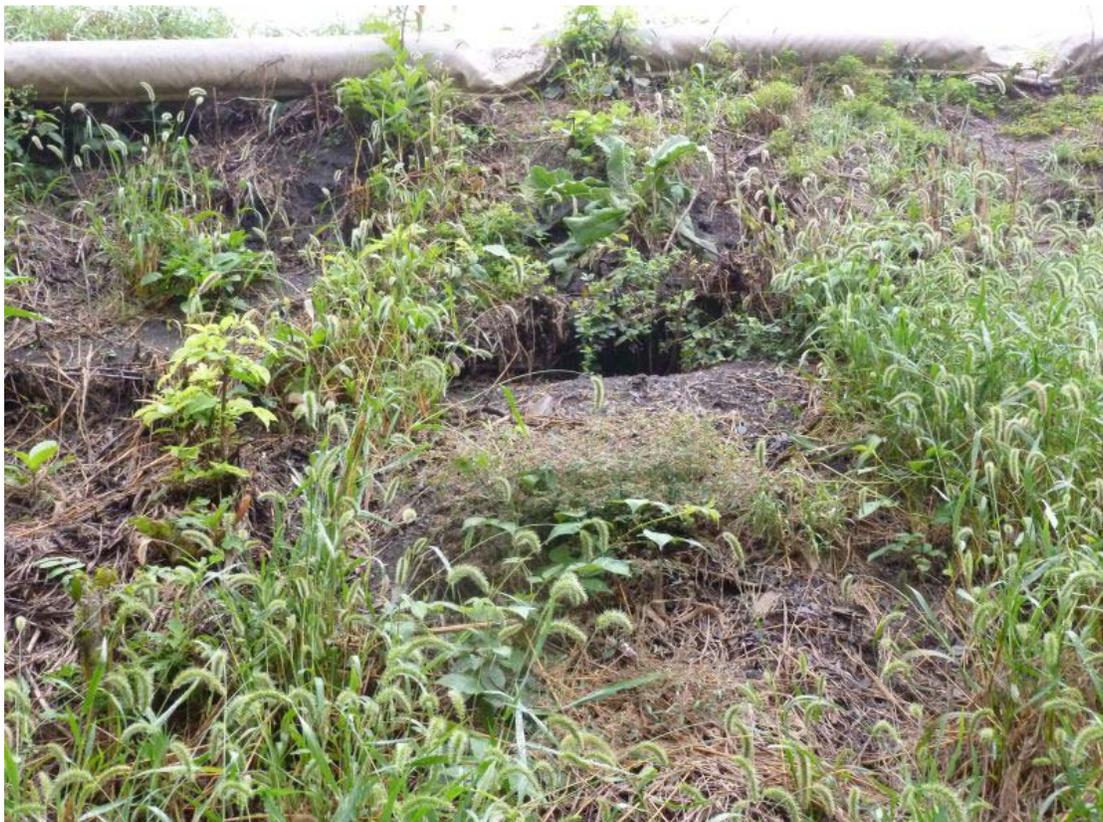
Photo Number:  
14

- The southern embankment outboard slope appeared in fair condition with some inadequate vegetation and no undesirable vegetation.
- The eastern embankment outboard slope had been cleared of shrubs and trees earlier in the year based on discussions with plant personnel. It was lacking vegetation in several areas likely cleared earlier in the year, showed some erosion and at least one animal burrow. There was some rip rap near the toe.

Description:  
Emergency Ash  
Pond eastern  
embankment/  
outboard slope  
erosion and  
animal burrow.

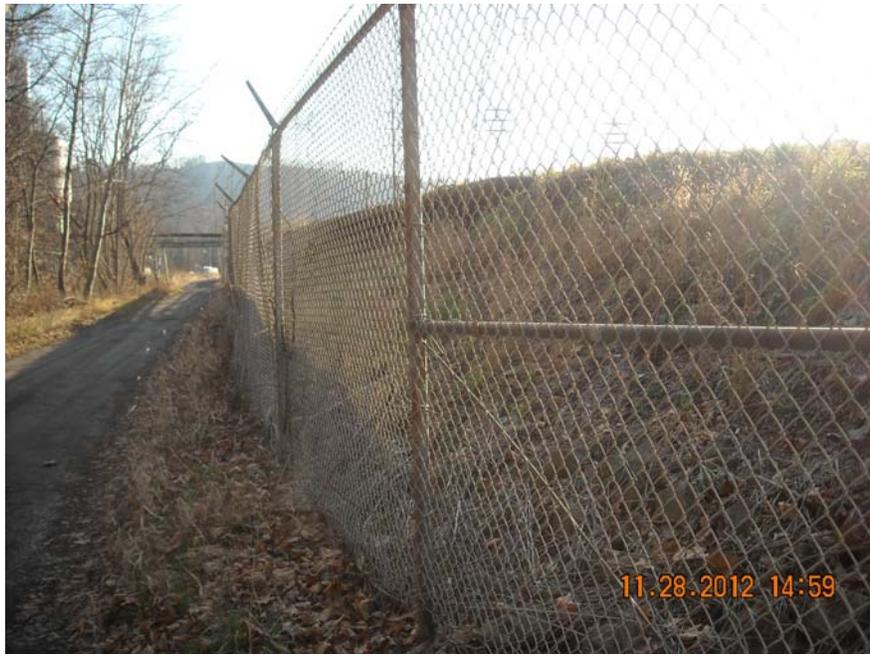
View of the Bottom Ash Pond (BAP) looking south depicting slopes which appears to be steeper than 1.5 Horizontal to 1 Vertical. .

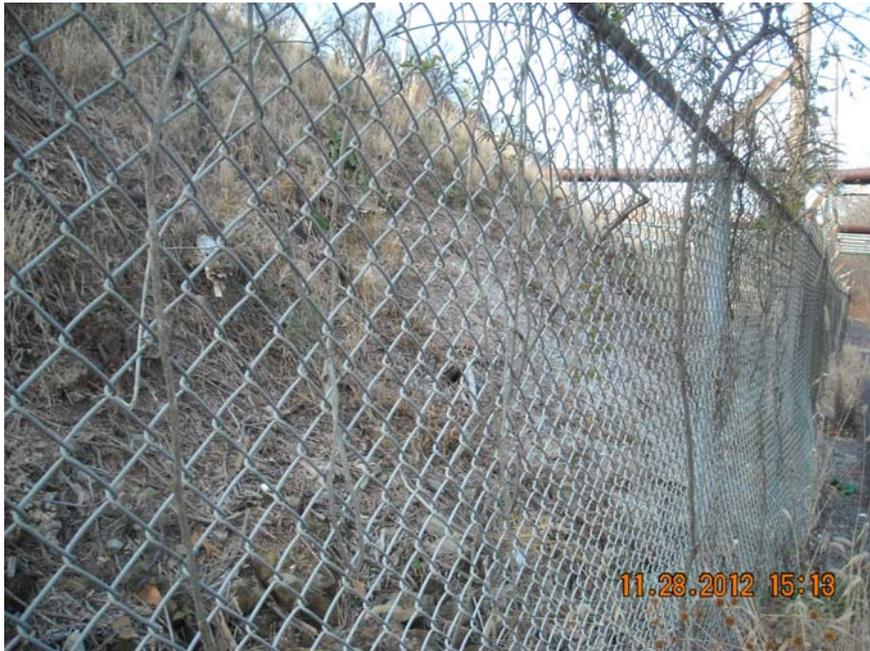
Photograph 2

View of the Emergency (BAP) looking south depicting slopes which appears to be steeper than 1.5 Horizontal to 1 Vertical design slopes.

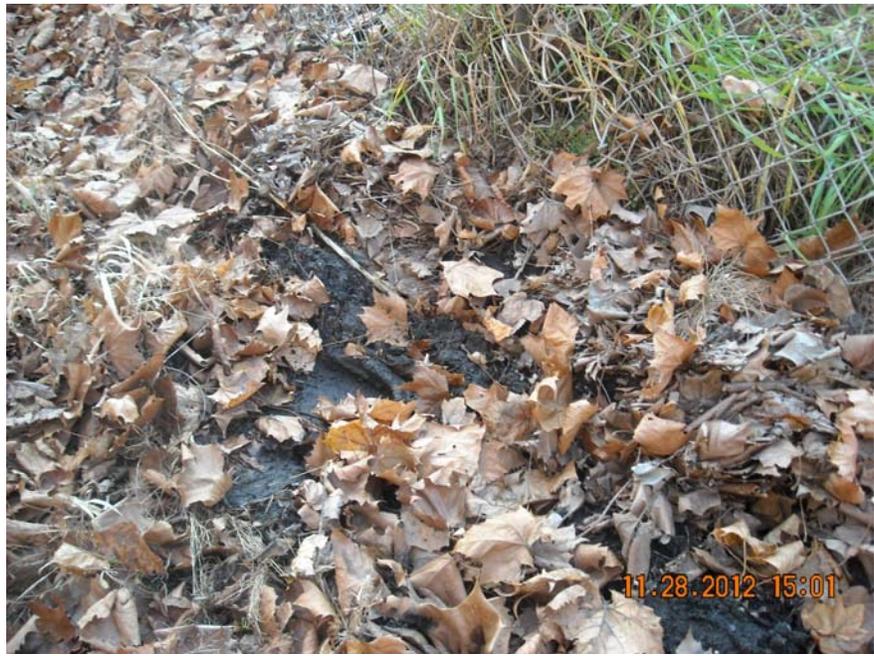
Picture of wet area along the east embankment of the BAP. Location of wet area is shown in Figure 1.

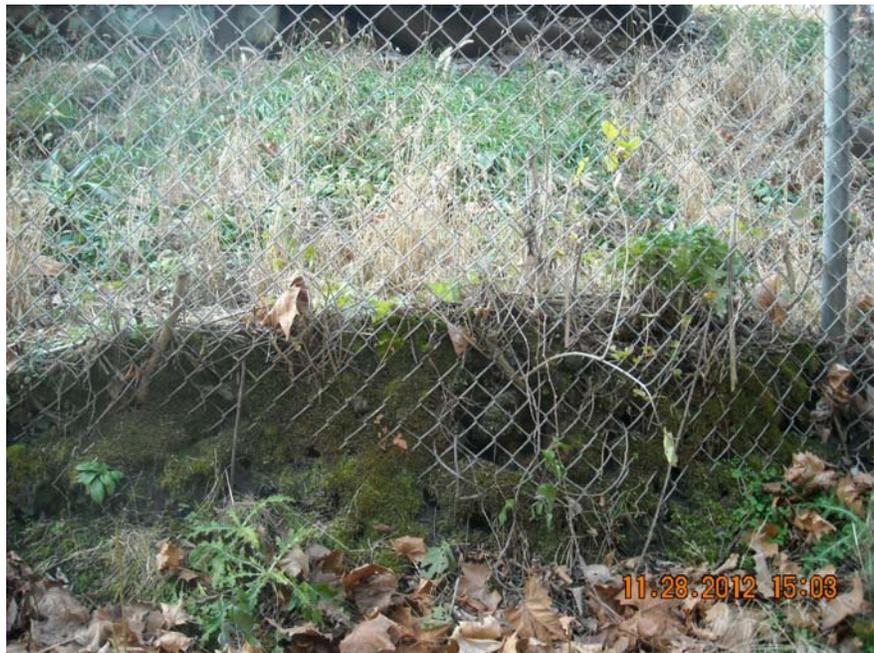
Photograph 4

Signs of soil accumulation along the BAP's east embankment perimeter fence.

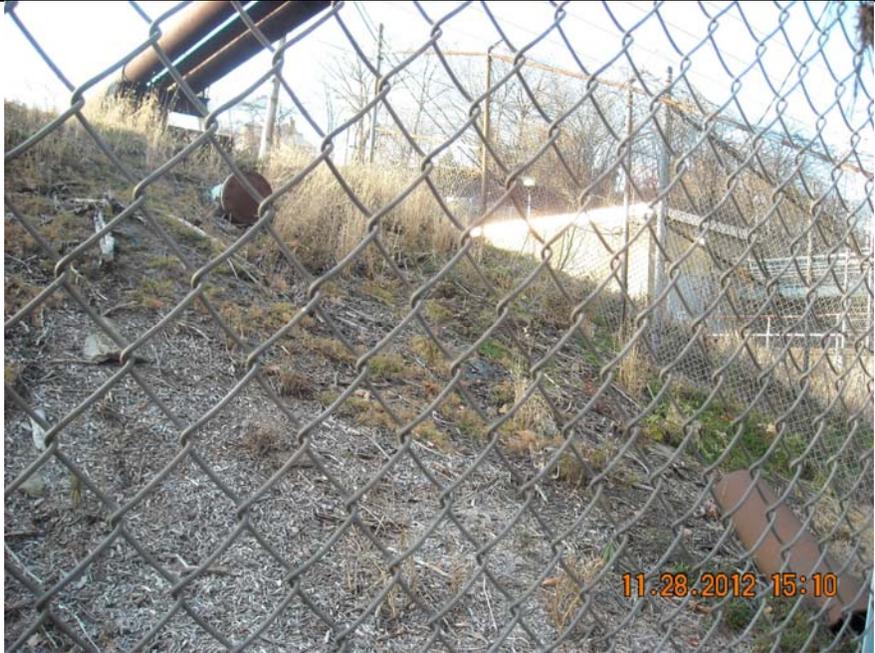
View of Emergency BAP's east slope, looking northwest. Note sparse vegetation.

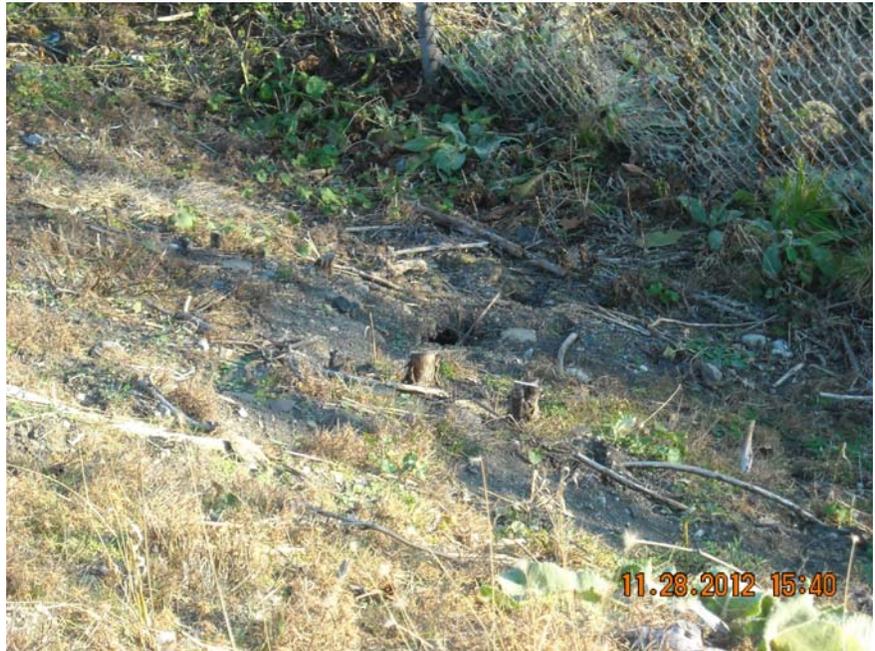
Photograph 6

View of the Emergency BAP south slope. Picture show what appears to be an animal burrow.
