SUBJECT: EPA Comments on “Assessment of Dam Safety of Coal Combustion Surface Impoundments: GenOn/NRG Elrama Power Station, Elrama, PA”

**From:** [Frank, Stephen](#)  
**To:** [Hoffman, Stephen](#); [Englander, Jana](#)  
**Subject:** Comments Request on Coal Ash Site Assessment Round 12 Draft Report - Elrama Generating Station  
**Date:** Friday, December 13, 2013 3:52:23 PM  
**Attachments:** [Elrama Pond Photos Prnt 11.26.13.pdf](#)  
[Elrama - Example Pond Inspection Reports.pdf](#)  
**Importance:** High

**Elrama Generating Station  
Bottom Ash Pond SPD-1**

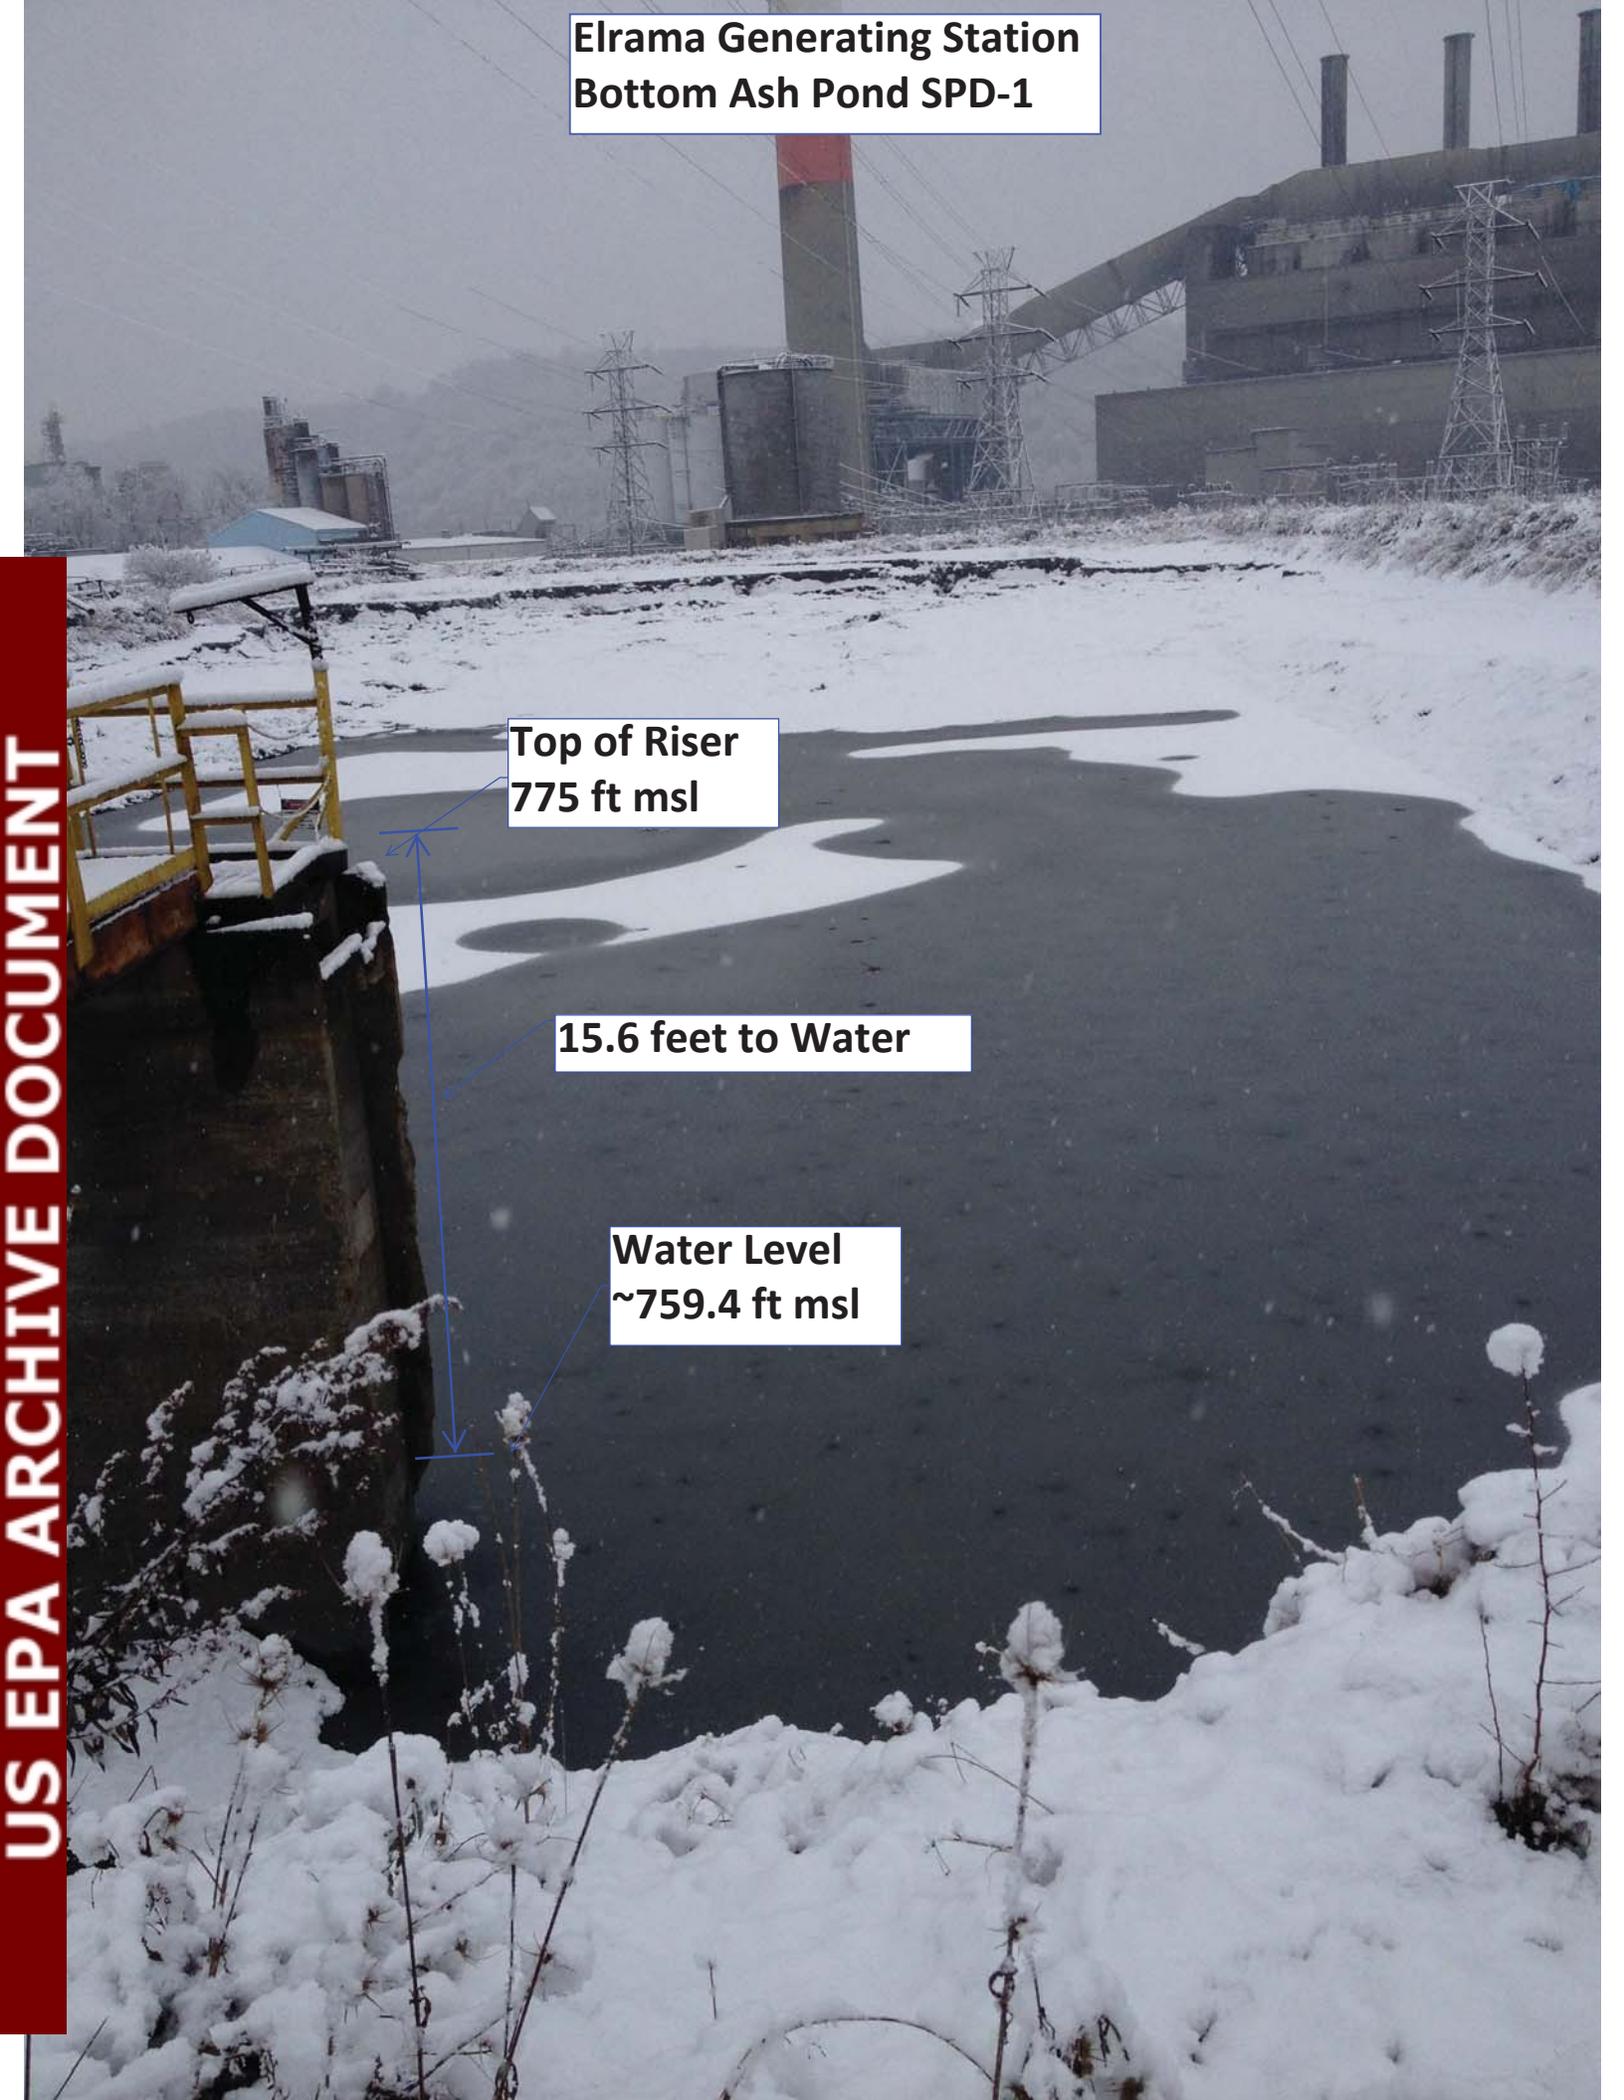
- d. The water levels in Bottom Ash Setting Ponds SPD-1 and SPD-2 are maintained at elevations of approximately 759.4 and 754.5 ft. msl, respectively, which is near or below the natural ground surface elevation of approximately 755 to 760 ft. msl at the eastern toe of the outer embankment. If water levels are maintained at these levels, failure of the embankments is not possible, and therefore, there is no potential for economic loss, environmental damage, disruption of lifeline facilities, etc. or interruption of railroad service.

**Top of Riser  
775 ft msl**

**15.6 feet to Water**

**Water Level  
~759.4 ft msl**

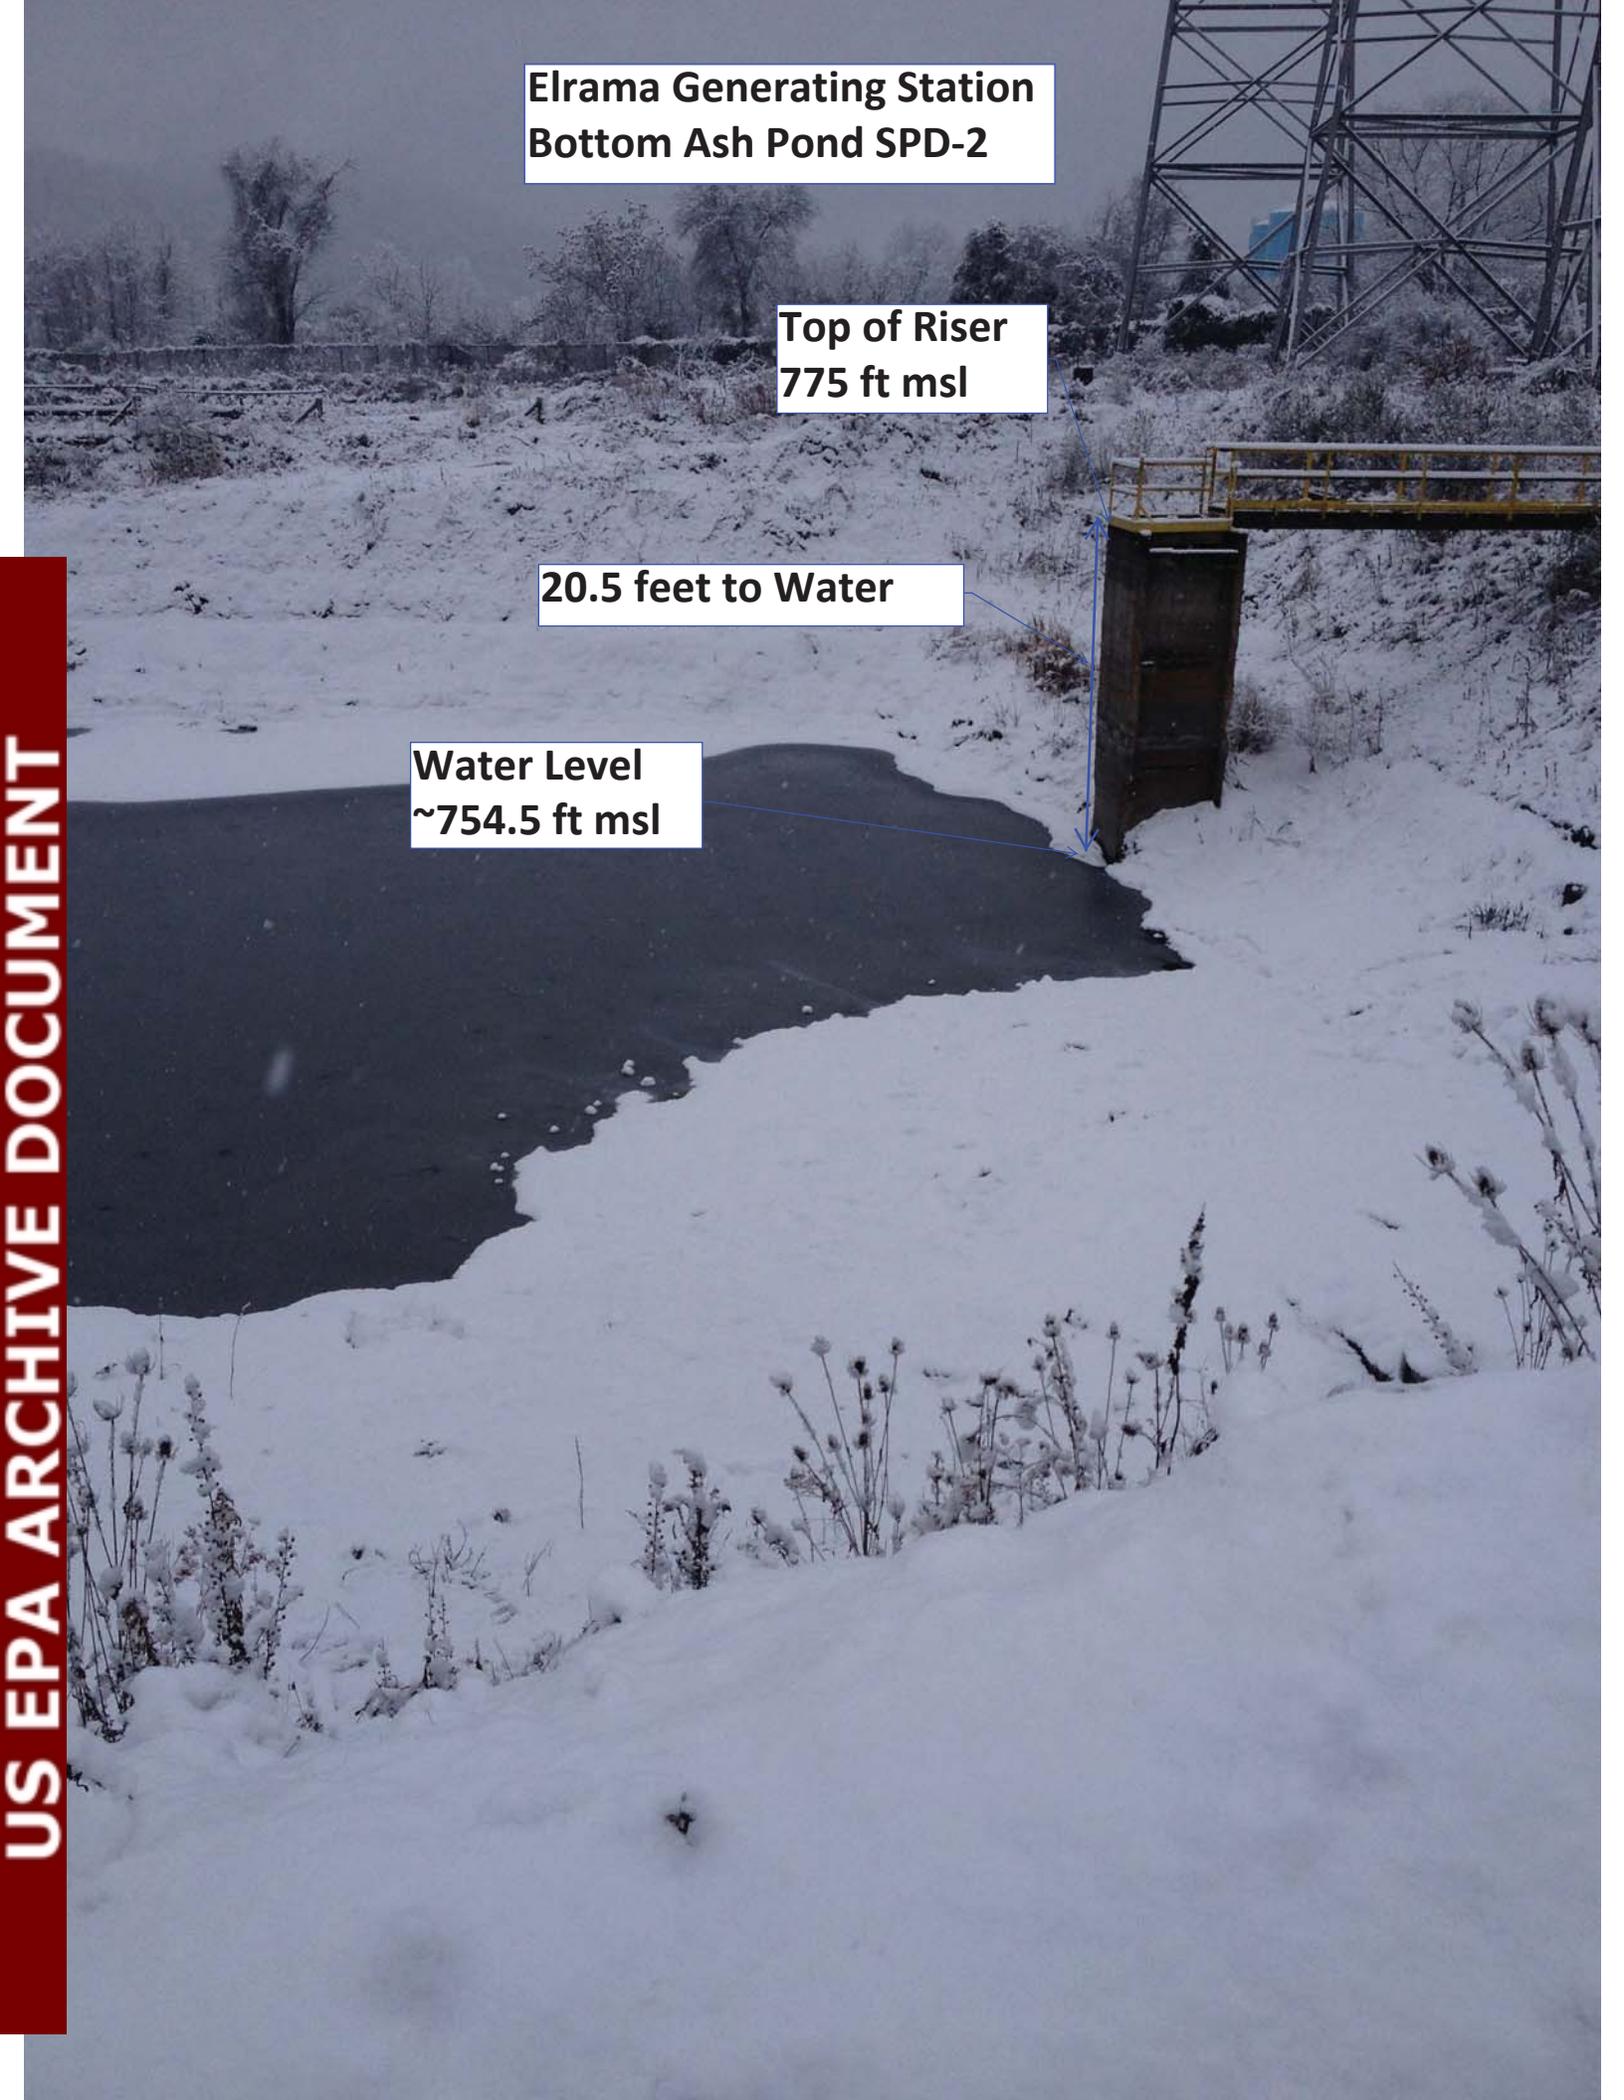
**Elrama Generating Station  
Bottom Ash Pond SPD-2**

**Top of Riser  
775 ft msl**

**20.5 feet to Water**

**Water Level  
~754.5 ft msl**

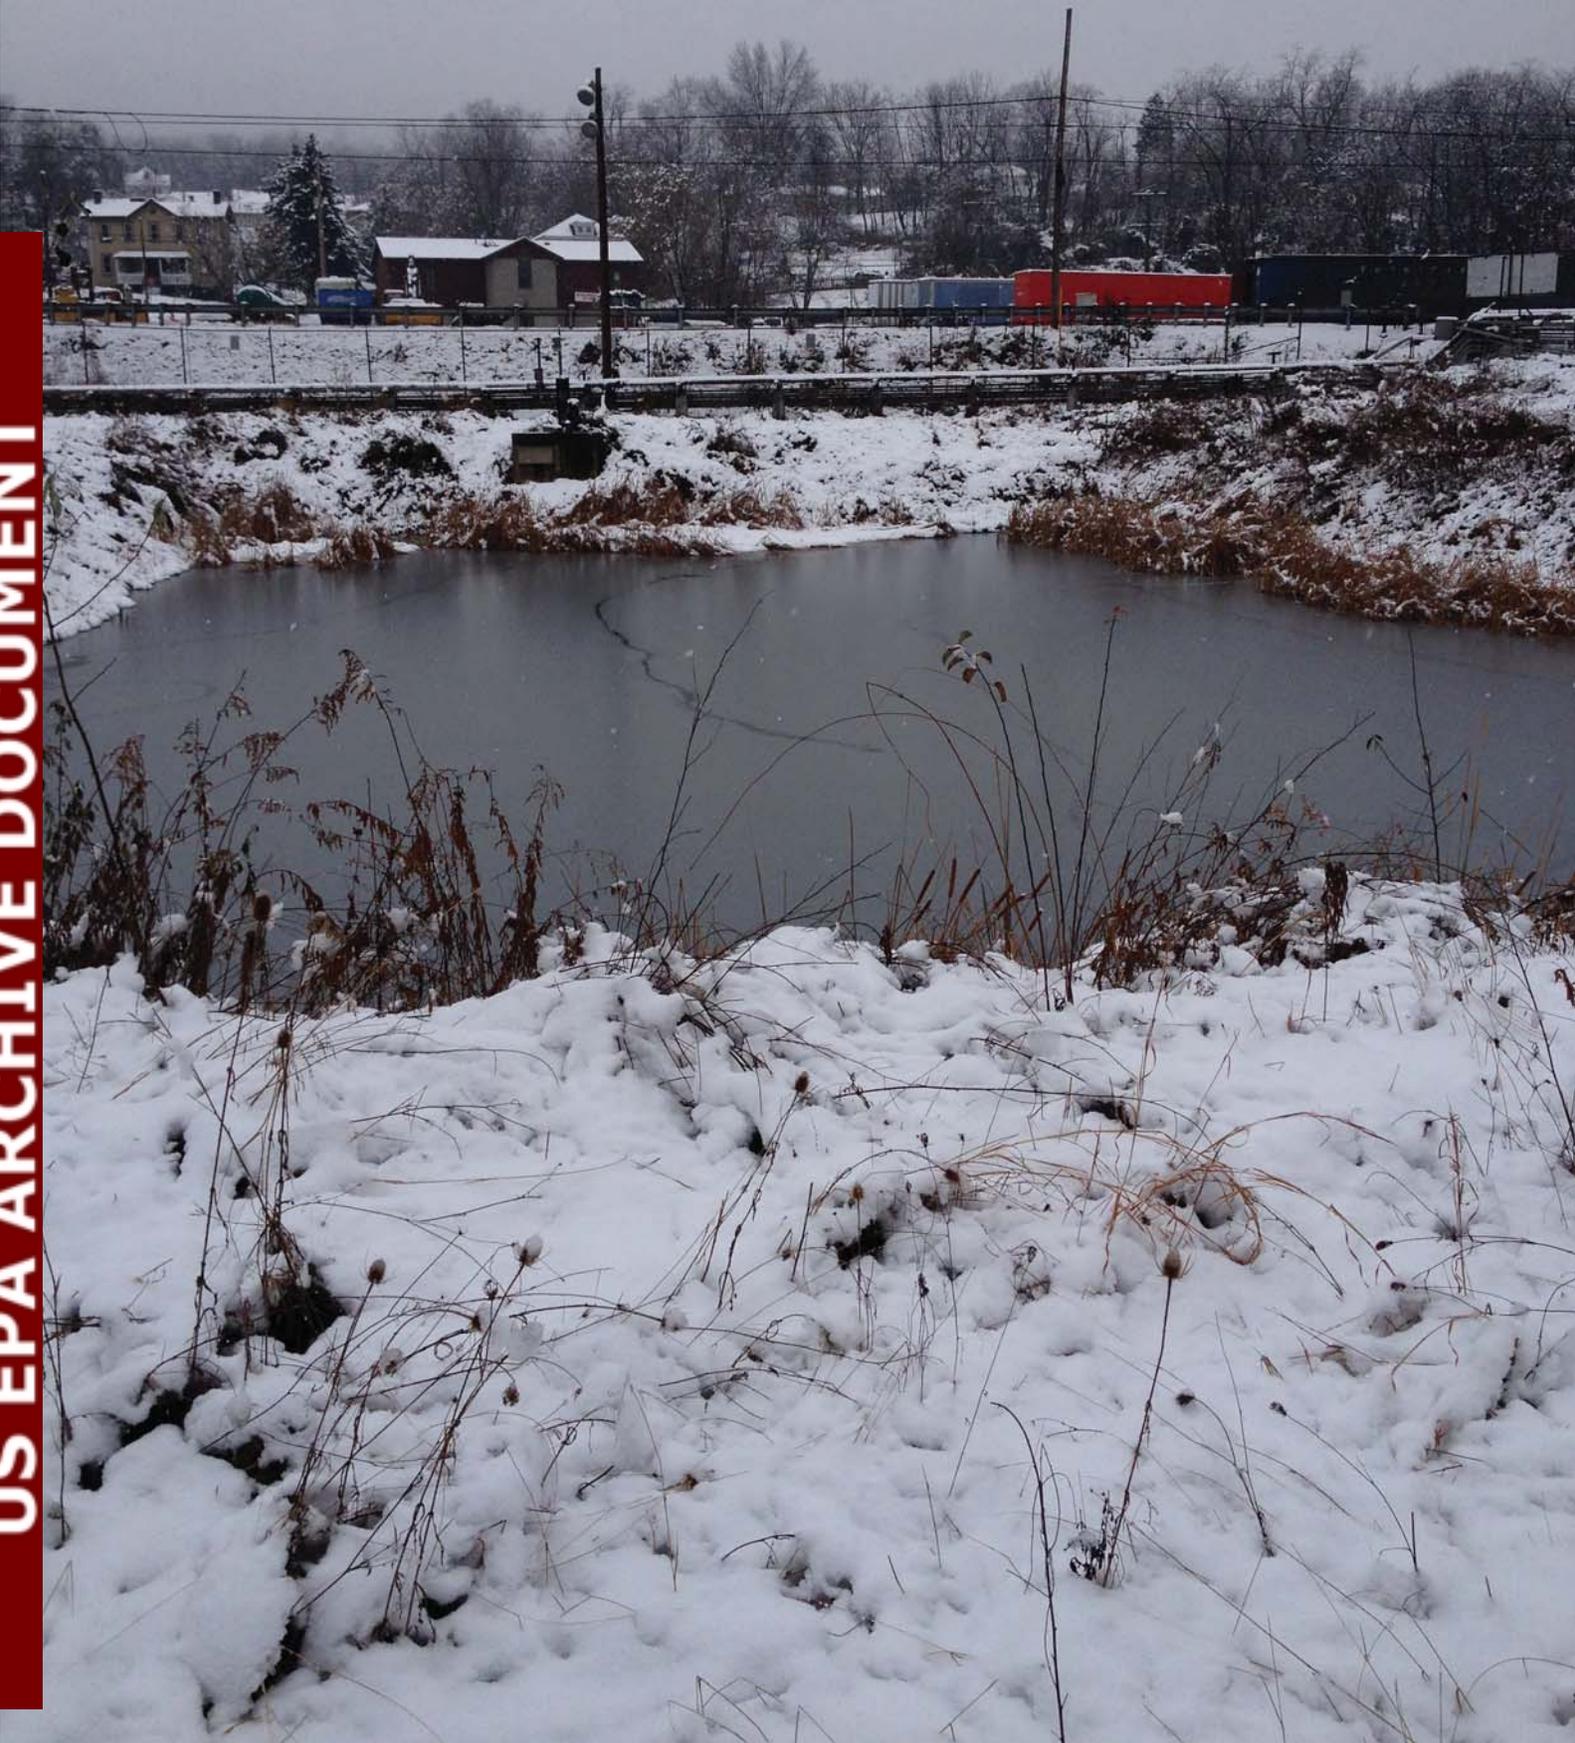
**Elrama Generating Station  
Emergency Pond**

- e. The Emergency Pond (SPD-5) is no longer used for process water and is approximately half full of only storm water, and the water level is at an elevation of approximately 770 ft. msl, which is below the natural ground surface at the eastern toe of the outer embankment (~777.5 ft. msl). As a result, failure of the eastern embankment is not possible and, therefore, would not result in economic loss, environmental damage, disruption of lifeline facilities or interruption of railroad service.
