Report of Dam Safety Assessment of Coal Combustion
Surface Impoundments
NRG Energy
Huntley Generating Station
Tonawanda, NY

AMEC Project No. 3-2106-0194

September 2011

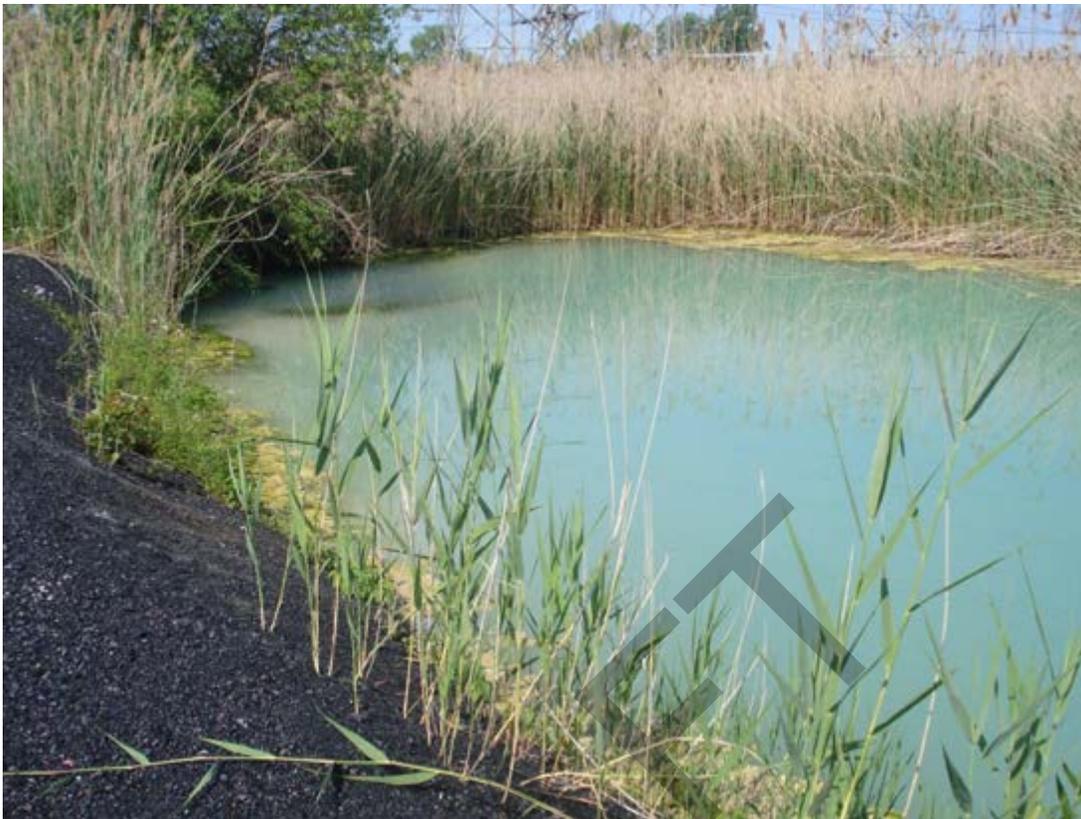
Pond 1 is located in the ash management area at the north end of the plant (North Ponds). The pond is situated in the southwest corner of this area. Pond 1 is bordered by a section of Pond 3 and a field to the east, Pond 2 to the north, a substation to the west and the plant grounds to the south. Pipes from the plant for wastewaters (and formerly CCW) enter Pond 1 from pipes on its southwest corner. Dense, tall grass and trees prevented a good view of the area (Photos 1-1 and 1-4). See the following photo presented as 1-1 in Appendix B.

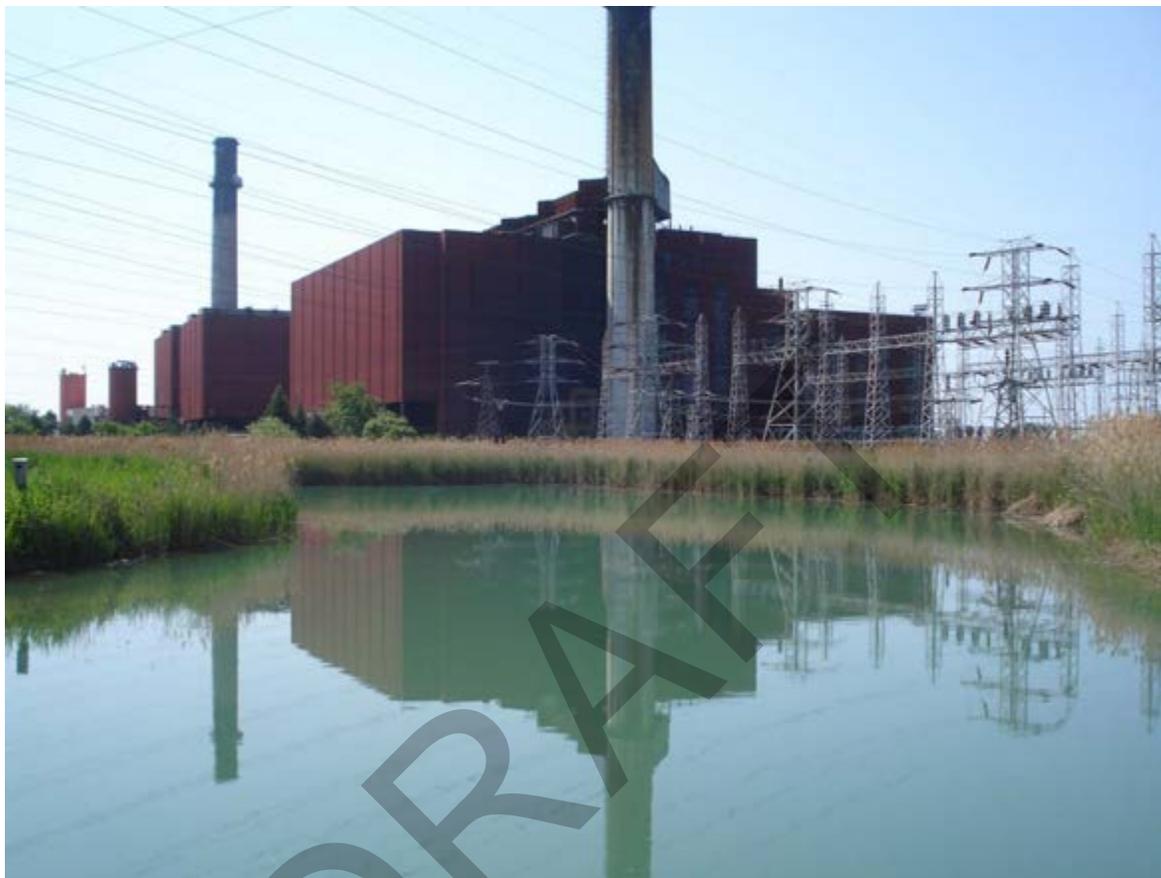
a ditch to the north, a substation to the west and Pond 1 to the south. An inlet pipe from Pond 1 enters Pond 2 at the southeast corner. Plans show the width of the top of the common dike of Pond 2 with Pond 1 as 20 feet. Dense, tall grass prevented a good view of the area. See the following photo presented as 2-1 in Appendix B.

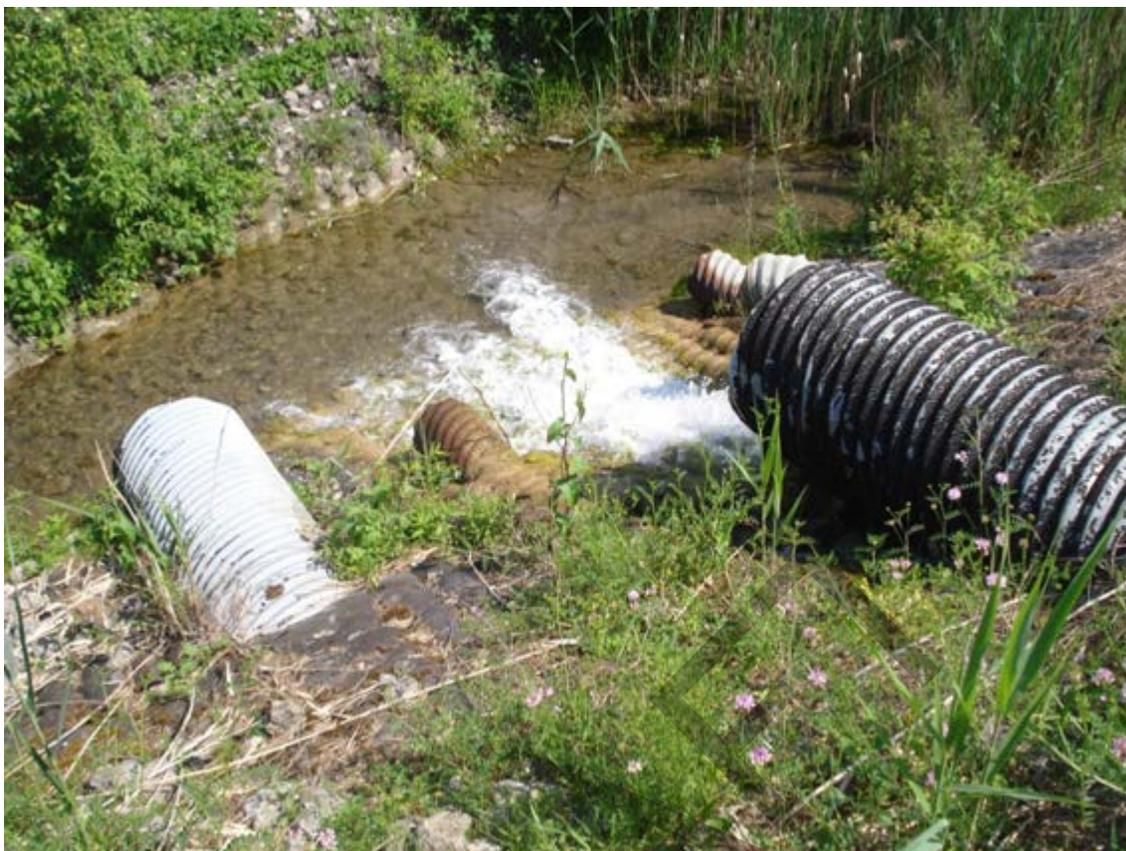
Pond 2 discharges flow by gravity through a 24-inch diameter gated culvert pipe located on the north dike (Photo 2-3). The flow discharges to a ditch that slopes from east to west along the north boundary of the property and then west to the Niagara River. "Fabriform" slope protection is present upstream and downstream in the outfall area. See the following photo of the outfall area presented as 2-4 in Appendix B. Three other 15-inch diameter gated pipes are present at the outlet and are reported to include an emergency overflow, a bottom drain and unknown drain. The inlet and outlet elevations of the 24-inch pipe are 576.3 and 569.0 feet, respectively.

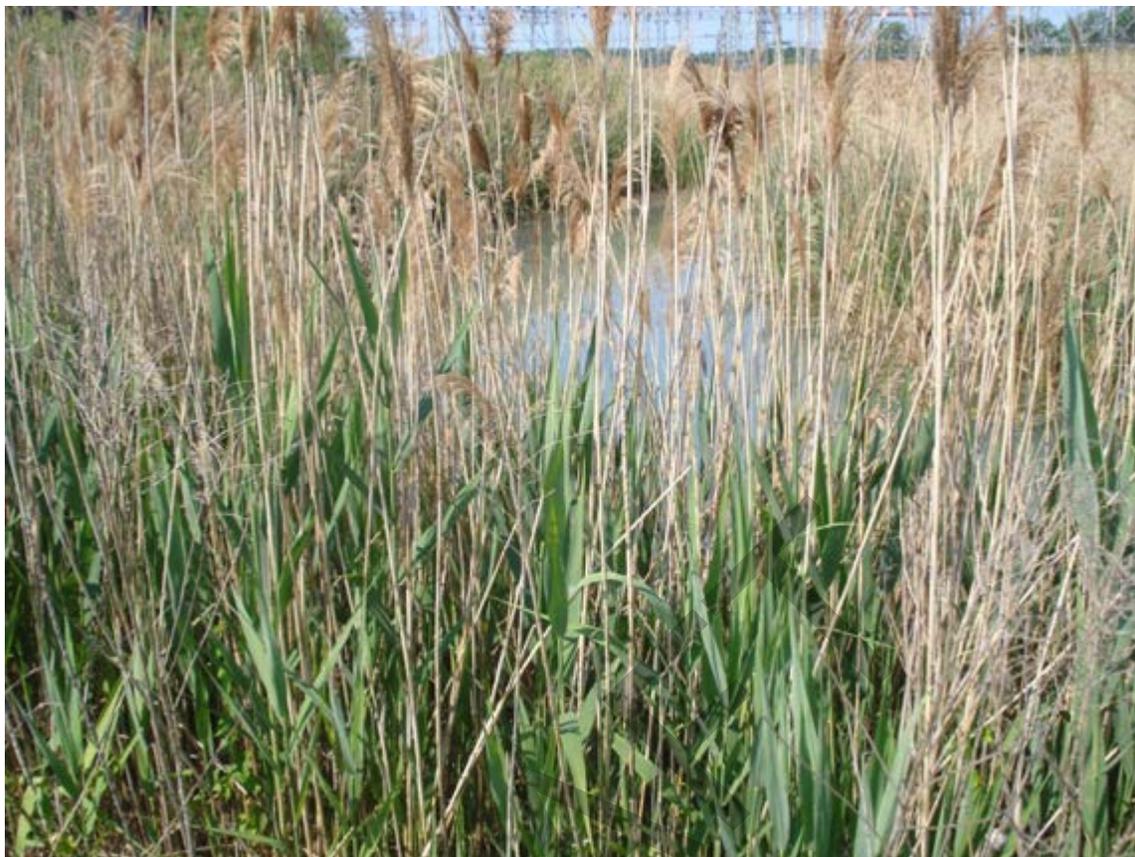
Pond 3 appears to be incised on the interior west embankment and diked on the east, north, south and inlet dikes. Drawings indicate the top of berm elevations range from about 581 to 582 feet on south side to about 576 to 579 feet on the north side. Although as-built information was not available for this pond, sections shown for future improvements (to-date not constructed) indicate a bowl-like shape with generally steeper than 2H:1V side slopes. The elevation of the berms appeared higher during the site visit, but dense, tall grass and occasional trees prevented a good view of the interior and exterior slopes (Photos 3-2 through 3-8). See the following photo presented as 3-2 in Appendix B.

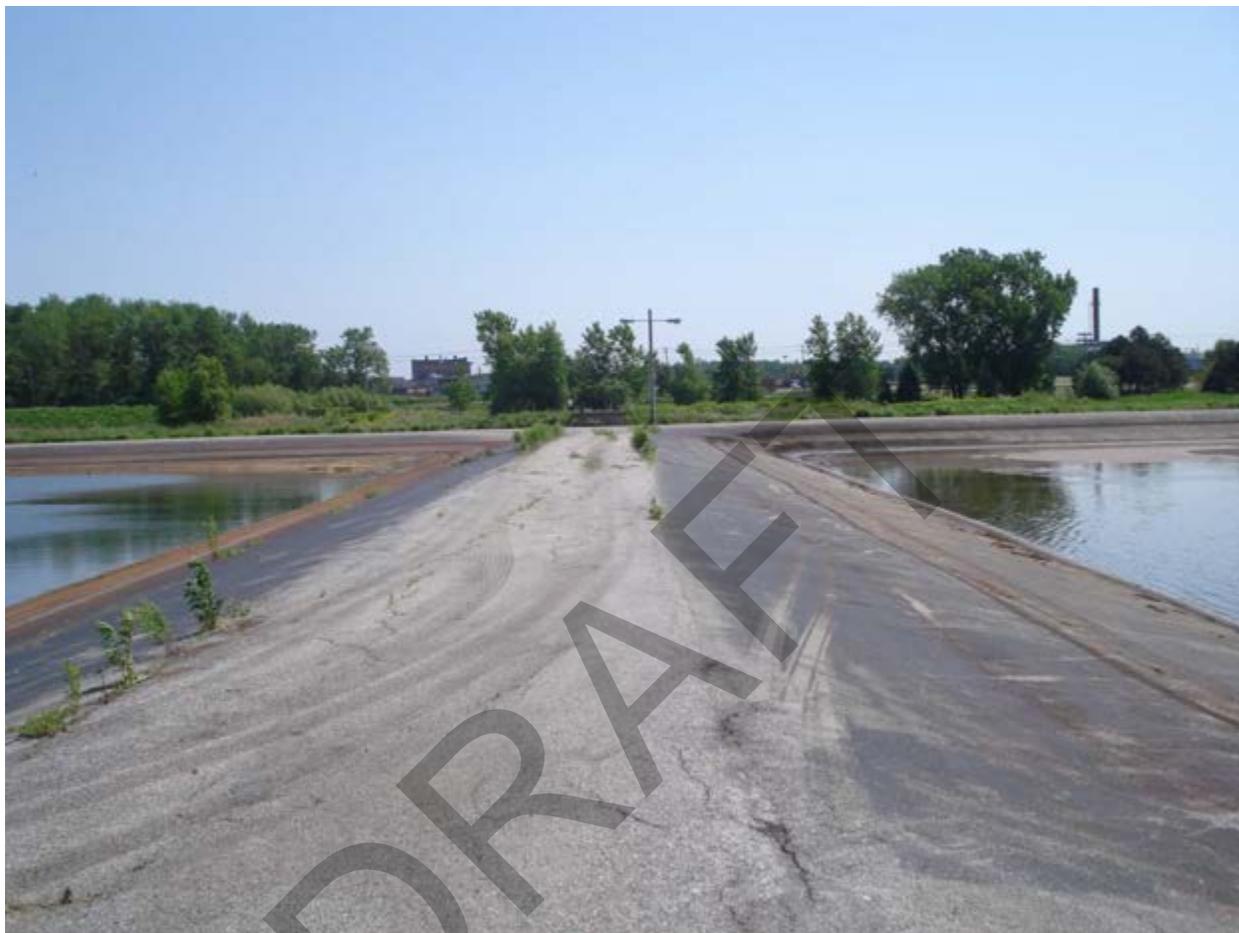
area and the South Pond to the south, and an open area and/or the Niagara River to the west. An 12-inch diameter inlet pipe from the flow control structure enters the basin at the northeast corner. Plans show the width of the top of the common dike of the North and South Equalization Basins as 12 feet. See the following photo presented as NEQ-6 in Appendix B.

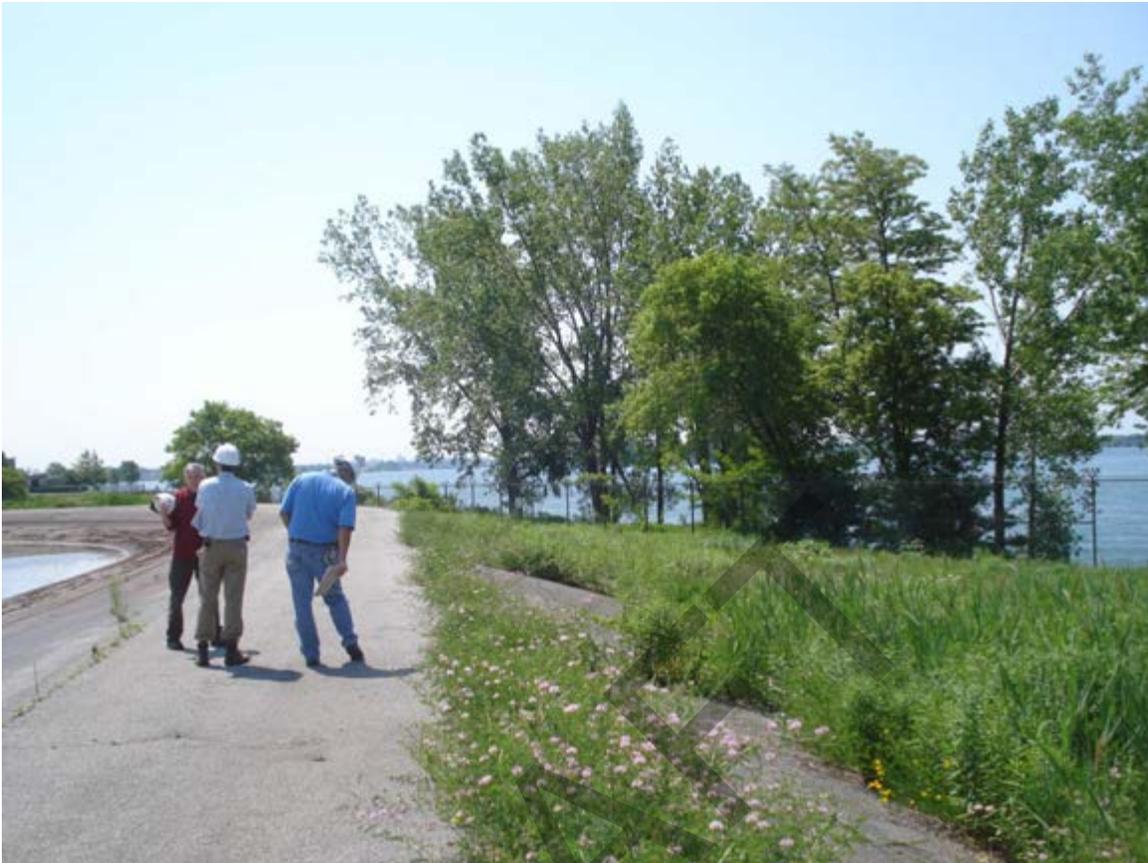
The South Equalization Basin is a diked impoundment. Drawings indicate the top of berm elevation is 580.3 feet. The bottom, upstream slopes, crest and portions of the downstream slopes have the same type and thickness of asphalt liner as the north basin. The lined slopes and crest appeared to be in fair condition with slight red staining on the lower sections of the upstream slopes and areas of cracks with or without protruding vegetation in several locations (Photos SEQ-1 through SEQ-4). The downstream slopes, especially on the west dike appeared to be in poor to fair condition with more degradation of the asphalt liner as evidenced by more protruding vegetation (Photo SEQ-3 and SEQ-4). As you proceed south along the west dike, the South Basin is located approximately 100 feet to 35 feet from the edge of the bank of the Niagara River (Photos SEQ-3 through SEQ-5). From the southwest corner of the South Basin looking south, the outlet pipe of the South Pond can be seen (Photo SEQ-6). The following photo presented as SEQ-3 in Appendix B presents a view of the southwest corner of the basin, Niagara River in background.

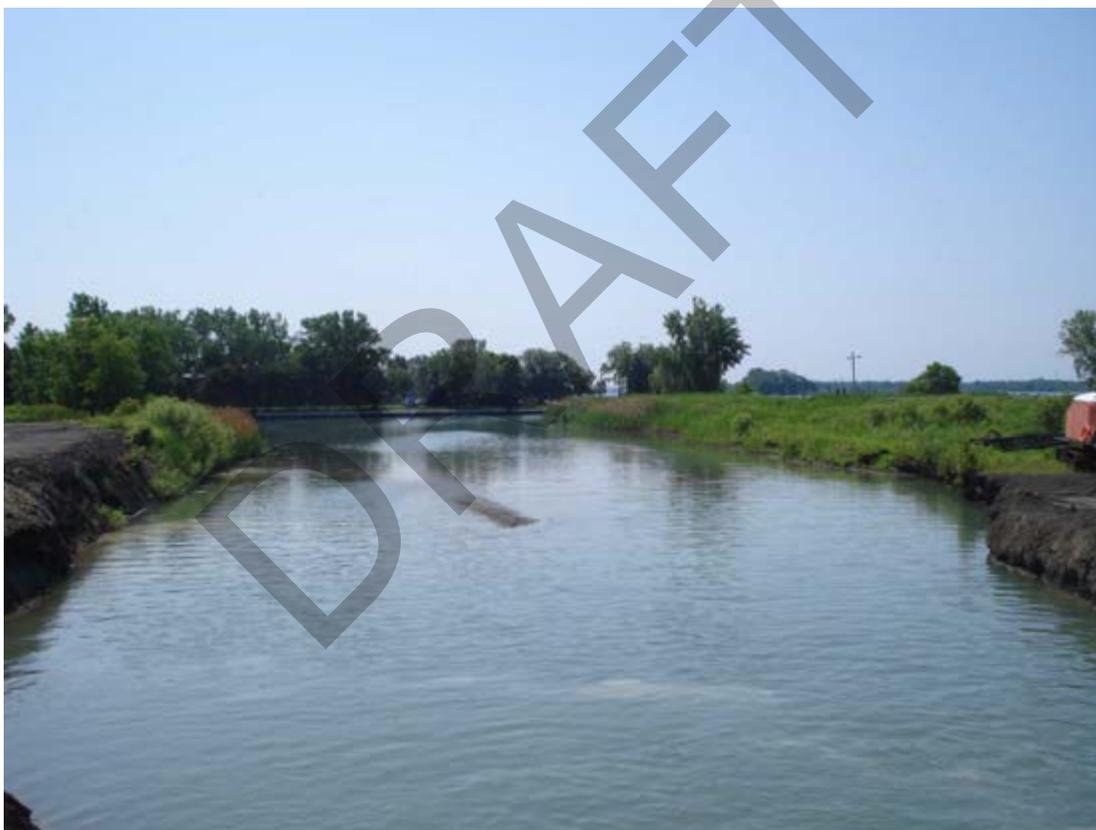
At the time of the field assessment, the upstream slopes at the north end of the South Pond were steep and void of vegetation (Photo S-2 and S-8). Generally, all other upstream slopes, crests and downstream slopes were covered with high grass preventing a good view of the slopes (Photos S-2, S-3, S-5, S-9 and S-10). Steep slopes appeared to be present on the inside of the curve on the west embankment and at the southeast end of the pond (Photos S-2 and S-10). See the following photo presented as S-2 in Appendix B.

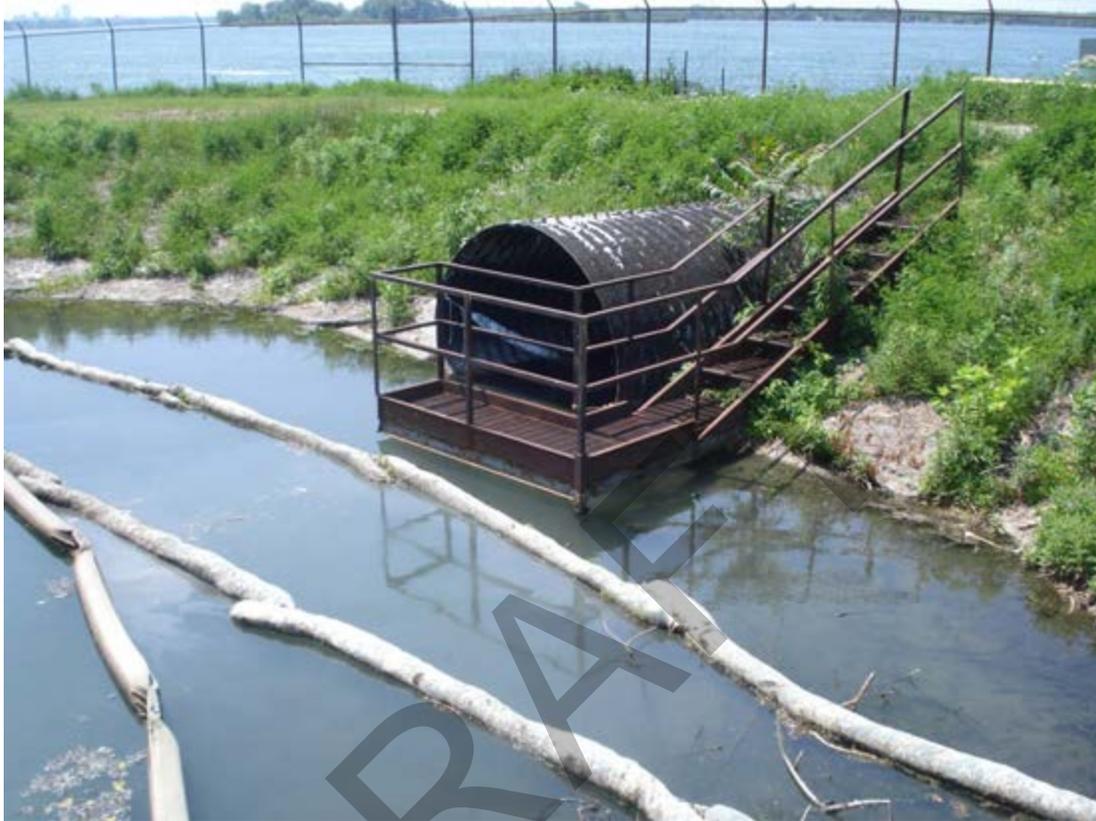
(Photo S-4 and S-7). The flow discharges to the Niagara River with grouted rip-rap slopes upstream and downstream of the outlet pipe (Photo S-6). The inlet and outlet elevations of the 92-inch by 65-inch arched CMP are 568.8 and 565.0 feet, respectively. See the following photo presented as S-4 in Appendix B showing the inlet of the outlet pipe.

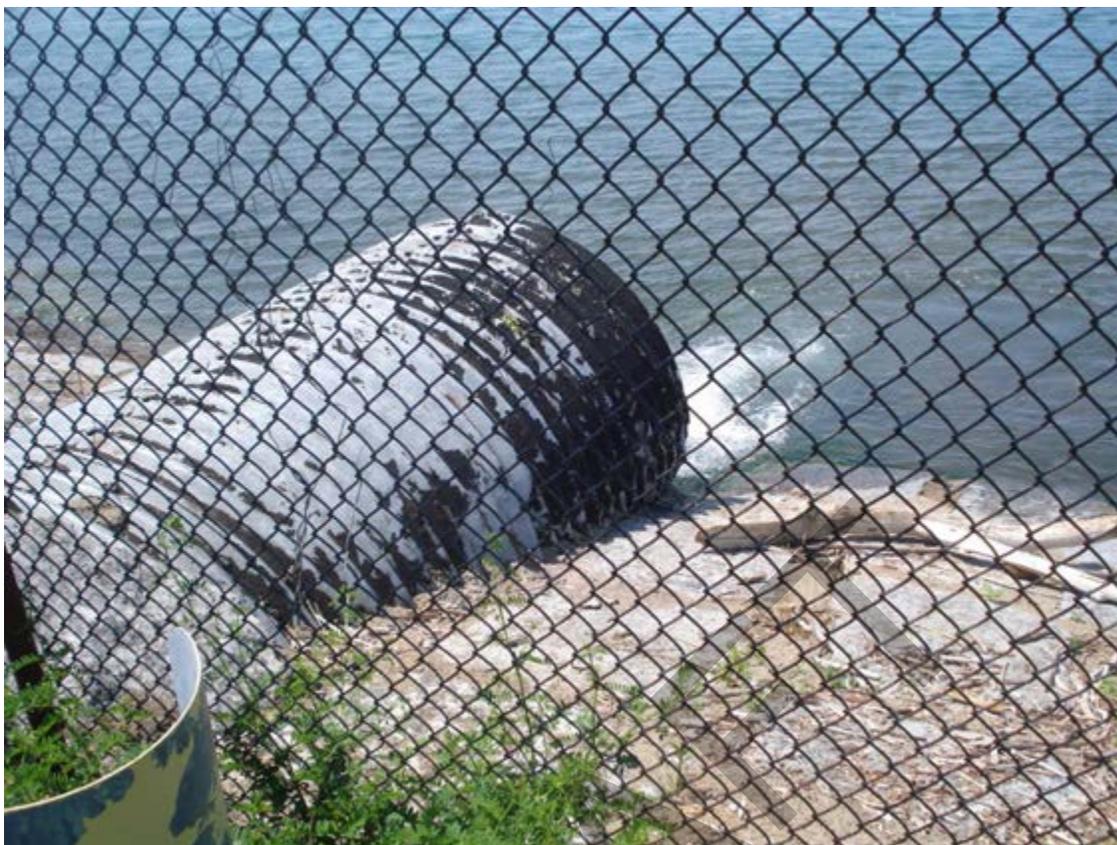
See the following photo presented as S-6 in Appendix B showing the outlet pipe area to the Niagara River.

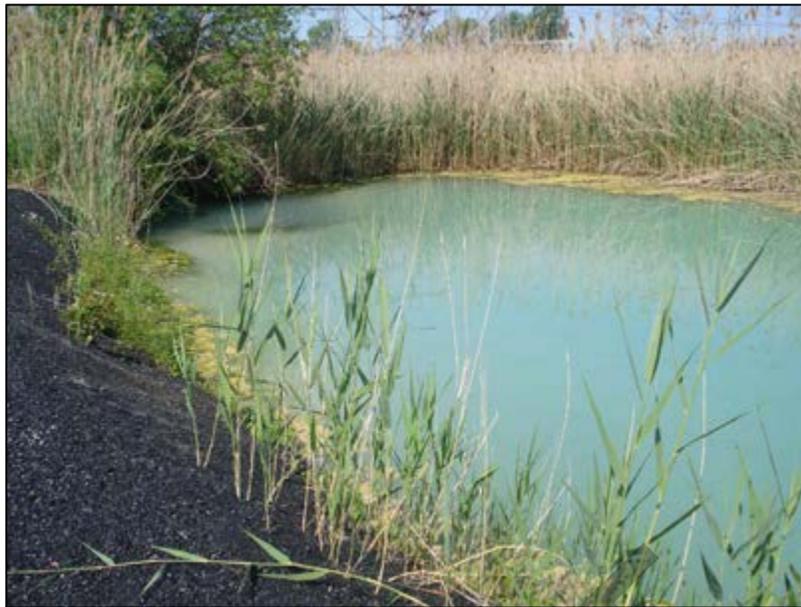
1-1

LOOKING NORTHWEST AT POND 1, HIGH VEGETATION

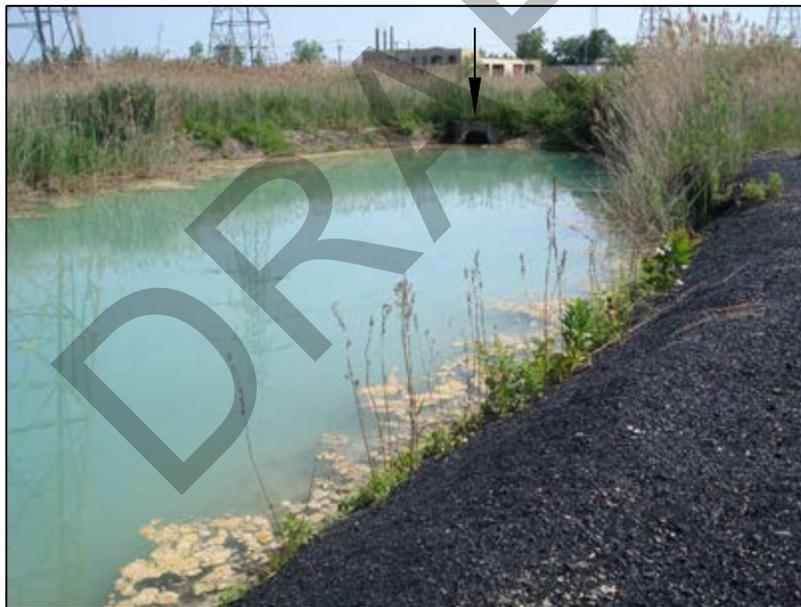
1-2

LOOKING NORTHEAST AT POND 1 AND OUTLET PIPE TO POND 3, HIGH VEGETATION

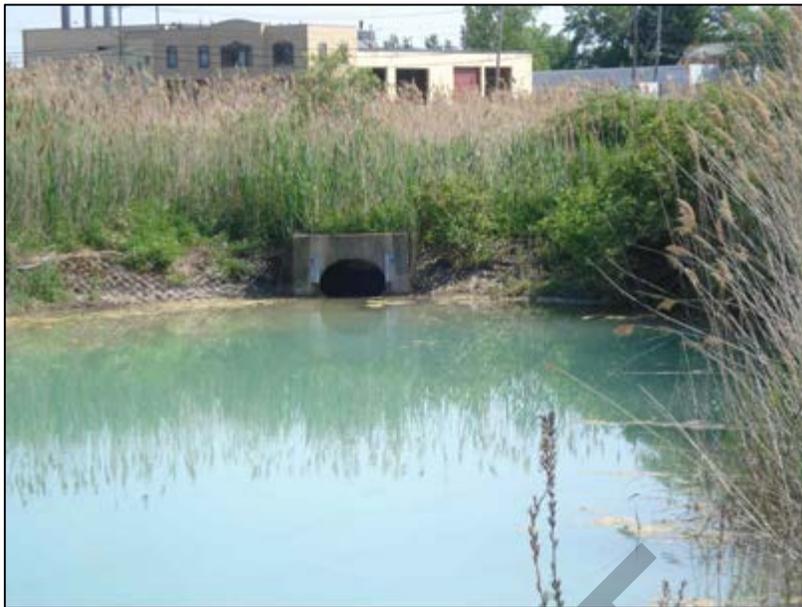
1-3

LOOKING NORTHEAST AT POND 1, CLOSEUP OF
OUTLET TO POND 3, HIGH VEGETATION

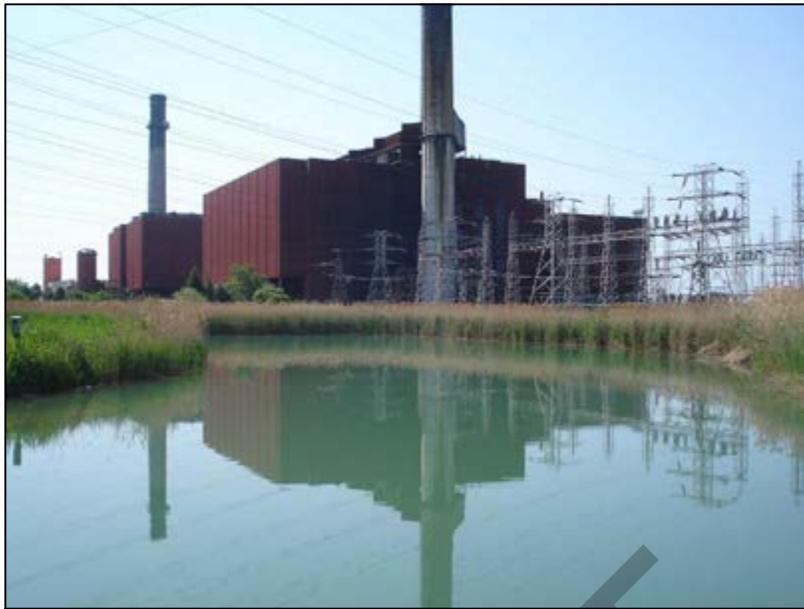
2-1
 LOOKING SOUTH AT INTERIOR OF
 POND 2, HIGH VEGETATION

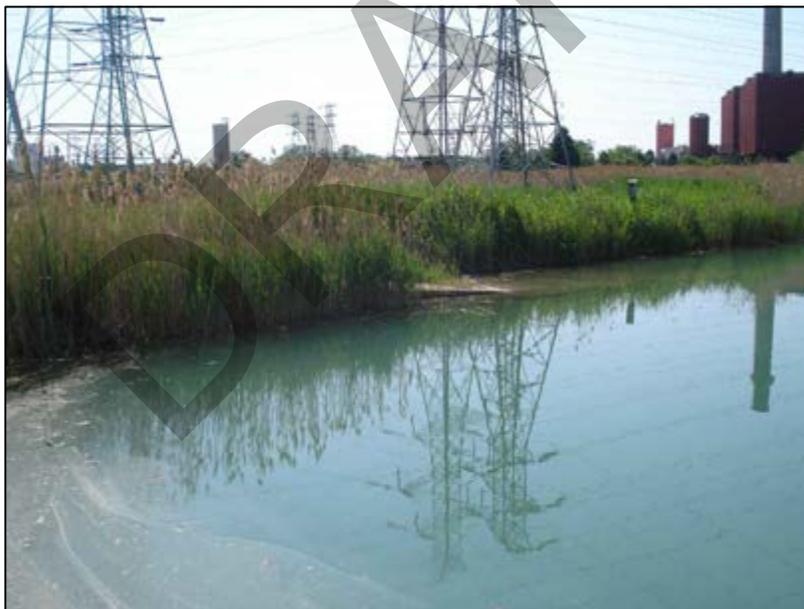
2-2
 LOOKING SOUTHEAST AT INTERIOR OF POND 2,
 HIGH VEGETATION, RAMP INTO POND

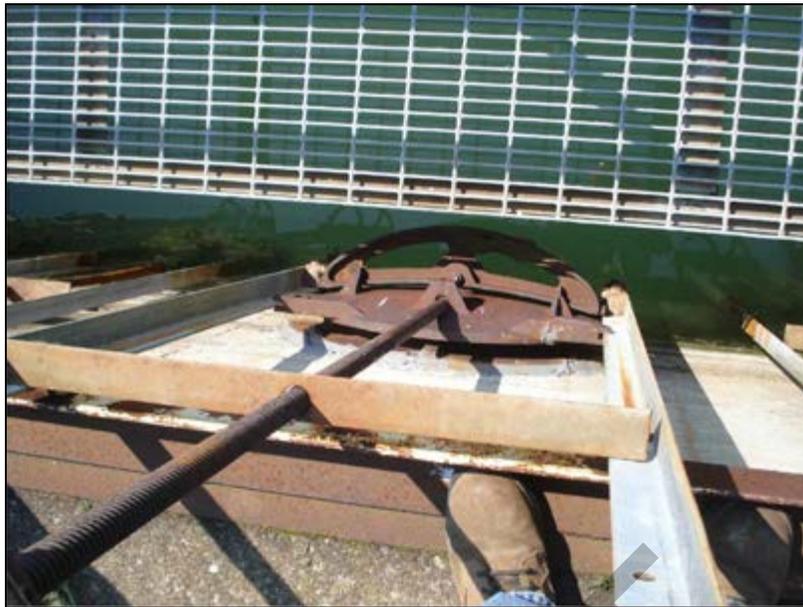
2-3

NORMAL GATED OUTLET PIPE FROM POND 2

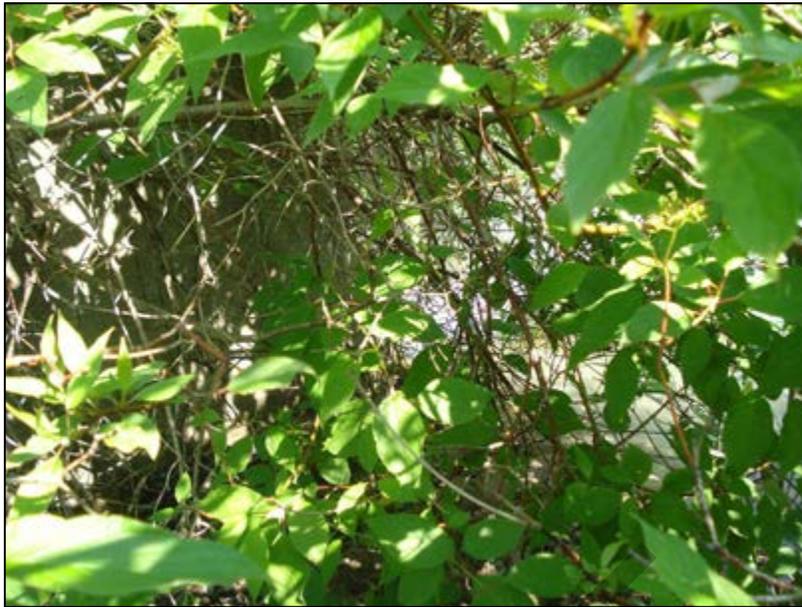
3-1

LOOKING NORTH AT INLET TO POND 3 FROM POND 1, HIGH VEGETATION

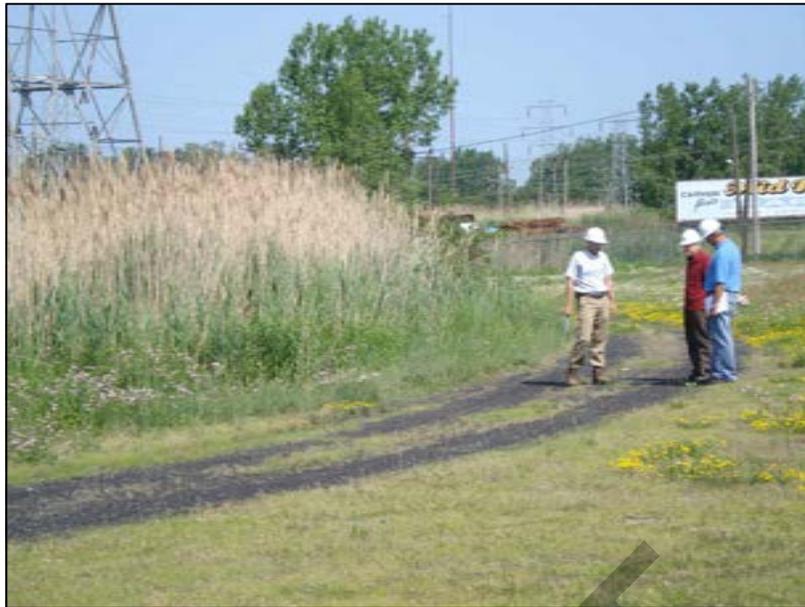
3-5
 LOOKING NORTHEAST AT EAST SIDE
 OF POND 3, HIGH VEGETATION

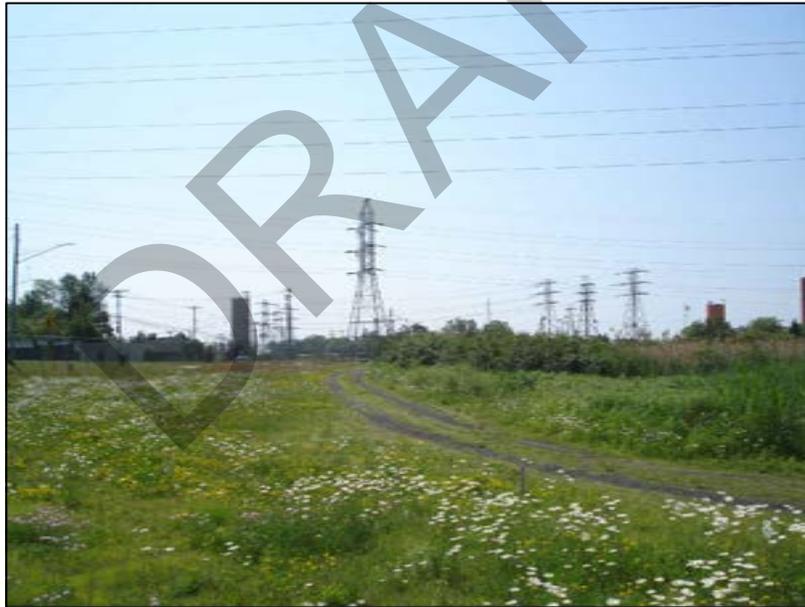
3-6
 LOOKING SOUTH AT EAST SIDE
 OF POND 3, HIGH VEGETATION

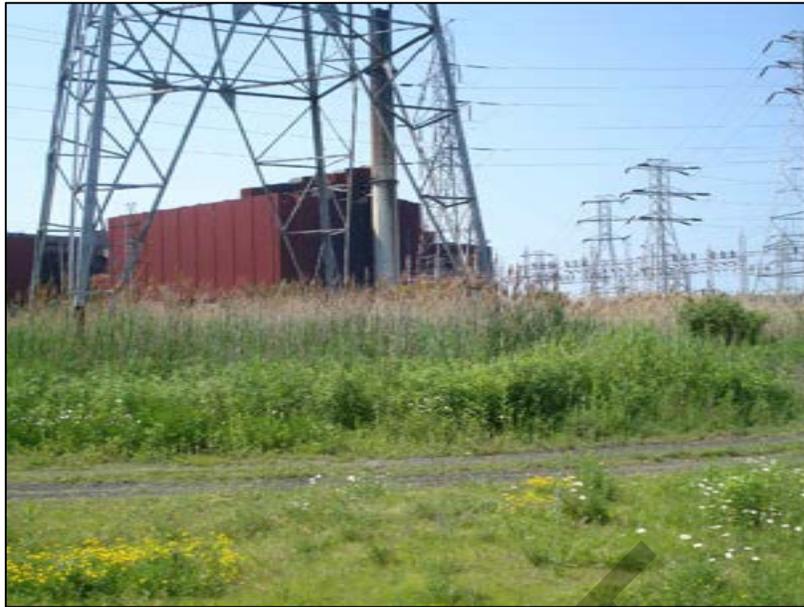
3-7

LOOKING SOUTHWEST AT POND 3, HIGH VEGETATION

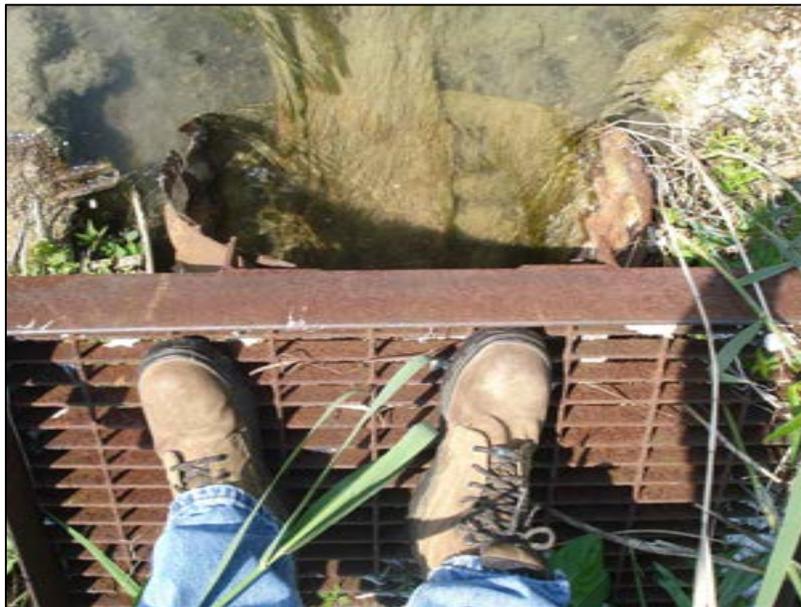
3-9

INLET OF OUTLET PIPE FROM POND 3

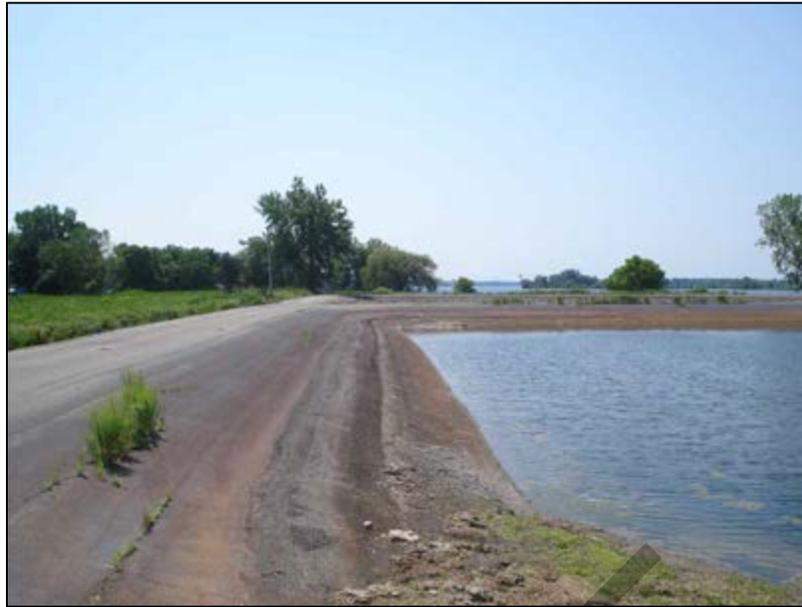
NEQ-1

LOOKING SOUTHEAST AT EAST CREST AND INTERIOR SLOPES OF NORTH AND SOUTH EQUALIZATION BASINS

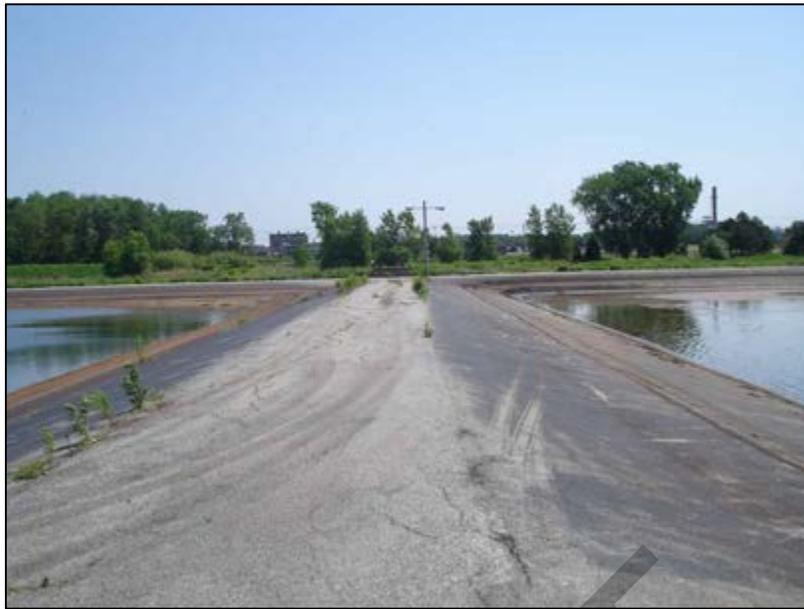
SEQ-1
 BETWEEN EQUALIZATION BASINS LOOKING EAST AT COMMON DIKE

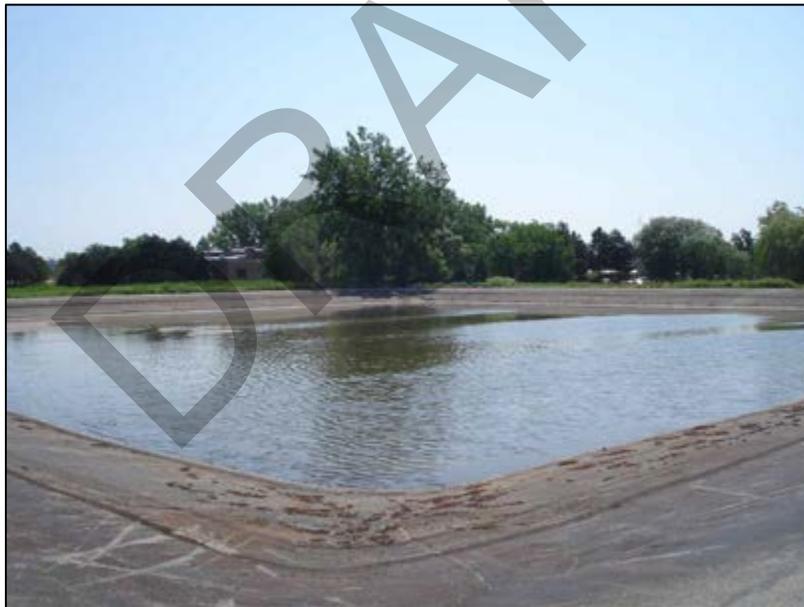
SEQ-2
 NORTHWEST CORNER OF SOUTH EQUALIZATION
 BASIN LOOKING SOUTHEAST ACROSS BASIN.

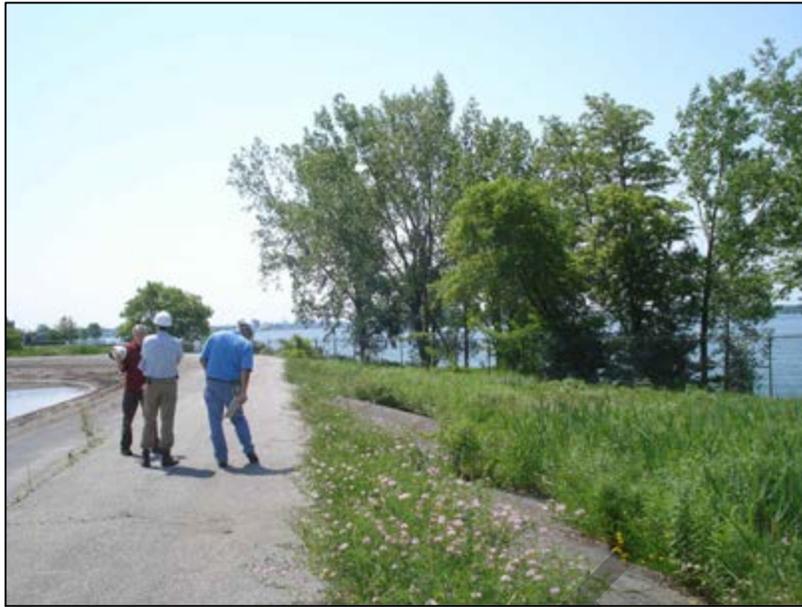
SEQ-3

SOUTH EQUALIZATION BASIN - LOOKING SOUTHWEST AT CREST AND DOWNSTREAM SLOPE OF WEST EMBANKMENT, HIGH VEGETATION

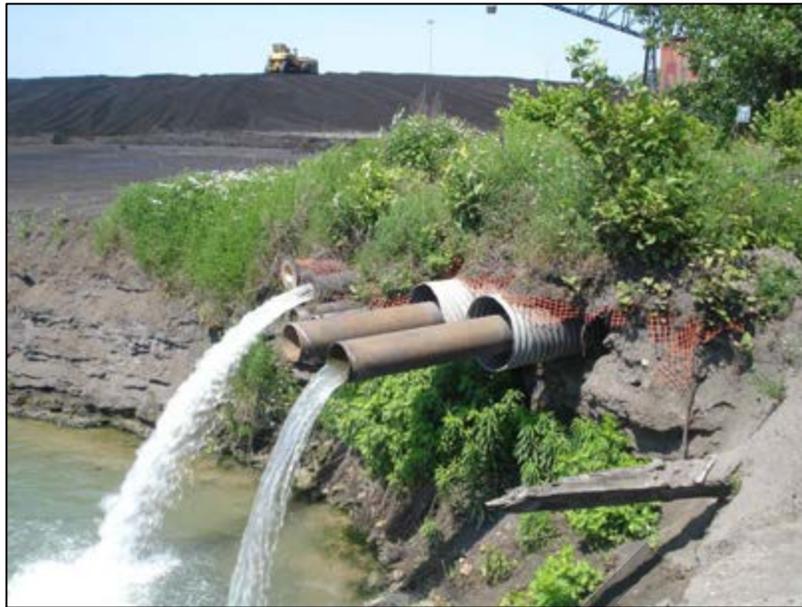
S-1

LOOKING NORTHWEST AT SLUICE PIPES INLETS AT NORTH END OF SOUTH POND

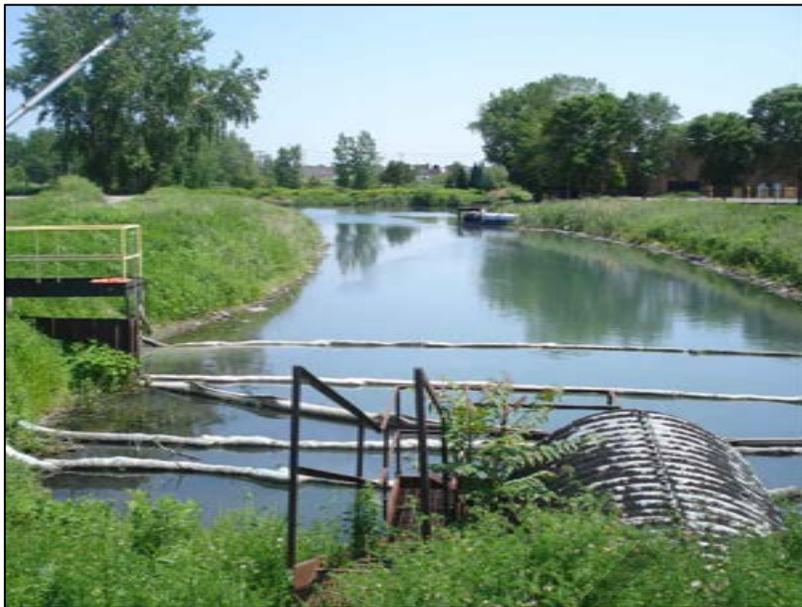
S-7

AT SOUTH POND OUTLET LOOKING EAST AT INTERIOR OF SOUTH END OF POND, HIGH VEGETATION

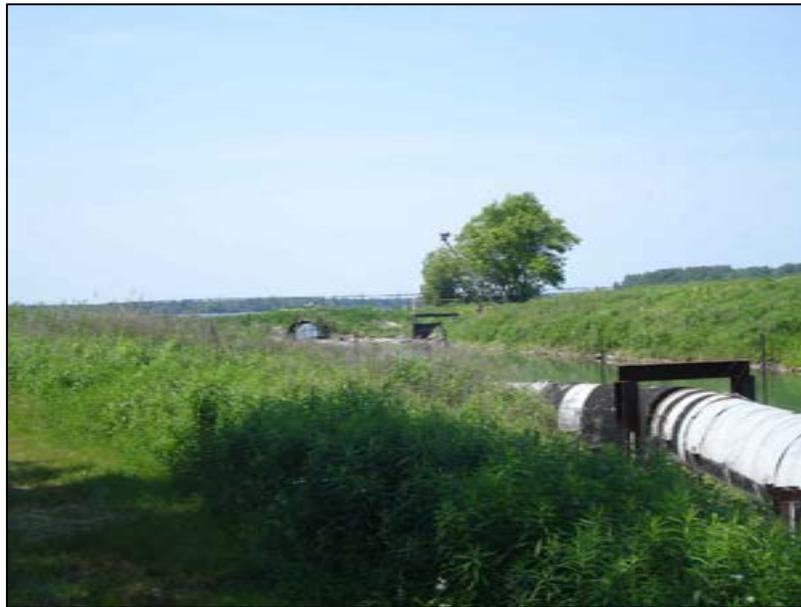
S-9

FROM SOUTH DIKE LOOKING WEST AT POND INTERIOR AND OUTLET TO NIAGARA RIVER, HIGH VEGETATION

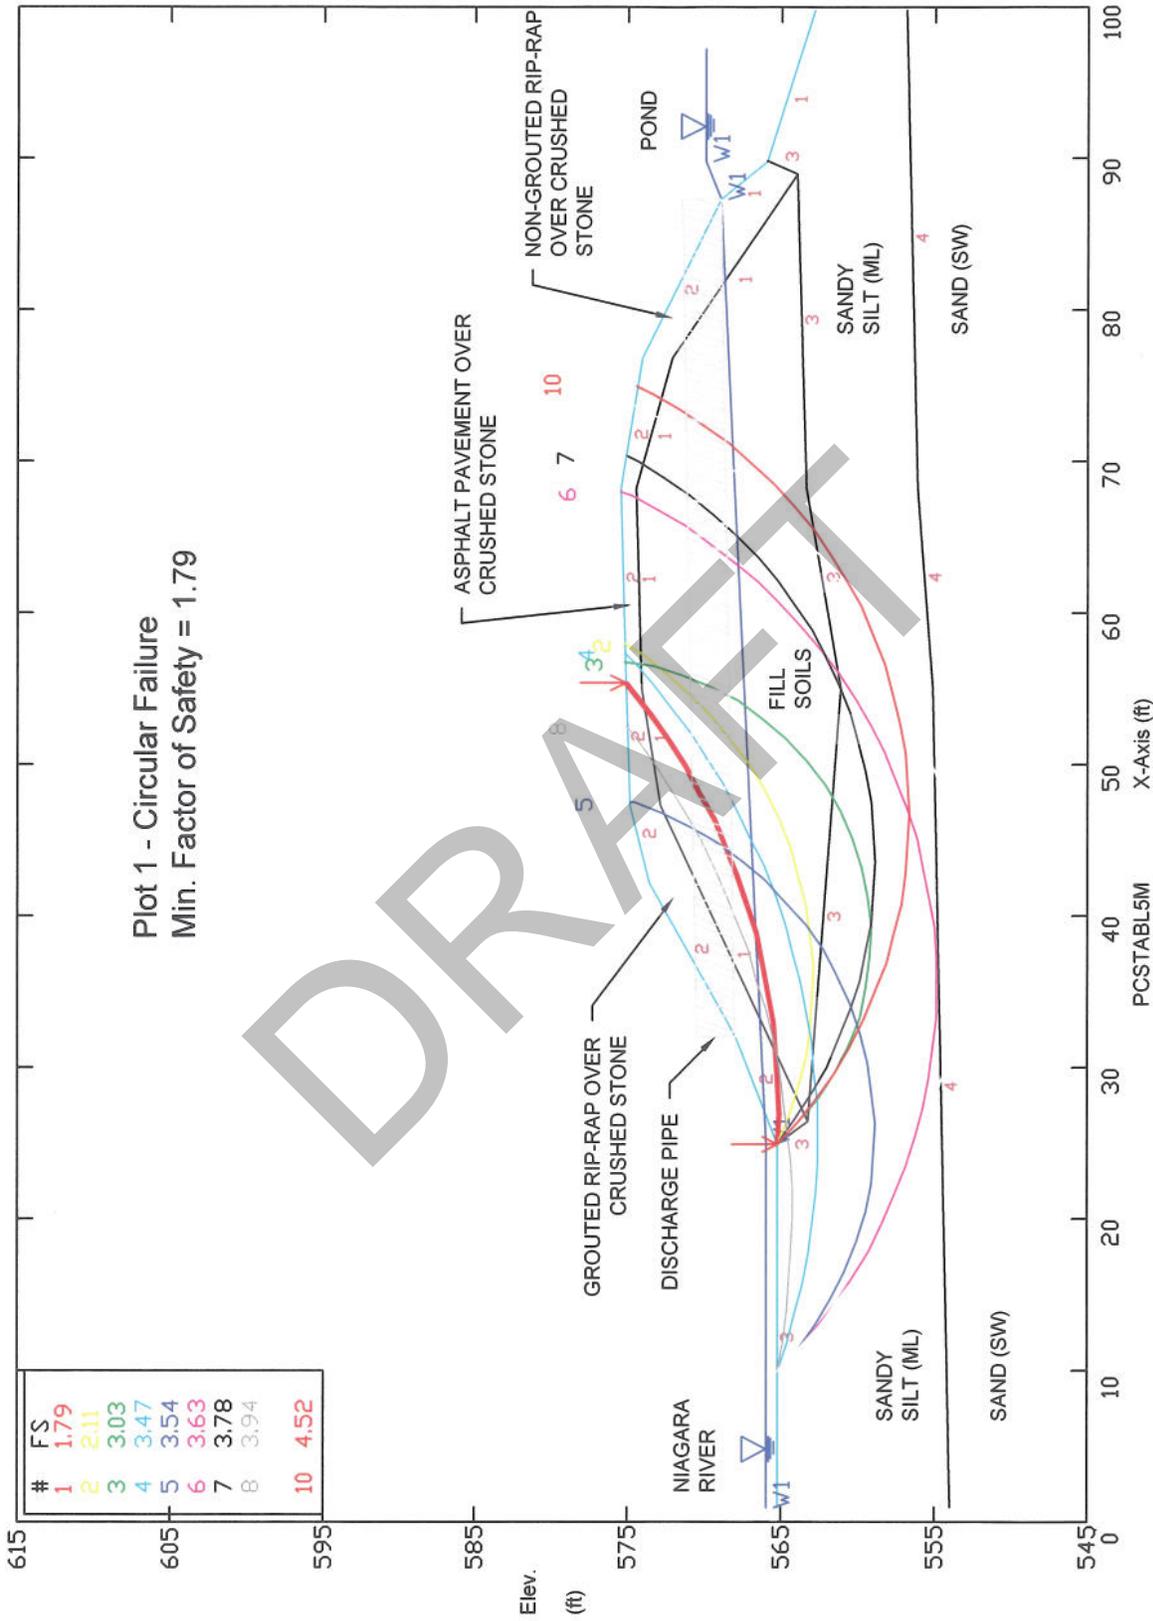
Ten Most Critical. C:NRG2.PLT By: djt 05-20-09 1:21pm

The results of GZA's stability analyses indicated minimum factors of safety of 1.79 and 1.78 for circular failure surfaces and minimum factors of safety of 3.53 and 2.20 for block failure surfaces on the exterior face of the outlet dike. The two sets of factors of safety for each case are based on the sandy silt (1) and sandy silt (2) parameters, respectively (as discussed above and shown in Table 7).

#	FS
1	1.79
2	2.11
3	3.03
4	3.47
5	3.54
6	3.63
7	3.78
8	3.94
10	4.52

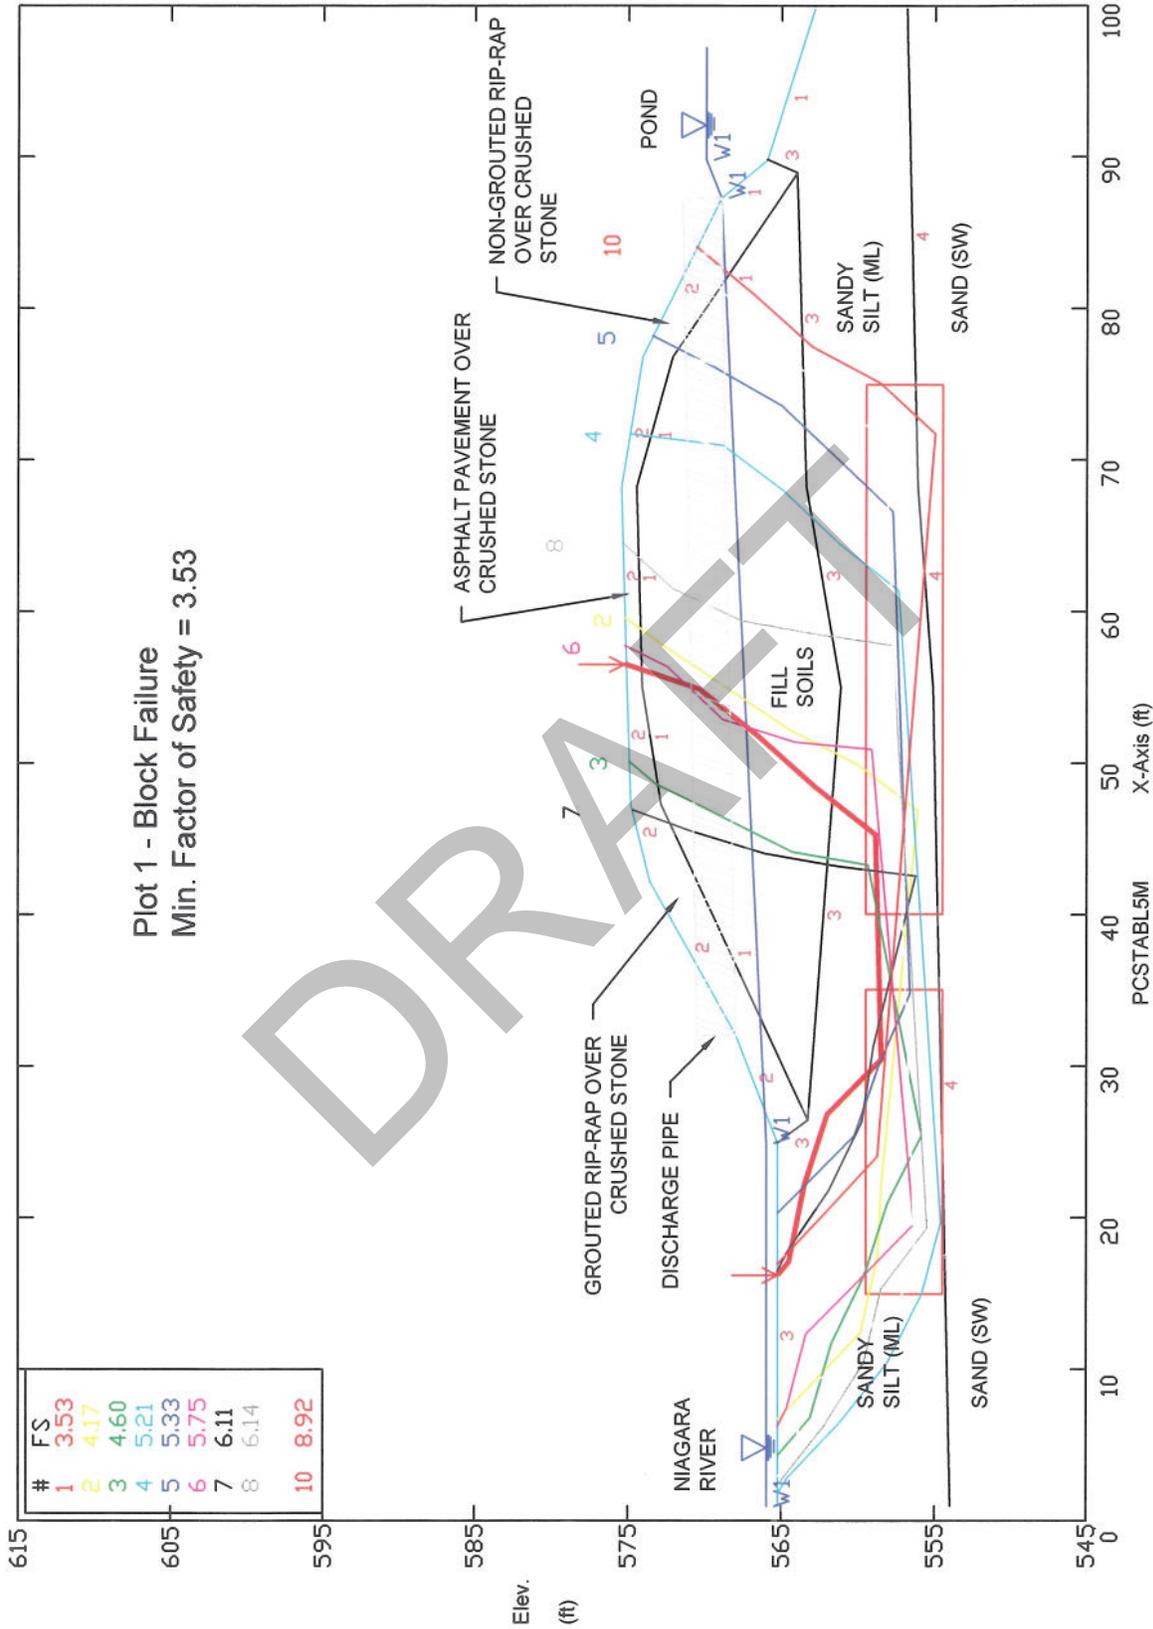
Ten Most Critical. C:NRG4.PLT By: djt 05-20-09 1:25pm

Plot 1 - Block Failure
Min. Factor of Safety = 3.53
