Report of Dam Safety Assessment of Coal Combustion
Surface Impoundments
NRG Energy
Huntley Generating Station
Tonawanda, NY

AMEC Project No. 3-2106-0194

September 2011

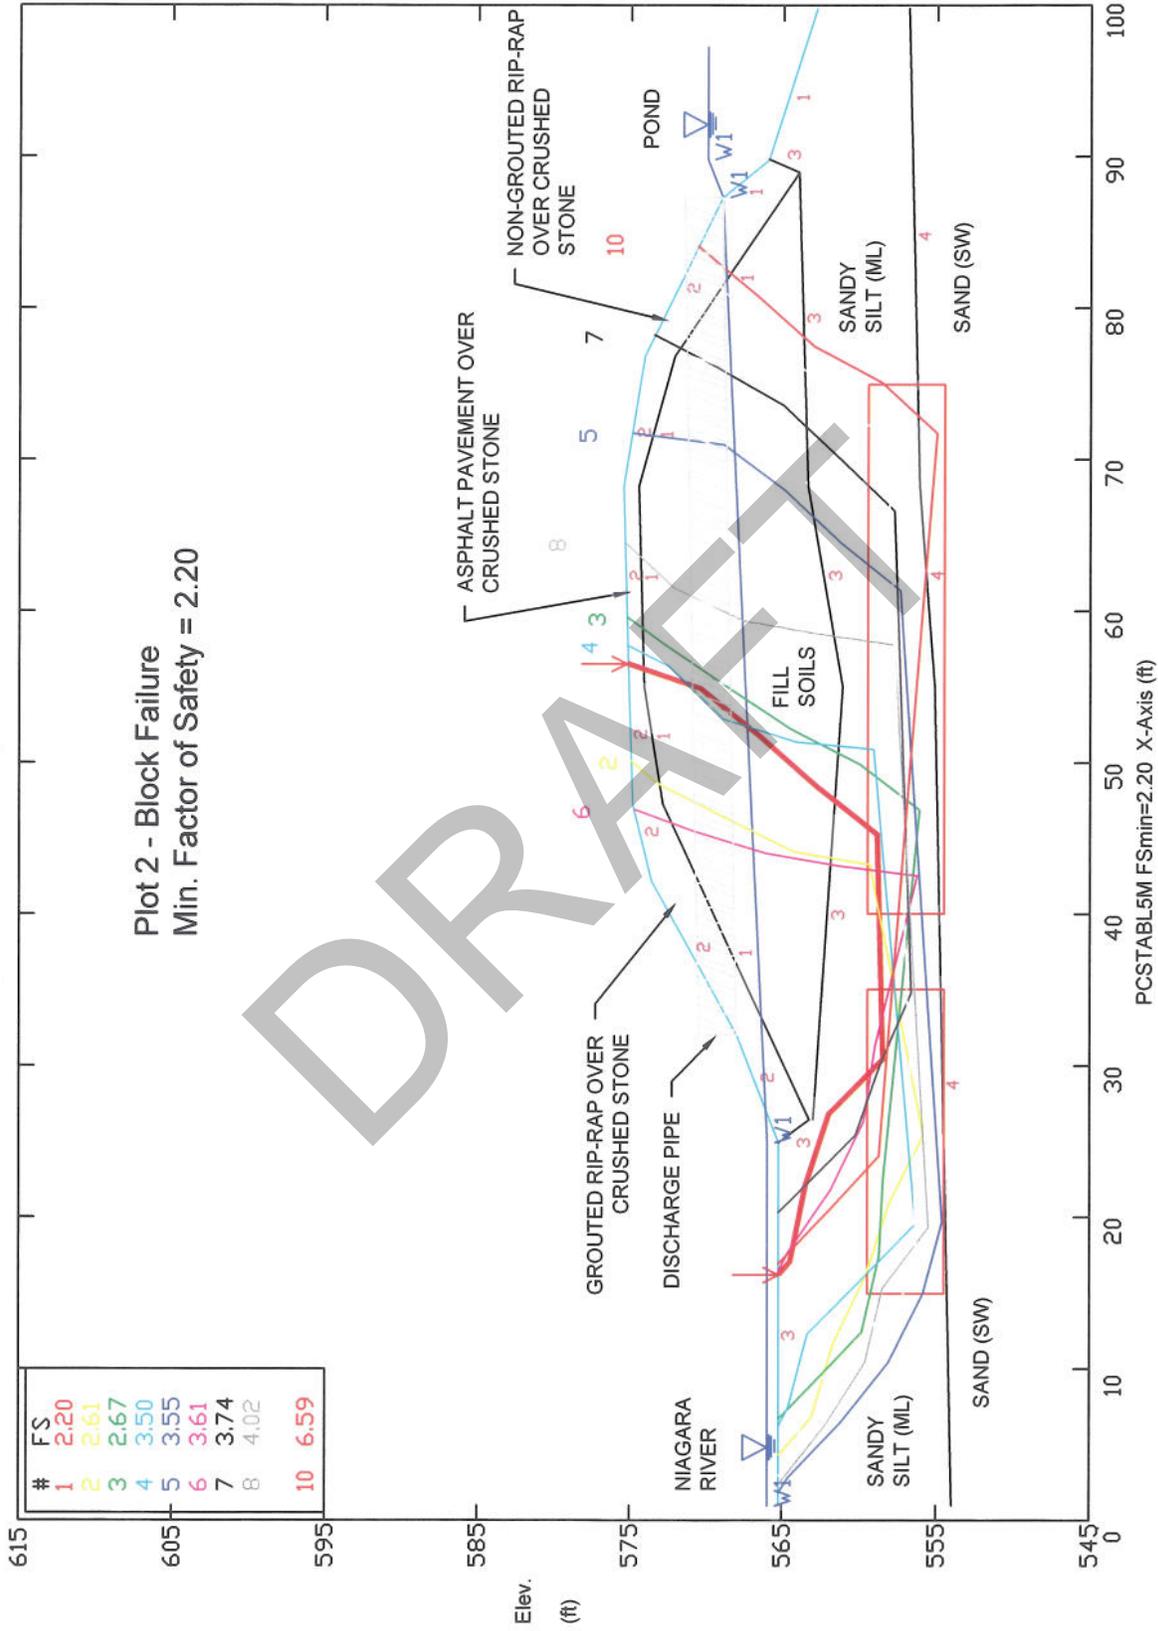
Ten Most Critical. C:NRG3.PLT By: djt 05-20-09 1:23pm

The results of GZA's stability analyses indicated minimum factors of safety of 1.79 and 1.78 for circular failure surfaces and minimum factors of safety of 3.53 and 2.20 for block failure surfaces on the exterior face of the outlet dike. The two sets of factors of safety for each case are based on the sandy silt (1) and sandy silt (2) parameters, respectively (as discussed above and shown in Table 7).

Plot 2 - Block Failure
Min. Factor of Safety = 2.20
