SUBJECT: AEP NRG Energy, Limestone Electric Station, Response to Comments

**Coal Combustion Residue Impoundment
Round 9 - Dam Assessment Report**

***Limestone Generating Station
DSDA & ST-18 Ponds***

***NRG Texas Power LLC
Jewett, Texas***

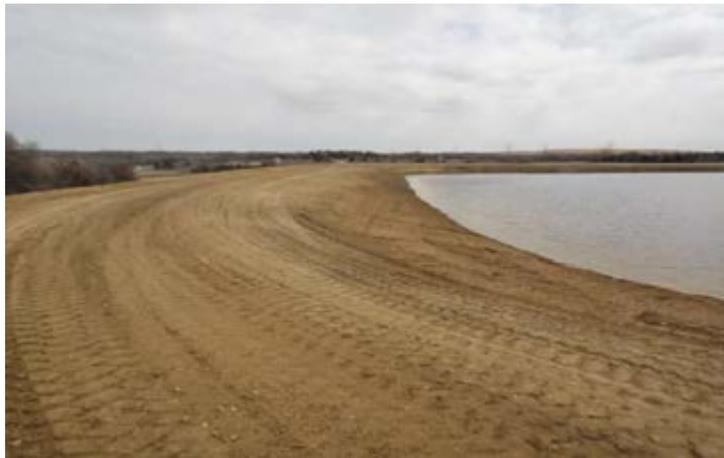
The embankments' crests showed no signs of depressions, tension cracks, or other indications of settlement or shear failure, and appeared to be in satisfactory condition. Vegetation, for the most part, was not present due to high amount of vehicular traffic (sludge haul trucks and process equipment). Figure 5.2.1-1 shows the typical conditions of the embankments crests.

Figure 5.2.1-1 Photo showing the lack of vegetation on the crest of the embankment.

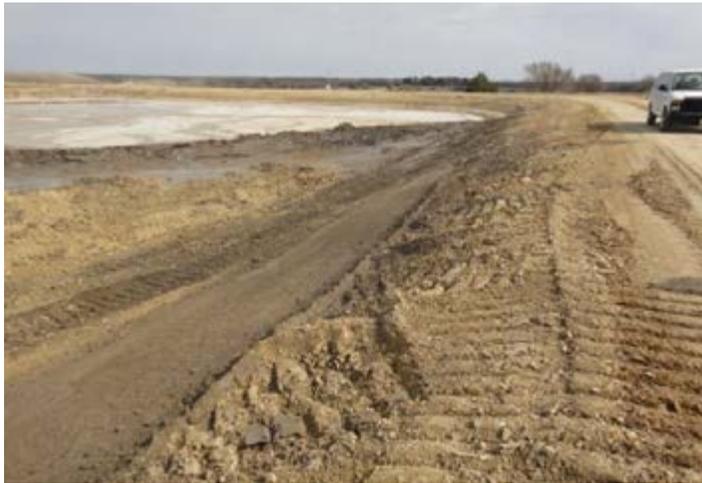
The impoundment's inside slope is generally bare earth, with the exception of a small corner of the east cell. Figures 5.2.2-1 and 5.2.2-2 show examples of these areas.

Figure 5.2.2-1. Inside slope bare earth.

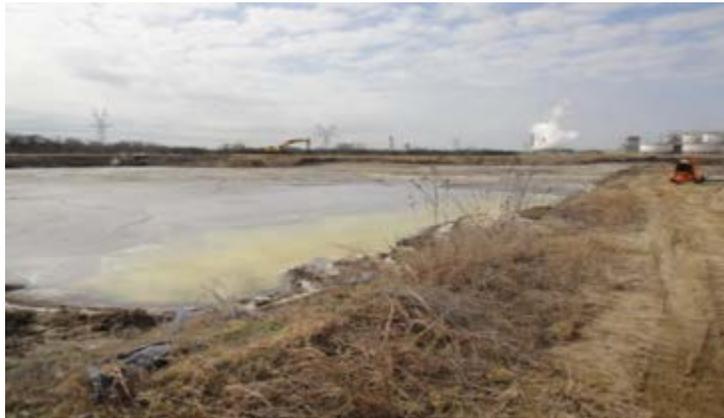
Figure 5.2.2-2. Sporadic area of vegetation on an inside slope.

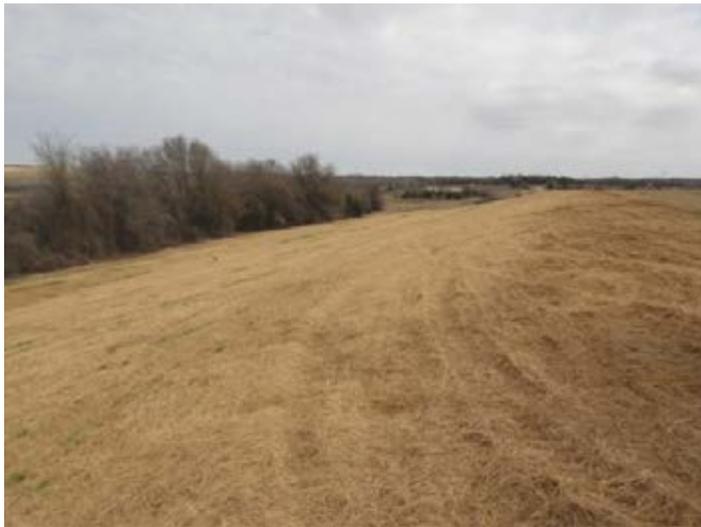
There were no observed scarps, sloughs, bulging, cracks, or depressions indicating slope instability or signs of erosion. The outside slope of this impoundment was uniformly graded and covered with mowed grass. The outside slope and toe appear to be in satisfactory condition. Figure 5.2.3-1 shows the general condition of the outside slope and toe.

Figure 5.2.3-1 Outside slope condition.

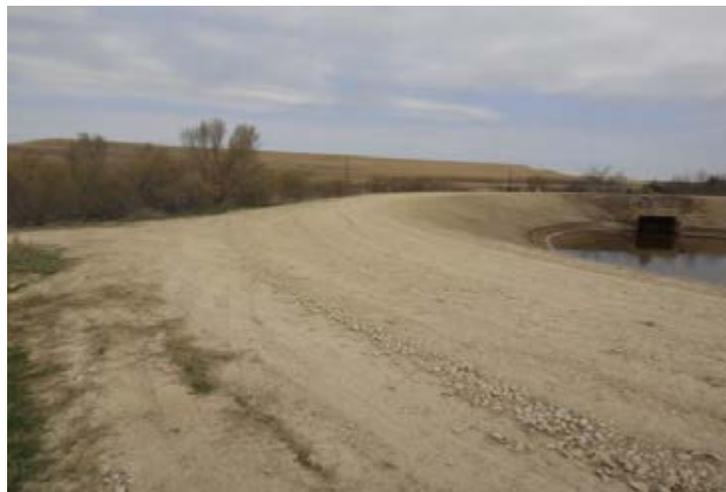
The crest of the ST-18 embankment showed no signs of depressions, tension cracks, or other indications of settlement or shear failure, and appeared to be in satisfactory condition. Vegetation was not present. Figure 5.3.1-1 shows the conditions of the embankment's crest on the west side.

Figure 5.3.1-1 Crest condition on the west side of the embankment.

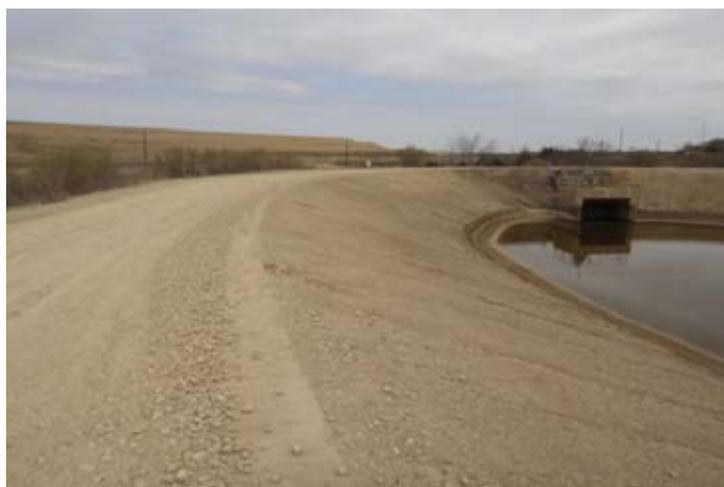
The embankment's inside slope is generally clear of any vegetation, with the exception of around the inlet pipe. Figure 5.3.1-1 shows the inside slope condition.

Figure 5.3.1-1. Figure showing the embankment's inside slope condition.

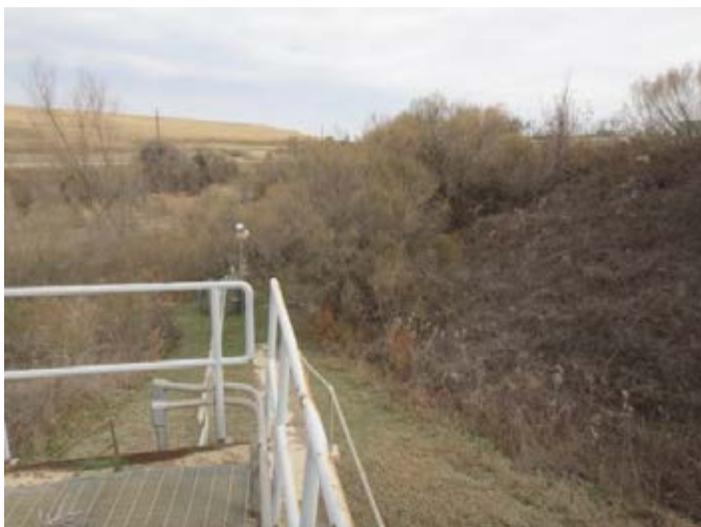
There were no observed scarps, sloughs, bulging, cracks, or depressions indicating slope instability or signs of erosion. While the outside slope of the embankment was uniformly graded, it was covered with various forms of vegetation including heavy woody brush and trees. Figure 5.3.3-1 shows the general condition of the outside slope and toe of the embankment.

Figure 5.3.3-1 Photo shows the general condition of the embankment's outside slope and toe.

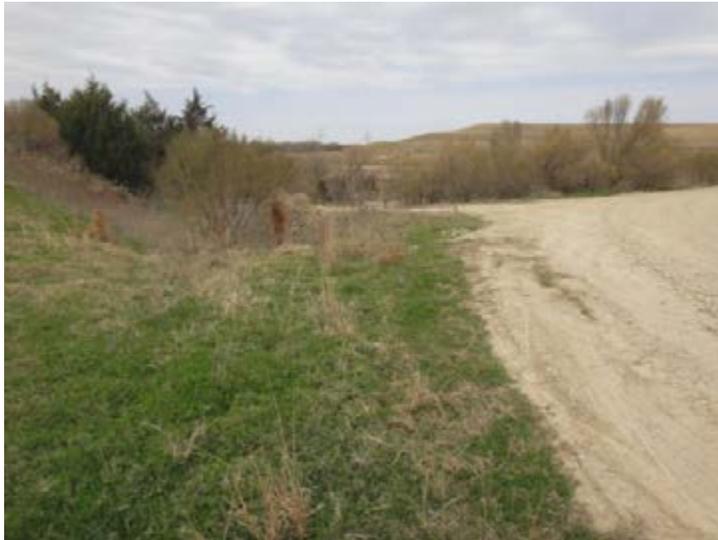
There were no observed scarps, sloughs, bulging, cracks, or depressions indicating slope instability or signs of erosion. While the groin area of the embankment was uniformly graded and transitioned smoothly into the slope, it was covered with grassy vegetation. Figure 5.3.4-1 shows the general condition of the groin areas of the embankment.

Figure 5.3.4-1 General condition of the embankment in groin area.

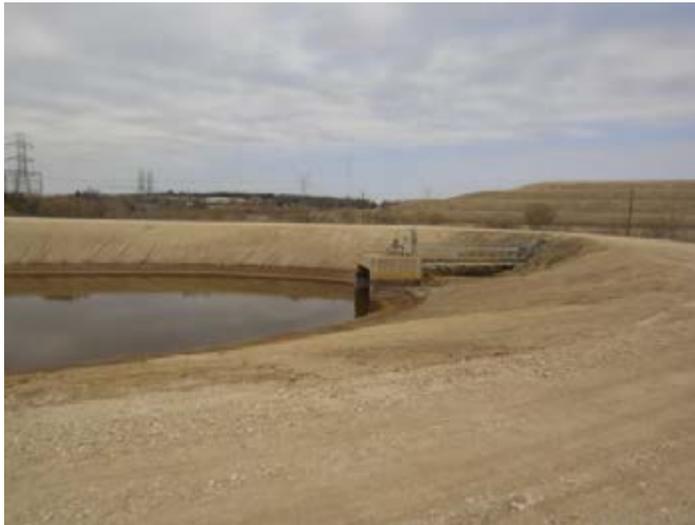
The level of ST-18 is controlled through the operation of sump pumps. Water is discharged into the plant's wastewater system. There were no observed cracks or depressions indicating concrete instability or signs of failure. Figure 5.5.2-1 shows the general condition of the ST-18 Outlet Structure.

Figure 5.5.2-1 General condition of the ST-18 Outlet Structure
