# Dam Safety Assessment of CCW Impoundments

GenOn Energy – New Castle Plant  
West Pittsburg, Lawrence County, Pennsylvania

November 30, 2012

GenOn Energy – New Castle Plant

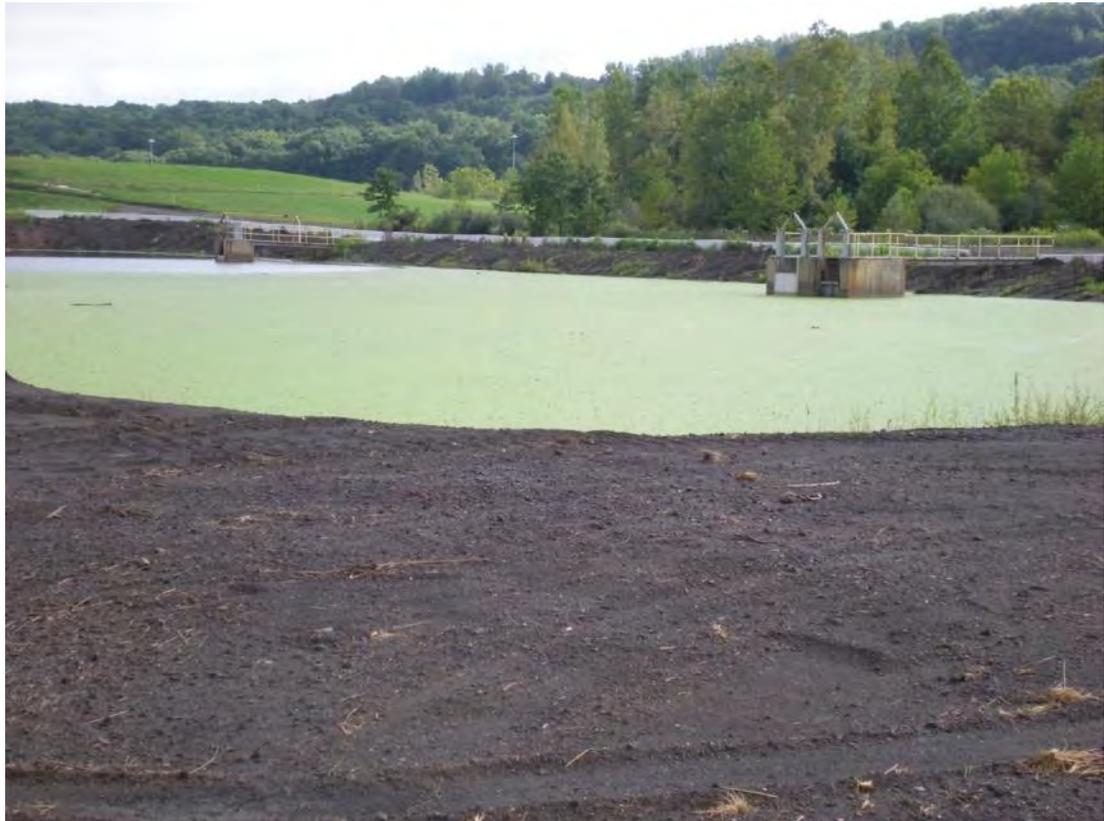
Photo Number:  
1

Description:  
North Ash Pond; northern and eastern interior slopes. Primary outlet structure to the left, secondary outlet structure to the right.

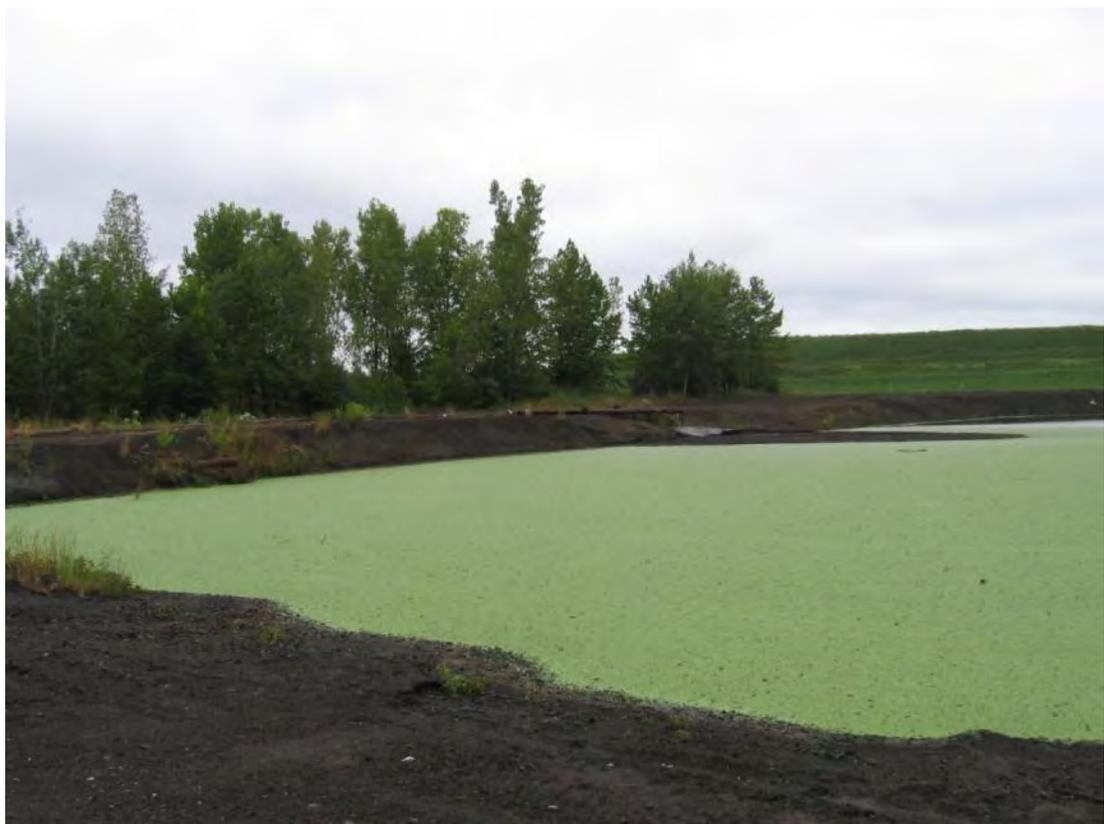
Photo Number:  
2

Description:  
North Ash Pond; northern and western interior slopes. Primary sluice discharge shown.

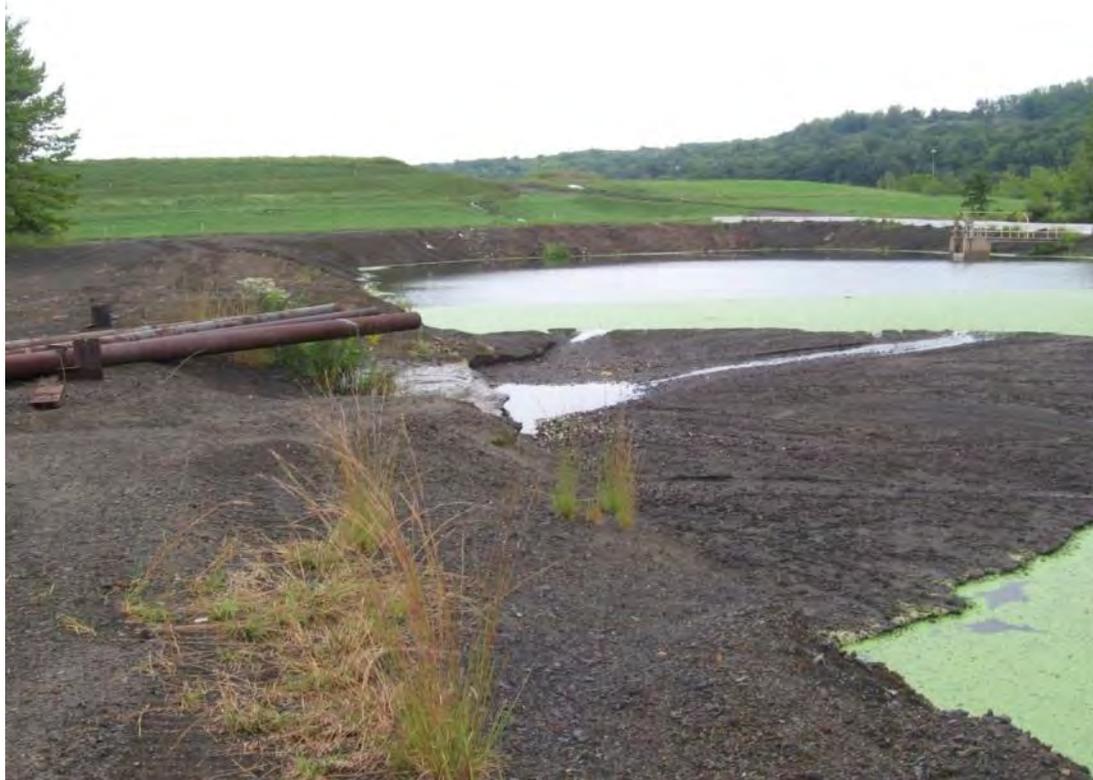
Photo Number:  
3

Description:  
North Ash Pond; primary sluice discharge pipes. Note ash delta formed at discharge.

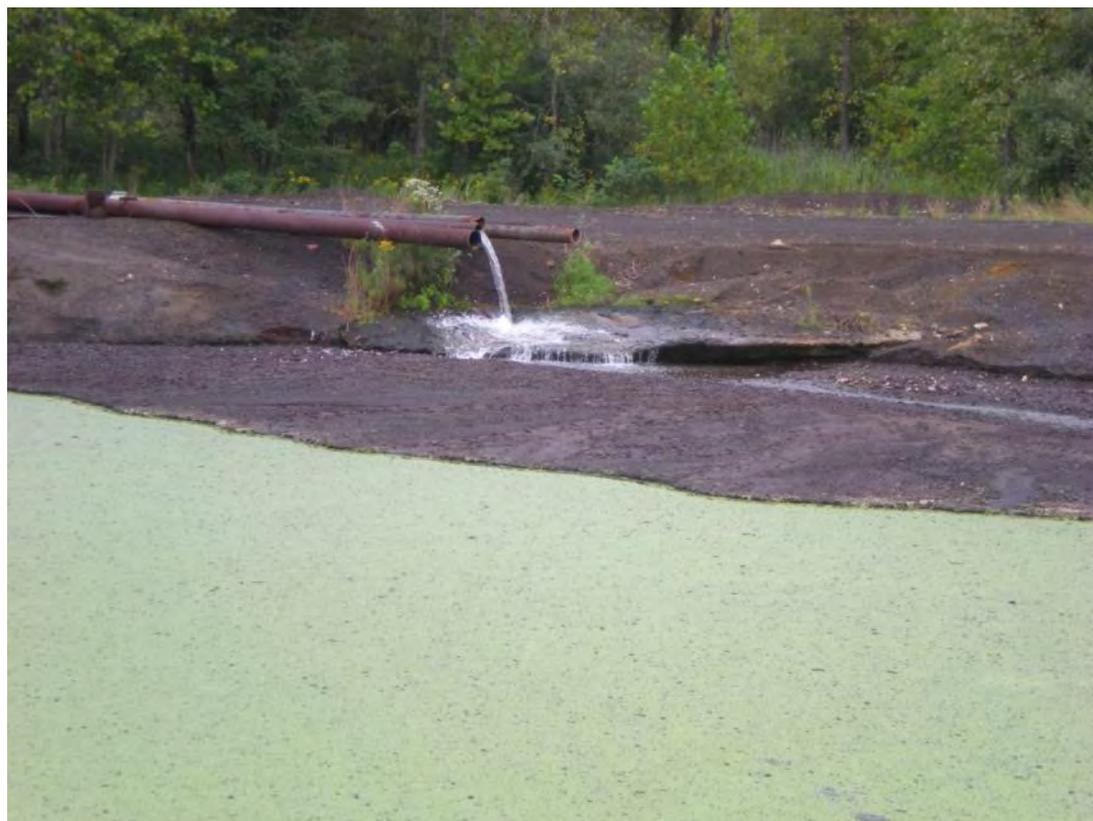
Photo Number:  
4

Description:  
North Ash Pond; sluice discharge onto poured concrete apron. Some undercutting of concrete apron visible.

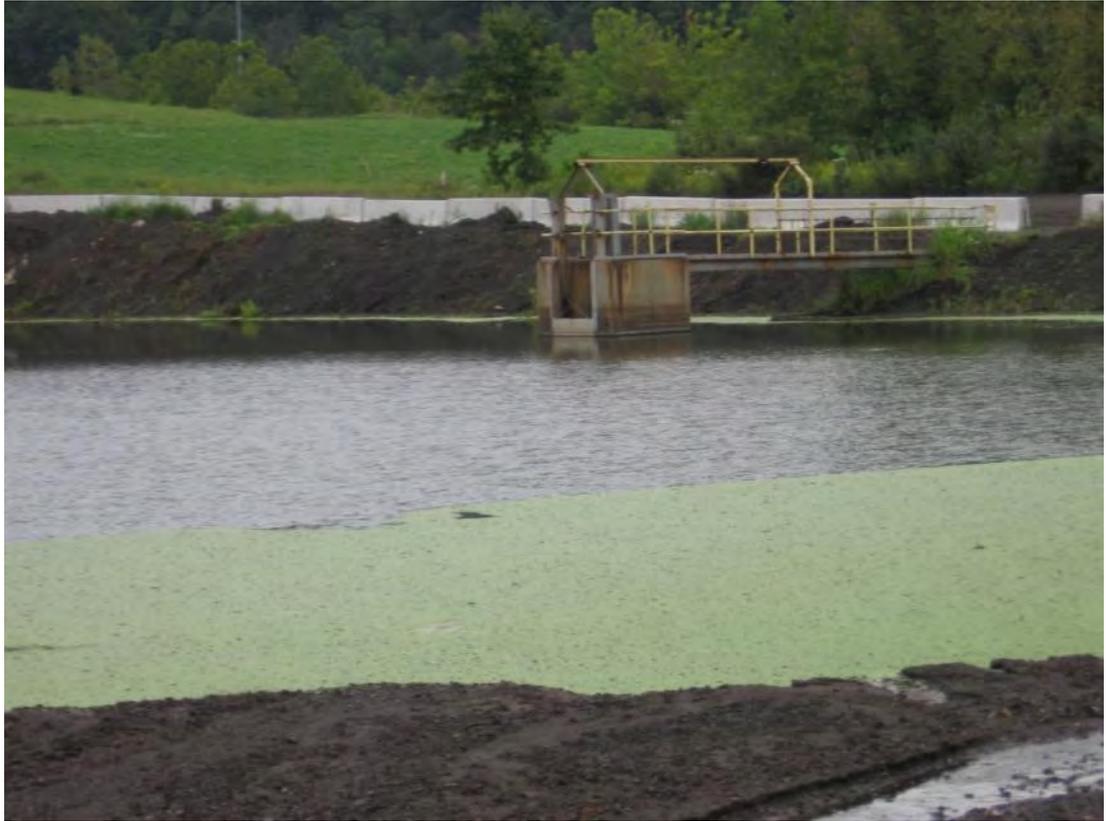
Photo Number:  
5

- The primary and secondary outlet structures appear to be in good condition and functioning normally. The water level was below the level of the stop logs in the secondary outlet structure at the time of inspection.

Description:  
North Ash Pond; View of primary outlet structure. Pond level control consists of slide gate and stop logs.

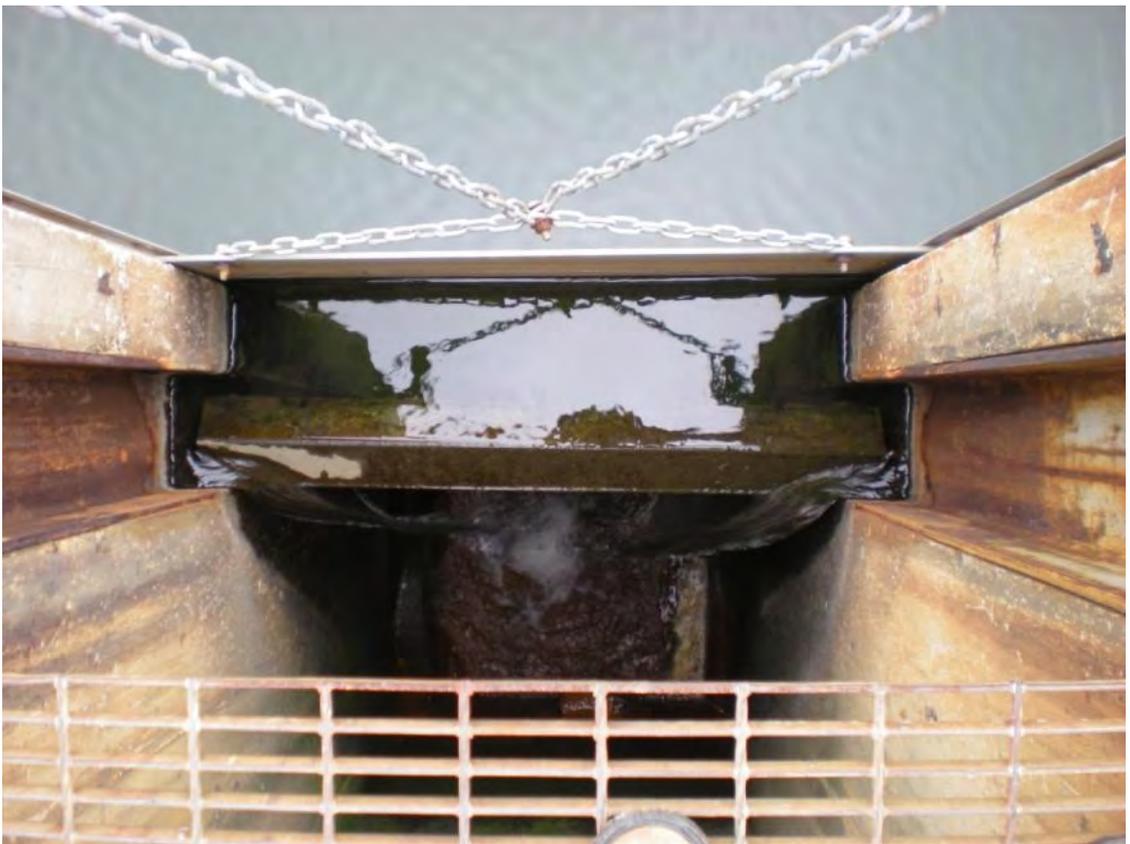
Photo Number:  
6

Description:  
North Ash Pond; View inside primary outlet structure. Water flowing clear.

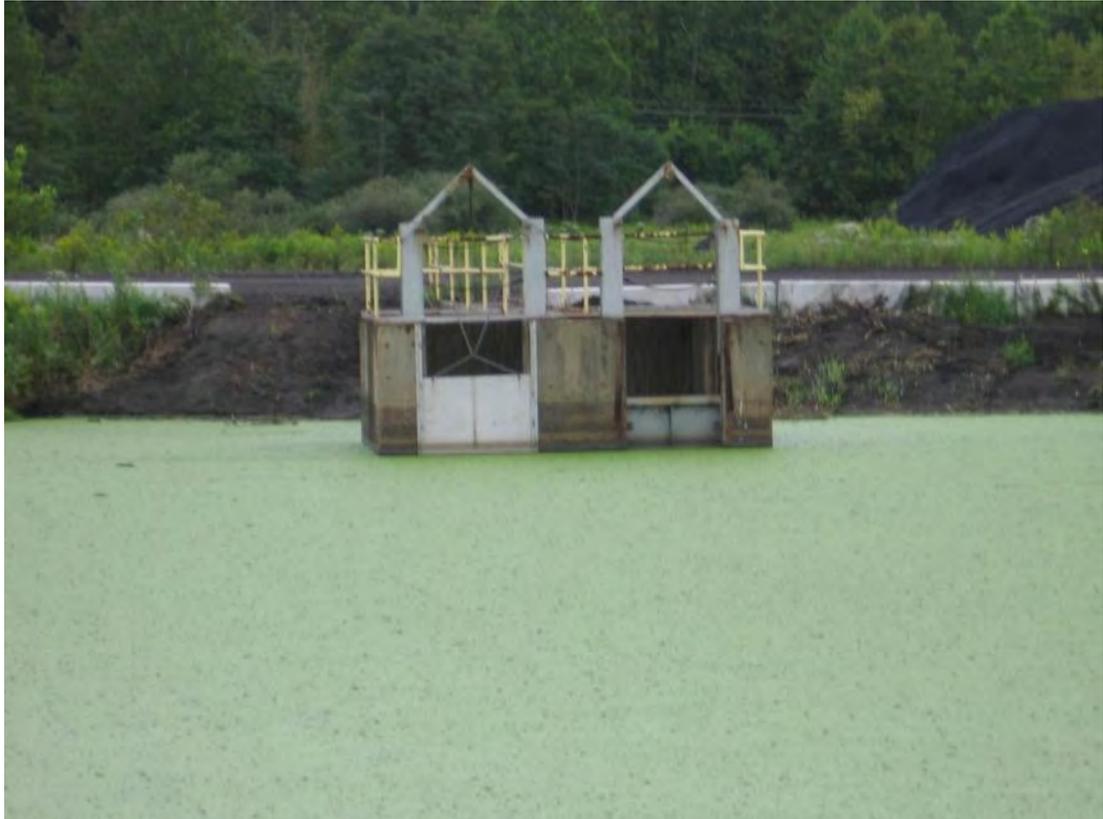
Photo Number:  
7

Description:  
North Ash Pond; View of secondary outlet structure used for overflow control. Pond level control consists of 2 slide gates and stop logs.

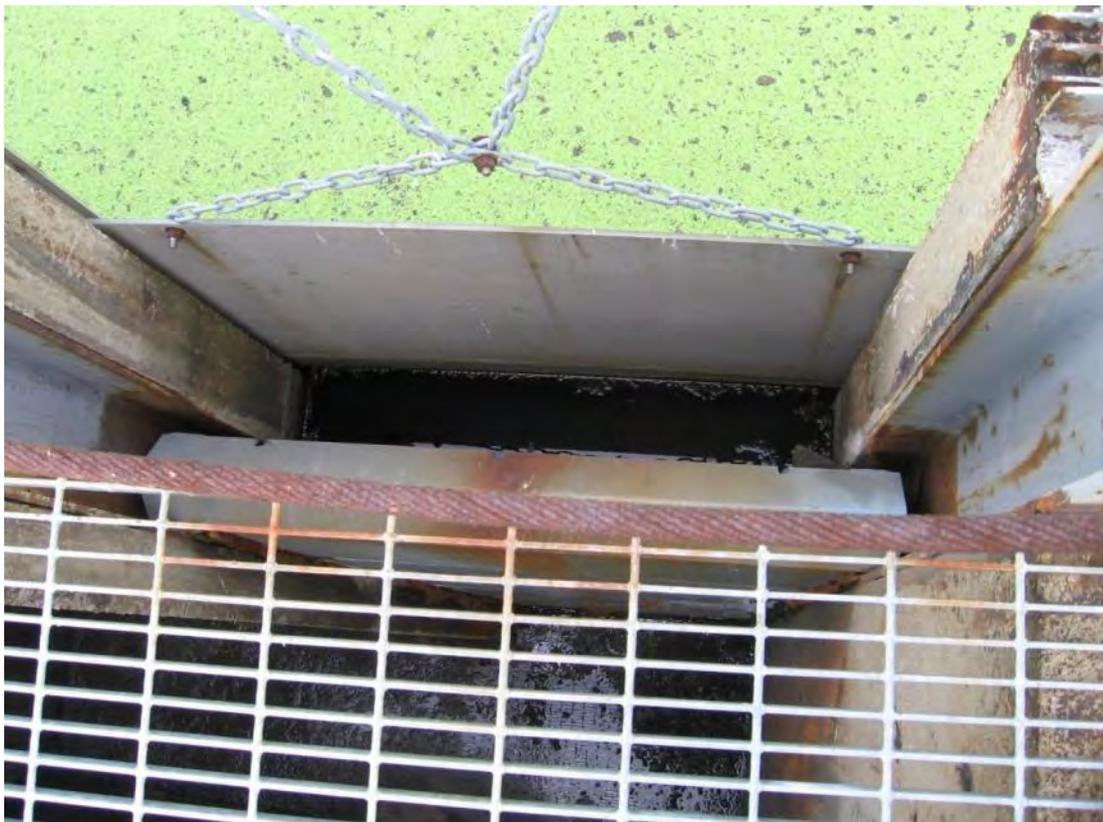
Photo Number:  
8

Description:  
North Ash Pond; View inside secondary outlet structure. Flow visible at bottom of structure from the primary outlet structure which drains to this structure.

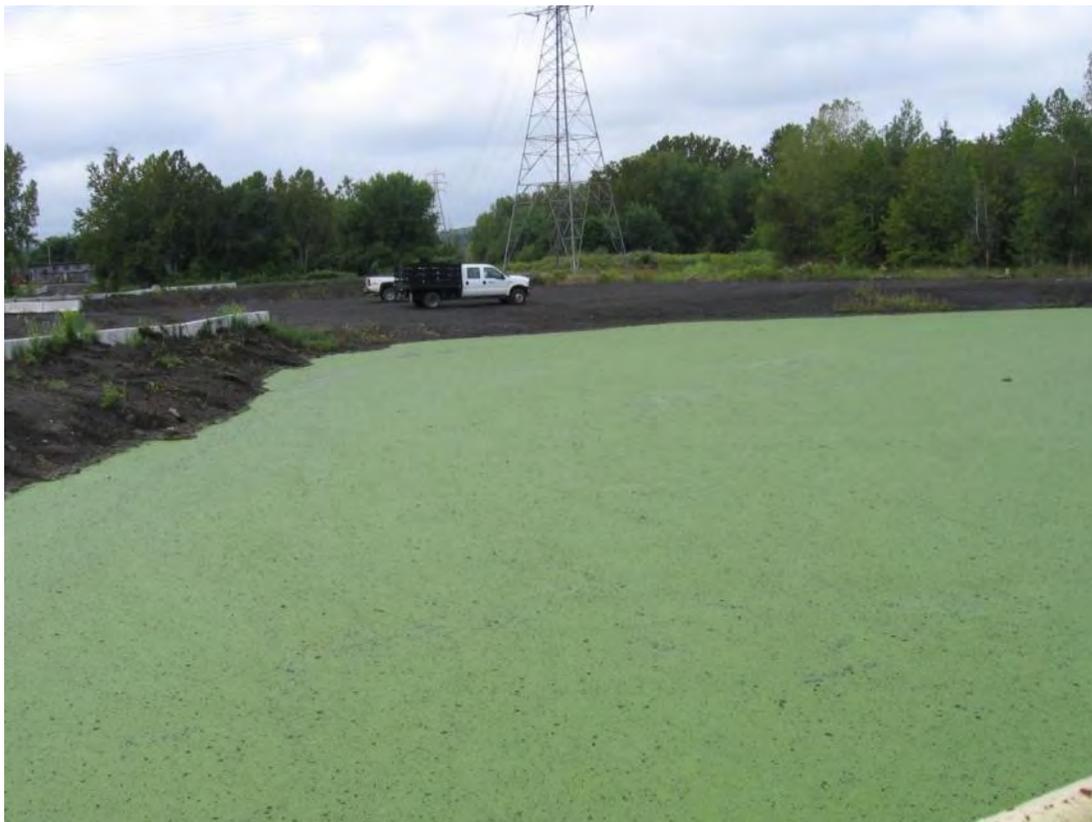
Photo Number:  
9

Description:  
North Ash Pond; View of south crest. South crest is the lowest crest elevation and shows only minimal built-up embankment to form the roadway.

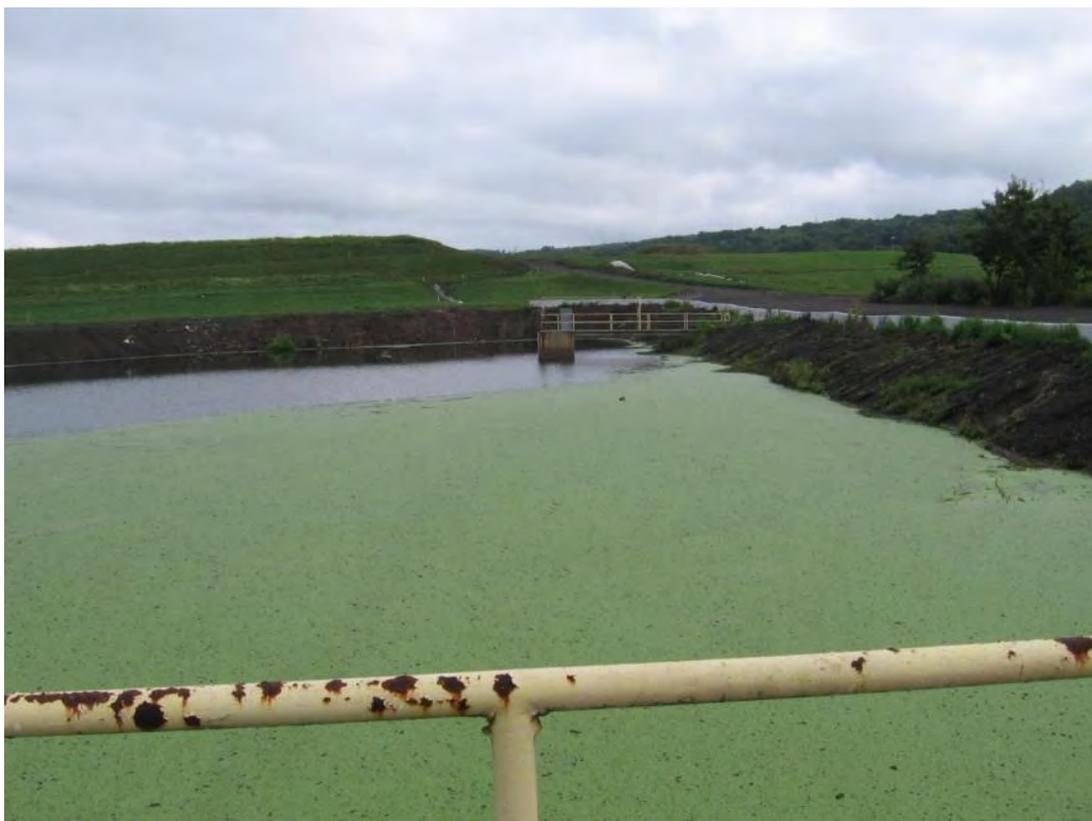
Photo Number:  
10

Description:  
North Ash Pond; View of northern and eastern interior side slopes and crest.

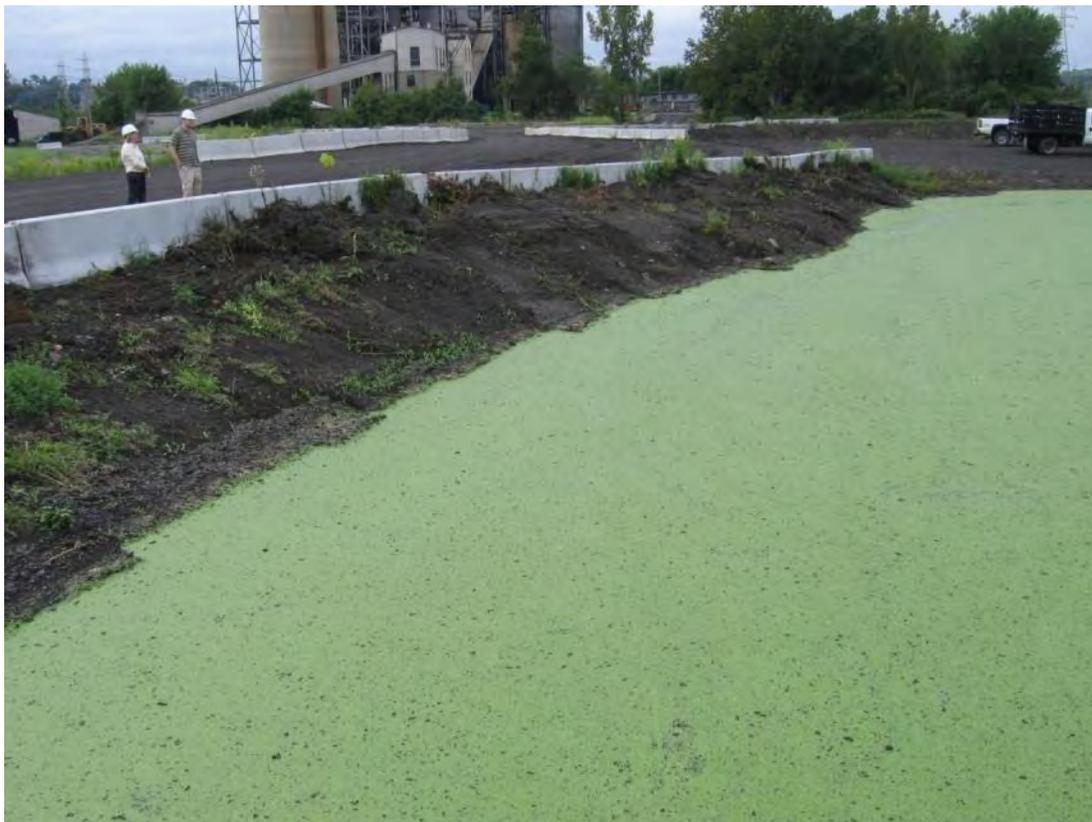
Photo Number:  
11

Description:  
North Ash Pond; View of eastern interior side slope and crest.

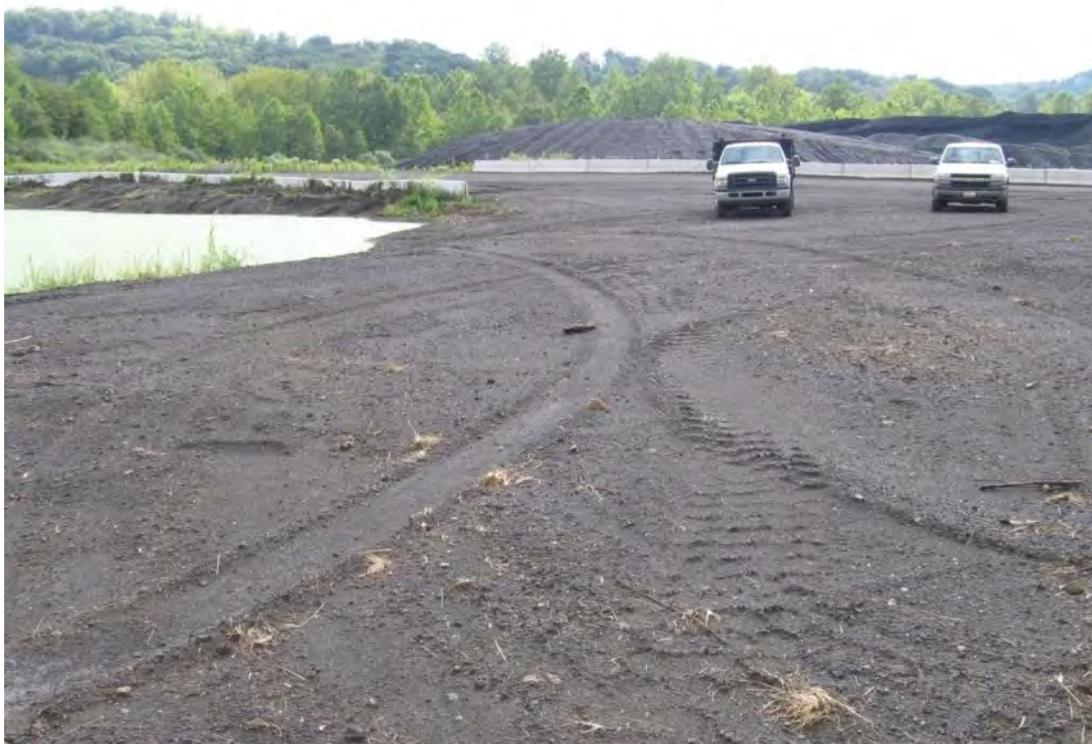
Photo Number:  
12

Description:  
North Ash Pond; View of crest south of the impoundment.

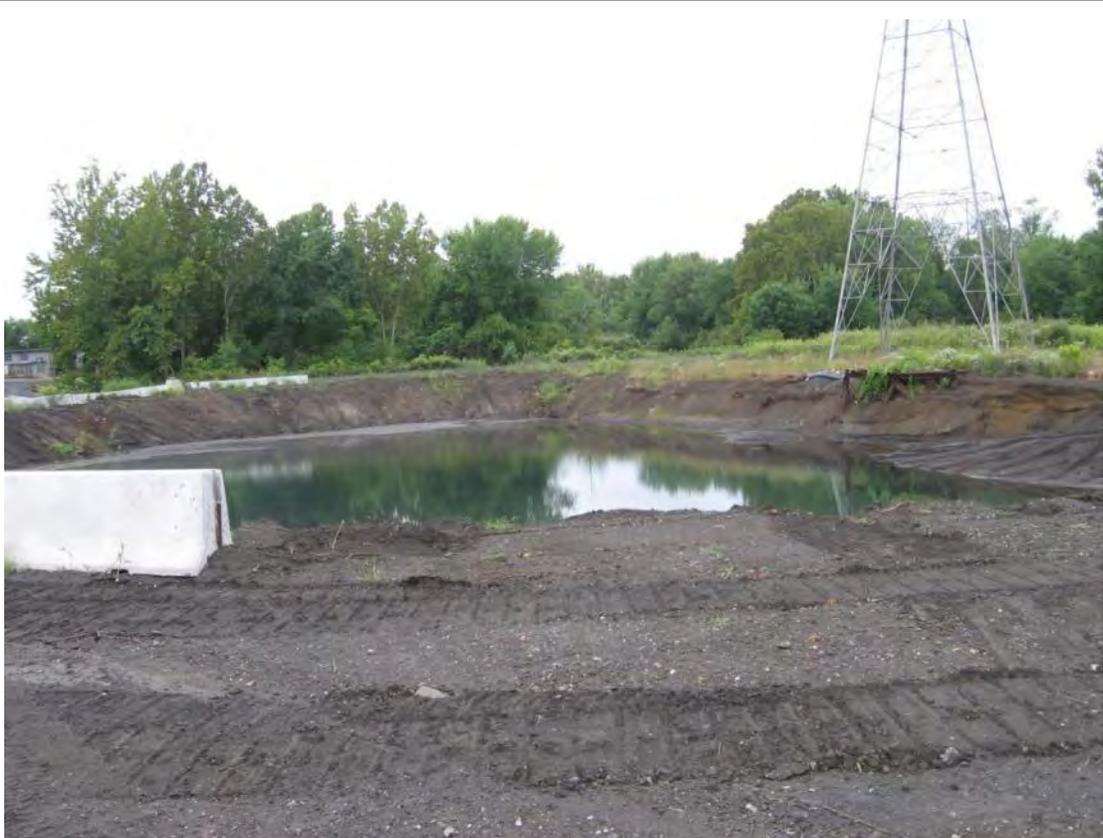
South Ash Pond

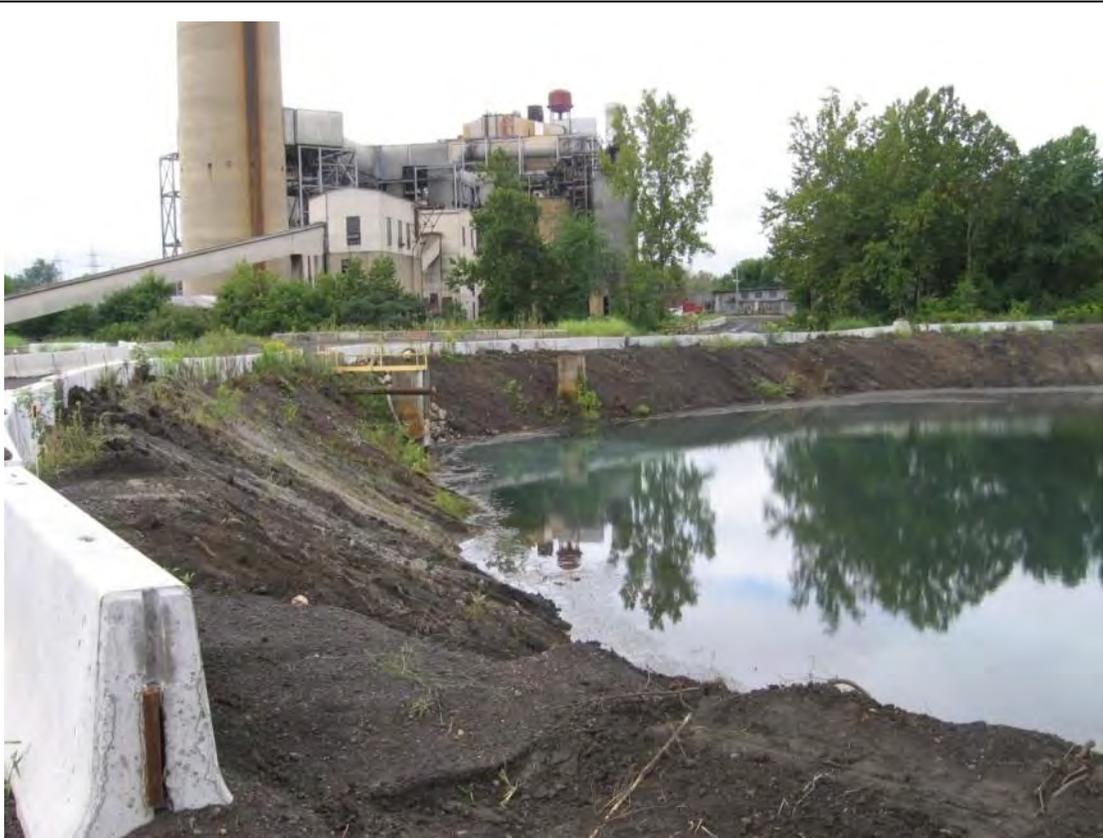
South Ash Pond eastern interior slope and outlet structures

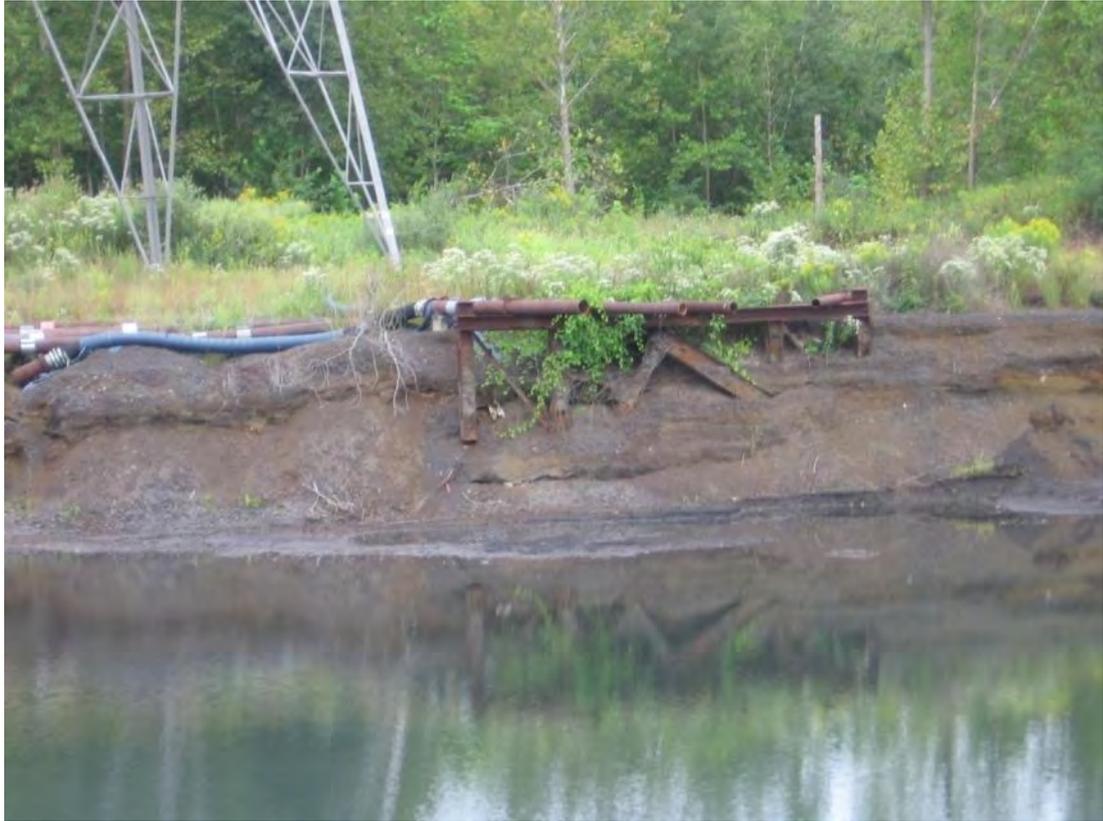
Photo Number:  
15

- There is poor vegetative cover over the inboard slopes which are experiencing significant erosion.
- The slope beneath the former bottom ash discharge piping is experiencing significant erosion. The structural support for the piping has been exposed.
- The outboard slope of the southern embankment is heavily vegetated, which limits visual inspection.
- The condition of the existing corrugated metal discharge pipe extending beneath the South Ash Pond from the North Ash Pond is unknown. Given that the release in 2006 from the South Ash Pond likely resulted

Description:  
South Ash  
Pond; Former  
sluice discharge  
piping

- Inboard slopes:
  - Repair erosion of the slope beneath the former bottom ash discharge piping. Repairs or regrading should be performed in accordance with an engineering design.

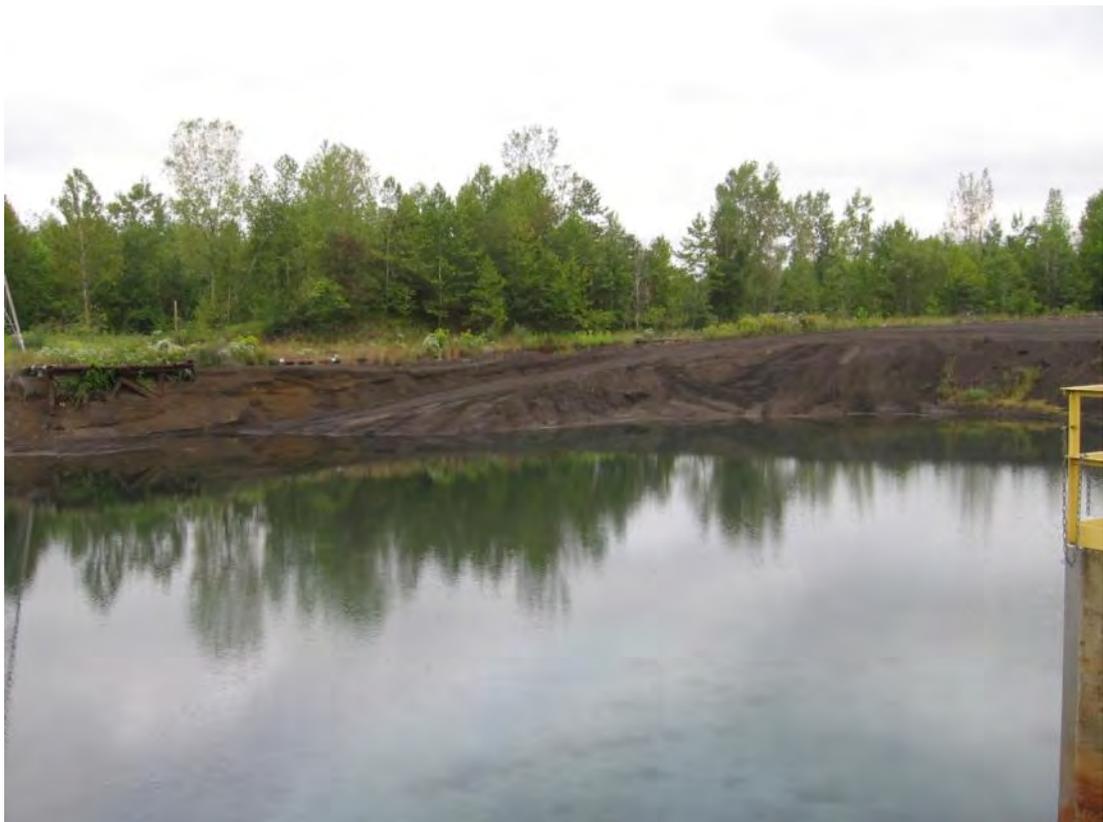
Photo Number:  
16

Description:  
South Ash  
Pond; Access  
ramp to South  
Ash Pond at NW  
corner of the  
impoundment

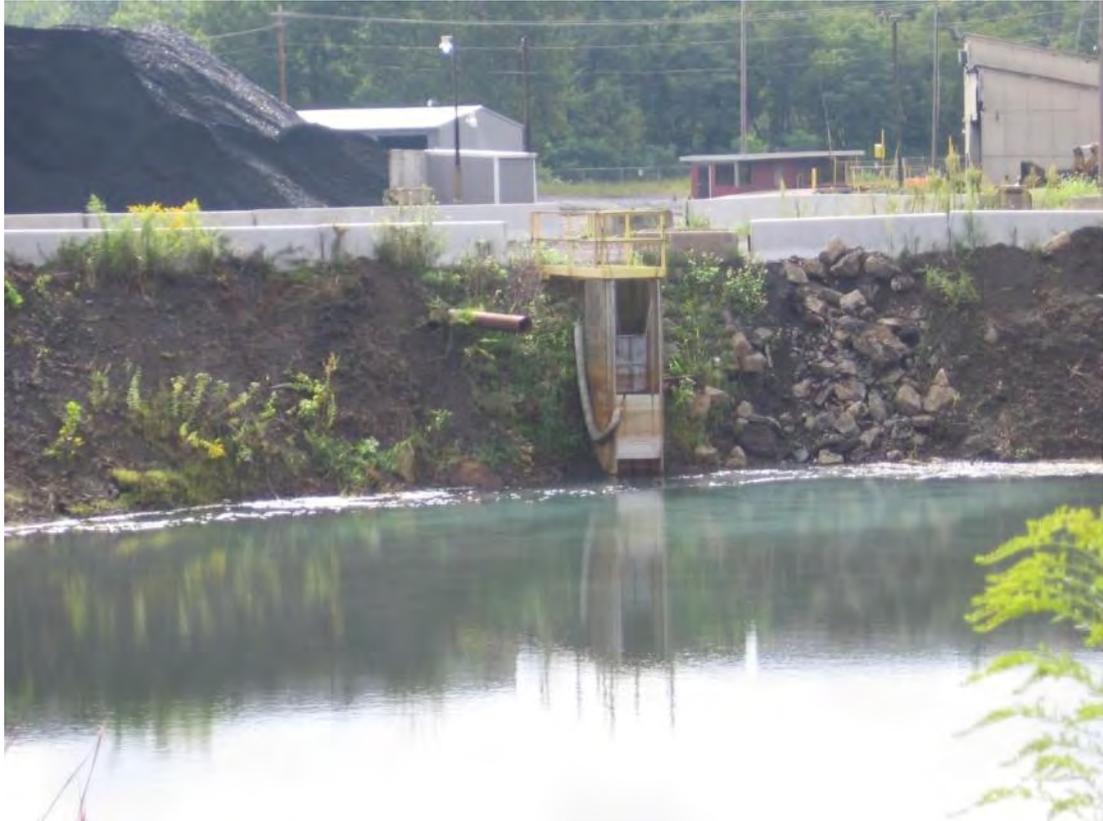
Photo Number:  
17

- The outlet structure appears to be in good condition and functioning normally. The water level was being maintained below the elevation of the stop logs at the time of inspection. There was no discharge from the outlet structure.

Description:  
South Ash Pond; View of outlet structure; Note apparent repair of minor erosion to the interior slope to the right of the outlet structure

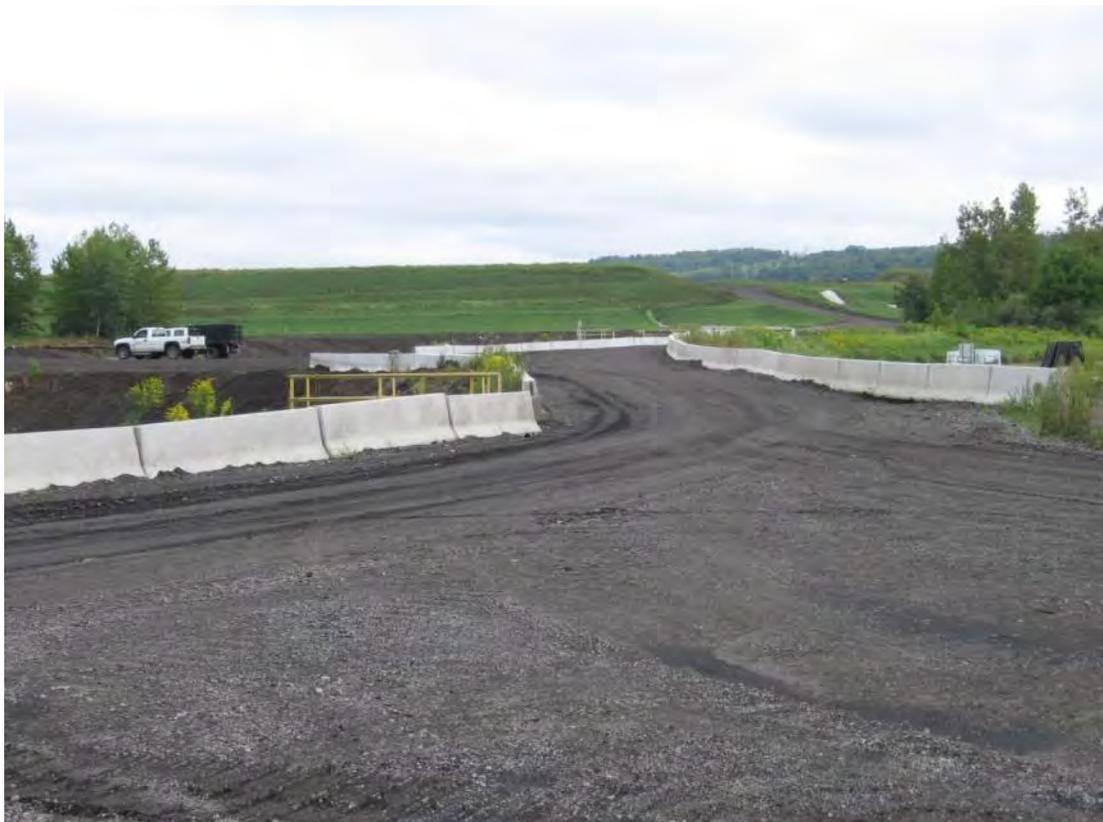
Photo Number:  
18

Description:  
South Ash Pond; Access driveway on eastern crest of the impoundment

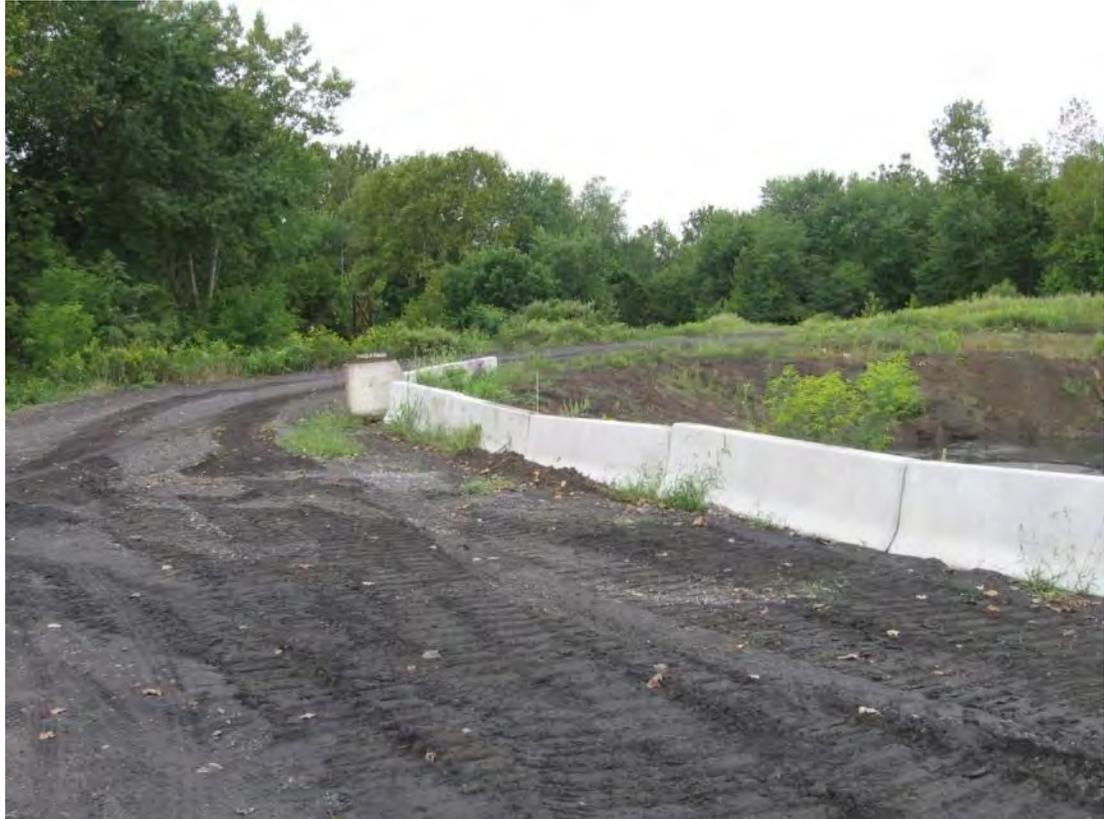
Photo Number:  
19

Description:  
South Ash  
Pond; Access  
drive along  
southern crest  
of the  
impoundment

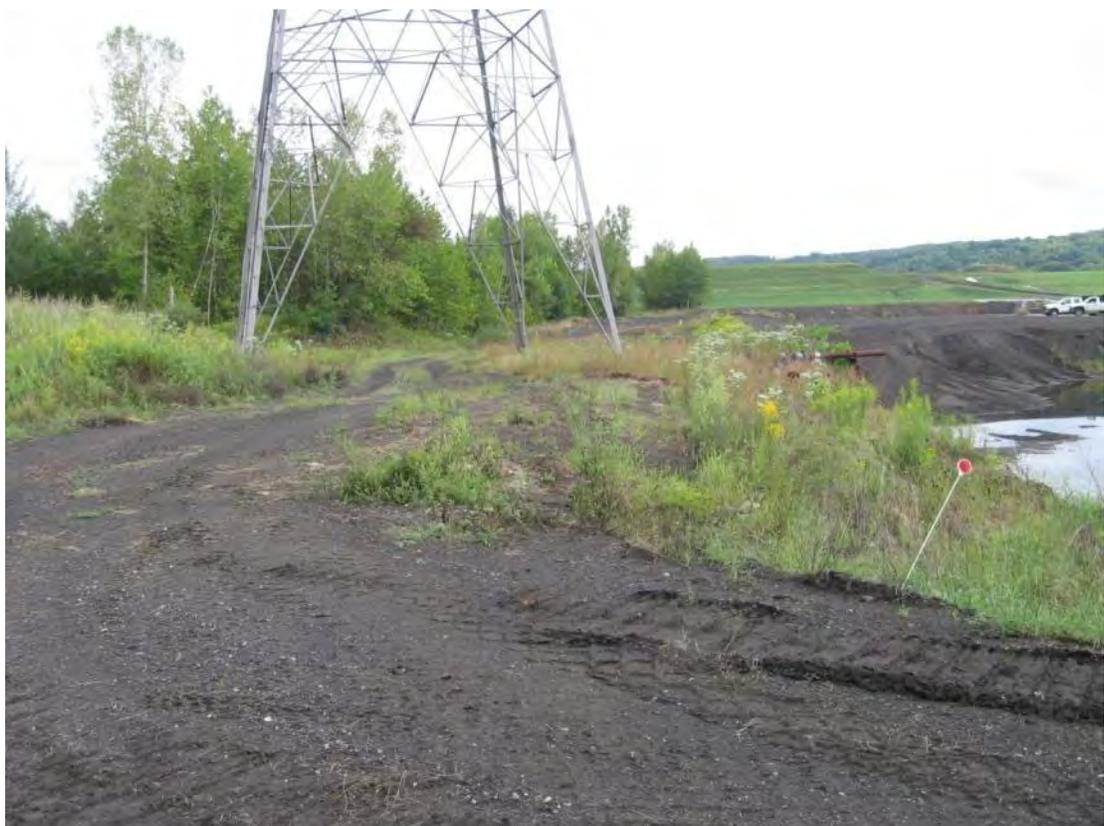
Photo Number:  
20

Description:  
South Ash  
Pond; Western  
crest of the  
impoundment,  
minimal built-  
up  
embankment to  
form access  
driveway.

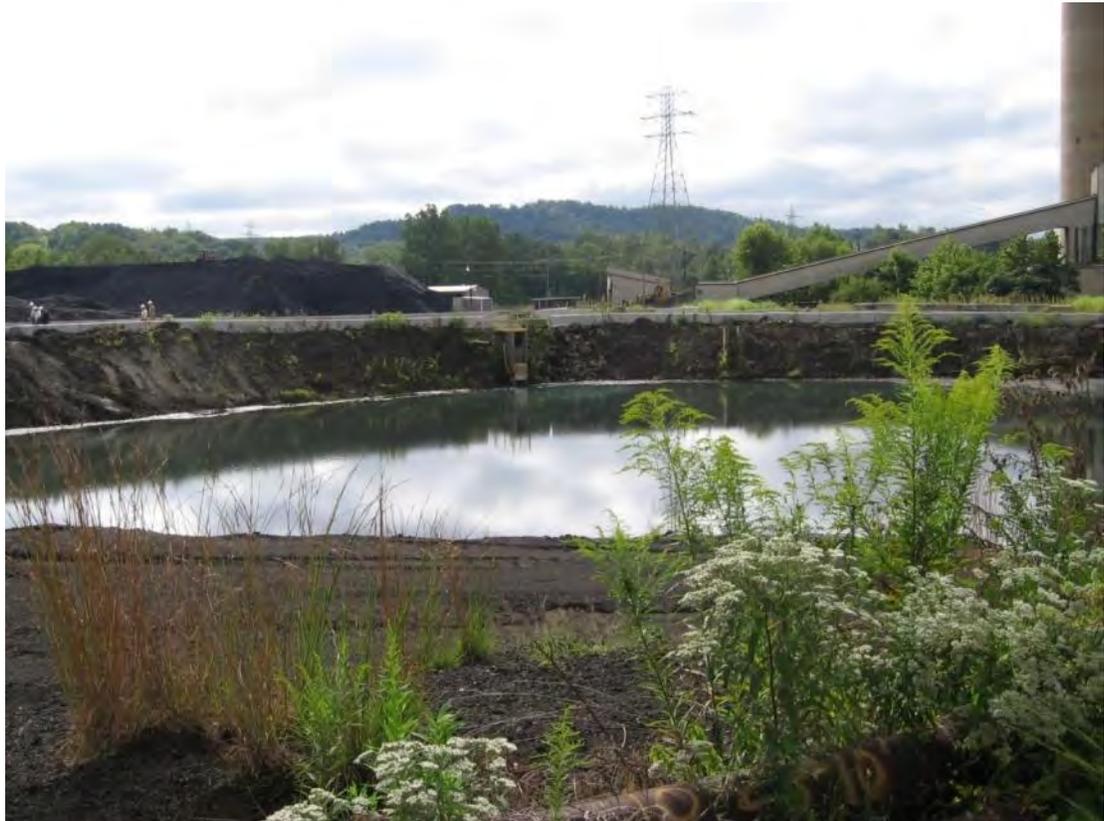
Photo Number:  
21

Description:  
South Ash Pond; Overall view looking southeast towards the coal pile storage area.

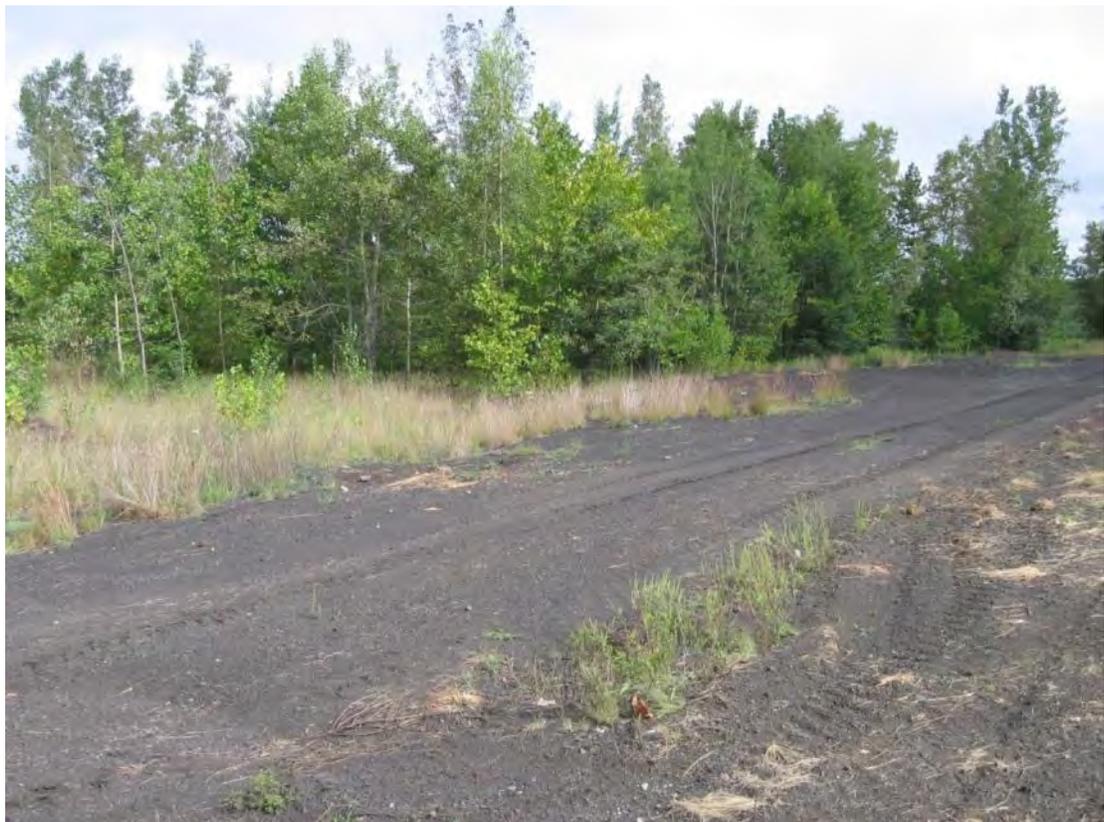
Photo Number:  
22

Description:  
Natural wooded area to the west of the impoundments, minimal built-up embankment to form the access drive

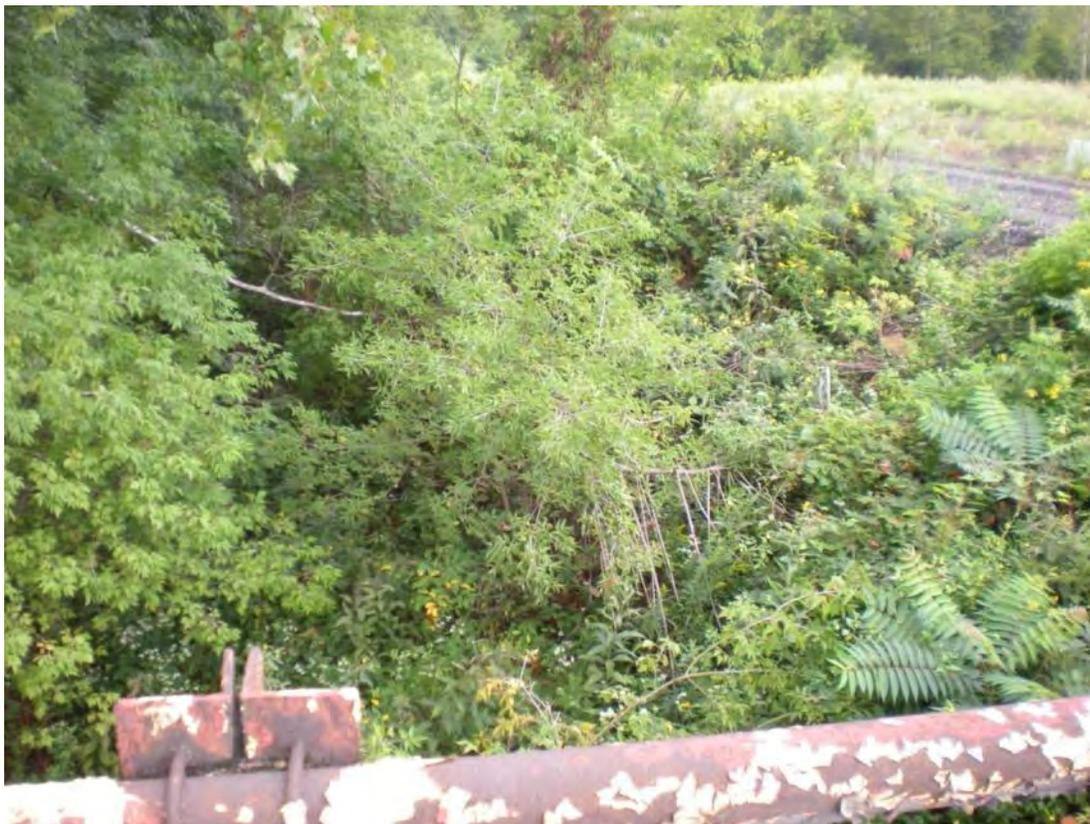
Photo Number:  
23

Description:  
Heavily vegetated outer side slope south of South Ash Pond leading down to the McKee Run.

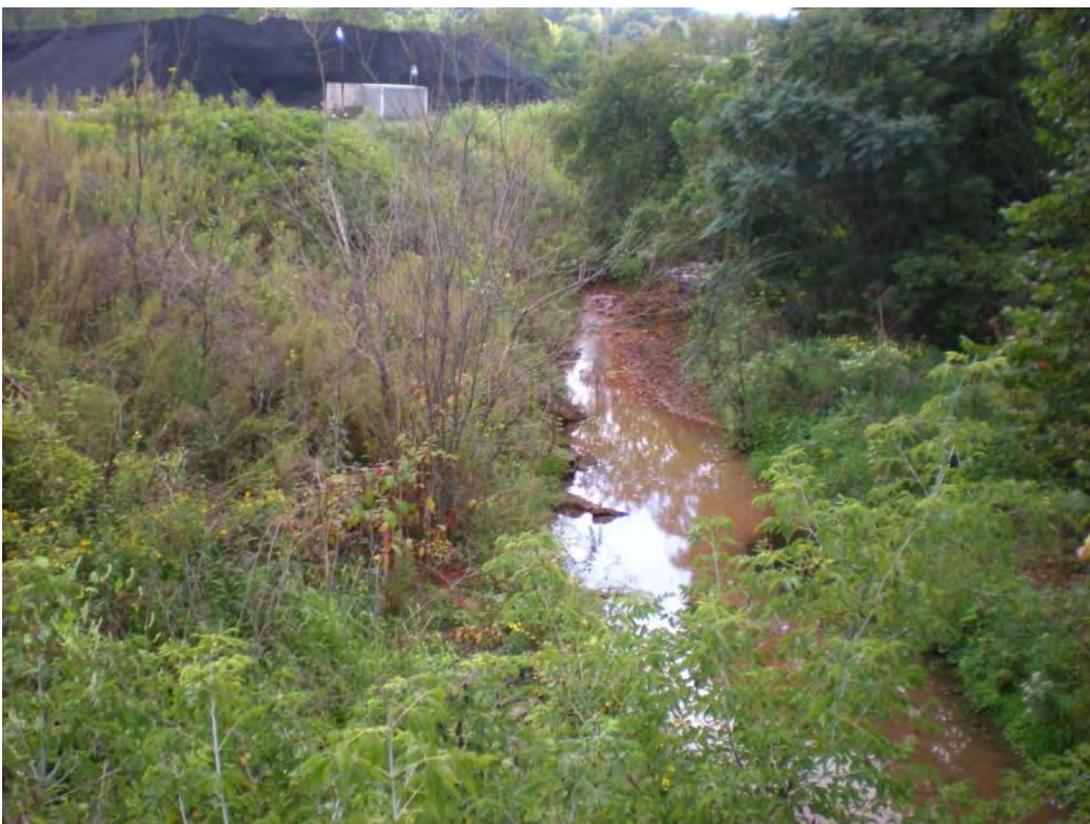
Photo Number:  
24

Description:  
View of the McKee Run upstream from the impoundments
