# Dam Safety Assessment of CCW Impoundments

GenOn Energy – New Castle Plant  
West Pittsburg, Lawrence County, Pennsylvania

November 30, 2012

GenOn Energy – New Castle Plant

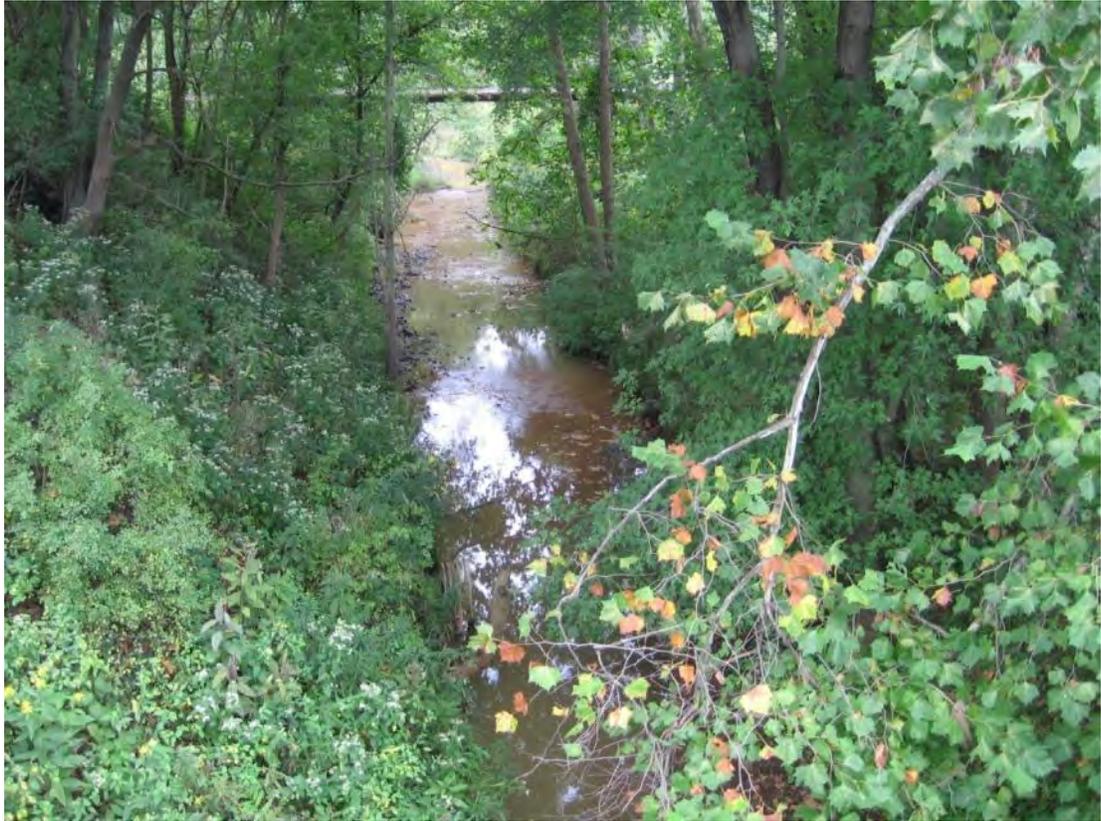
Photo Number:  
25

Description:  
View of the  
McKee Run  
south of the  
South Ash  
Pond.

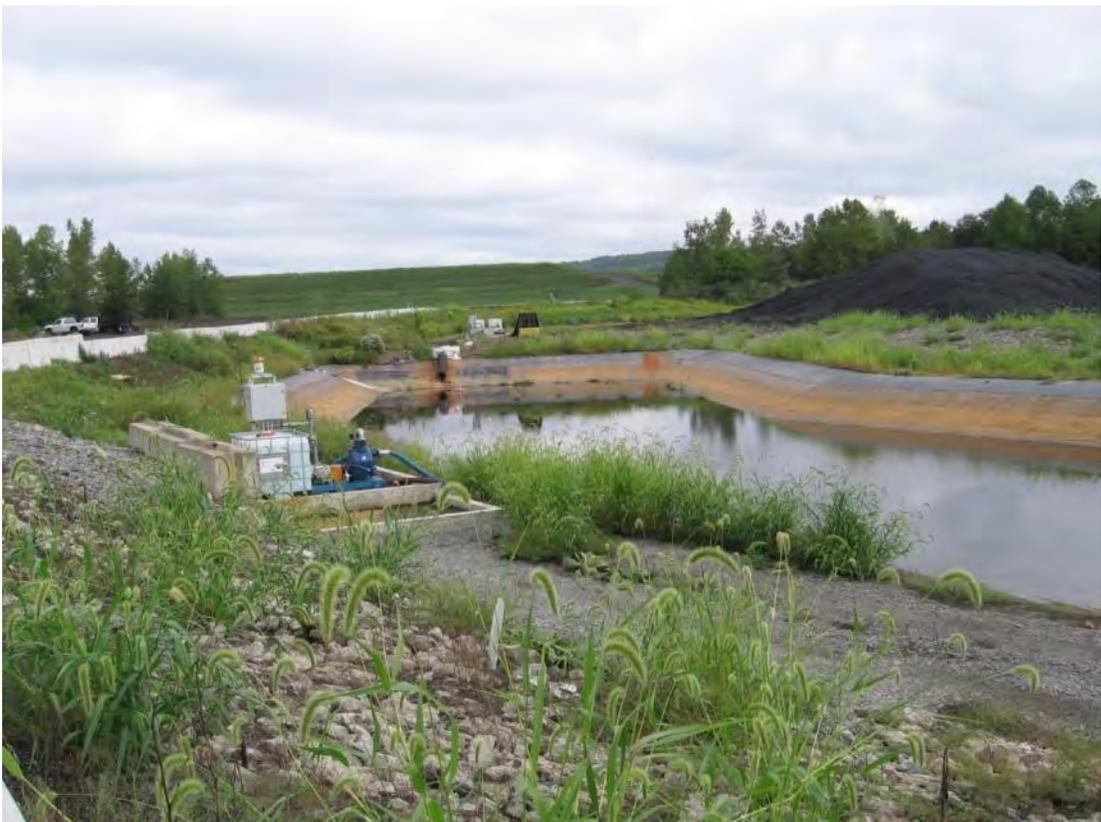
Photo Number:  
26

Description:  
Coal Pile  
Sedimentation  
Basin, not a part  
of this  
assessment.  
Photo included  
for reference as  
the source of  
occasional  
pumped water  
to the South  
Ash Pond.
