FINAL REPORT

# Dam Safety Assessment of CCW Impoundments

NRG Power Midwest LP  
New Castle Generating Station  
West Pittsburg, Lawrence County, Pennsylvania

January 17, 2014

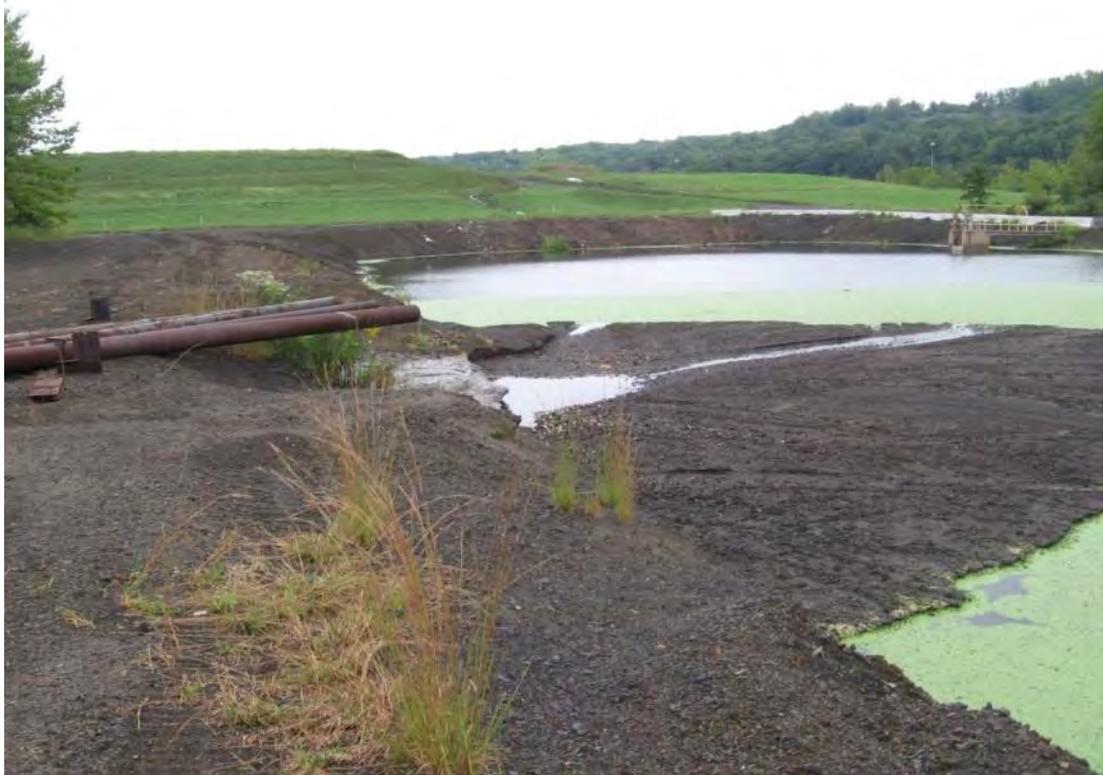
Photo Number:  
3

Description:  
North Ash Pond; primary sluice discharge pipes. Note ash delta formed at discharge.

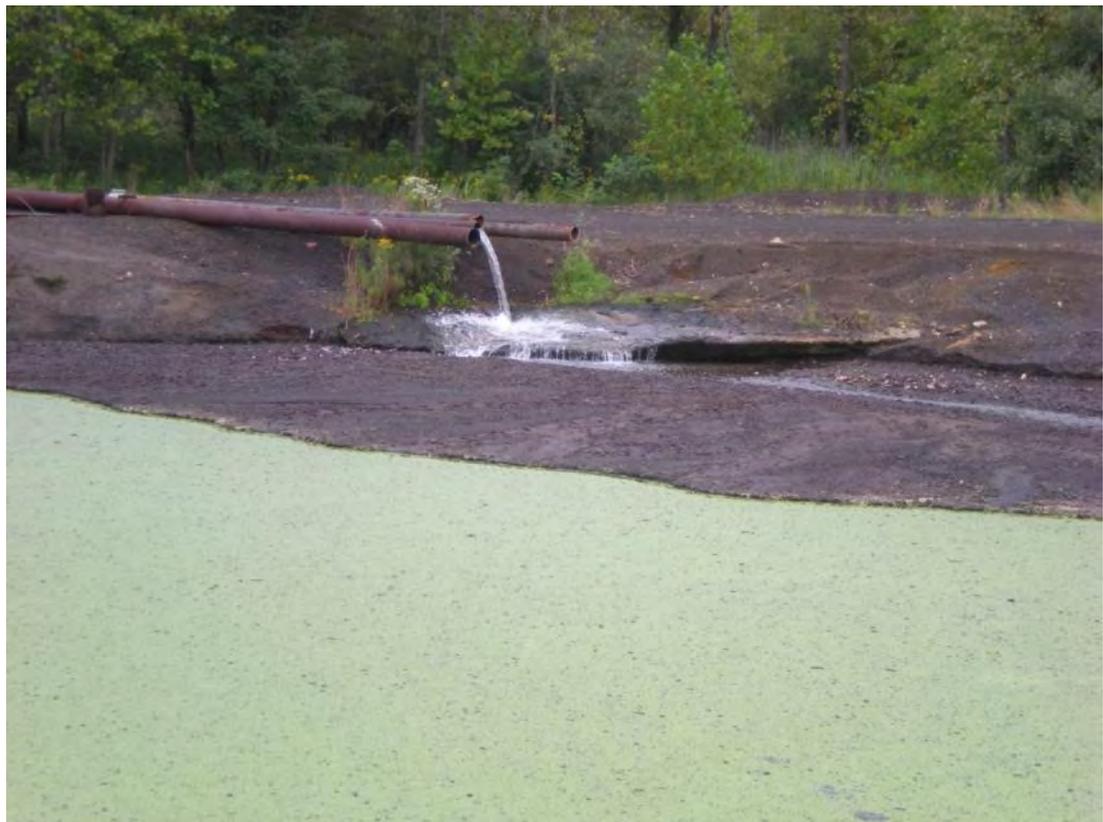
Photo Number:  
4

Description:  
North Ash Pond; sluice discharge onto poured concrete apron. Some undercutting of concrete apron visible.

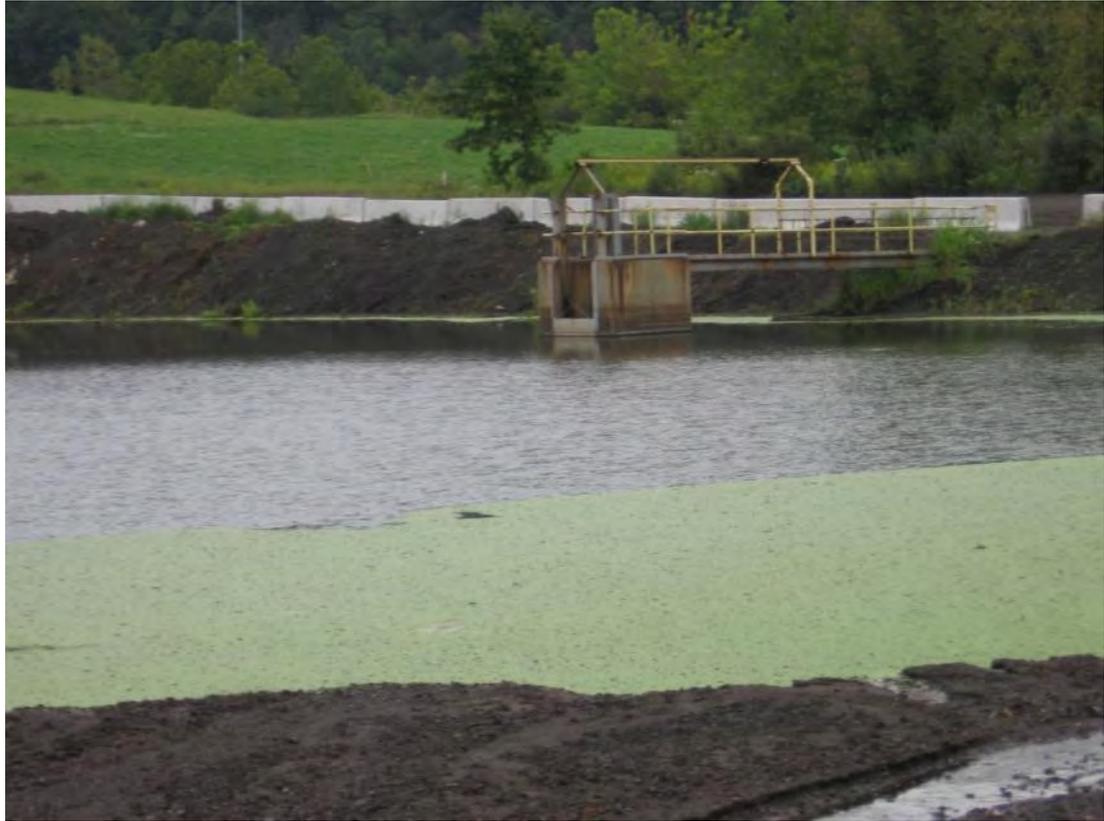
Photo Number:  
5

- The primary and secondary outlet structures appear to be in good condition and functioning normally. The water level was below the level of the stop logs in the secondary outlet structure at the time of assessment.

Description:  
North Ash Pond; View of primary outlet structure. Pond level control consists of slide gate and stop logs.

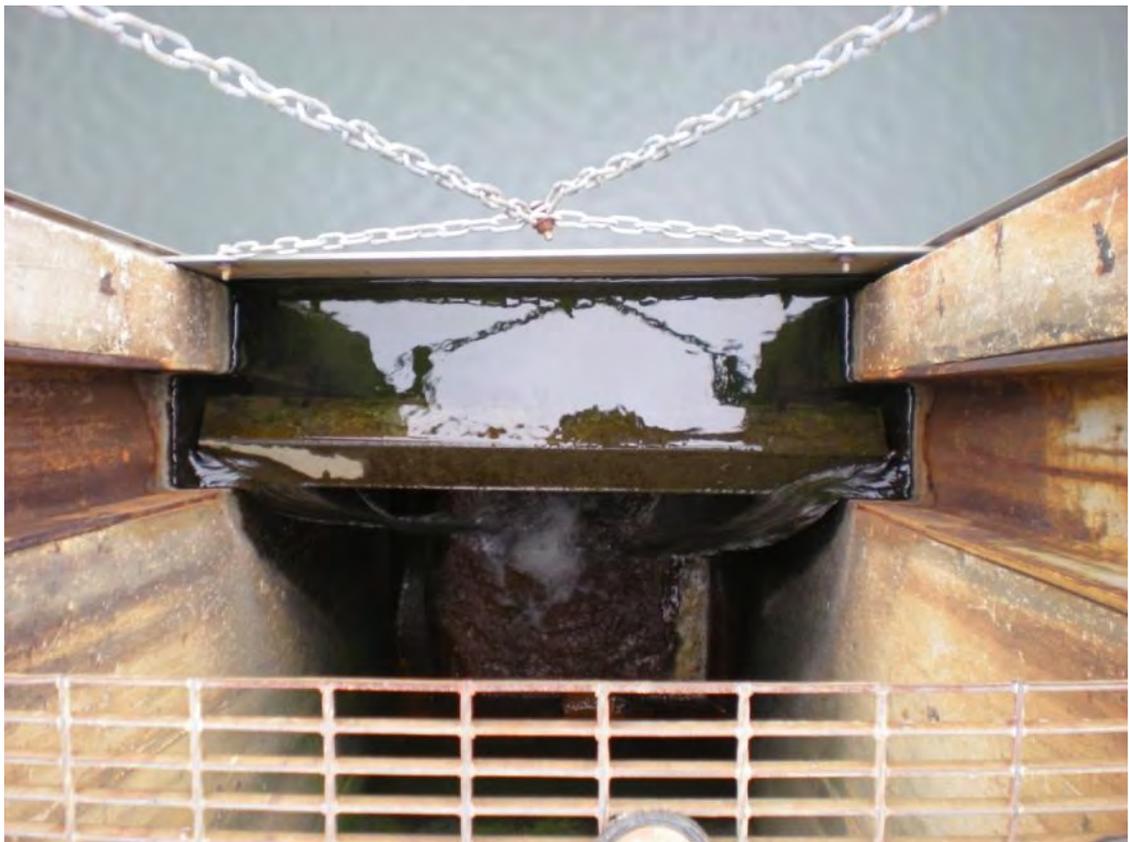
Photo Number:  
6

Description:  
North Ash Pond; View inside primary outlet structure. Water flowing clear.

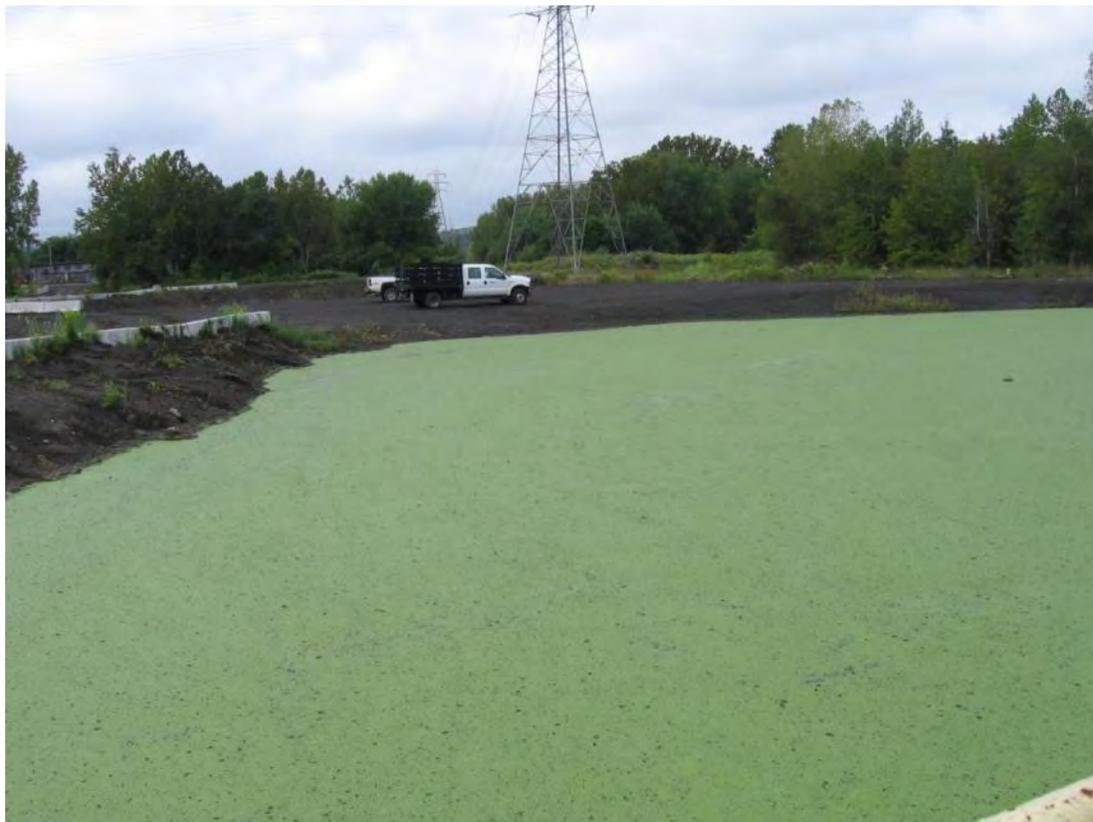
Photo Number:  
9

Description:  
North Ash Pond; View of south crest. South crest is the lowest crest elevation and shows only minimal built-up embankment to form the roadway.

- Additional studies:
  - Perform a hydrologic and hydraulic analysis of the impoundment for the 1-year through 100-year, 24-hour duration design storm events to confirm that adequate freeboard is available during normal operating conditions. A revised configuration of the secondary outlet stop log elevations could be considered in this analysis and implemented in the field to provide additional freeboard if necessary.

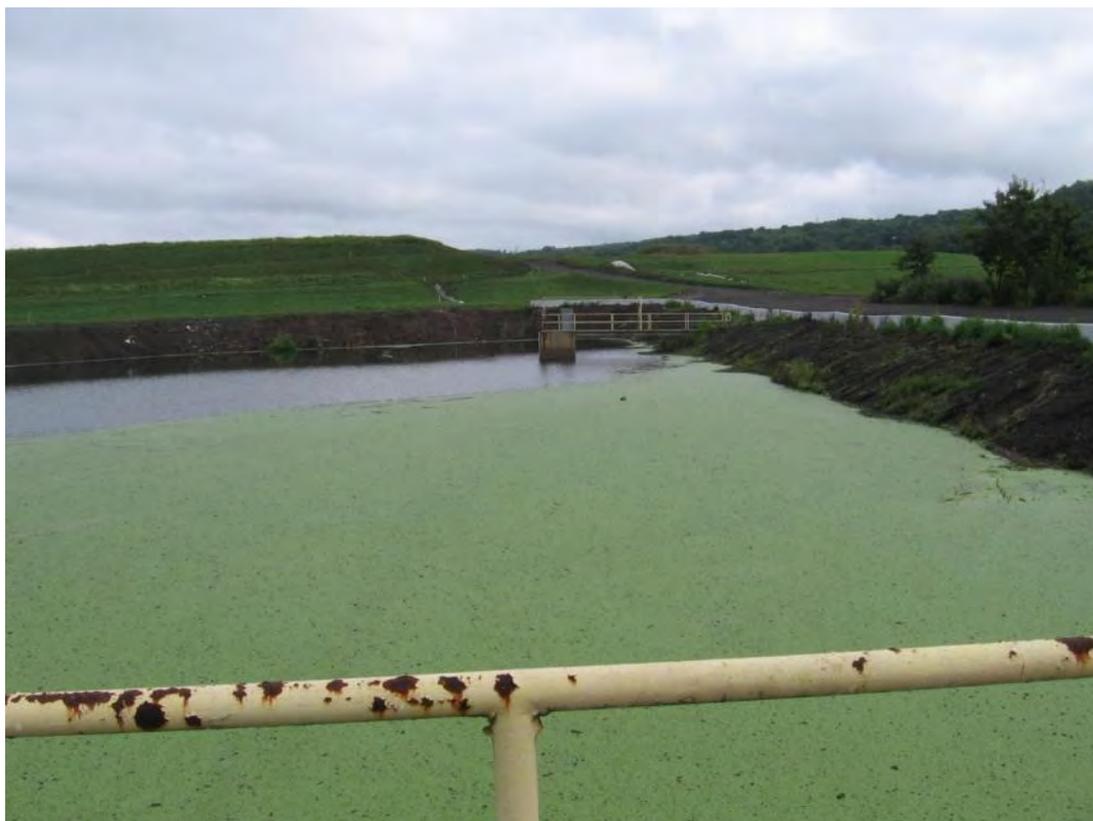
Photo Number:  
10

Description:  
North Ash Pond; View of northern and eastern interior side slopes and crest.

- Inboard slopes:
  - Monitor all inboard slopes for signs of erosion. Repair in accordance with an engineered design.
  - Consider regrading and revegetating the inboard slopes above the waterline to reduce erosion due to stormwater runoff. Any regrading should be done in accordance with an engineered design.

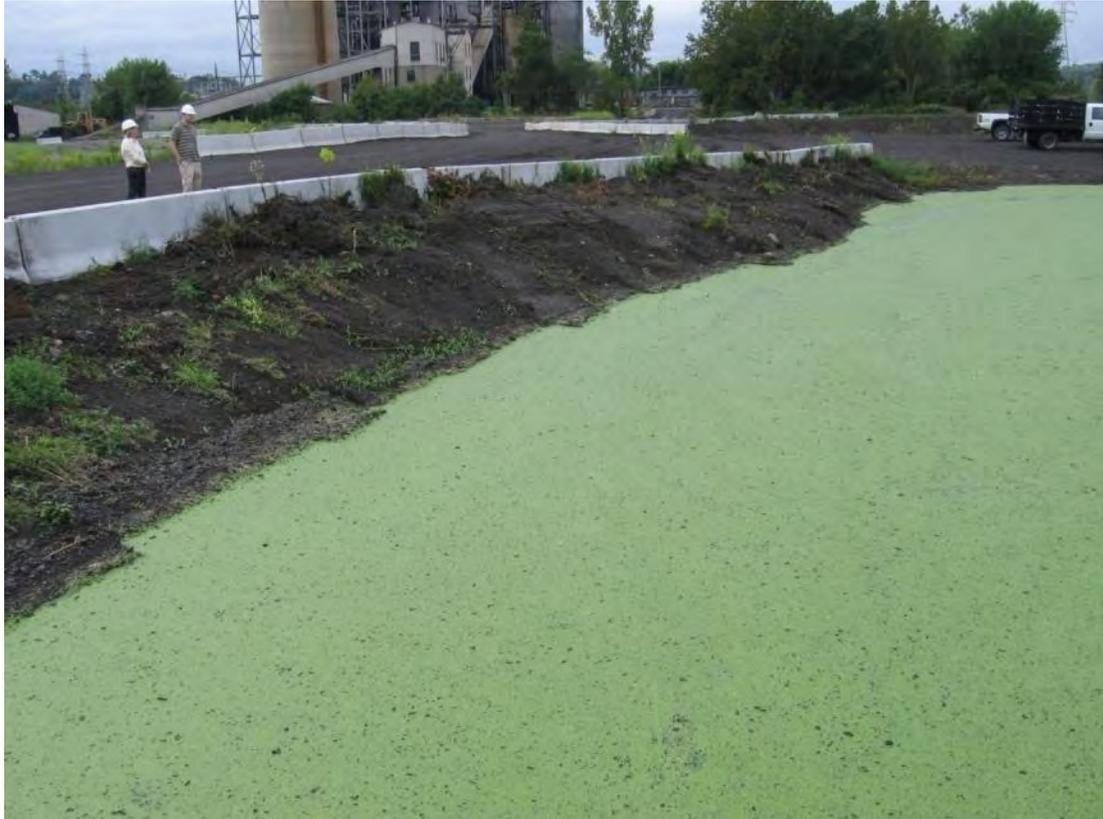
North Ash Pond; View of eastern interior side slope and crest.

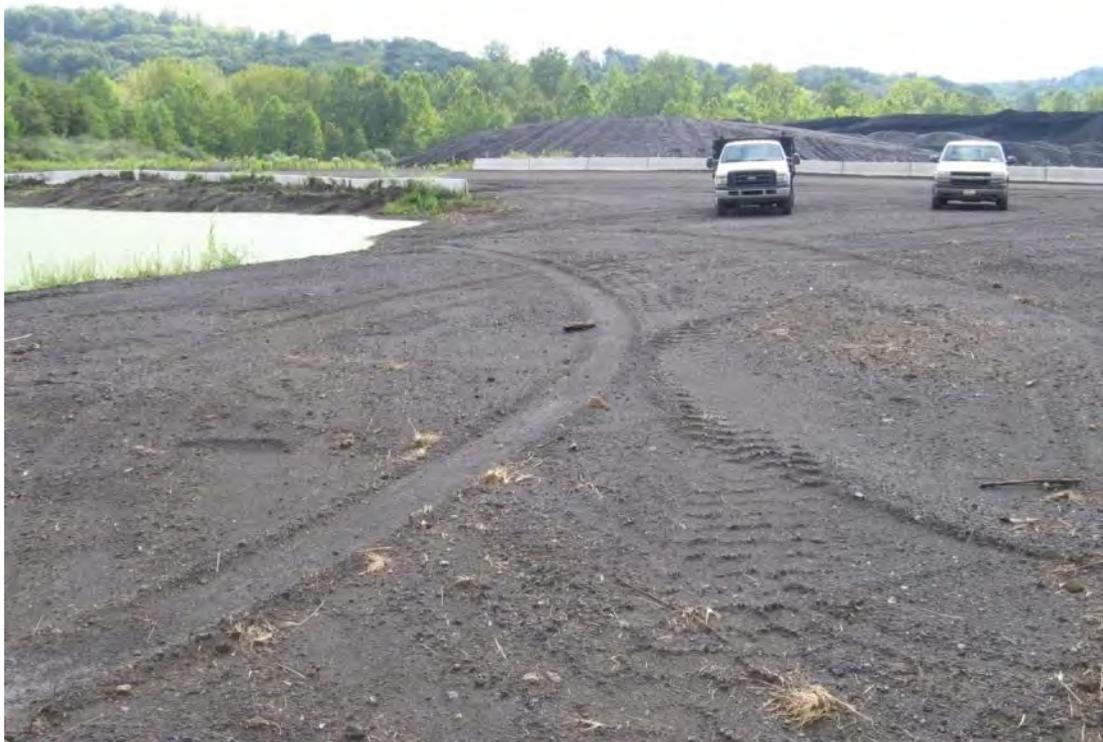
North Ash Pond; View of crest south of the impoundment.

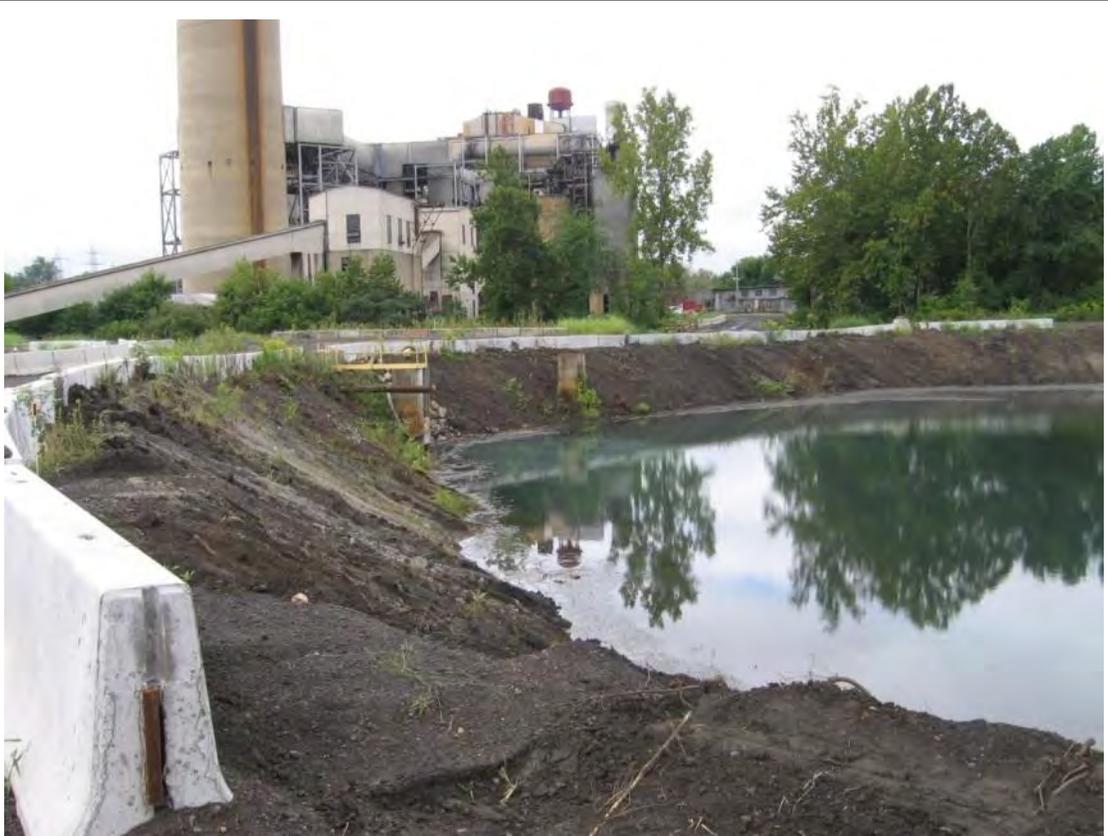
South Ash Pond  
eastern interior  
slope and outlet  
structures

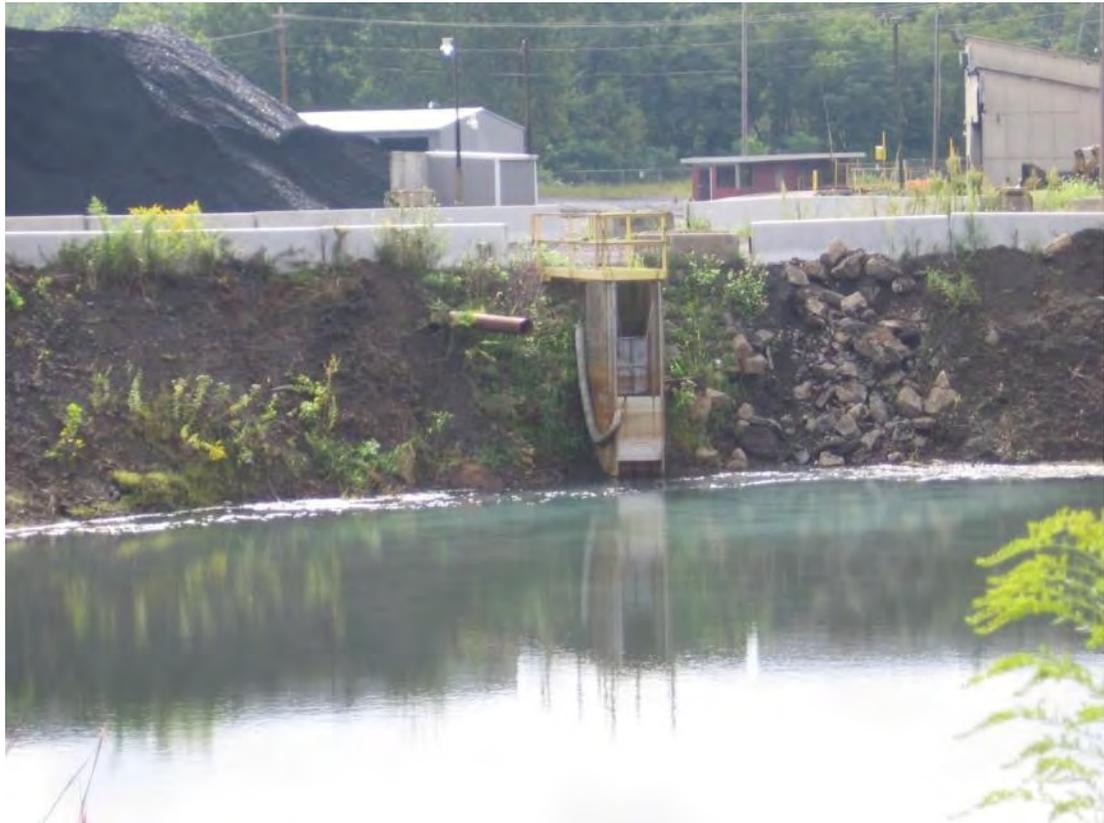
Photo Number:  
17

- The outlet structure appears to be in good condition and functioning normally. The water level was being maintained below the elevation of the stop logs at the time of assessment. There was no discharge from the outlet structure.

Description:  
South Ash Pond; View of outlet structure; Note apparent repair of minor erosion to the interior slope to the right of the outlet structure

- Monitor all inboard slopes for signs of continuing erosion. Repair in accordance with an engineered design.
  - Consider regrading and revegetating the inboard slopes above the waterline to reduce erosion due to stormwater runoff. Any regrading should be done in accordance with an engineered design.

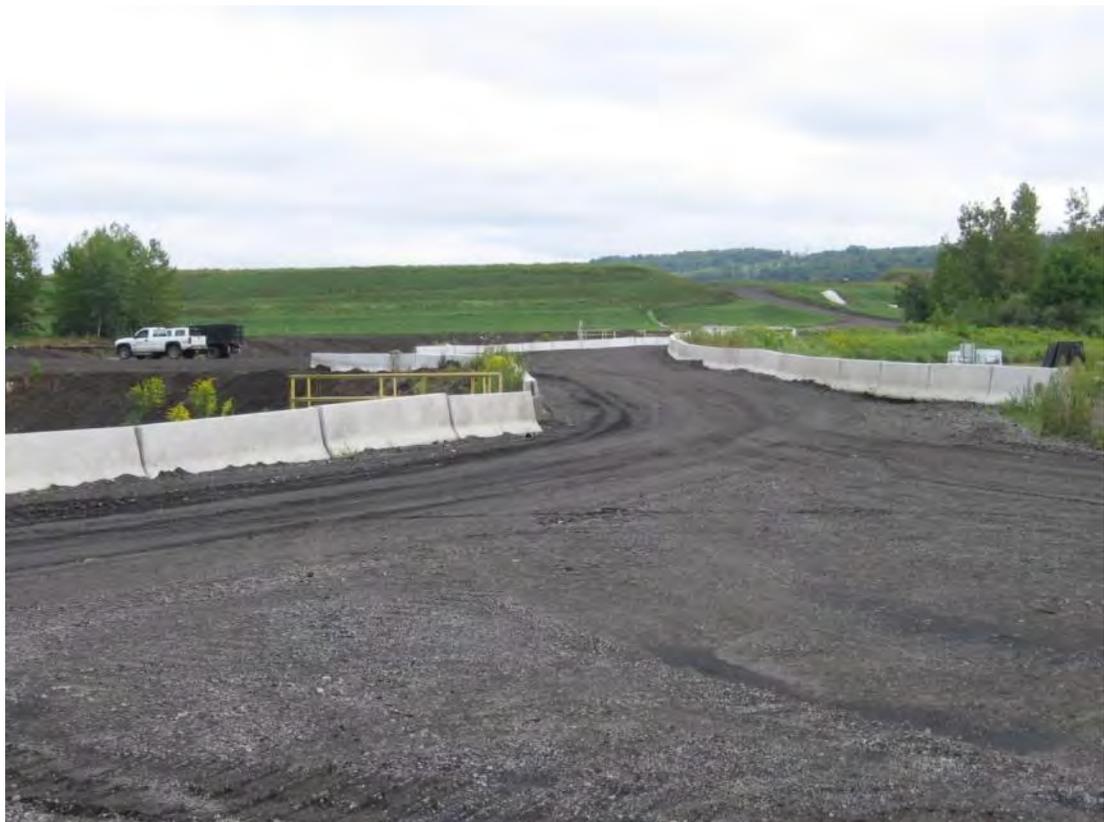
Photo Number:  
18

Description:  
South Ash Pond; Access driveway on eastern crest of the impoundment

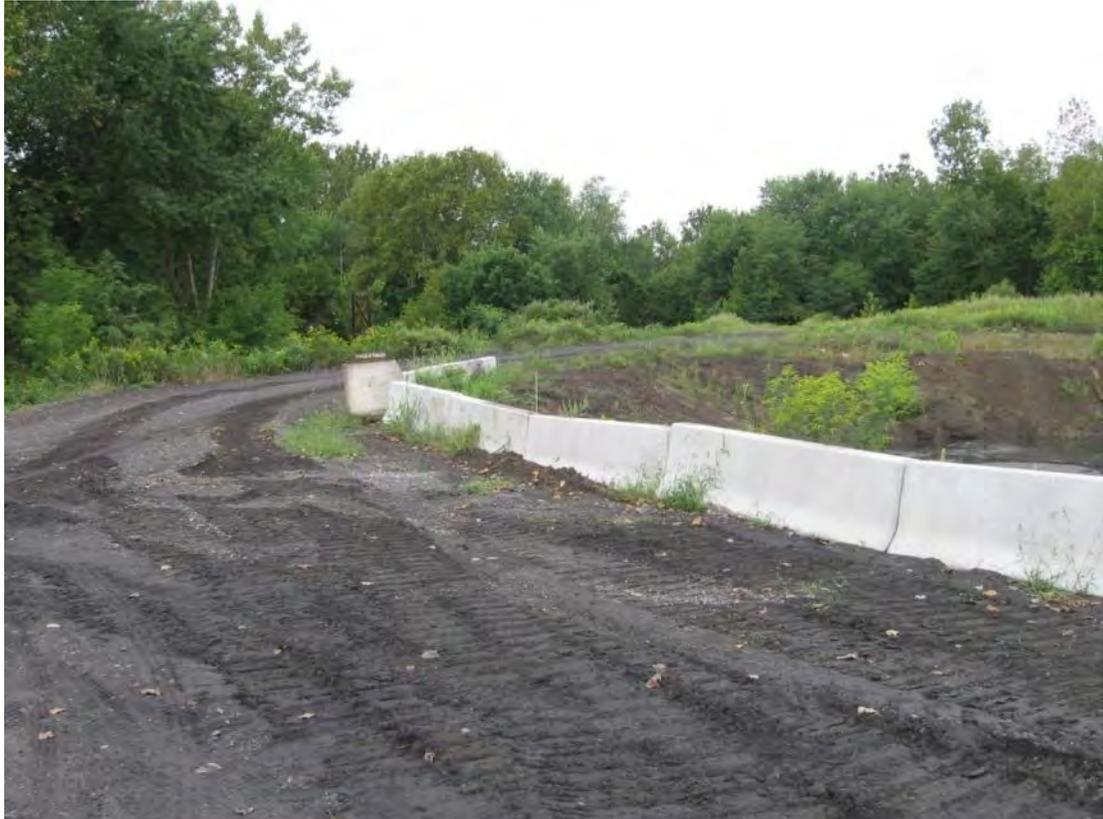
Photo Number:  
19

Description:  
South Ash Pond; Access drive along southern crest of the impoundment

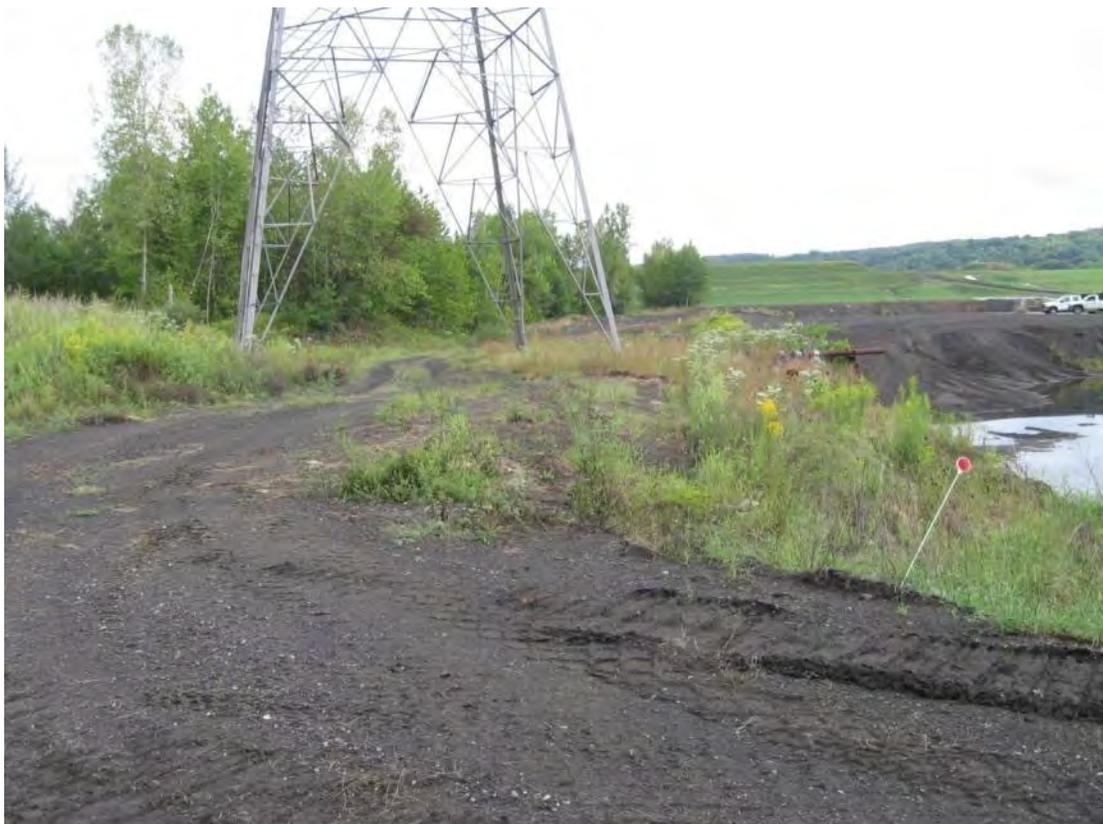
Photo Number:  
20

Description:  
South Ash Pond; Western crest of the impoundment, minimal built-up embankment to form access driveway.

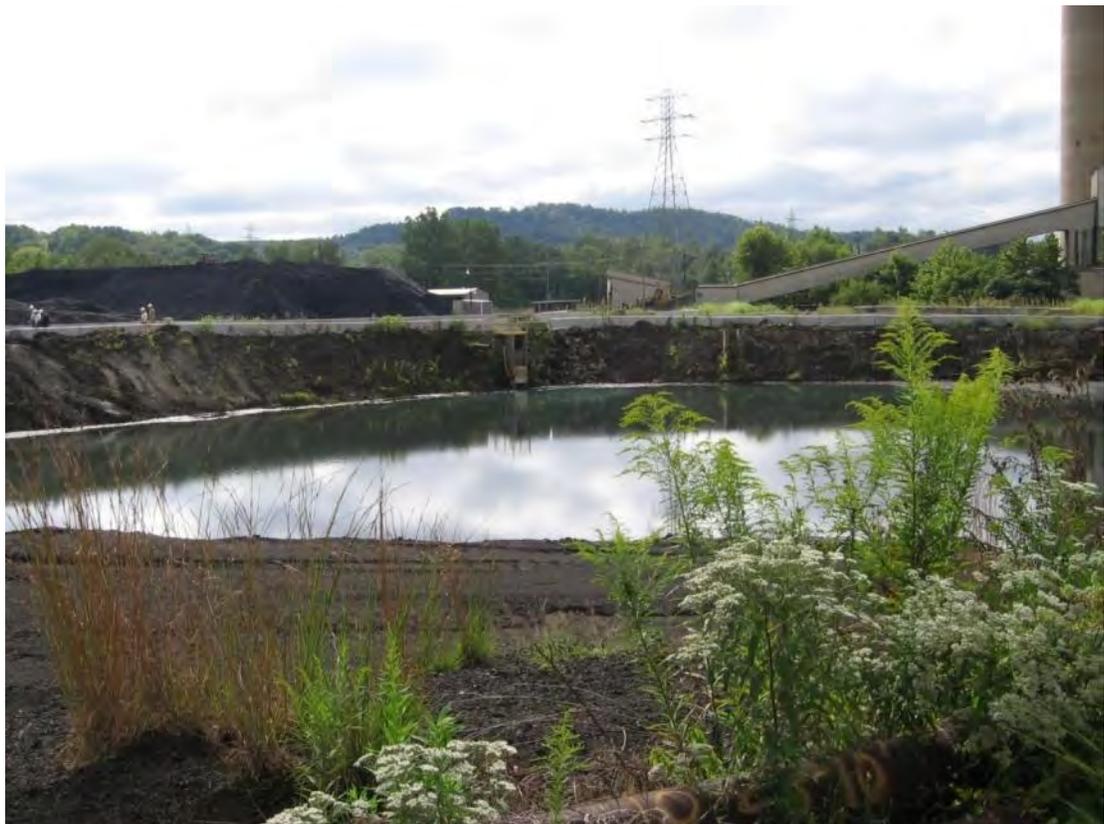
Photo Number:  
21

Description:  
South Ash Pond; Overall view looking southeast towards the coal pile storage area.

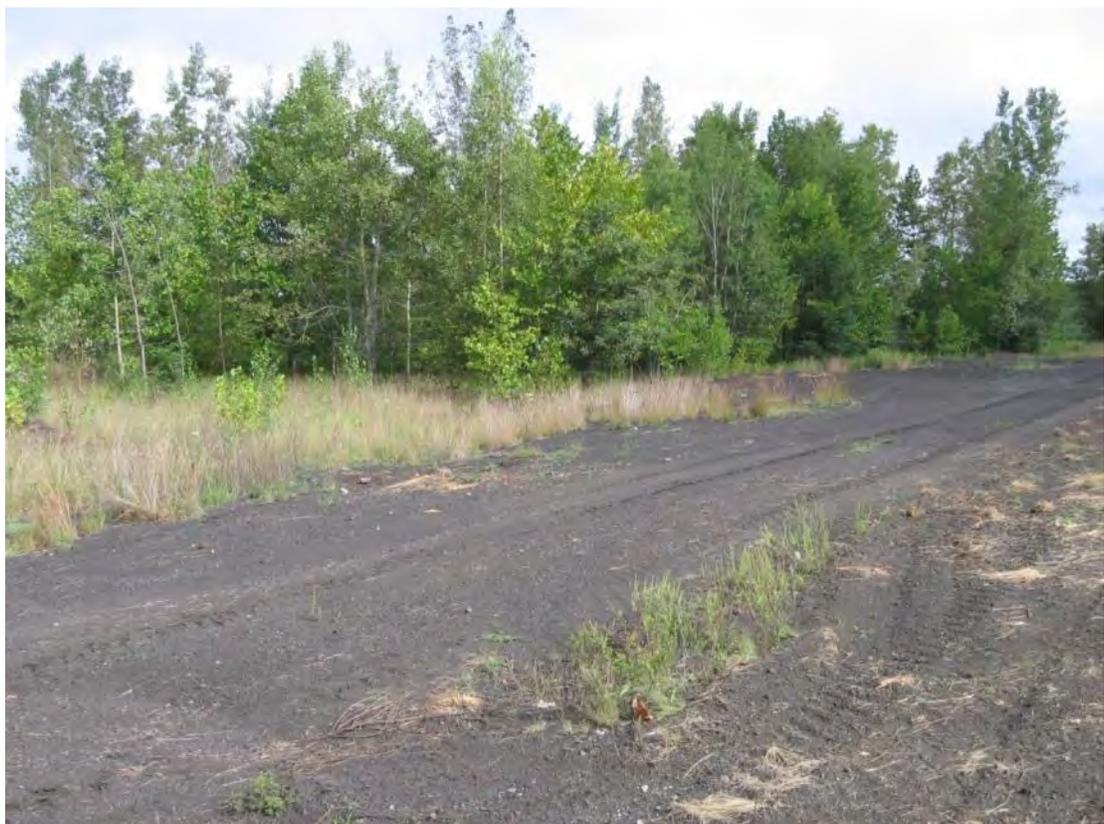
Photo Number:  
22

Description:  
Natural wooded area to the west of the impoundments, minimal built-up embankment to form the access drive

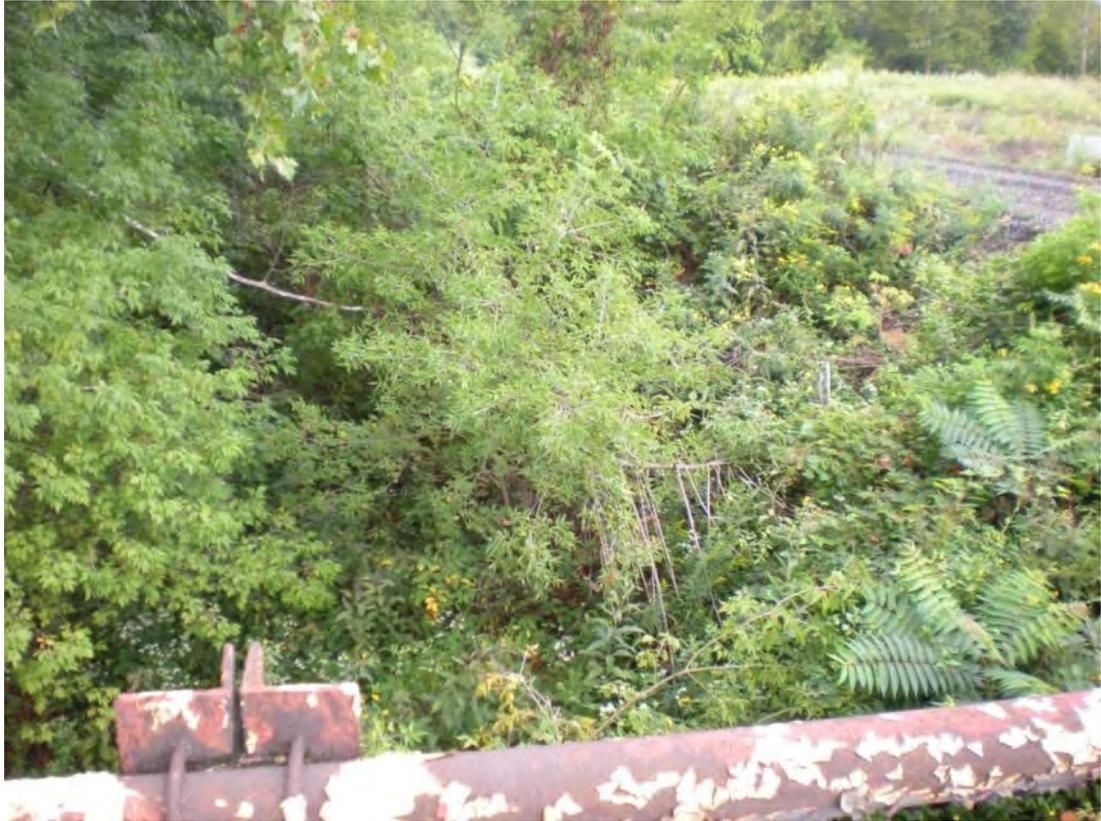
Photo Number:  
23

- The bottom elevation of the pond is approximately the same elevation as the McKee Run, with a normal water surface elevation at approximately 8 feet above the normal water surface of the McKee Run. The outboard slope (the natural bank of the McKee Run) is typically about 2:1. It is probable that the base of the natural slope is partially saturated during normal conditions, but no seepage was observed at the toe of slope, which is a condition that would typically be necessary to create potential slope stability problems for a natural slope at this inclination and height. Further, the width to height ratio of the slope considering the width at the water line is large, which further reduces the likelihood of deep seated slope failures capable of releasing the impounded contents of the unit.

- If the outboard slope was prone to instability, there would be some history of slope sloughing, or other outward signs of slope distress. No signs of such distress or of past repairs or stabilization efforts were observed in the site visit.

Description:  
Heavily vegetated outer side slope south of South Ash Pond leading down to the McKee Run.

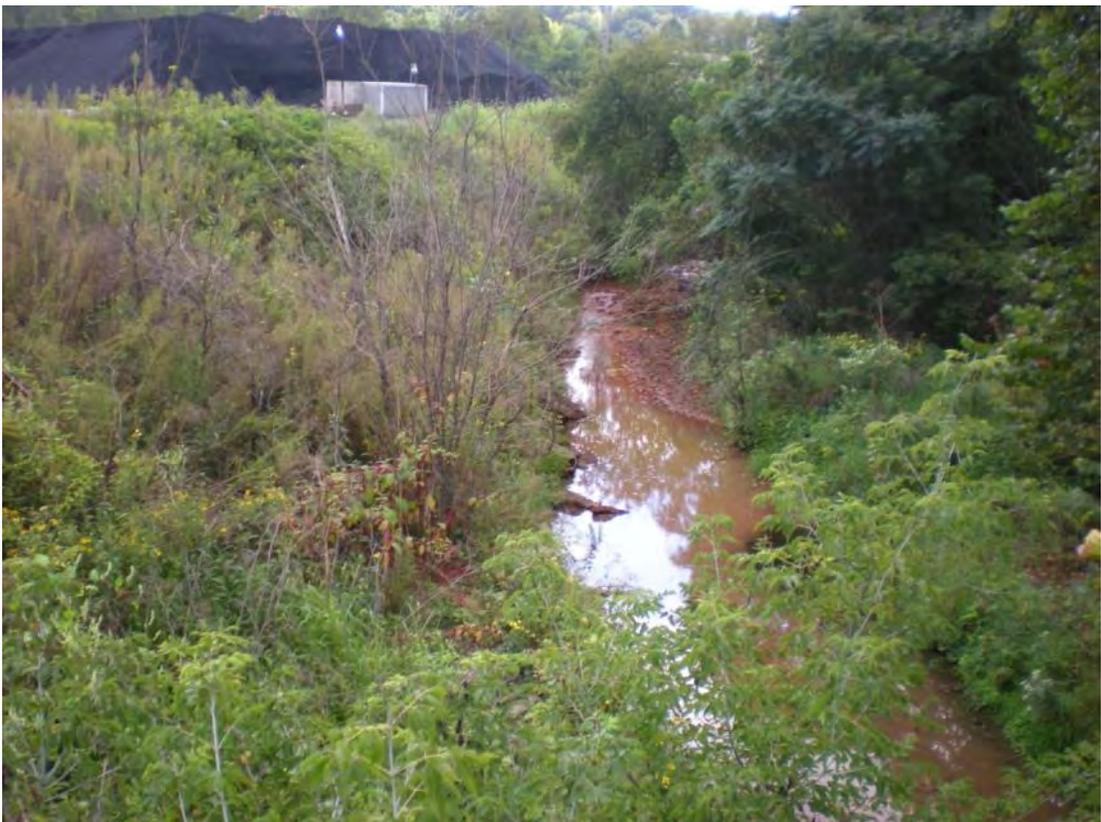
Photo Number:  
24

Description:  
View of the McKee Run upstream from the impoundments
