SUBJECT: EPA Comments on "Assessment of Dam Safety of Coal Combustion Surface Impoundments: GenOn Energy – Shawville Generating Station, Shawville, PA"

DATE: September 9, 2013

22 November 2013

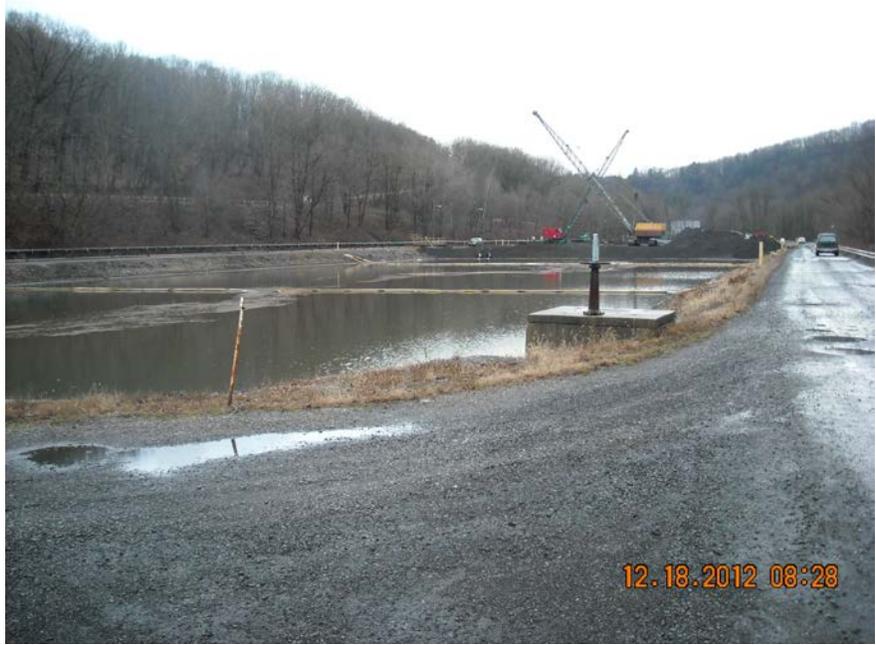
Location: Ash Pond A

Ash Pond A as viewed from the north corner, looking south. The valve structure for the emergency overflow pipe is visible in the foreground.

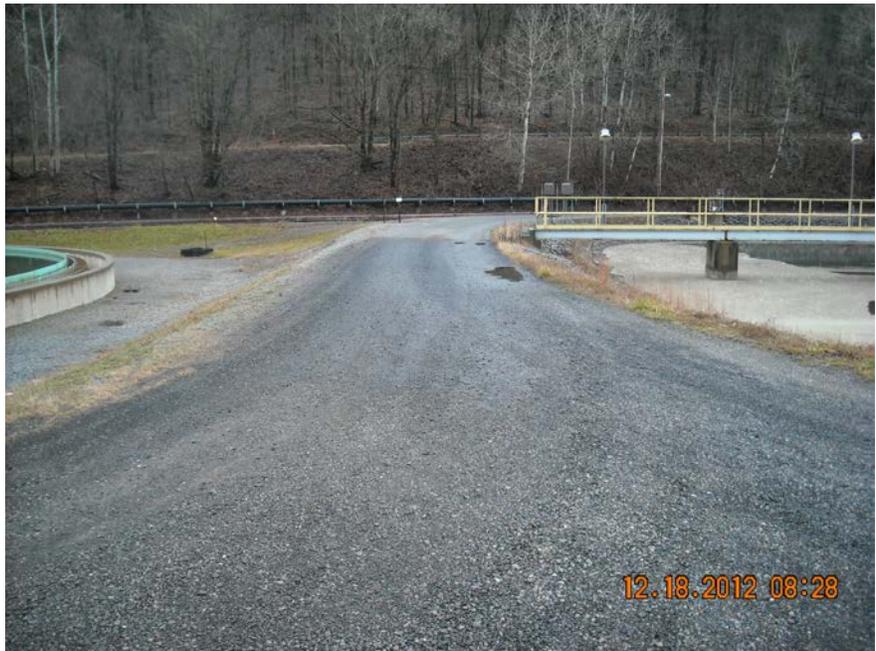
Photograph 2

View of the northeast berm of Ash Pond A. Walkway on the right leads to the decant structure. The water treatment facility appears on the left side of the photo.

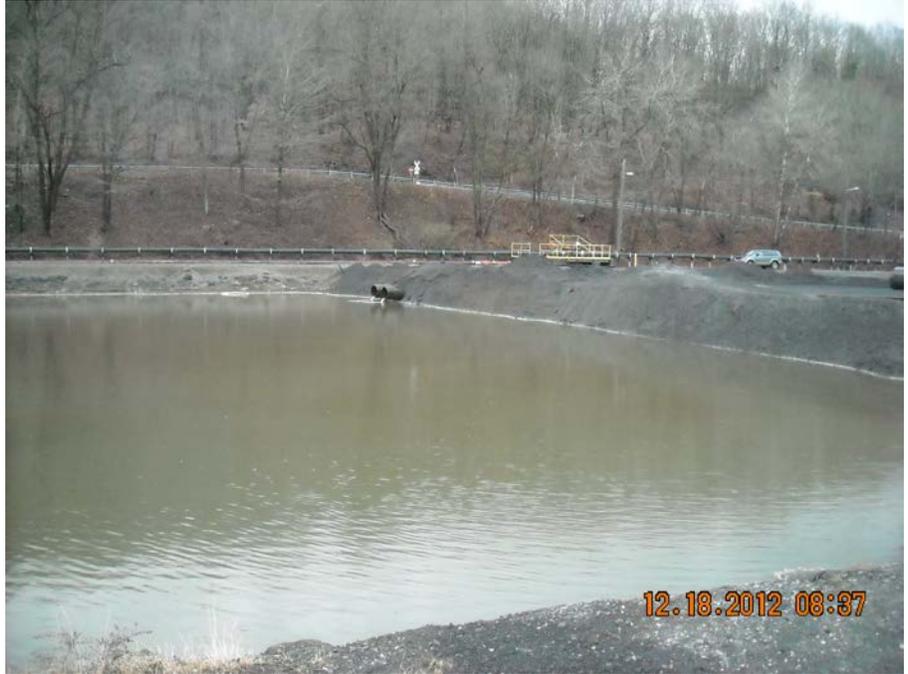
Picture of the dividing berm between Ash Pond A and Ash Pond B. Picture is from the northwest berm of Ash Pond A, looking south.

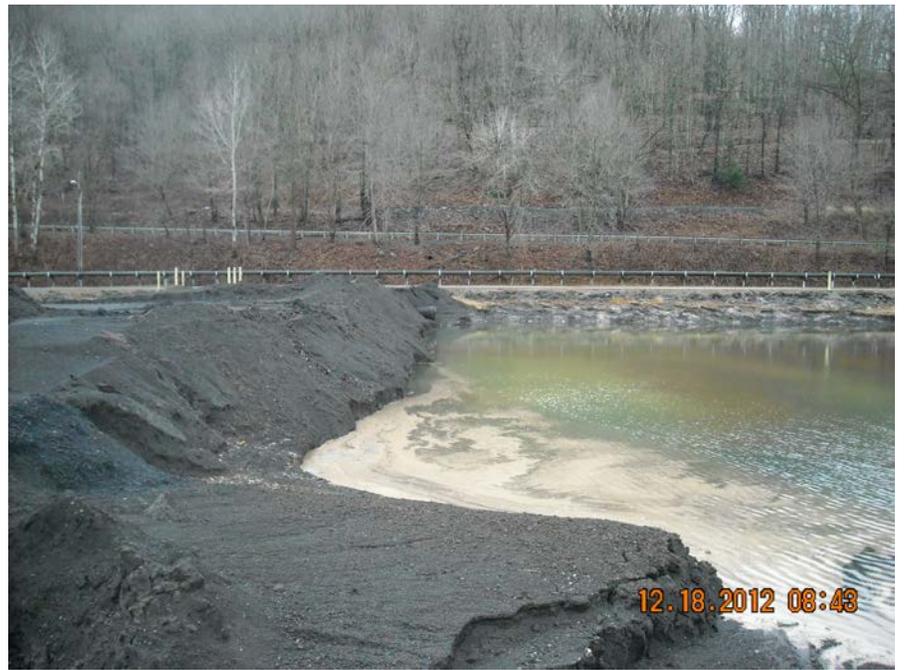
Photograph 4

Picture of the dividing berm from the Ash Pond B side, looking southeast.

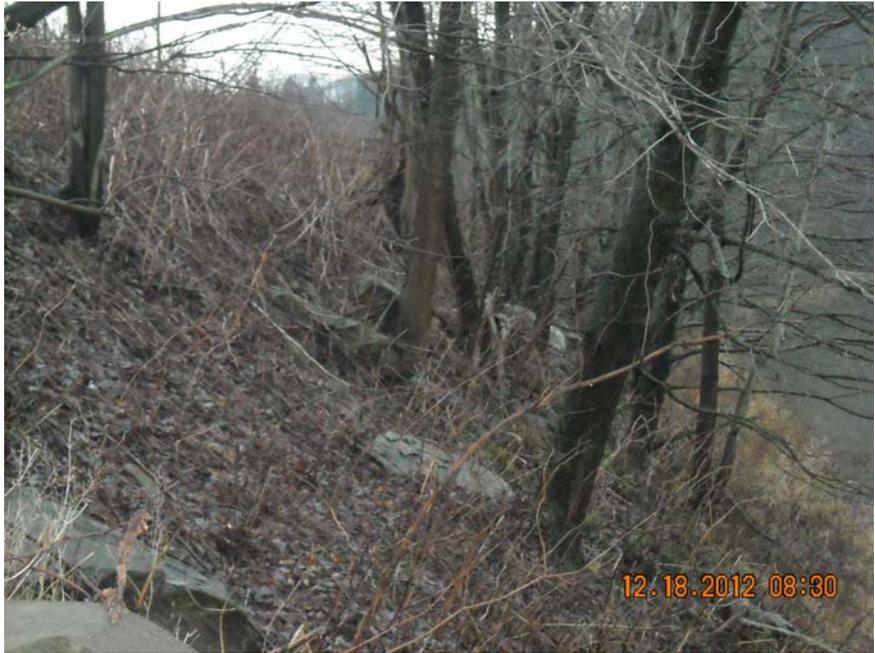
Outer slope (i.e. northwest slope) of Ash Pond A, looking southwest along the bank of the West Branch Susquehanna River. Large boulders, trees, and grass line the slopes.

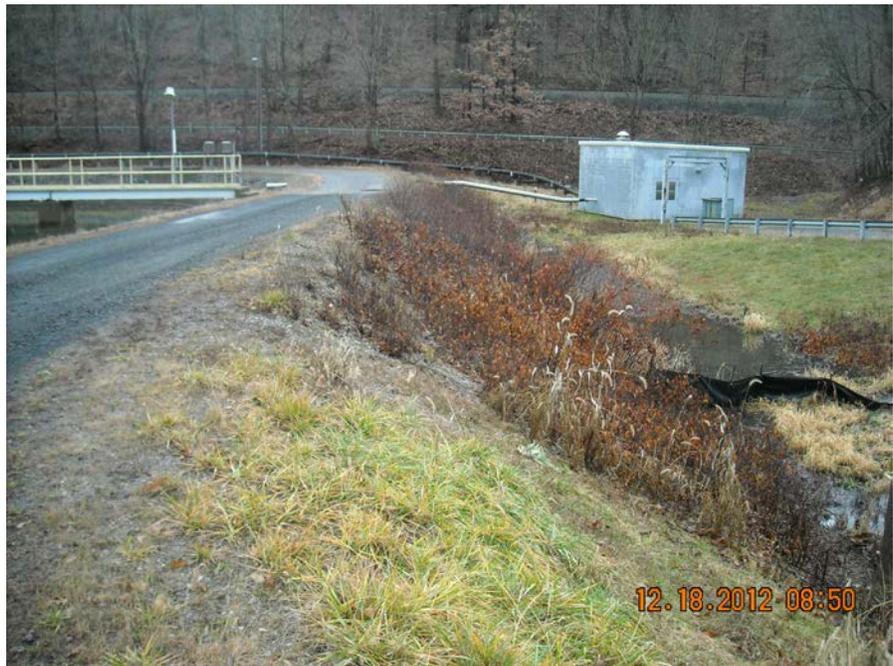
Photograph 6

View of the southwest slope of Ash Pond B, looking southeast. Berm is relatively short (less than ten feet high), and a natural counterweight exists to the other side of the incised ditch shown here.

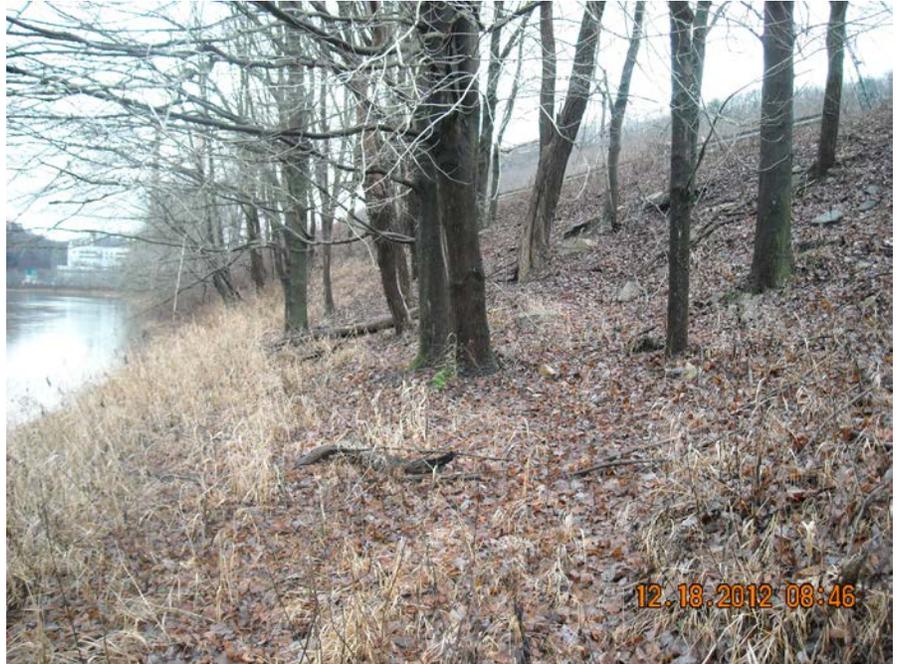
Outer slope (i.e. northwest slope) of Ash Pond B, looking northeast along the bank of the West Branch Susquehanna River. Boulders, trees, and grass line the slopes.

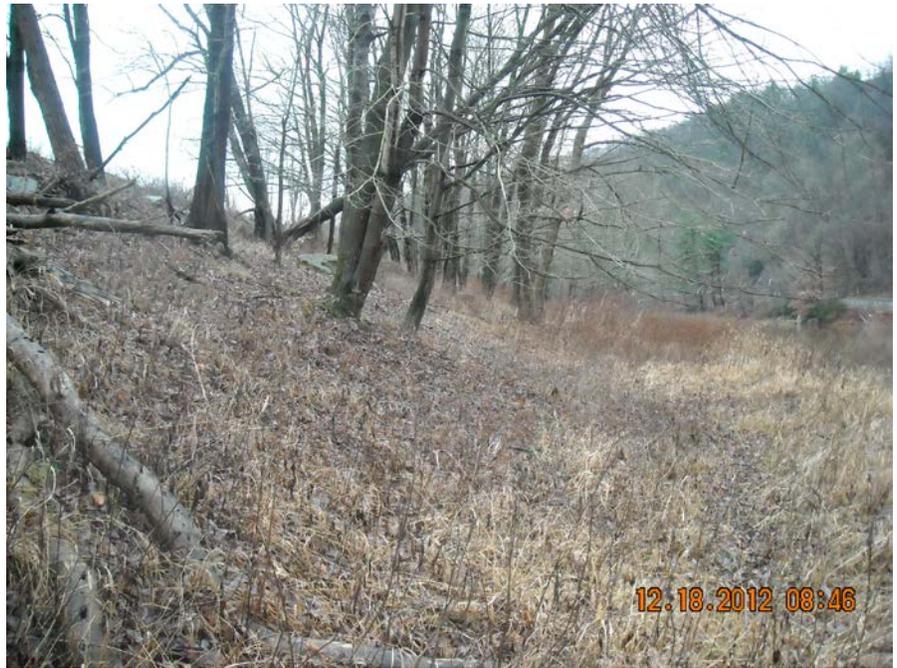
Photograph 6

Outer slope (i.e. northwest slope) of Ash Pond B, looking southwest along the bank of the West Branch Susquehanna River. Large boulders, trees, and grass line the slopes.

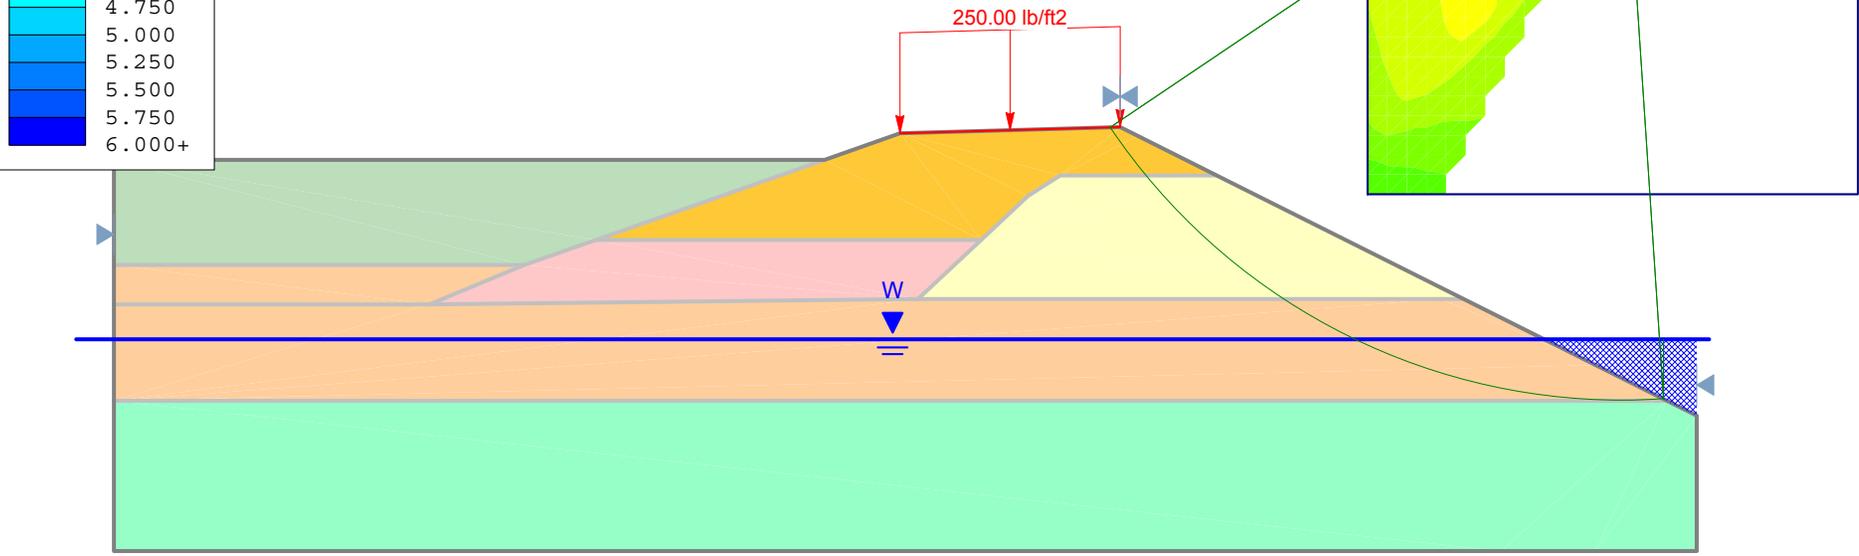
Case 1, Static, Circular Failure

Embankment Slopes	Loading Conditions	Failure Mode	Calculated F.S.	Target F.S
Case 1 (assume silt, i.e., ML, in pre-existing soil berm)	Static	Circular	1.51	1.5
		Block	1.59	1.5
	Seismic	Circular	1.27	1.2
		Block	1.33	1.2
Case 2 (assume clay, i.e. CL, in pre-existing soil berm)	Static	Circular	1.53	1.5
		Block	1.60	1.5
	Seismic	Circular	1.28	1.2
		Block	1.34	1.2

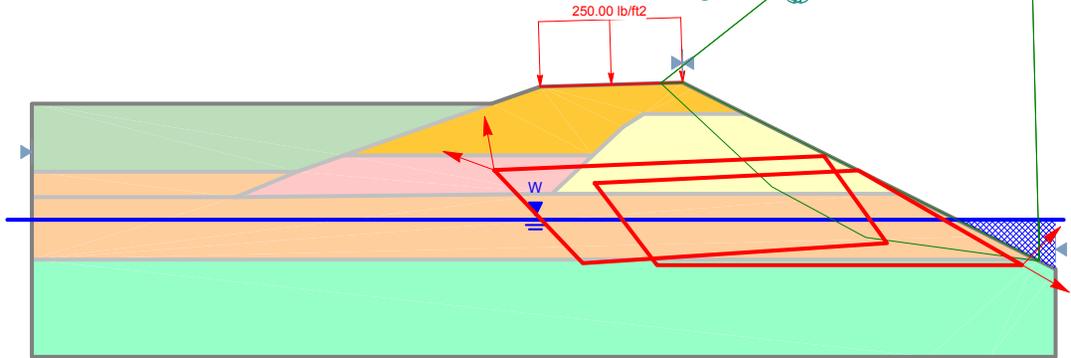
Case 1, Seismic, Block Failure

1.328

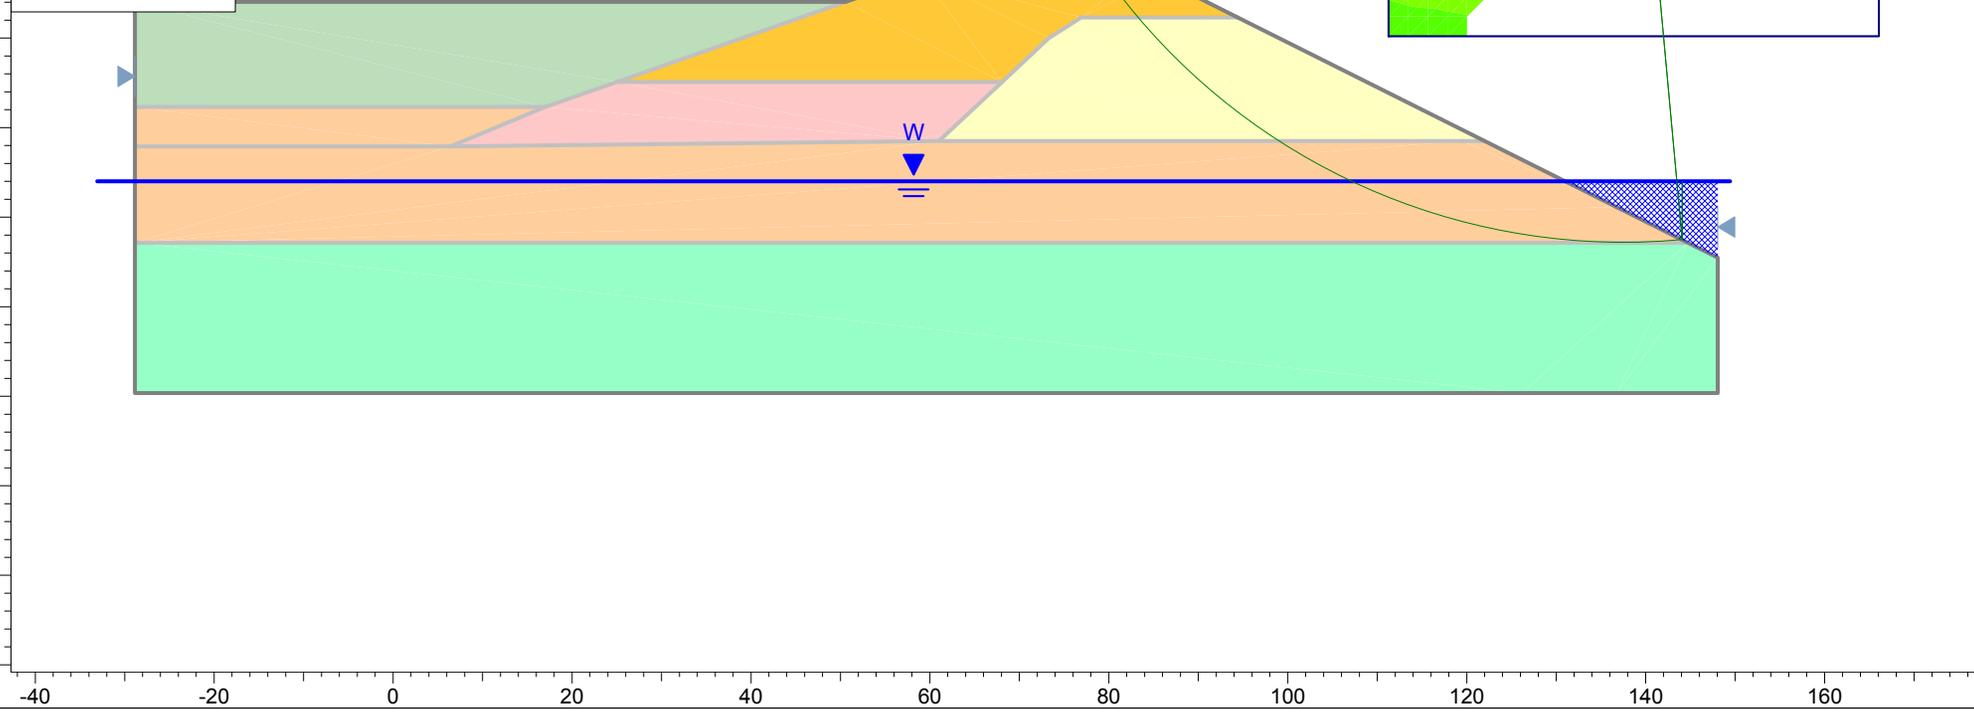
Case 2, Static, Circular Failure

1.529

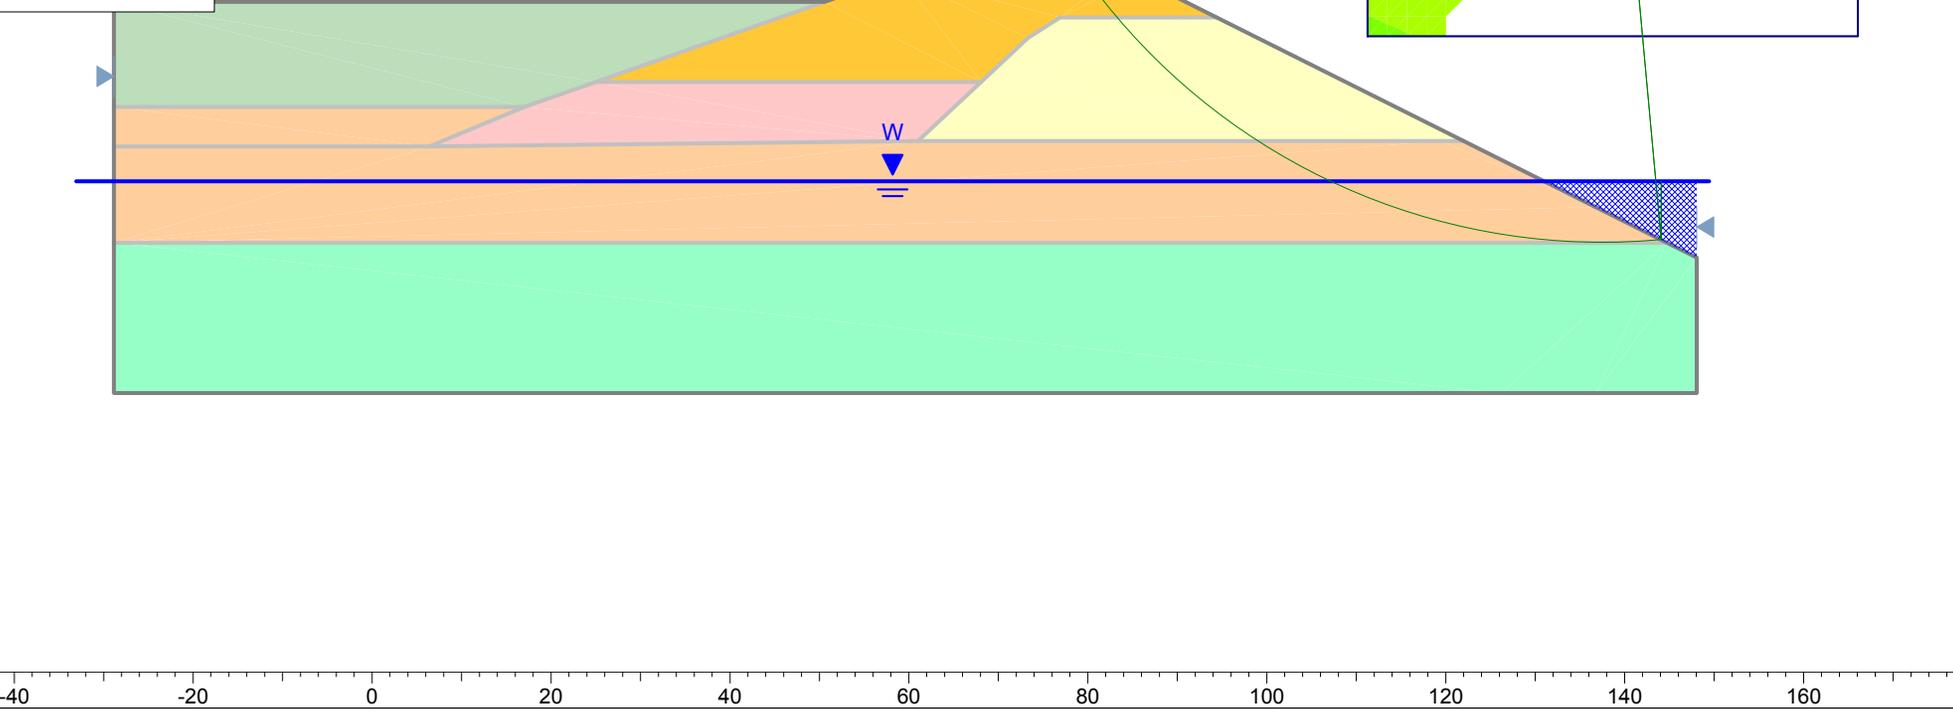
Case 2, Seismic, Circular Failure

1.283

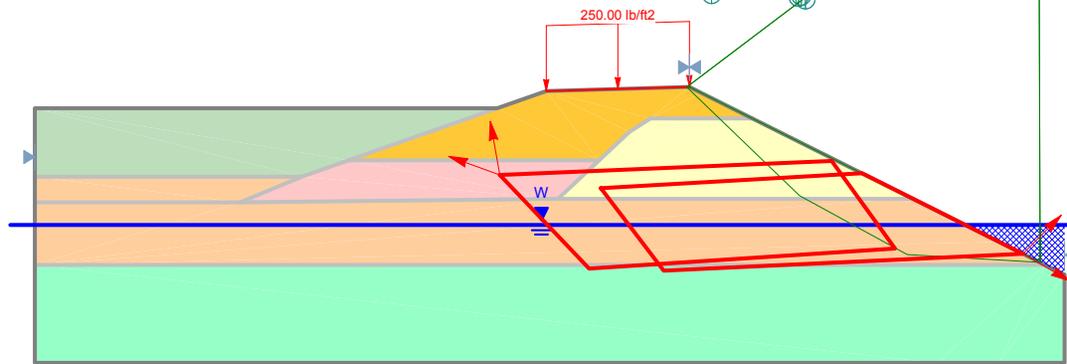
Case 2, Seismic, Block Failure

1.341
