PRELIMINARY REPORT

Dam Safety Assessment of CCW Impoundments

GenOn Energy – Shawville Generating Station Shawville, Clearfield County, Pennsylvania

December 17, 2012

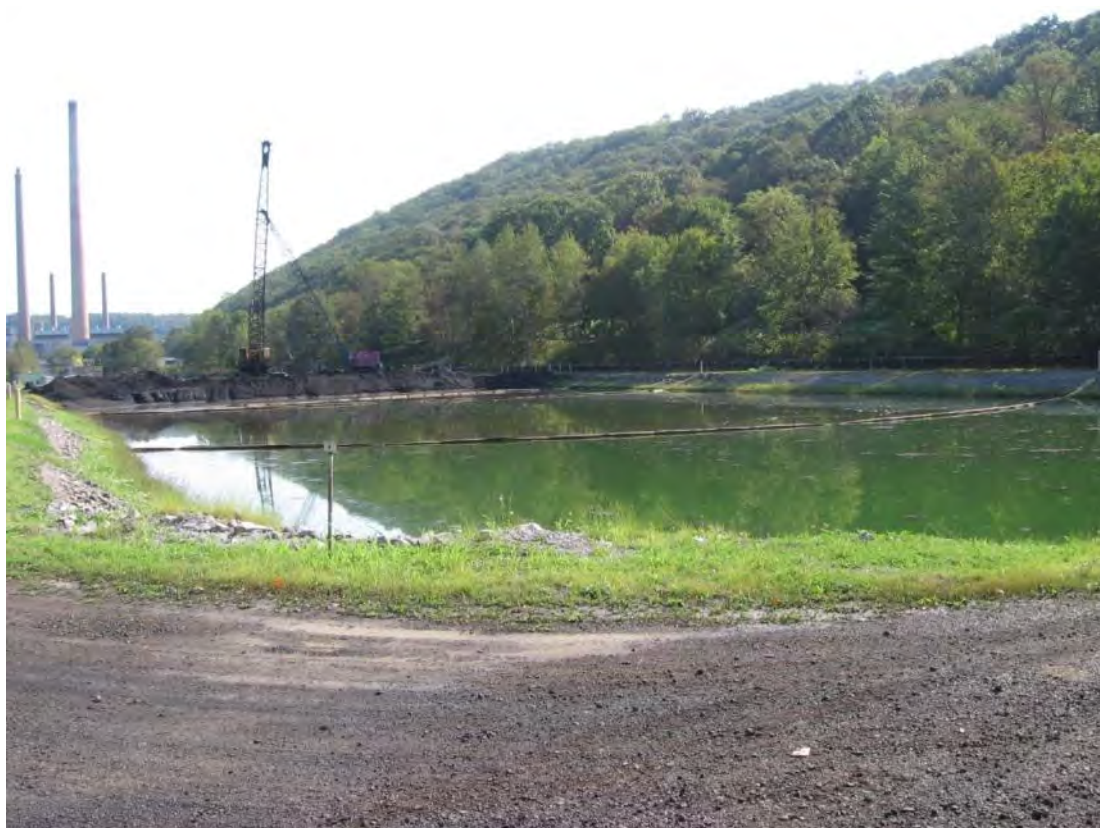
Date:
9/6/12Photo Number:
1Photographer:
S. SzewczakOrientation:
SE

Ash Pond B;
Overall view.
Ash Pond B
currently active
during
maintenance on
primary Ash
Pond A.

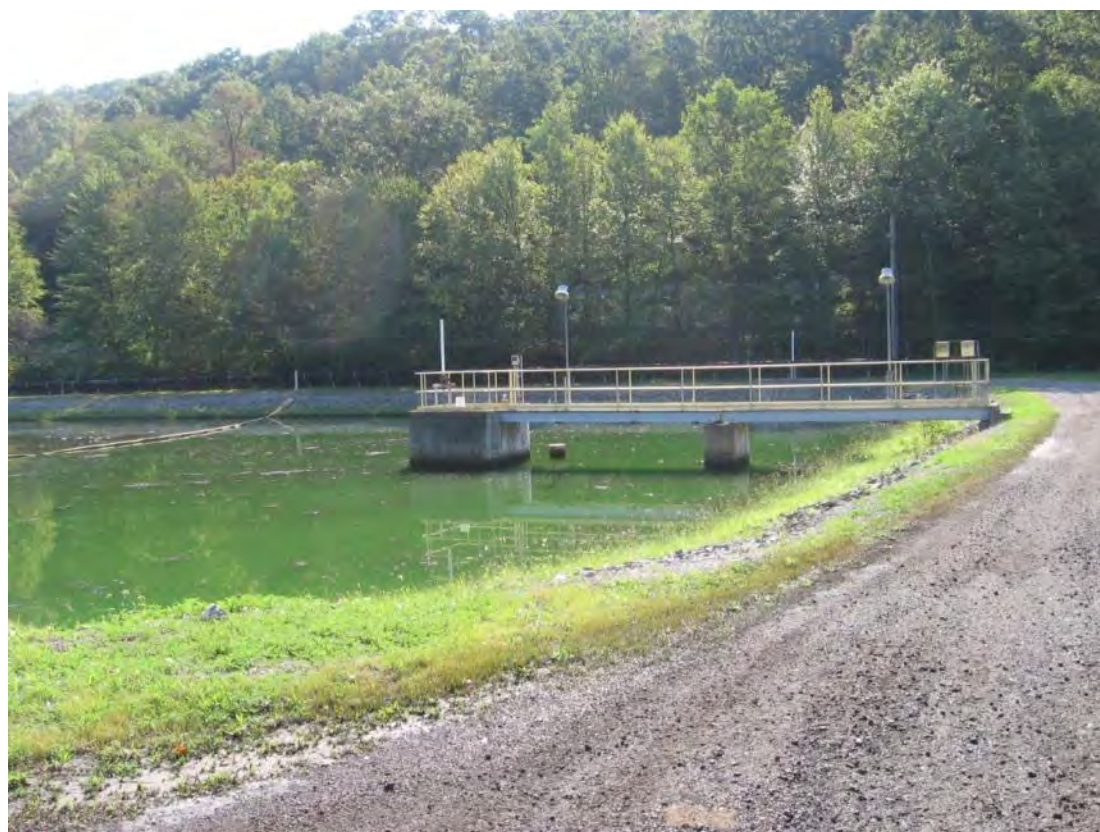
Date:
9/6/12Photo Number:
2Photographer:
S. Szewczak

Ash Pond B;
View of decant
structure.

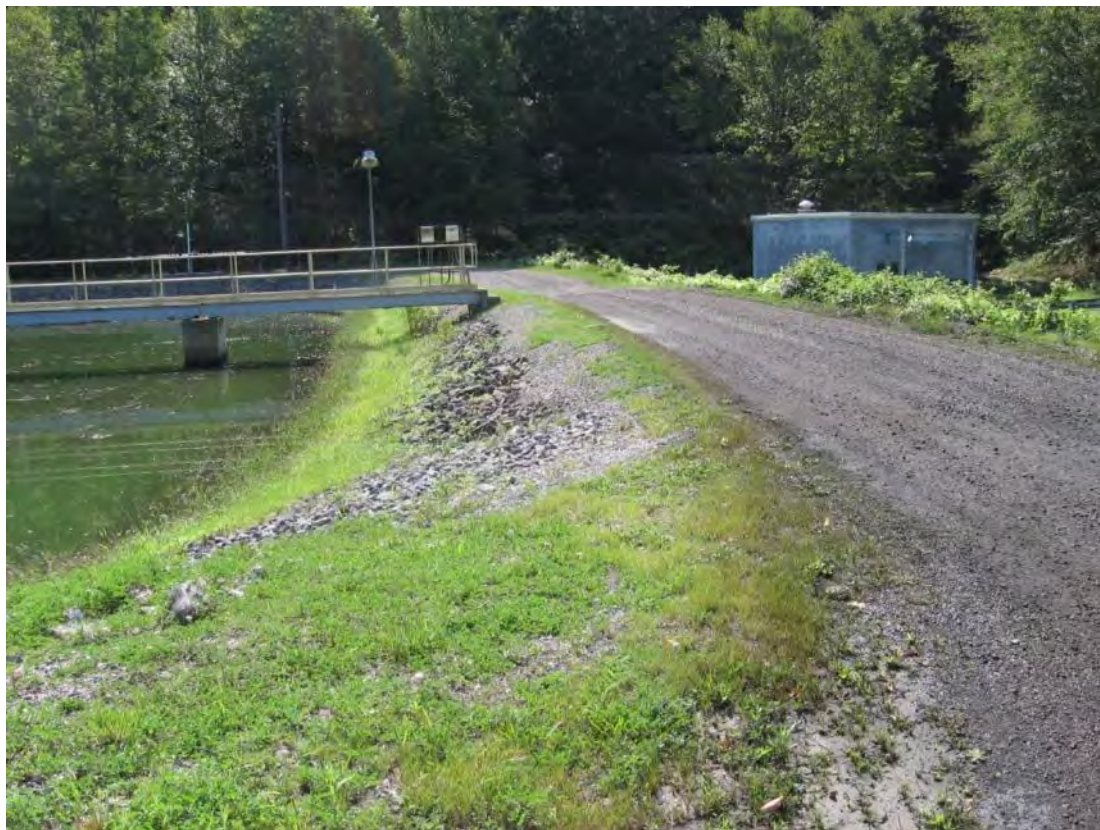
Date:
9/6/12Photo Number:
3Photographer:
S. SzewczakOrientation:
NE

Description:
Ash Pond B;
Inboard slope
and crest of
southwestern
embankment.
Note triangular
emergency
overflow
section located
just past
walkway.
Building on
right is the
leachate pump
station from
facility landfill.

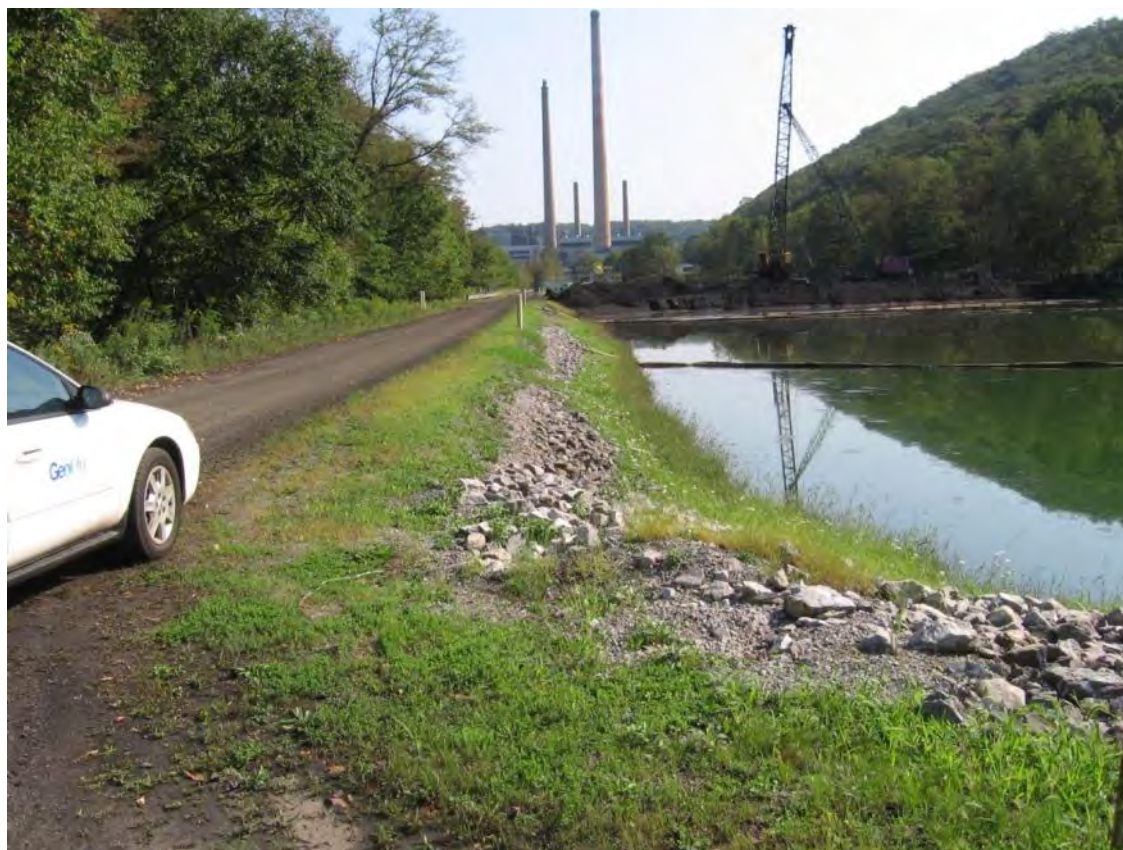
Date:
9/6/12Photo Number:
4Photographer:
S. Szewczak

Description:
Ash Pond B;
Inboard slope
and crest of
northwestern
embankment.

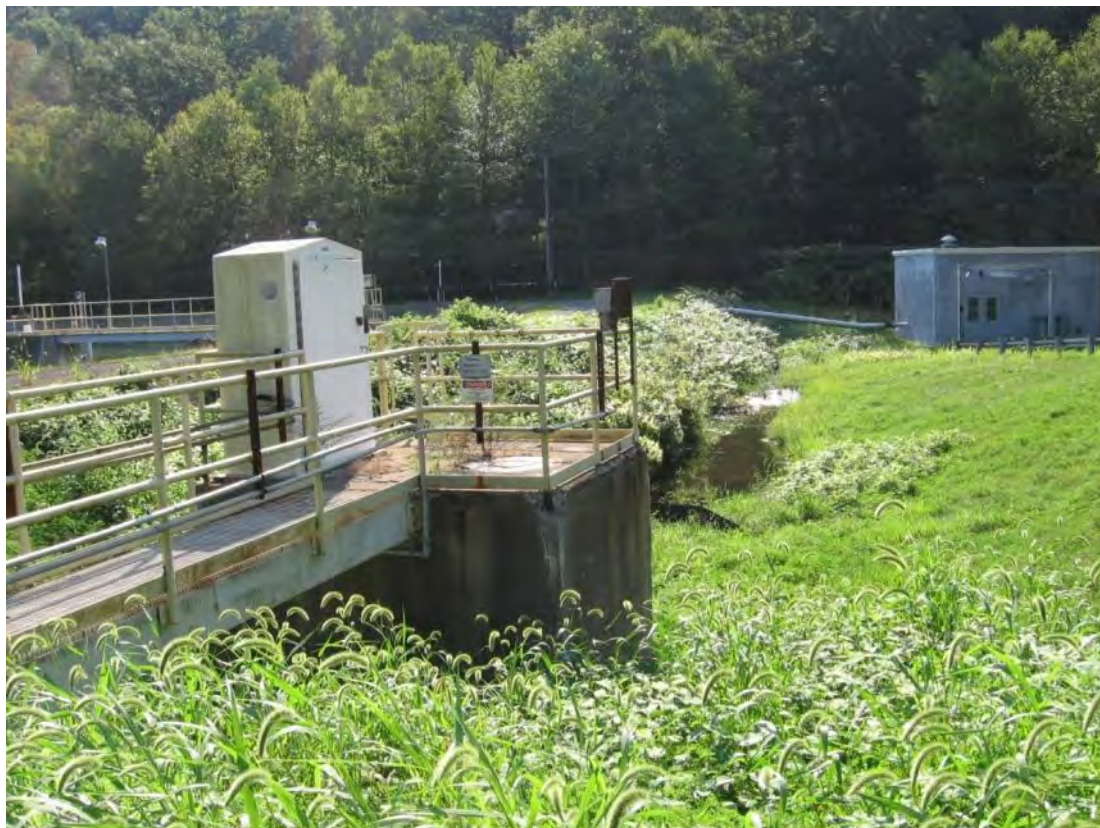
Stormwater management area along outer toe of Ash Pond B southwestern embankment. Structure in foreground is the former outlet structure for prior Pond 2 now converted to a stormwater inlet structure.

- Continue to monitor the stormwater management area for signs of erosion due to stormwater runoff from upstream areas. Repair in accordance with an engineered design as needed.

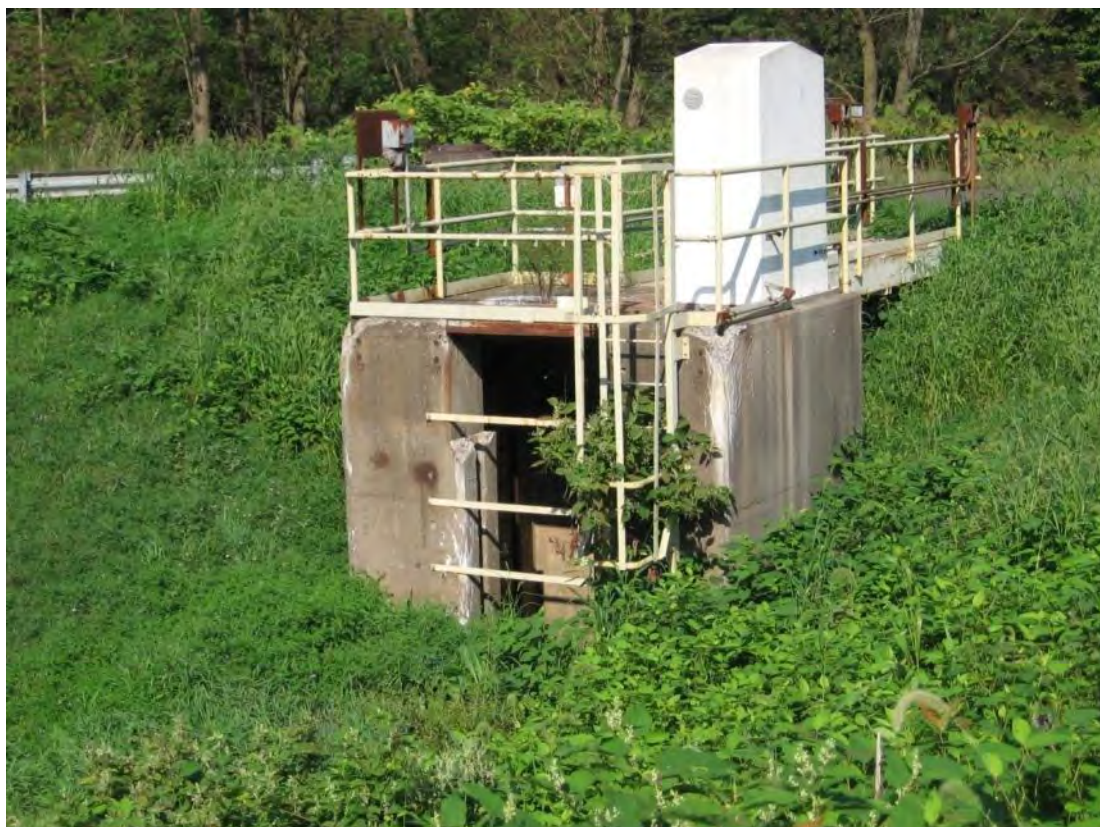
Former outlet structure for the prior Pond 2, now converted to a stormwater inlet structure.

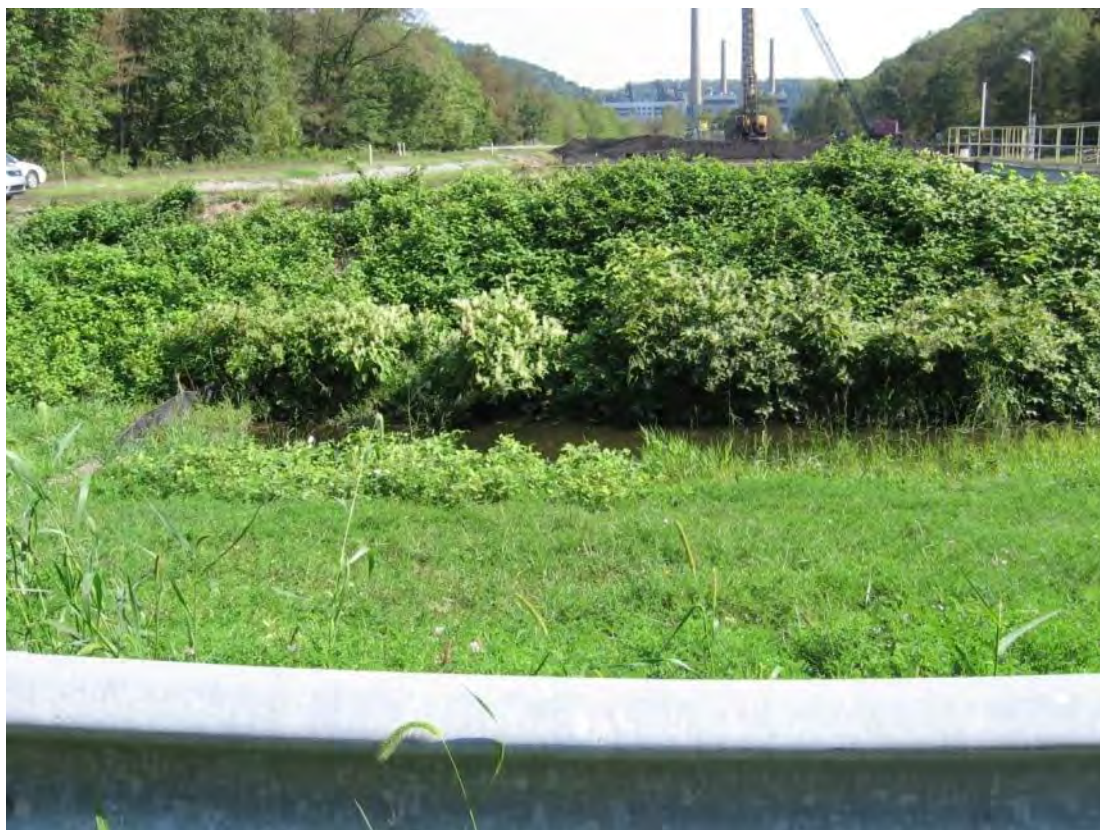
Ash Pond B;
Outer slope of
southwestern
embankment.
Water along toe
is stormwater
runoff from
upstream
diversion
ditches. No
evidence of
seepage
through the
embankment.

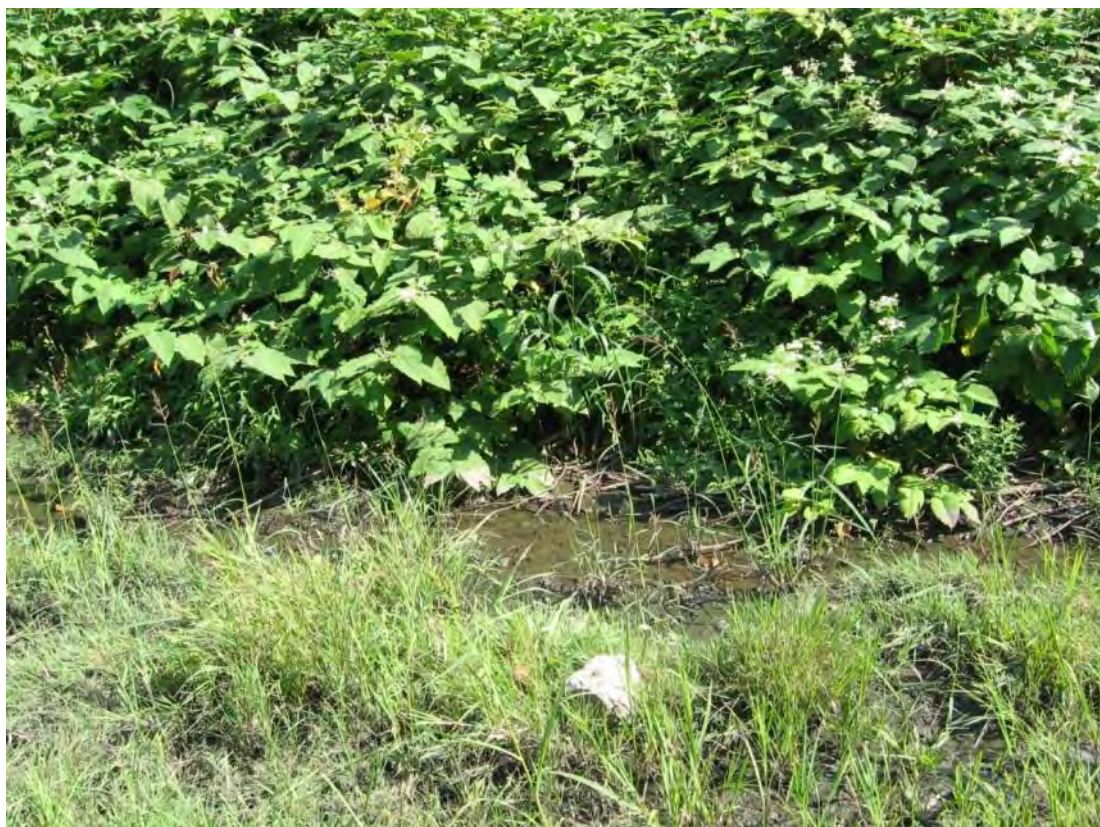
Typical view of
toe of slope of
Ash Pond B
southwestern
embankment.

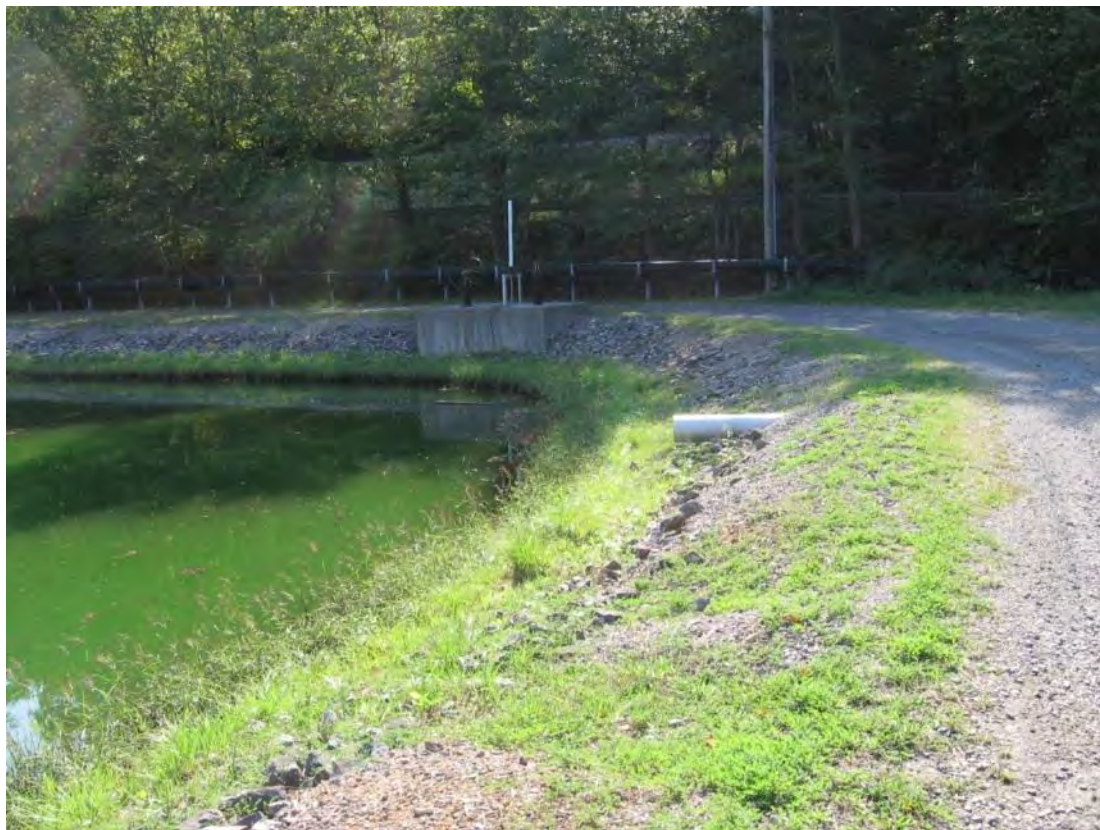
Photo Number:
9

Description:
Ash Pond B; inboard slope of southeastern embankment.

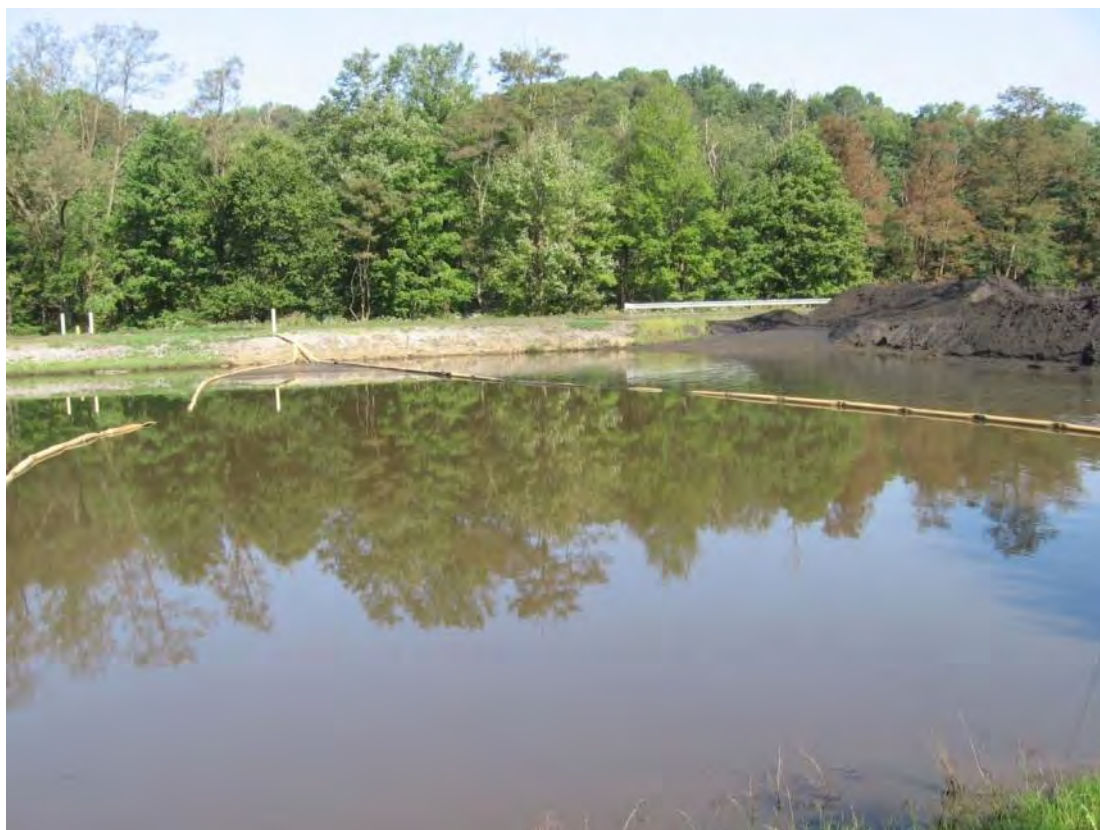
Date:
9/6/12Photo Number:
12Photographer:
S. Szewczak

Description:
Ash Pond B;
view of interior
side slope of
northwestern
embankment.
Note grouted
rock section for
maintenance
dredging.

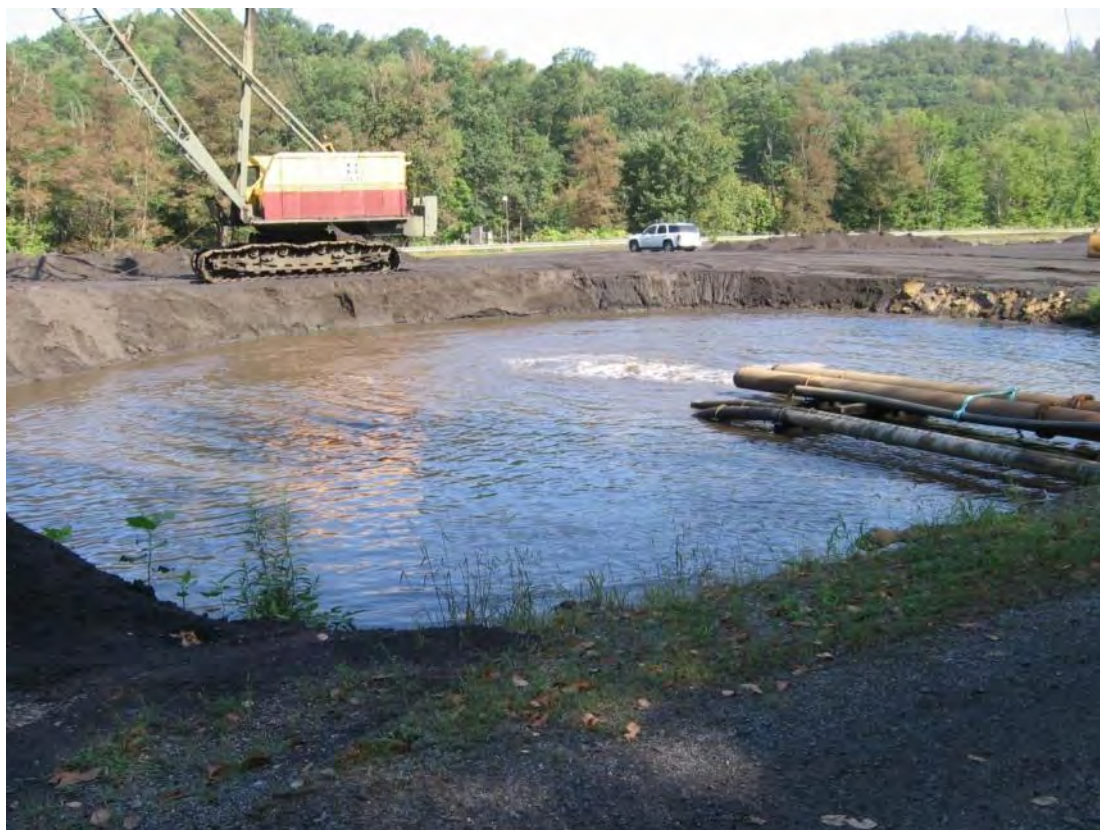
Photo Number:
13

Description:
Ash Pond B;
Constructed
forebay and ash
sluice piping at
the southeast
corner.
Forebay berm
constructed of
compacted ash.

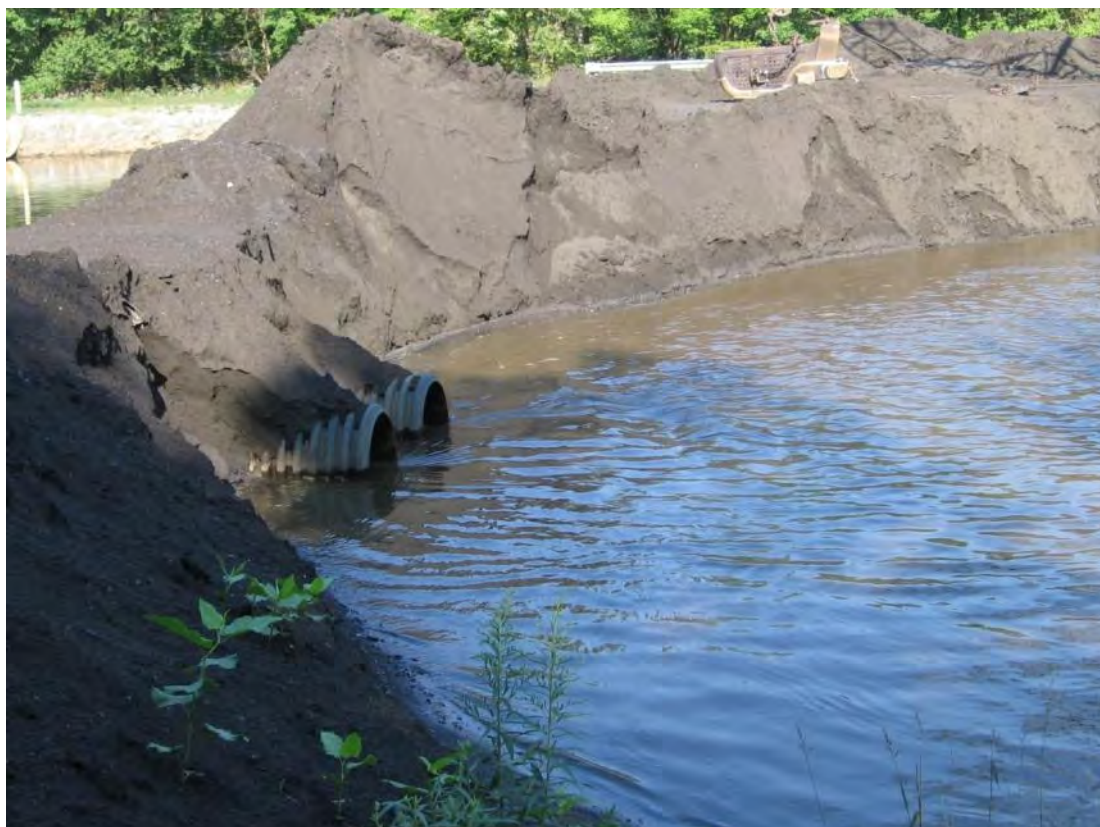
Photo Number:
14

Description:
Ash Pond B; (2)
24" HDPE pipes
connecting the
forebay to the
main portion of
Pond B through
the compacted
ash berm.

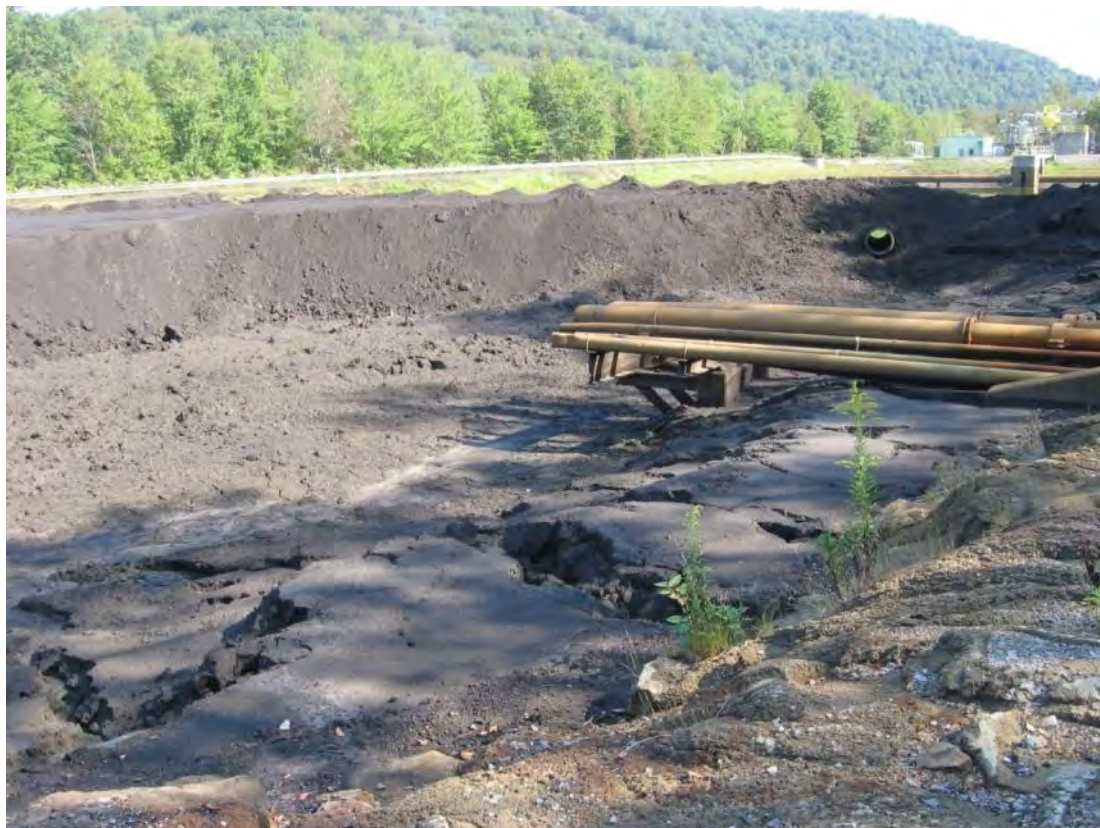
Ash Pond A;
View of
constructed
forebay and ash
sluice discharge
piping at the
southwest
corner. Pond A
has just
completed
annual
maintenance
cycle so the
forebay is dry.

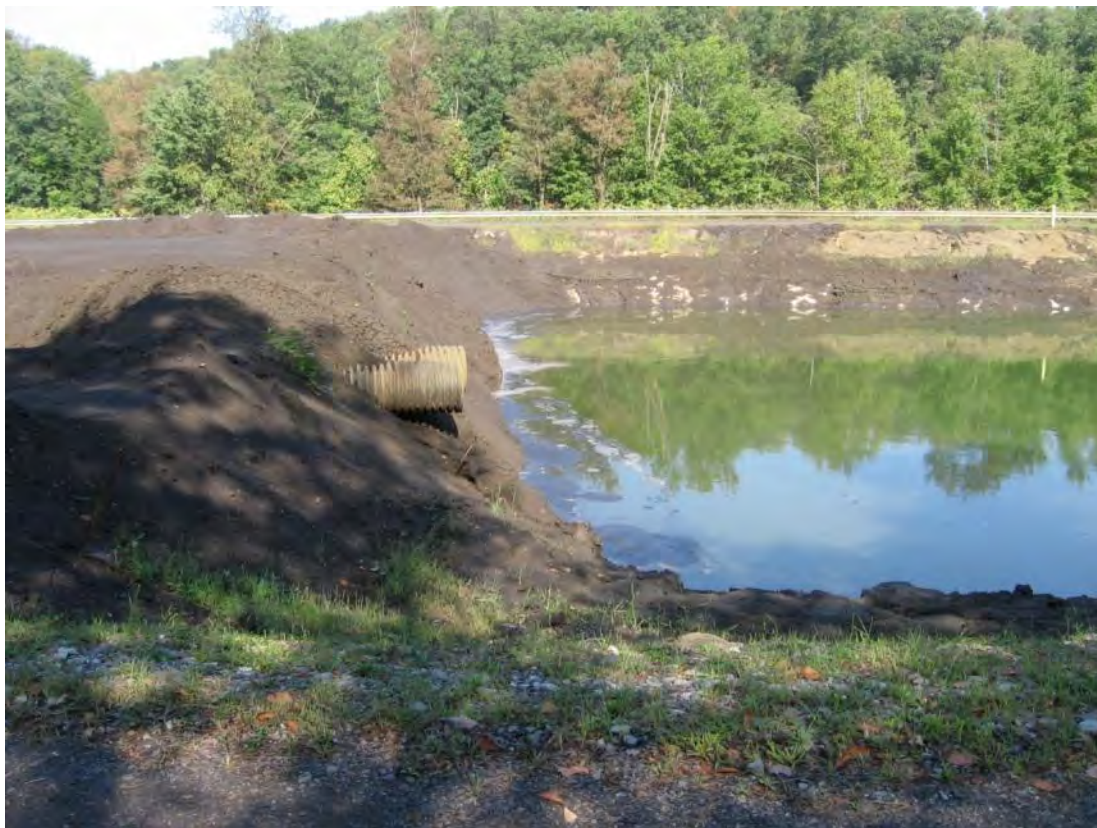
Orientation:
NWDescription:
Ash Pond A,
interior side
slope of
constructed
forebay berm.

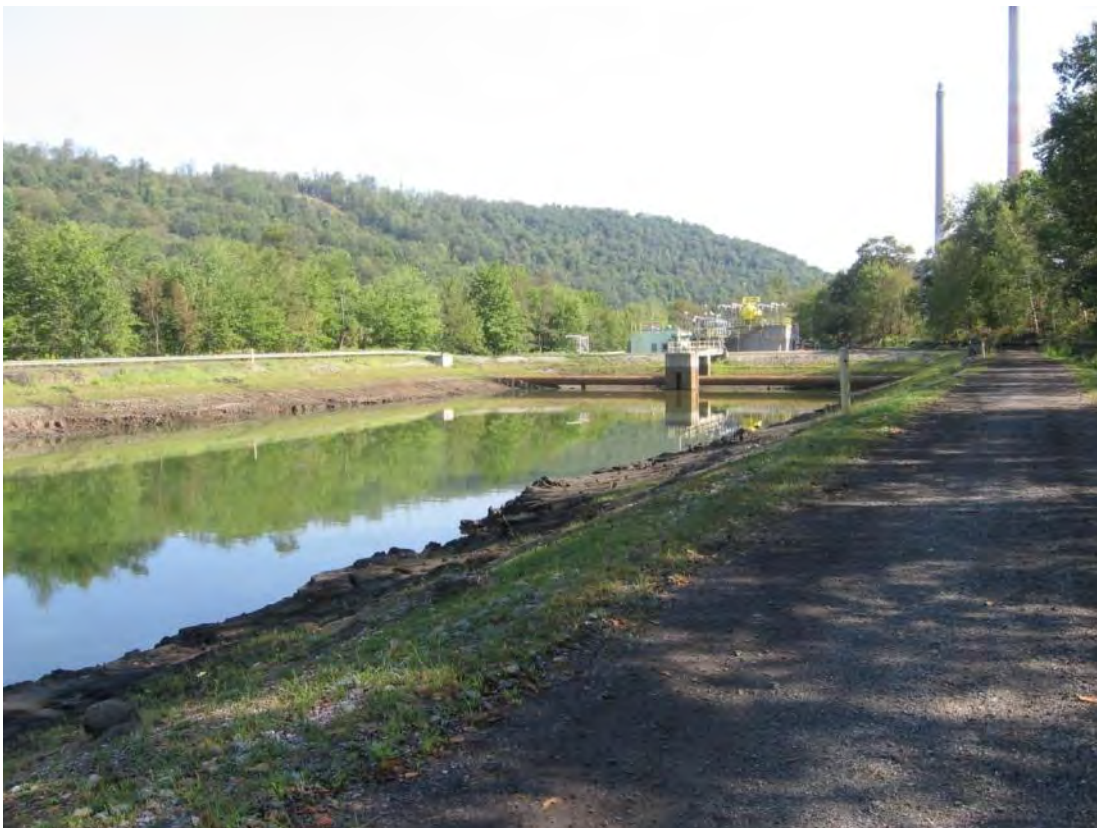
Date:
9/6/12Photo Number:
20Photographer:
S. Szewczak

Date:
9/6/12Photo Number:
19Photographer:
S. SzewczakOrientation:
NEDescription:
Ash Pond A;
Overall view
looking towards
the generating
station. Note
that water level
has been
lowered for
maintenance by
approximately 6
feet.

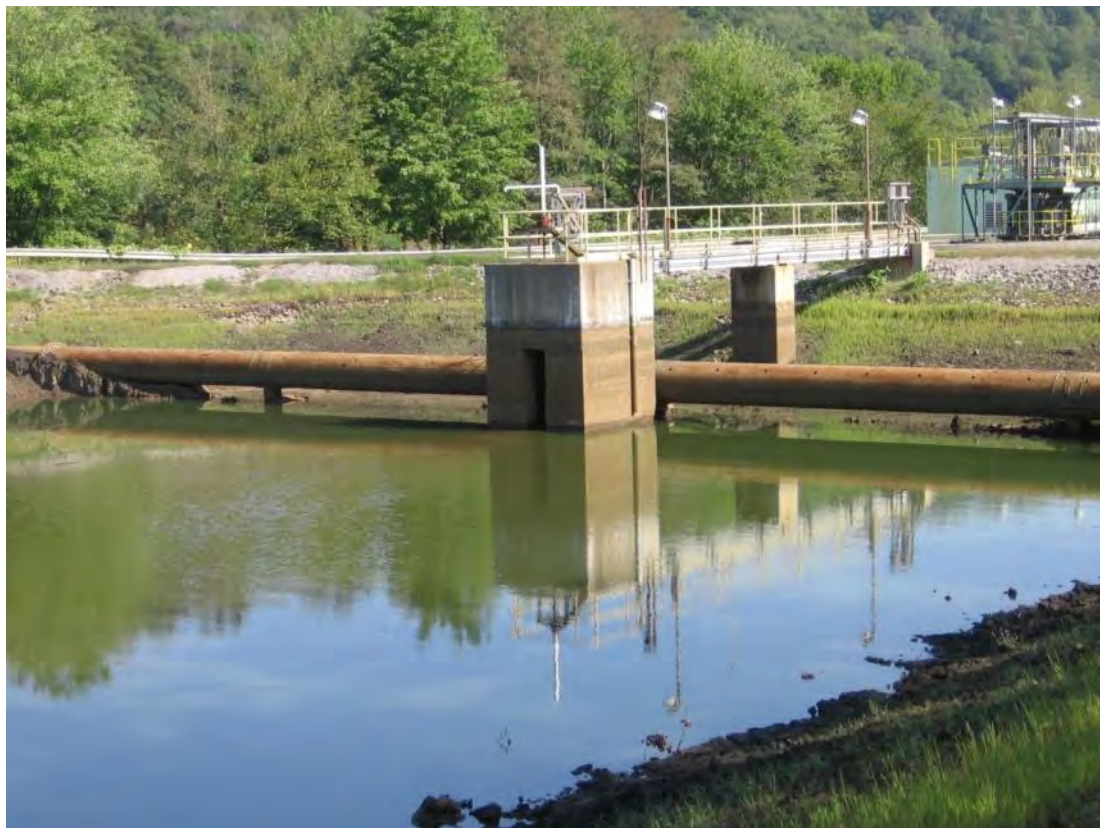
- The decant structure appears to be in good condition and functioning normally. The water level was low enough for observation of the main 36" diameter steel perforated pipe which appears in good condition.

Orientation:
NEDescription:
Ash Pond A;
decant
structure and
36" diameter
perforated steel
decant pipe.

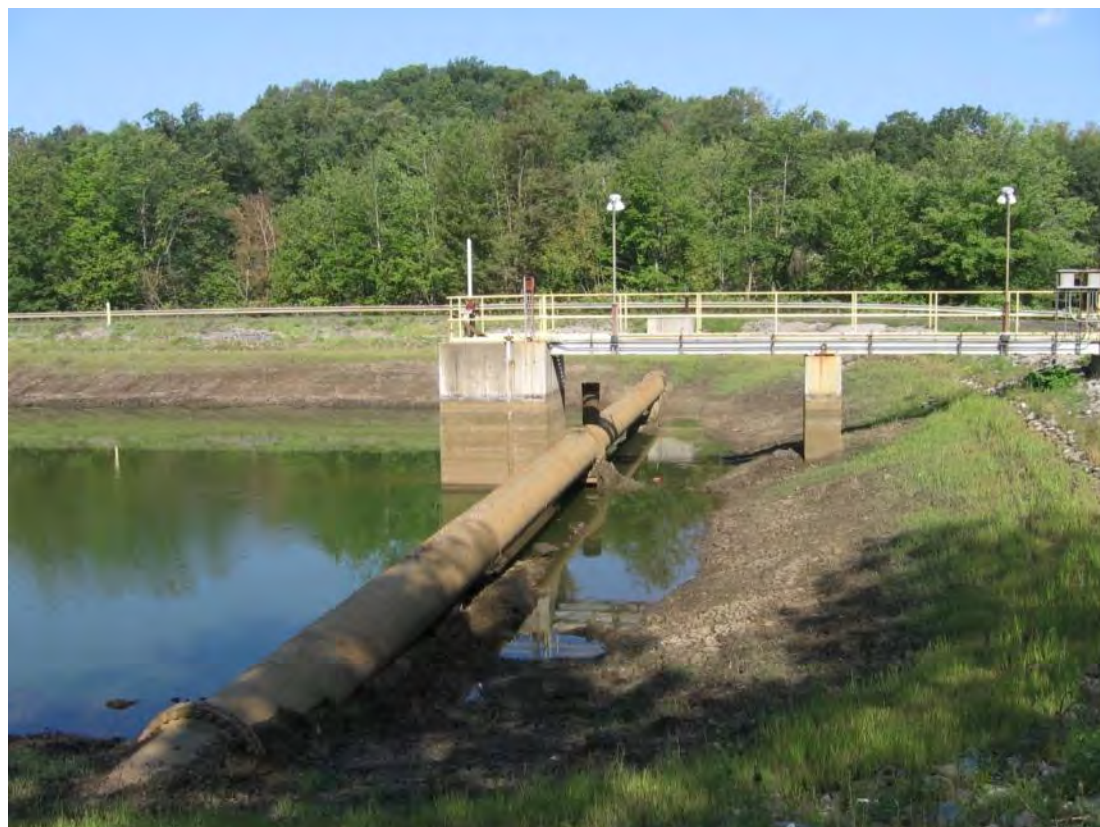
Date:
9/6/12Photo Number:
22Photographer:
S. Szewczak

Date:
9/6/12Photo Number:
21Photographer:
S. SzewczakOrientation:
NWDescription:
Ash Pond A;
decant
structure and
36" diameter
perforated steel
decant pipe.

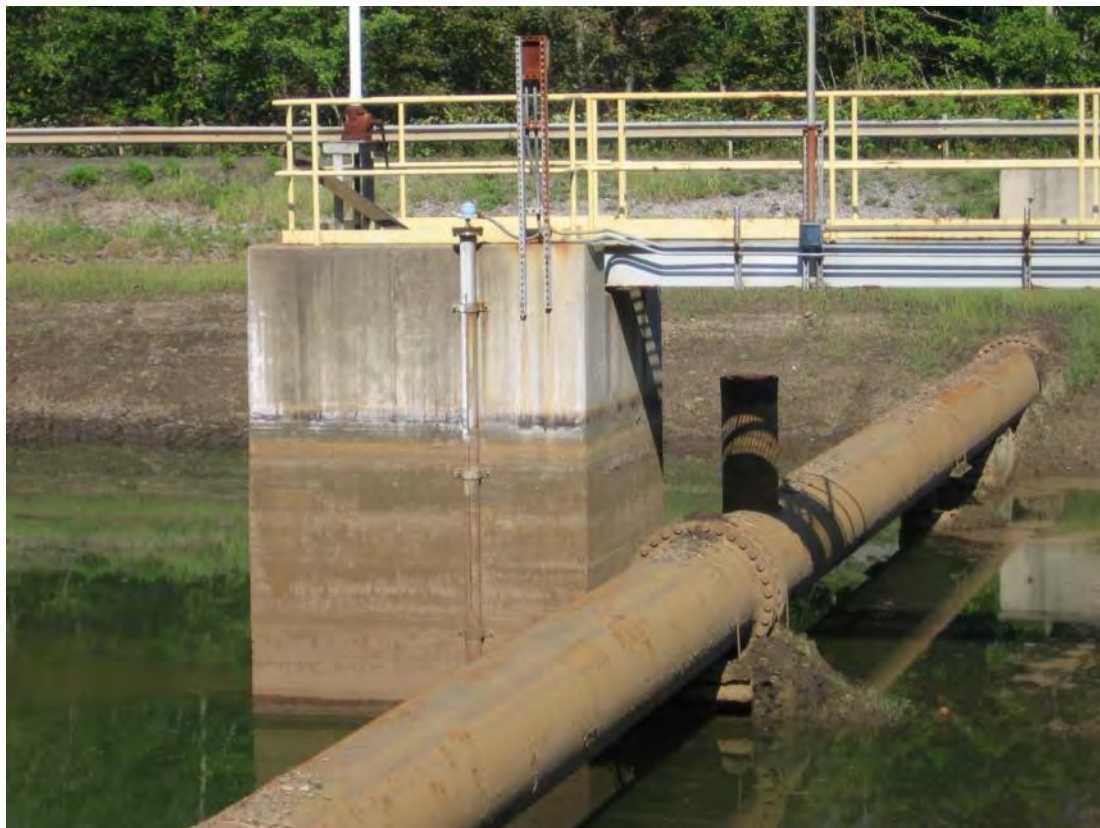
Orientation:
NWDescription:
Ash Pond A;
close up view of
decant
structure.

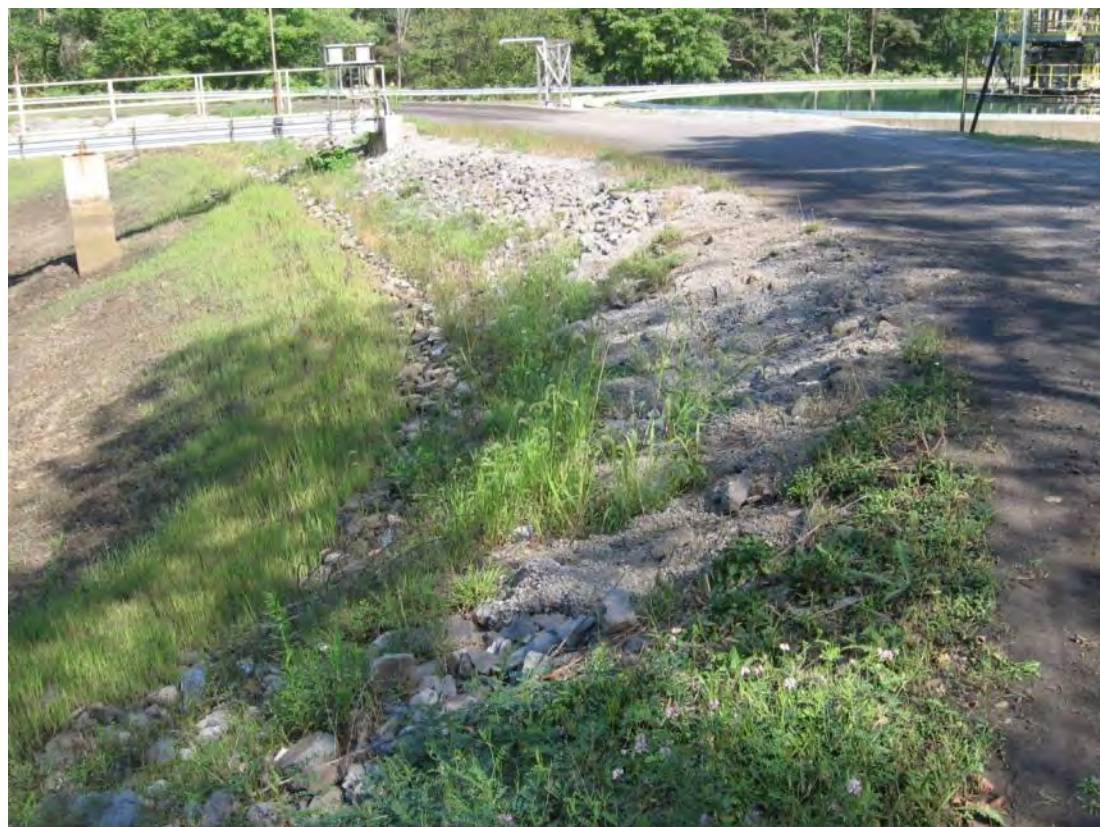
Date:
9/6/12Photo Number:
24Photographer:
S. Szewczak

Date:
9/6/12Photo Number:
23Photographer:
S. SzewczakOrientation:
NWDescription:
Ash Pond A;
inboard side
slope of
northeastern
embankment.

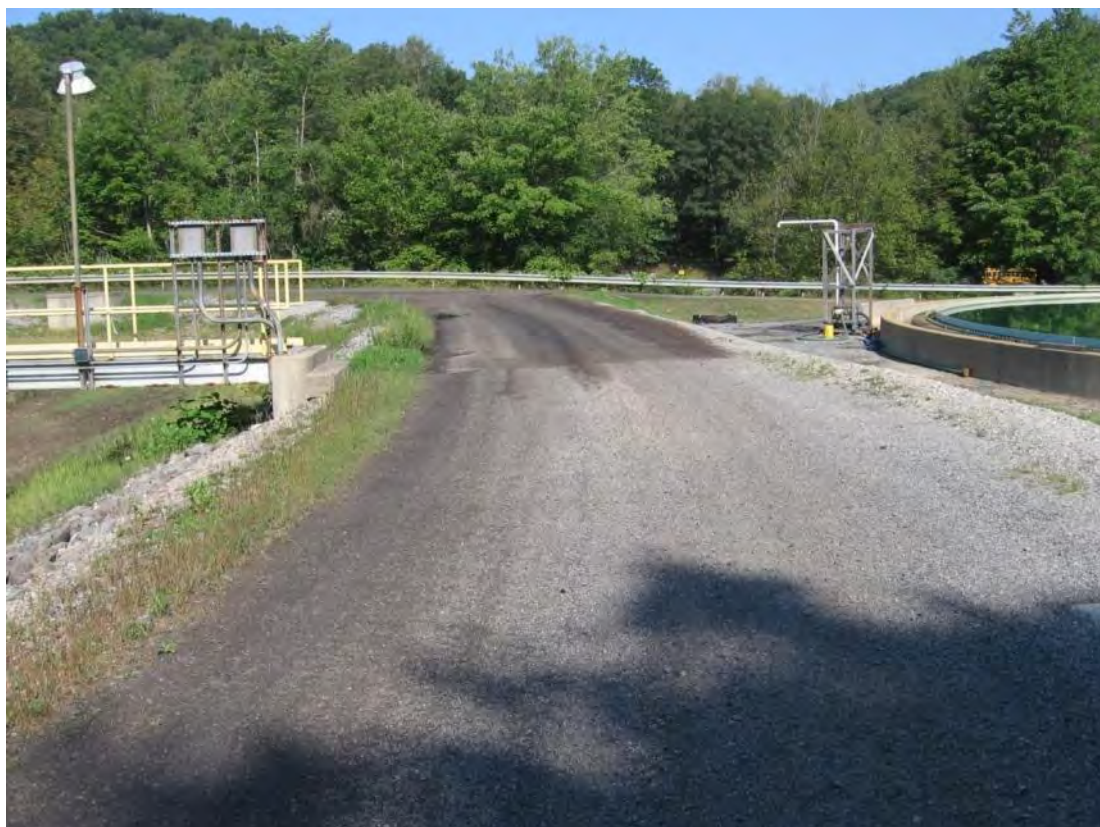
Ash Pond A; crest of northeastern embankment. Wastewater treatment plant clarifier tank visible to the right.

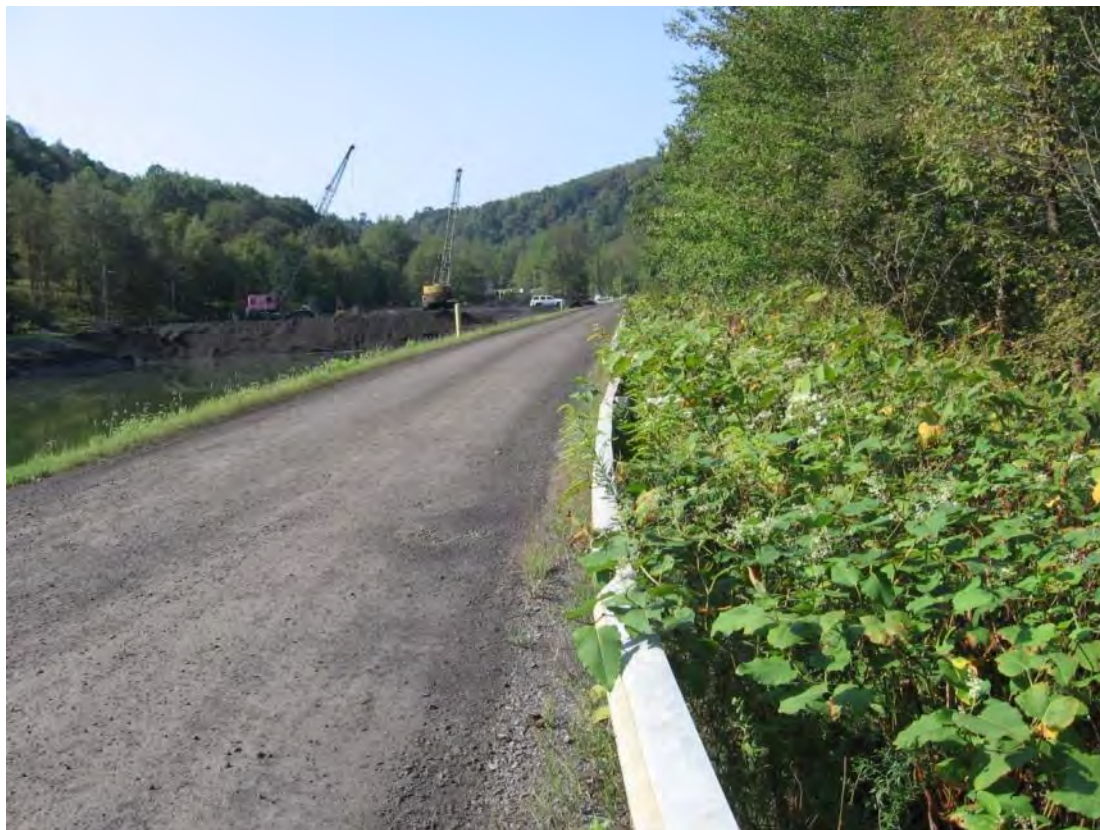
Description:
Ash Pond A;
crest and
outboard slope
of northwestern
embankment
looking towards
Ash Pond B.
Note heavy
vegetation on
outboard slope.

- Evaluate the condition of the large trees along the outboard slope of the northwestern embankment, primarily those above the impoundment bottom elevation. Diseased or dead trees should be removed.

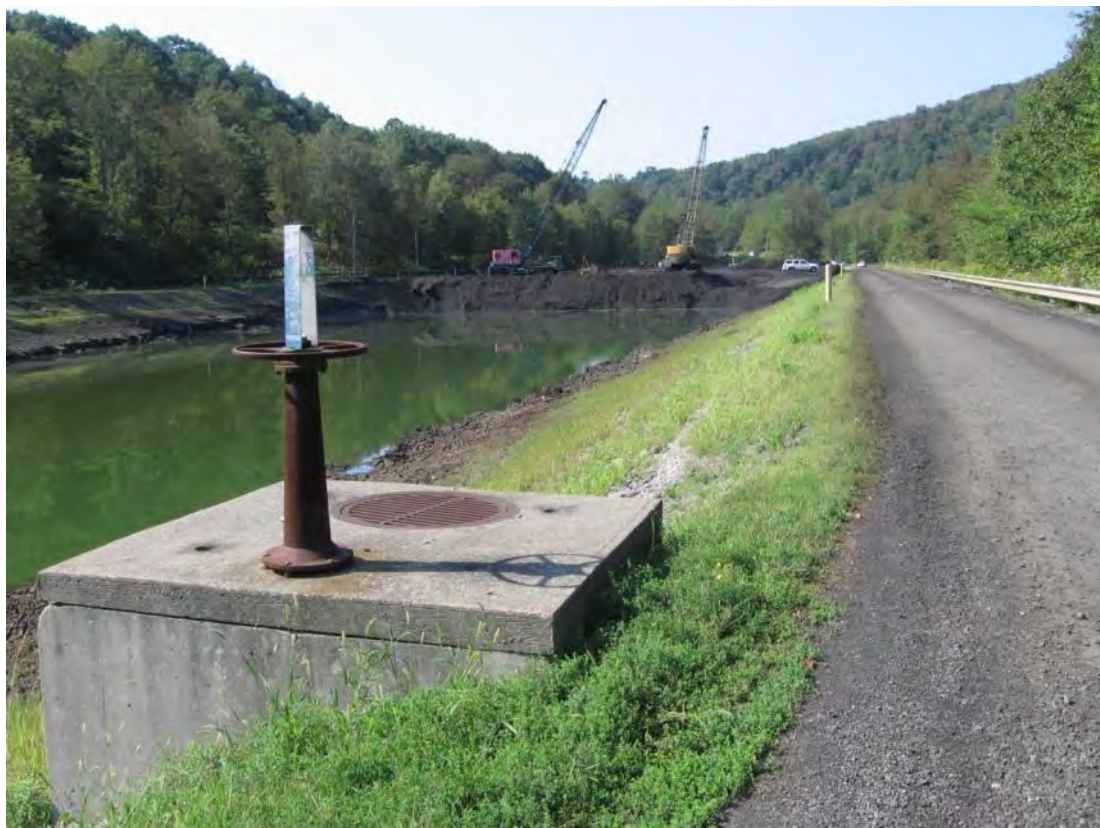
Date:
9/6/12Photo Number:
28Photographer:
S. Szewczak

Description:
Ash Pond A;
inboard side
slope of
northwestern
embankment.
Structure in
foreground is
Clarifier Bypass
Structure (used
for overflow
only)

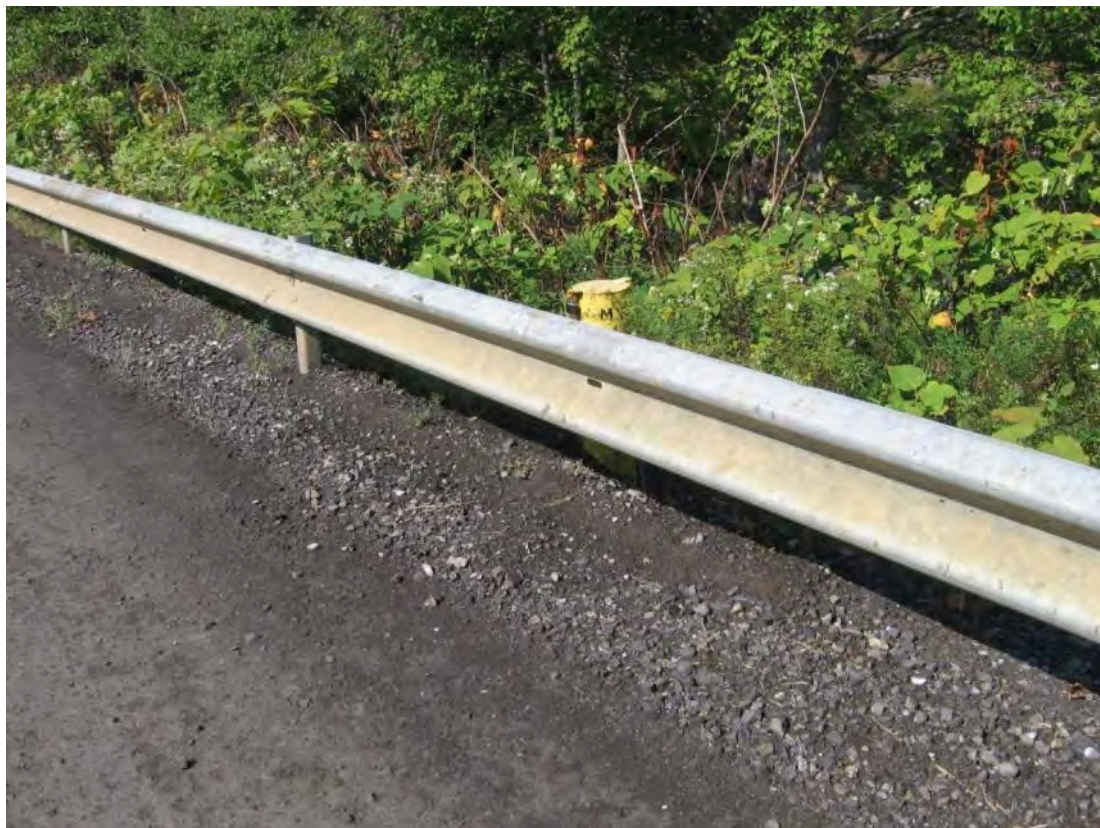
Orientation:
WDescription:
Monitoring Well
MW-10 located
in the
northwestern
embankment of
Ash Pond A.

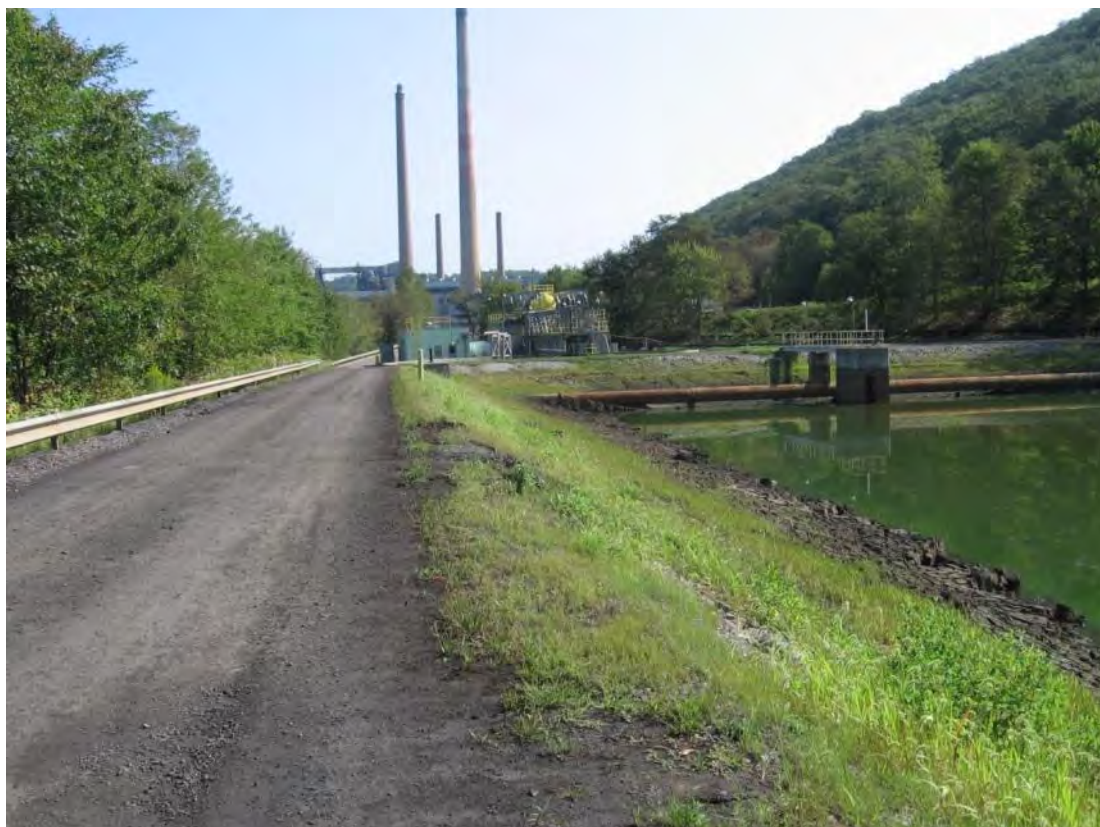
Date:
9/6/12Photo Number:
30Photographer:
S. Szewczak

Date:
9/6/12Photo Number:
29Photographer:
S. SzewczakOrientation:
NEDescription:
Ash Pond A;
inboard side
slope and crest
of northwestern
embankment
looking towards
the generating
station.
