PRELIMINARY REPORT

Dam Safety Assessment of CCW Impoundments

GenOn Energy – Shawville Generating Station Shawville, Clearfield County, Pennsylvania

December 17, 2012

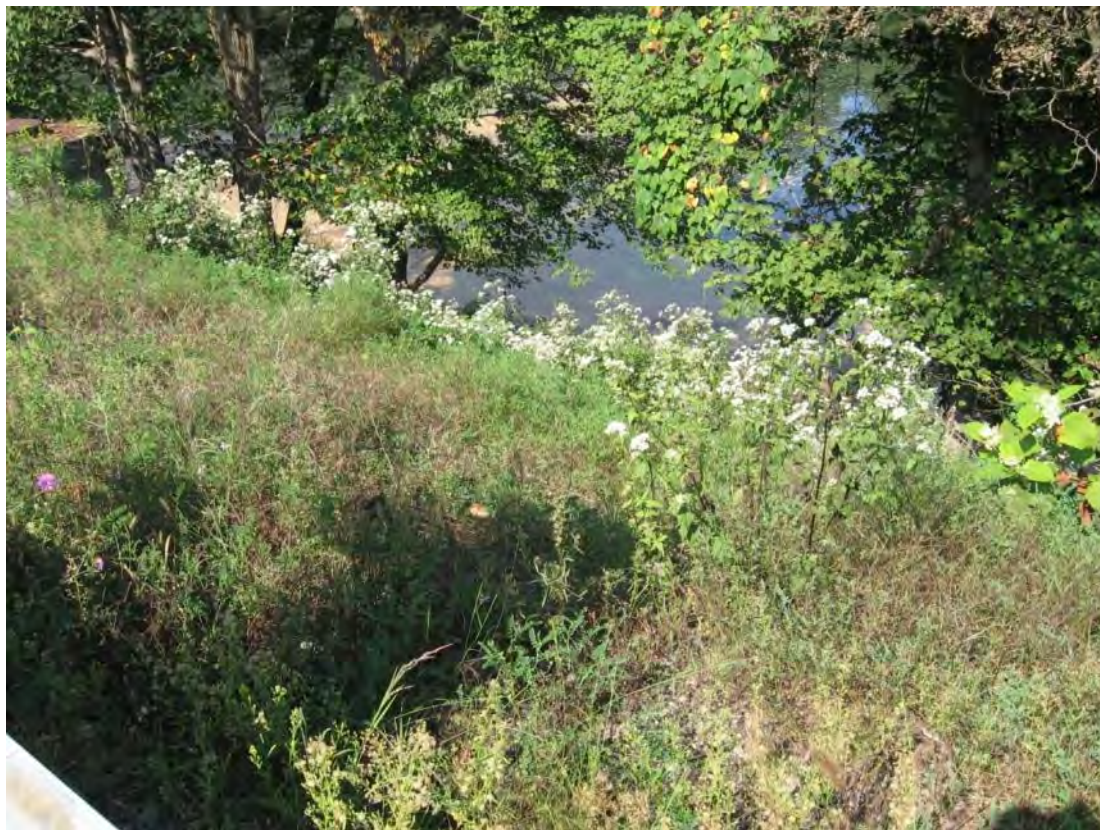
Ash Pond A;
Outer side slope
of northwestern
embankment
looking down at
the West
Branch of the
Susquehanna
River.

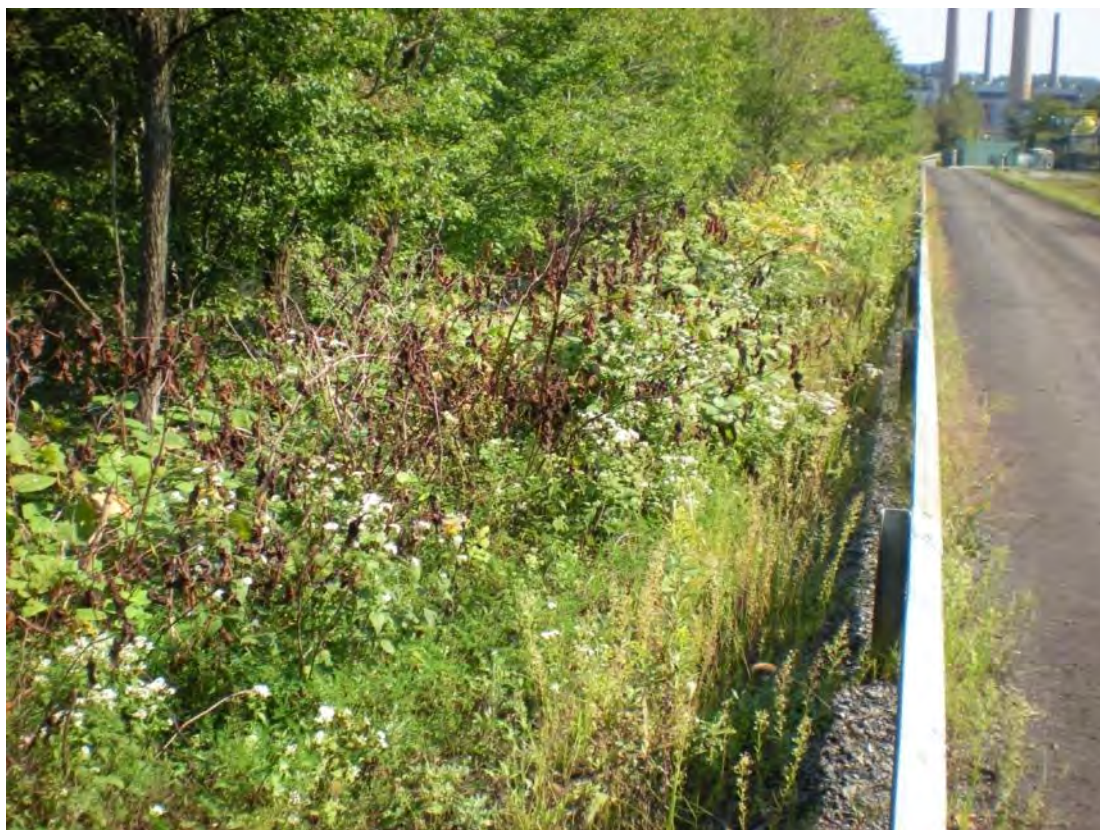
Ash Pond A;
Outer side slope
of northwestern
embankment
heavily
vegetated.

- Evaluate the condition of the large trees along the outboard slope of the northwestern embankment, primarily those above the impoundment bottom elevation. Diseased or dead trees should be removed.

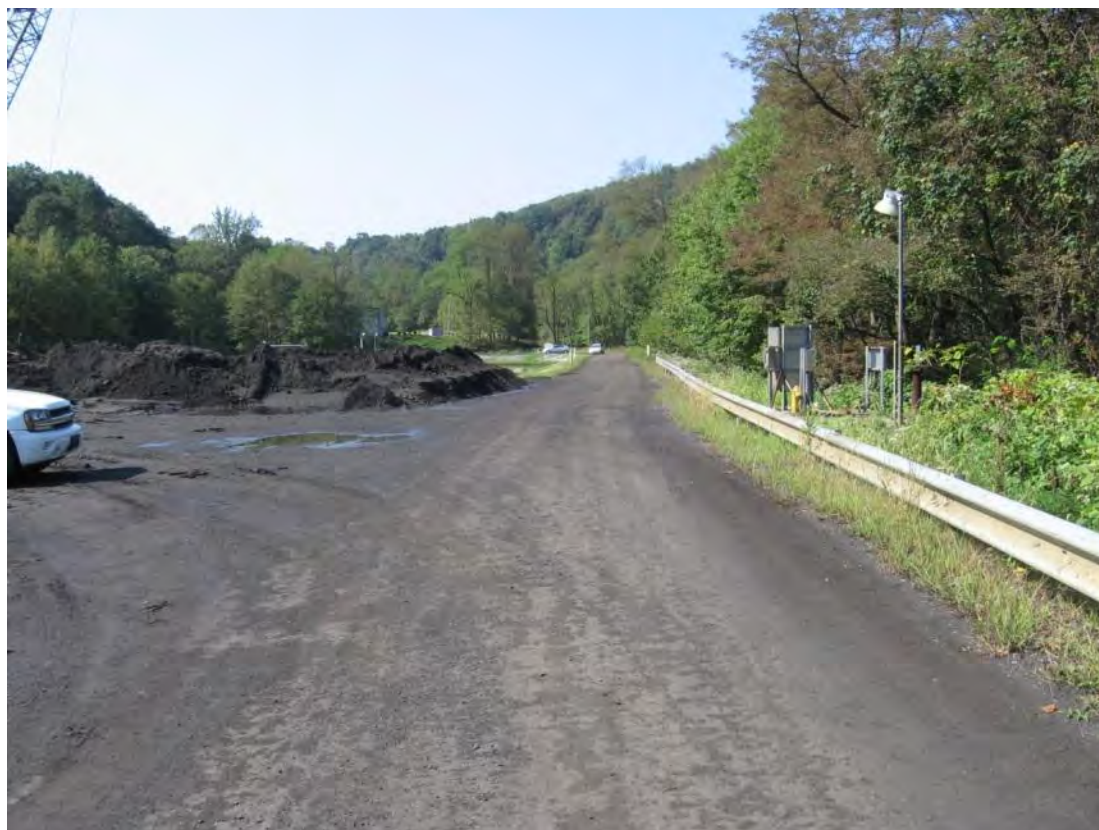
Crest of the northwestern embankment at the central dividing dike. Dredged ash from Pond A temporarily stockpiled prior to landfilling.

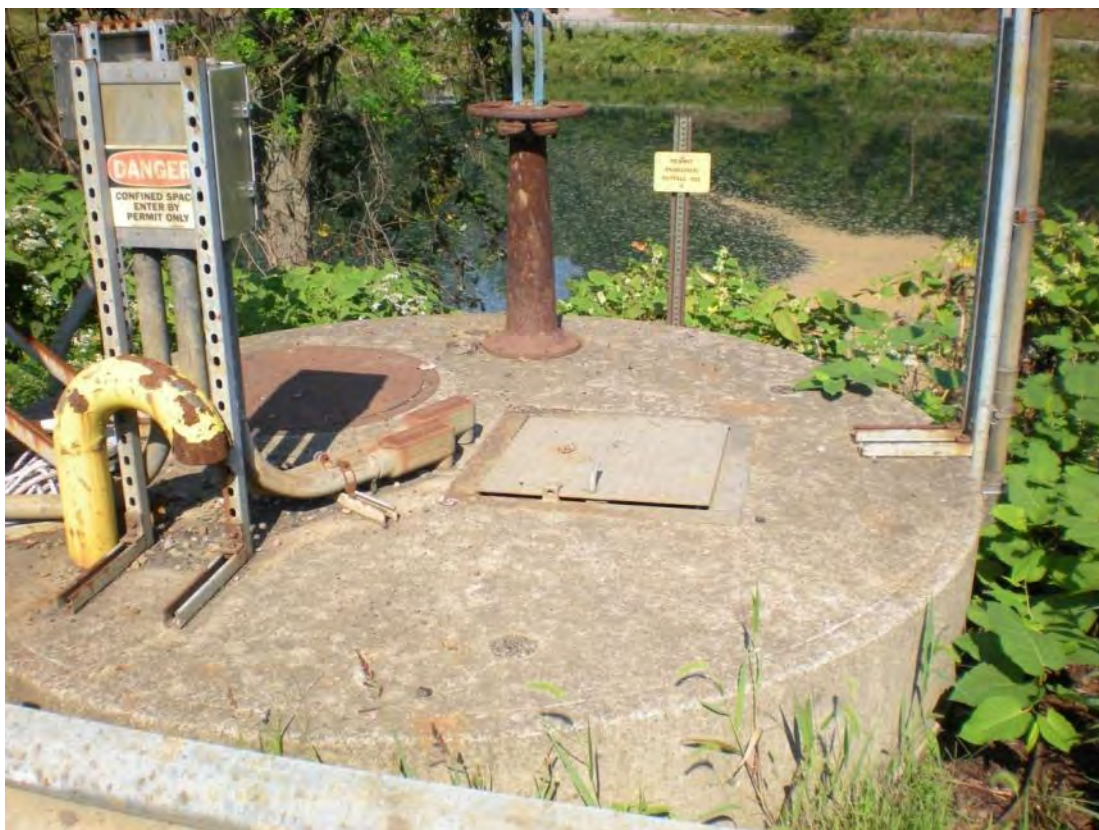
Subdrain pumping station. Collects leachate from beneath pond liners only, not used for decant.

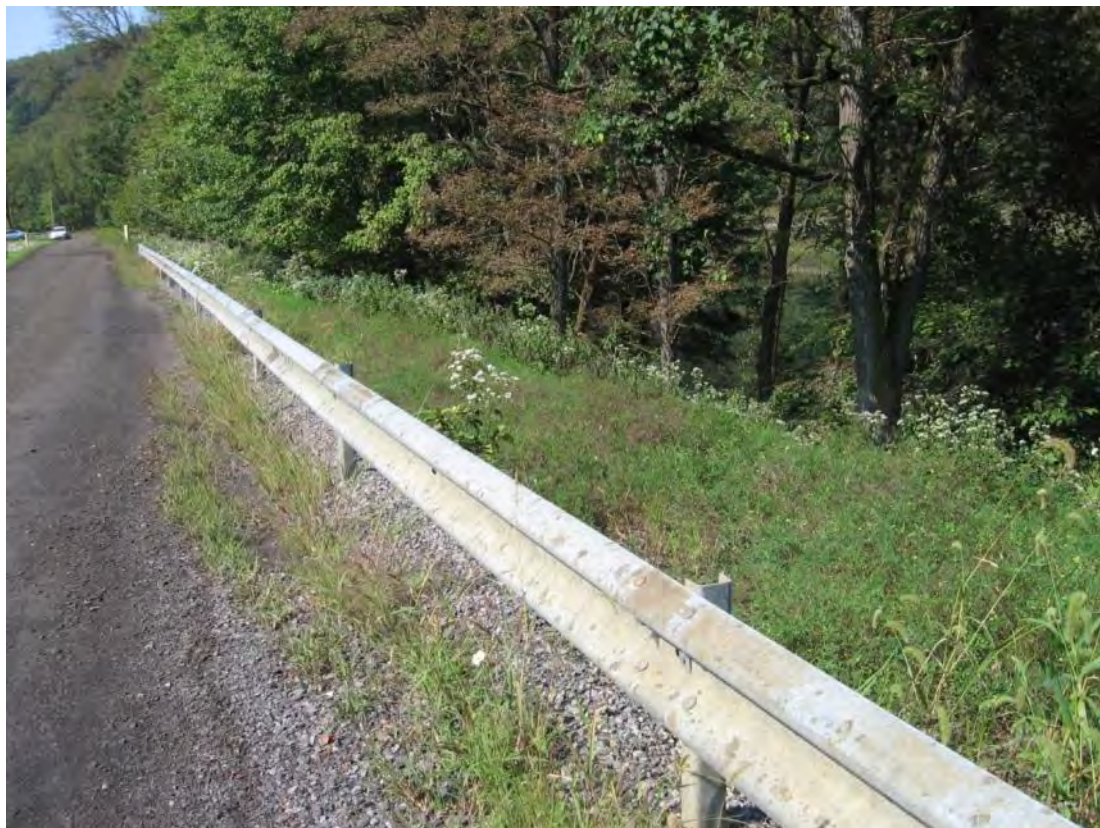
Ash Pond B;
Outboard slope
of northwestern
embankment.

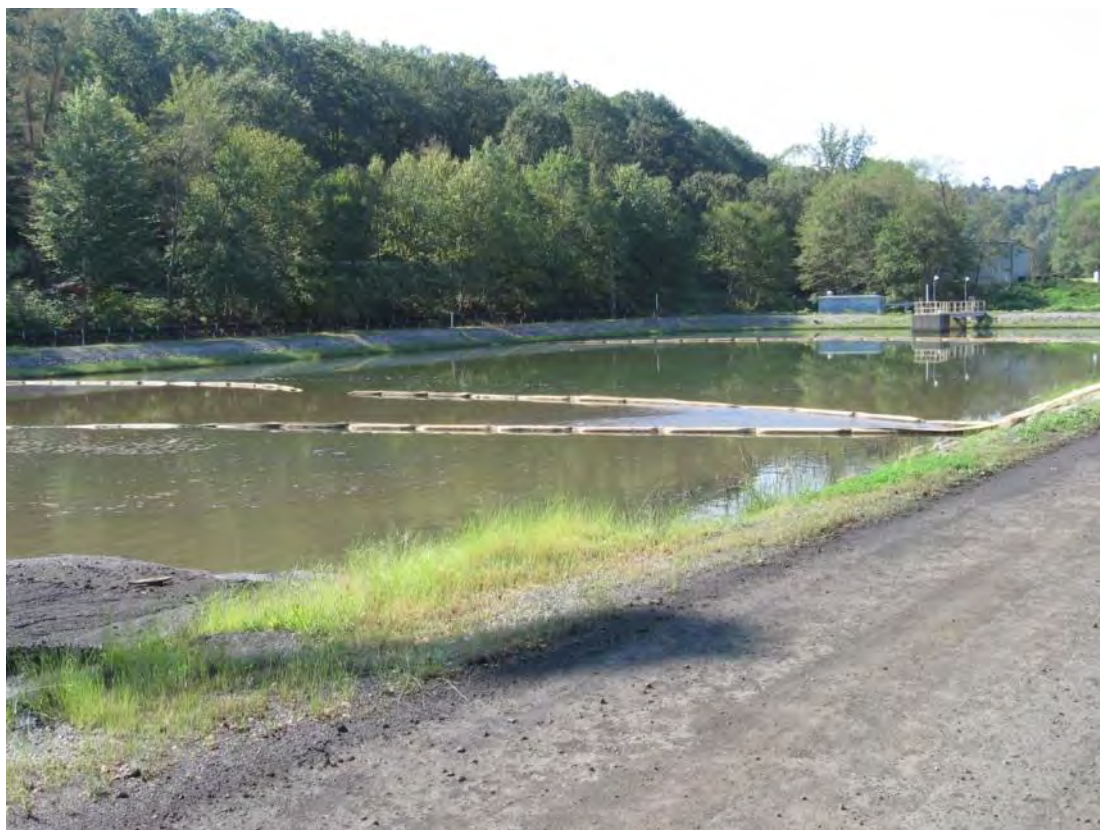
Ash Pond B;
Overall view.
Note floating
turbidity
curtains.

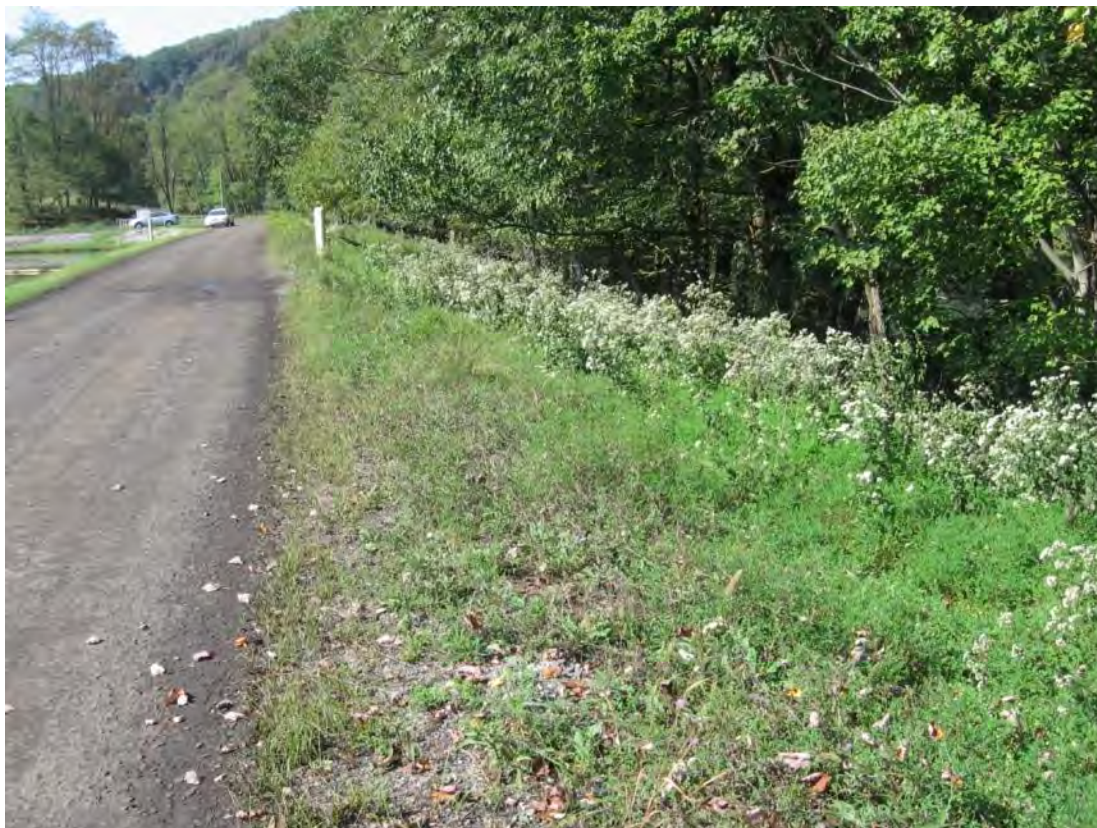
Ash Pond B;
Crest and
outboard slope
of northwestern
embankment

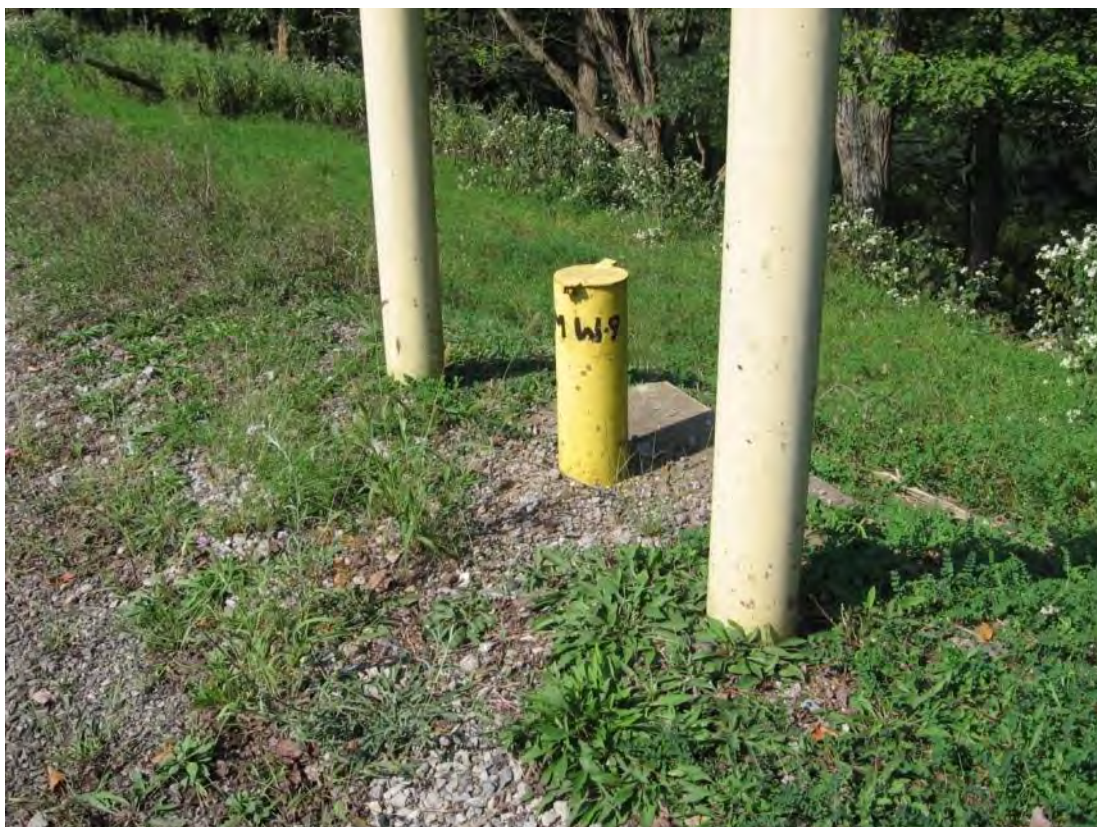
Monitoring Well
MW-9 located
in the
northwestern
embankment of
Ash Pond B.

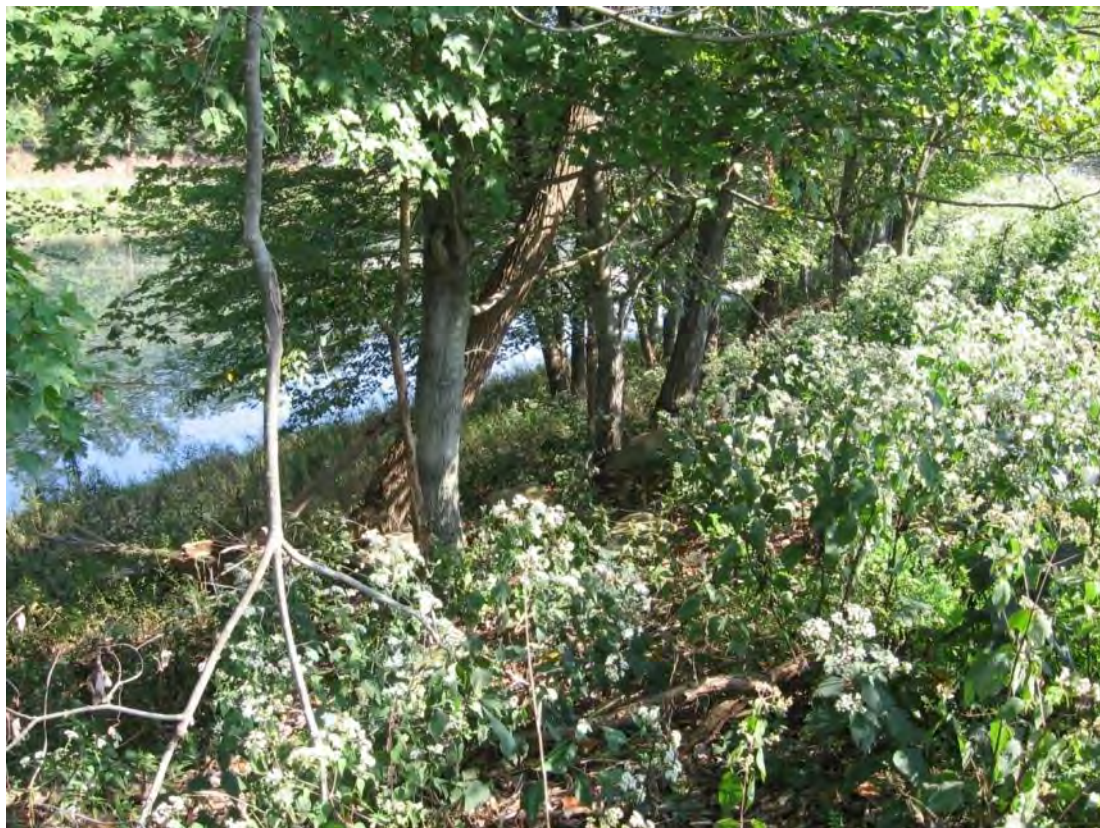
Orientation:
NEDescription:
Typical
condition of
outboard slope
of northwestern
embankment
looking down at
the West
Branch of the
Susquehanna
River.

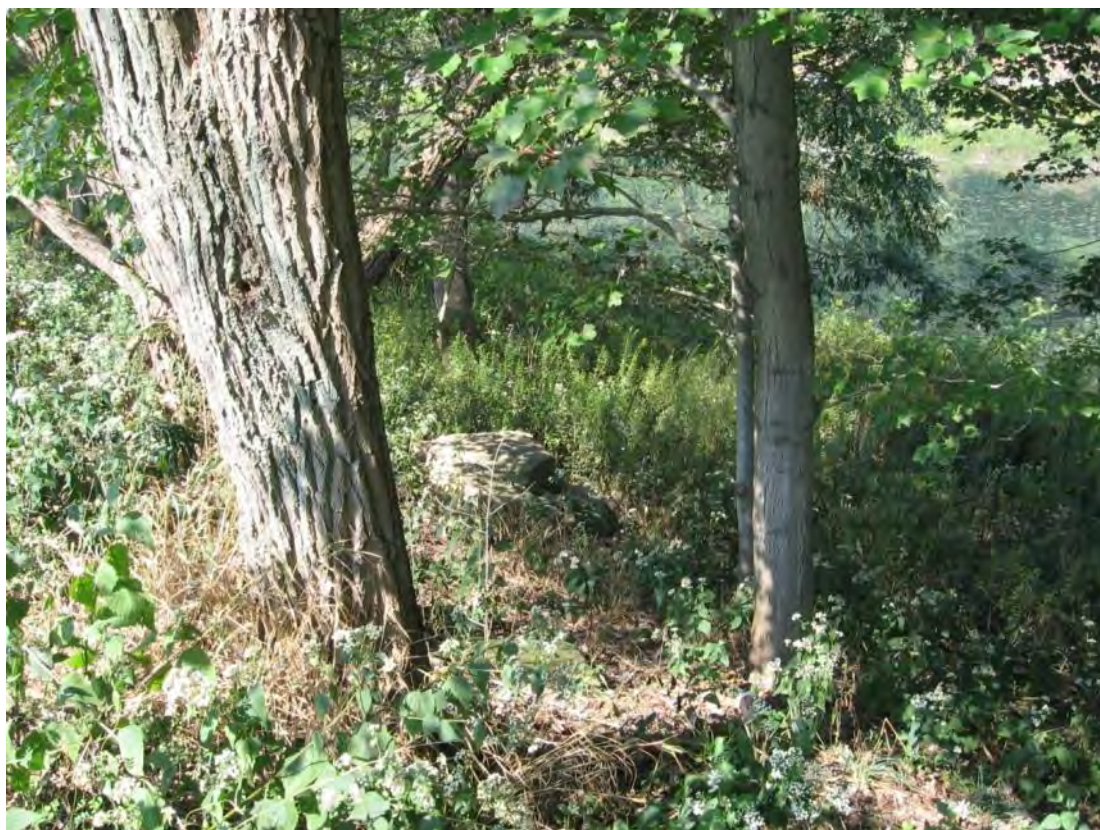
Date:
9/6/12Photo Number:
40Photographer:
G. Emmanuel

Date:
9/6/12Photo Number:
39Photographer:
G. EmmanuelOrientation:
WDescription:
Typical
condition of
outboard slope
of northwestern
embankment
looking down at
the West
Branch of the
Susquehanna
River.
