Dam Safety Assessment of CCW Impoundments

**NRG REMA LLC – Shawville Generating Station
Shawville, Clearfield County, Pennsylvania**

**United States Environmental Protection Agency
Washington, DC**

December 16, 2013

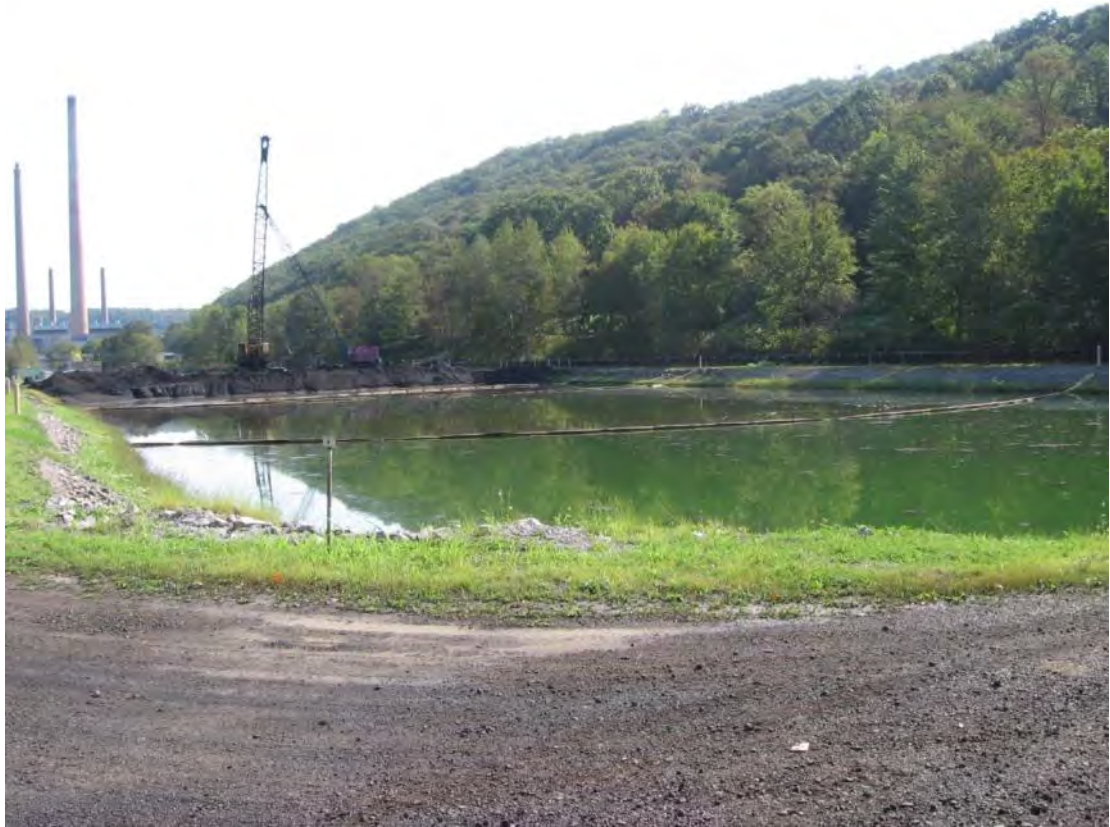
Photo Number:
1

Description:
Ash Pond B;
Overall view.
Ash Pond B
currently active
during
maintenance on
primary Ash
Pond A.

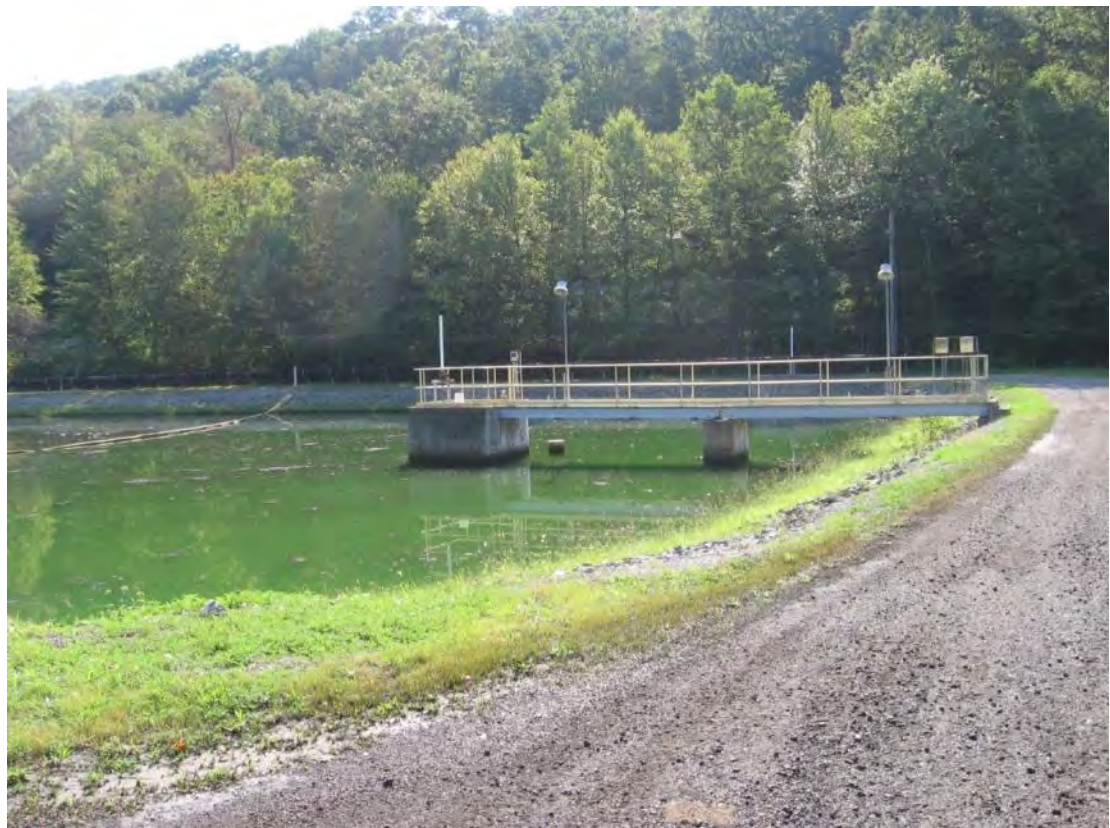
Photo Number:
2

Description:
Ash Pond B;
View of decant
structure.

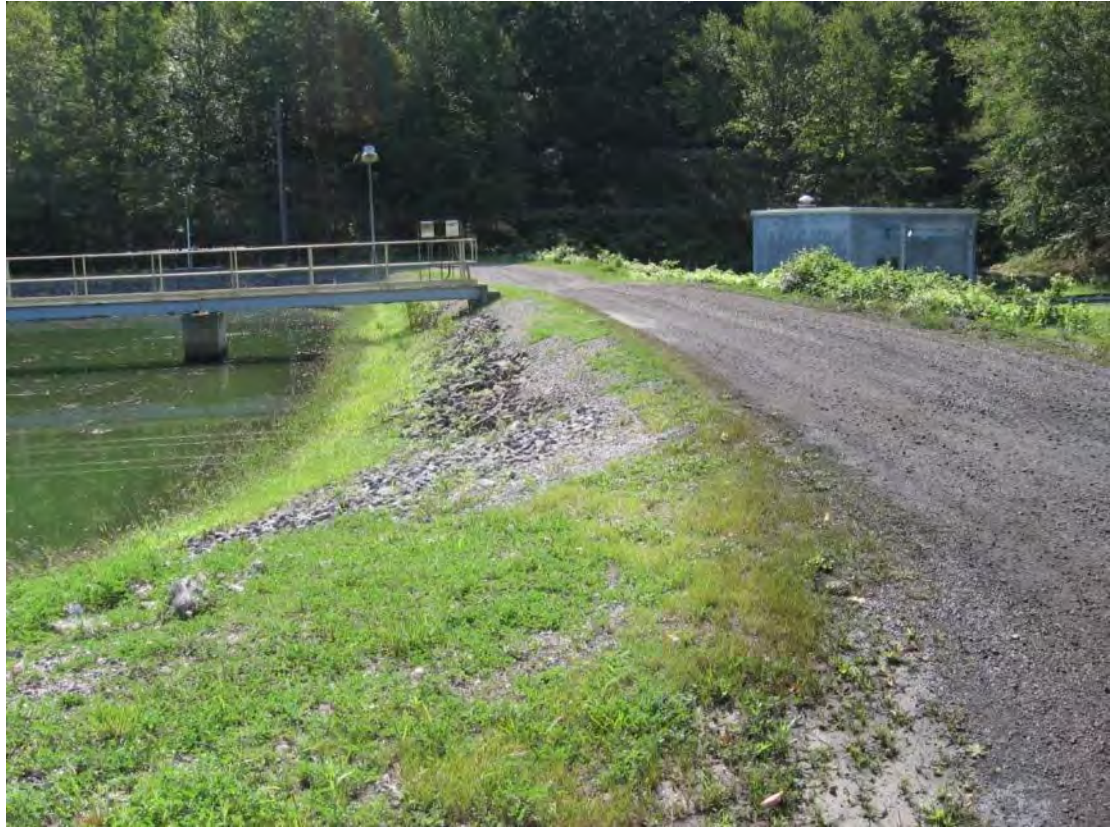
Photo Number:
3

Description:
Ash Pond B;
Inboard slope
and crest of
southwestern
embankment.
Note triangular
emergency
overflow
section located
just past
walkway.
Building on
right is the
leachate pump
station from
facility landfill.

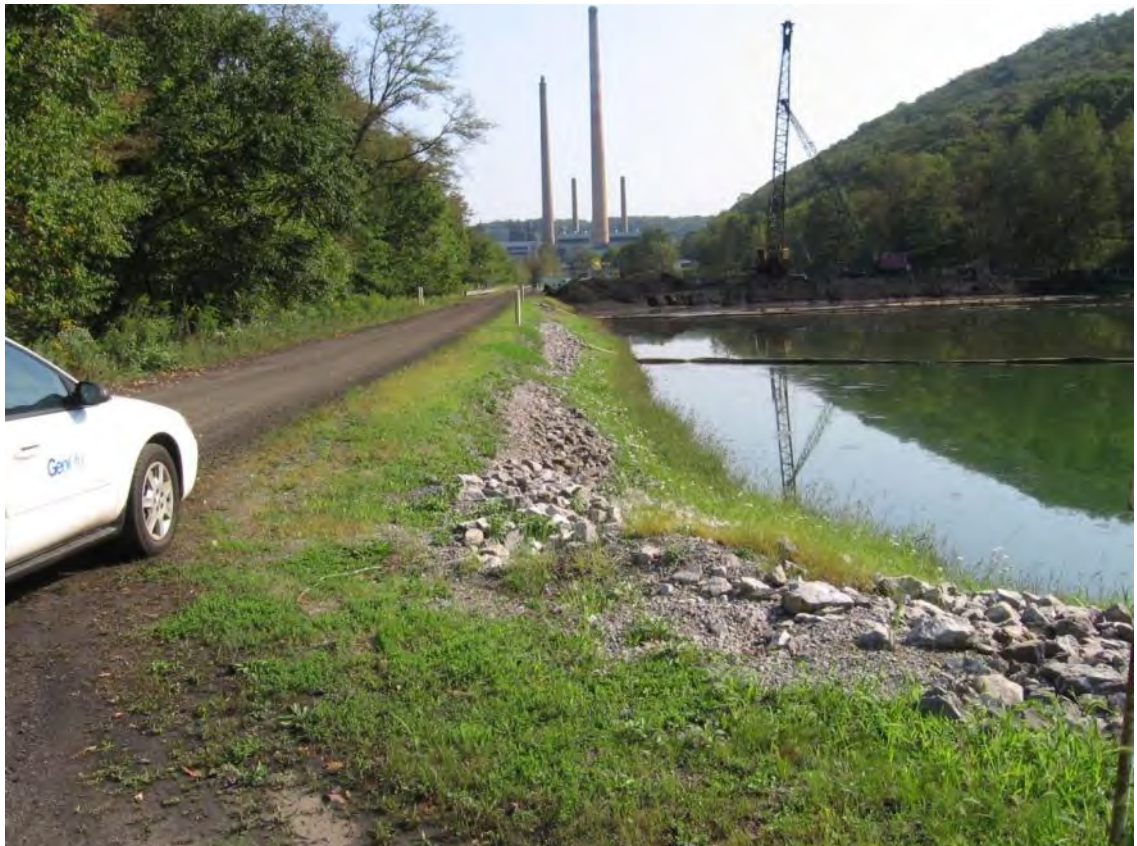
Photo Number:
4

Description:
Ash Pond B;
Inboard slope
and crest of
northwestern
embankment.

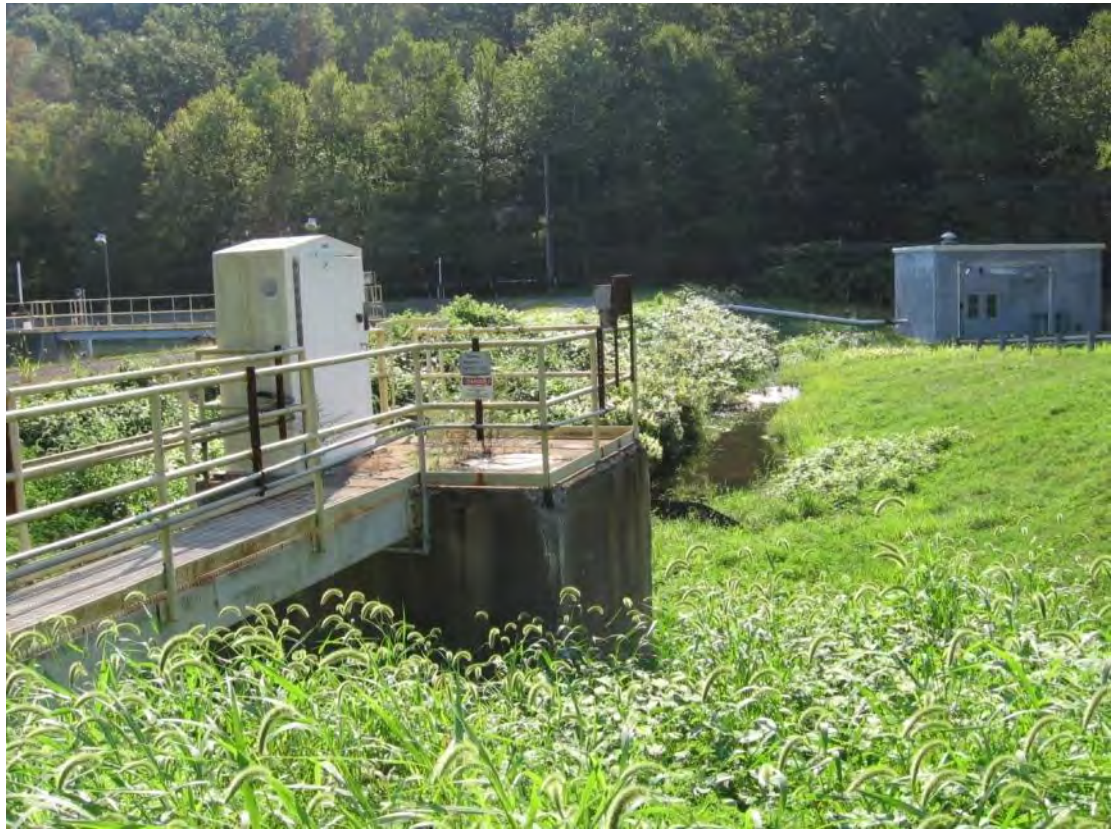
Photo Number:
5

Description:
Stormwater management area along outer toe of Ash Pond B southwestern embankment. Structure in foreground is the former outlet structure for prior Pond 2 now converted to a stormwater inlet structure.

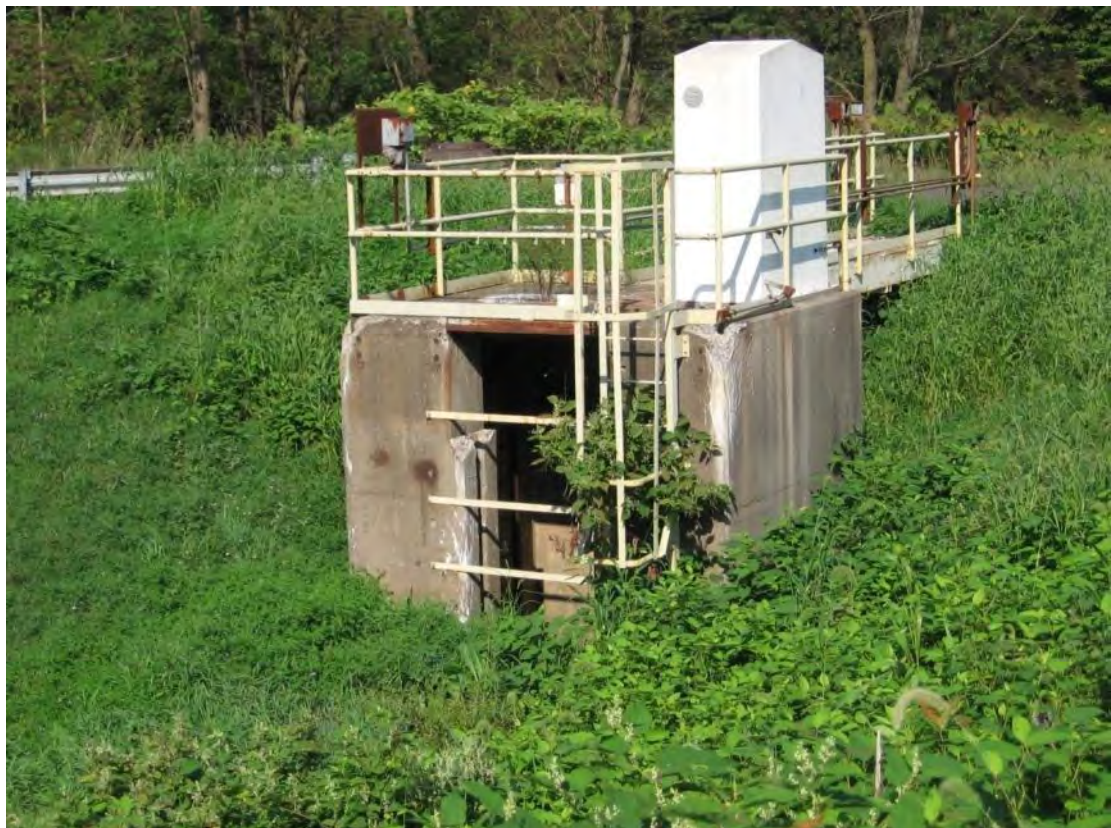
Photo Number:
6

Description:
Former outlet structure for the prior Pond 2, now converted to a stormwater inlet structure.

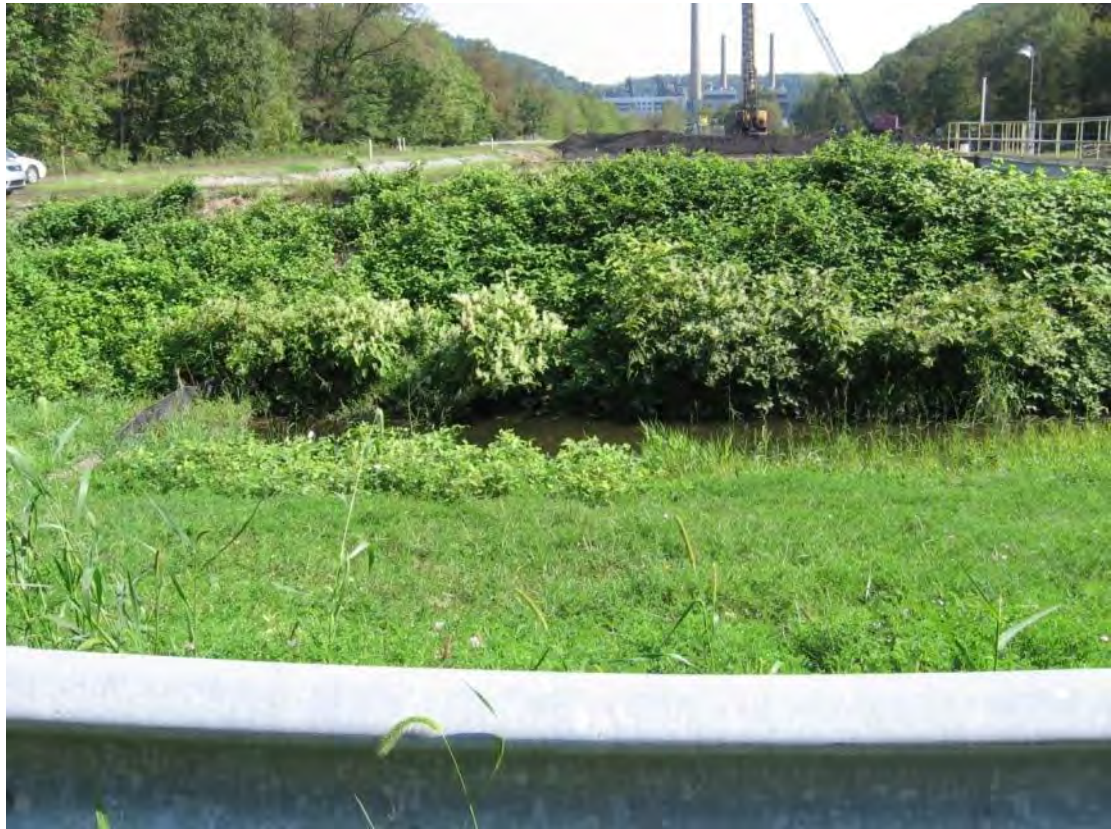
Photo Number:
7

Description:
Ash Pond B;
Outer slope of
southwestern
embankment.
Water along toe
is stormwater
runoff from
upstream
diversion
ditches. No
evidence of
seepage
through the
embankment.

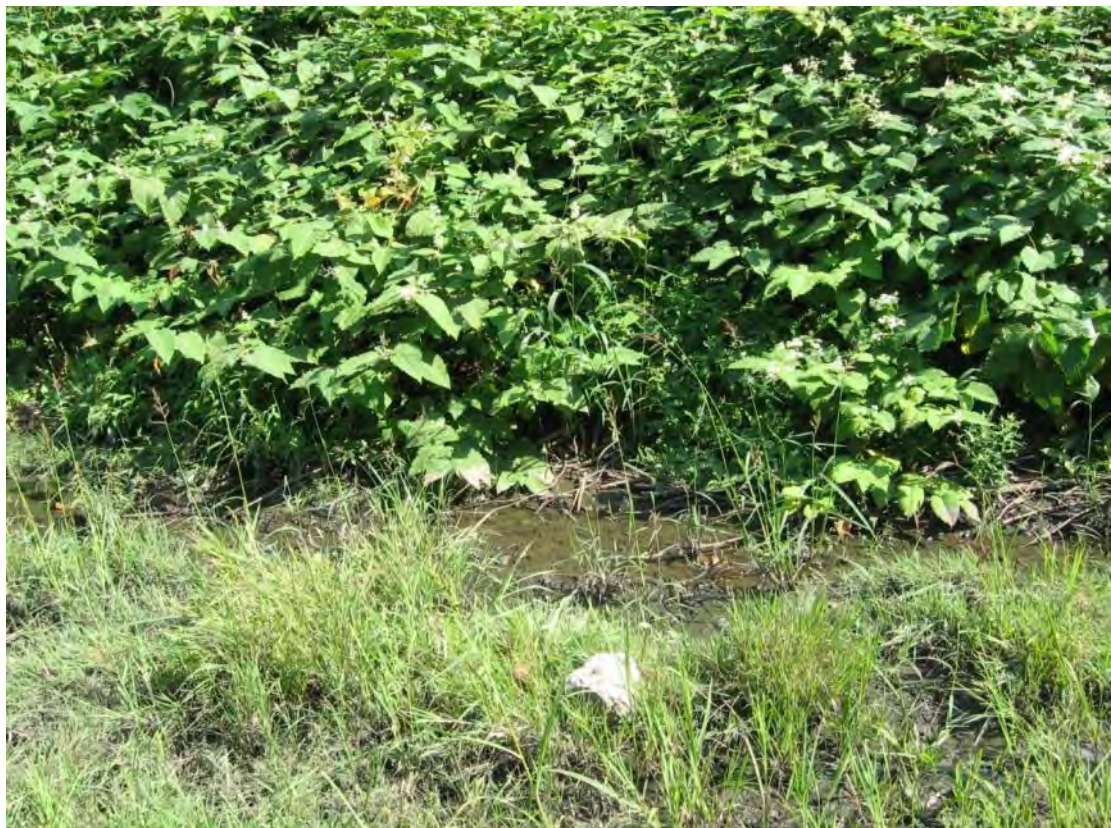
Photo Number:
8

Description:
Typical view of
toe of slope of
Ash Pond B
southwestern
embankment.

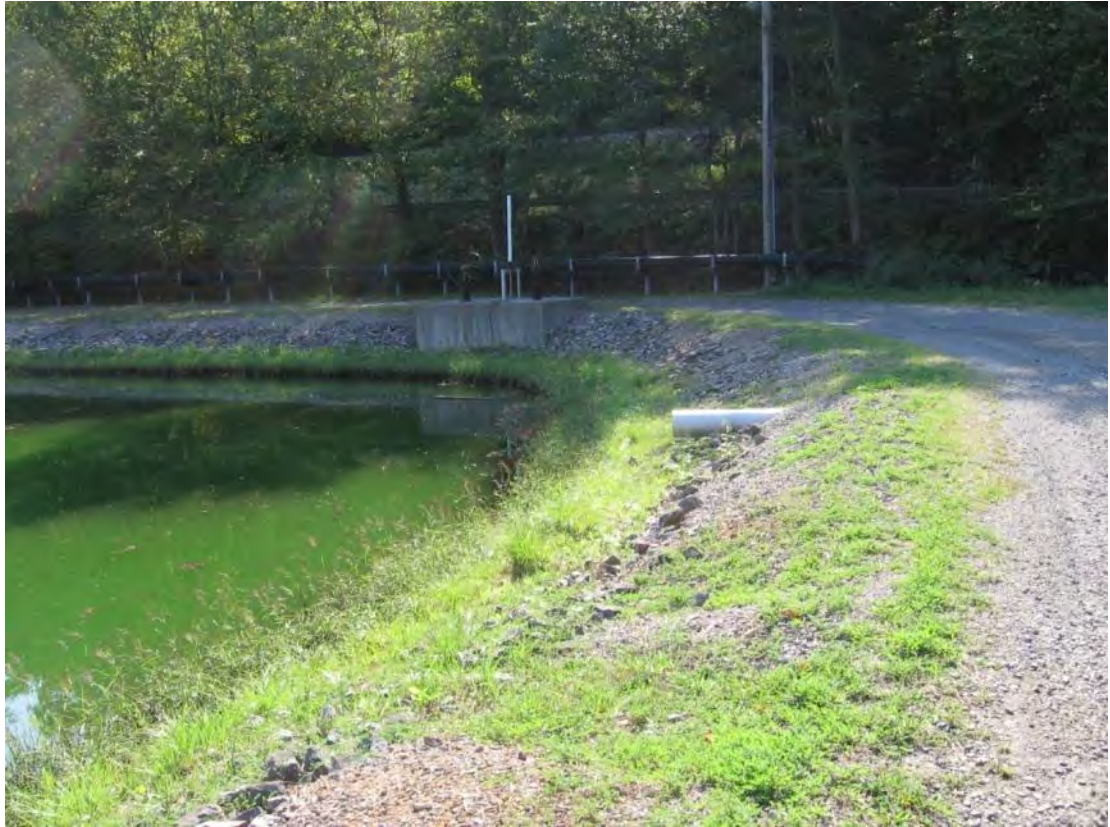
Photo Number:
9

Description:
Ash Pond B; Ash Sluice Recycle Structure. Receives flow from the decant structure & perforated steel pipe; drains to the plant for recycling of sluiced water. Pipe in foreground is a discharge for blowdown of the leachate pump station.

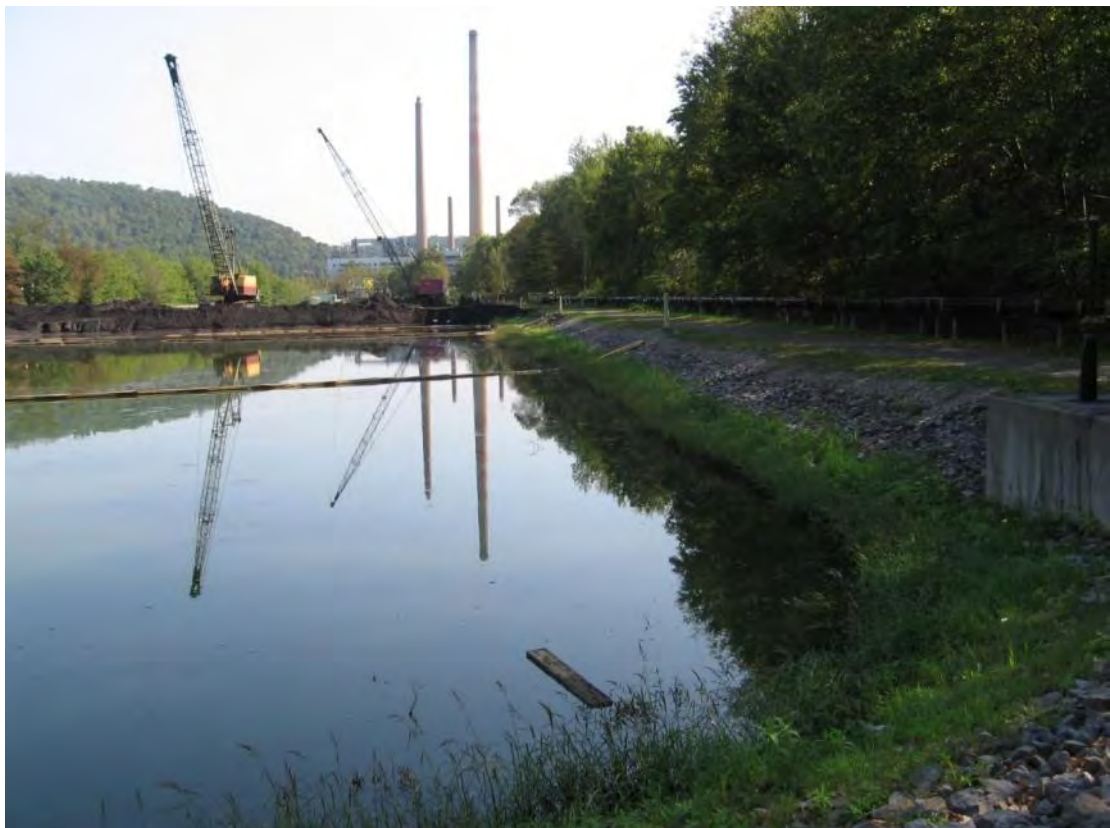
Photo Number:
10

Description:
Ash Pond B; inboard slope of southeastern embankment.

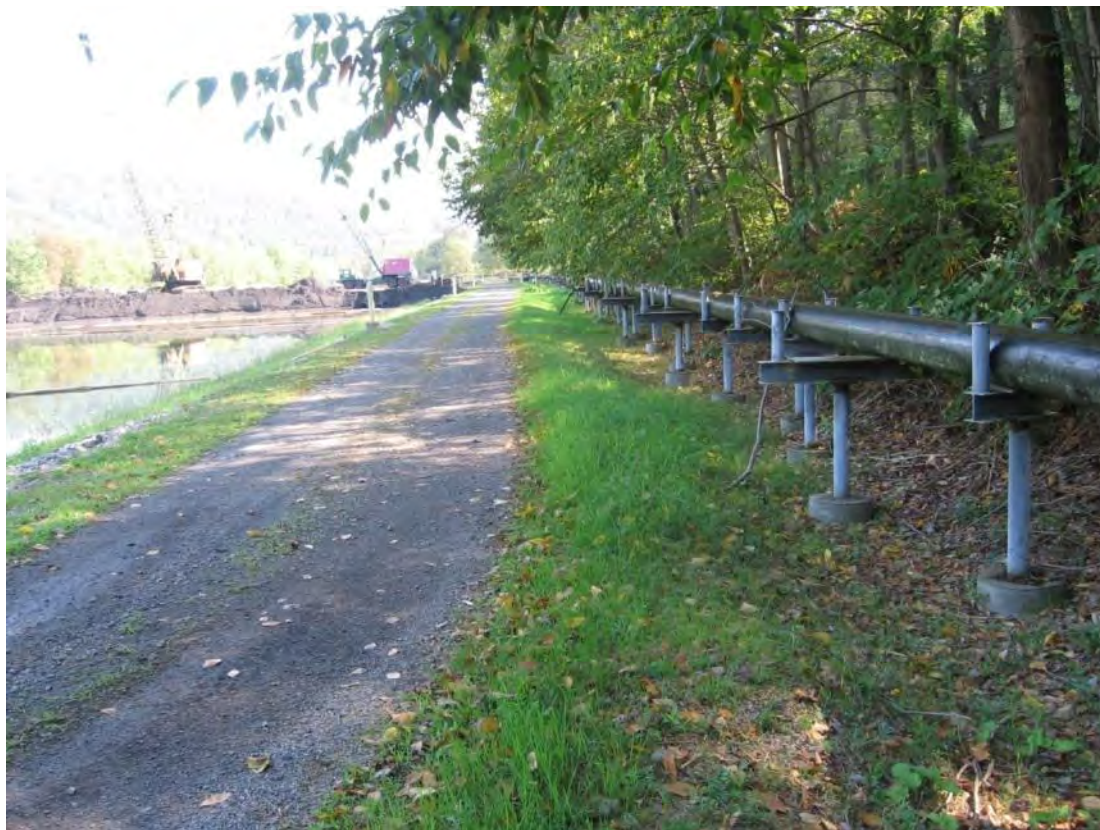
Photo Number:
11

Description:
Ash Pond B;
Crest of
southeastern
embankment.
Note diversion
swale above
(right) of the
crest to collect
runoff from the
roadway above.

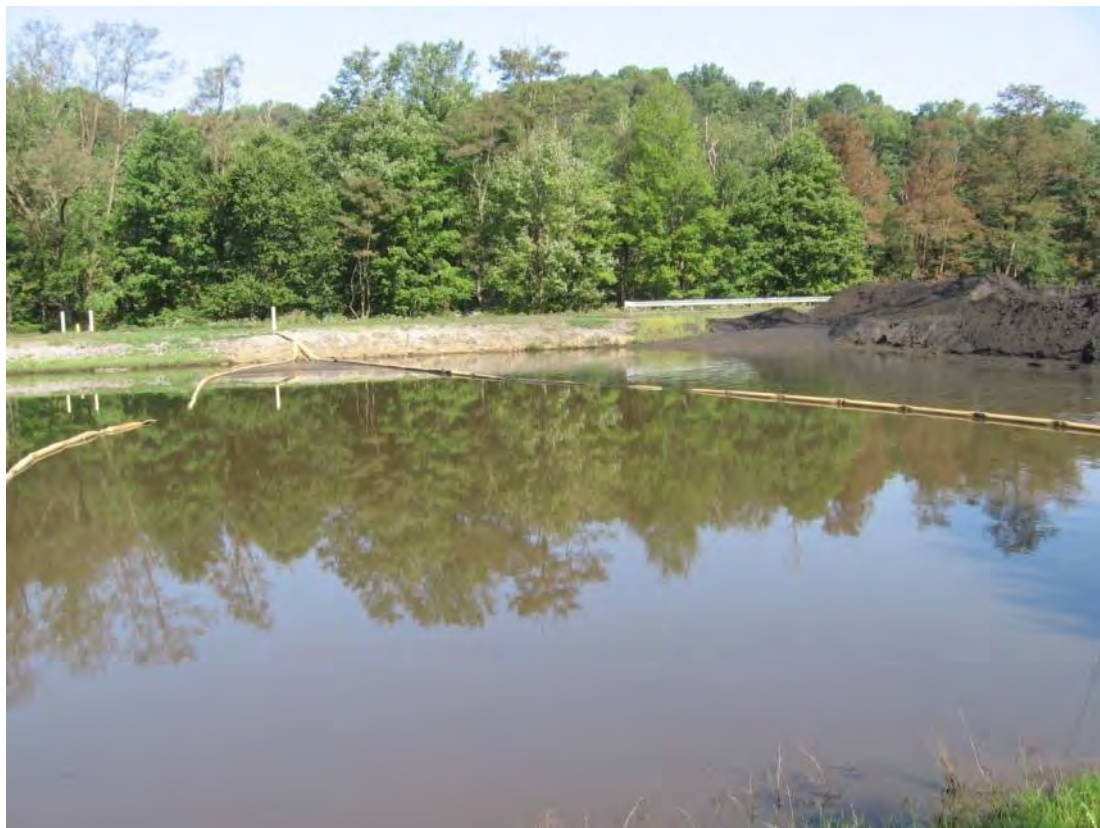
Photo Number:
12

Description:
Ash Pond B;
view of interior
side slope of
northwestern
embankment.
Note grouted
rock section for
maintenance
dredging.

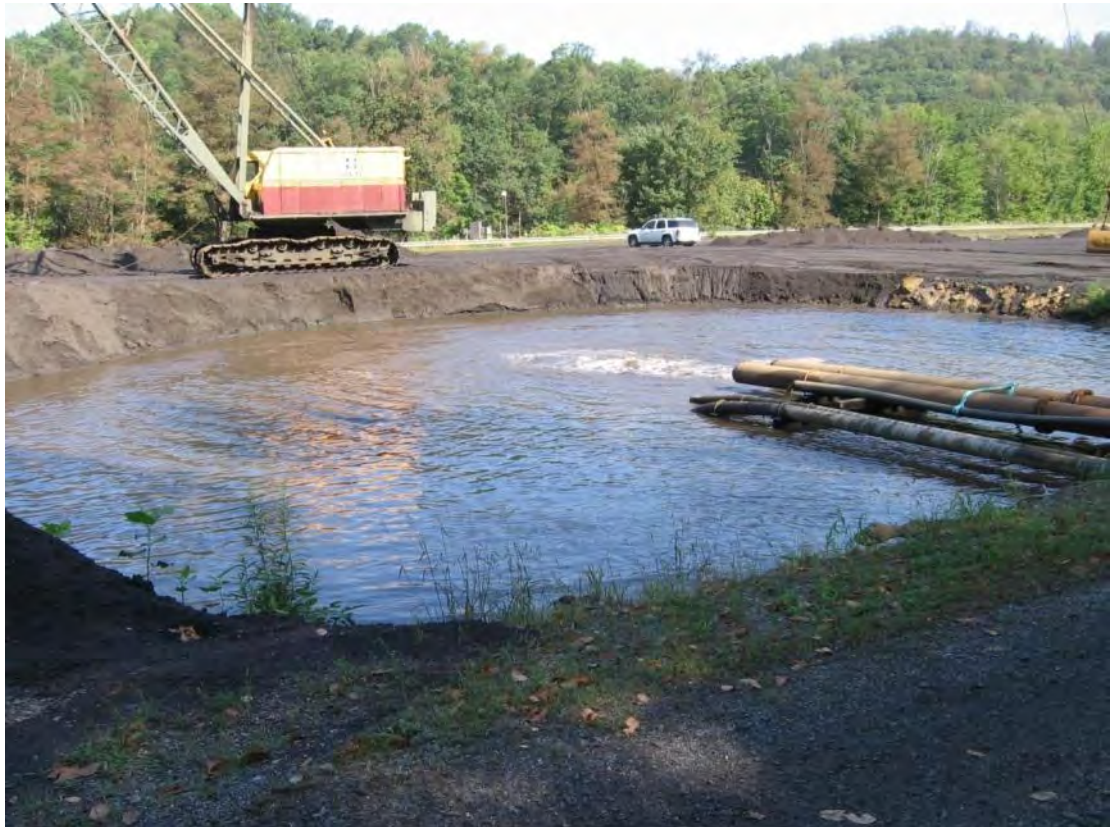
Photo Number:
13

Description:
Ash Pond B;
Constructed
forebay and ash
sluice piping at
the southeast
corner.
Forebay berm
constructed of
compacted ash.

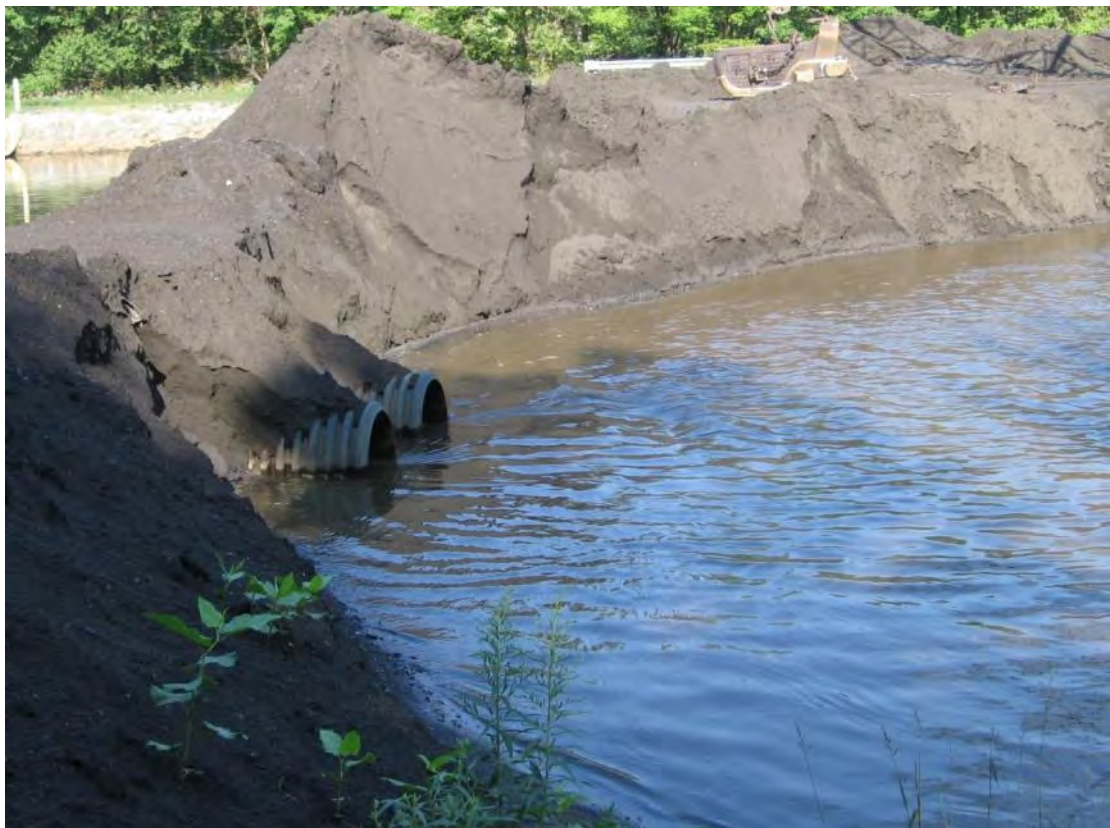
Photo Number:
14

Description:
Ash Pond B; (2)
24" HDPE pipes
connecting the
forebay to the
main portion of
Pond B through
the compacted
ash berm.

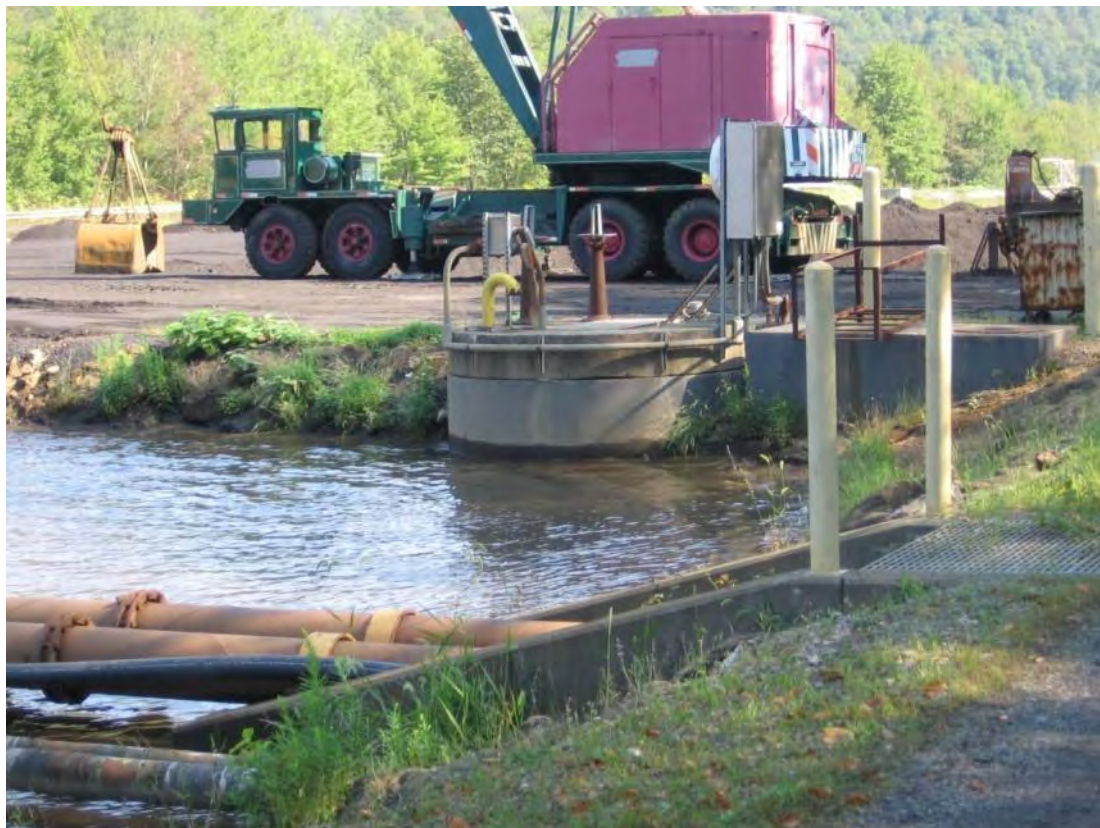
Photo Number:
15

Description:
Underdrain pump station. Collects water from both Pond A and B underdrains to dewater the ponds during maintenance. Water pumped to the plant wastewater treatment facility.

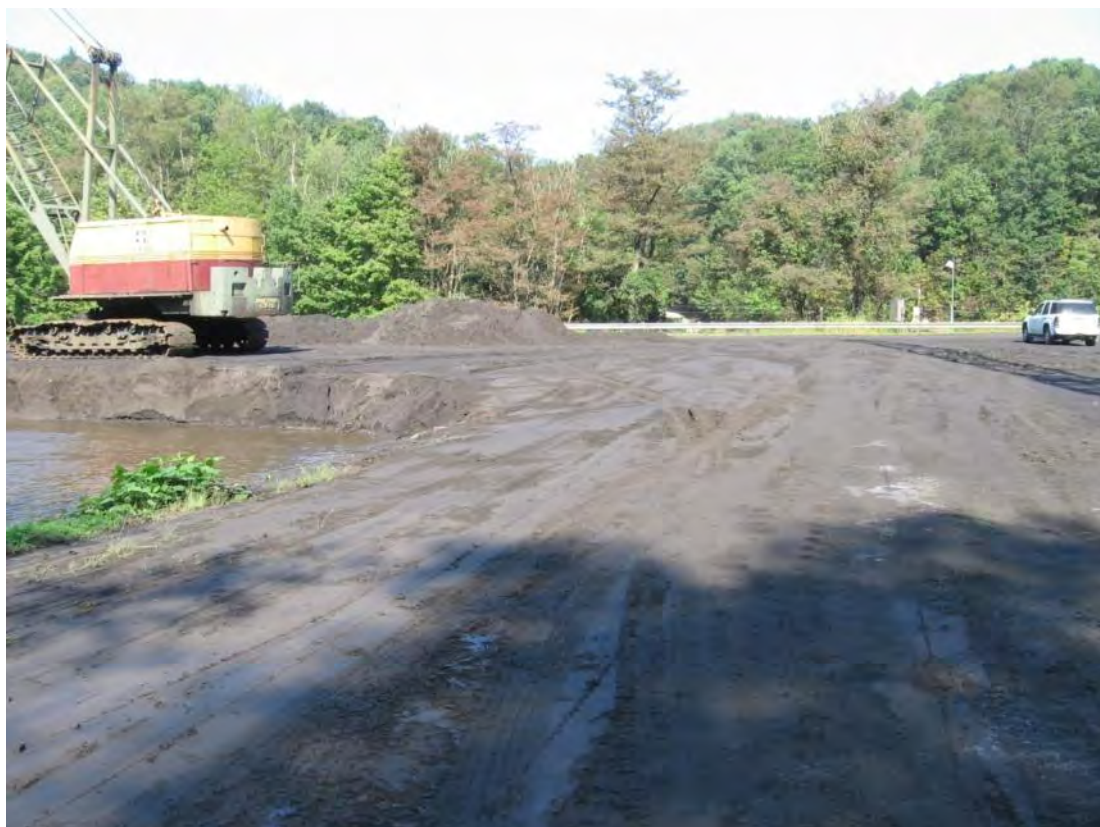
Photo Number:
16

Description:
Center Dividing Embankment separating the impoundment into the two (2) cells: Ash Pond A (right) and Ash Pond B left. Berm primarily compacted earth topped with a compacted ash roadway surface.

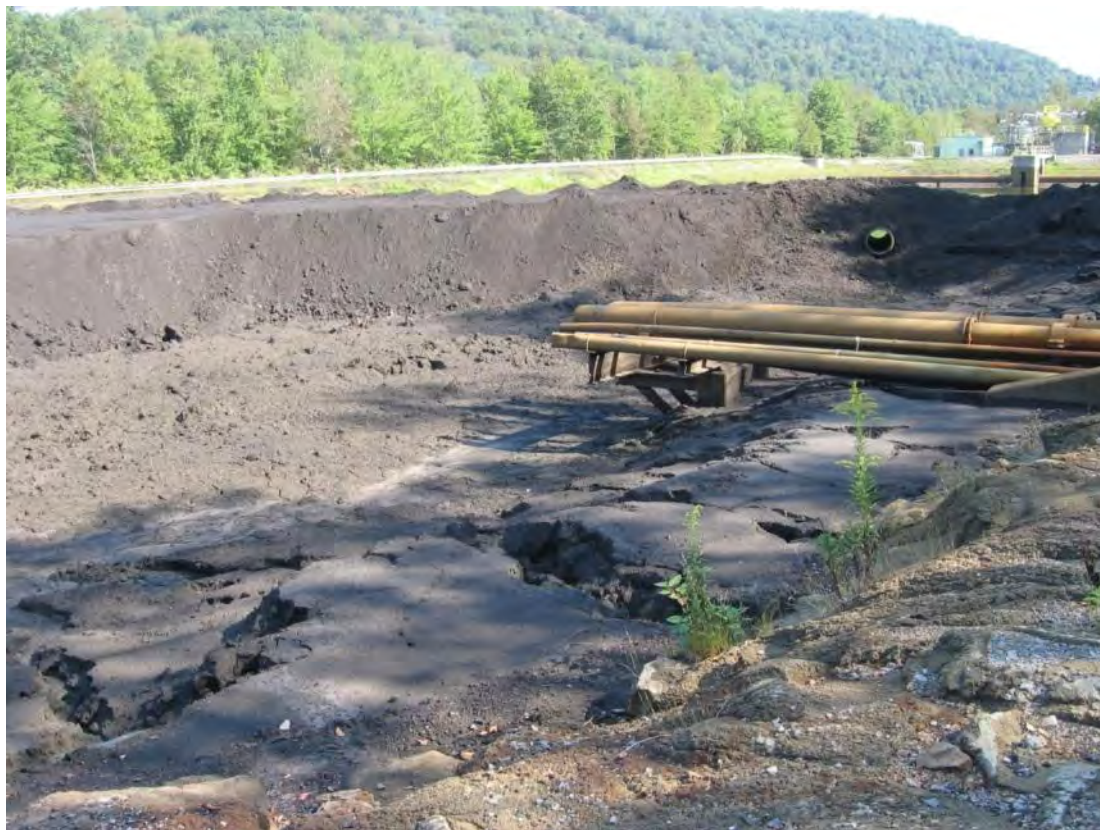
Photo Number:
17

Description:
Ash Pond A;
View of
constructed
forebay and ash
sluice discharge
piping at the
southwest
corner. Pond A
has just
completed
annual
maintenance
cycle so the
forebay is dry.

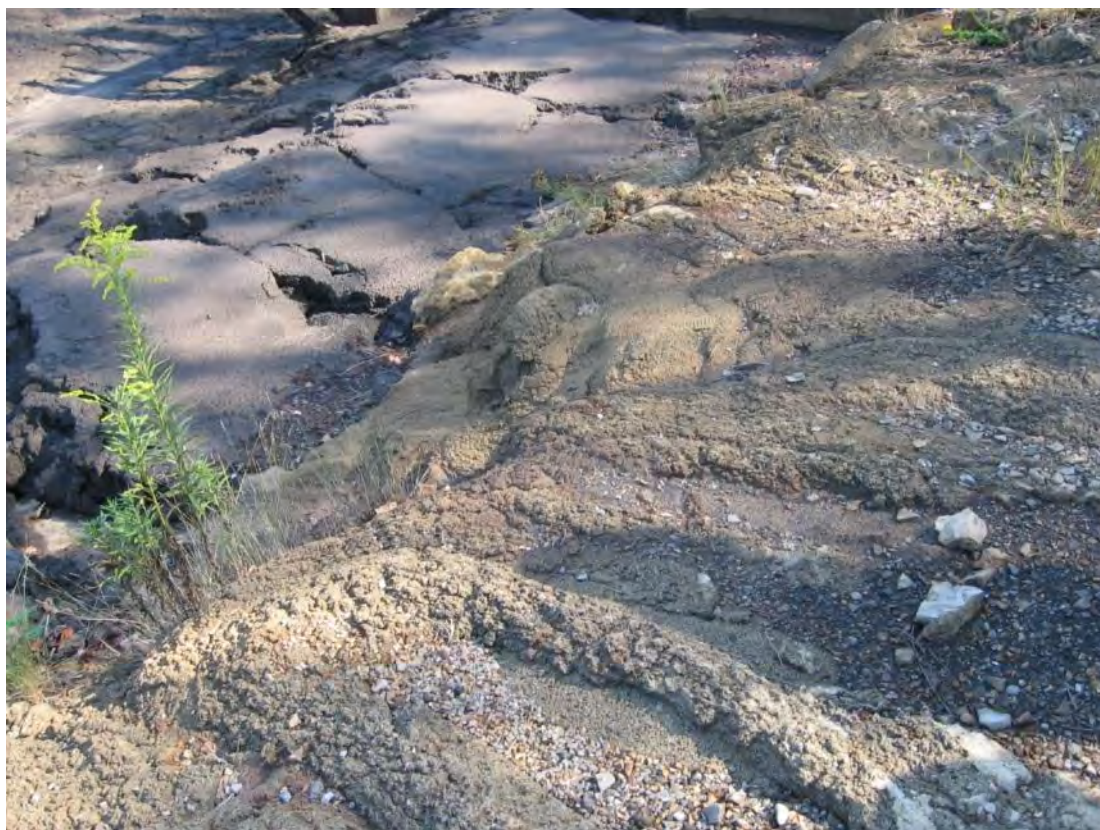
Photo Number:
18

Description:
Close up view of
grouted rock
armor section,
typical of both
Pond A and B.

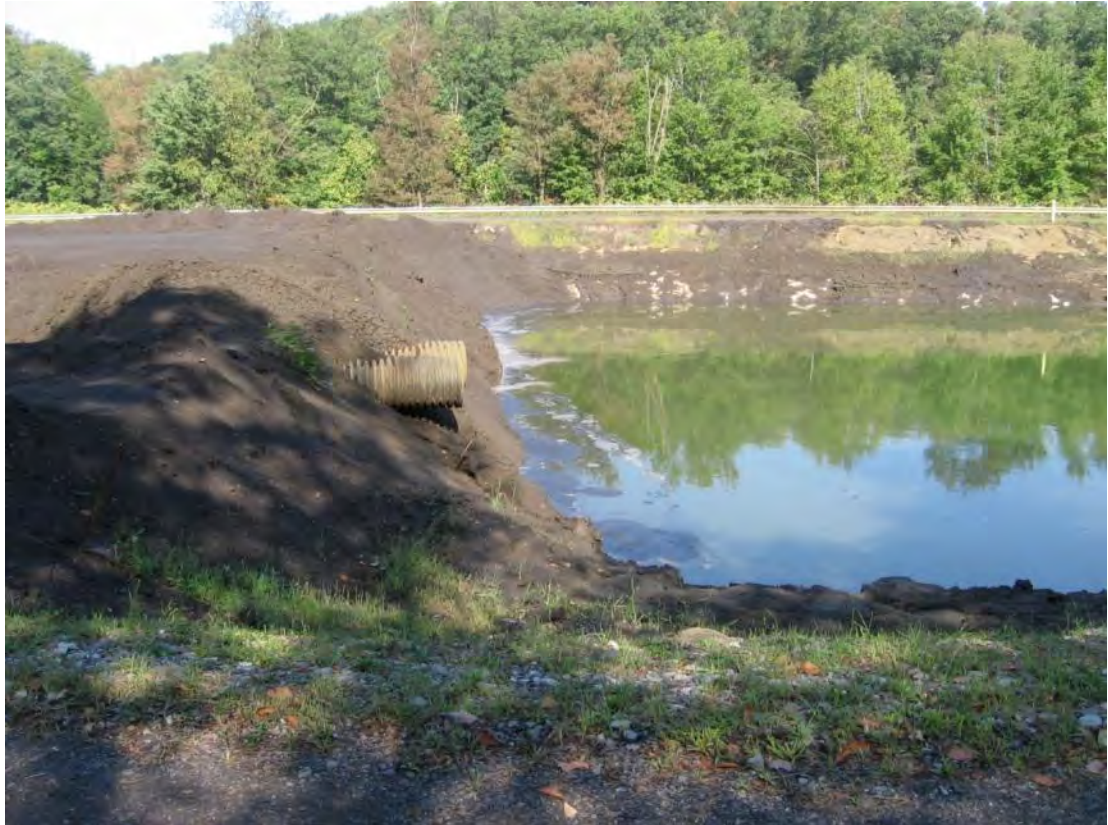
Photo Number:
19

Description:
Ash Pond A,
interior side
slope of
constructed
forebay berm.

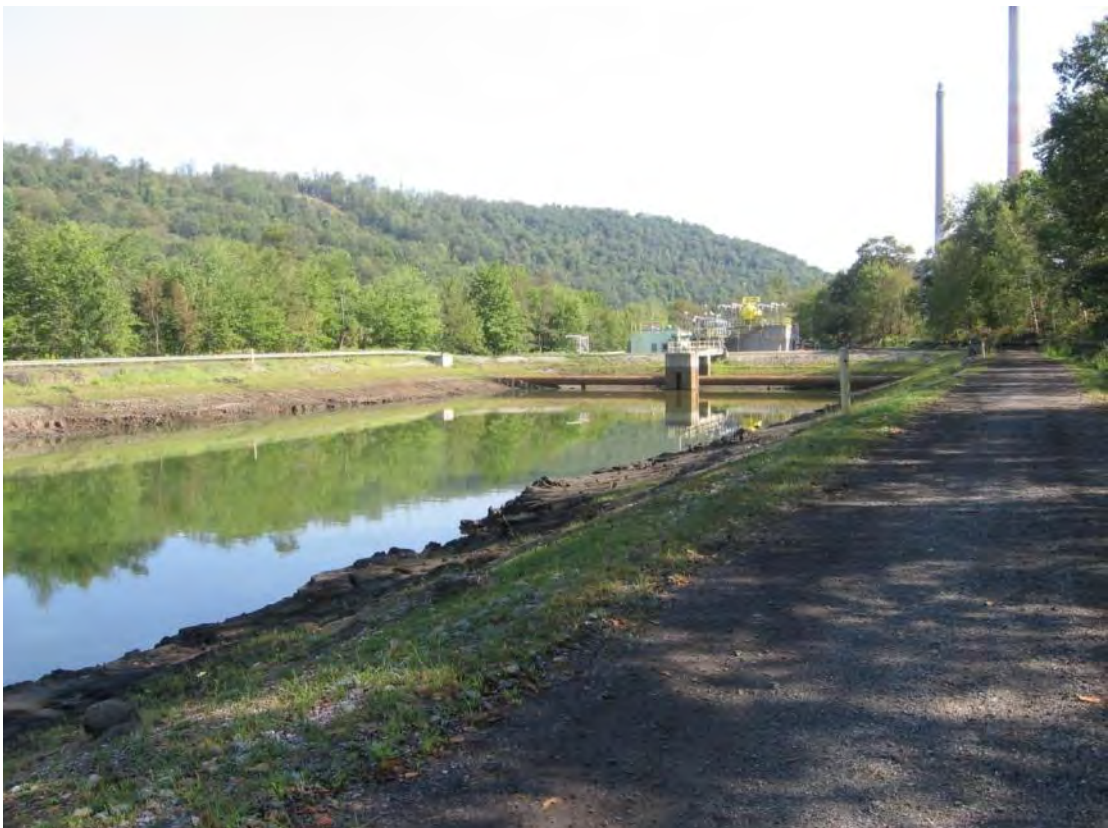
Photo Number:
20

Description:
Ash Pond A;
Overall view
looking towards
the generating
station. Note
that water level
has been
lowered for
maintenance by
approximately 6
feet.

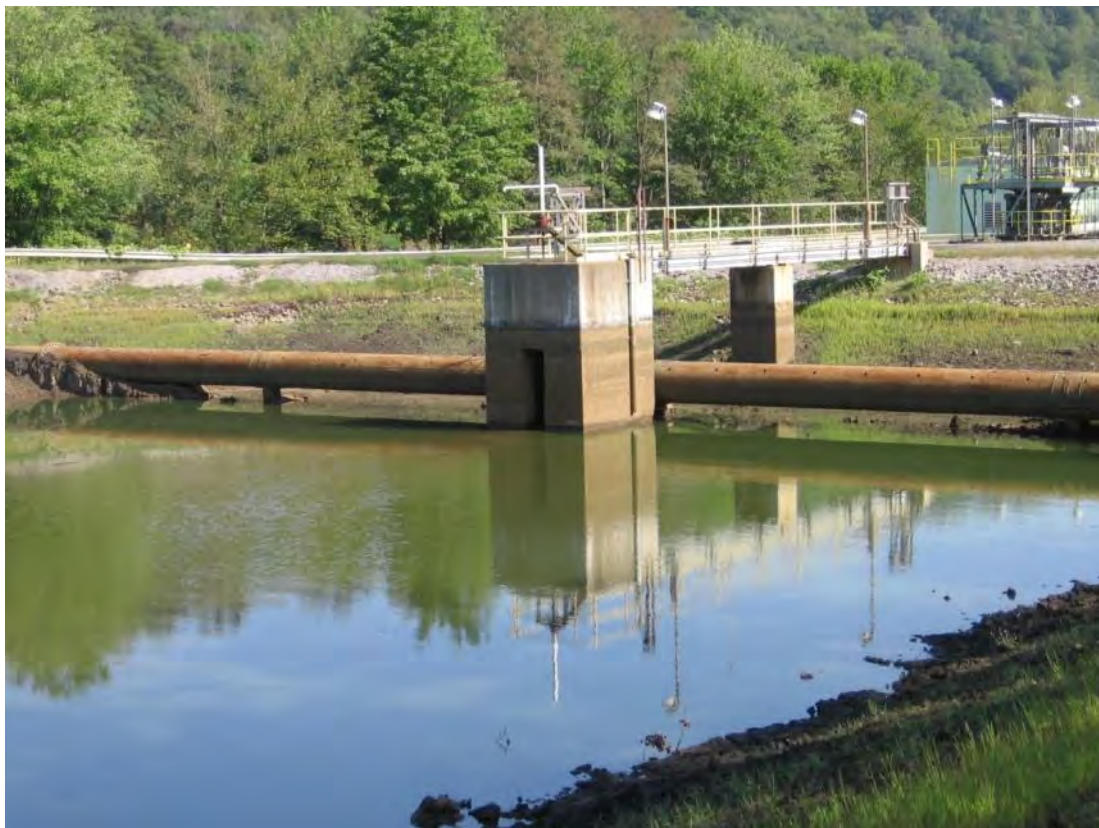
Photo Number:
21

Description:
Ash Pond A;
decant
structure and
36" diameter
perforated steel
decant pipe.

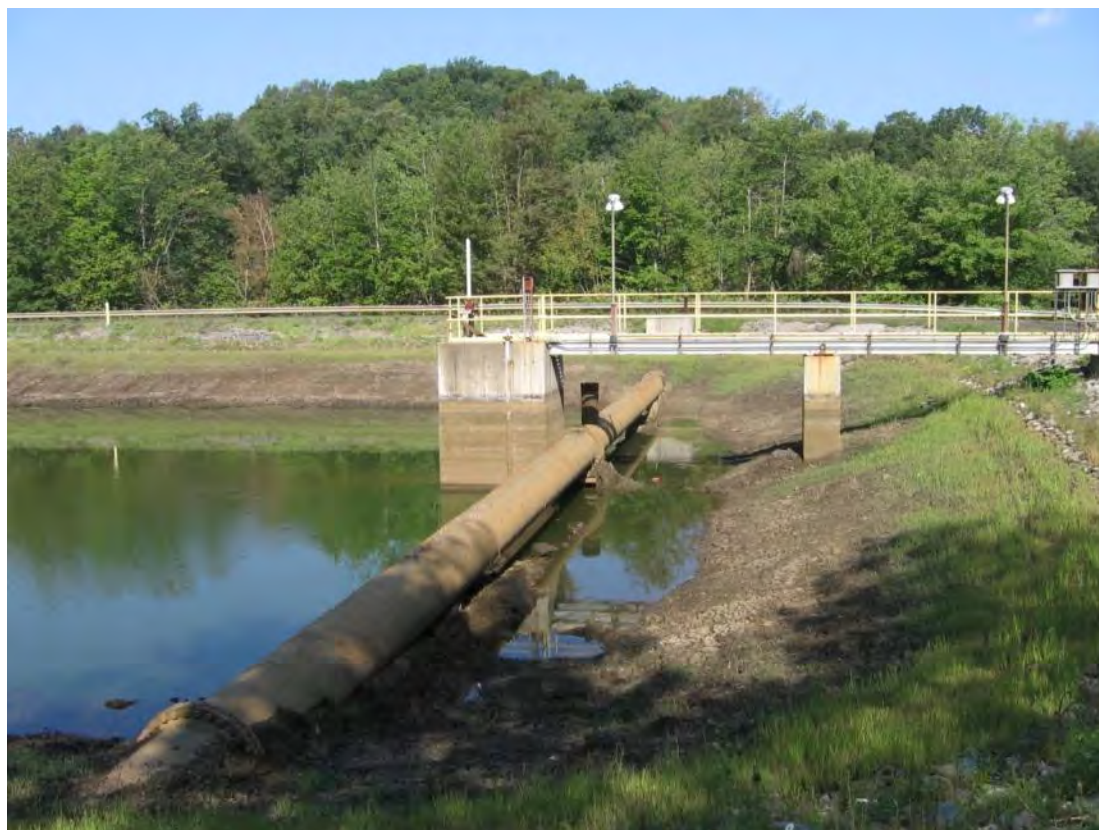
Photo Number:
22

Description:
Ash Pond A;
decant
structure and
36" diameter
perforated steel
decant pipe.

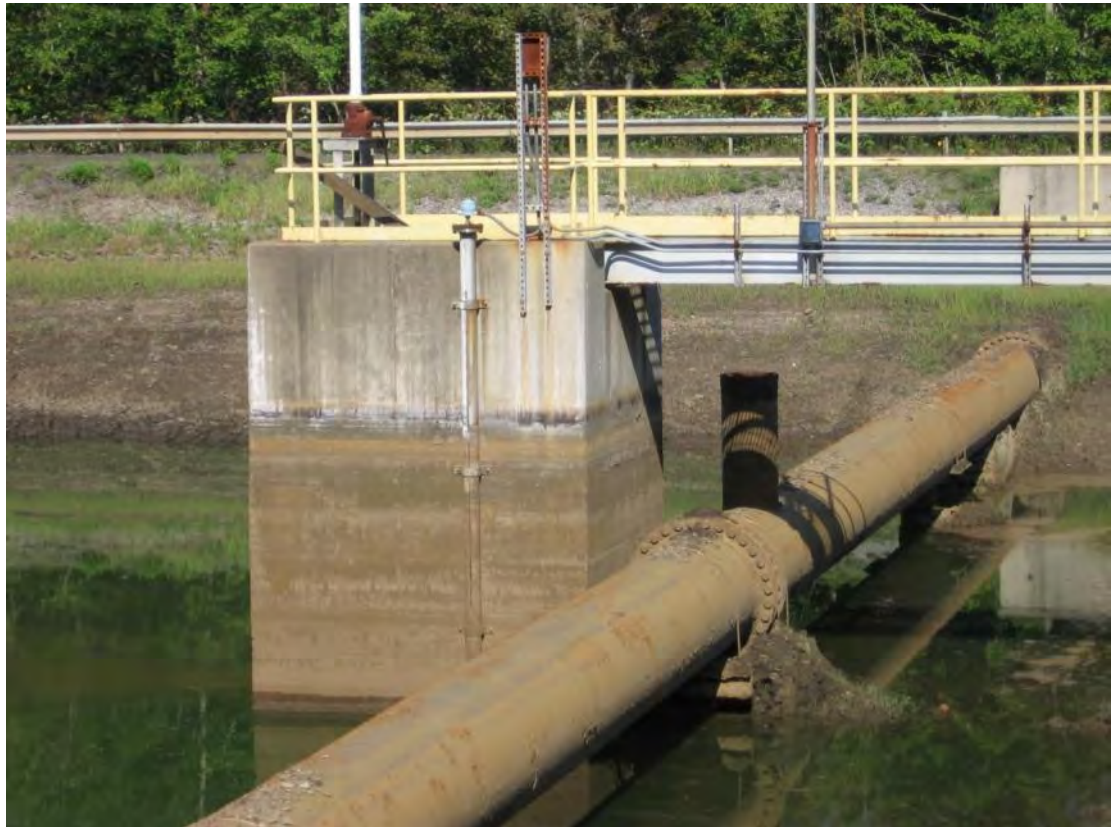
Description:
Ash Pond A;
close up view of
decant
structure.

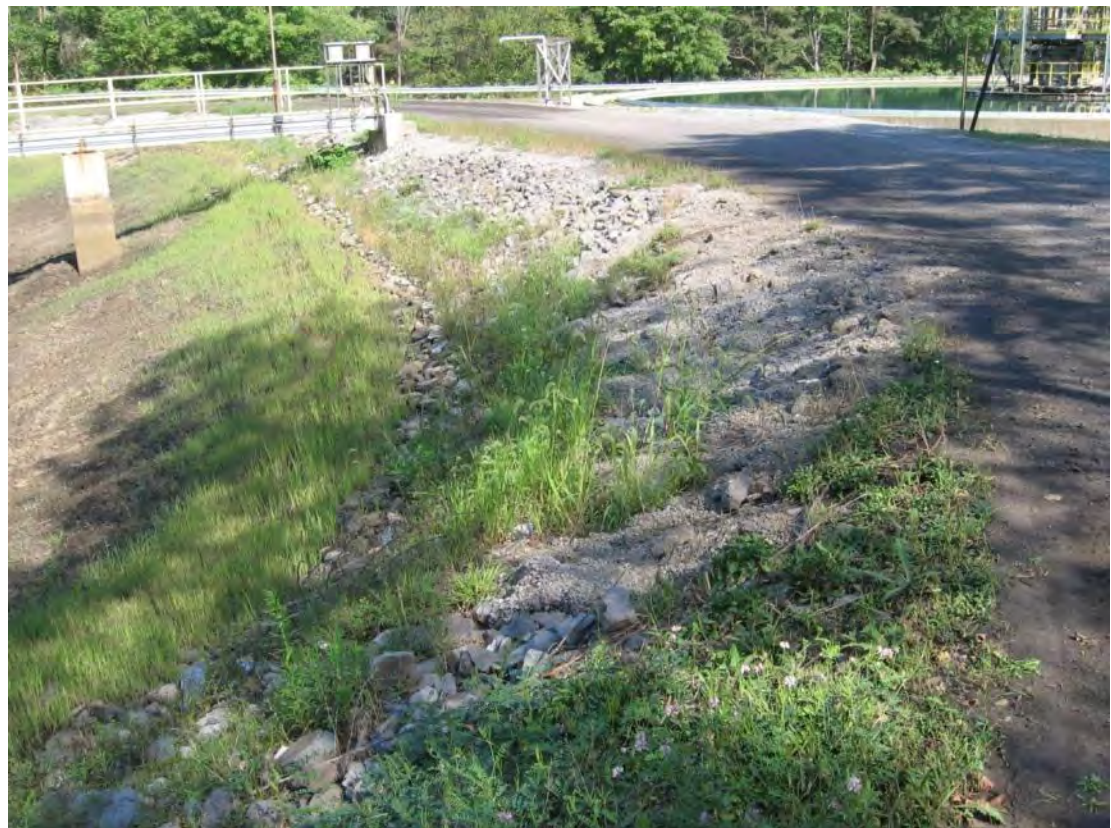
Description:
Ash Pond A;
inboard side
slope of
northeastern
embankment.
