Dam Safety Assessment of CCW Impoundments

**NRG REMA LLC – Shawville Generating Station
Shawville, Clearfield County, Pennsylvania**

**United States Environmental Protection Agency
Washington, DC**

December 16, 2013

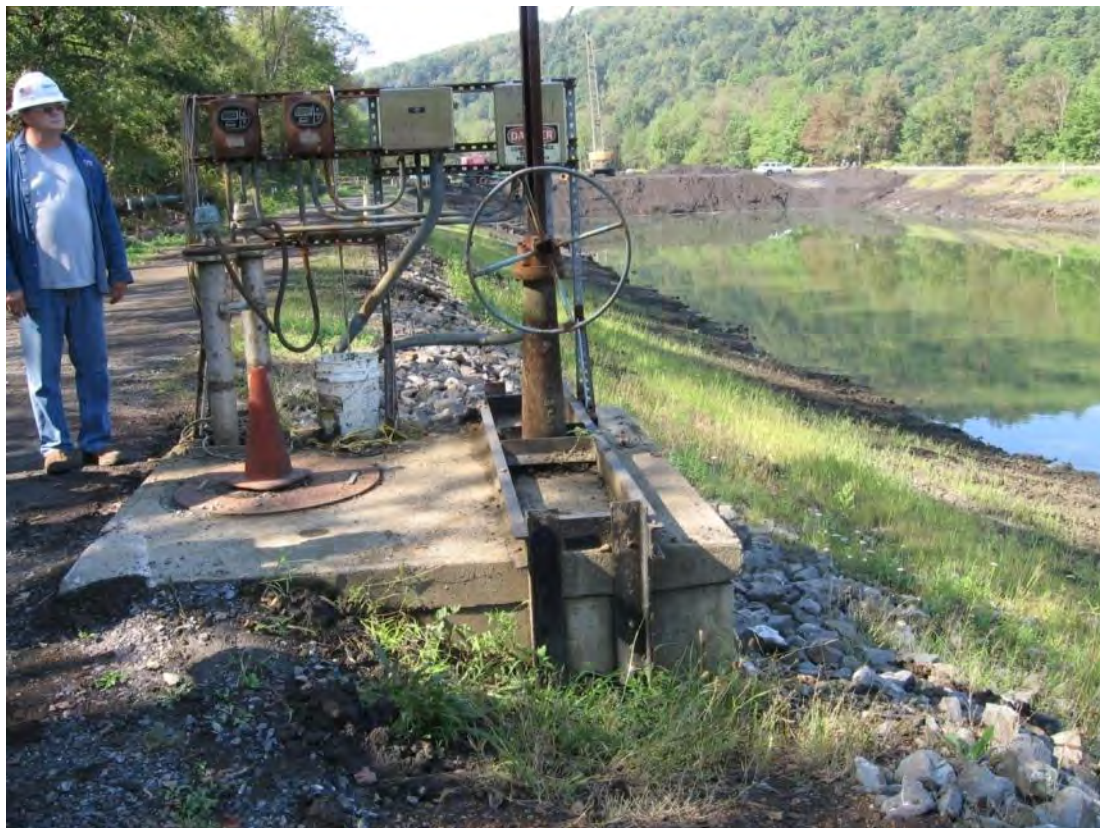
Description:
Ash Pond A; Ash Sluice Recycle Collection Structure. Receives flow from the perforated steel pipe and drains to the plant for recycling of sluiced water. Controls are for pond level control and isolation of Ash Ponds A and B.

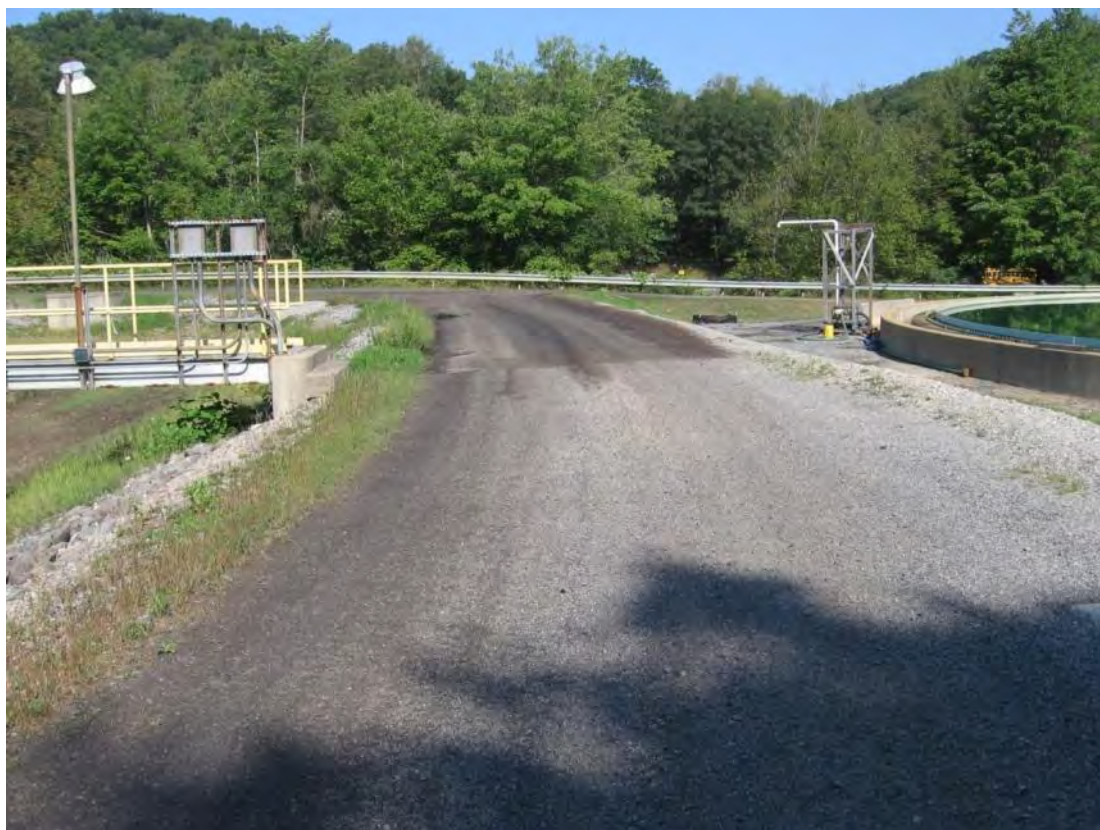
Description:
Ash Pond A; crest of northeastern embankment. Wastewater treatment plant clarifier tank visible to the right.

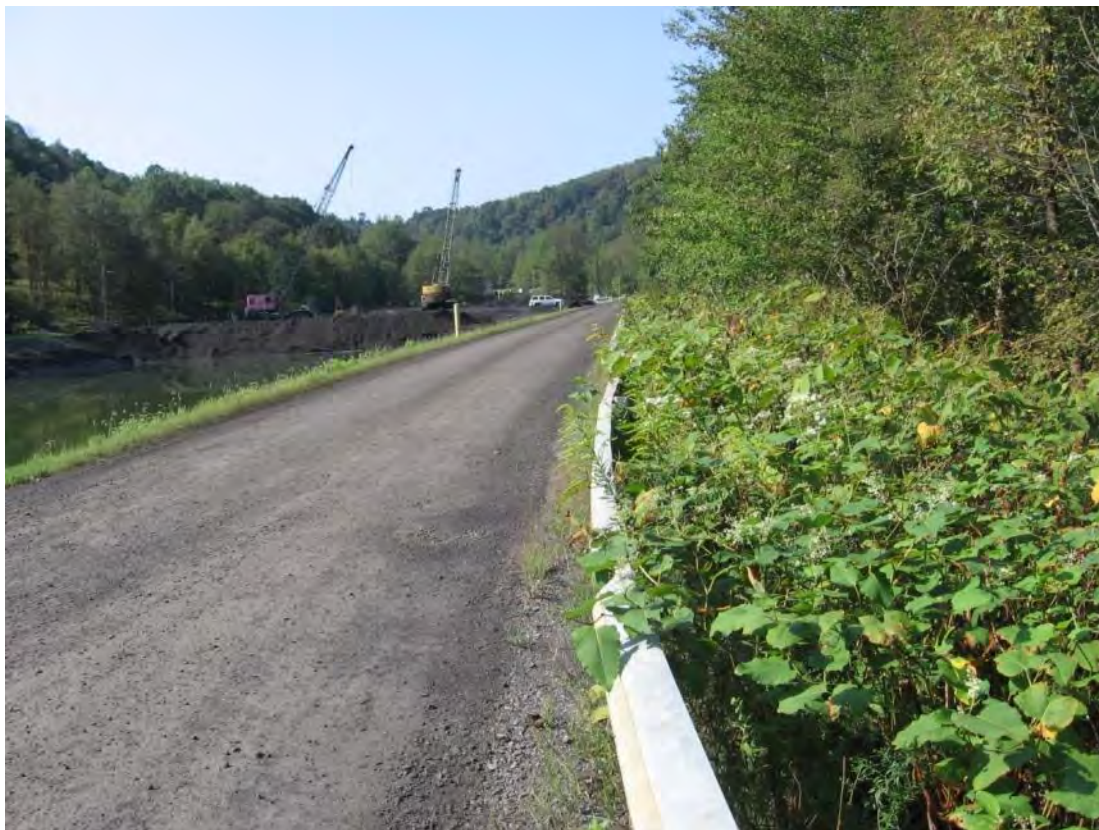
Description:
Ash Pond A;
crest and
outboard slope
of northwestern
embankment
looking towards
Ash Pond B.
Note heavy
vegetation on
outboard slope.

- Evaluate the condition of the large trees along the outboard slope of the northwestern embankment, primarily those above the impoundment bottom elevation. Diseased or dead trees should be removed.

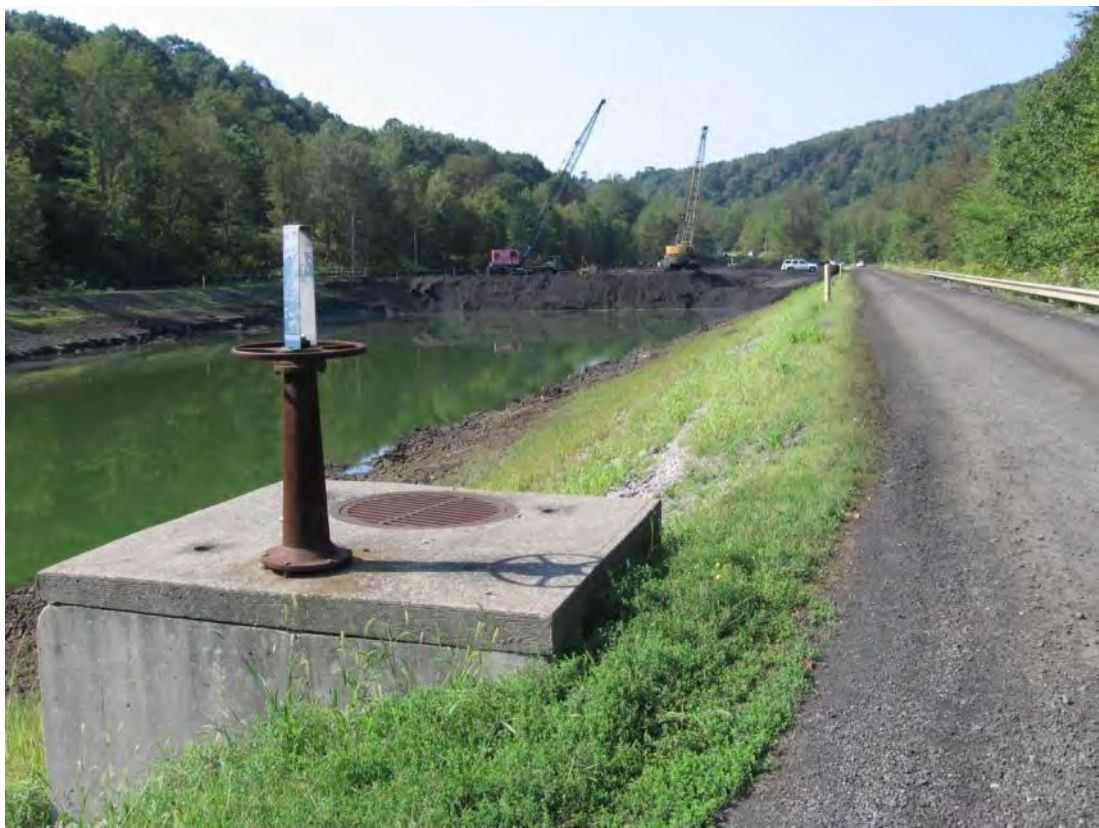
Description:
Ash Pond A;
inboard side
slope of
northwestern
embankment.
Structure in
foreground is
Clarifier Bypass
Structure (used
for overflow
only)

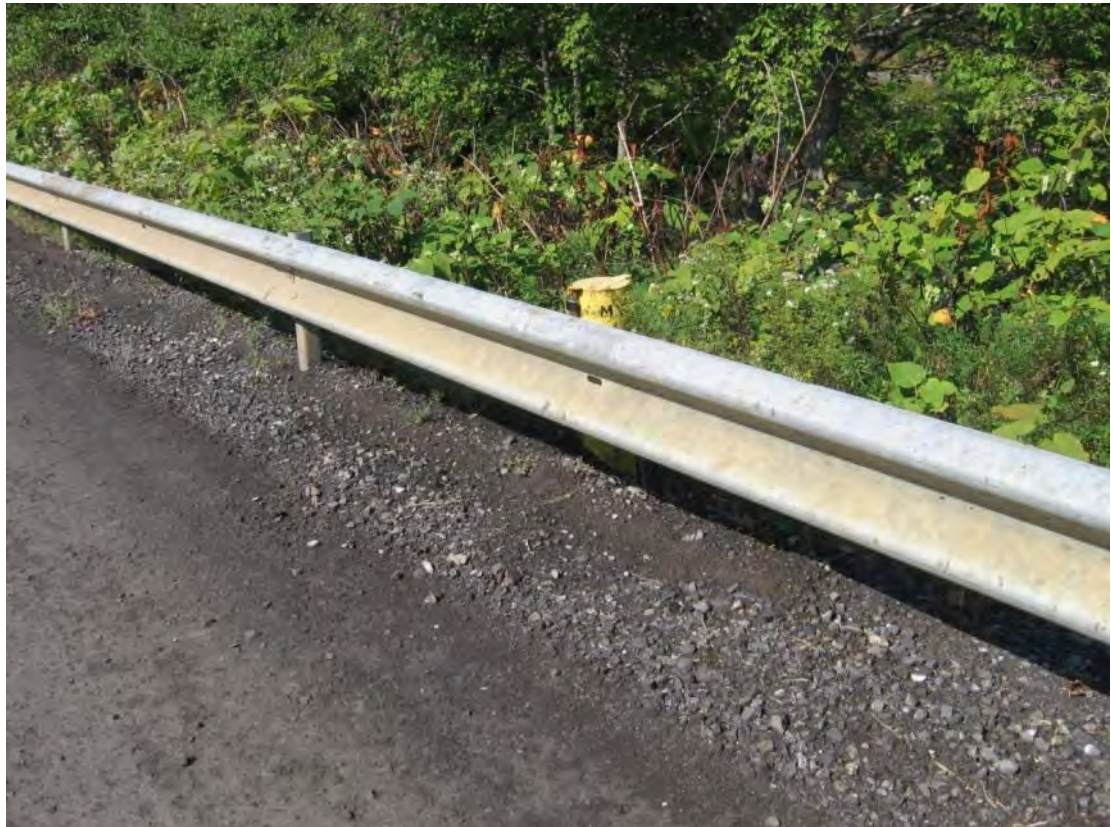
Description:
Monitoring Well
MW-10 located
in the
northwestern
embankment of
Ash Pond A.

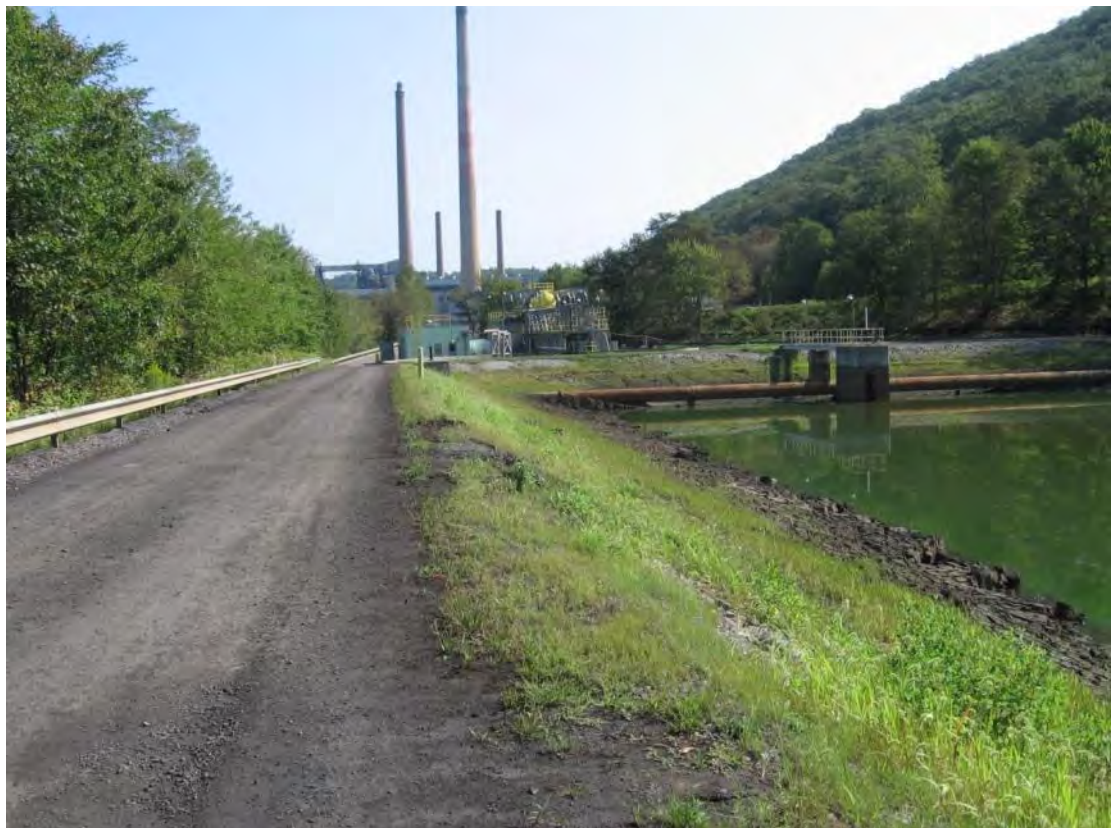
Description:
Ash Pond A;
inboard side
slope and crest
of northwestern
embankment
looking towards
the generating
station.

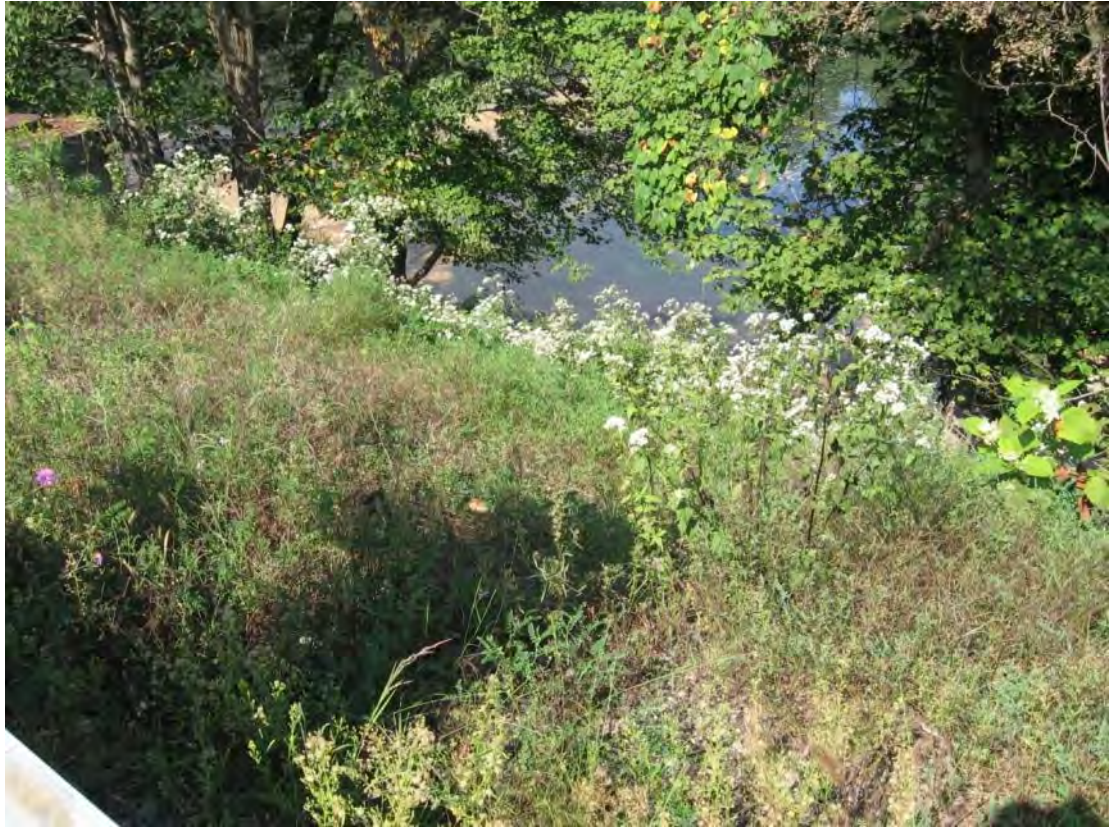
Description:
Ash Pond A;
Outer side slope
of northwestern
embankment
looking down at
the West
Branch of the
Susquehanna
River.

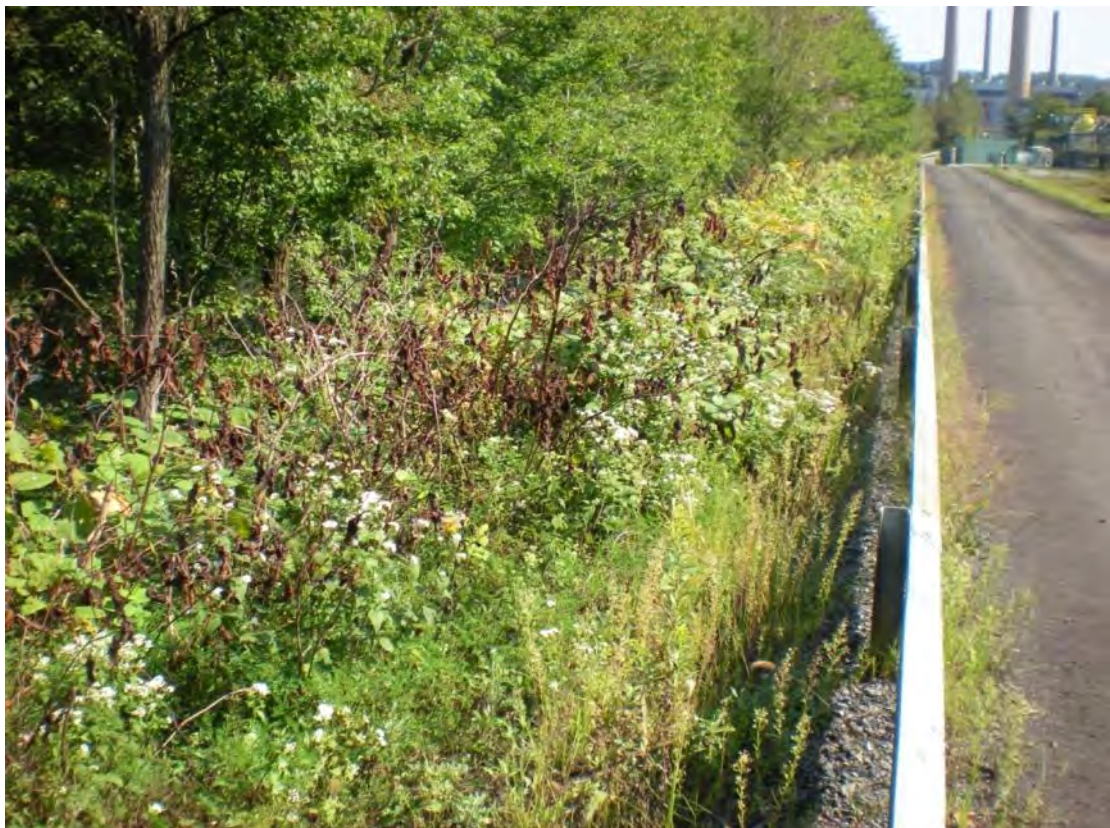
Description:
Ash Pond A;
Outer side slope
of northwestern
embankment
heavily
vegetated.

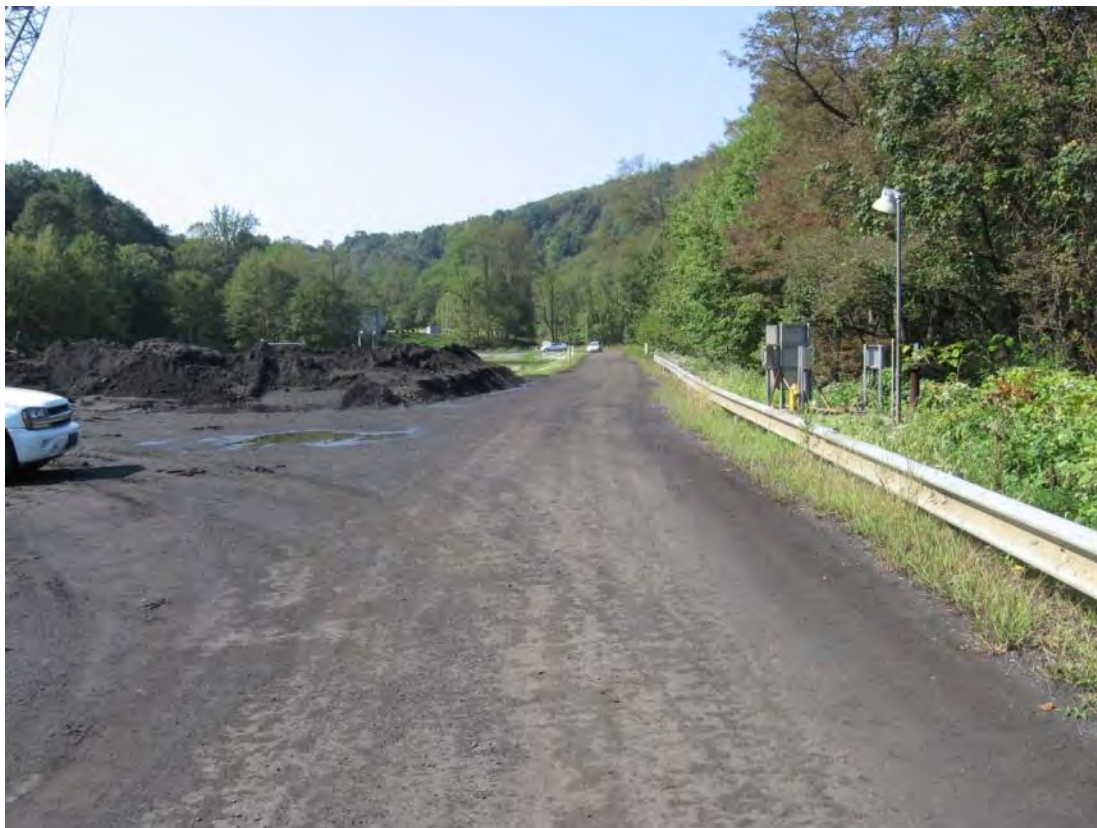
Description:
Crest of the
northwestern
embankment at
the central
dividing dike.
Dredged ash
from Pond A
temporarily
stockpiled prior
to landfilling.

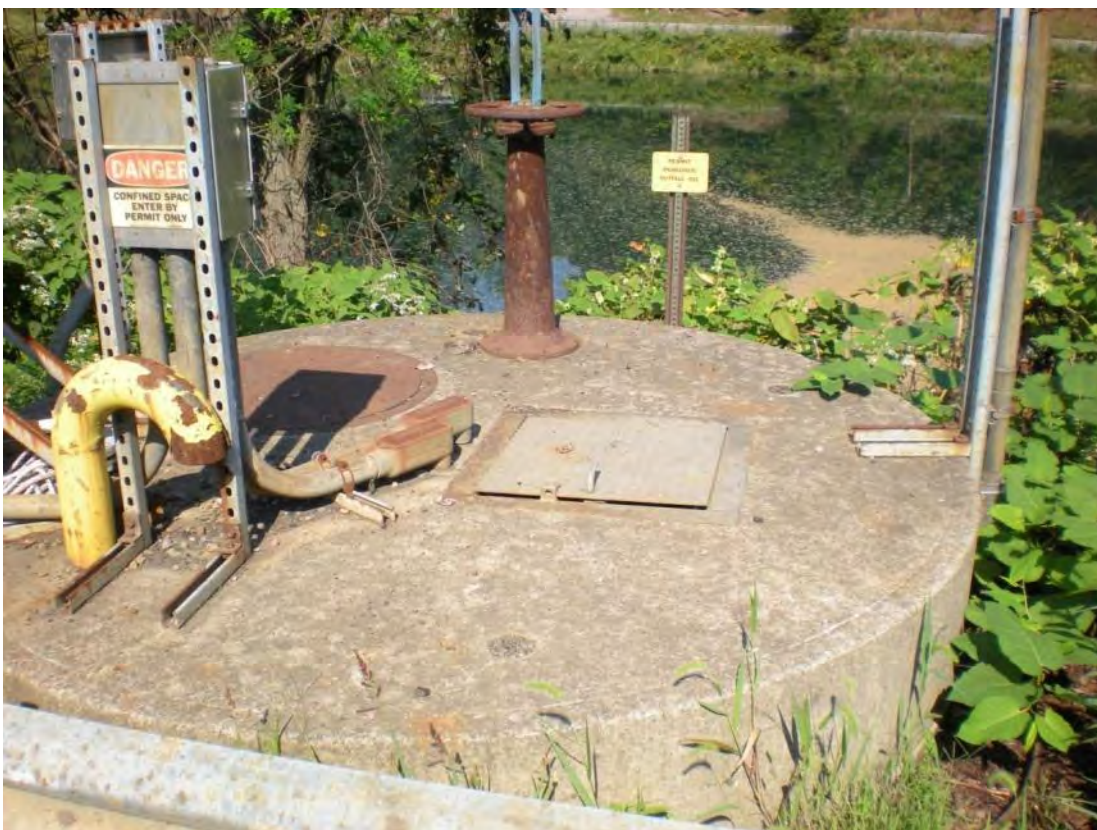
Description:
Subdrain
pumping
station.
Collects
leachate from
beneath pond
liners only, not
used for decant.

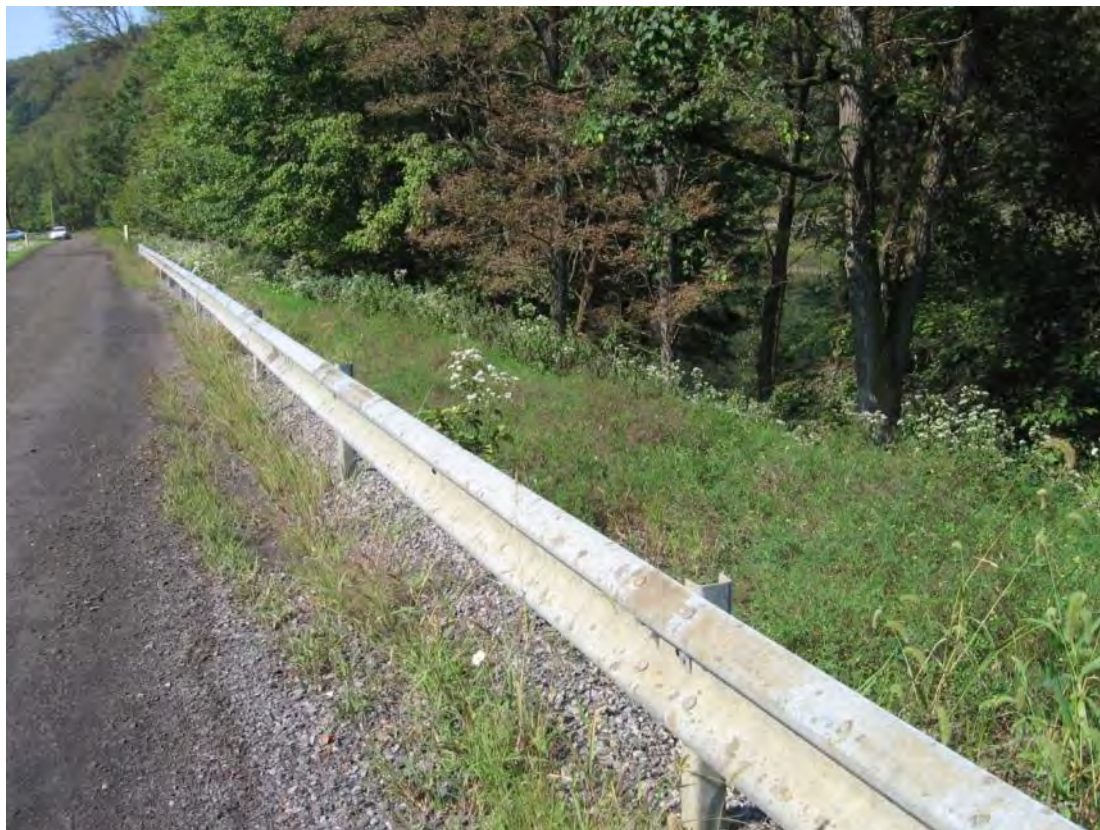
Description:
Ash Pond B;
Outboard slope
of northwestern
embankment.

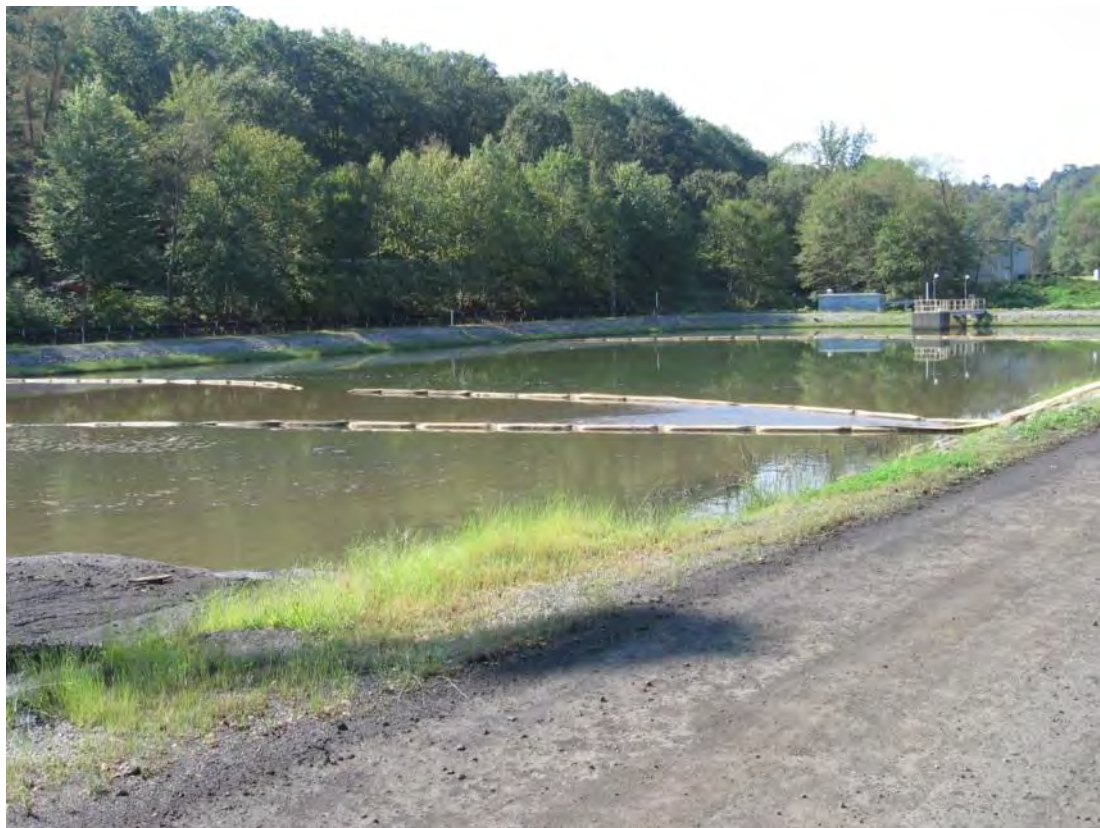
Description:
Ash Pond B;
Overall view.
Note floating
turbidity
curtains.

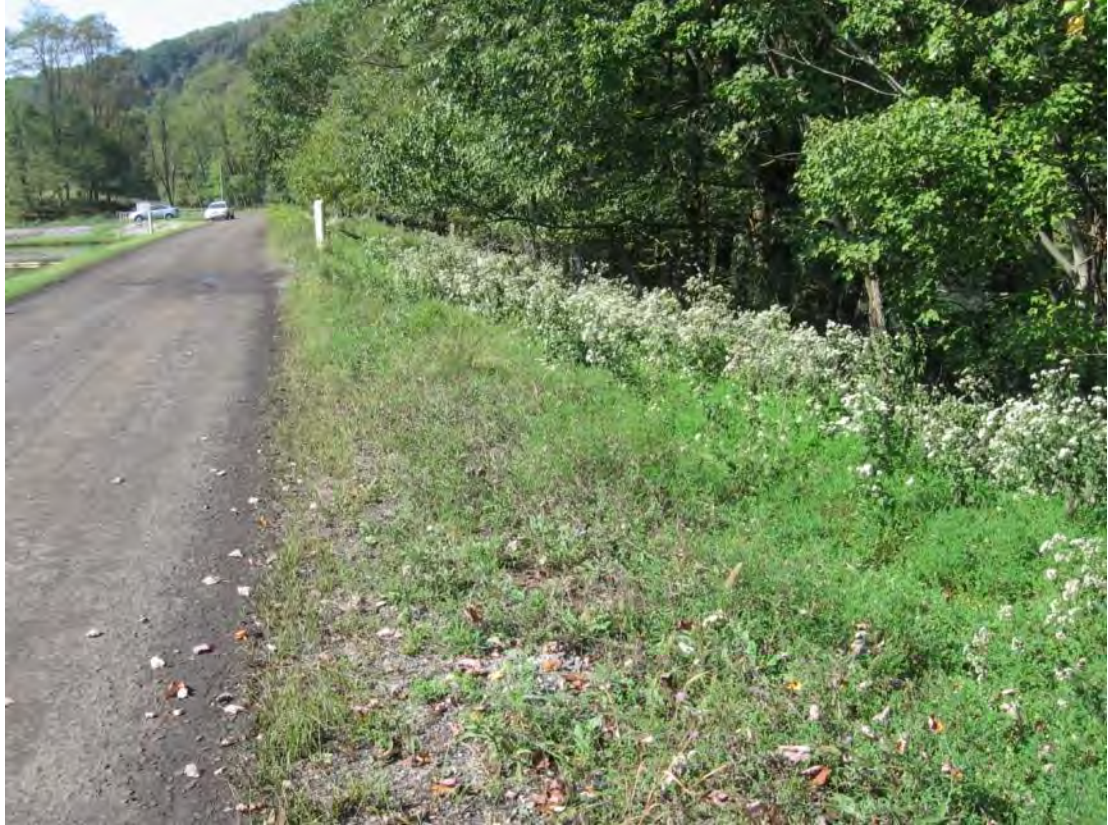
Description:
Ash Pond B;
Crest and
outboard slope
of northwestern
embankment

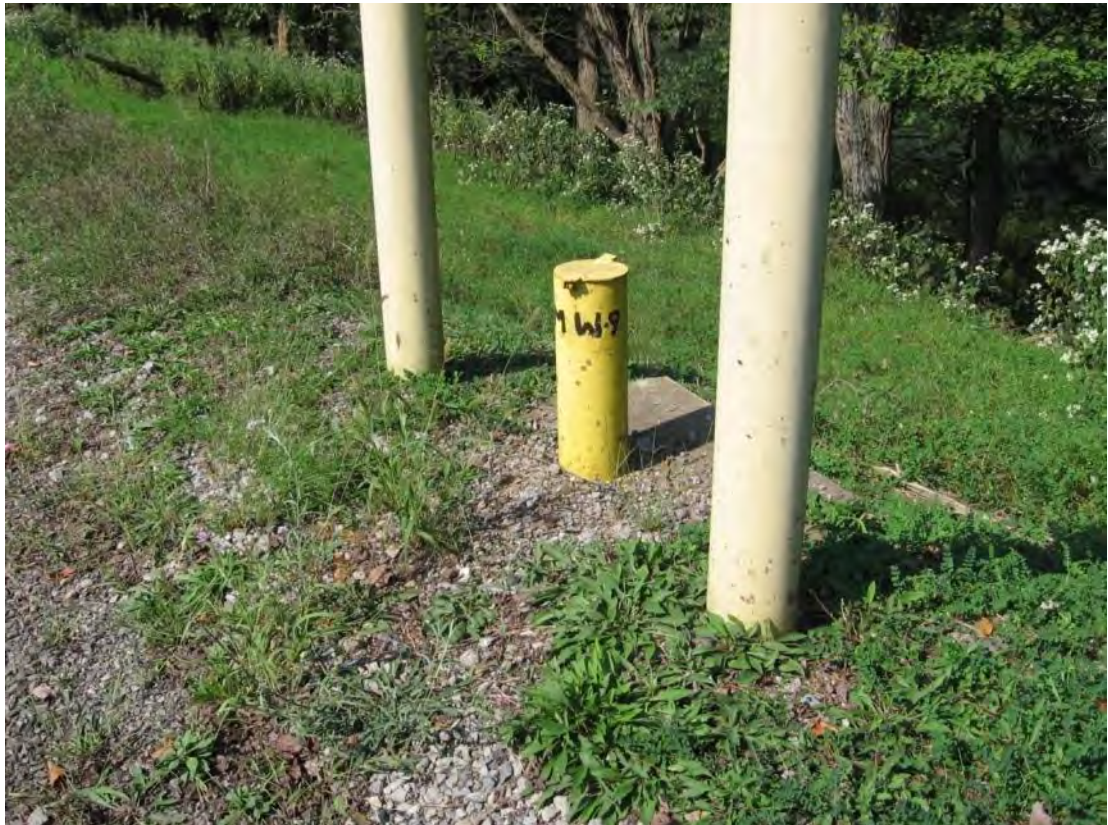
Description:
Monitoring Well
MW-9 located
in the
northwestern
embankment of
Ash Pond B.

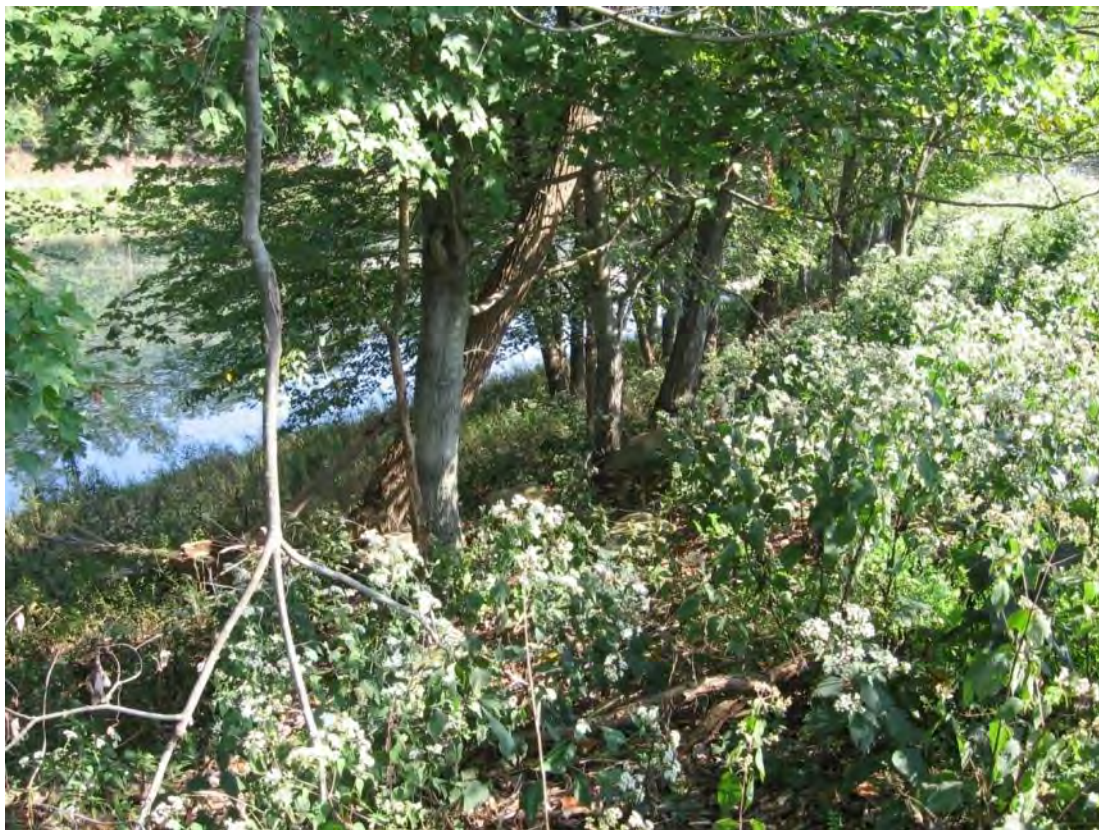
Description:
Typical
condition of
outboard slope
of northwestern
embankment
looking down at
the West
Branch of the
Susquehanna
River.

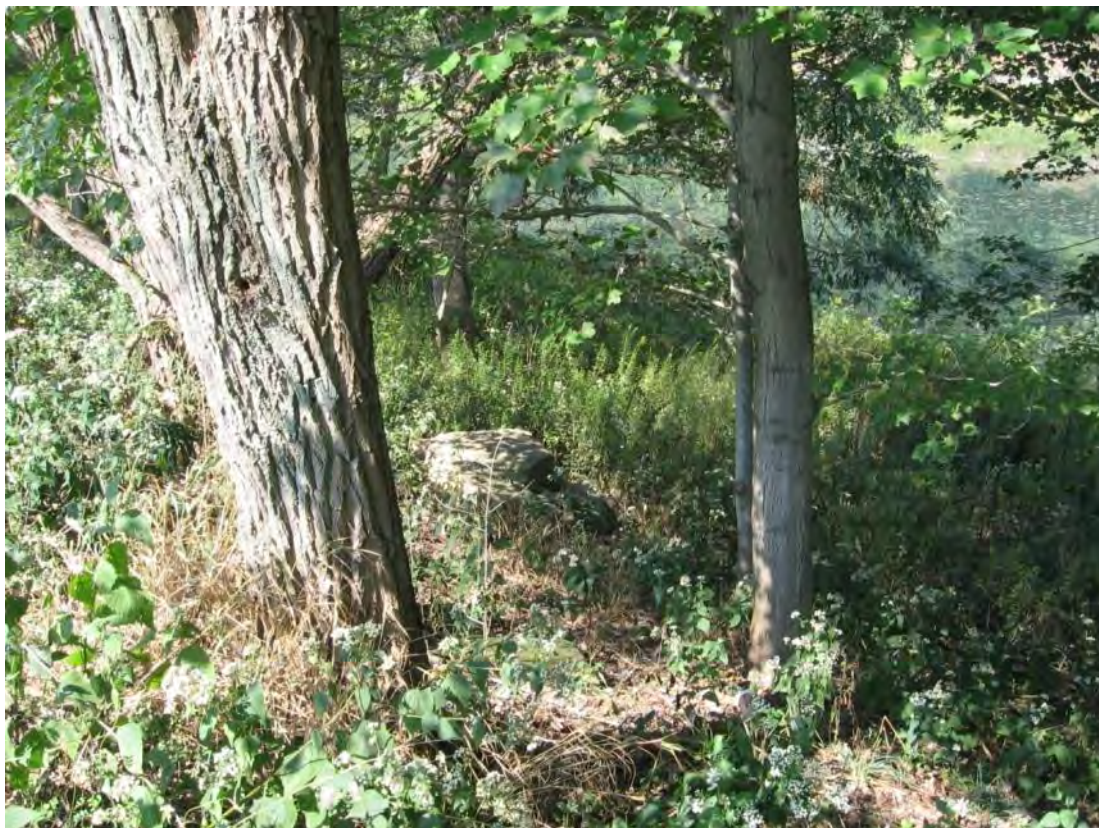
Description:
Typical
condition of
outboard slope
of northwestern
embankment
looking down at
the West
Branch of the
Susquehanna
River.

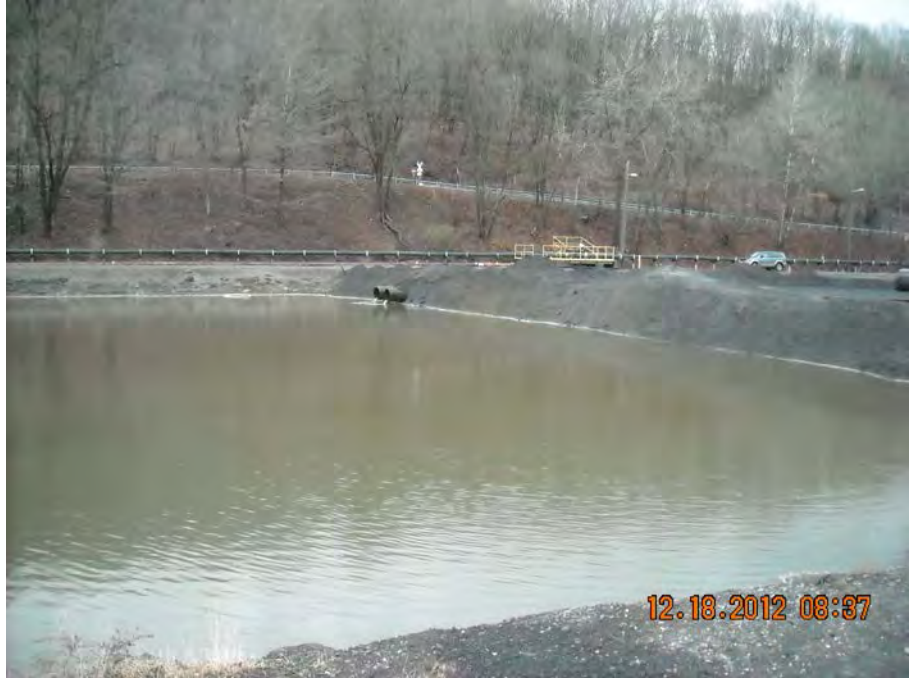
Photograph 4

Picture of the dividing berm between Ash Pond A and Ash Pond B. Picture is from the northwest berm of Ash Pond A, looking south.

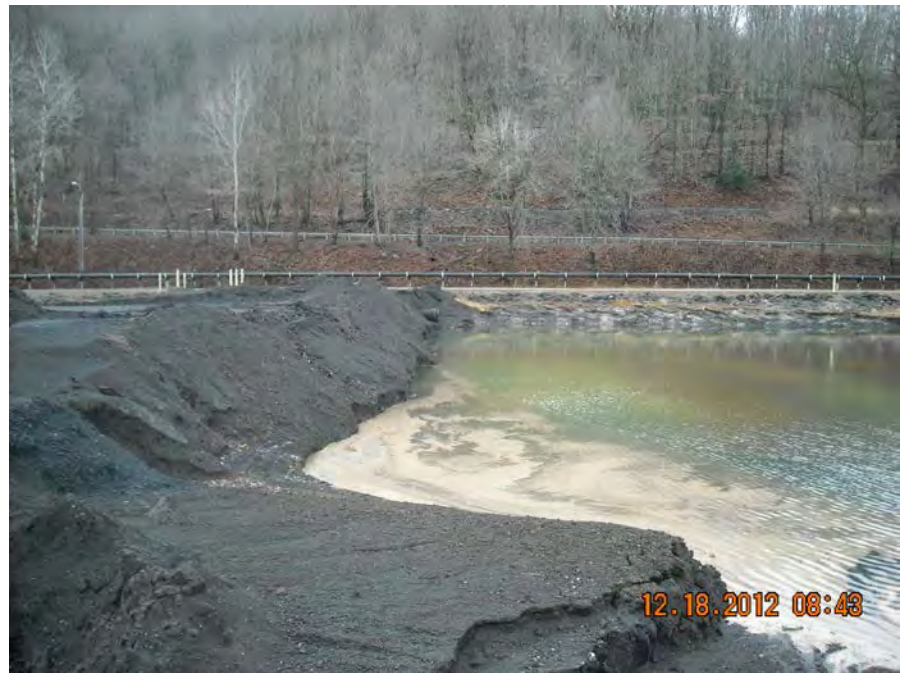
Picture of the dividing berm from the Ash Pond B side, looking southeast.
