From: Nate Nemani/R5/USEPA/US  
To: James Kohler/DC/USEPA/US@EPA  
Cc: Jose Cisneros/R5/USEPA/US@EPA  
Date: 11/13/2009 03:32 PM  
Subject: Re: Fw: Comment Request on EPA's Draft Coal Ash Impoundment Assessment Reports

Re: Xcel Energy Response to CHA Draft Report on USEPA Assessment of Dam Safety  
at the Sherburne County Power Station

**Attachment 1: Comments on Draft Report Assessing Safety of Coal  
Combustion Surface Impoundments at the Sherburne County Power Station**

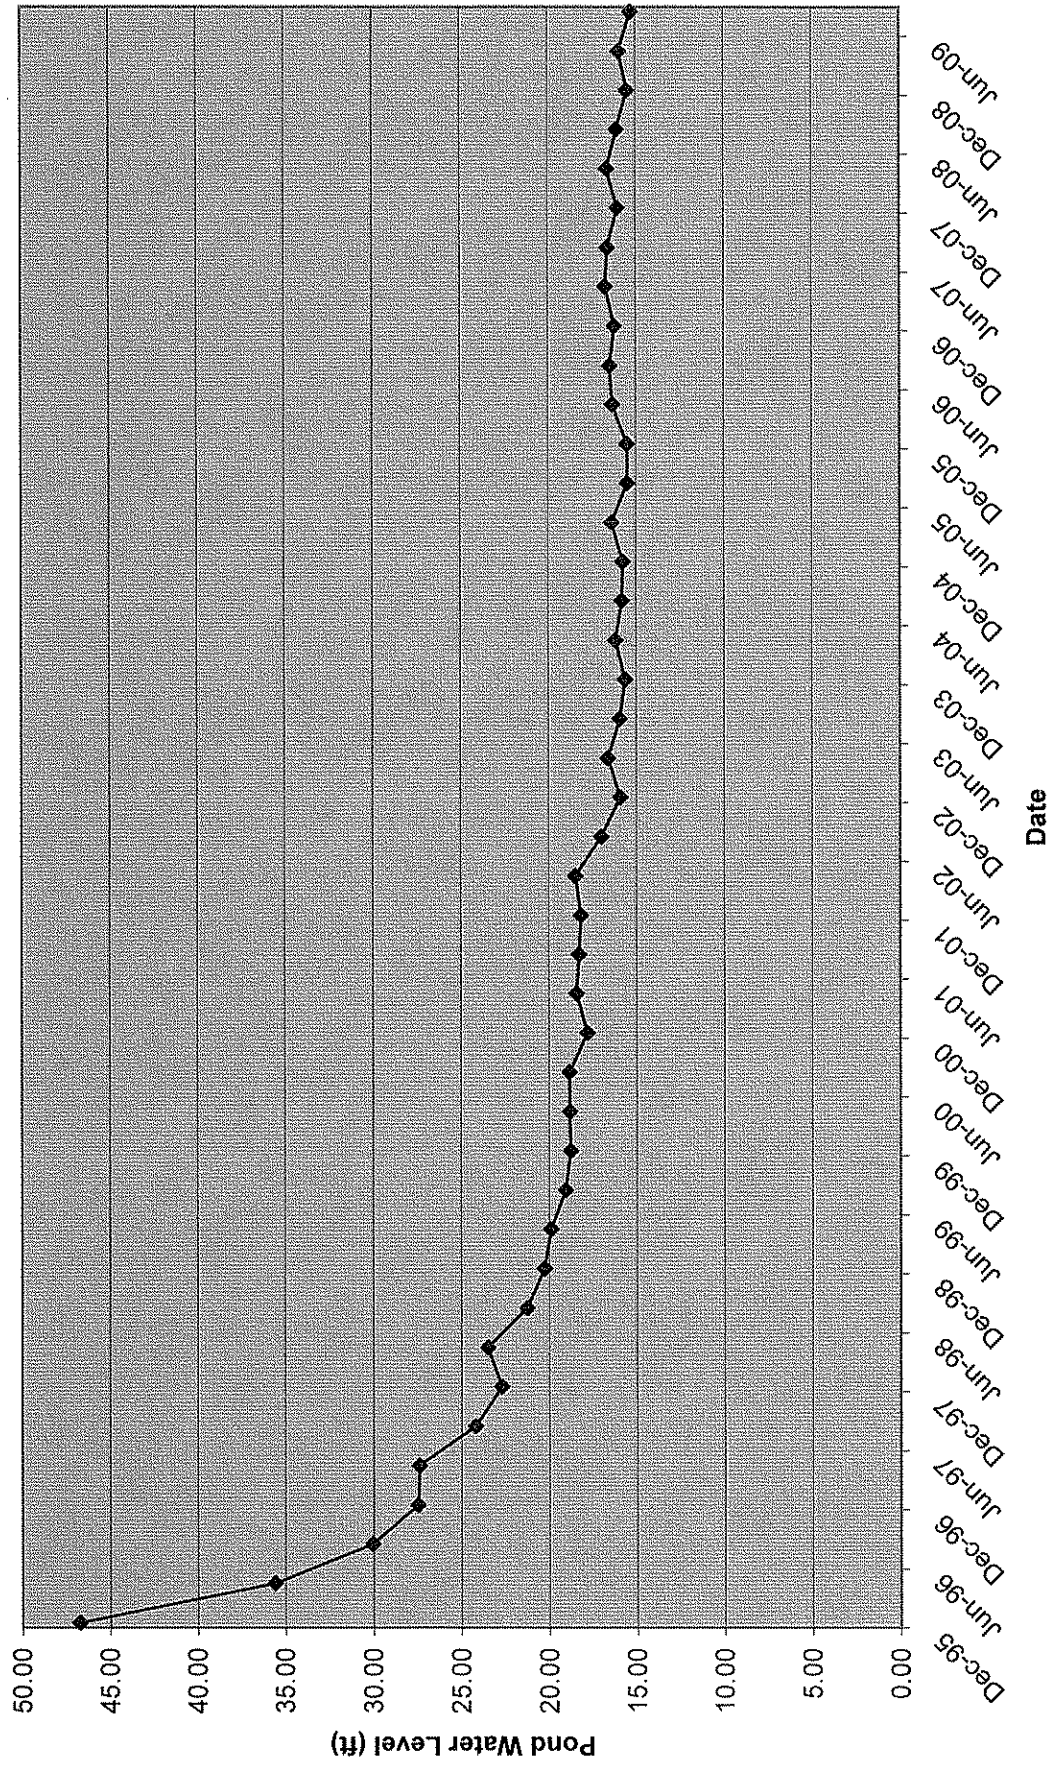
Attachment 2 - Pond #1 Dewatering Data

Page 94, Section 3.5, paragraph 4 – Pond water elevation data is available since dewatering started in Pond 1 in 1995. The information for Pond #1 has been enclosed in Attachment 2 to this comment letter. It is noteworthy that the water level is several feet below the surrounding grade and is now within the basin portion of the pond. Pond #2 does not have piezometer data since the pond is still active.
