February 27, 2012

RE: NV Energy Response to Recommendations in EPA Letter Dated January 12, 2012

**RE: Liquefaction Analysis – Coal Combustion Waste Impoundments  
Reid Gardner Generating Station**

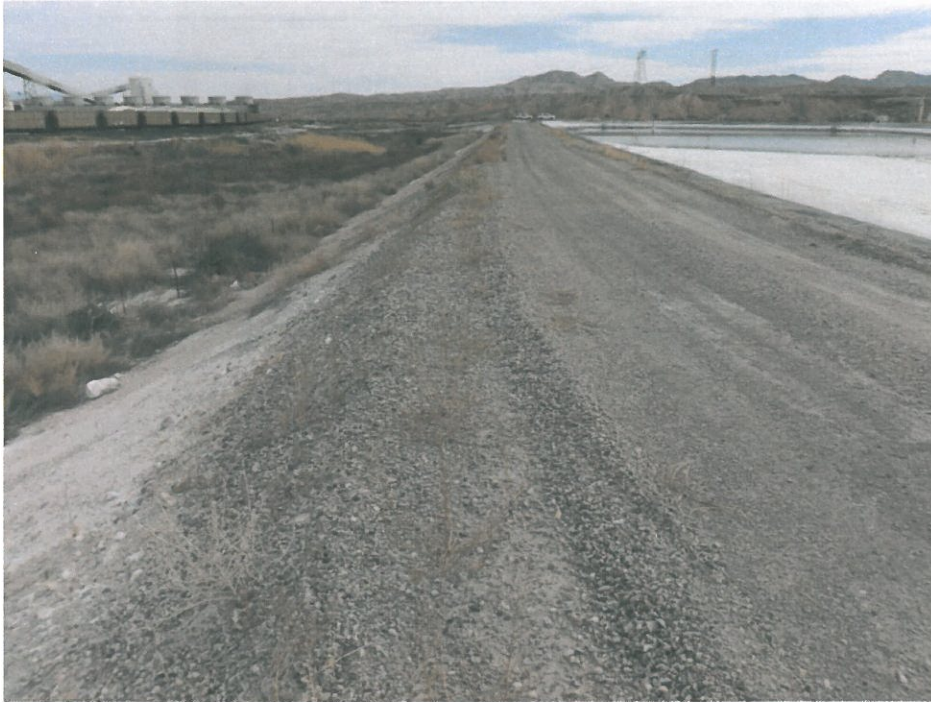
**Photo 13: Looking southeast. North dike of Pond F. Typical soil cement slope protection. Muddy River located at left.**

As a result of discussions with the EPA and Nevada Division of Environmental Protection (NDEP) representatives during their joint inspection at the Reid Gardner Generating Station on February 15, 2011, the vegetation along the base of the northwest corner of Pond F was cleared on May 3, 2011. By clearing this vegetation, it now allows NVE staff to observe the condition of the embankment closest to the Muddy River.

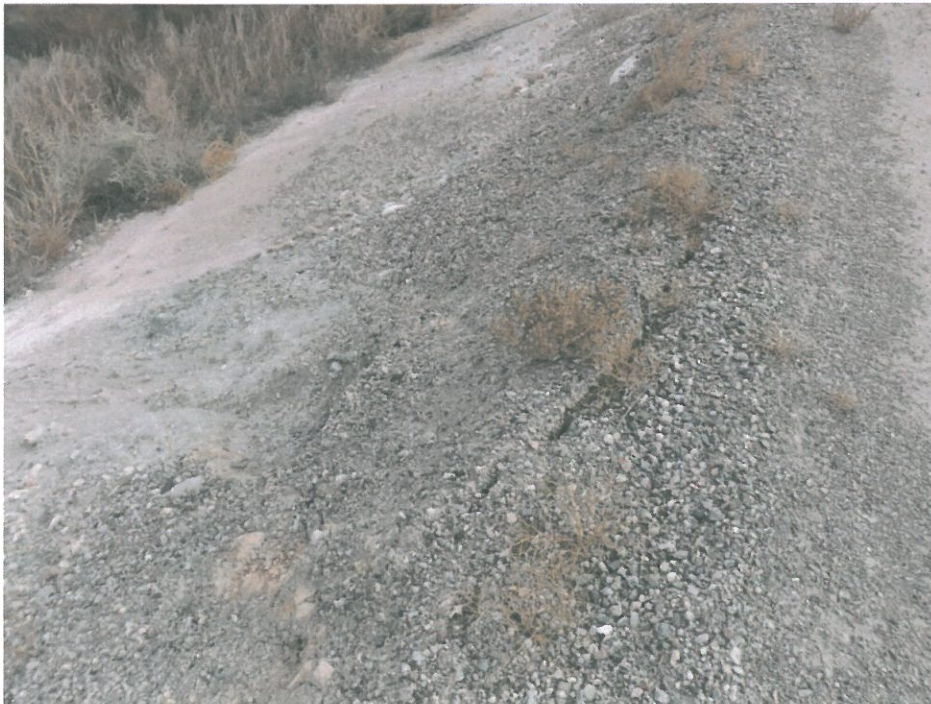
**Photo 14: Pond F. Typical cracking and vegetation located along edge of crest and slope.**

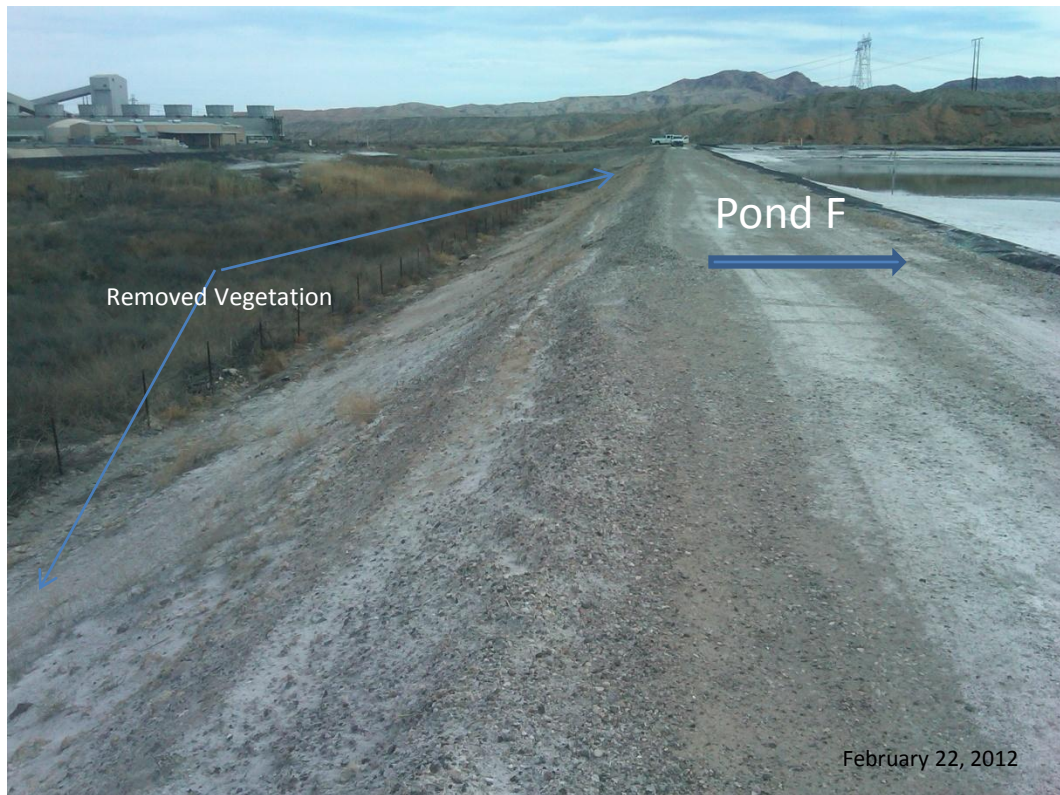
Reid Gardner Generating Station Looking Southeast. North dike of Pond F

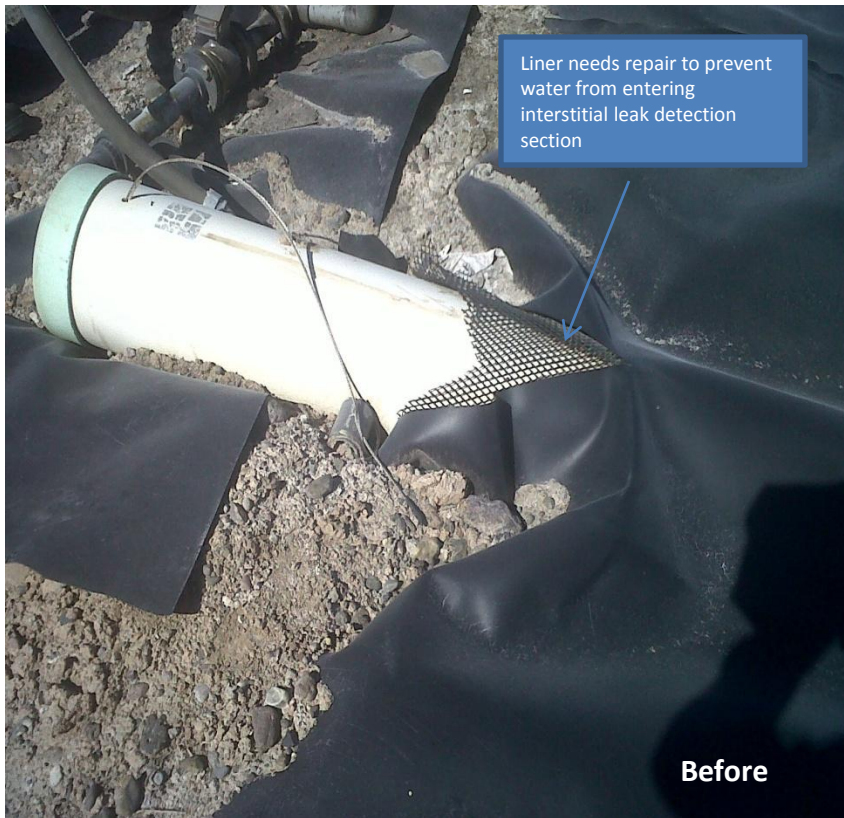
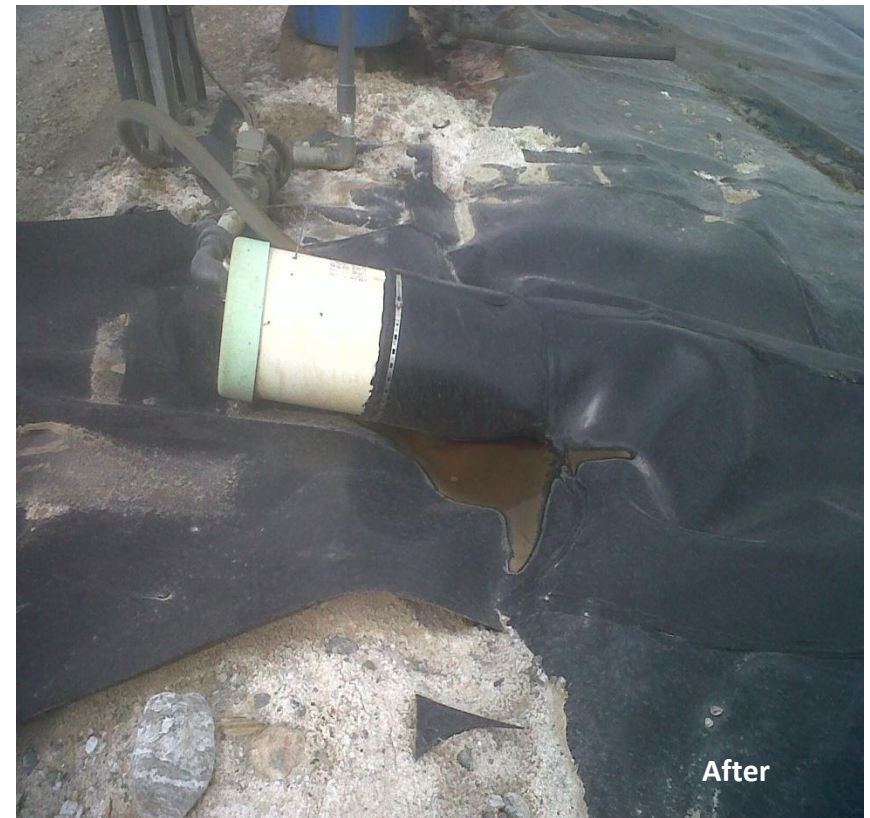
## Photo Location #1

# Reid Gardner – Pond E1

NV Energy (NVE) is pleased to inform your office that we have completed repairs to the interstitial leak detection system outlet boots noted in your July 19, 2011 letter.

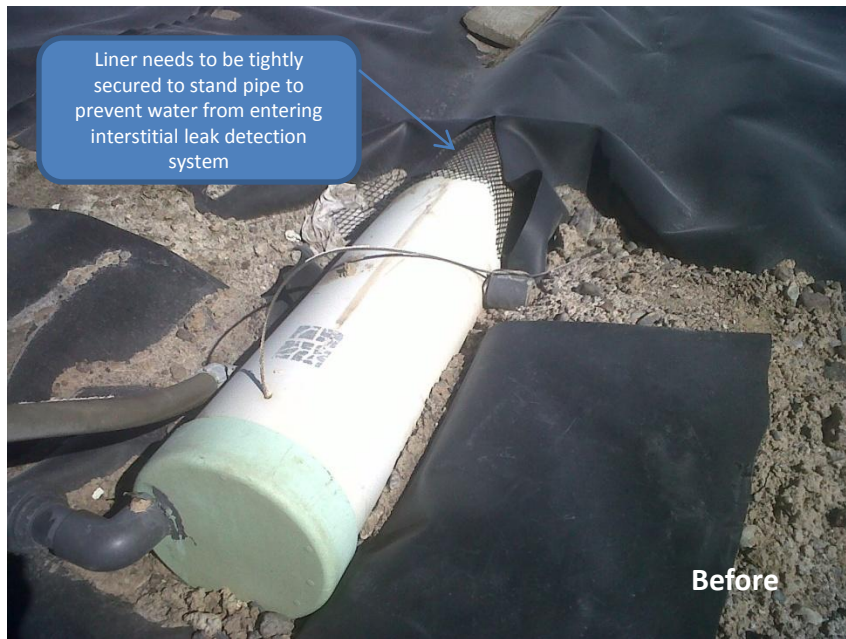
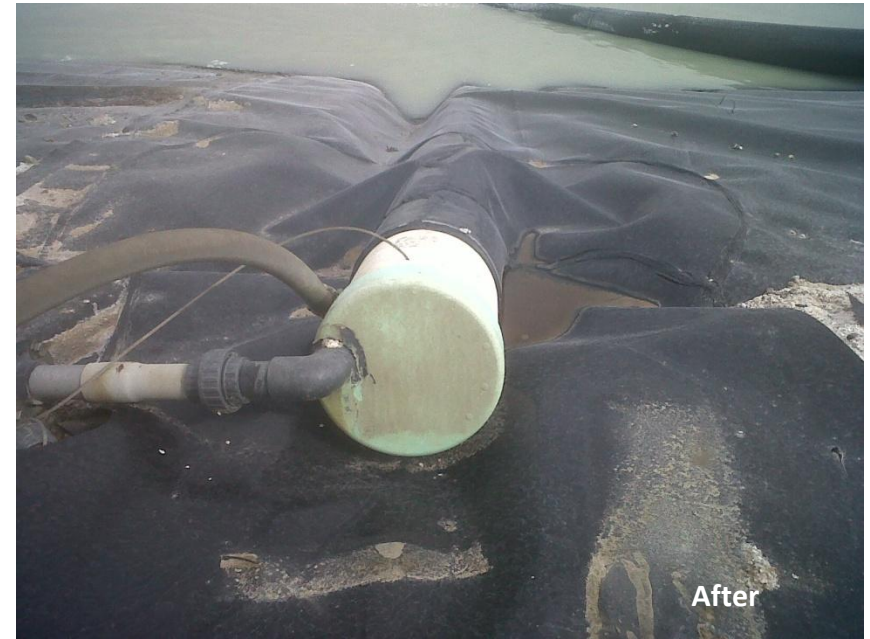
## Photo Location #2

# Reid Gardner – Pond E1

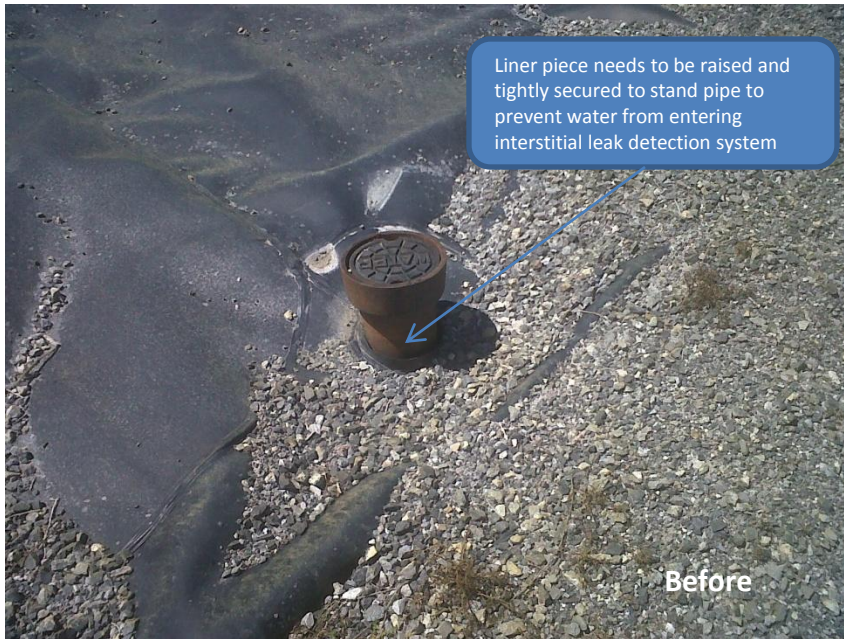
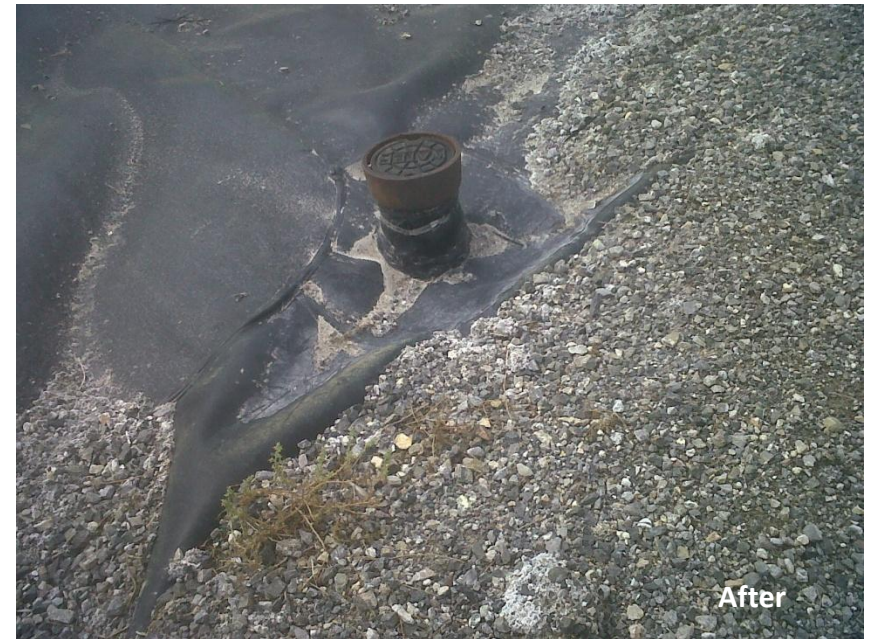
## Photo Location #3

# Reid Gardner – Pond 4B-1

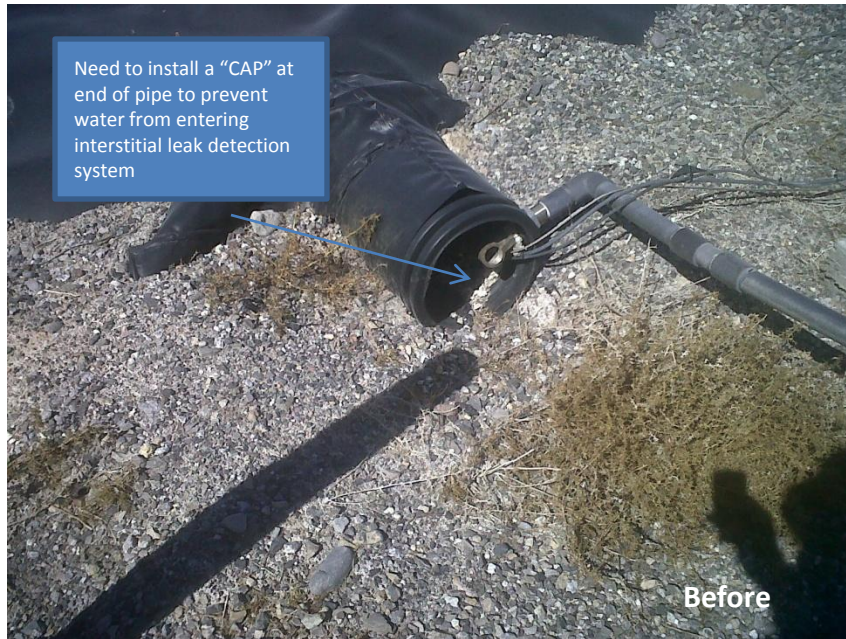
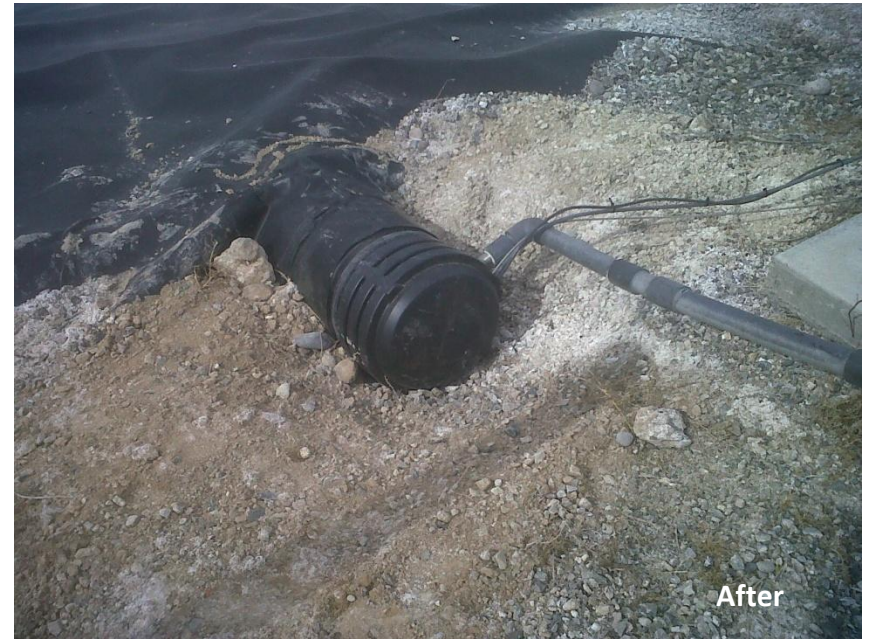
## Photo Location #4

# Reid Gardner – Pond 4B-2

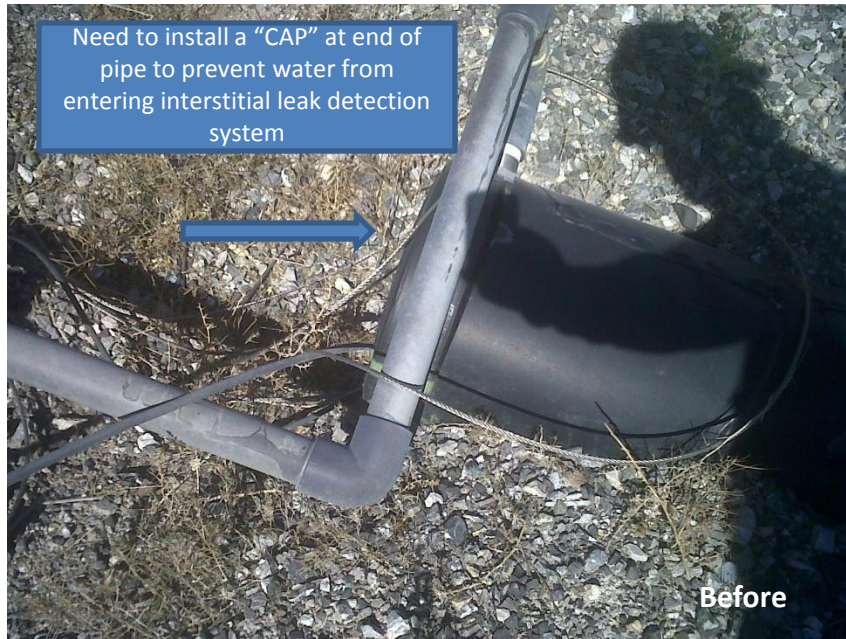
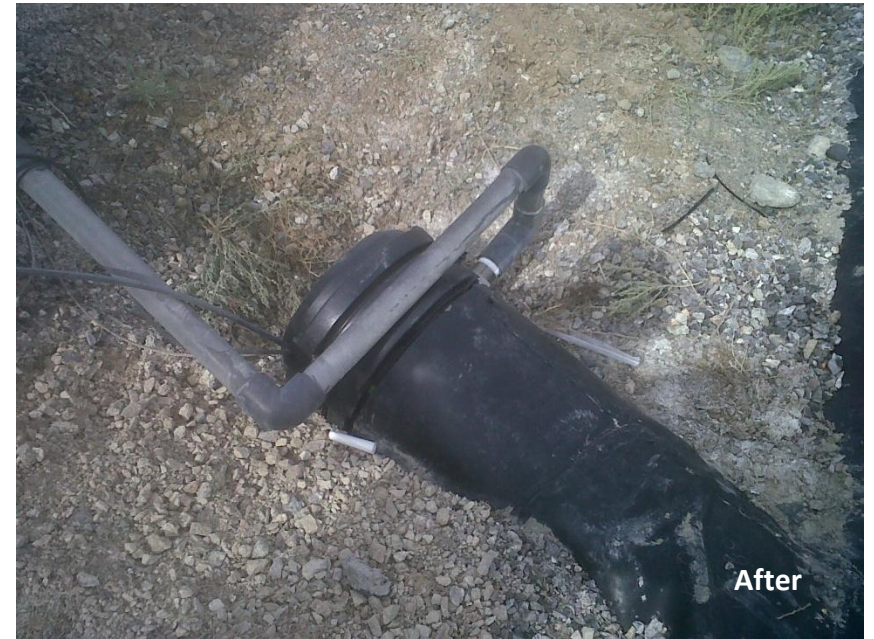
## Photo Location #5

# Reid Gardner – Pond 4B-1

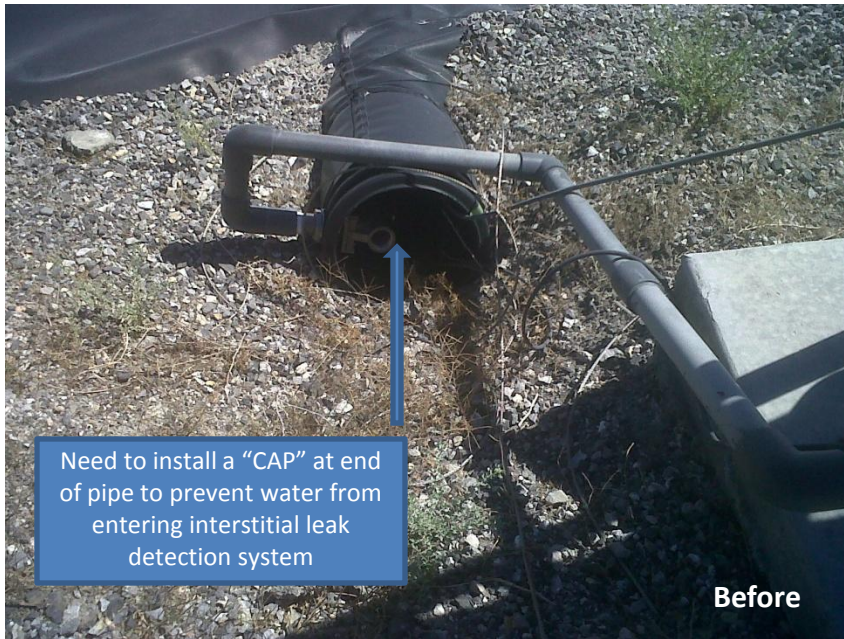
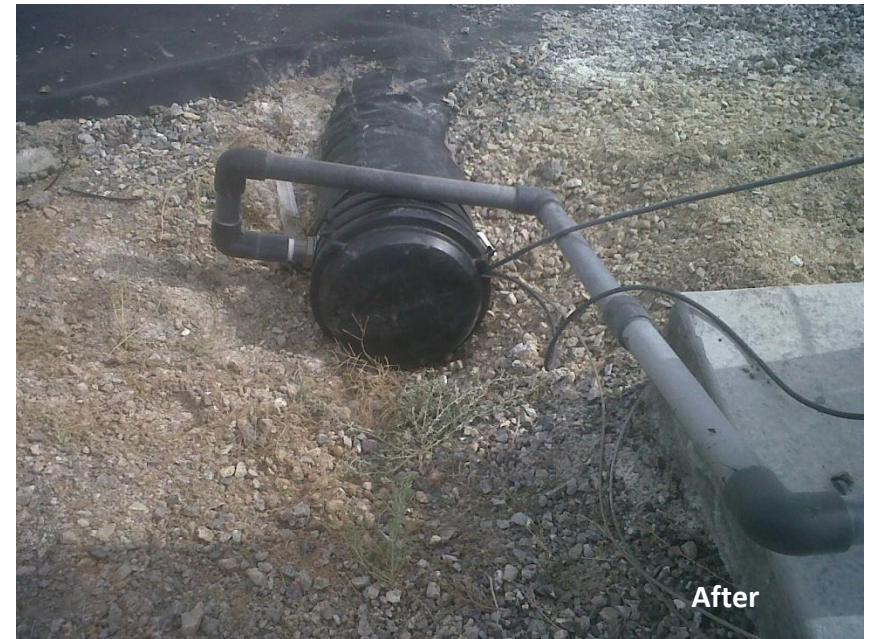
## Photo Location #6

# Reid Gardner – Pond 4B-1

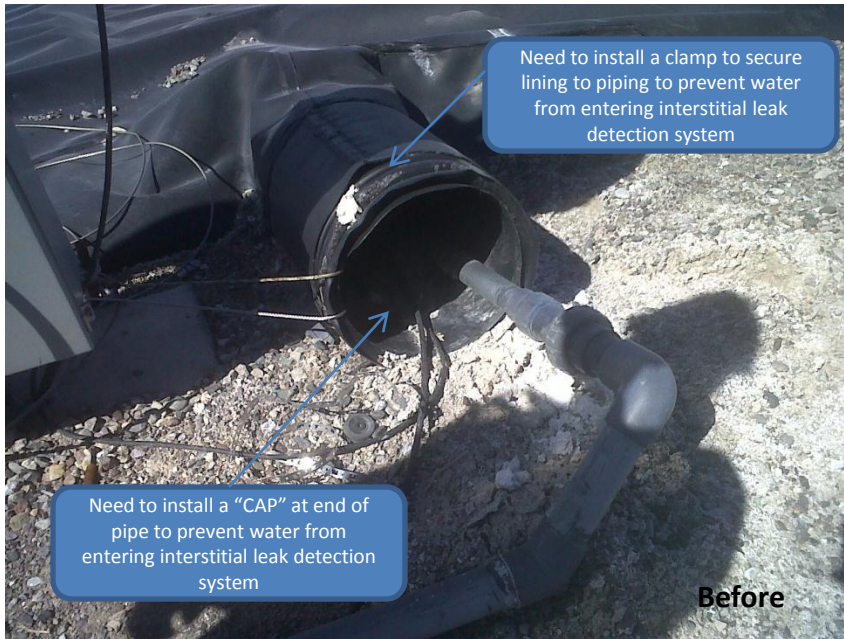
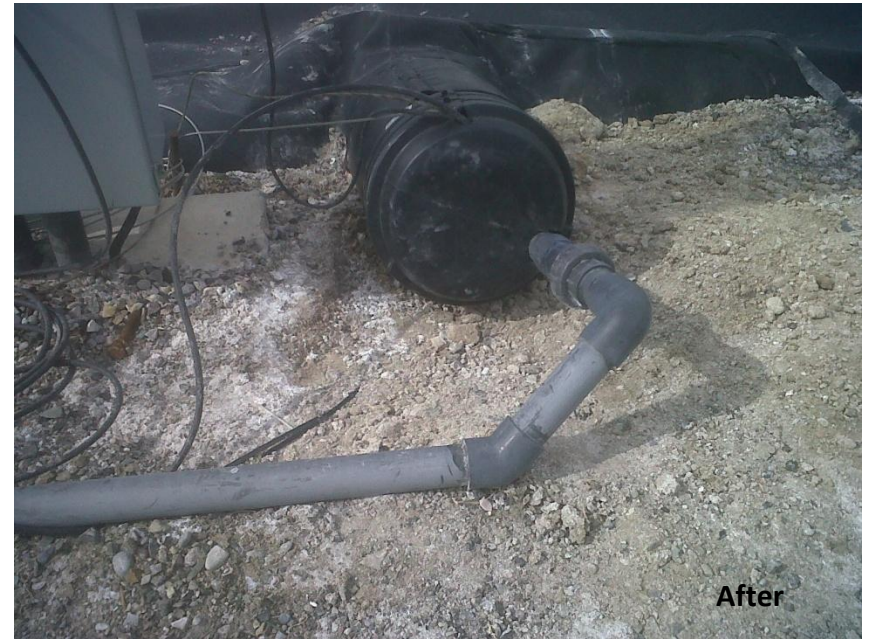
## Photo #7

# Reid Gardner – Pond 4B-3

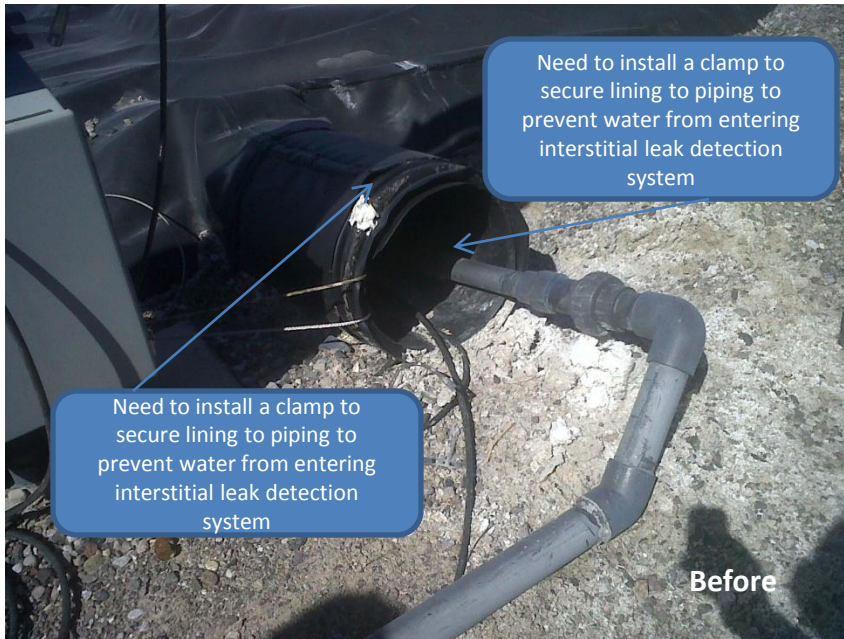
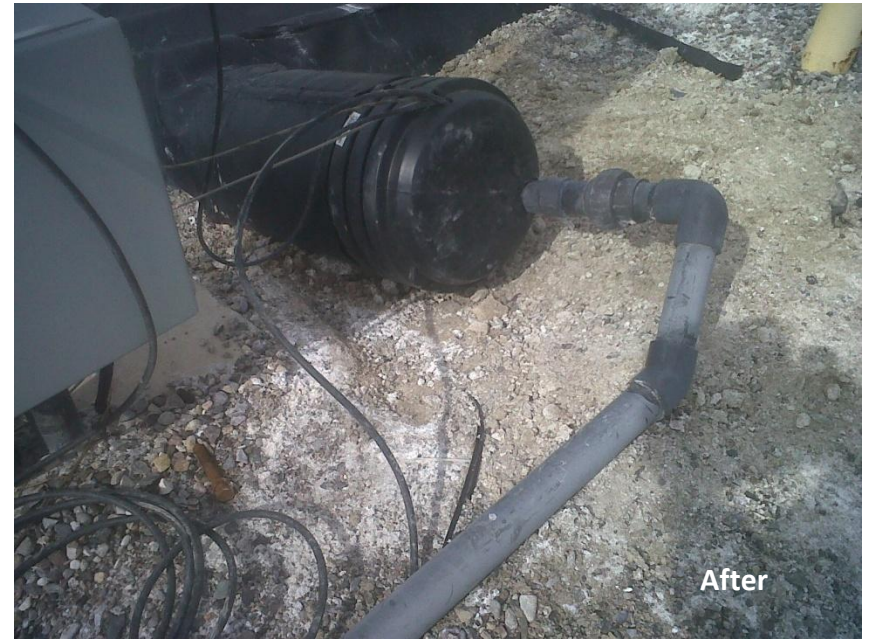
## Photo Location #8

# Reid Gardner – Pond 4B-3

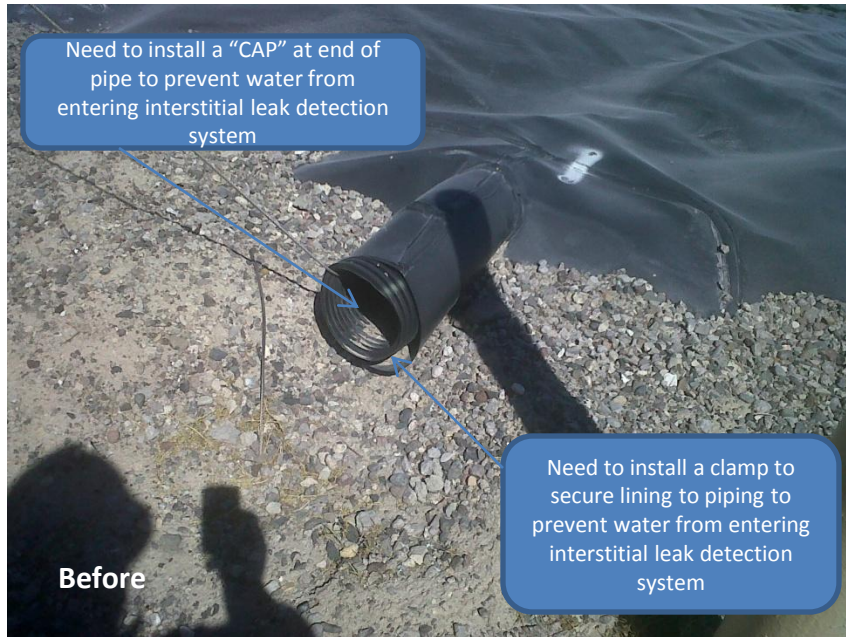
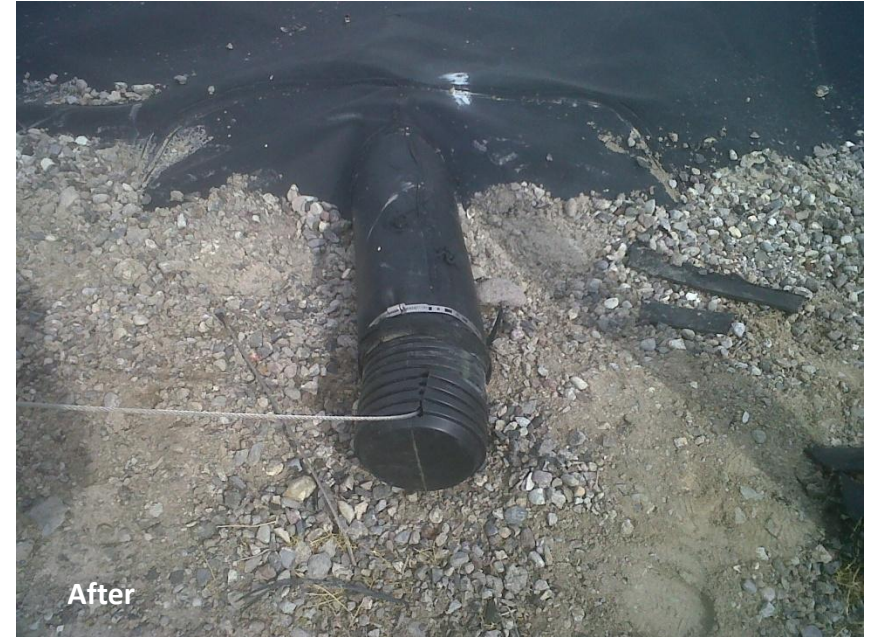
## Photo Location #9

# Reid Gardner – Pond 4B-3

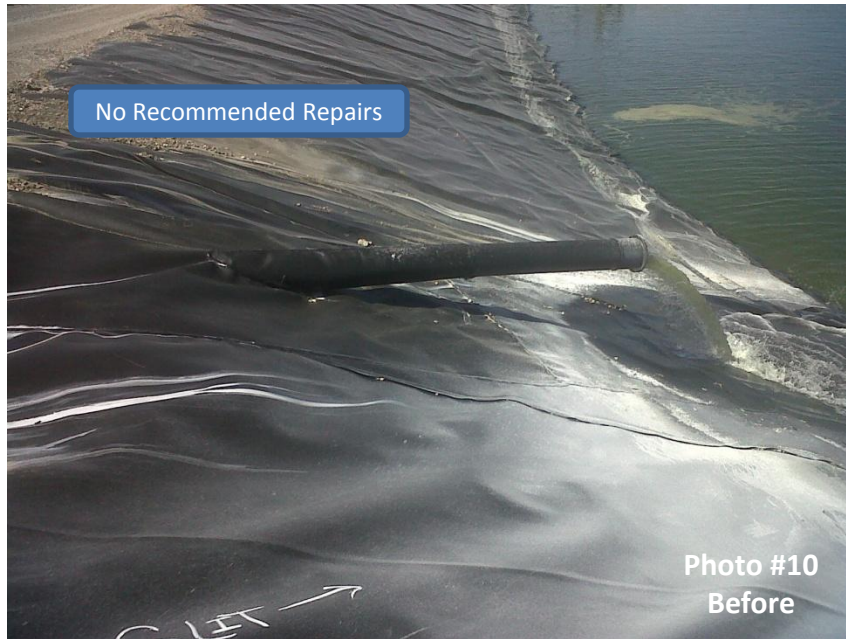
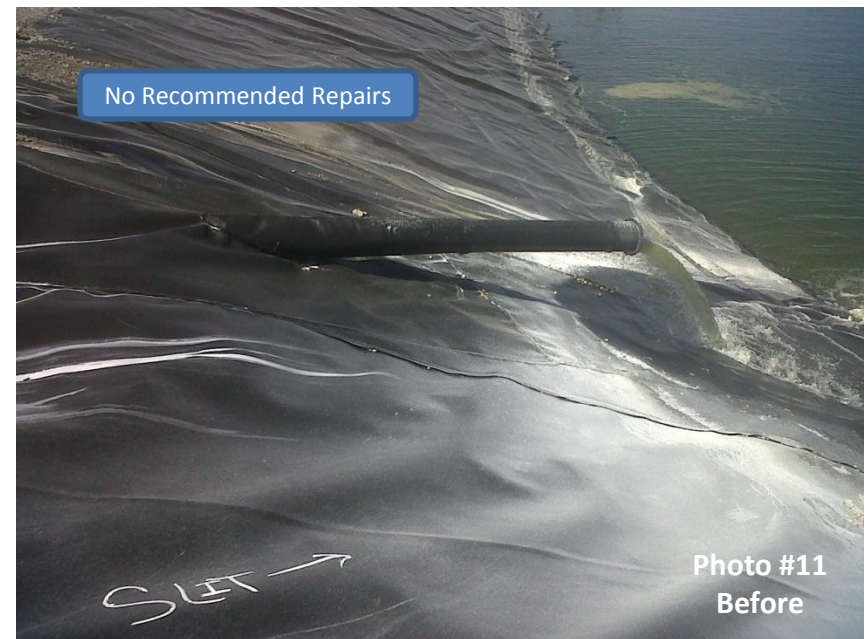
## Photo Location #10 and #11

# Reid Gardner – Pond 4C-3

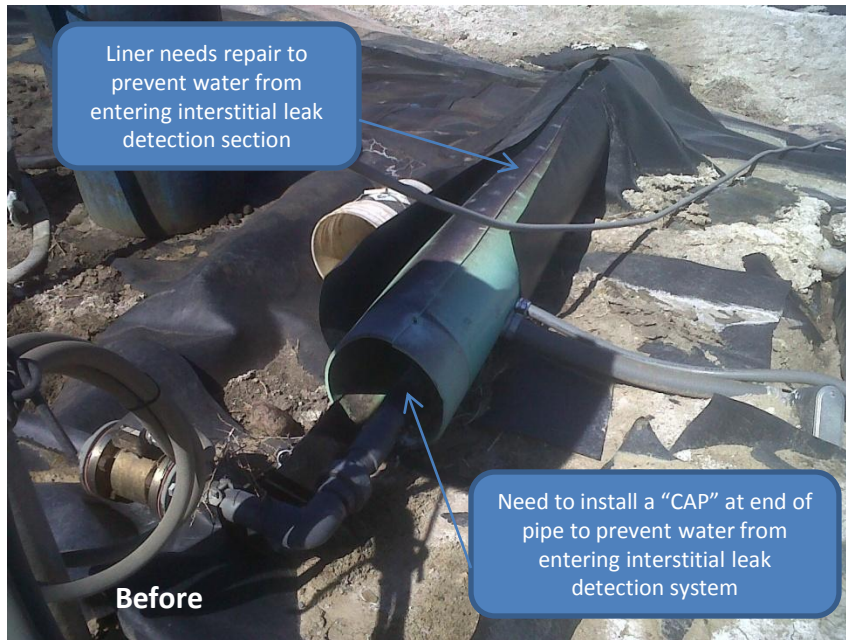
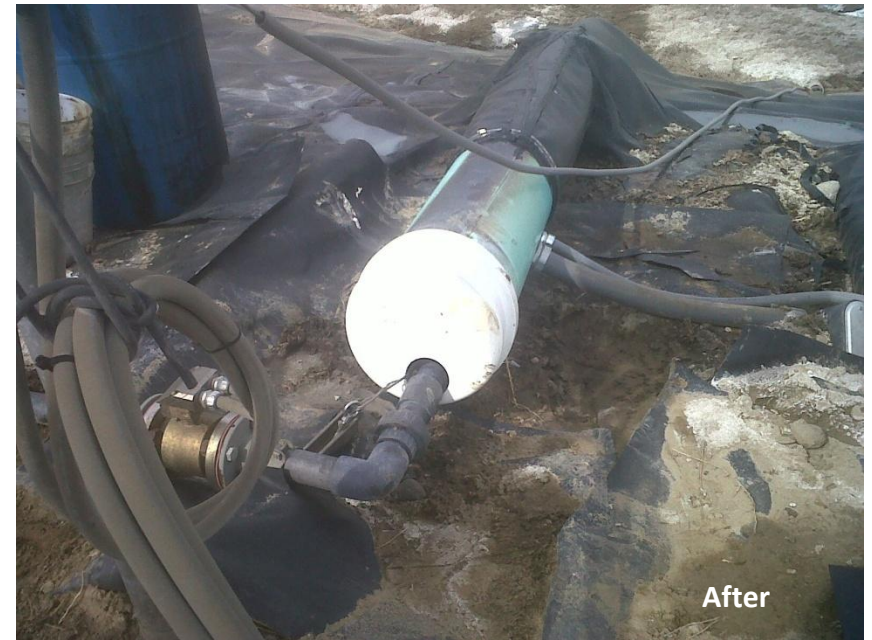
## Photo Location #12

# Reid Gardner – Pond 4C-2

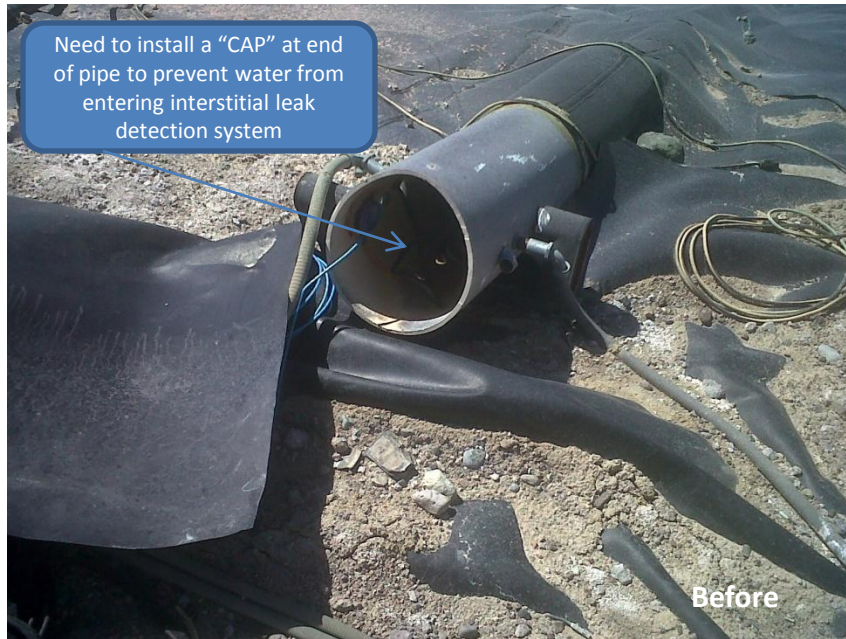
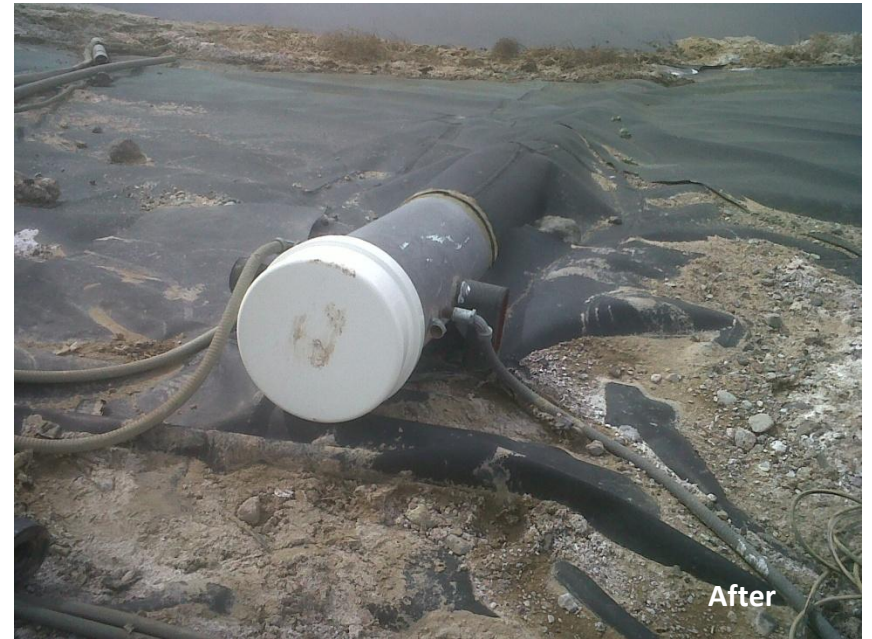
## Photo Location #13

# Reid Gardner – Pond 4C-1
