Specific Site Assessment for Coal Combustion Waste Impoundment at PacifiCorp Energy, Dave Johnston Power Plant

Glenrock, Wyoming

June 2011
Project 092884

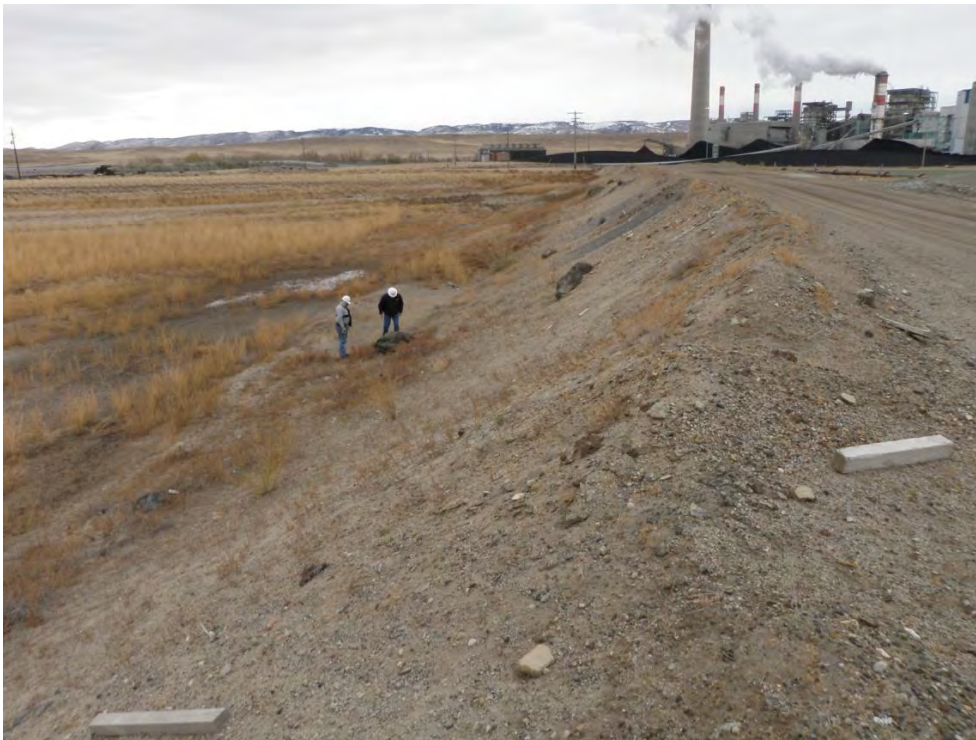
The downstream slope of the east embankment dam was covered with sparse grassy vegetation. The downstream slope was estimated to be approximately 2H:1V. No signs of scarps, sloughs, depressions or other indications of slope instability or signs of erosion were observed.

Photo 4: 4A Ash Pond east embankment dam downstream side looking south.

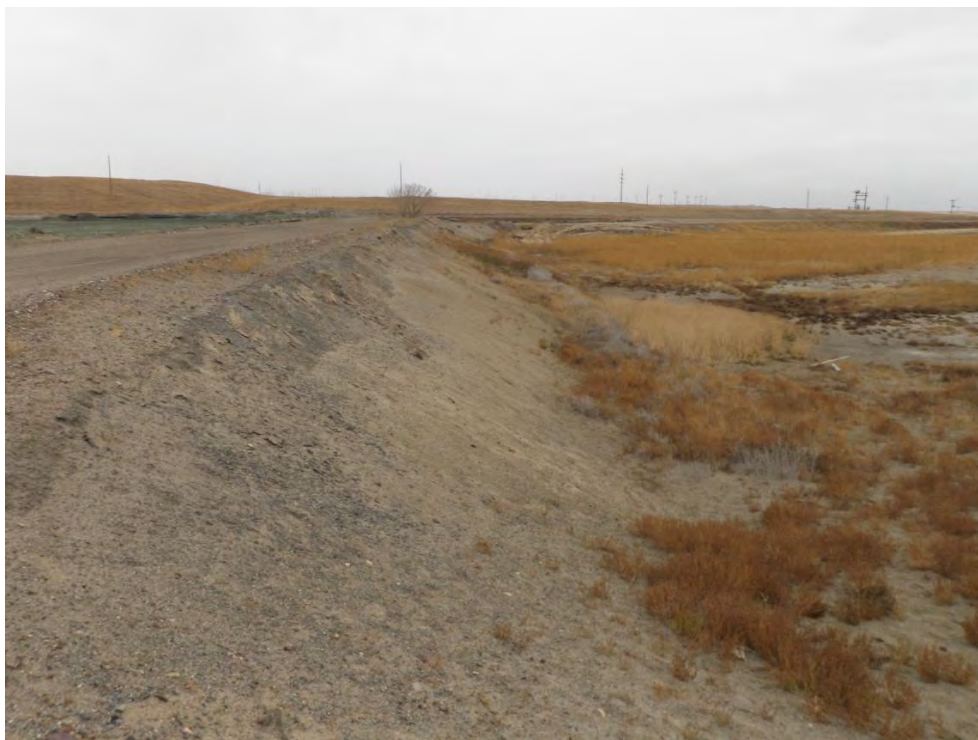
Photo 5: 4A Ash Pond east embankment dam downstream side looking north.

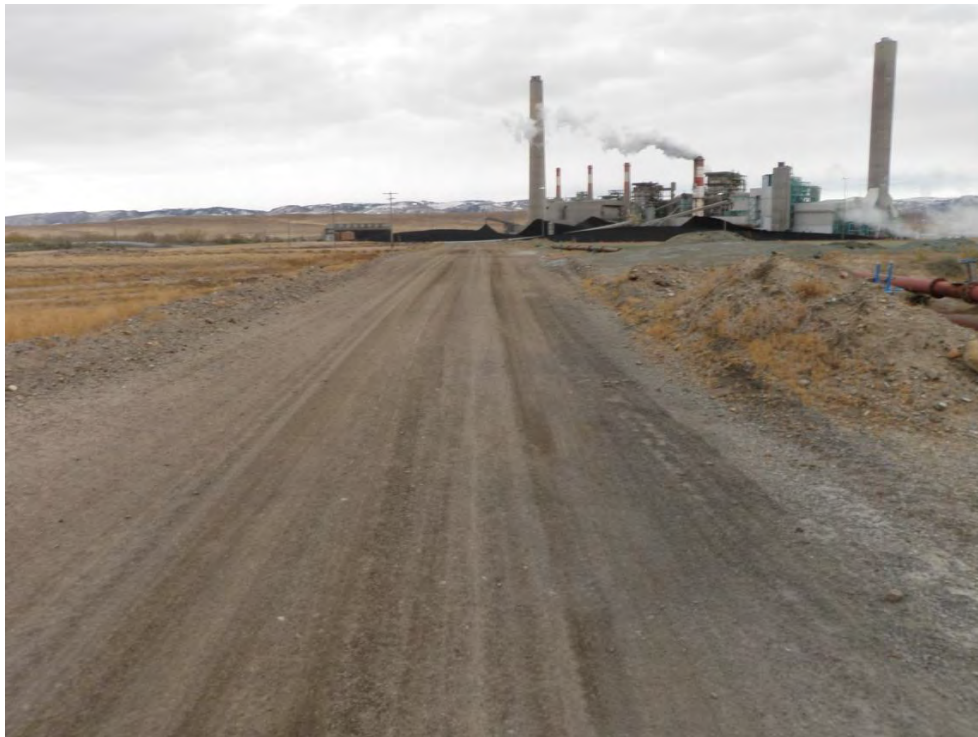
The crest of the east embankment dam appeared to be in good condition. No signs of cracking, settlement, movement, erosion or deterioration were observed. The dam crest surface was generally composed of road base material that traverses the length of the dam.

Photo 6: 4A Ash Pond east embankment dam crest looking south.

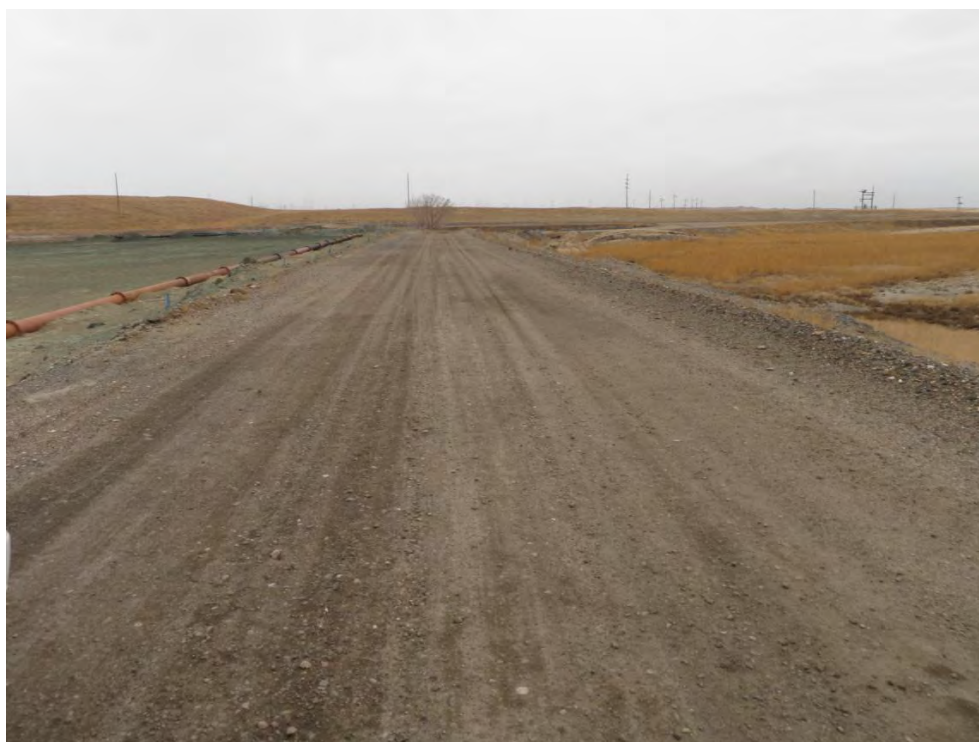
Photo 7: 4A Ash Pond east embankment dam crest looking north.

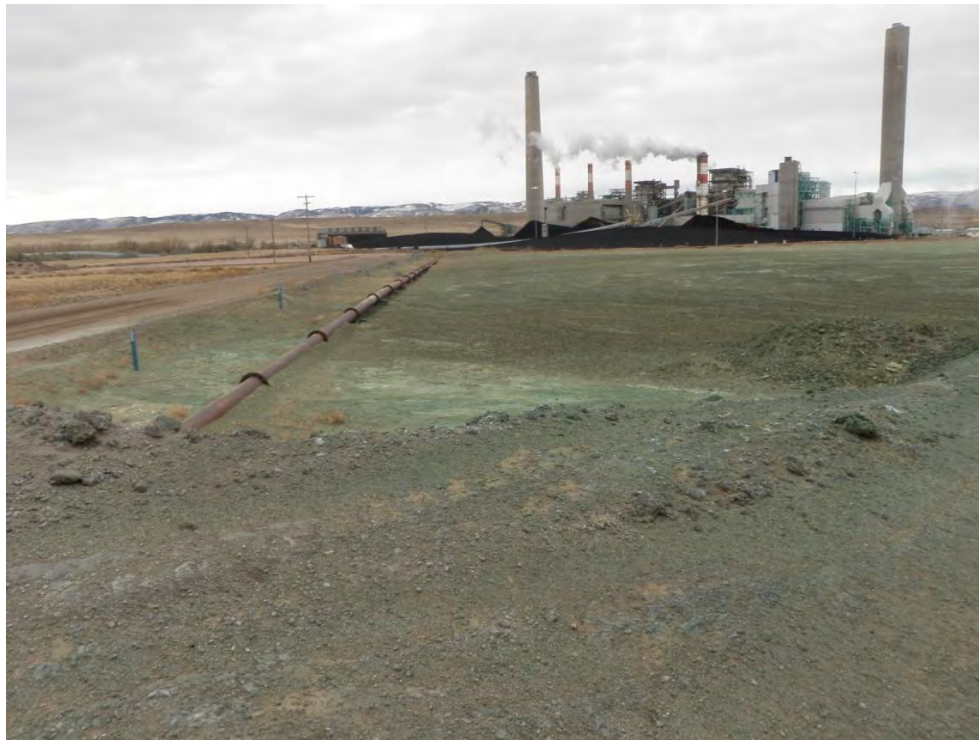
The visible portion of the upstream slope of the east embankment dam was generally exposed earth with little or no vegetation or erosion control measures and an estimated slope of approximately 4H:1V. The slope appeared stable and there appeared to be sufficient crest width to maintain overall dam stability. No scarps, sloughs, depressions or other indications of slope instability or signs of erosion were observed.

**Photo 8: 4A Ash Pond east embankment dam upstream side looking south.
Note that pond is full of CCW solids and not currently receiving wastewater.**

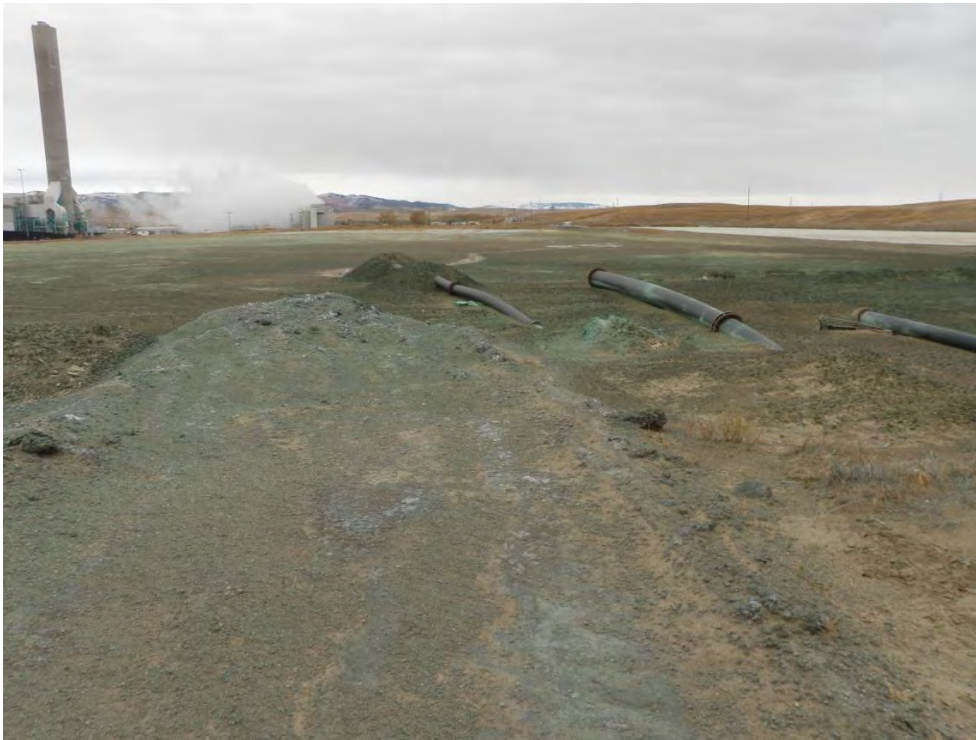
Photo 9: 4A Ash Pond looking southwest showing full pond.

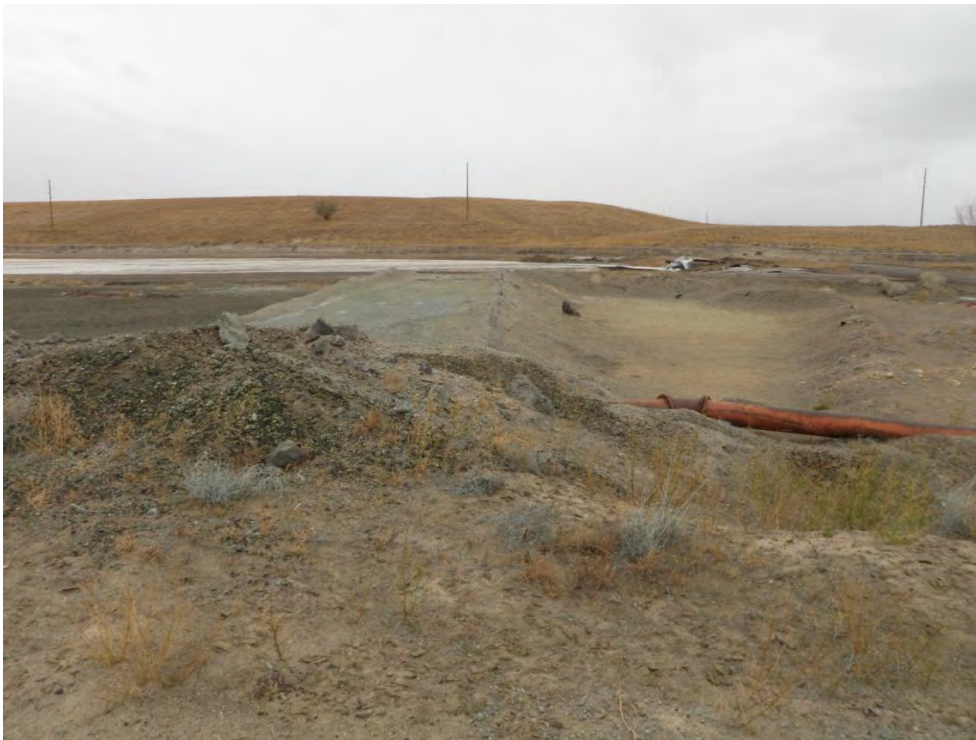
Photo 10: 4A Ash Pond east embankment dam upstream side looking north.

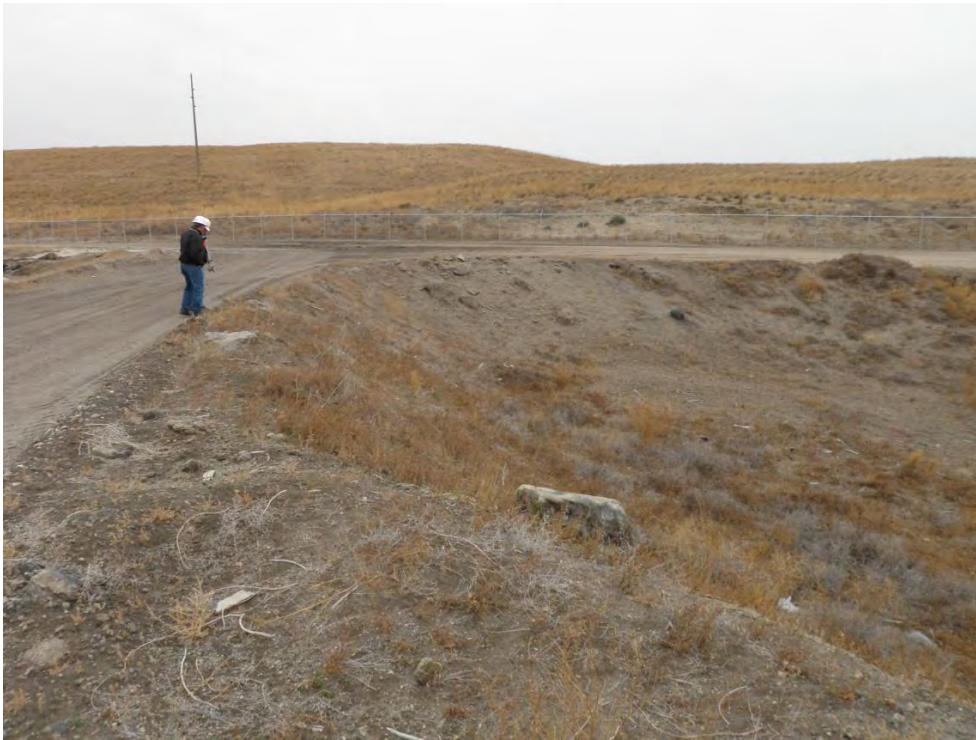
Photo 15: 4B Ash Pond east embankment dam downstream side. Topographic depression to right.

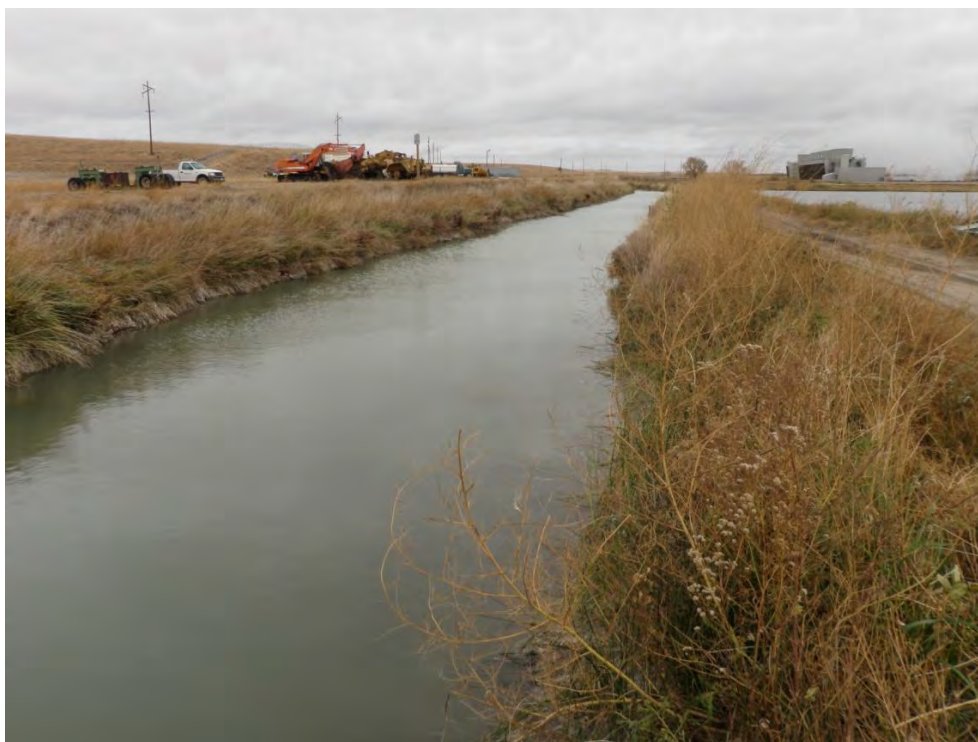
The cut slope to the south of the Blowdown Canal failed during a rainstorm in 2008 and resulted in the release of approximately 300 gallons to the recirculation canal. The plant subsequently re-configured the blowdown canal to reduce the potential for future releases. It is our opinion that an uncontrolled release from the Blowdown Canal would overtop the east divider dike and enter the 1B Ash Pond or 1B Clear Pond and would not pose a threat to human life, property or the environment.

**Photo 34: Blowdown Canal looking northeast from southwest corner.
Natural cut slope on left, 1B Ash Pond on right.**

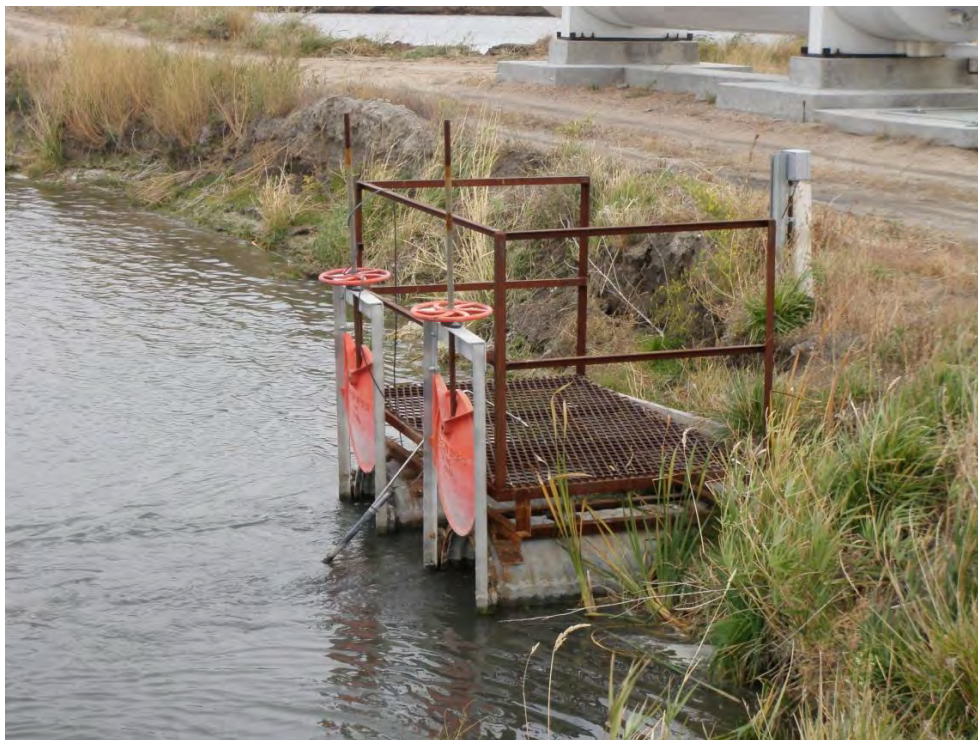
Photo 42: Intake culverts at southeast corner of 1A Clear Pond. Water flows from 1A to 1B Clear Pond through the interior dike and is treated with CO₂ to adjust pH.

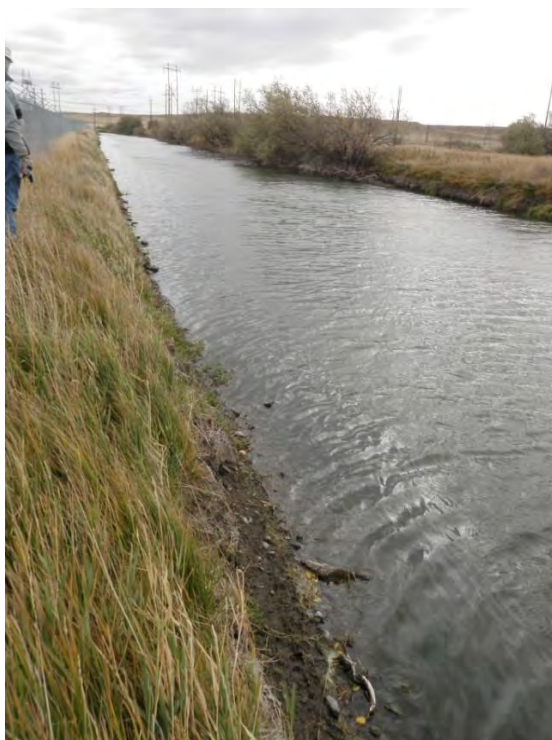
A breach in the 1A/1B Clear Pond south dam would result in an uncontrolled release of CCW to the recirculation canal and ultimately the North Platte River. It is our opinion that an uncontrolled release of the contents of the CCW impoundments into the North Platte River would not pose a threat to human life or property. Some environmental damage to the North Platte River should be expected.

Photo 48: 1A / 1B Clear Pond south embankment dam downstream looking southeast showing steep downstream slope and Recirculation Canal.

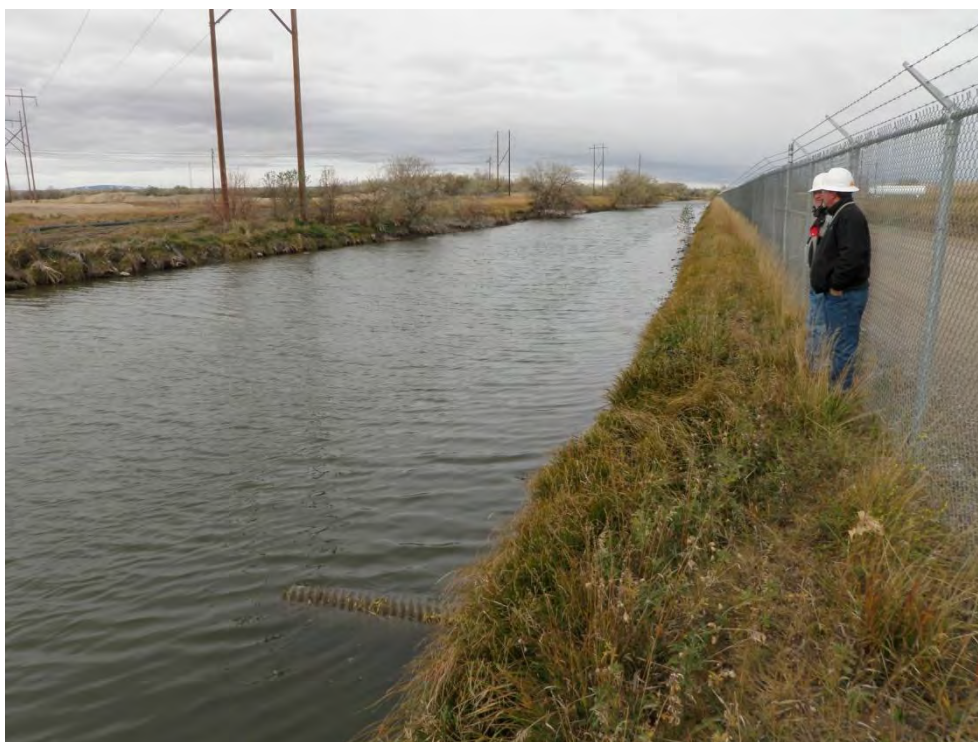
Photo 51: 1A / 1B Clear Pond south embankment dam downstream side looking northwest showing steep downstream slopes and Recirculation Canal. Inactive 008 Outfall in foreground left.
