Dam Safety Assessment of CCW Impoundments

Hunter Power Plant
Castle Dale, Utah

December 21, 2012

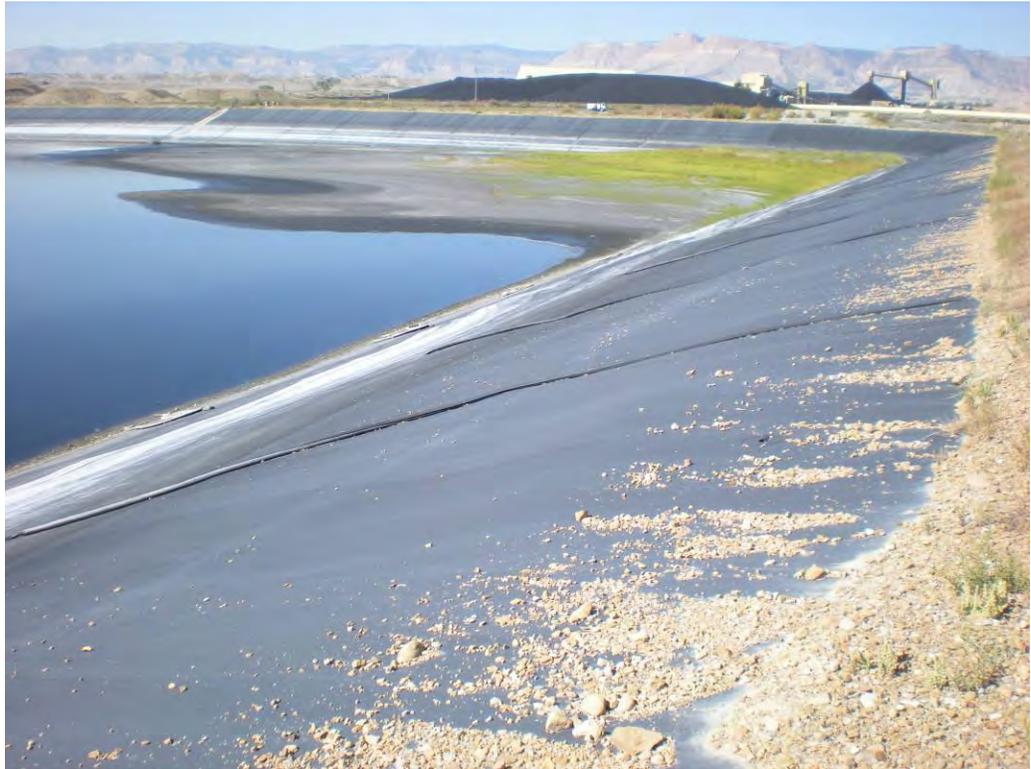
View of northwest corner of Wastewater Pond #1. Some solids have accompanied the wastewater that enters the pond in this corner. Pond slopes are lined with hypalon. Per the drawings, the pond bottom is lined with PVC.

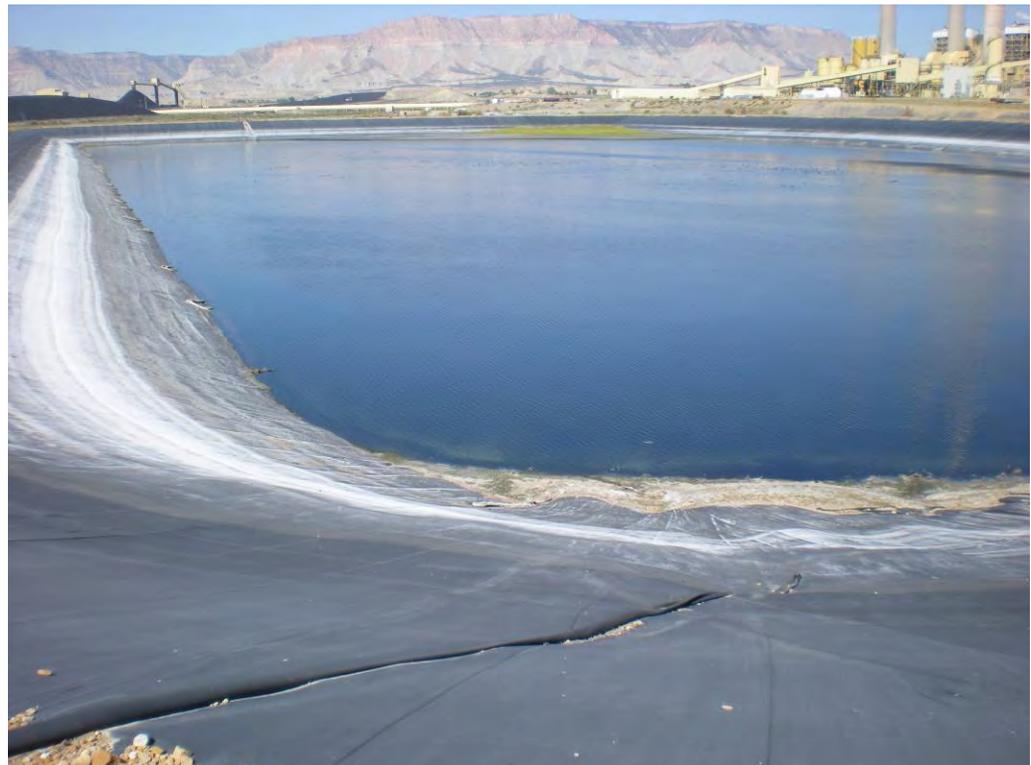
View of Wastewater Pond #1 from the southeast corner looking northwest. The pond is nearly empty. It's stored water is pumped to nearby fields for irrigation.

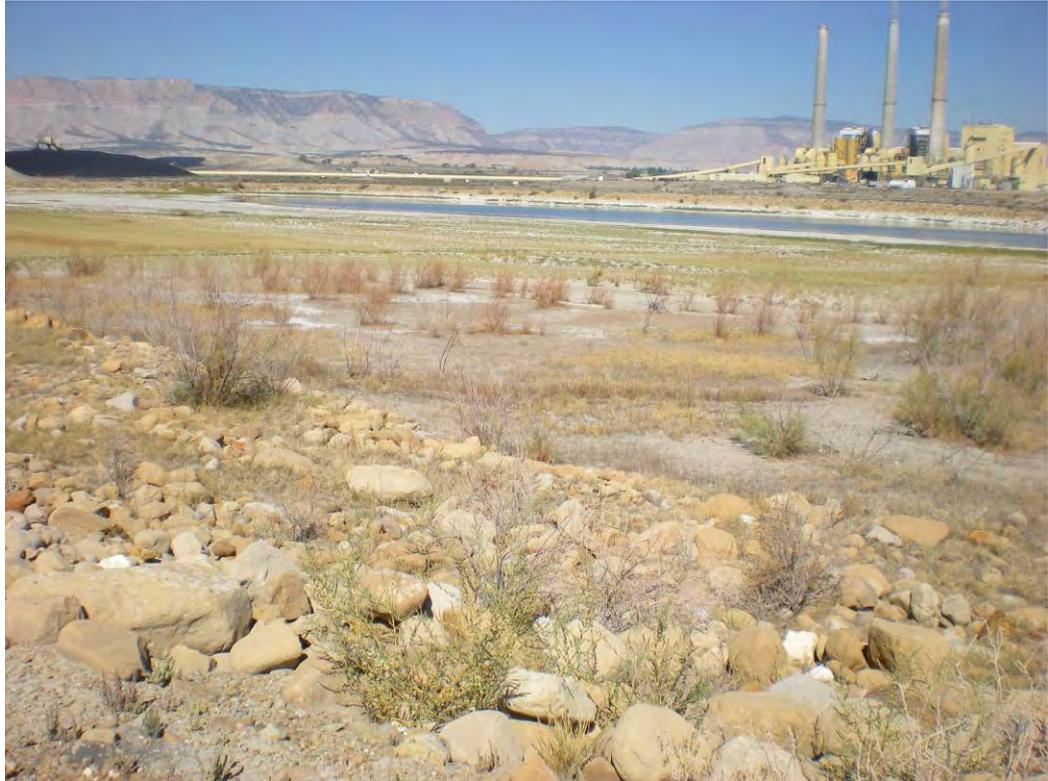
View looking across the interior of Wastewater Pond #2. The pond has a 2-ft. thick clay liner on the bottom and slopes. The slopes are protected by a layer of rip rap. Volunteer vegetation has taken hold while the pond is nearly empty.

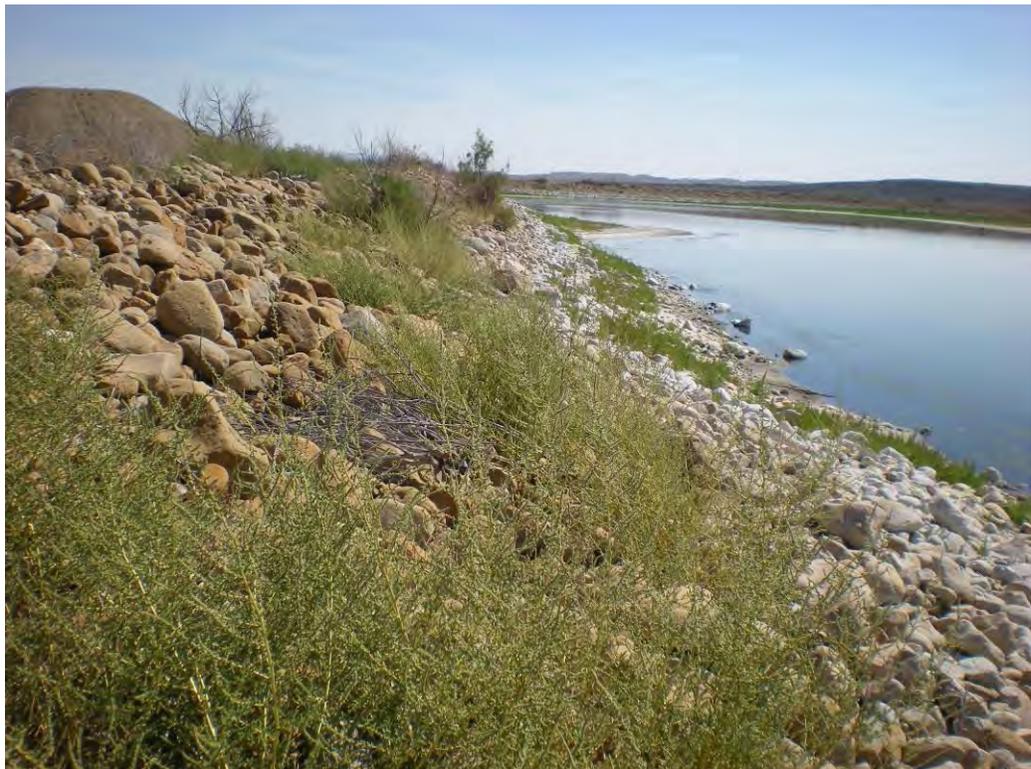
View of the north side slope of Wastewater Pond #2 looking east from its northwest corner. Some volunteer vegetation has taken hold in the rip rap protection.

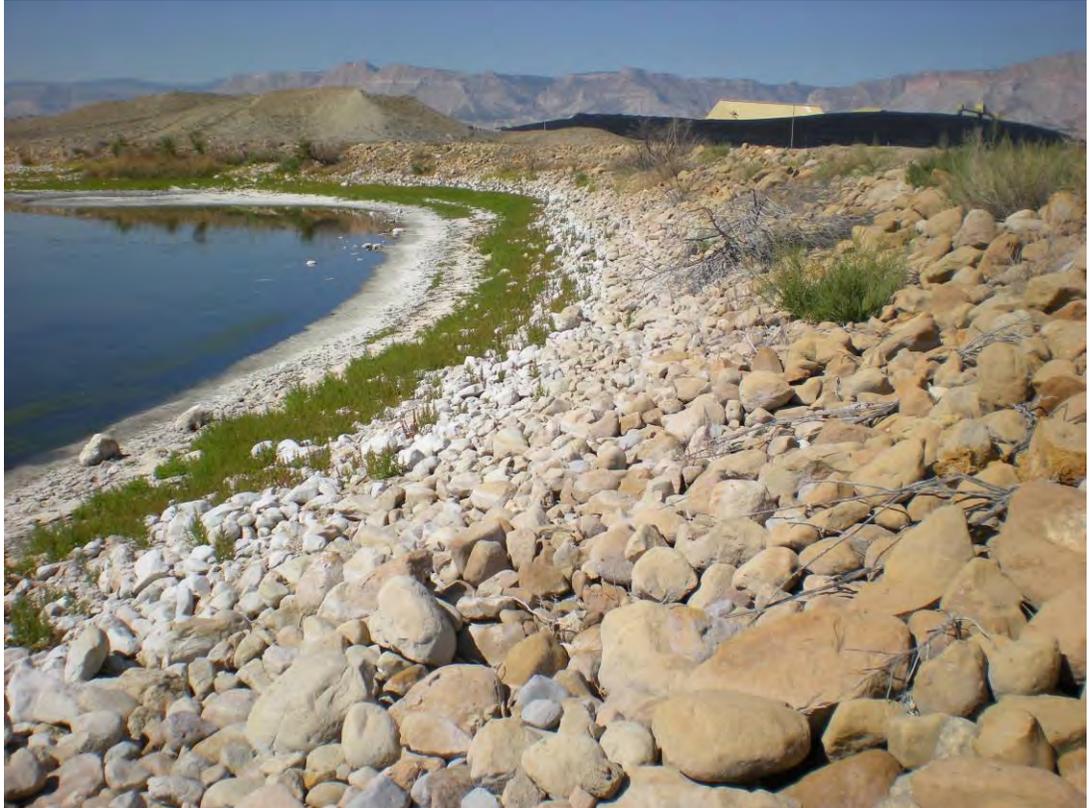
Photo Number:
5

Description:
View of the west side slope of Wastewater Pond #2 from the northwest corner.

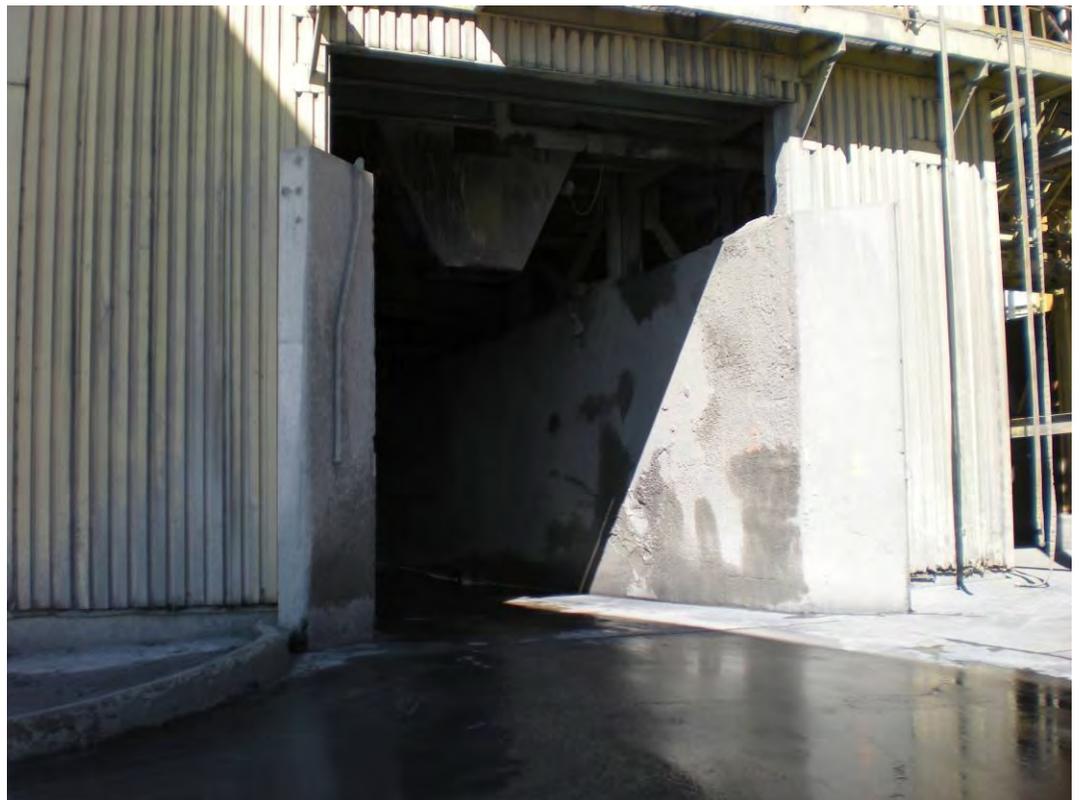
Photo Number:
6

Description:
Typical flyash loading hopper. Fly ash is handled dry at the Hunter Plant and delivered via truck to the Plant's ash landfill.

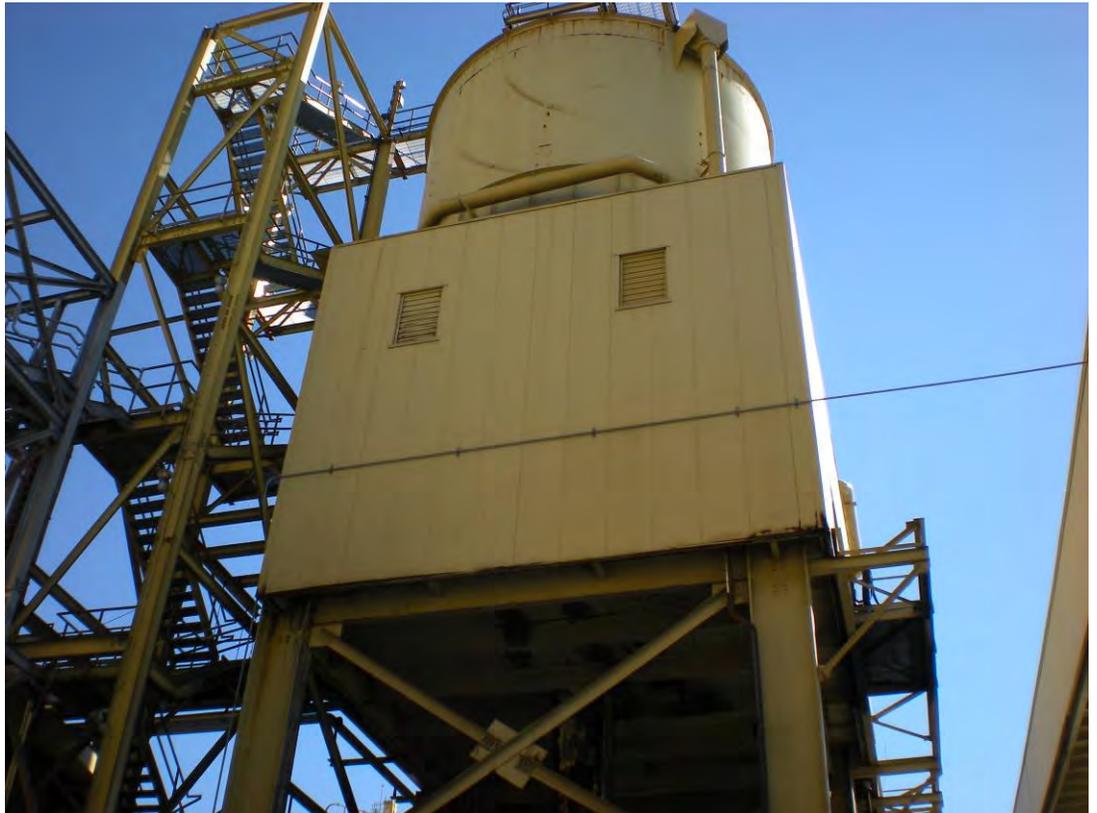
This hydrobin is used to separate sluice water from bottom ash at Unit 3. The

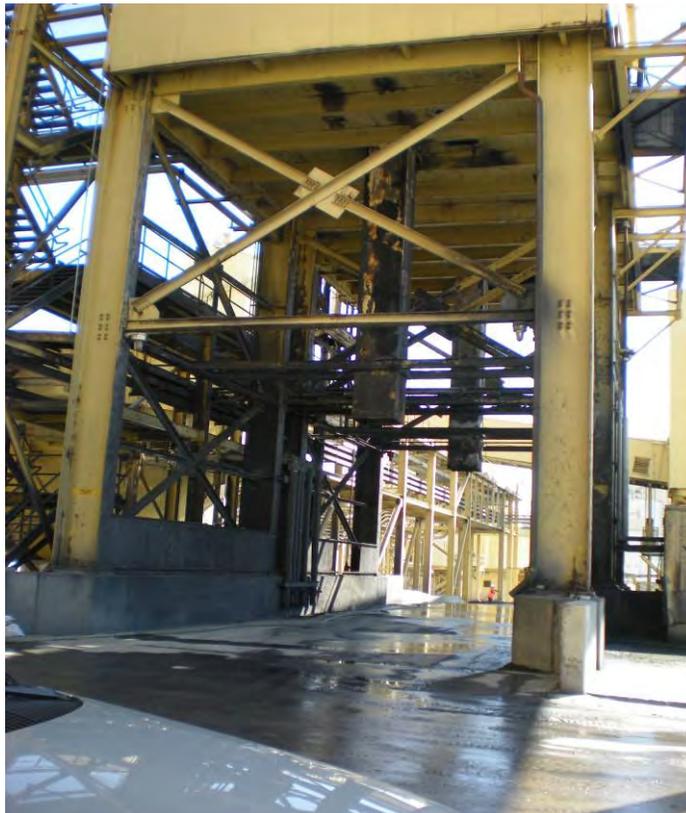
Bottom ash dewatered in the hydrobin is directly loaded into truck from this hopper to be taken to the onsite ash landfill for disposal.
