Dam Safety Assessment of CCW Impoundments

**Hunter Power Plant
Castle Dale, Utah**

**United States Environmental Protection Agency
Washington, DC**

November 15, 2013

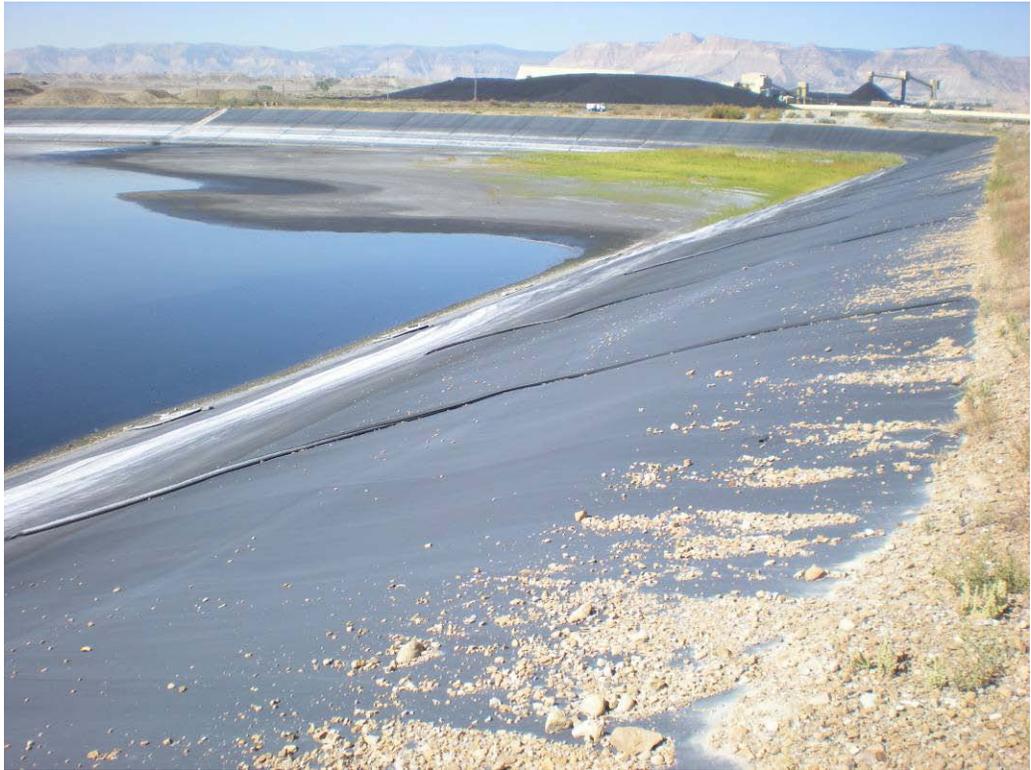
Photo Number:
1

View of northwest corner of Wastewater Pond #1. Some solids have accompanied the wastewater that enters the pond in this corner. Pond slopes are lined with hypalon. Per the drawings, the pond bottom is lined with PVC.

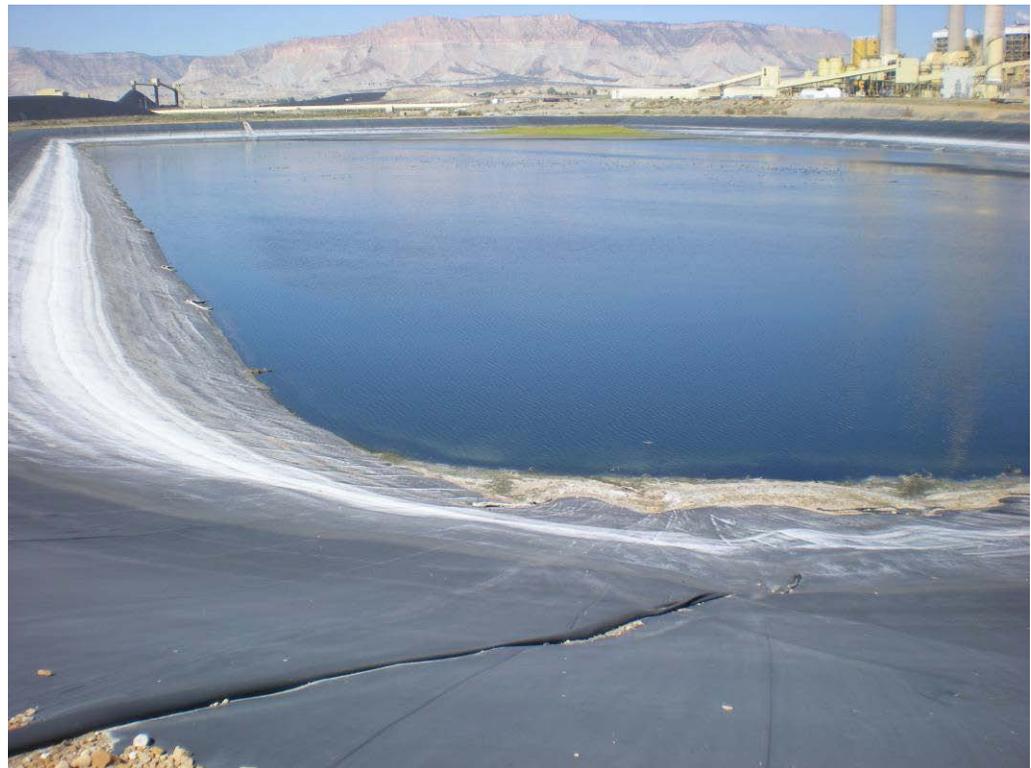
Photo Number:
2

View of Wastewater Pond #1 from the southeast corner looking northwest. The pond is nearly empty. It's stored water is pumped to nearby fields for irrigation.

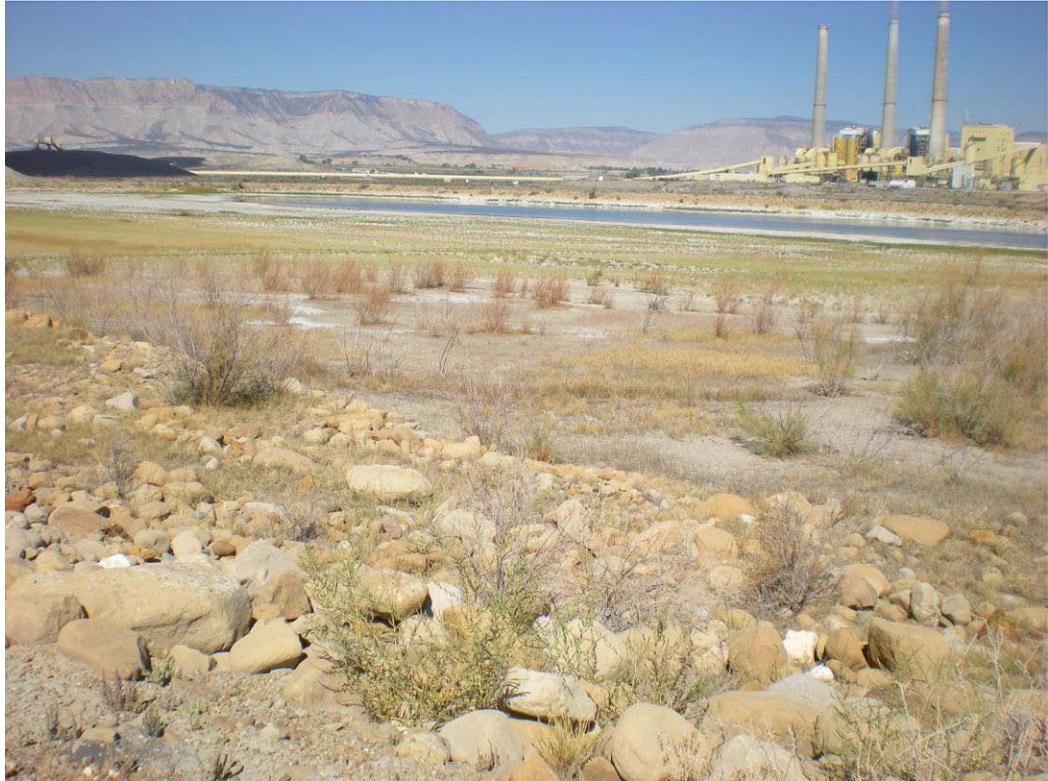
Photo Number:
3

View looking across the interior of Wastewater Pond #2. The pond has a 2-ft. thick clay liner on the bottom and slopes. The slopes are protected by a layer of rip rap. Volunteer vegetation has taken hold while the pond is nearly empty.

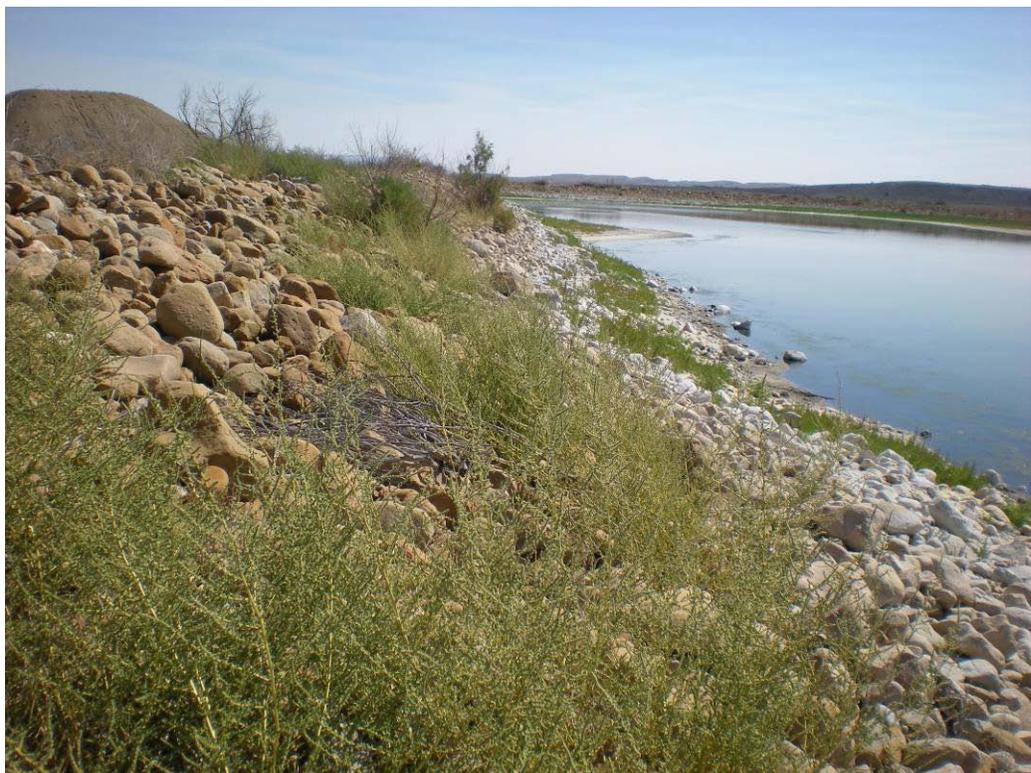
Photo Number:
4

View of the north side slope of Wastewater Pond #2 looking east from its northwest corner. Some volunteer vegetation has taken hold in the rip rap protection.

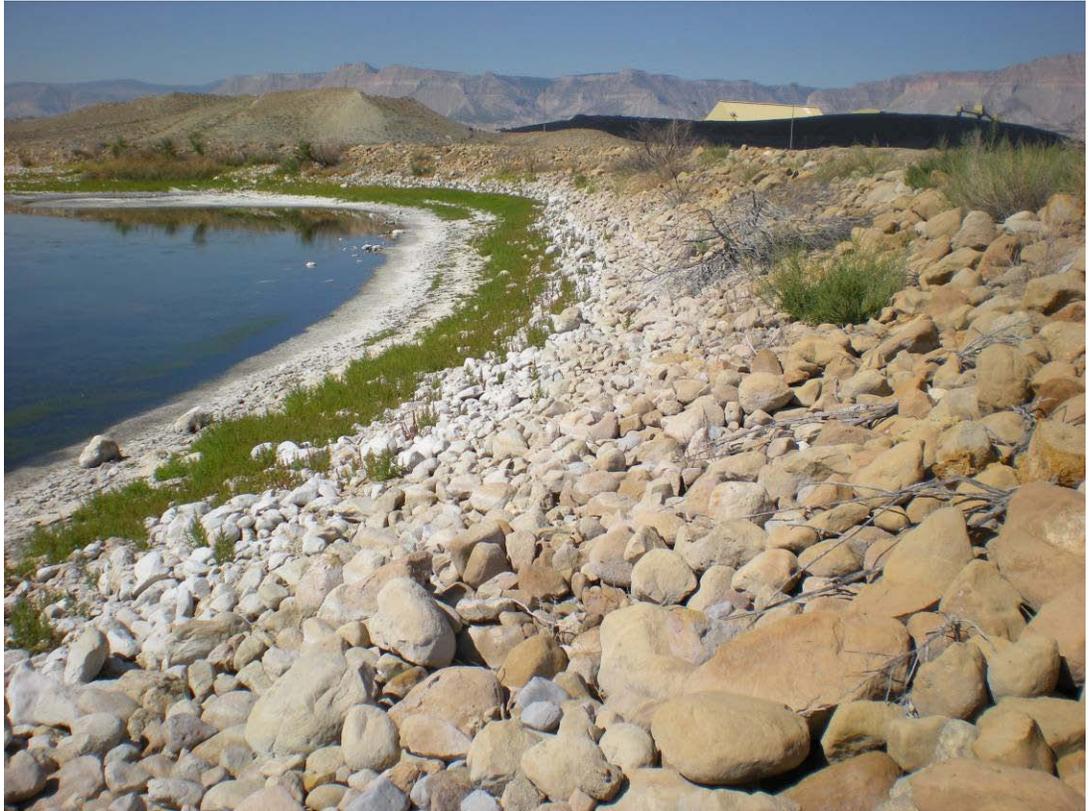
Photo Number:
5

Description:
View of the west side slope of Wastewater Pond #2 from the northwest corner.

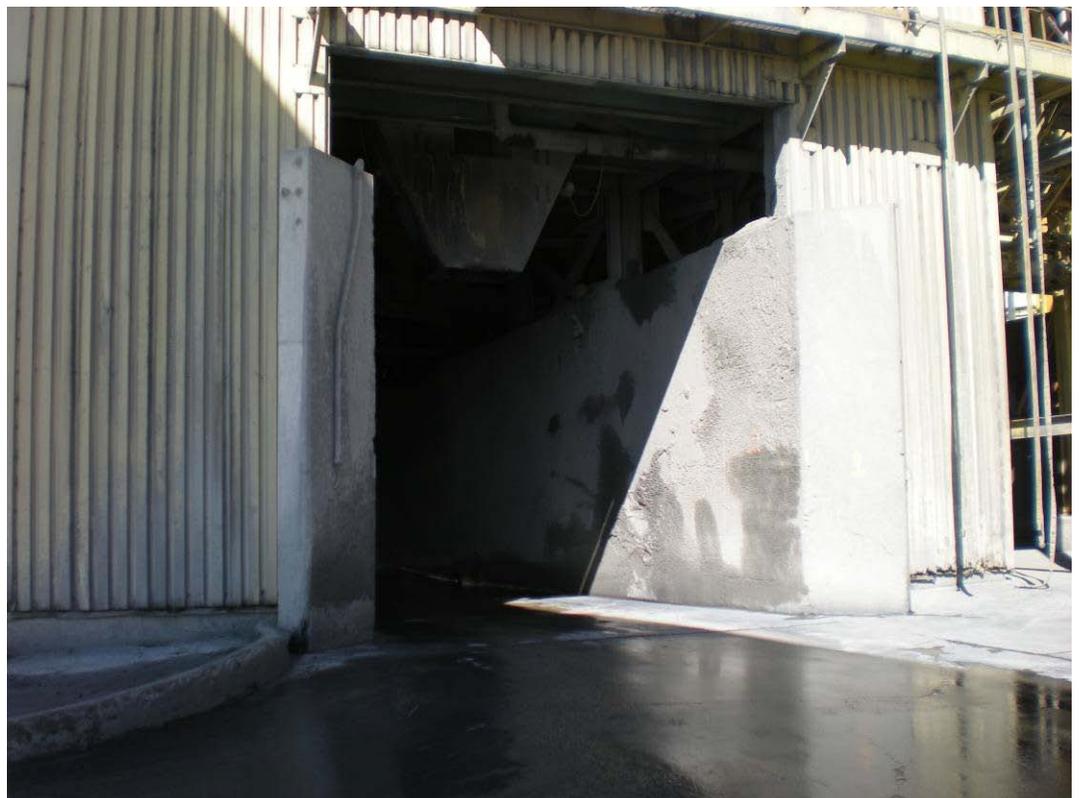
Photo Number:
6

Description:
Typical flyash loading hopper. Fly ash is handled dry at the Hunter Plant and delivered via truck to the Plant's ash landfill.

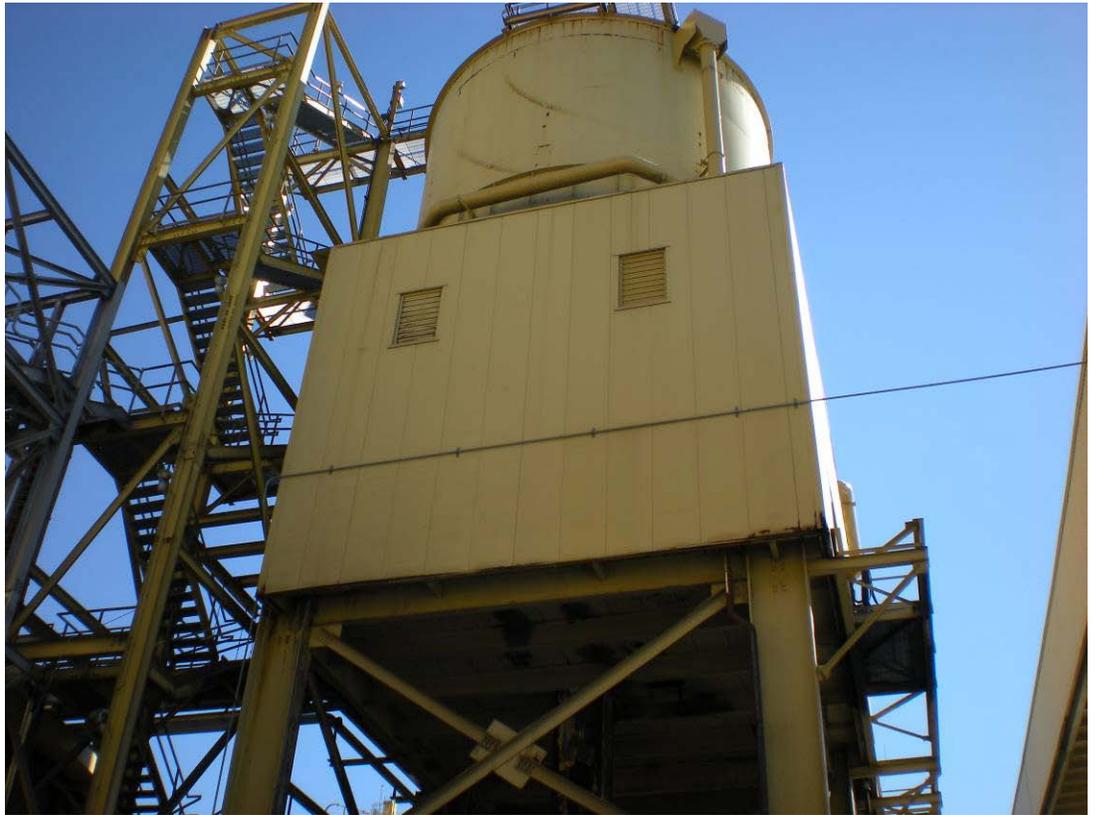
This hydrobin is used to separate sluice water from bottom ash at Unit 3. The

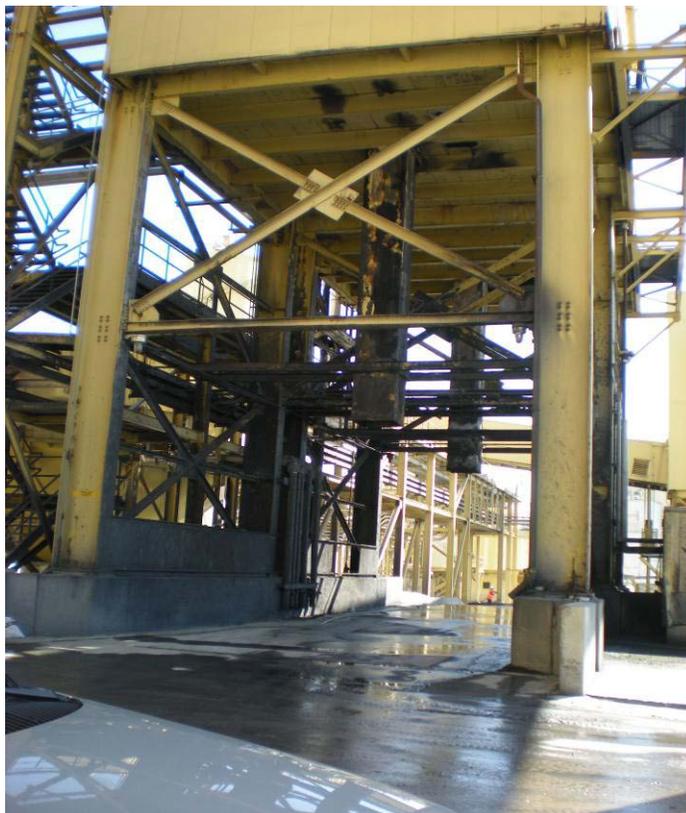
Bottom ash dewatered in the hydrobin is directly loaded into truck from this hopper to be taken to the onsite ash landfill for disposal.
