Coal Combustion Residue Impoundment

Round 9 - Dam Assessment Report

L.V. Sutton Steam Electric Plant

Ash Ponds

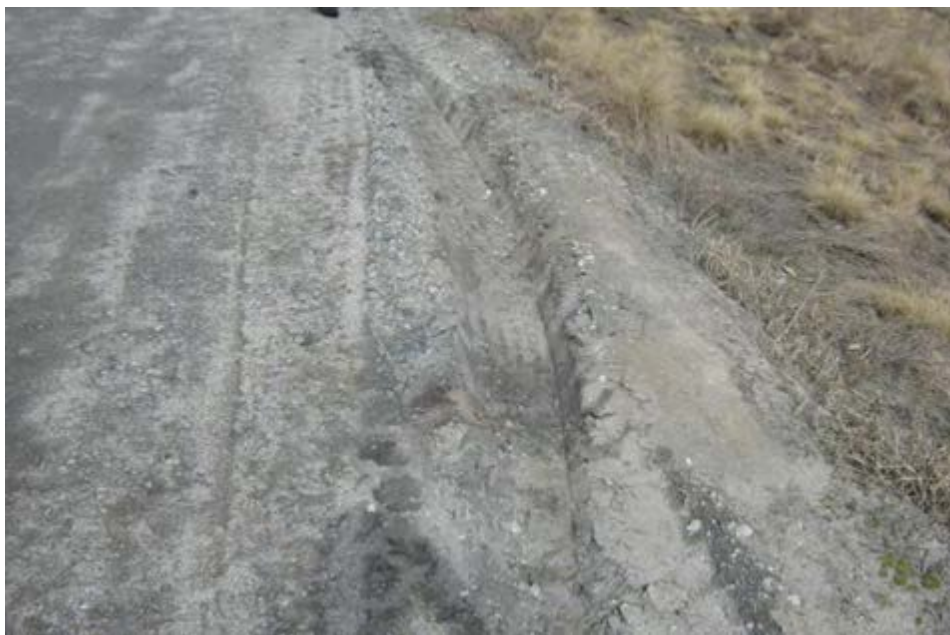
The crest had no signs of depressions, tension cracking, or other indications of settlement or shear failure and appeared to be in satisfactory condition; however, there were signs of minor rutting, most likely from vehicular traffic.

Vehicular rutting along crest

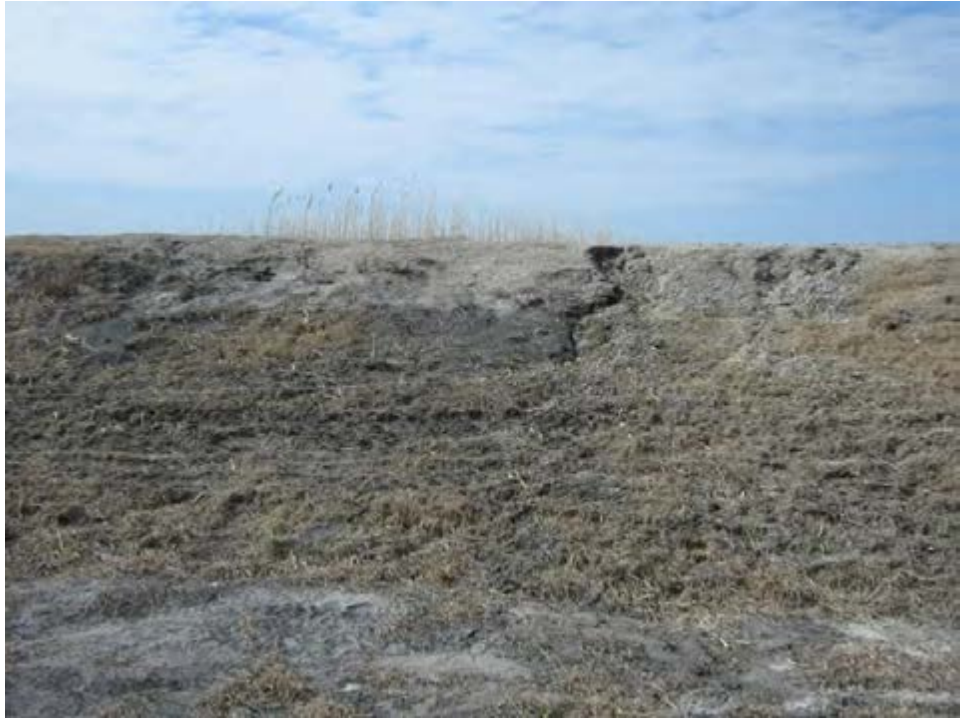
There were no signs of surficial sloughing along the downstream slope. Rill erosion and animal burrows were found in multiple places along the embankment. There were also areas that were bare and need to be seeded.

Rill erosion along downstream slope, 1984 Ash Pond

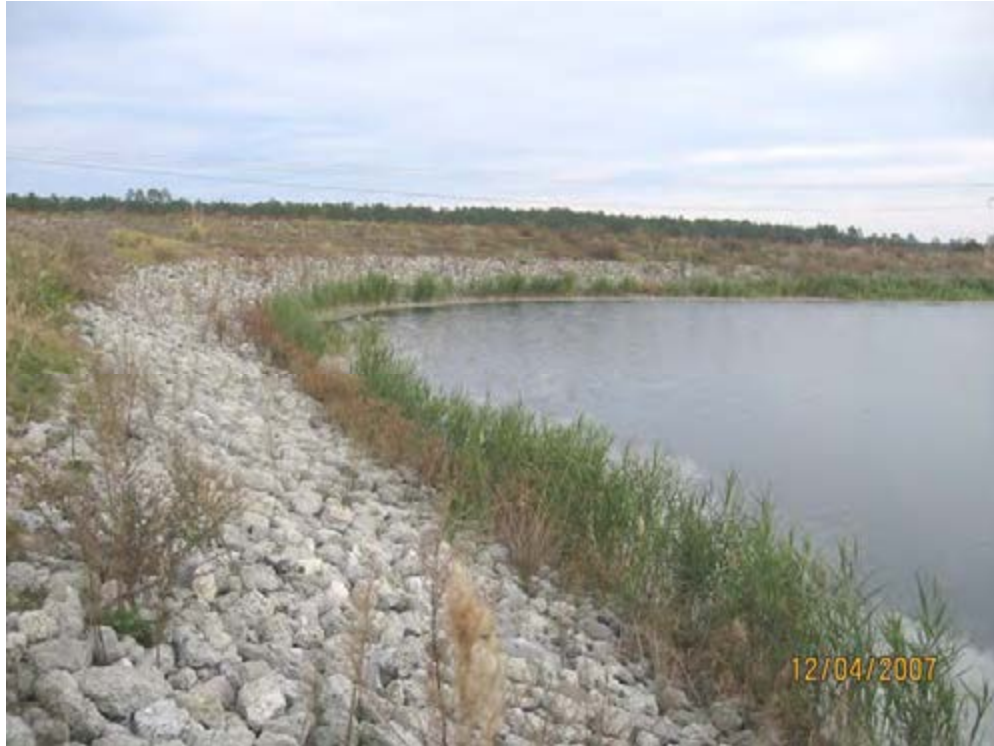
Photo 6. 1984 Ash Pond – Interior slope newly repaired with rip rap. Typical of section with good rip rap.

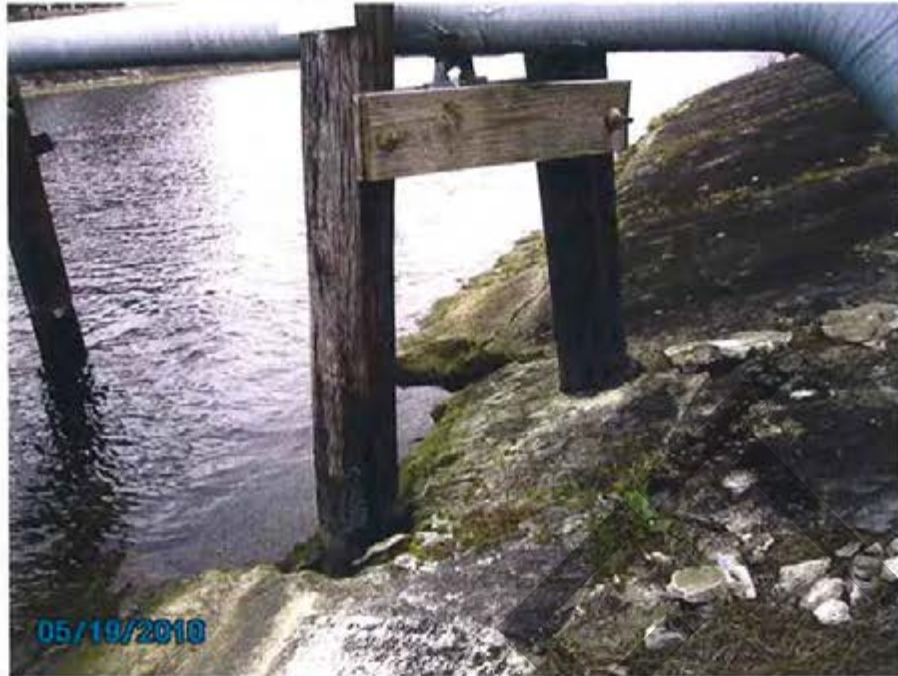
39. Cooling Pond – View of slope protection damage at pipe support on interior slope near the sluice gate structure.

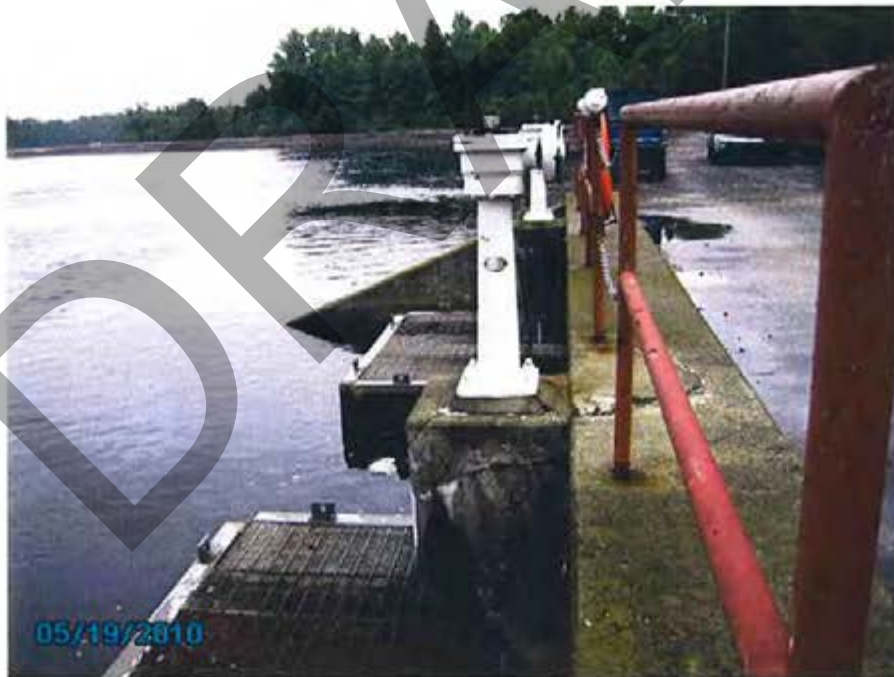
40. Cooling Pond – View of concrete cracking at sluice gate support on north side of discharge structure.

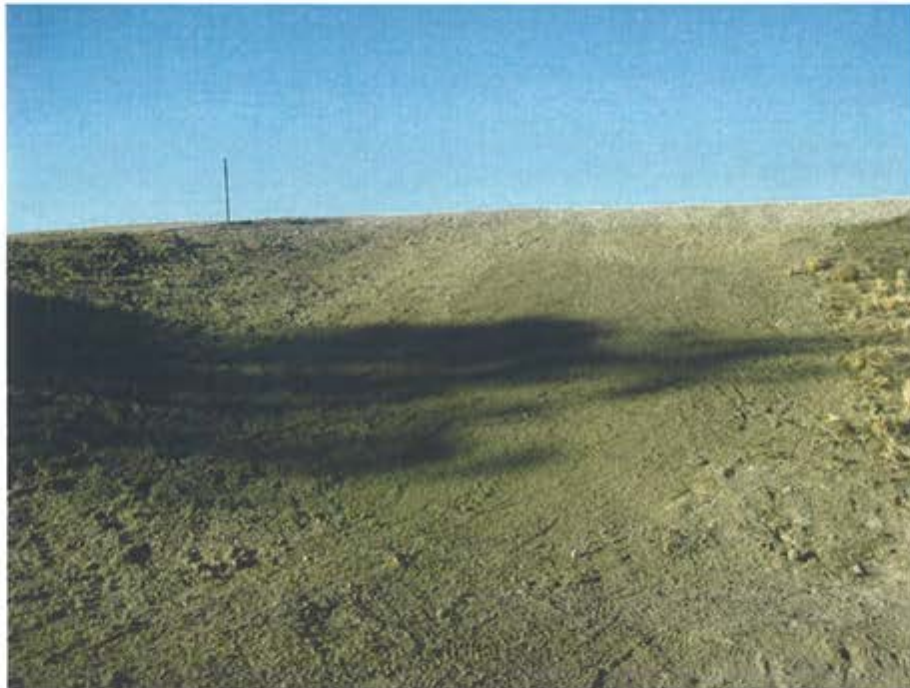
Photo 6. Completed repair slope.
