US EPA ARCHIVE DOCUMENT

| Site Name: <u>Progress Energy Asheville</u> | Date: <u>29 MAY 2009</u> |
| Unit Name: <u>1964 POND</u> | Operator's Name: <u>PROGRESS ENERGY</u> |

PHOTOGRAPH LOCATION PLAN  
ASH PONDS - PROGRESS ENERGY  
ASHEVILLE STEAM ELECTRIC PLANT  
SKYLAND, NORTH CAROLINA

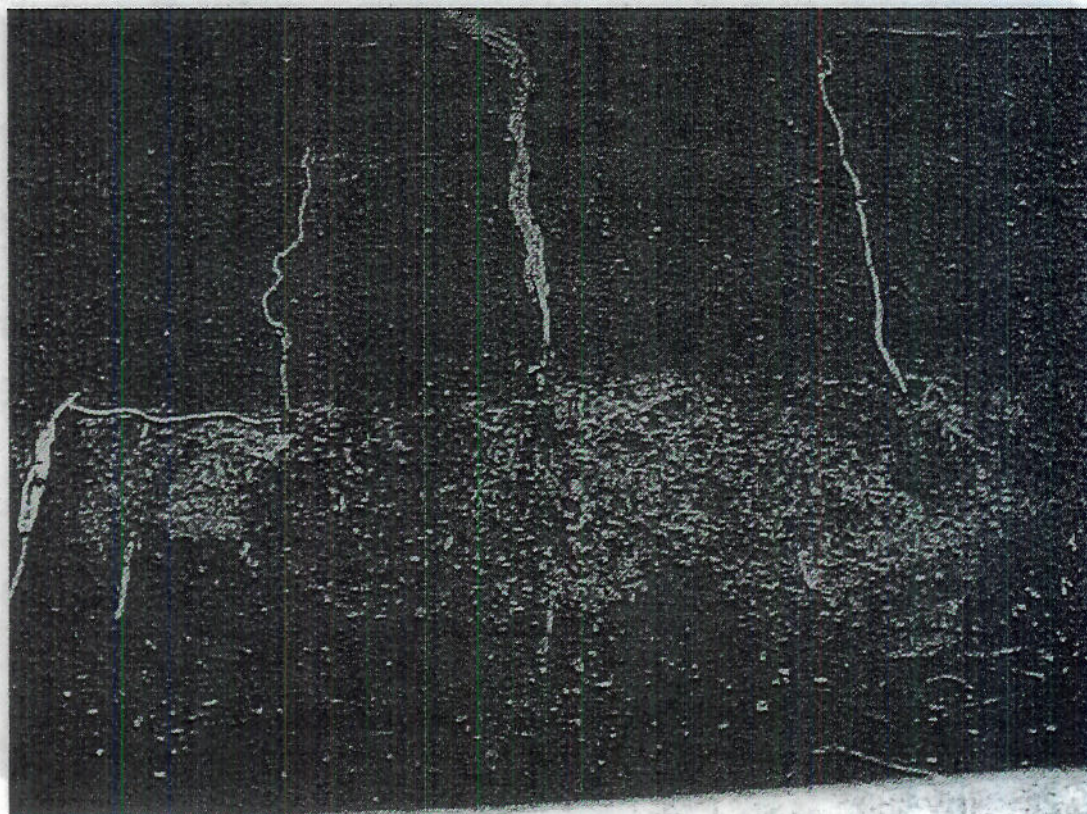
Photograph 8: Cooling Lake Dam – spalling concrete on ogee spillway.

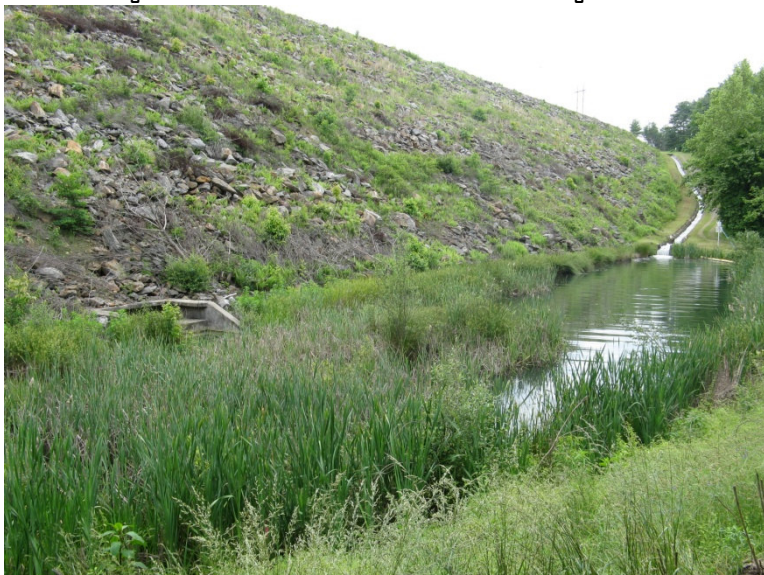
Photo 6: 1964 Dam - Concrete Flume Deterioration, Right Groin, Photo: 090, 5/29/09  
(note: right and left are based on the observer facing downstream)
