**Coal Combustion Waste Impoundment
Dam Assessment Report**

*Site 7
1982 Pond & 1964 Pond
Progress Energy Carolinas
Asheville, North Carolina*

**Project # 0-381
Assessment of Dam Safety
Coal Combustion Surface Impoundments
For the REAC Program**

June 2009

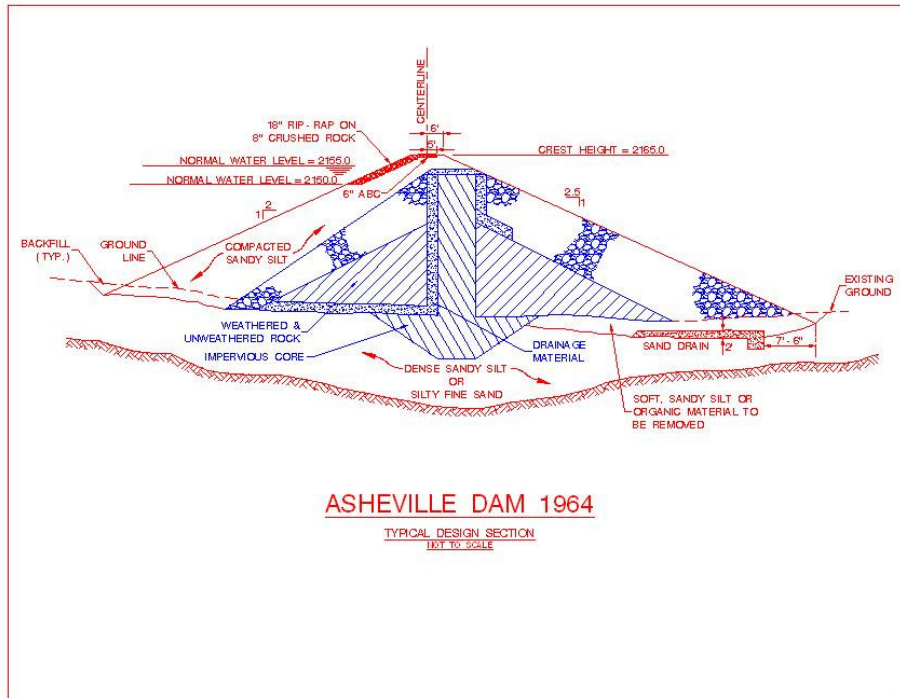
1964 Dam – The dam embankment is a composite of compacted random earth fill and rock fill with a vertical impervious core and chimney drain system to control seepage. The following figure of the 1964 Dam Typical Design Section is representative of the configuration of the management unit.

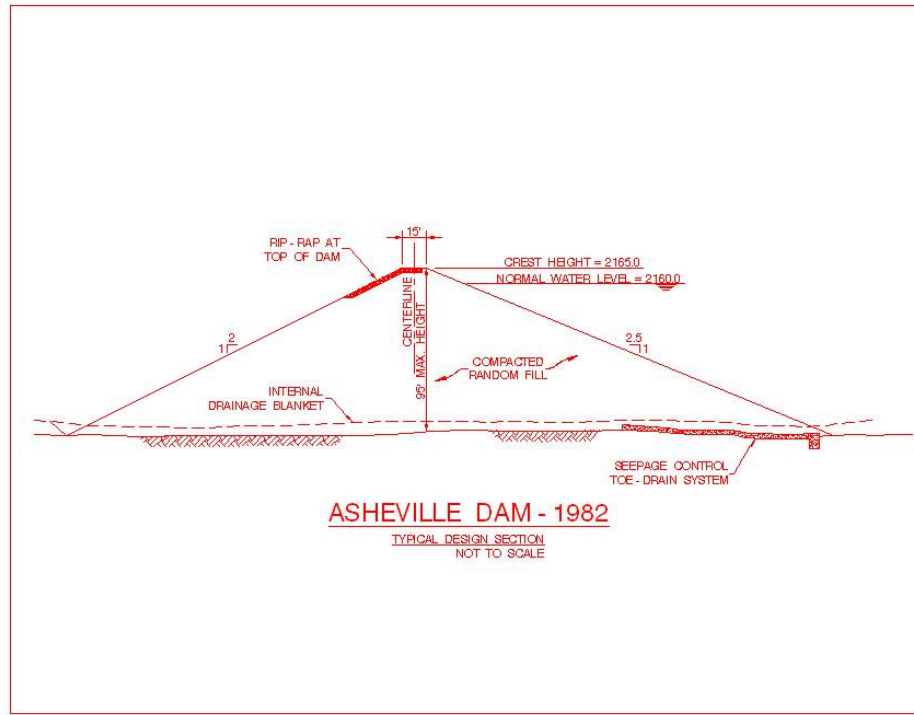
1982 Dam - The dam embankment consists of compacted random earth fill with an internal drainage blanket and toe-drain system to control seepage. The following figure of the 1982 Dam Typical Design Section is representative of the configuration of the management unit.
