# Assessment of Dam Safety Coal Combustion Surface Impoundments Draft Report

Progress Energy  
Carolinas  
Cape Fear Plant

Moncure, North Carolina

July 17, 2009

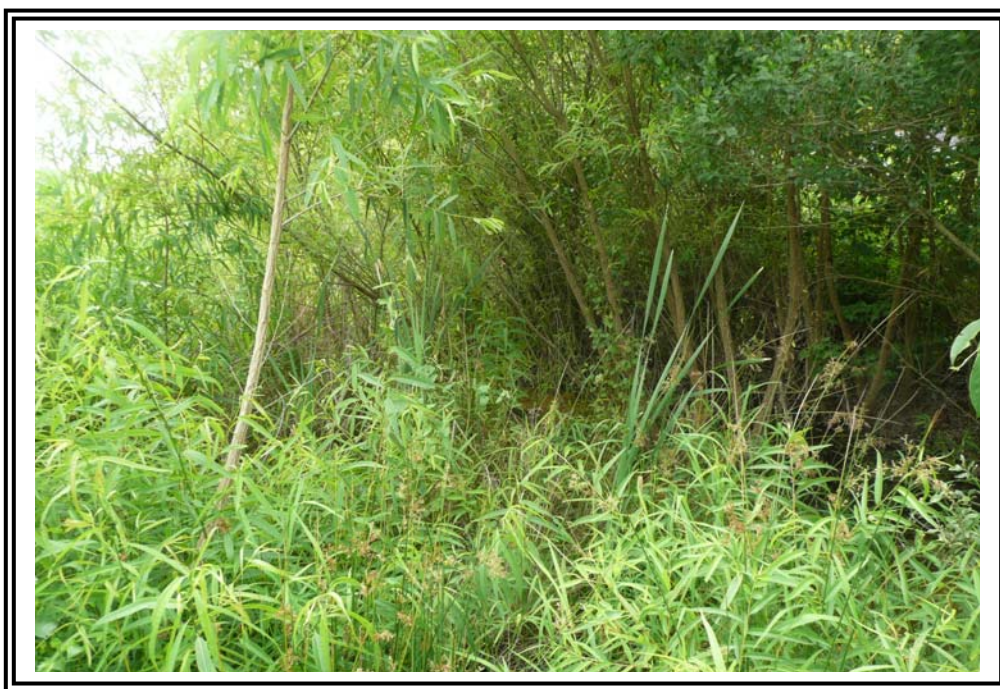
5

Woody growth along the West Dike of the 1985 Ash Pond.

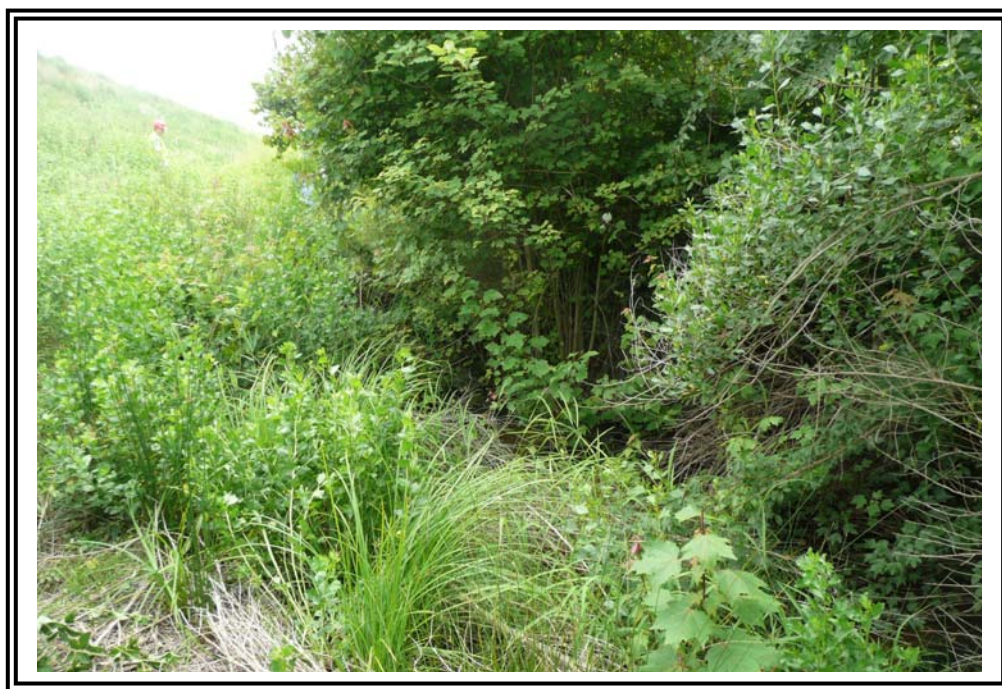
7

Tree growth at the toe of the 1985 Ash Pond West Dike.

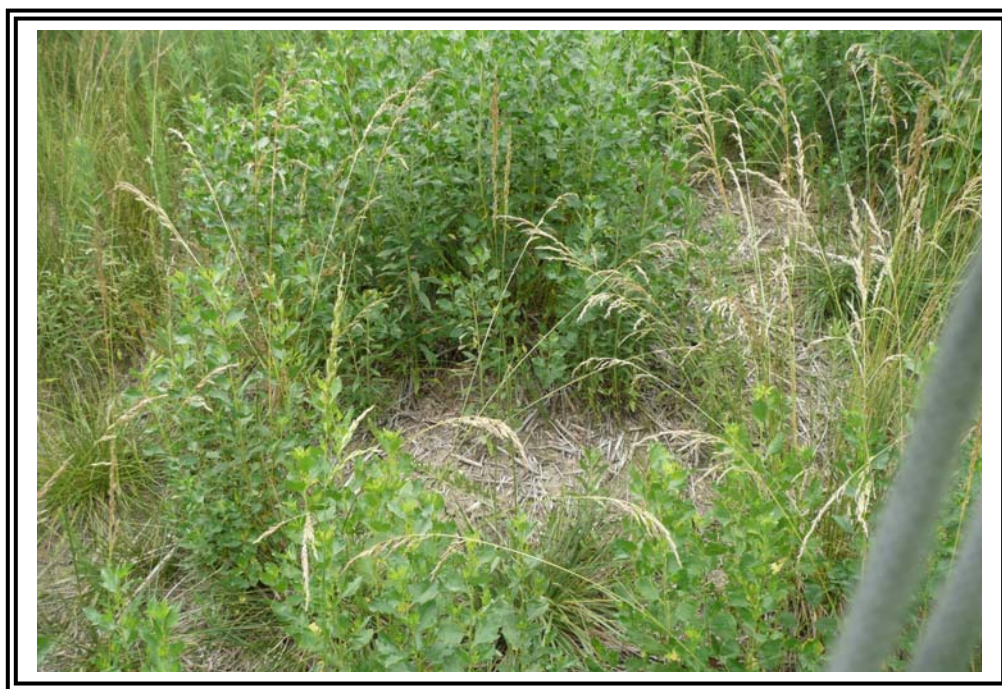
11

Sparse and weedy vegetation cover on the 1985 Ash Pond West Dike.

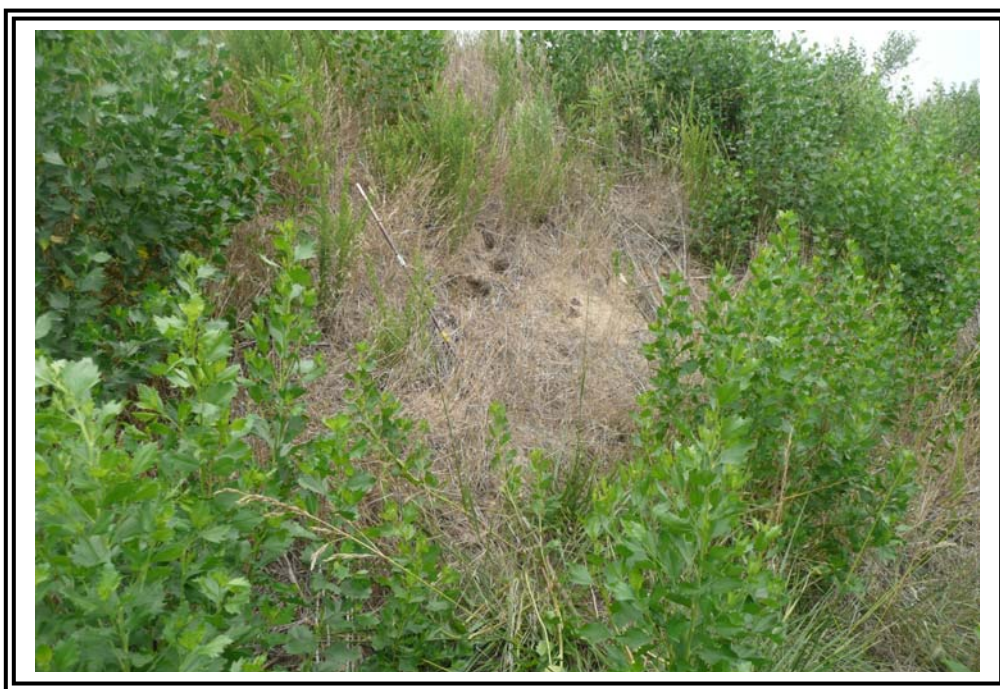
13

In the southern portion of the west dike, a 3 to 4 foot high scarp was observed near the top of the slope as shown in Photo 13. CHA observed that in the area of the voids discussed in the paragraph above, and at the edges of the scarp, the vegetation was dead.

Scarp about 3 to 4 feet high near the top of the 1985 Ash Pond West Dike.

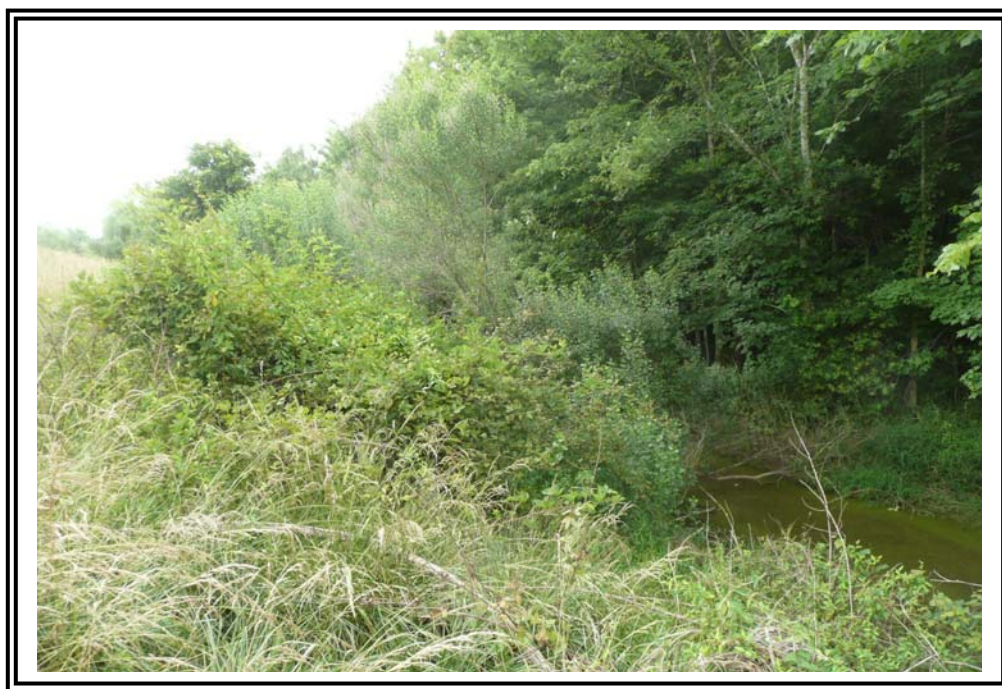
15

Drainage swale/channel adjacent to toe of 1985 Ash Pond.

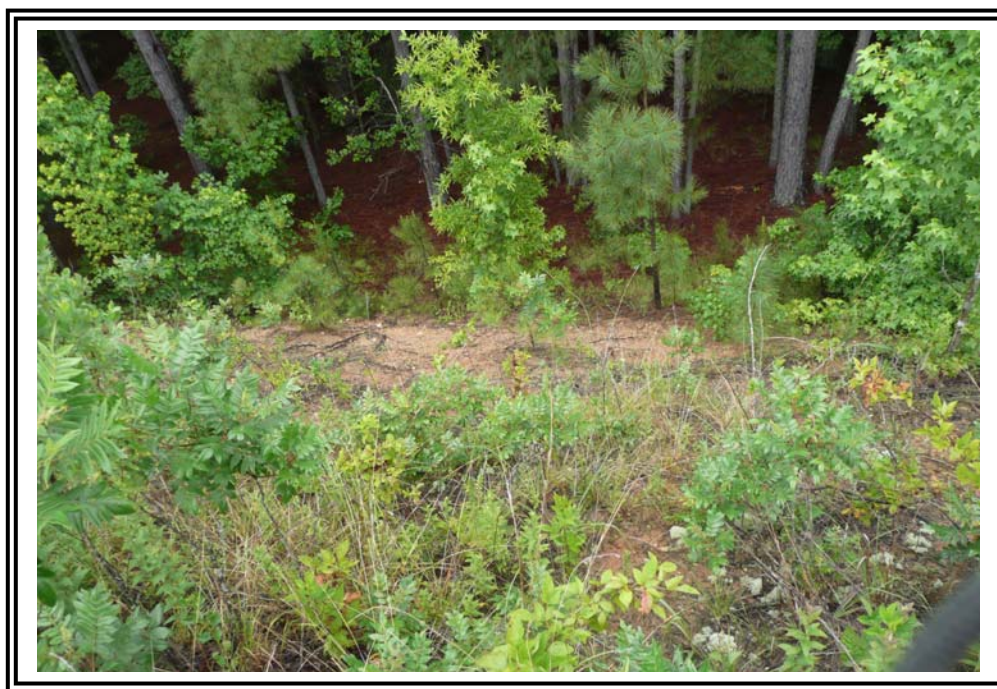
61

Downstream slope of the 1978 Ash Pond Dike.  
Note: Rows of trees are immediately beyond the toe.

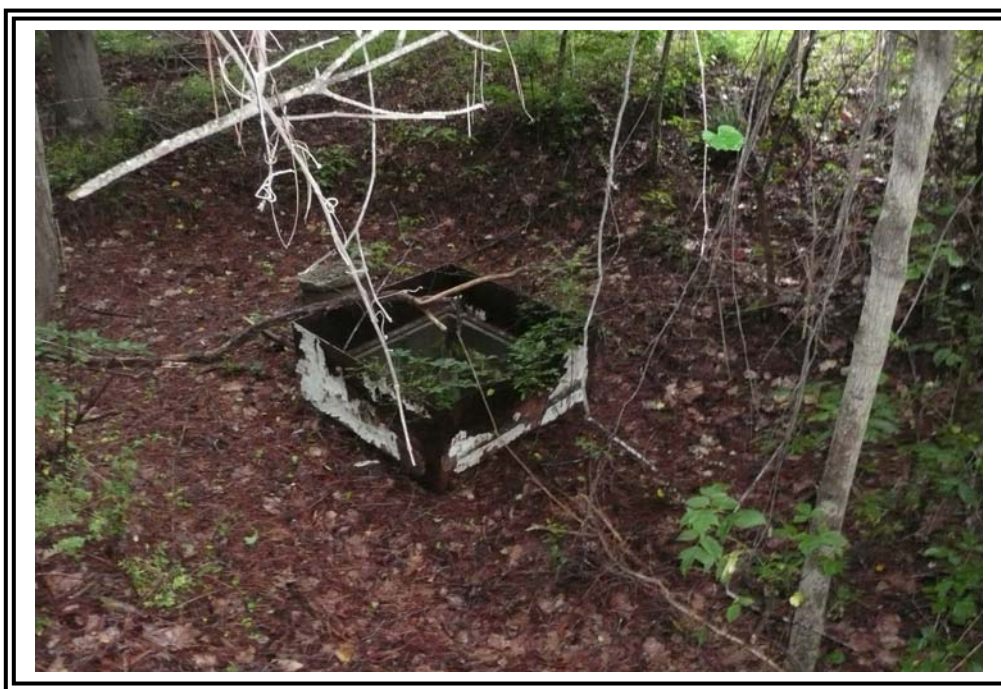
77

1970 Ash pond outlet control structure. Note: water level in south end of pond was several feet lower than outlet during our visit.

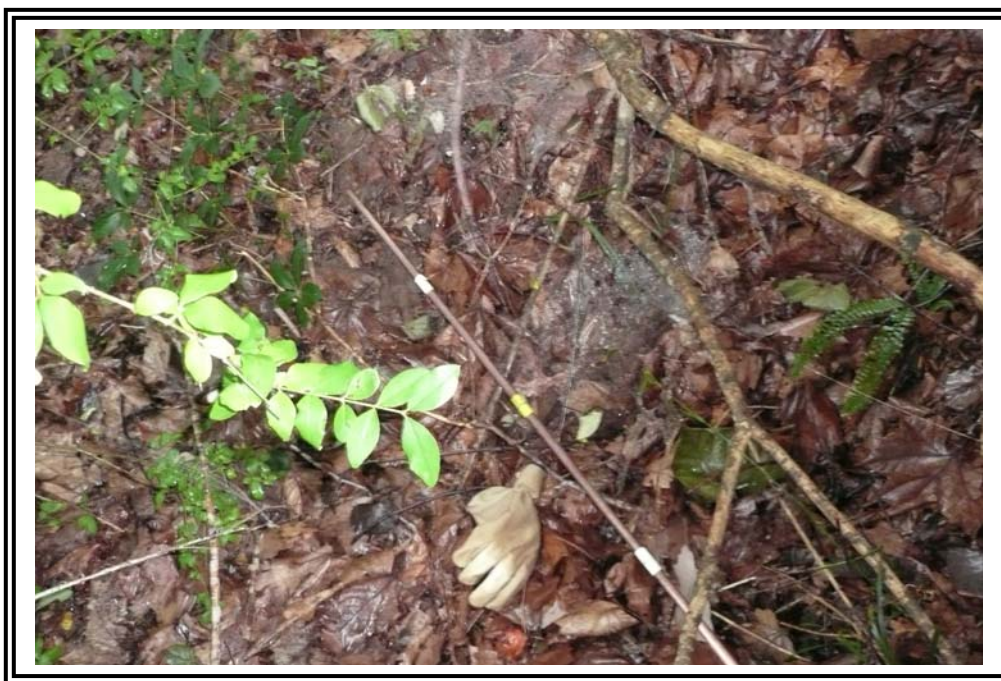
82

Erosion feature along 1970 Ash Pond west dike toe. Work glove placed below 4' probing rod supported at edge of feature for scale purposes.

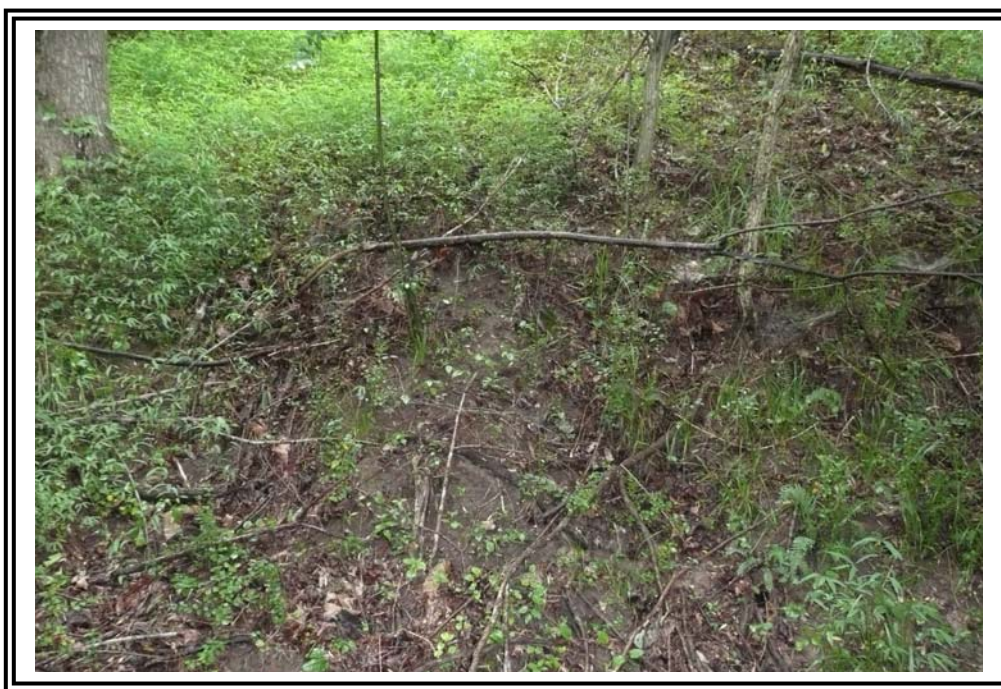
83

Surface erosion on 1970 Ash Pond west dike downstream slope.

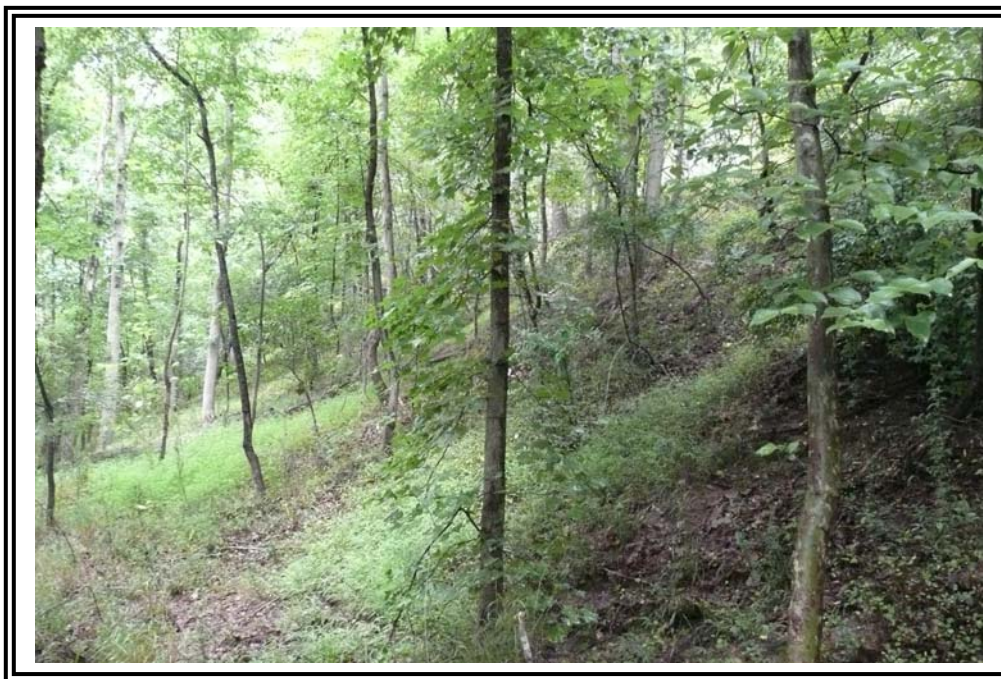
86

Steepened conditions on 1963 Ash Pond west dike from surface erosion and sloughing.

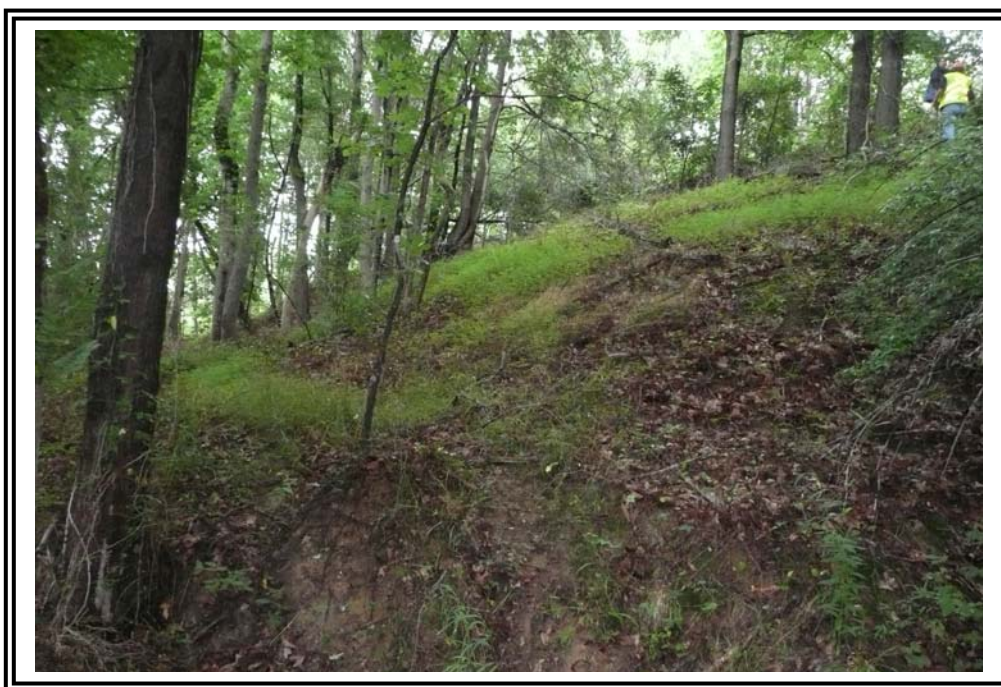
87

Steepened conditions on 1963 Ash Pond west dike from surface erosion and sloughing.

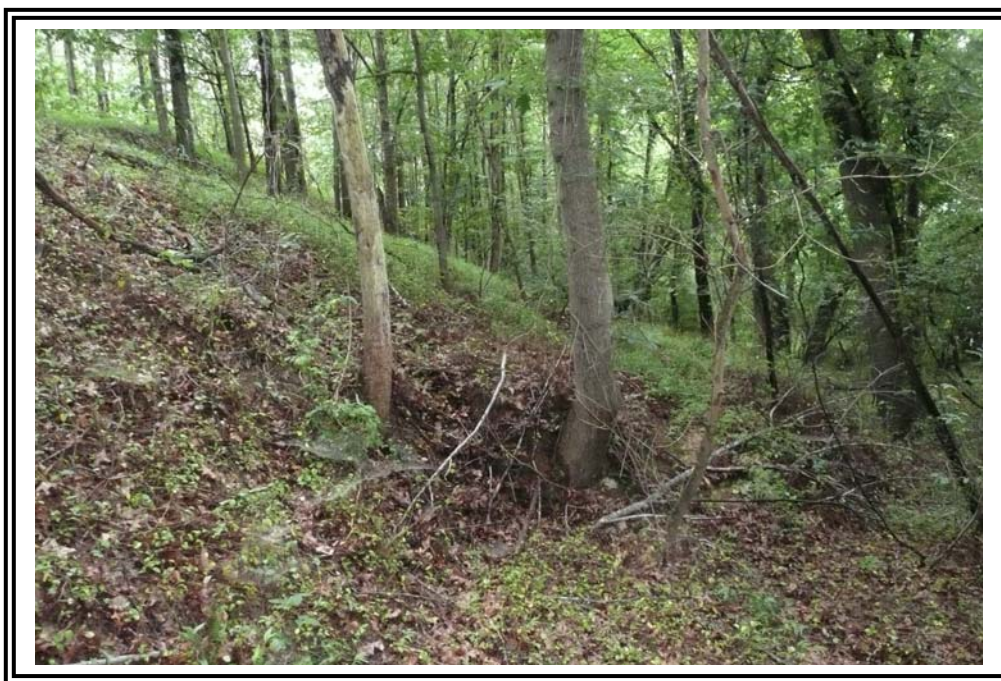
88

In 1982, a slope failure occurred on the north end of the west dike in the 1963/1970 ash pond adjacent to the Cape Fear River. According Progress Energy's engineering consultant (MACTEC), at that time it was proposed to repair the failure with a rip-rap berm placed at the dike toe on the banks of the river channel. As the repair was being implemented, construction activity initiated additional instability and deformation (possibly localized vibratory induced liquefaction) and the work was halted with only a portion of the proposed rip-rap being placed at the river's edge and base of the dike. An independent engineering review and analysis of the failure was completed after the partial repair construction was halted and concluded that the dike was acceptable because the pond had been inactive since 1970 and the dike was impounding mostly sedimented ash.

Steepened conditions on 1963 Ash Pond west dike from surface erosion and sloughing from the partially repaired 1982 slide.

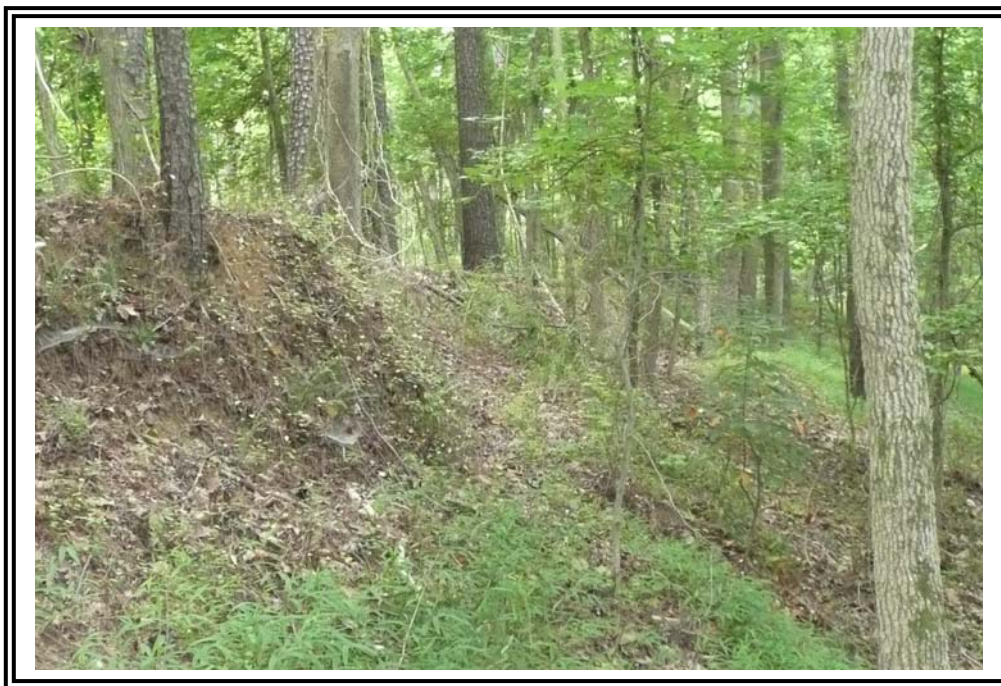
Along the northwest to east sides of the 1956 Ash Pond there is 3 to 8 feet of freeboard between the top of the deposited ash and the crest of the dikes. The downstream slopes are severely eroded, have experienced fallen (uprooted) trees, and sloughing. Examples of these conditions and the resulting steepening of the downstream slopes are shown in Photos 98 through 101, and 103.

Typical of frequent areas of erosion on the downstream slopes of the 1956 Ash Pond Dikes.
