Coal Combustion Residue Impoundment

Round 9 - Dam Assessment Report

H.F. Lee Steam Electric Plant

*Active Ash Pond; Ash Pond 1; Ash Pond 2;
Ash Pond 3*

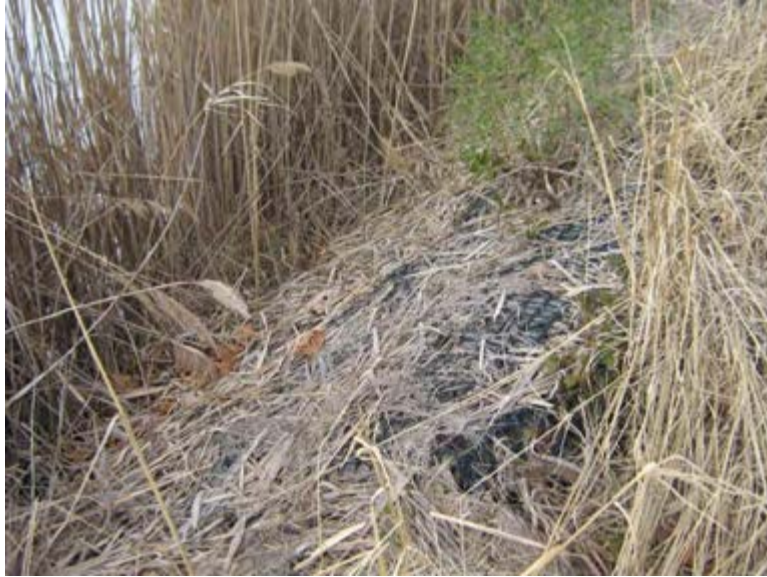
The upstream slopes are mostly vegetated with tall grasses and other wetland vegetation. The upstream slope is also embedded with stone/riprap held down by a geotextile fabric. No scarps, sloughs, depressions, bulging or other indications of slope instability or signs of erosion were observed.

Riprap and geotextile fabric along upstream slope

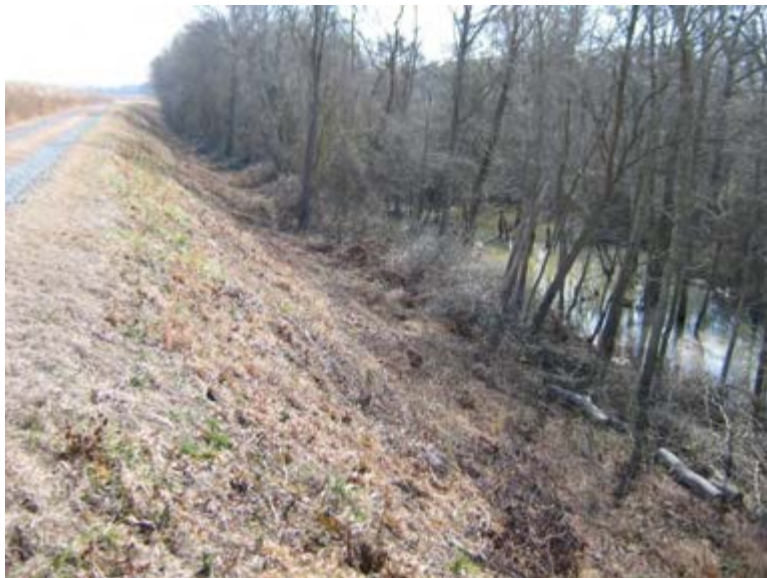
There were no signs of surficial sloughing, rill erosion or cause for concerns along the downstream slope and toe. The repair from 2000 due to seepage is complete and is being monitored. Repairs were made after the initial site visit that addressed seepage along the downstream slope (Appendix A, Doc 11: Approval to Impound and Doc 12: Seepage Repair As-builts). There were areas where a concrete buttress was along the downstream sloped, which was explained by Progress Energy to be a part of the original design. There were wetlands and drainage channels along the toe of the slope in areas.

Wetlands along downstream toe

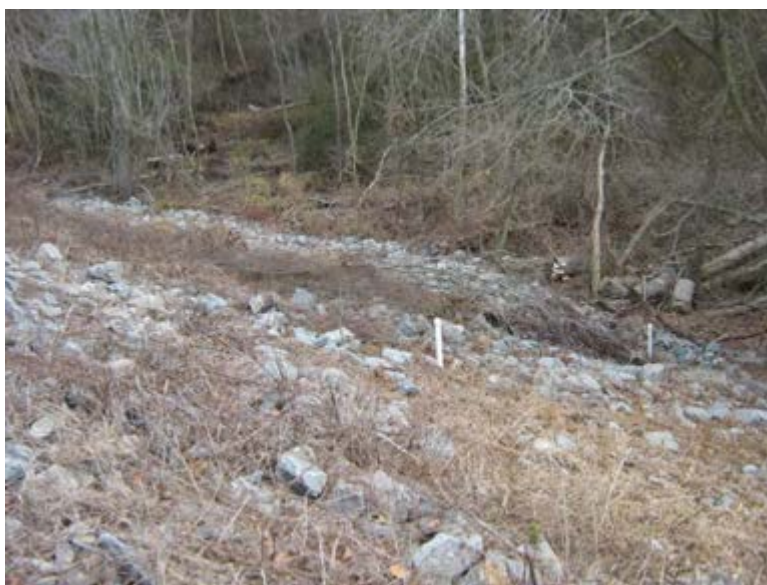
Riprap at seepage location that was repaired

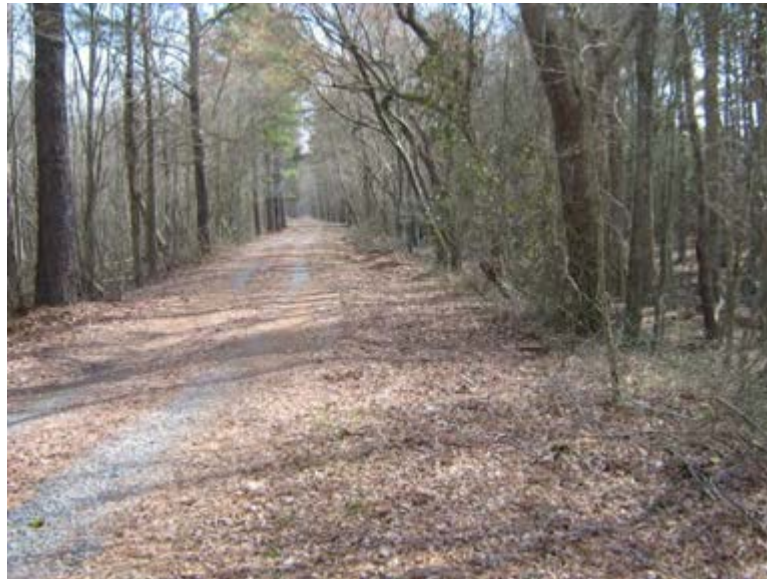
The crest had no signs of depressions, tension cracking, or other indications of settlement or shear failure and appeared to be in satisfactory condition.

Typical view of crest, upstream and downstream slope

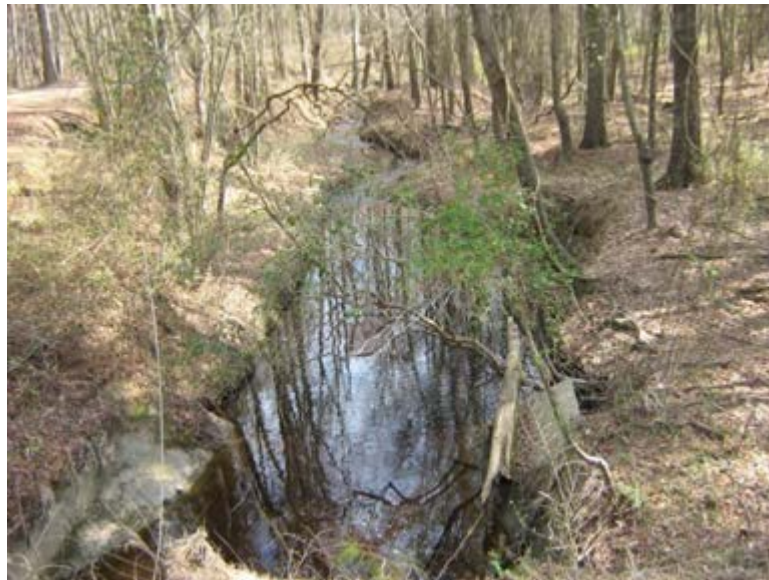
Also, Pond 2 of the three inactive Ash Ponds was observed to have a significant area of scarp at the toe of the downstream embankment caused by erosion from the adjacent creek. Stabilization and protection against future erosion is recommended.

The downstream slopes were heavily vegetated. There were 2 areas observed showing significant undercutting along the east side of the embankment where an active stream flows at the toe.

Significant erosion was occurring downstream of this picture

Stabilization and protection against future erosion is recommended for Ash Pond 2 (in-active). No recommendations appear warranted at this time for Ash Pond 1 (in-active) and Ash Pond 3 (in-active).

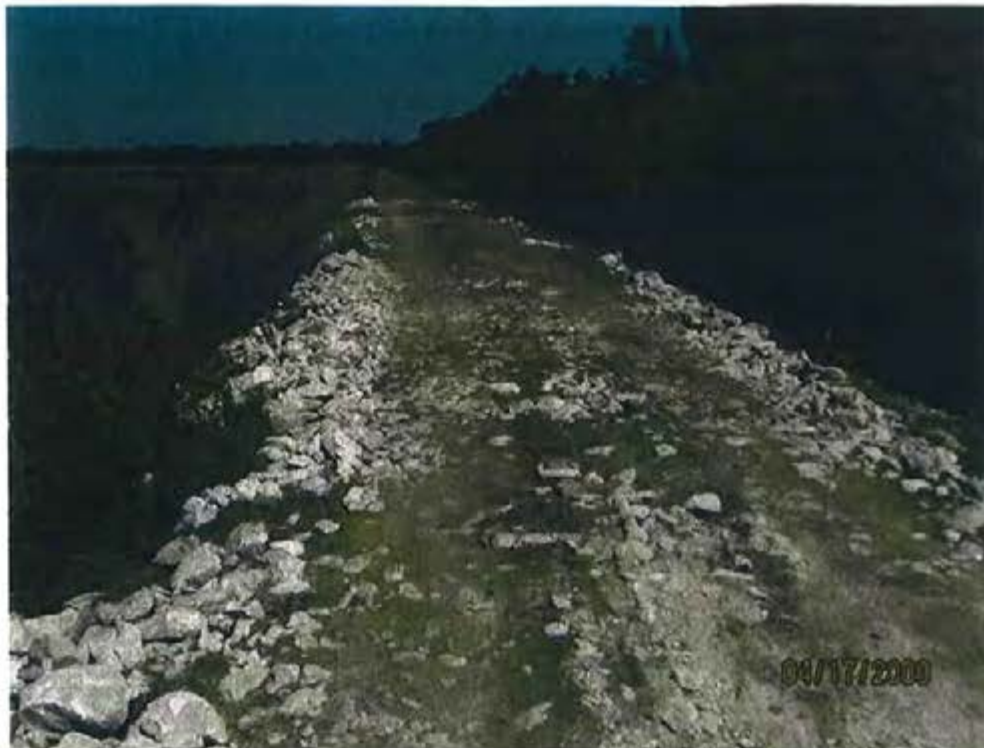
5. Crest condition 4-17-09. Additional cleanup of rip rap needed.

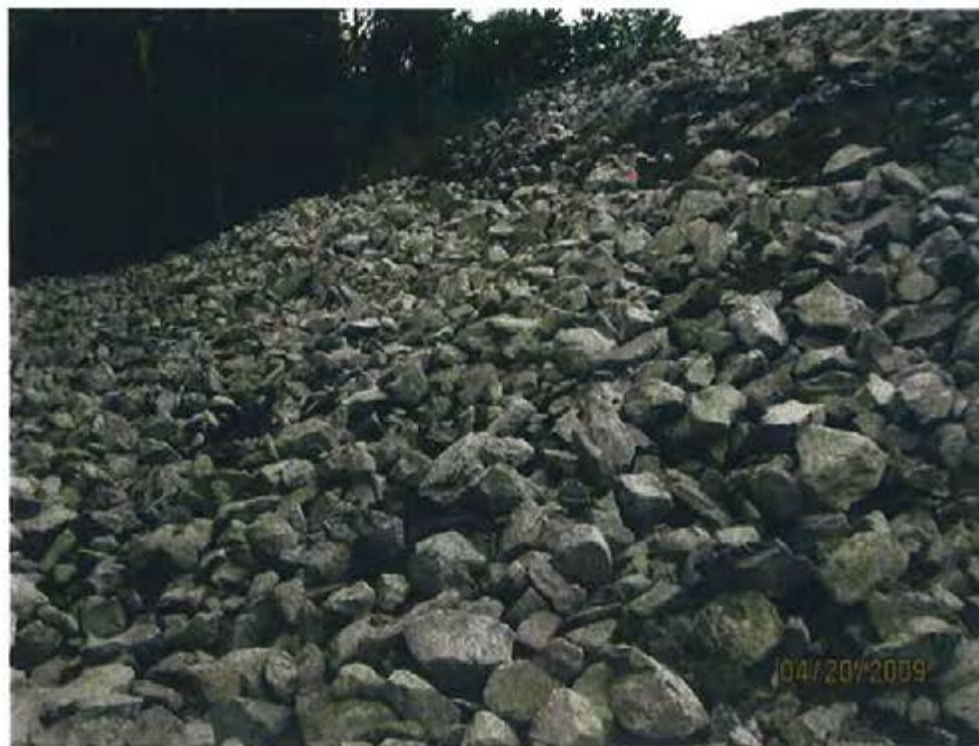
6. Overview 4-20-09. Note a few remaining spots that need more rip rap.

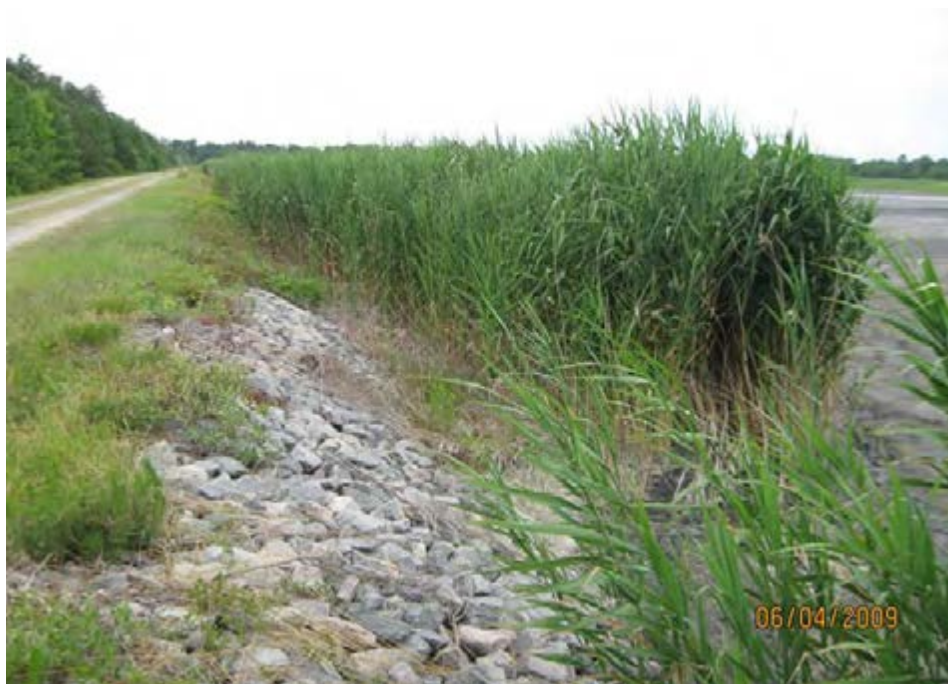
22. ASH POND- Crest and interior slope-east dike. Note good conditions of rip rap repair.

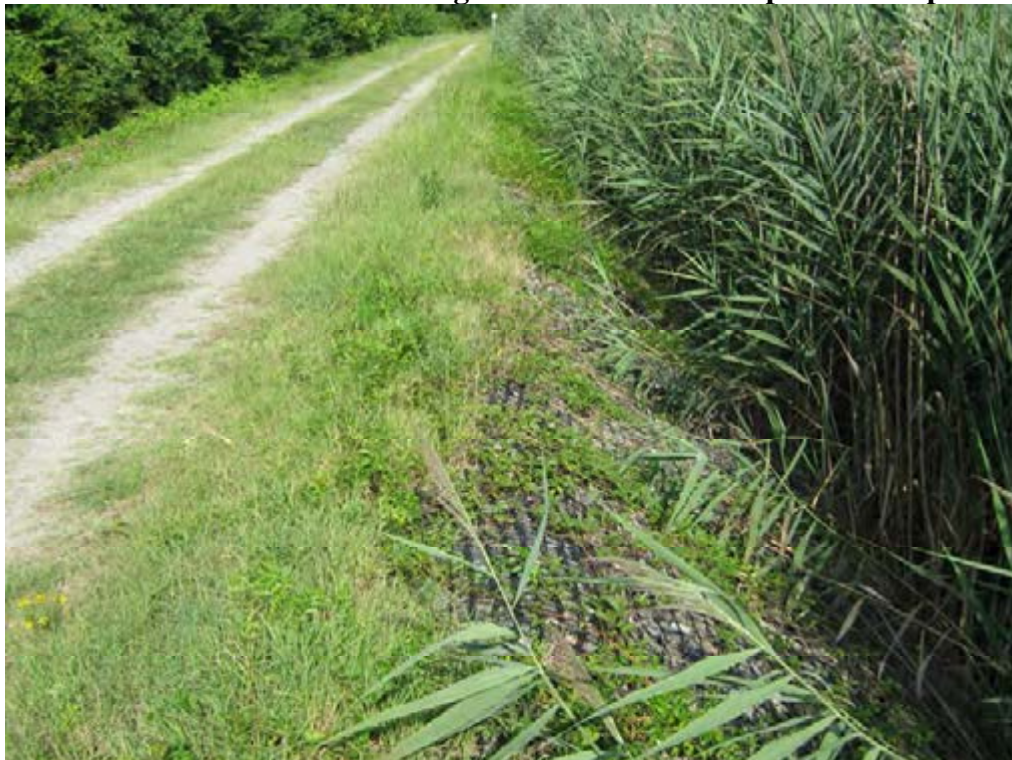
25. ASH POND- Interior slope repair-south dike

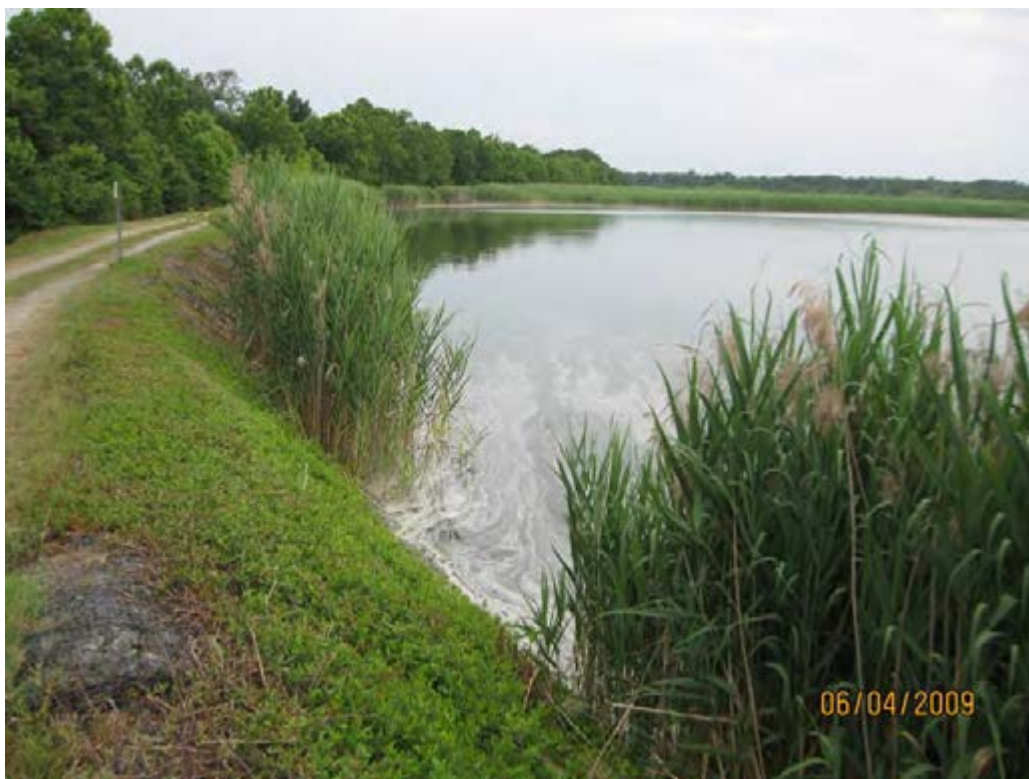
26. ASH POND- Interior slope of south dike. Note vegetation on erosion matting.

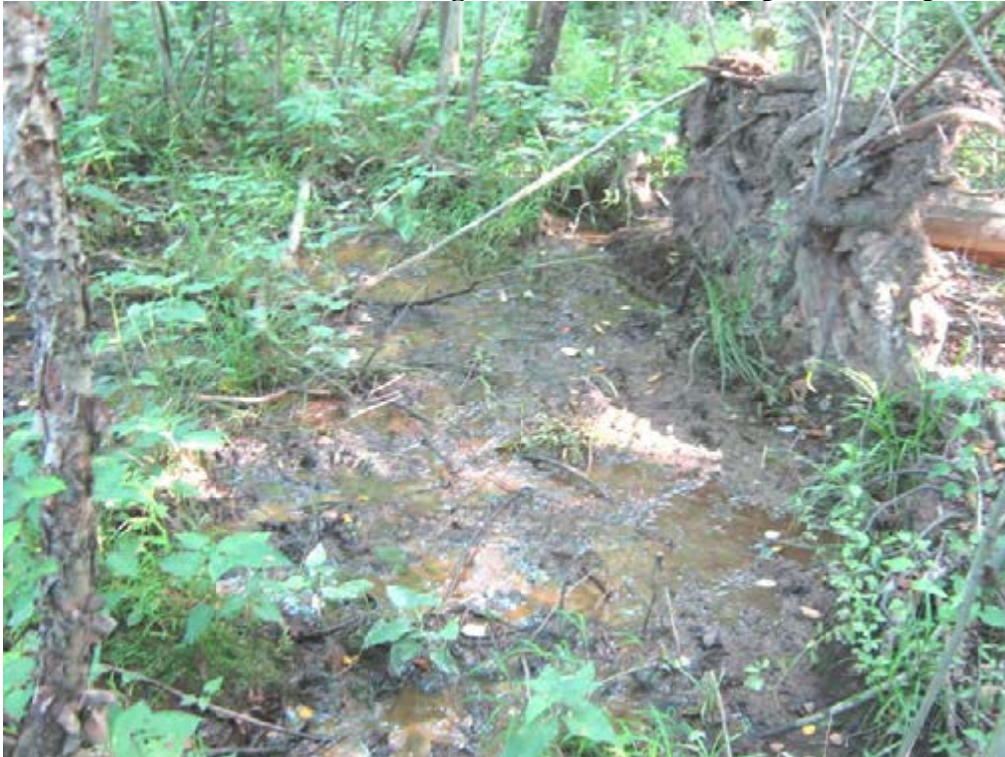
33. ASH POND-Fallen tree and slight seepage at toe of secondary settling pond-north of repair area.
