**CAROLINA POWER & LIGHT  
MAYO ELECTRIC GENERATING PLANT**

**MAYO CREEK DAM  
ASH POND DAM  
PERSON COUNTY, NORTH CAROLINA**

**FIVE-YEAR INDEPENDENT CONSULTANT INSPECTION  
AS REQUIRED BY  
NORTH CAROLINA UTILITIES COMMISSION**

**December 22, 1999**

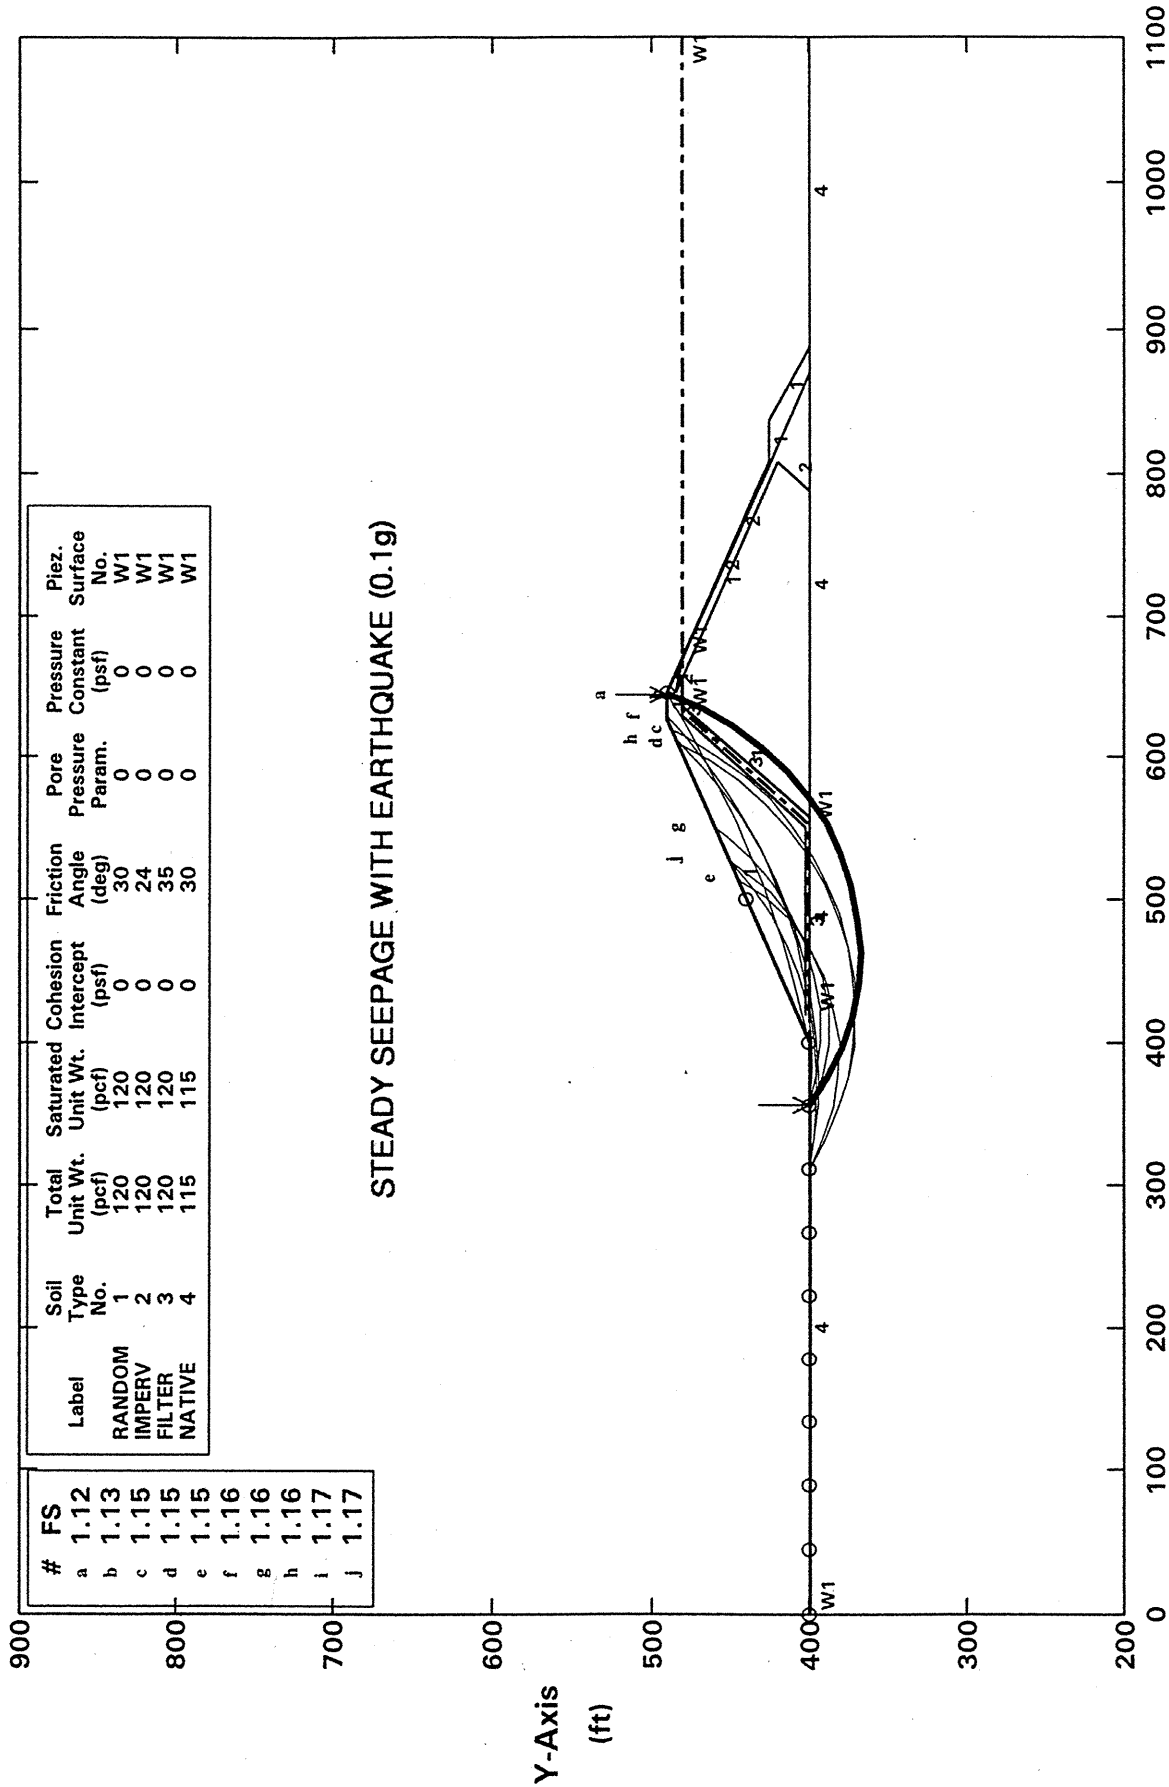
STABL6H FSmin = 1.12 X-Axis (ft)  
Factors Of Safety Calculated By The Modified Bishop Method

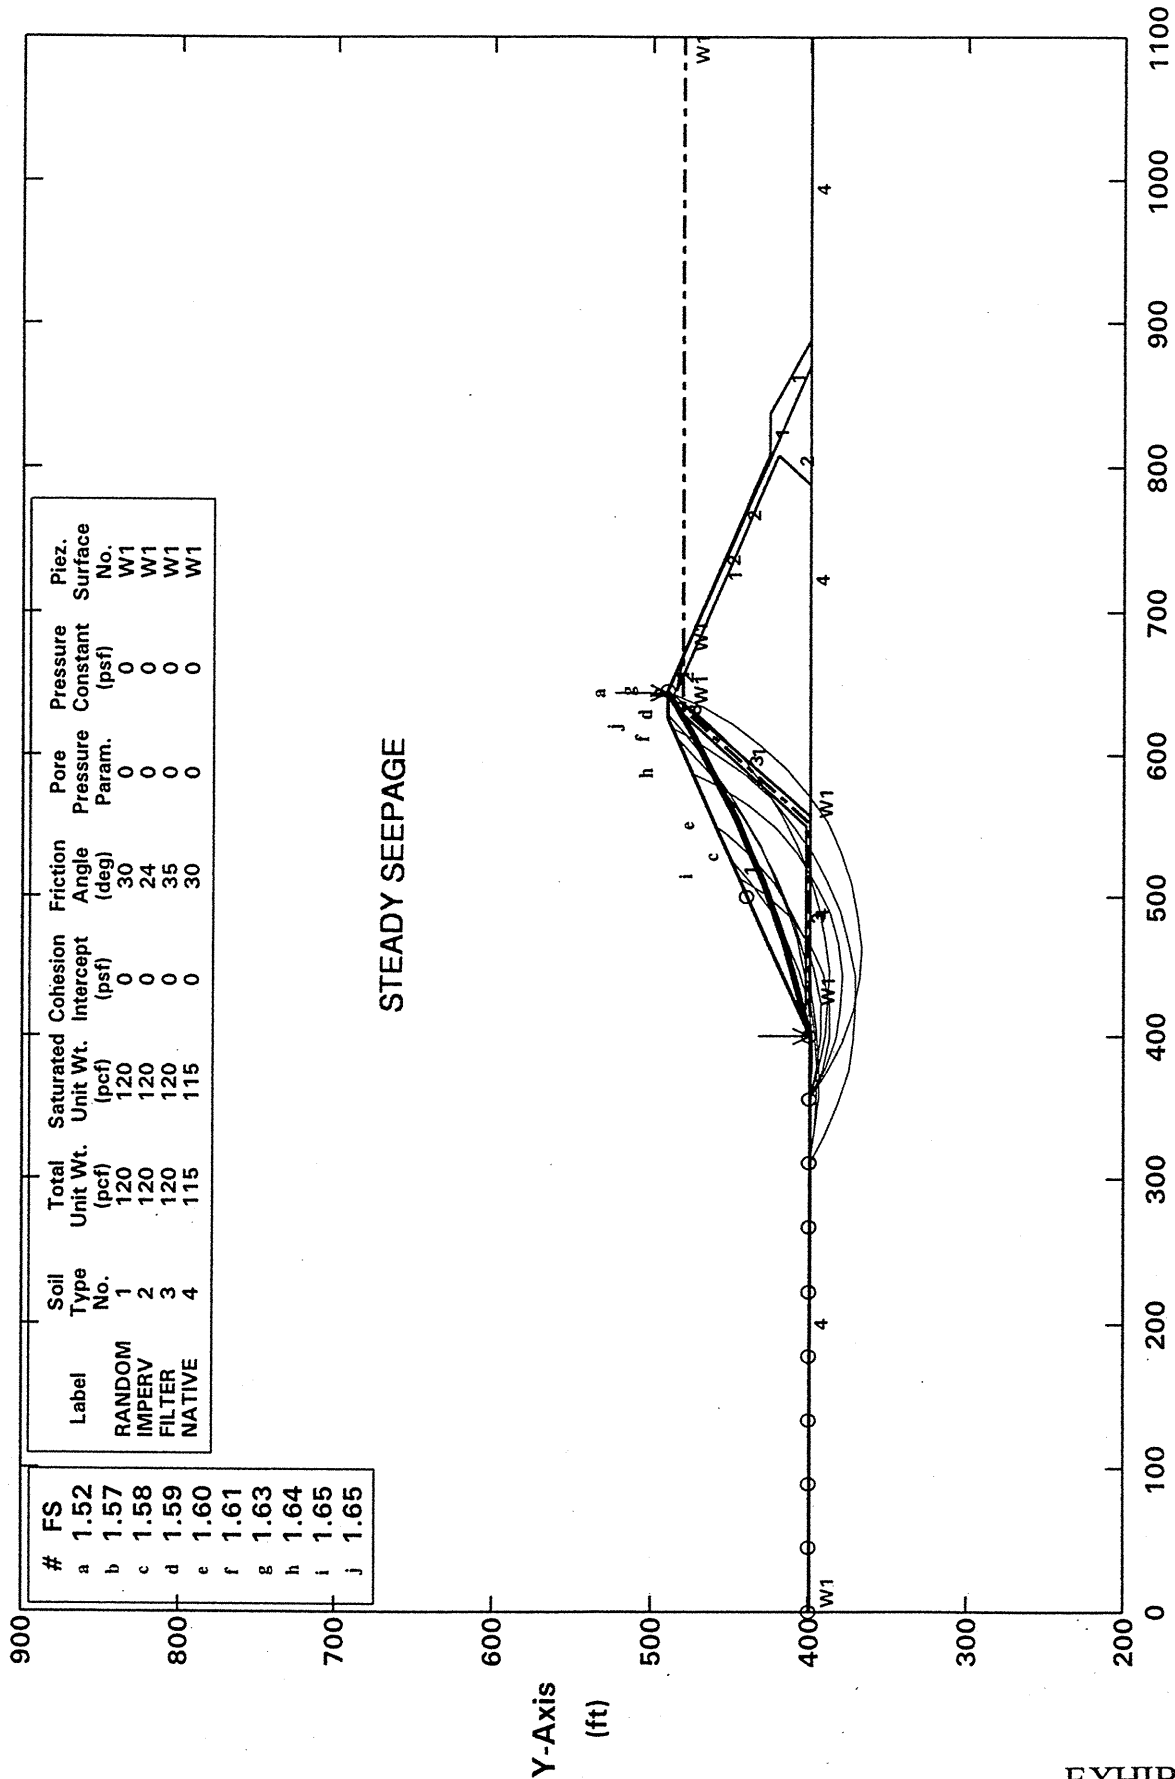
STABL6H FSmin = 1.52 X-Axis (ft)

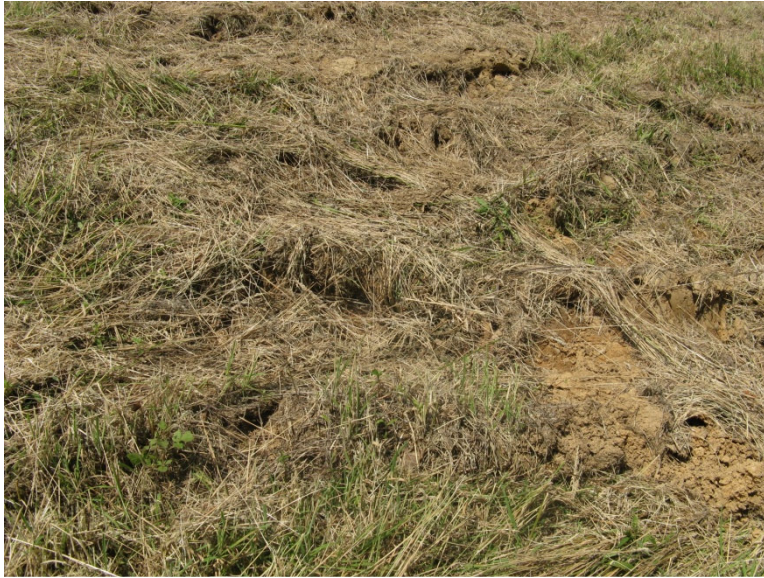
Photo 4: Mowing Equipment Rutting, Downstream Embankment, Photo: 007, 6/3/09
