**Coal Combustion Residue Impoundment
Round 9 - Dam Assessment Report**

H. B. Robinson Power Station

***Progress Energy Carolinas
Hartsville, South Carolina***

Dewberry & Davis, LLC
Fairfax, Virginia

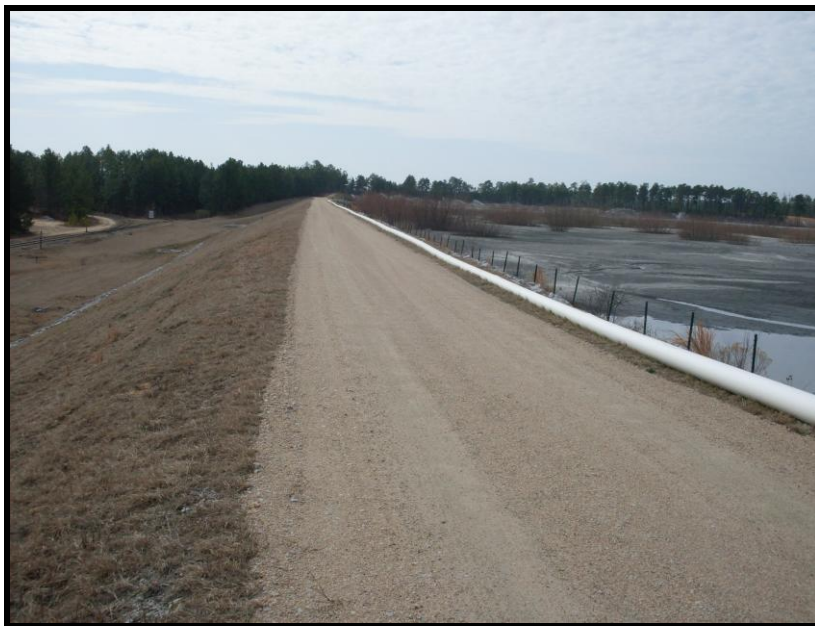
Photograph 5.1. Typical view of crest, looking south.

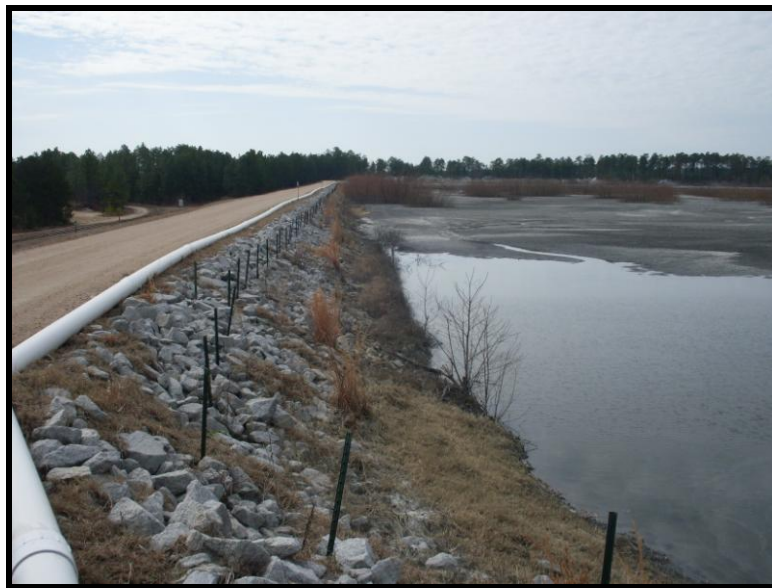
The upstream slope of the north portion of the dike embankment (north of the finger dike) was observed to be lined with riprap with a minor amount of dormant vegetation, including woody vegetation, growing in it, as shown in Photograph 5.3a. The upstream slope of the embankment south of the finger dike was observed to have a dormant cover of grass and weeds (see Photograph 5.2). A small-diameter metal pipe from the Darlington County Plant on the north side of the pond conveys discharge from an oil-water separator through the north side dike embankment extension and into the pond, as shown in Photograph 5.3b. Former erosion at the discharge location had been repaired with the riprap shown in the photograph. The upstream toe and much of the upstream slope is buried with ash, particularly along the south portion of the dike, as shown in Photograph 5.3c; this photograph also shows where the ash is sluiced into the pond and the dust-control sprinkler system in operation in the background. Only a small amount of water was observed in the pond, mostly at the north end next to the dike (see Photograph 5.3a). No slumps, slides, or other signs of shear failure were observed in the visible parts of the slope above the ash and water levels. No significant erosion was noted.

Photograph 5.3a. Upstream slope of north portion of dike, looking south.

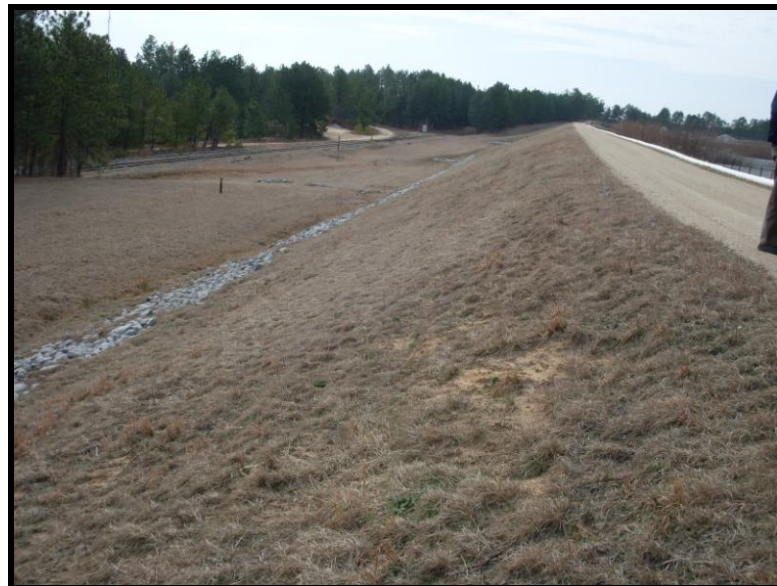
maintained, as shown in Photographs 5.4a, 5.4b, and 5.4c. Minor erosion from mowing equipment was observed on the slope. A portion of the buried sluice line along the downstream slope face was observed to be exposed due to erosion, and minor erosion was observed elsewhere along the soil-covered sluice line, as shown in Photograph 5.5. Progress Energy personnel indicated that the soil cover over the sluice line was not compacted. Local embankment soil material loss due to erosion into the riprap and minor depressions were observed at a number of locations on the downstream slope above the riprap; one of the worst of these is shown in Photograph 5.6a. It was noted that in a number of locations soil had eroded (or moved by creep) onto the surface of the riprap. Some areas of sparse grass growth on the outside slope were also observed (see Photograph 5.4a), but no major areas of erosion were noted. No slumps, slides, bulges, tension cracks, or other obvious signs of shear failure were observed on the downstream slope. No seepage or active animal holes were observed. Wet soils were observed in the shallow swale along the right (south) toe of the dike, but no seepage or flowing water appeared to be associated with this wet area, as shown in Photograph 5.6b. It appeared to be due to poor drainage. The catch basin at the low point of the toe (see Photograph 5.8) was observed to be surrounded with stone and a fine filter that apparently tends to easily clog with vegetation and grass clippings, which retards flow from the toe swale into the catch basin.

Photograph 5.4a. Downstream slope and toe of north portion of dike, looking south.

- a. Re-establishing good grass cover in areas of sparse grass growth and in areas damaged by mowers;
- b. Filling holes in the embankment slope just above the downstream toe riprap with suitable filter materials to minimize continuing erosion of embankment soil into the voids of the riprap; lining the larger holes with filter fabric before filling them with coarse filter stone may be beneficial;

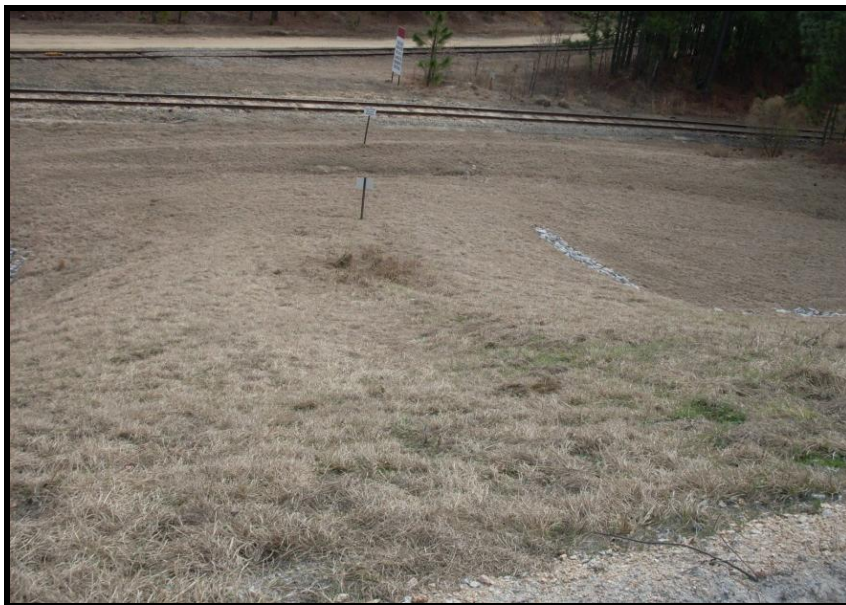
Photograph 5.5. Minor erosion observed along buried sluice line on the downstream slope, looking east.

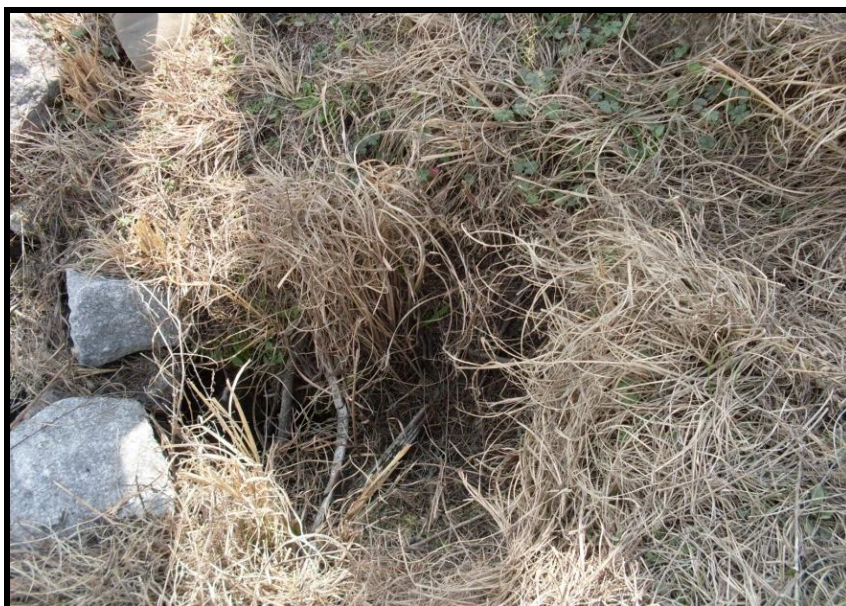
Photograph 5.6a. Hole due to soil material loss into riprap voids, observed on downstream slope above riprap at toe.

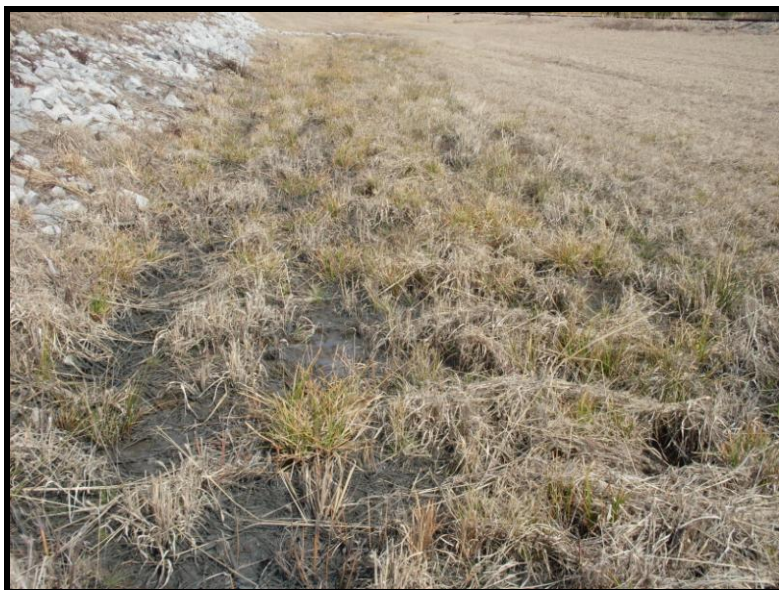
Photograph 5.6b. Wet soils in shallow swale along right (south) toe of dike embankment, looking north.

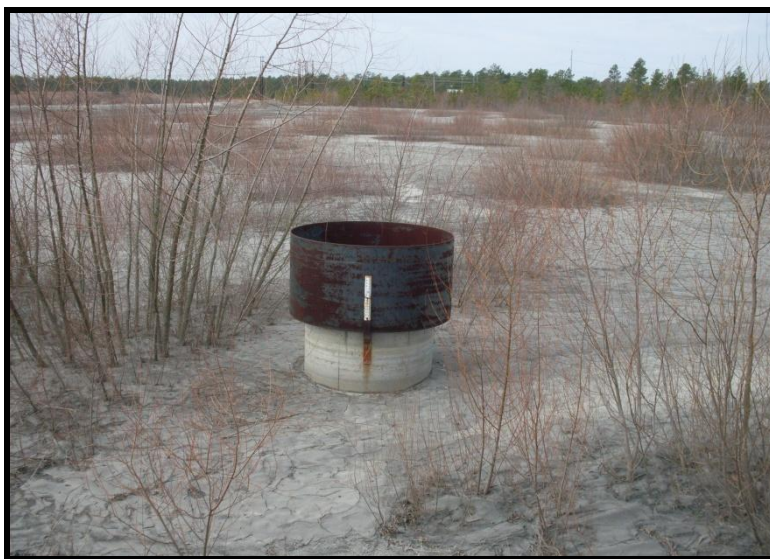
The Ash Pond overflow structure was observed on the northeast side of the pond just upstream of the dike. The 48-inch diameter RCP overflow structure with a metal skimmer was observed to be in good condition. The skimmer had rust on its surface, but it appeared sound. No water was flowing into the structure and was not even impounded around the structure at the time of the visit, as shown in Photograph 5.7.

Photograph 5.7. Ash Pond overflow structure, looking west.

It is recommended that record drawings be corrected or amended, as appropriate, to eliminate confusion as to the size of the buried portion of the overflow riser at the Ash Pond.

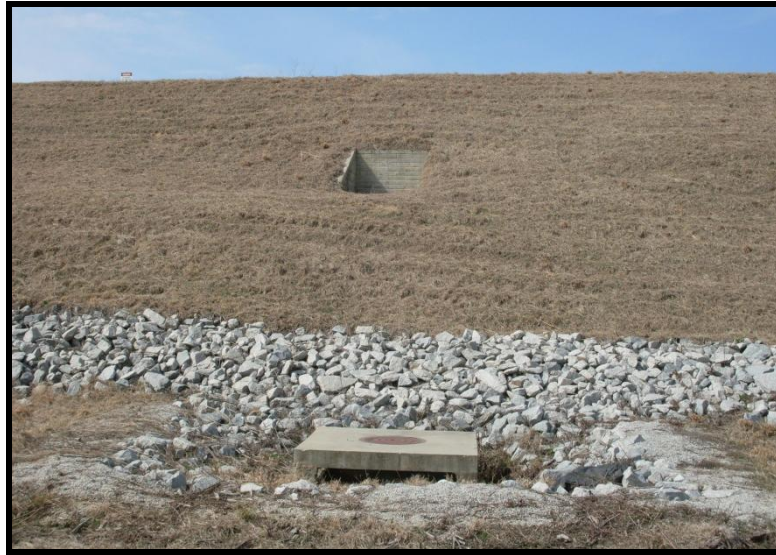
observed to be very steep, and the small riprap that had been placed around the end of the outfall had eroded off its geotextile bedding.

Photograph 5.8. Showing manhole access to outlet conduit on the slope, and covered catch basin at the downstream toe of the embankment of the ash pond dike, looking west.

It is recommended that periodic interior inspection of the outlet structure with a “borehole” video camera be included as part of PEC’s inspection program for the ash pond dike (see Subsection 9.3.1 for discussion).

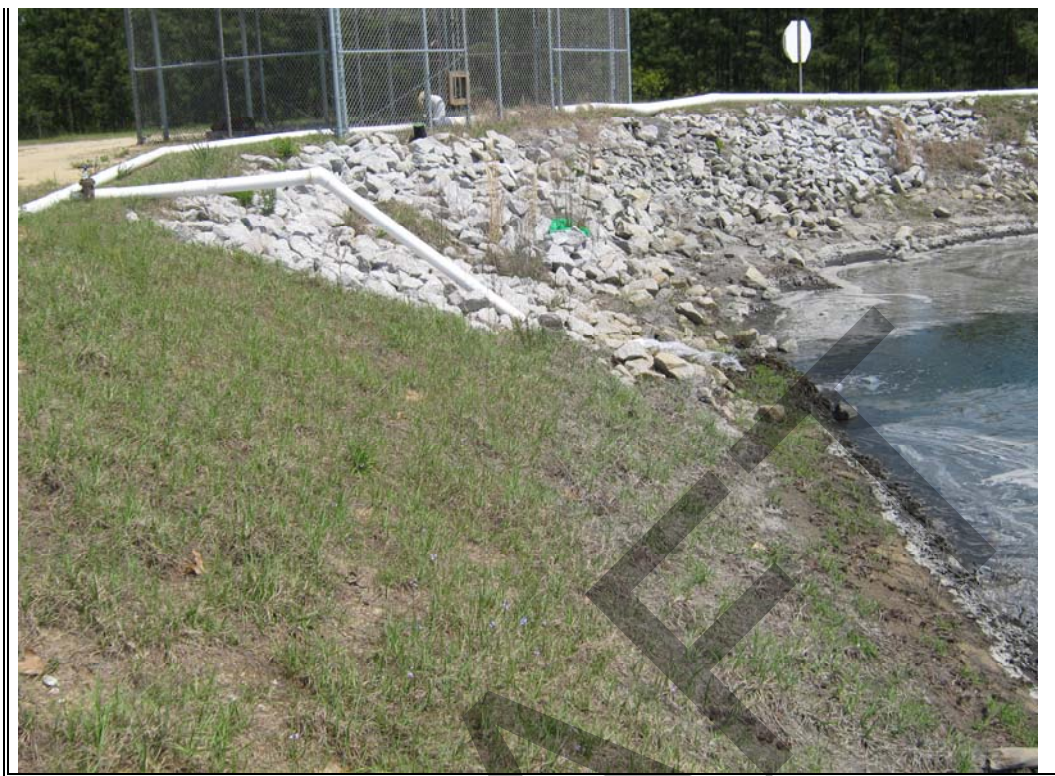
Photograph 50: Rip rap in good condition at junction of North Pond dike and northern extension dike.

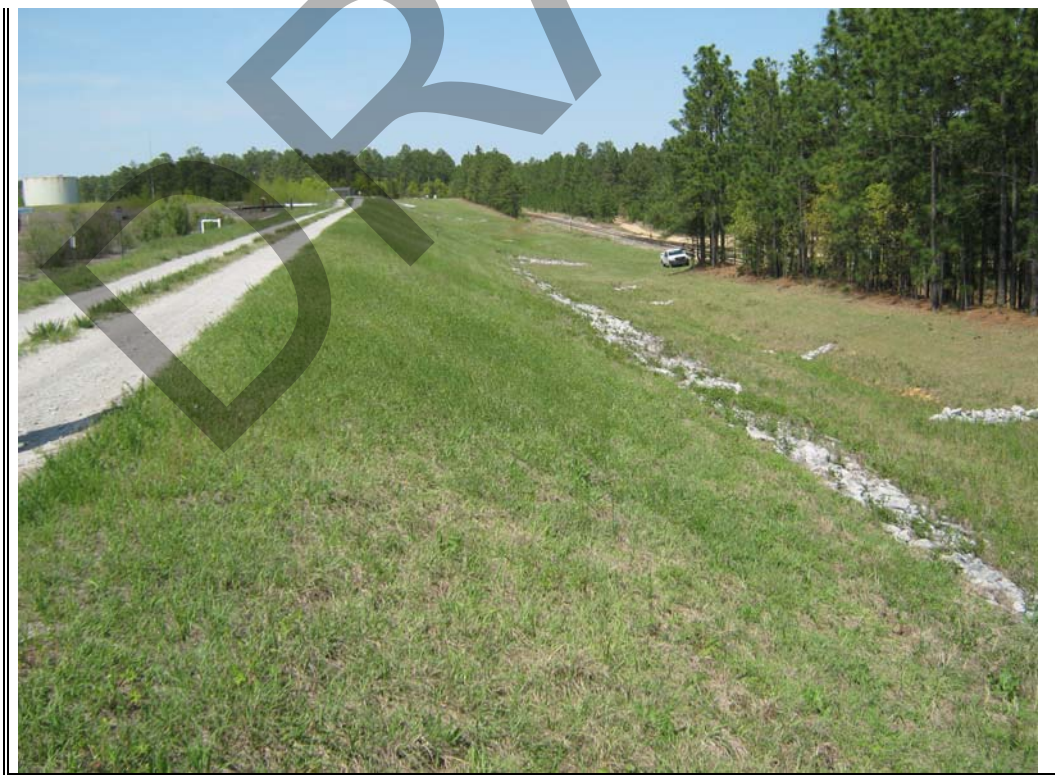
Photograph 51: Exterior of South Pond dike. Note good vegetative cover of slope and drainage ditch adjacent to dike toe.

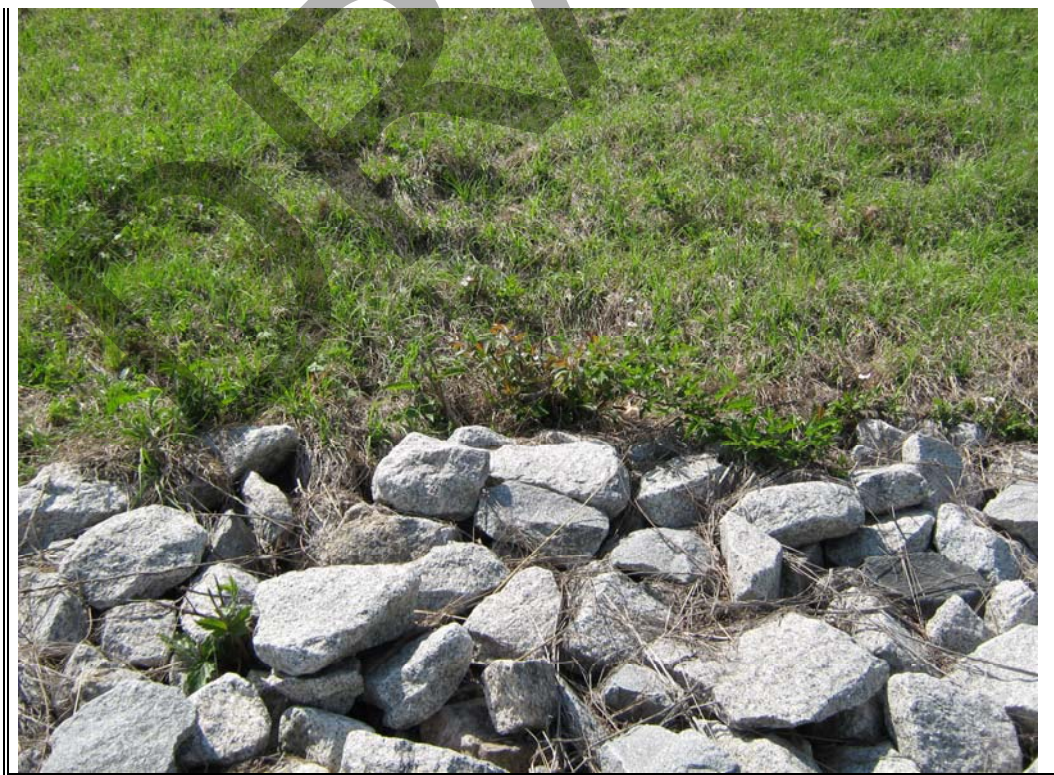
Photograph 55: Local spot in North Pond dike rock toe – soil slope where slight loss of material. Typical of conditions addressed as necessary by Plant.

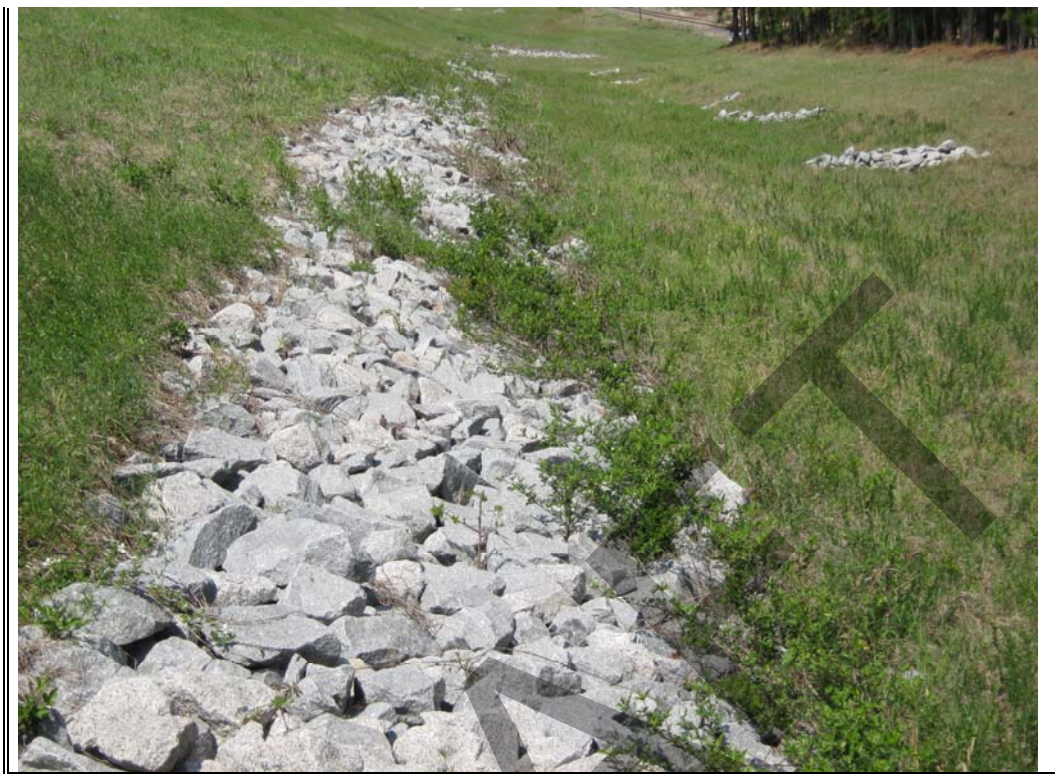
Photograph 56: Rock toe and rock check dams at toe of North Pond dike.

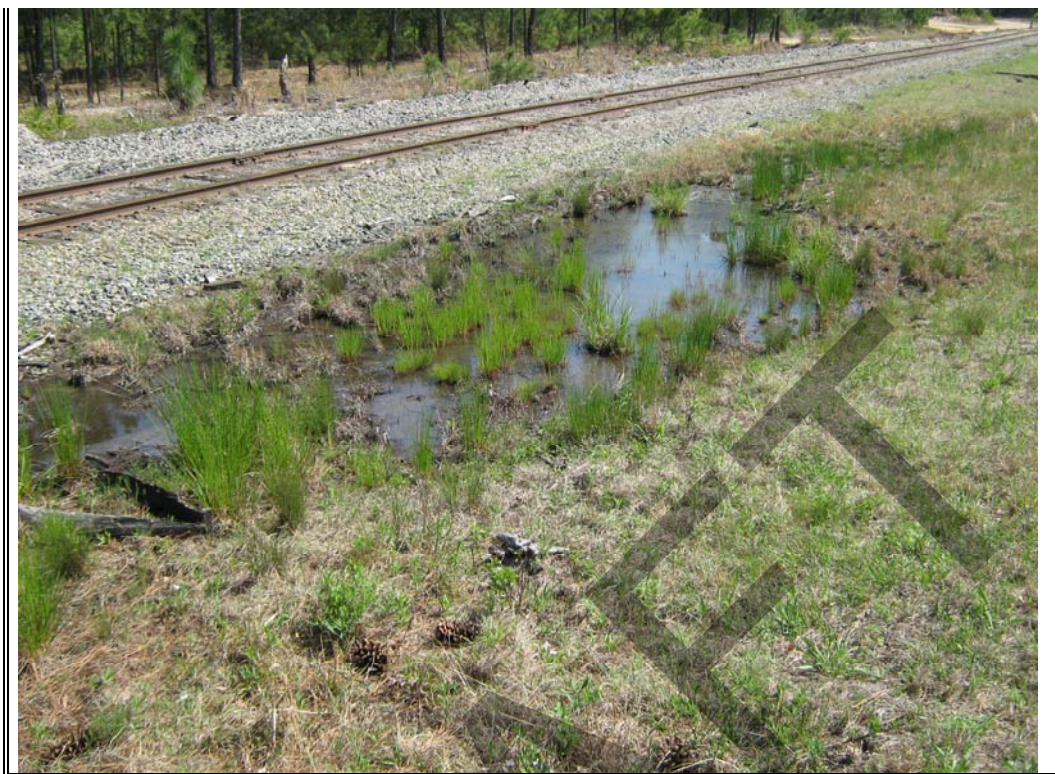
Photograph 58: Standing water adjacent to railroad in topographic low area. A normal condition not related to seepage.
