Coal Combustion Residue Impoundment

Round 9 - Dam Assessment Report

L.V. Sutton Steam Electric Plant

Ash Ponds

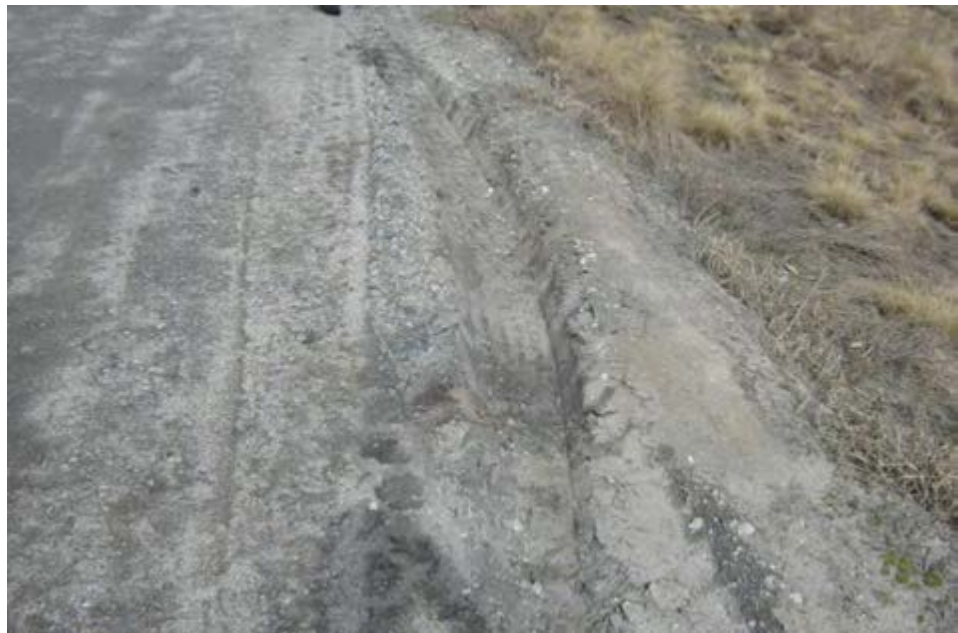
The crest had no signs of depressions, tension cracking, or other indications of settlement or shear failure and appeared to be in satisfactory condition; however, there were signs of minor rutting, most likely from vehicular traffic.

Vehicular rutting along crest

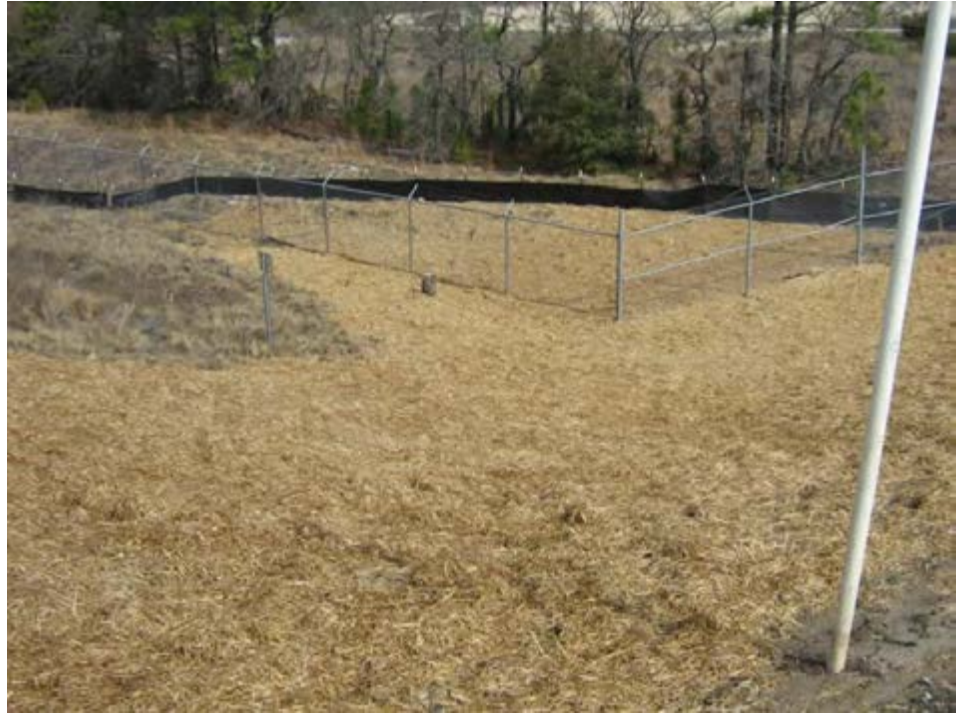
There were no signs of surficial sloughing along the downstream slope. Rill erosion and animal burrows were found in multiple places along the embankment. There were also areas that were bare from recent repairs and needed to be seeded. Up to 12-inch diameter trees and numerous shrubs were found on the downstream slope of the south embankment of the 1971 Ash Pond adjacent to the canal. The management or removal of these trees is being coordinated with the North Carolina Department of Environment Natural Resources (NCDENR).

Repair along downstream east slope

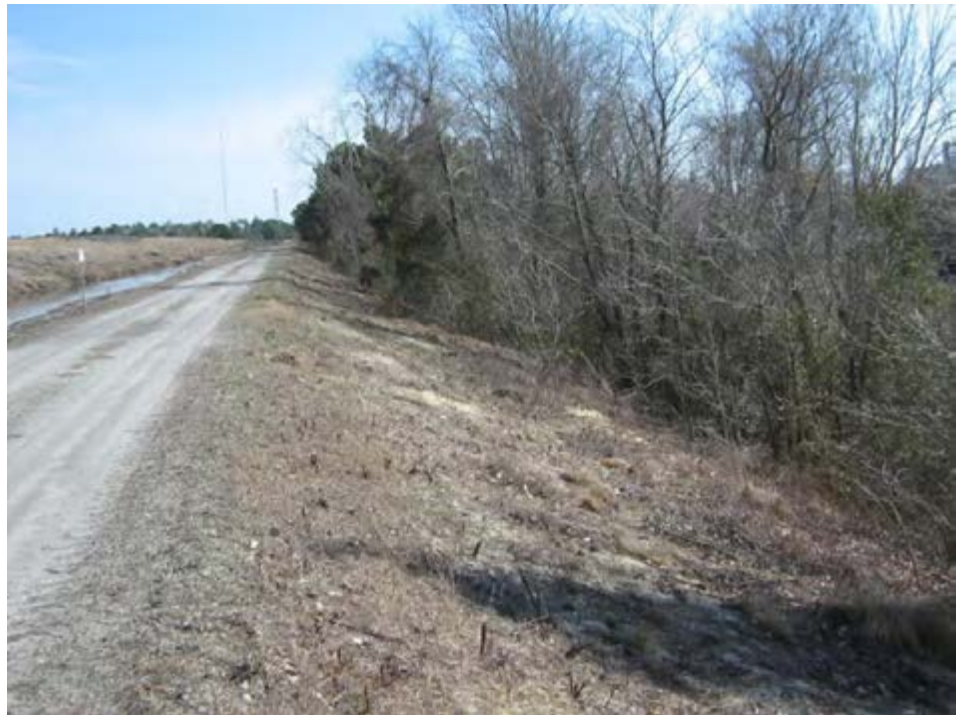
Overall, the visual assessment of the ash pond embankment system is satisfactory; however, up to 12-inch diameter trees and numerous shrubs were found on the outer slope of the south embankment of the 1971 Ash Pond (State ID No. NEWHA-004) adjacent to the canal. The 1971 Ash Pond is inactive. The management or removal of these trees is being coordinated with the North Carolina Department of Environment Natural Resources (NCDENR). Within the 1984 Ash Pond (State ID No. NEWHA-005) there were also a few areas of minor depressions, non-structural surface erosion, and multiple burrows that require remediation. These areas are reportedly being addressed on a regular maintenance schedule.

Trees along downstream south slope

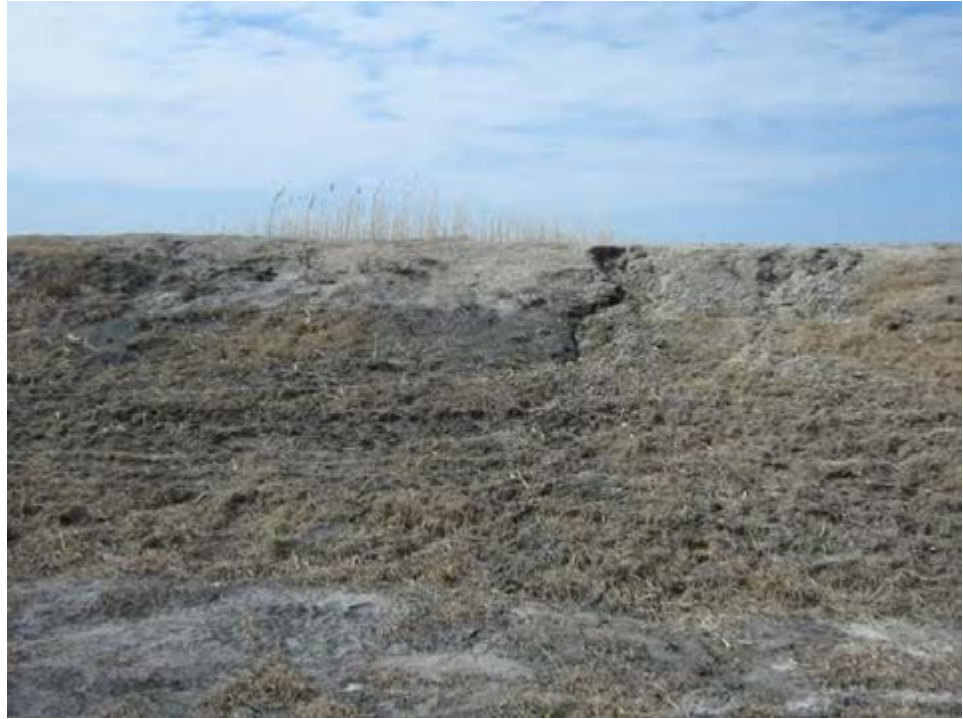
There were no signs of surficial sloughing along the downstream slope. Rill erosion and animal burrows were found in multiple places along the embankment. There were also areas that were bare and need to be seeded.

Rill erosion along downstream slope, 1984 Ash Pond

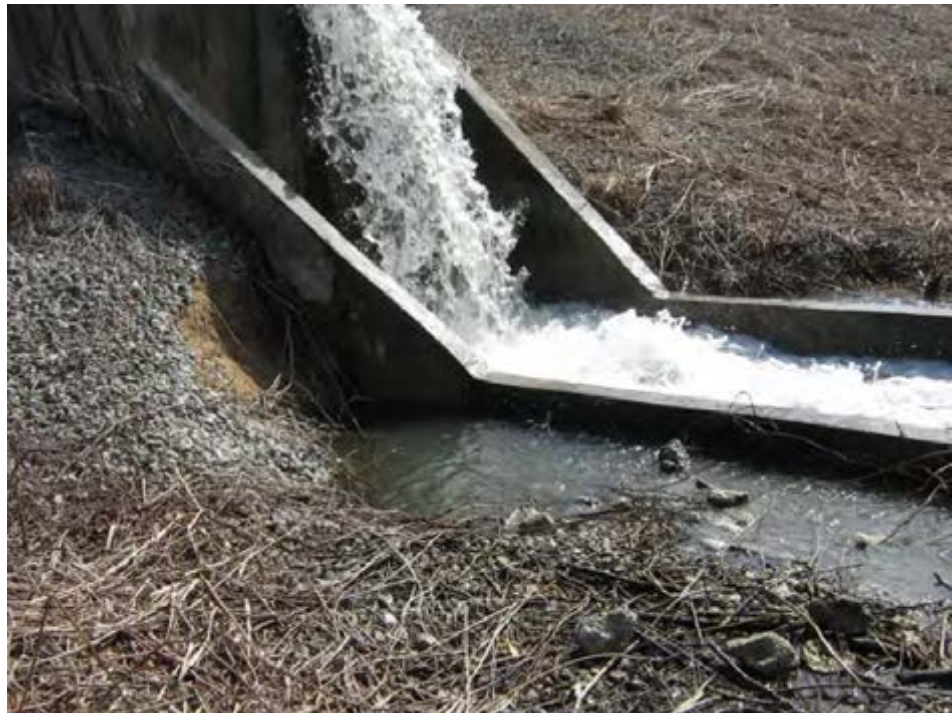
The visual portion of the outlet conduit was functioning properly with no apparent deterioration. There was minor undercutting around the concrete outfall caused by splashing from the raised outfall weir.

Concrete outfall of 1984 Ash Pond where undercutting is present

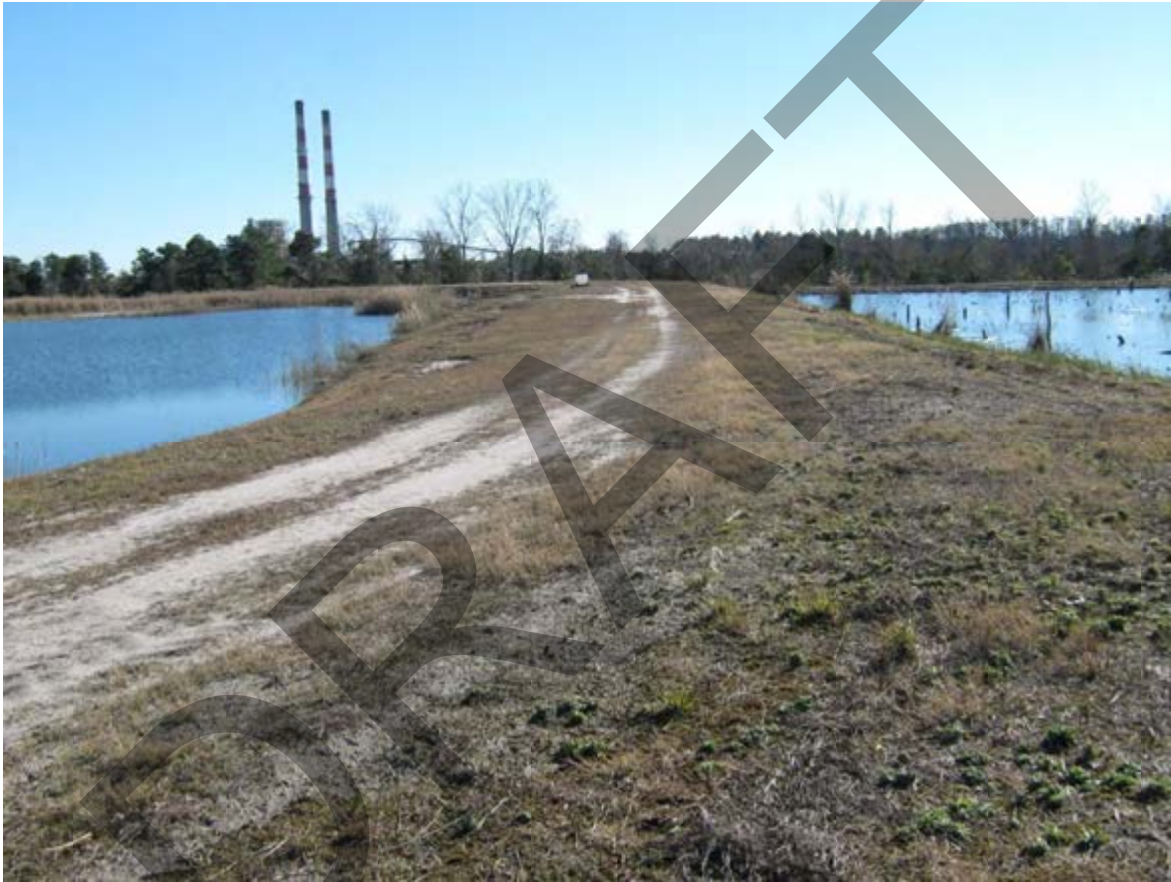
The current field inspection of the interior storage area indicated that the containment berm and discharge structure were generally in satisfactory condition. During a follow-up site visit by MACTEC on 12/15/10, we observed that the interior storage area was actively impounding water. We also observed that the containment berm slopes have been cut and cleared of brush to facilitate inspection. The following photograph showing the containment berm and impounded water (to left of photo) was taken during the site visit on 12/15/10. The area of standing water to right of photograph is near the discharge structure on the west side of the 1983/1971 Ash Pond area.

1983/1971 Ash Pond – View of containment berm for interior storage area (12/15/10)
