**Coal Combustion Residue Impoundment
Round 9 - Dam Assessment Report**

L.V. Sutton Steam Electric Plant

Ash Ponds

***Progress Energy Carolinas, Inc.*
*Wilmington, North Carolina***

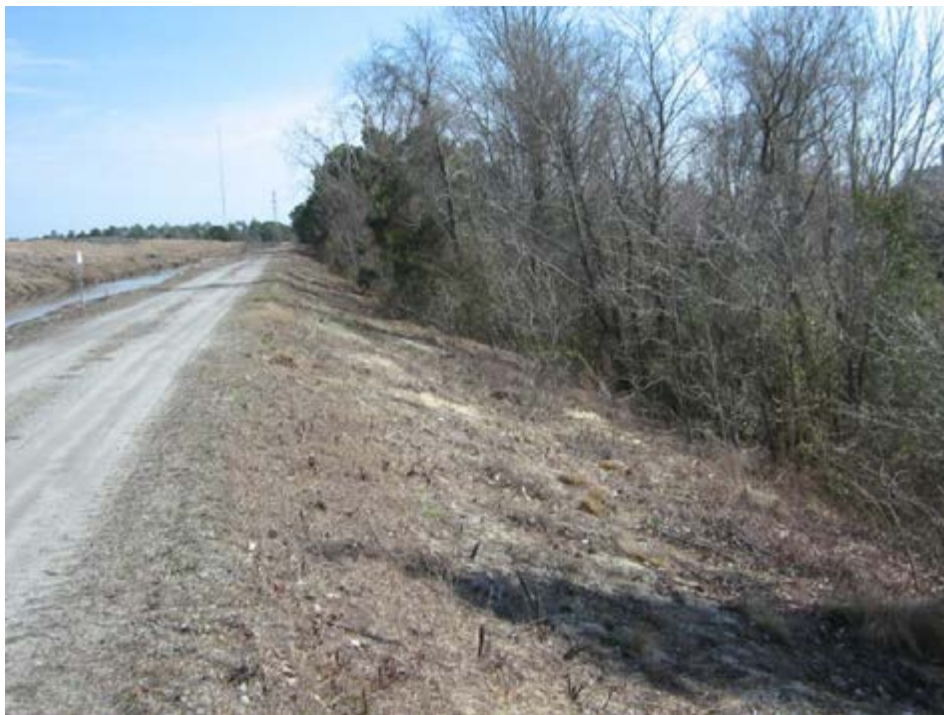
There were no signs of surficial sloughing along the downstream slope. Rill erosion and animal burrows were found in multiple places along the embankment. There were also areas that were bare from recent repairs and needed to be seeded. Up to 12-inch diameter trees and numerous shrubs were found on the downstream slope of the south embankment of the 1971 Ash Pond adjacent to the canal (see photo below). The management or removal of these trees is being coordinated with the North Carolina Department of Environment Natural Resources (NCDENR).

Trees along downstream south slope of 1971 ash pond.

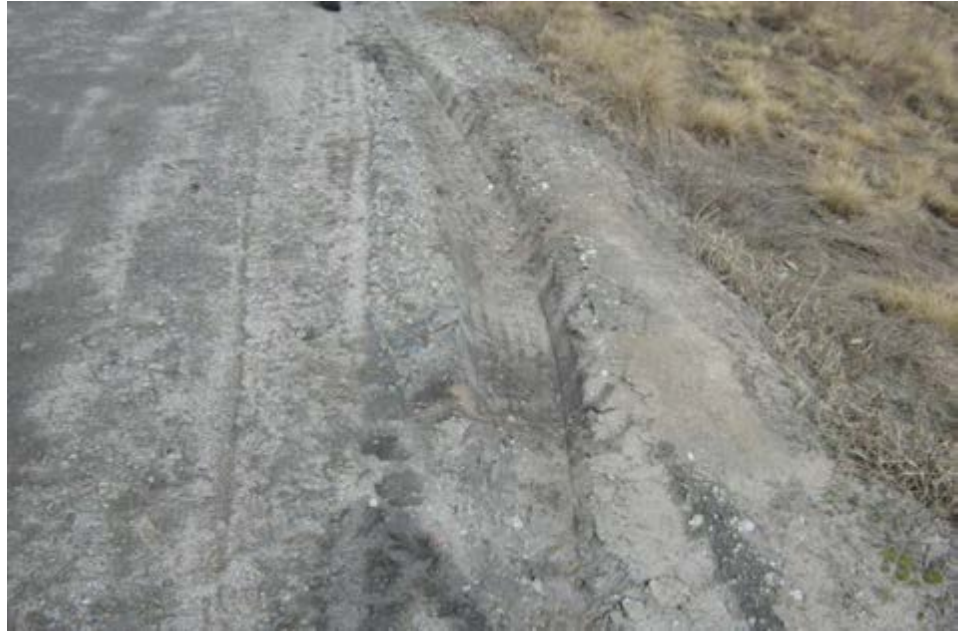
The crest had no signs of depressions, tension cracking, or other indications of settlement or shear failure, and appeared to be in satisfactory condition; however, there were signs of minor rutting, most likely from vehicular traffic. As reported by J. Mark Frederick, Plant Manager of Progress Energy's Sutton Steam Electric Plant, the increased vehicular traffic, especially in the area of the overflow repair, contributed to the rutting. He also stated once construction of the minor overflow repair was complete, the roadway was restored.

Vehicular rutting along crest of 1984 ash pond

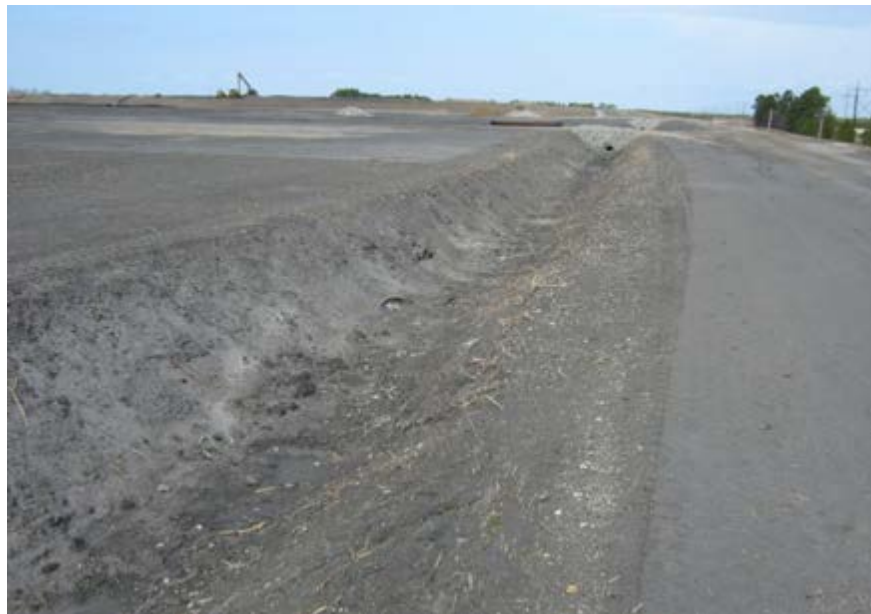
Upstream slopes along 1984 ash pond to be vegetated, Spring 2011. Work conducted in this area was to repair the small overflow from the 1984 ash pond

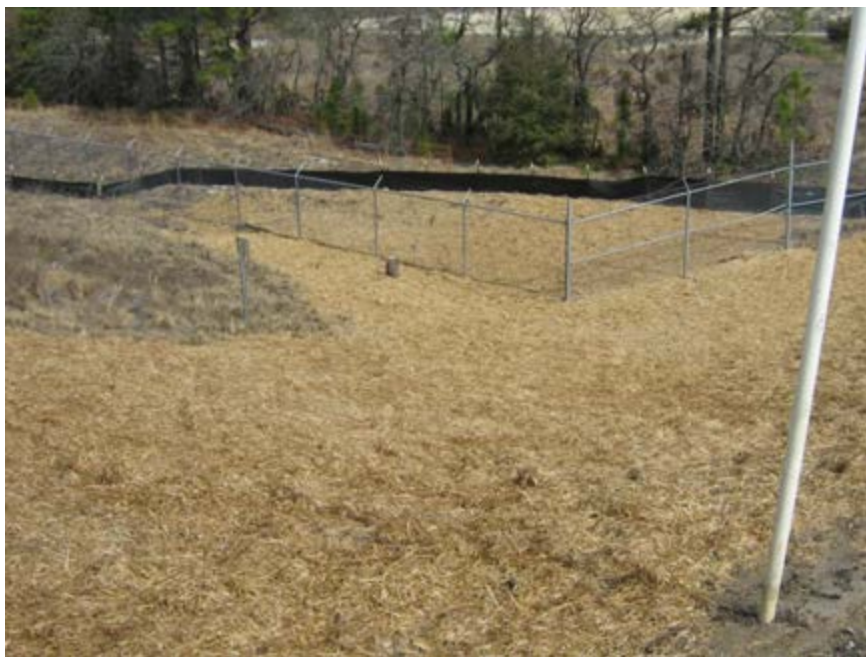
Repair along downstream east slope of 1984 ash pond. Work conducted in this area was to repair the minor overflow from the 1984 ash pond

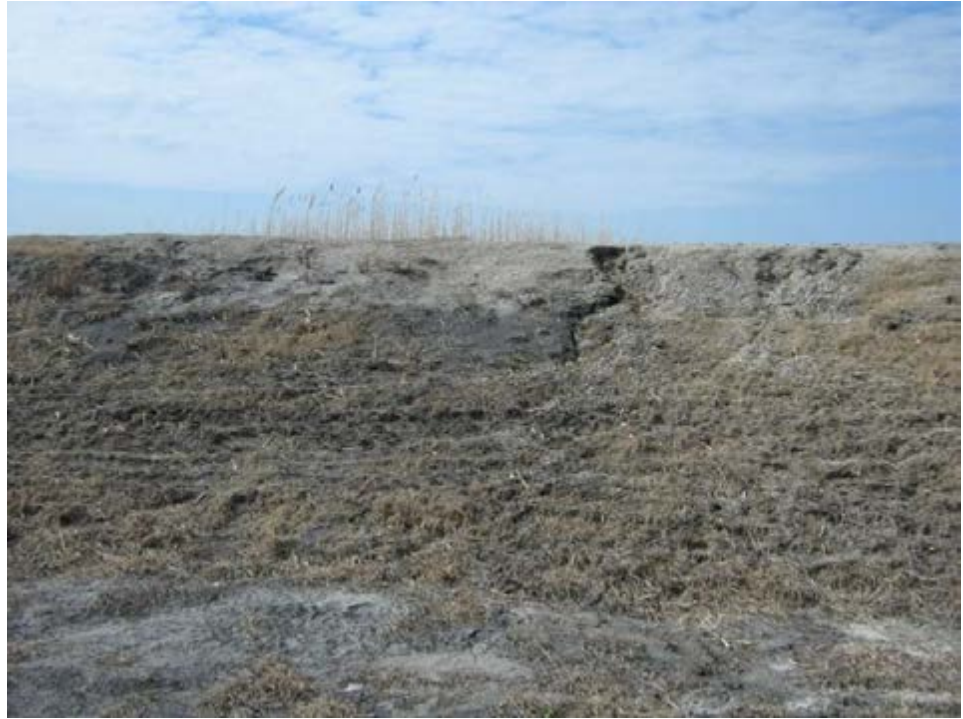
There were no signs of surficial sloughing along the downstream slope. Rill erosion and animals burrows were found in multiple places along the embankment. There were also areas that were bare and need to be seeded.

Rill erosion along downstream slope of internal dike of the 1984 Ash Pond

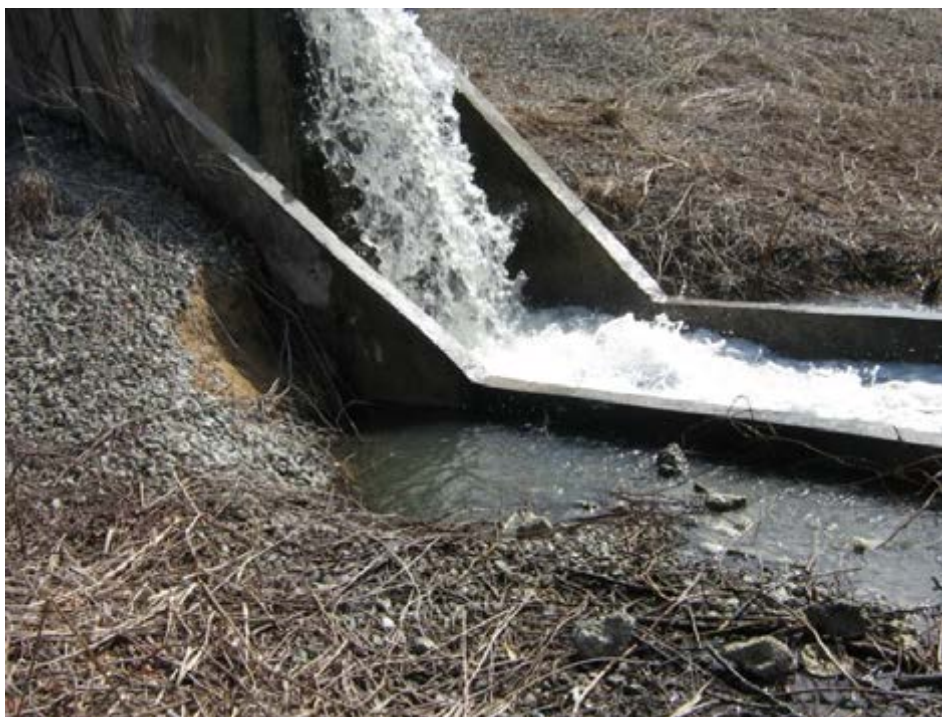
The visual portion of the outlet conduit was functioning properly with no apparent deterioration. There was minor undercutting around the concrete outfall caused by splashing from the raised outfall weir.

Concrete outfall of 1984 Ash Pond where undercutting is present

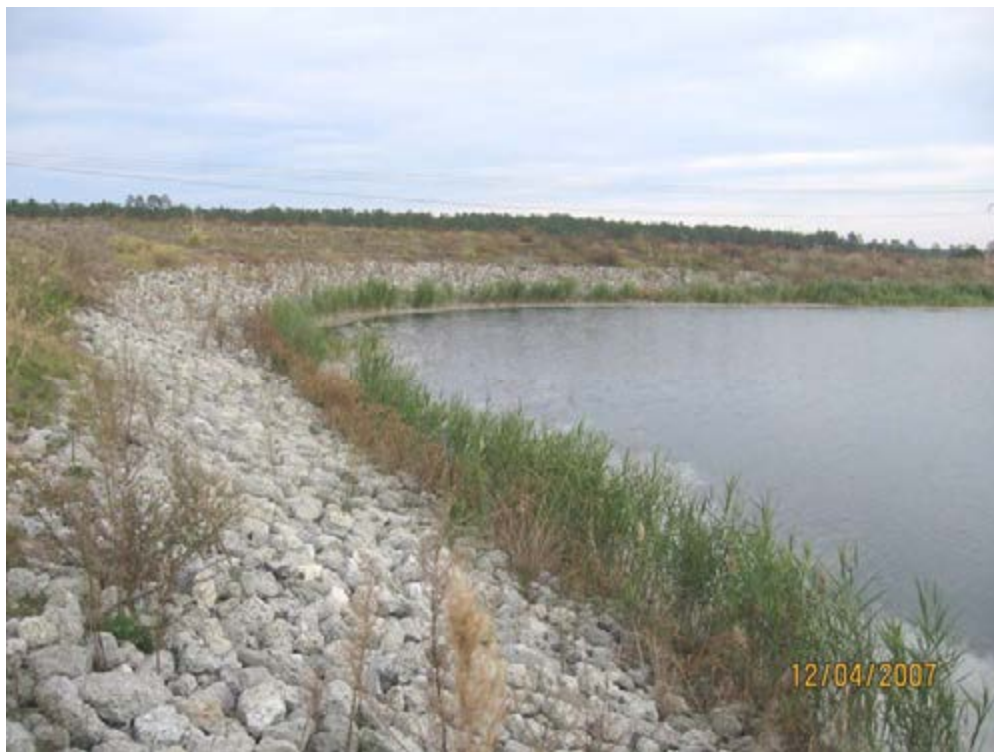
Photo 6. 1984 Ash Pond – Interior slope newly repaired with rip rap. Typical of section with good rip rap.

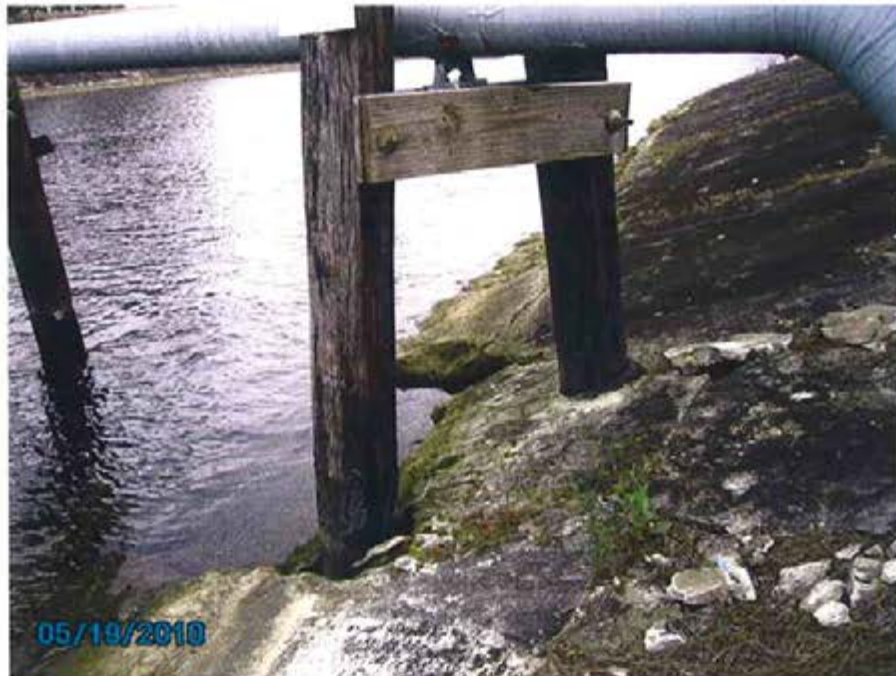
39. Cooling Pond – View of slope protection damage at pipe support on interior slope near the sluice gate structure.

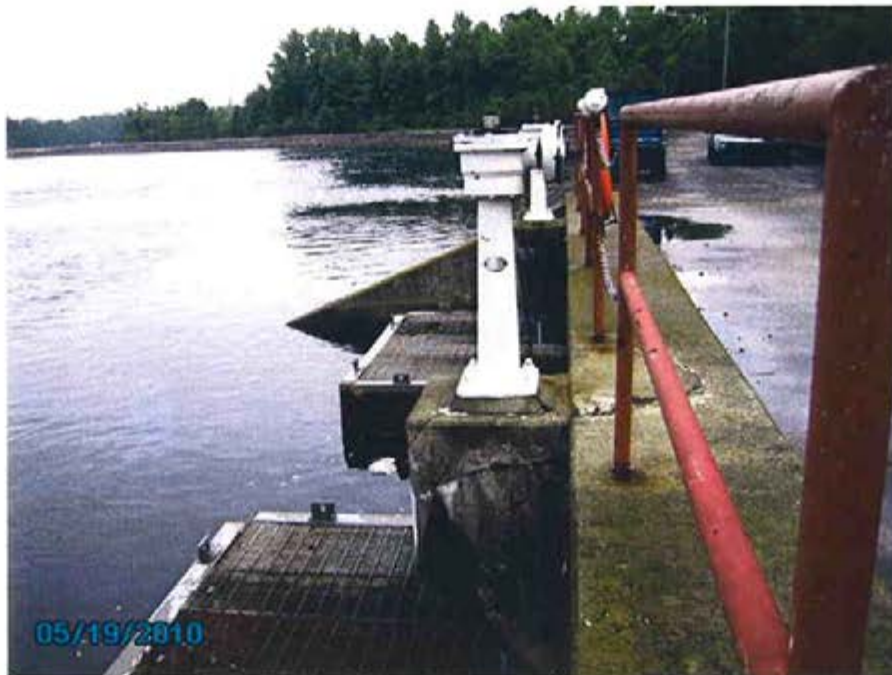
40. Cooling Pond – View of concrete cracking at sluice gate support on north side of discharge structure.

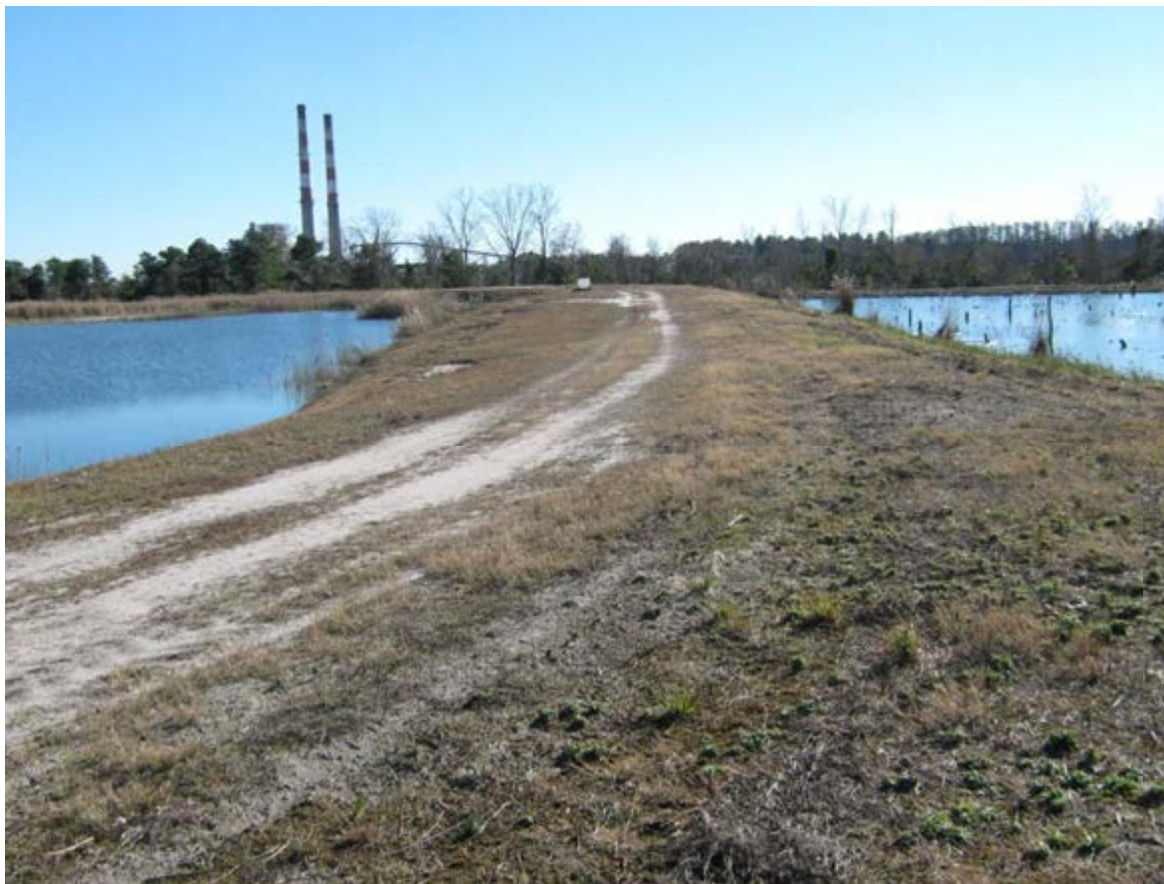
The current field inspection of the interior storage area indicated that the containment berm and discharge structure were generally in satisfactory condition. During a follow-up site visit by MACTEC on 12/15/10, we observed that the interior storage area was actively impounding water. We also observed that the containment berm slopes have been cut and cleared of brush to facilitate inspection. The following photograph showing the containment berm and impounded water (to left of photo) was taken during the site visit on 12/15/10. The area of standing water to right of photograph is near the discharge structure on the west side of the 1983/1971 Ash Pond area.

1983/1971 Ash Pond – View of containment berm for interior storage area (12/15/10)

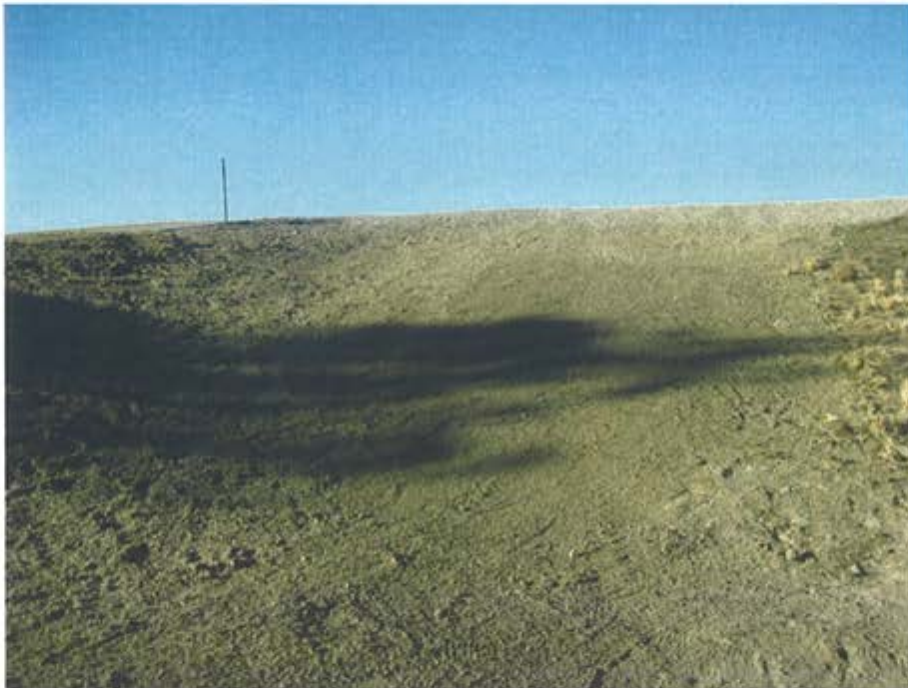
Photo 6. Completed repair slope.
