Coal Combustion Residue Impoundment

Round 9 - Dam Assessment Report

Weatherspoon Steam Electric Plant

Ash Pond Embankment

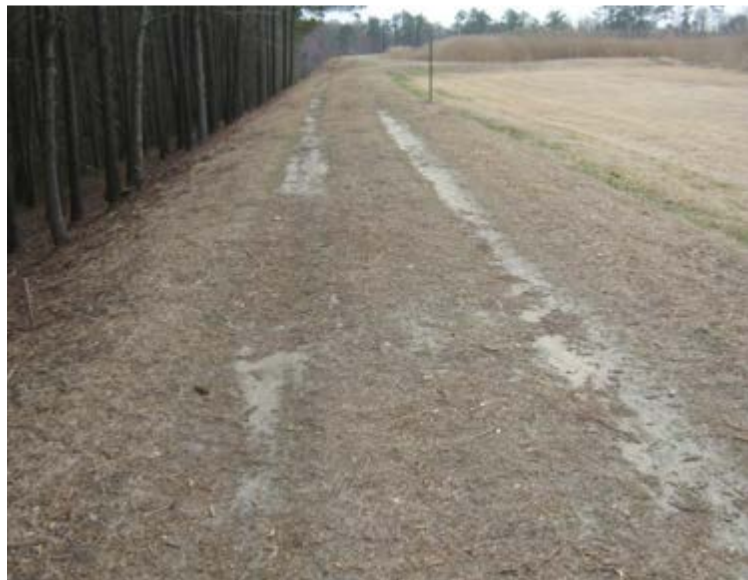
The crest had no signs of depressions, tension cracking, or other indications of settlement or shear failure and appeared to be in satisfactory condition; however, there were signs of minor rutting most likely from vehicular traffic.

Crest showing minor rutting – Northern Ash Area

- Remediate the original dike
- Install animal guards at toe drains
- Address trees and woody vegetation along downstream slopes
- Monitor seepage along downstream toe along southern, eastern and western dikes
- Repair rutting along crest
- Monitor and address standing water within roadside ditches downstream of toe

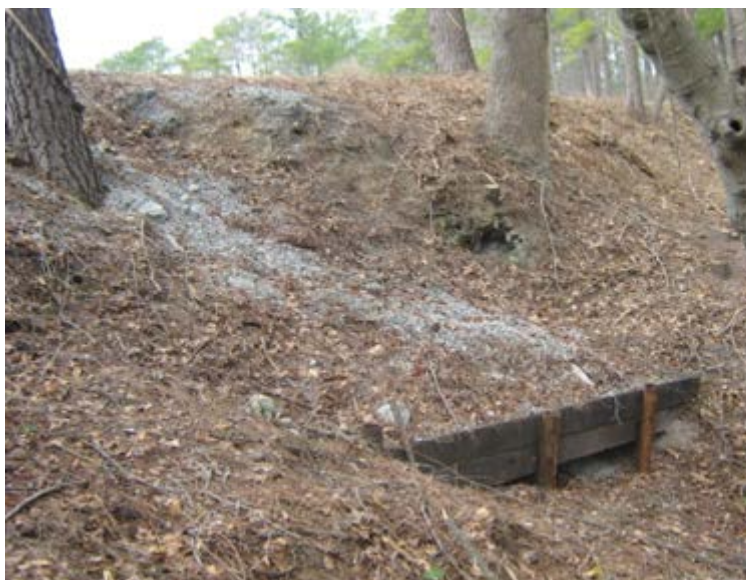
Areas of the downstream slope were eroding, in disrepair and had large trees established within the embankment. This area needs to be remediated. We were made aware by Progress Energy that a plan is already in place and they are awaiting approval from NCDENR to begin the repairs.

Downstream slope – Northern Ash Area

An action plan needs to be developed to address removing all trees and wooded vegetation along any ash pond embankment and for remediating the original dike. It was noted that the tree removal and dike repair will require NCDENR approval. A potential for liquefaction analysis should be provided. An action plan needs to be developed to address the areas of the embankment that do not meet minimum factors of safety standards.

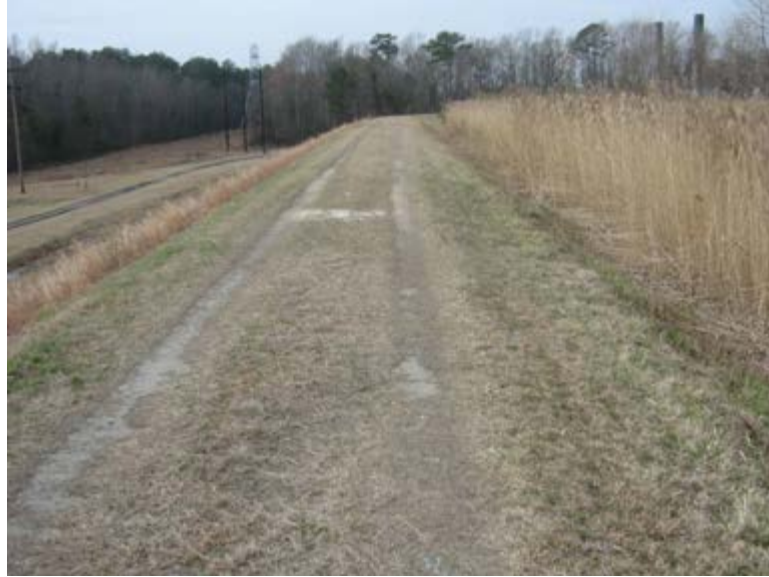
The crest had no signs of depressions, tension cracking, or other indications of settlement or shear failure and appeared to be in satisfactory condition; however, there were signs of minor rutting most likely from vehicular traffic.

Crest - Southern Ash Area

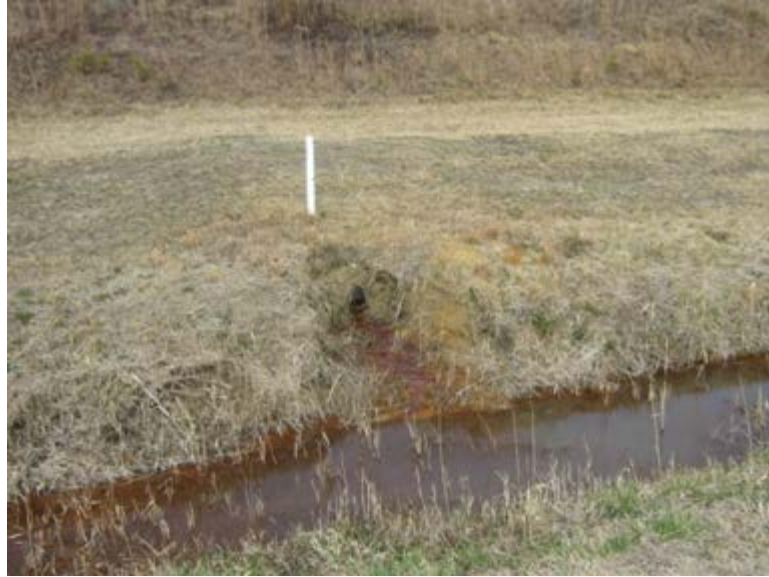
No scarps, sloughs, depressions, bulging or other indications of slope instability or signs of erosion were observed. It is recommend the power plant install animal guards for the toe drains. Seepage was observed at a few locations and this needs to be monitored.

Toe drains – Southern Ash Area

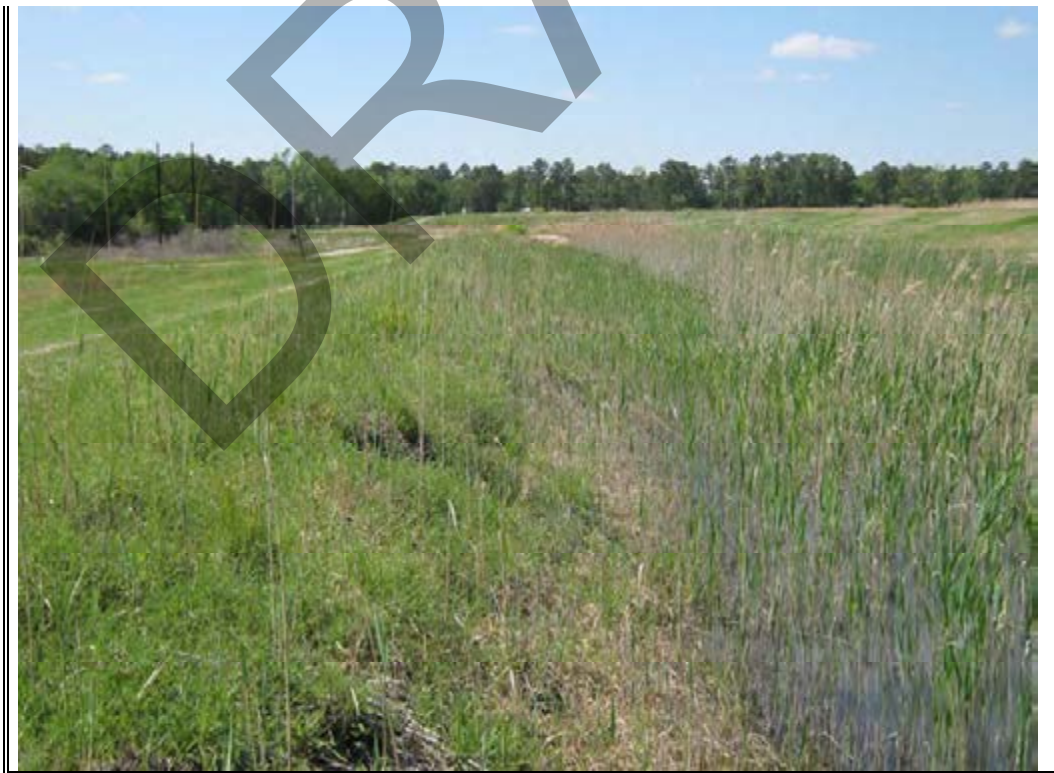
Photograph 16: Interior slope – Southern Ash Area, west dike.

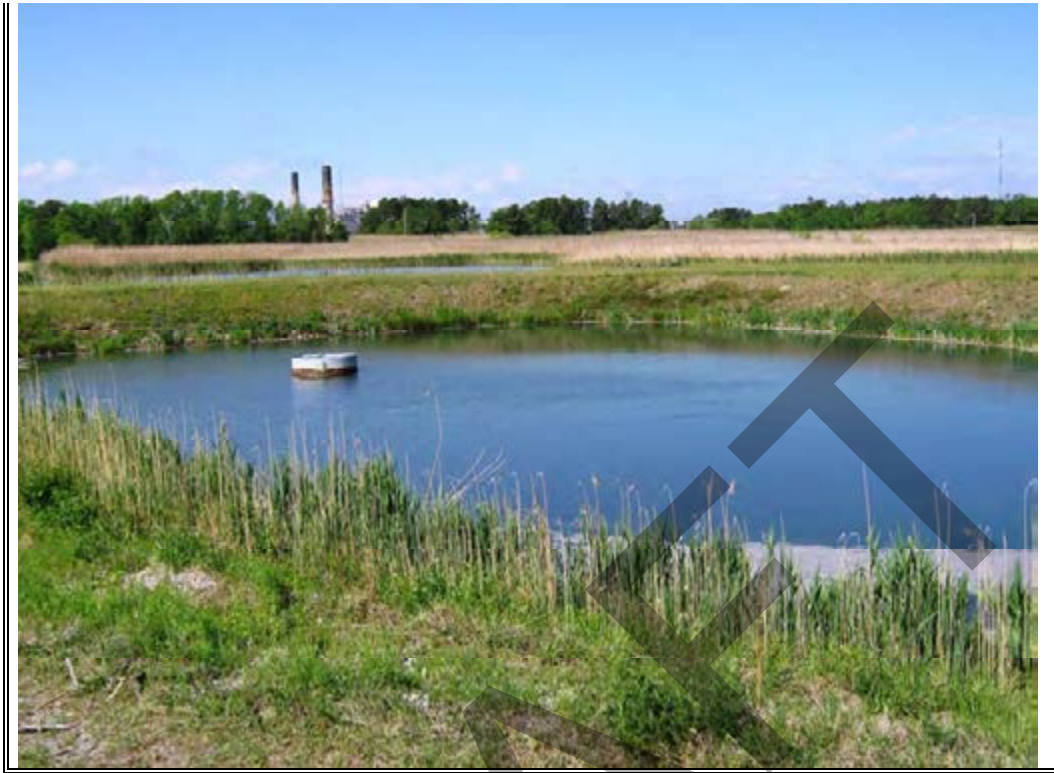
Photograph 17: Interior slopes and skimmer, settling basin – Southern Ash Area.
