FINAL
Coal Ash Impoundment –
Specific Site Assessment Report
PPL Montana
Colstrip Power Plant

Submitted by:
GEI Consultants, Inc.
6950 South Potomac Street, Suite 300
Centennial, CO 80112

September 2009
Project 091330

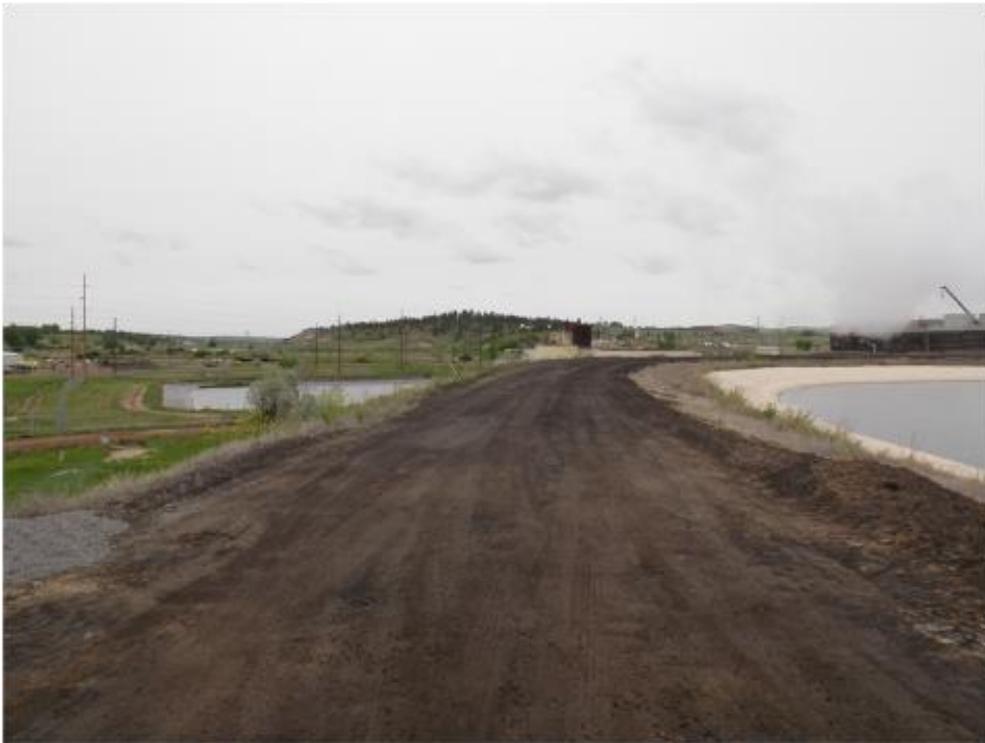
The embankment crest appeared to be in good condition. No signs of cracking or settlement were observed during the assessment. No vegetation was present on the dam crest. (Photos 3 and 4).

Photo 3: Units 1 & 2 Bottom Ash Ponds: west cell, looking north at crest of west embankment. Note RFP lining on upstream slope.

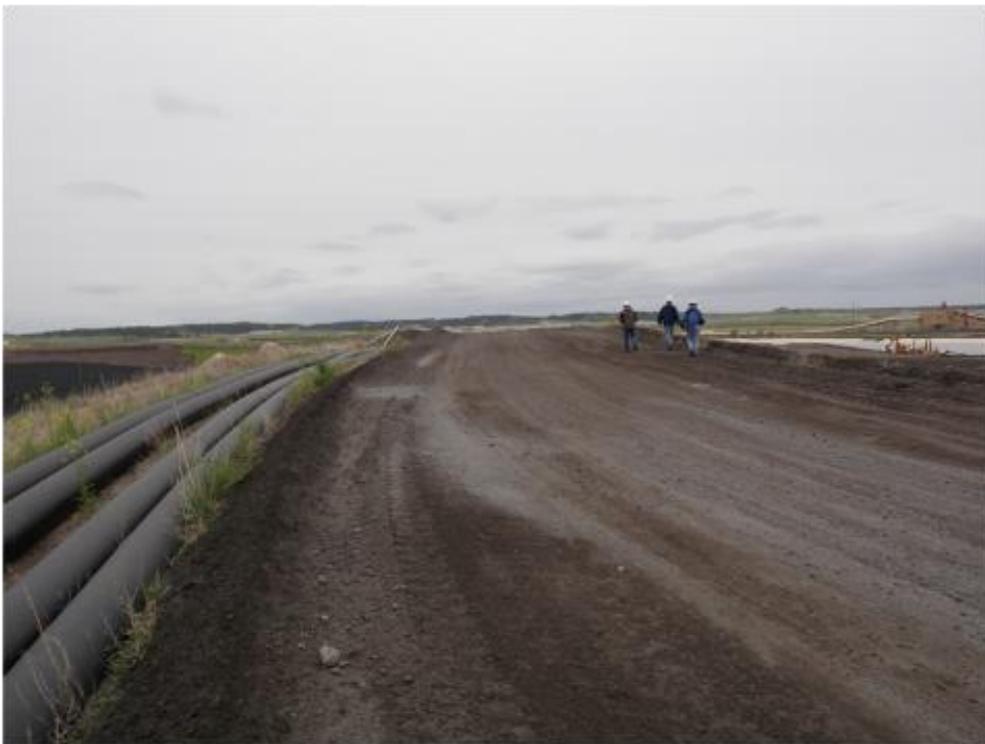
Photo 4: Units 1 & 2 Bottom Ash Ponds: east cell, looking south at crest of east embankment.

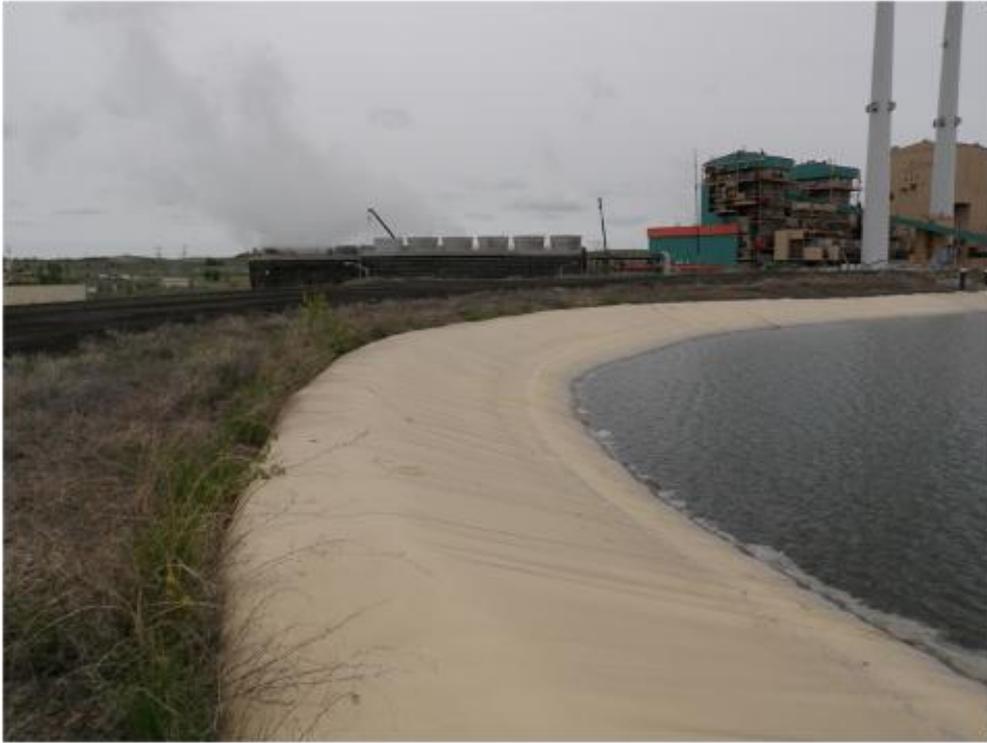
The upstream slope of the bottom ash pond embankment is protected from erosion by an RFP liner (west cell – Photo 5) and a clay liner (east cell – Photo 6) and appeared to be in good condition. A concern with regard to the upstream slope was a 24-inch HDPE pipe that protrudes from the interior southwest corner of the west cell of the bottom ash ponds (Photo 7). This pipe serves as a carrier pipe for two smaller 4-inch discharge pipes. The carrier pipe terminates in the interior of the embankment and provides a direct seepage path to the interior of the dam should the pond water level rise above the invert of the pipe. Measures should be taken to seal off the carrier pipe. PPL Montana has indicated the carrier pipe may not be needed for much longer and can be modified or removed.

Photo 5: Units 1 & 2 Bottom Ash Ponds: west cell, looking northwest corner of pond upstream slope.

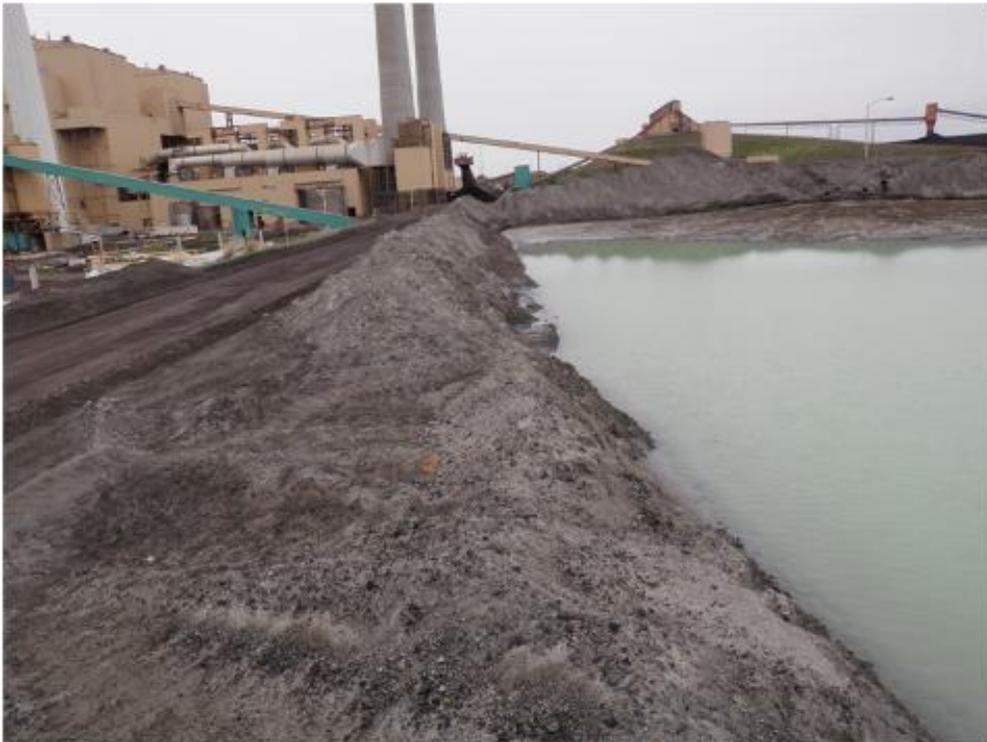
Photo 6: Units 1 & 2 Bottom Ash Ponds: east cell, looking east along upstream slope. Note fly ash pushed up against the upstream slope.

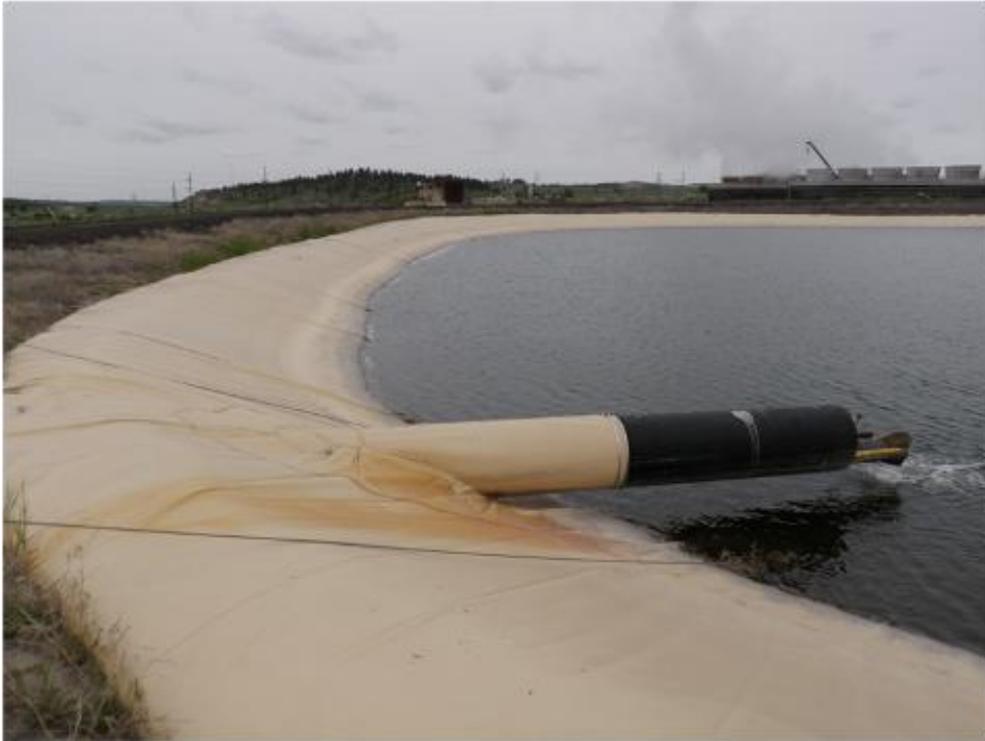
Photo 7: Units 1 & 2 Bottom Ash Ponds: looking north at carrier pipe penetration of RFP lining near southwest corner of pond and upstream slope. Note carrier pipe end is not sealed and would allow seepage directly to embankment at higher pond levels.

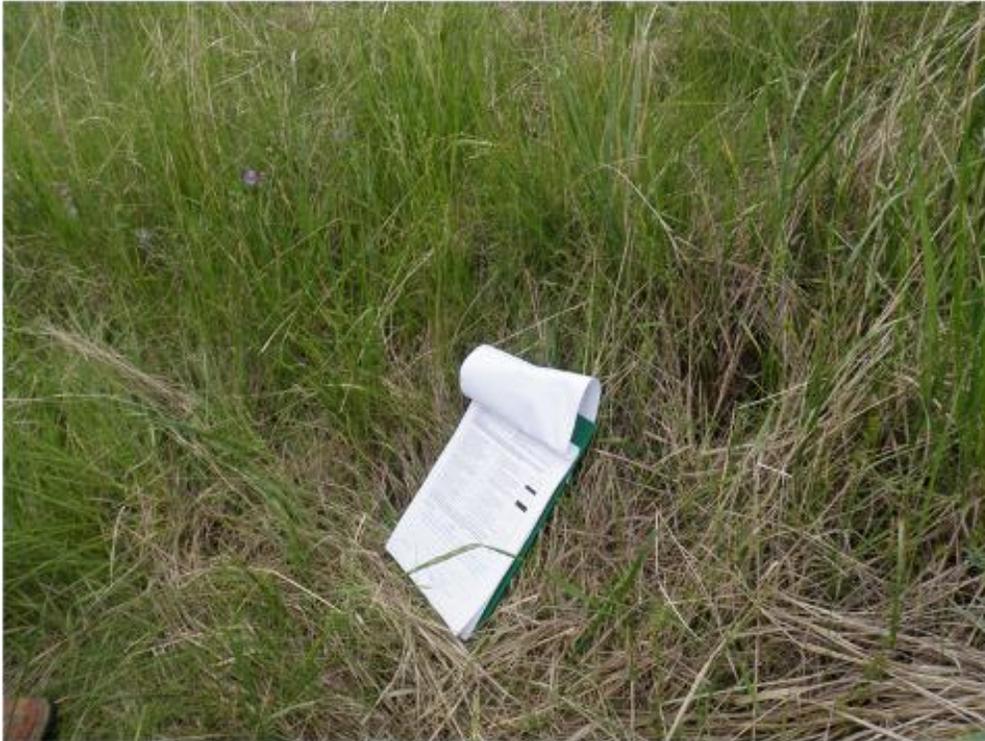
Photo 9: Units 1 & 2 Bottom Ash Ponds: west cell, rodent holes in downstream slope near northwest corner of west cell.

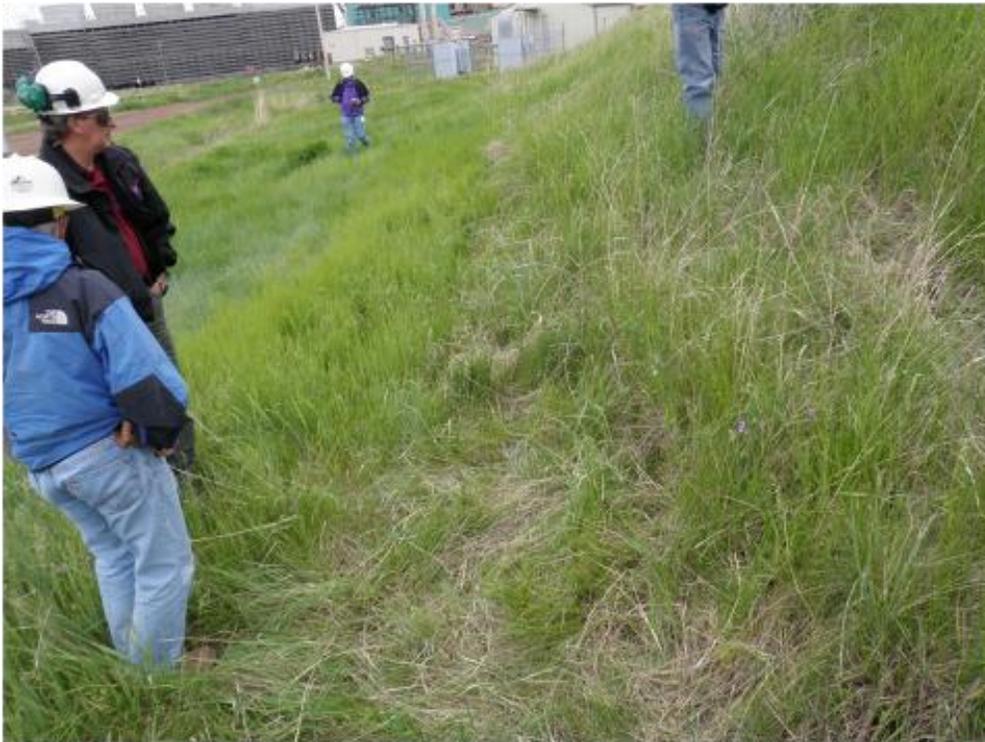
Photo 10: Units 1 & 2 Bottom Ash Ponds: west cell, view of over-steepened slope at downstream toe near northwest corner, most likely caused by excavation for pipe alignment adjacent to toe.

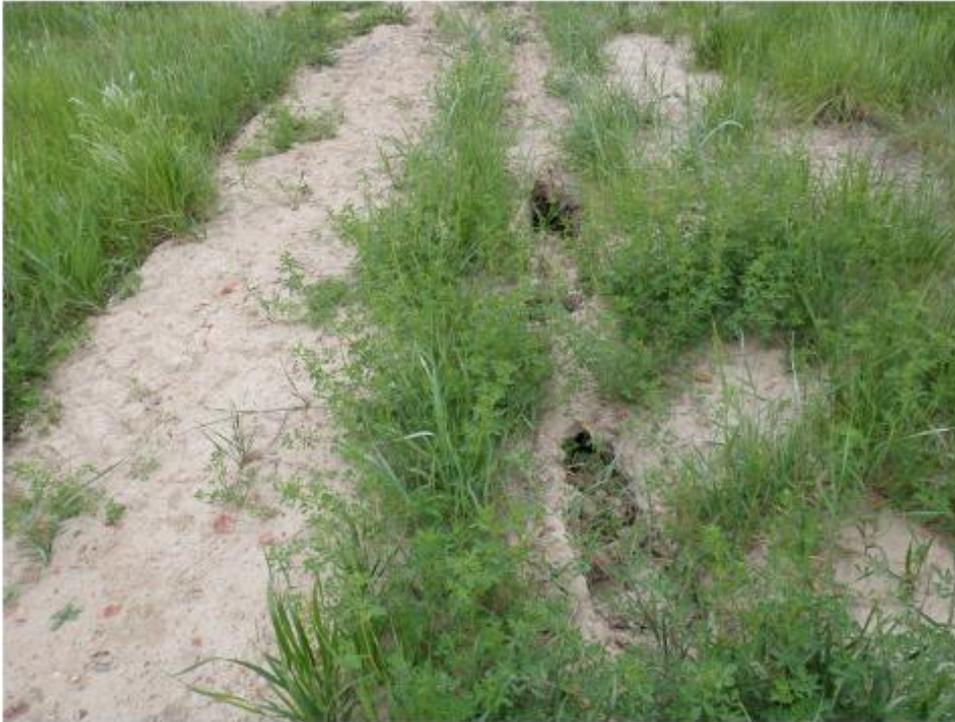
Photo 11: Units 1 & 2 Bottom Ash Ponds: west cell, view of settlement holes near northwest corner caused by poor compaction of pipe trench backfill. Similar holes were found along the entire toe of the Bottom Ash and "A" Pond embankments.

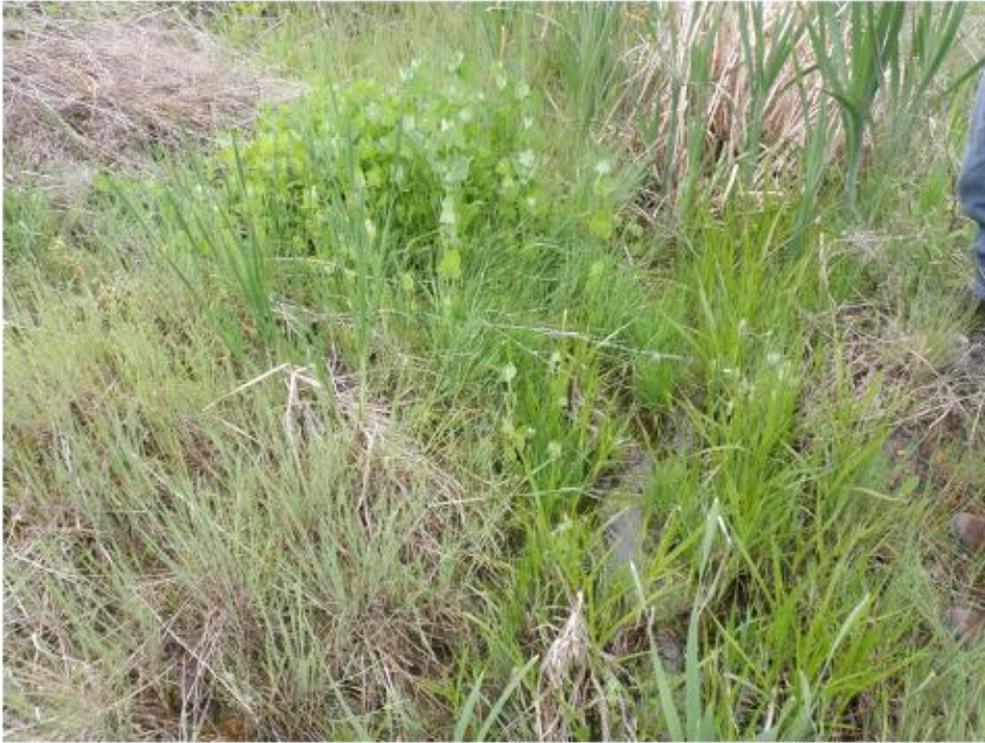
Evidence of seepage (standing water with vegetation) was observed near the northeast corner of the east cell of the Bottom Ash Ponds (Photo 13). The ponded water was at the downstream toe of the east embankment and has been active for a long period based on the locally dense stand of grass. A box culvert that penetrates the embankment near the crest is the likely seepage pathway. The water level of the east cell was observed to be at the invert of the box culvert. The east cell has a clay lining. The box culvert enables discharge pipes to

Photo 13: Units 1 & 2 Bottom Ash Ponds: east cell, view of ponded seepage water at downstream toe near northeast corner of east cell. Seepage results from flow through box culvert that penetrates embankment crest.

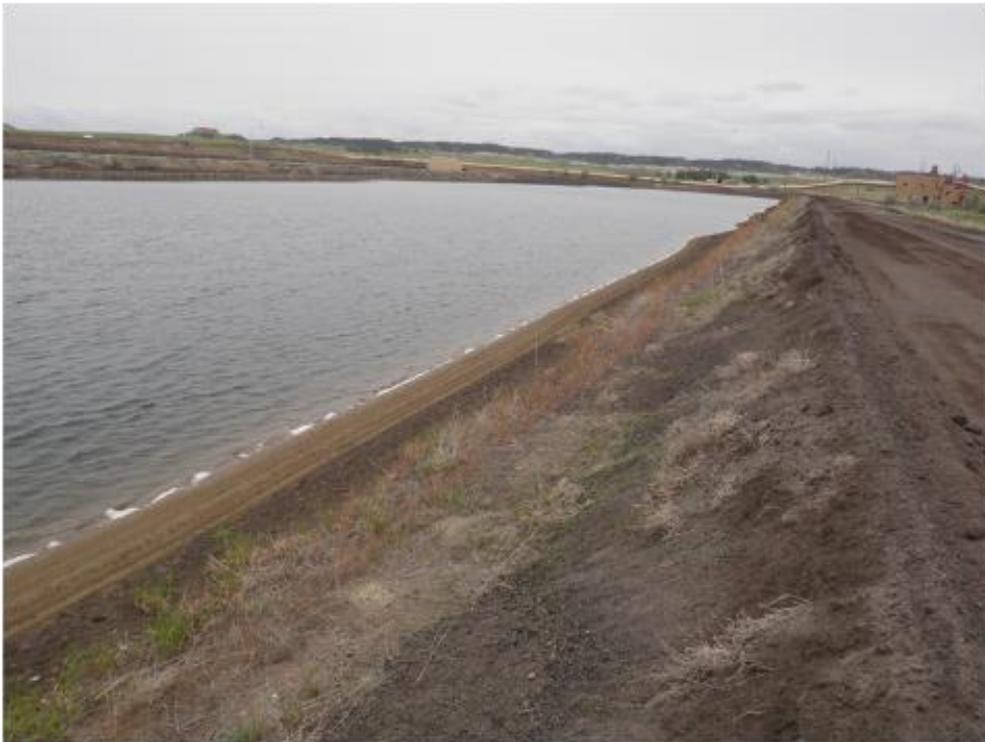
Photo 16: Units 1 & 2 "A" Pond: looking south at upstream slope of west embankment. Note minor vegetation.

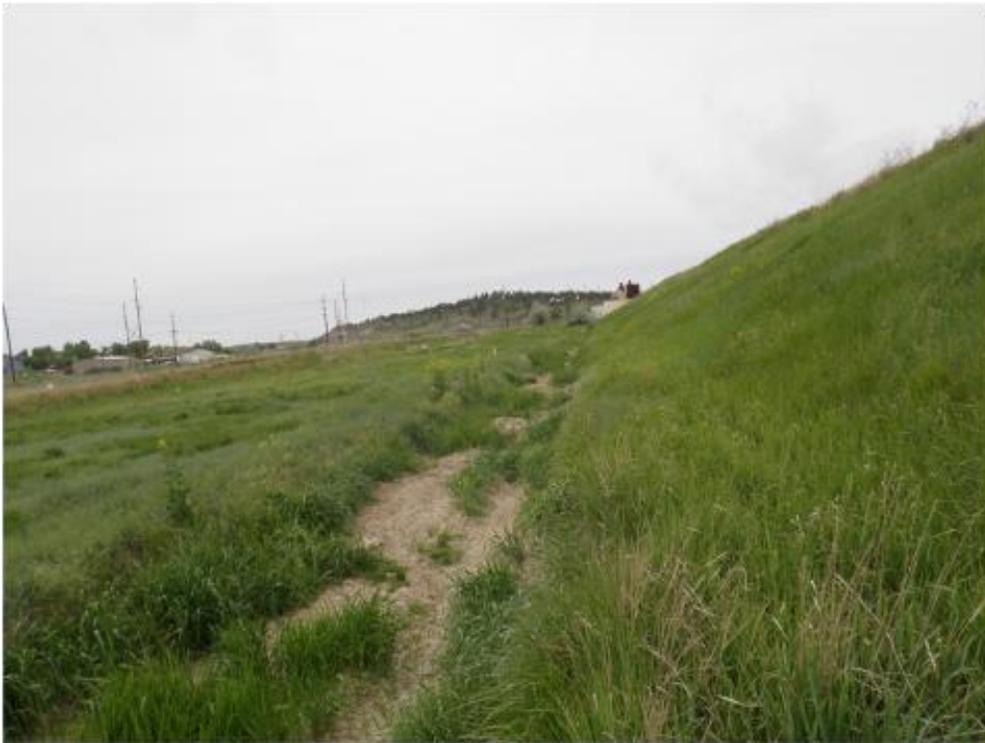
Photo 17: Units 1 & 2 "A" Pond: looking north at downstream toe and slope of west embankment. Note disturbed soil of pipe trench backfill along toe.

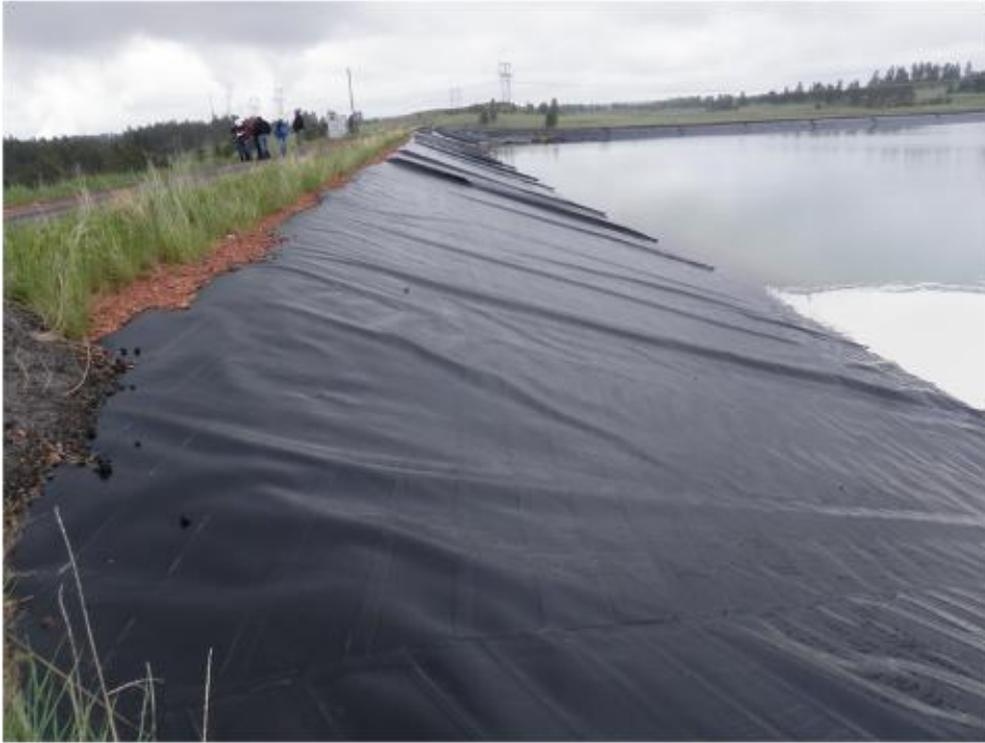
Photo 21: Units 1 & 2 STEP Dam – upstream slope at clearwell, looking to right. Note RFP liner in good condition and slope appears uniform and regular.

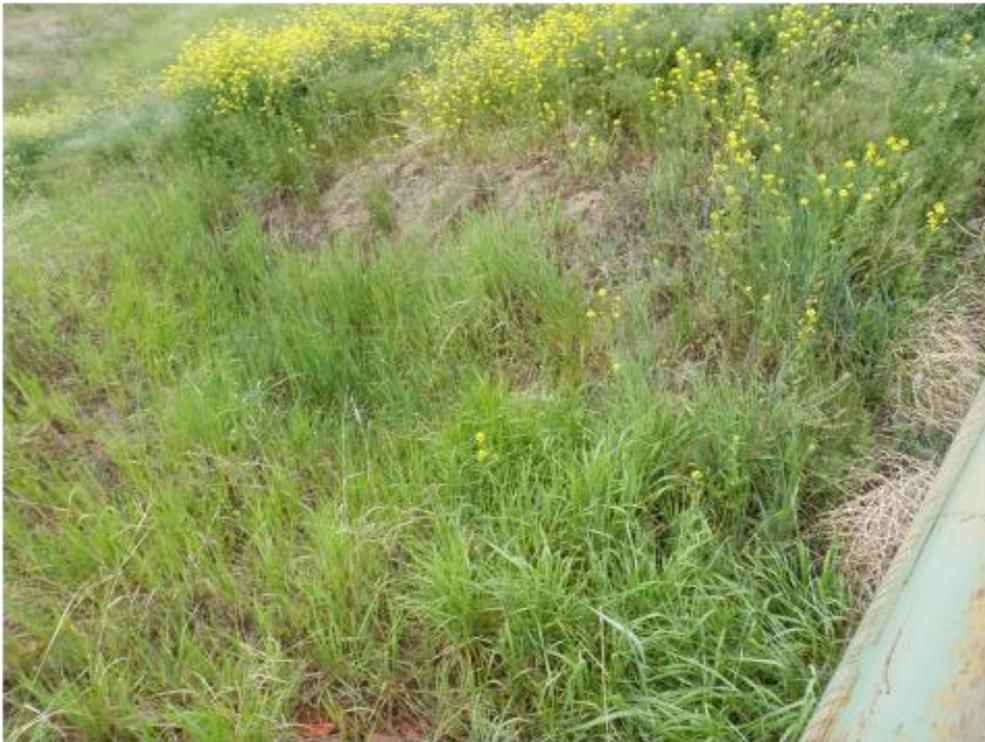
Photo 22: Units 1 & 2 STEP Dam: erosion on upstream slope due to surface water run-on near groin at right abutment.

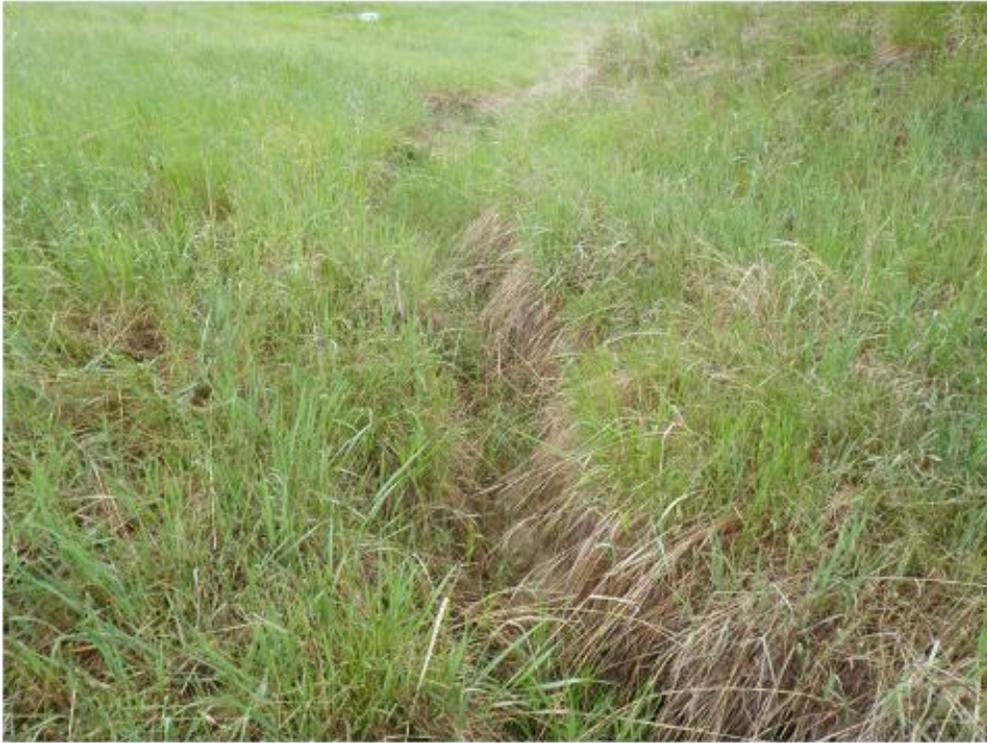
Photo 25: Units 1 & 2 STEP Dam: erosion in groin near right downstream groin caused by stormwater runoff from a drainage area located to the right of the dam.

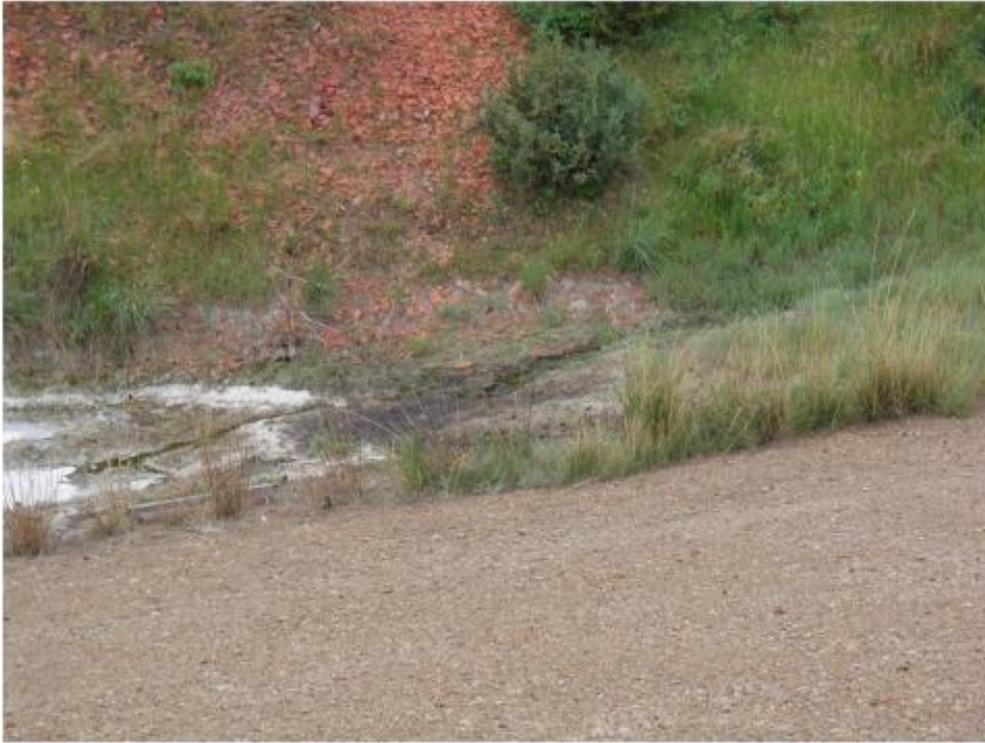
Photo 31: Units 3 & 4 Main Dam: seepage at left abutment on upstream face. Seep is above the reservoir elevation and apparently originates from perched water in adjacent divider berm or in abutment.

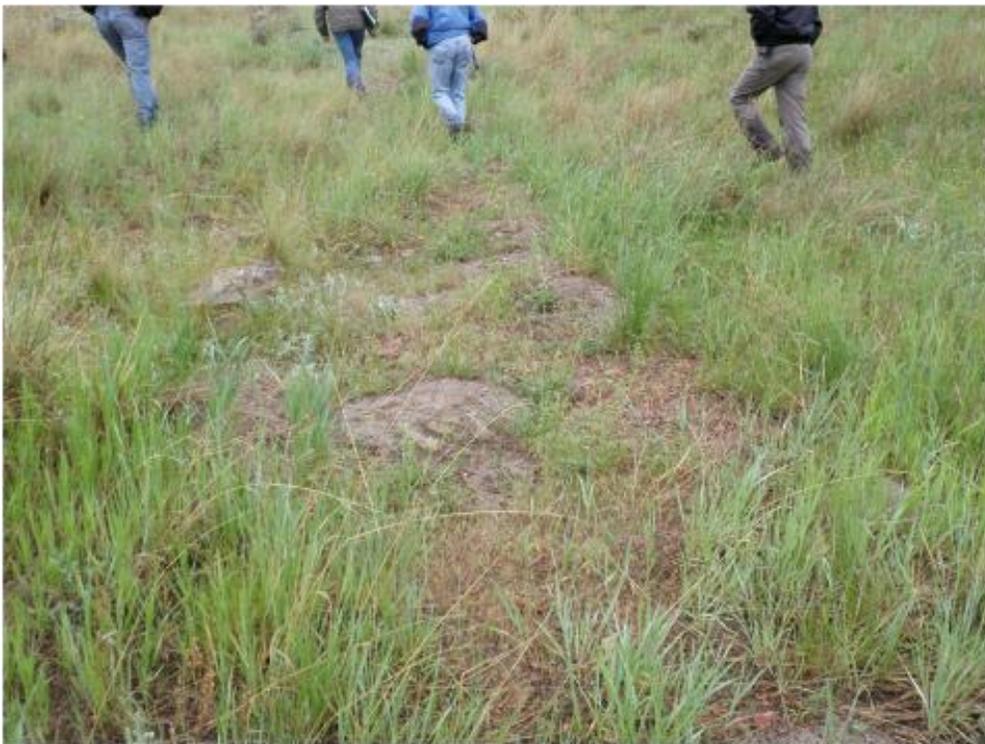
Photo 34: Units 3 & 4 Main Dam: Drain sand exposed by rodent activity in right groin drain system.

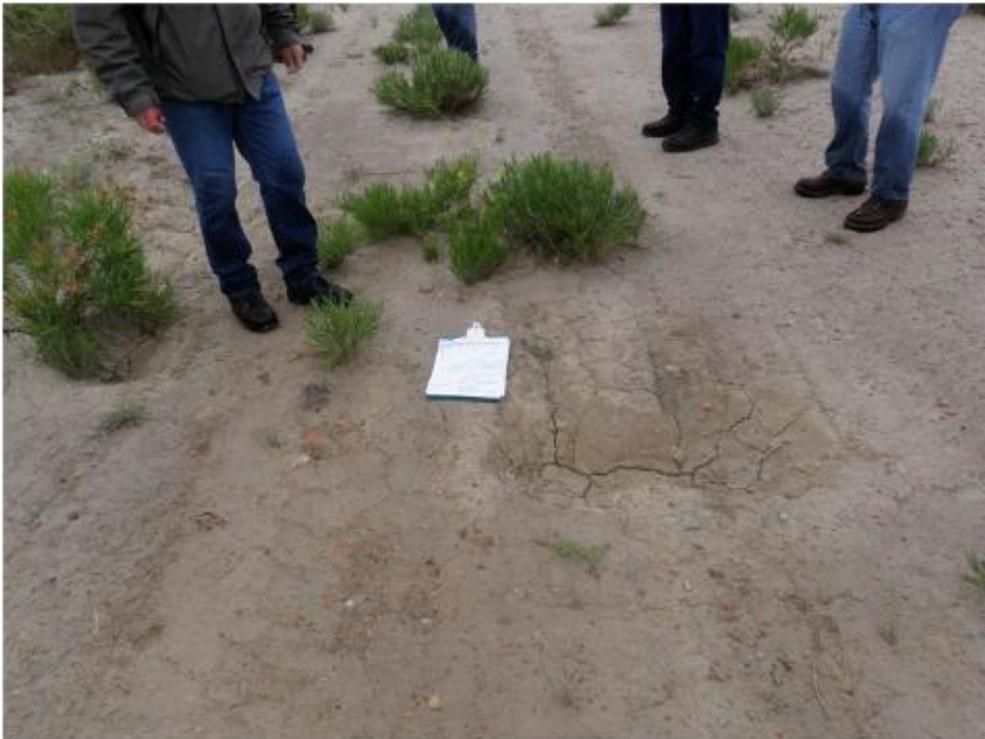
Photo 38: Units 3 & 4 Saddle Dam: Healed/infilled cracks on crest (originally observed in association with the 1999 seepage event). Cracks are aligned with the upstream side of the concrete cutoff wall.

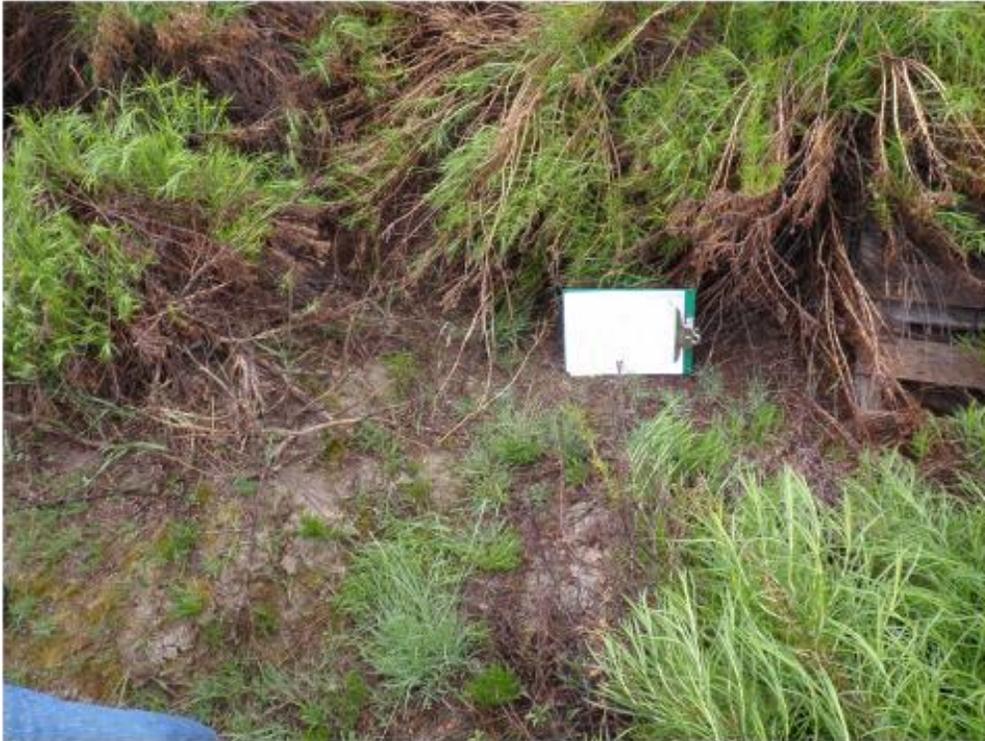
Photo 39: Units 3 & 4 Saddle Dam: Healed/infilled crack on crest (originally observed in 1999 – up to 1 foot wide and several feet deep).

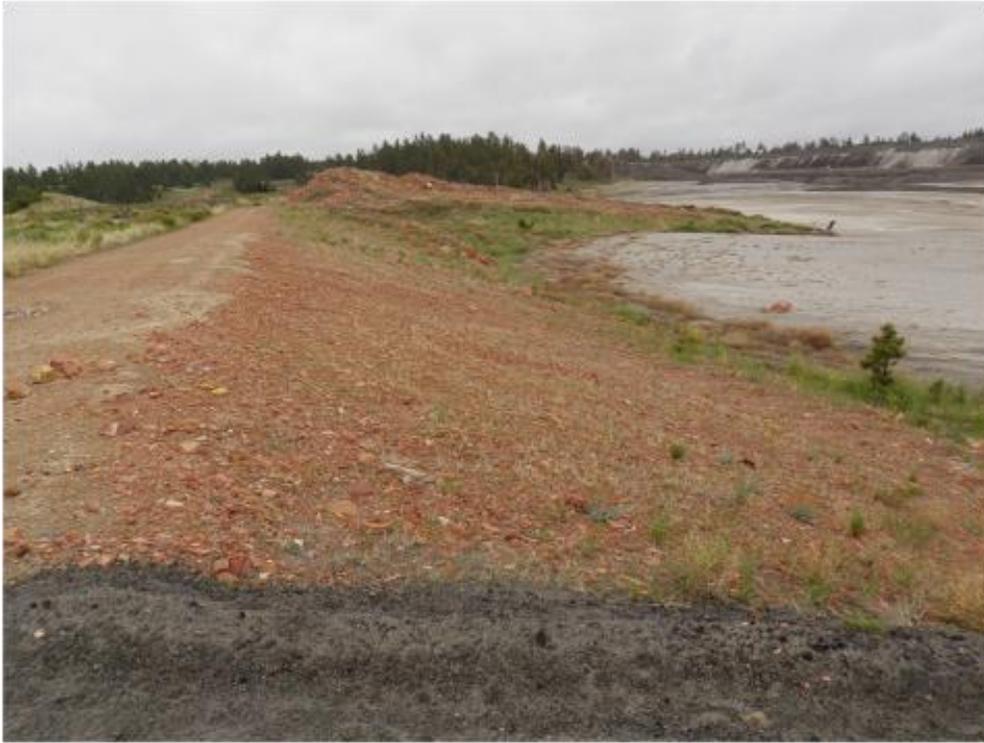
Photo 41: Units 3 & 4 Saddle Dam: Upstream face near mid-point along dam length and near intersection with "G" cell divider dike. Note minor vegetation on soil cement.

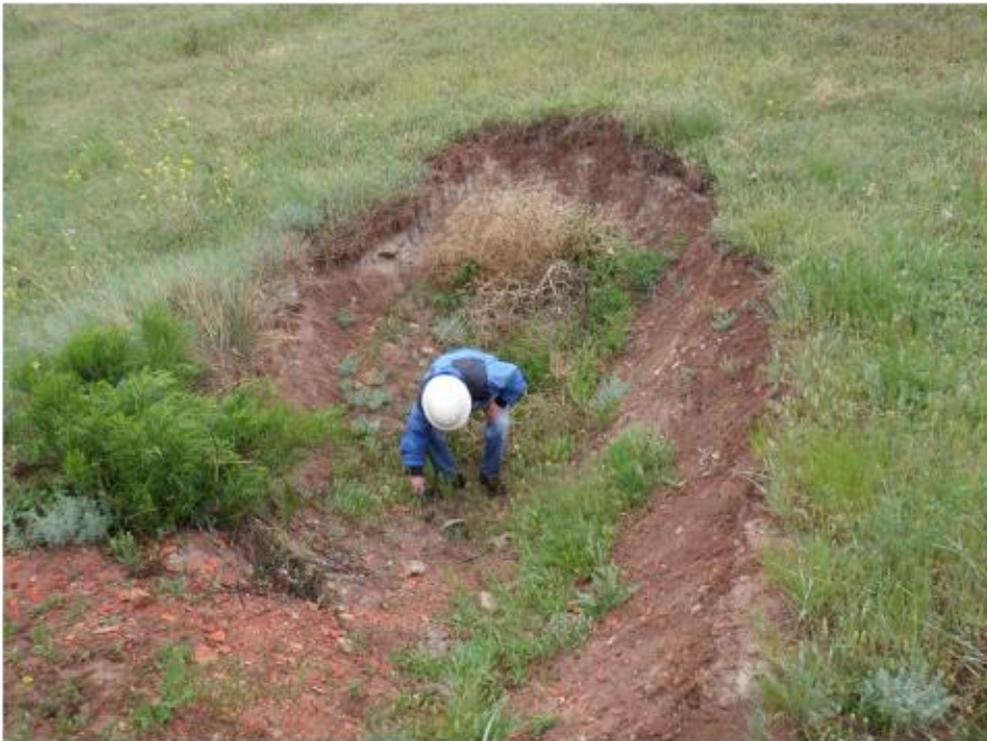
Photo 44: Units 3 & 4 Saddle Dam: Test pit excavated in 1999 that has not been backfilled. Granular drain material and broken toe drain pipe was exposed in the test pit.

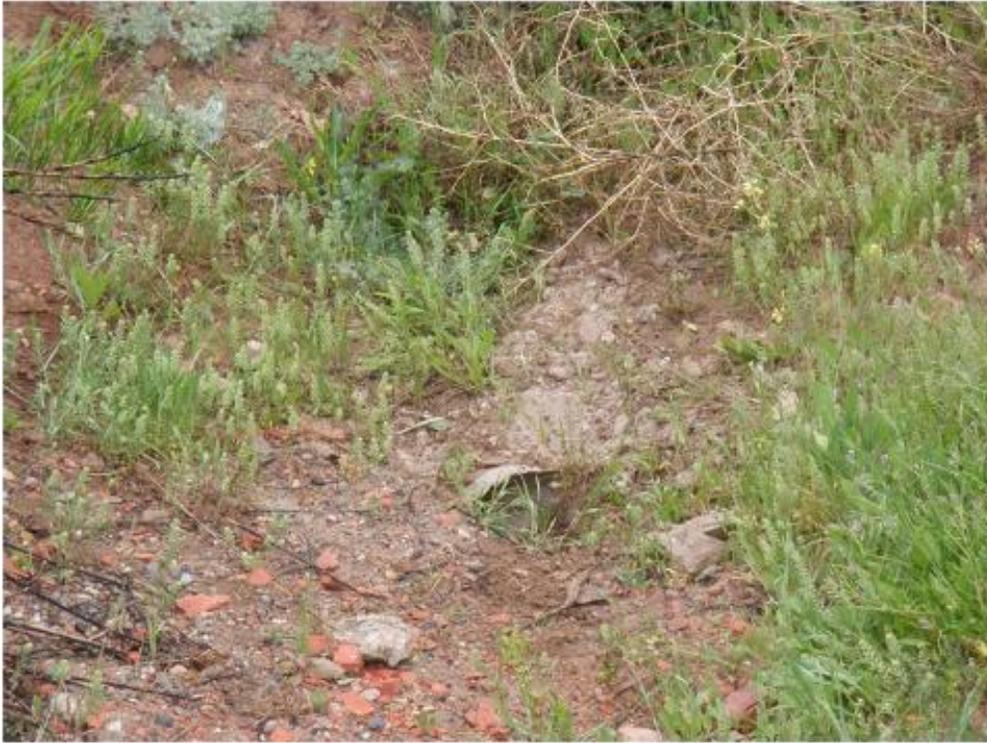
Photo 45: Units 3 & 4 Saddle Dam: Close-up view of drain sand and drain pipe in test pit.

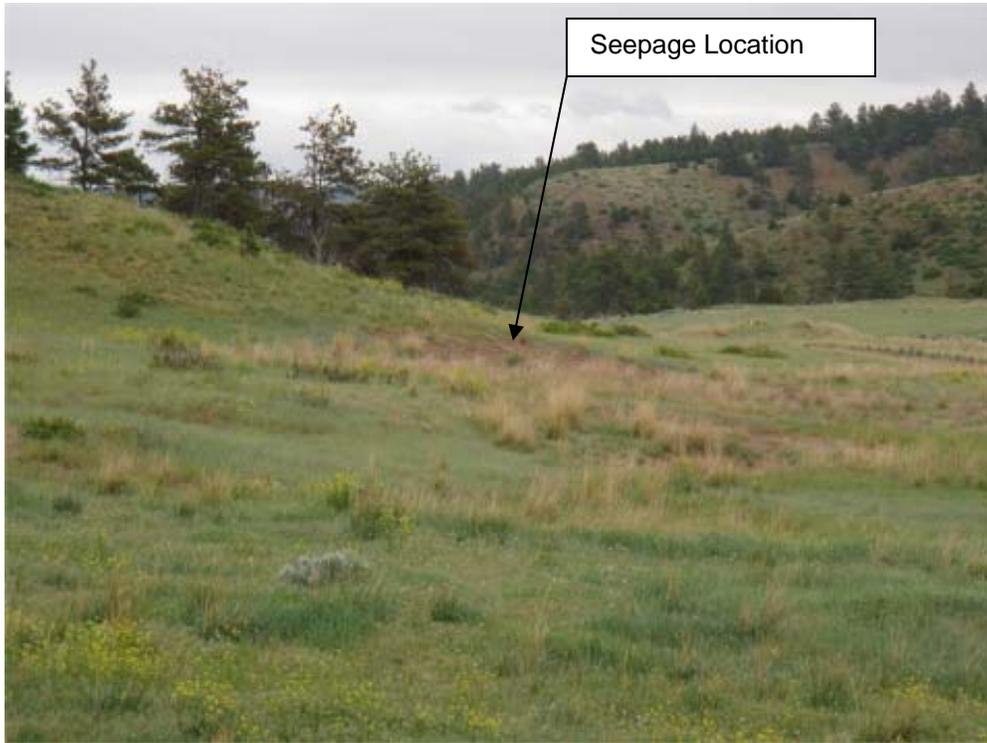
Photo 47: Units 3 & 4 Saddle Dam: Looking directly downstream at location where the 1999 seepage day-lighted near base of the rock hill. The bare ground marks the seepage location, which is about 100 yards downstream of the dam toe.
