**Coal Combustion Waste Impoundment  
Dam Assessment Report**

***Martins Creek Steam Electric Station  
PPL Generation  
Bangor, Pennsylvania***

**Project # 0-381  
Assessment of Dam Safety  
Coal Combustion Surface Impoundments  
for the REAC Program**

**September 2009**

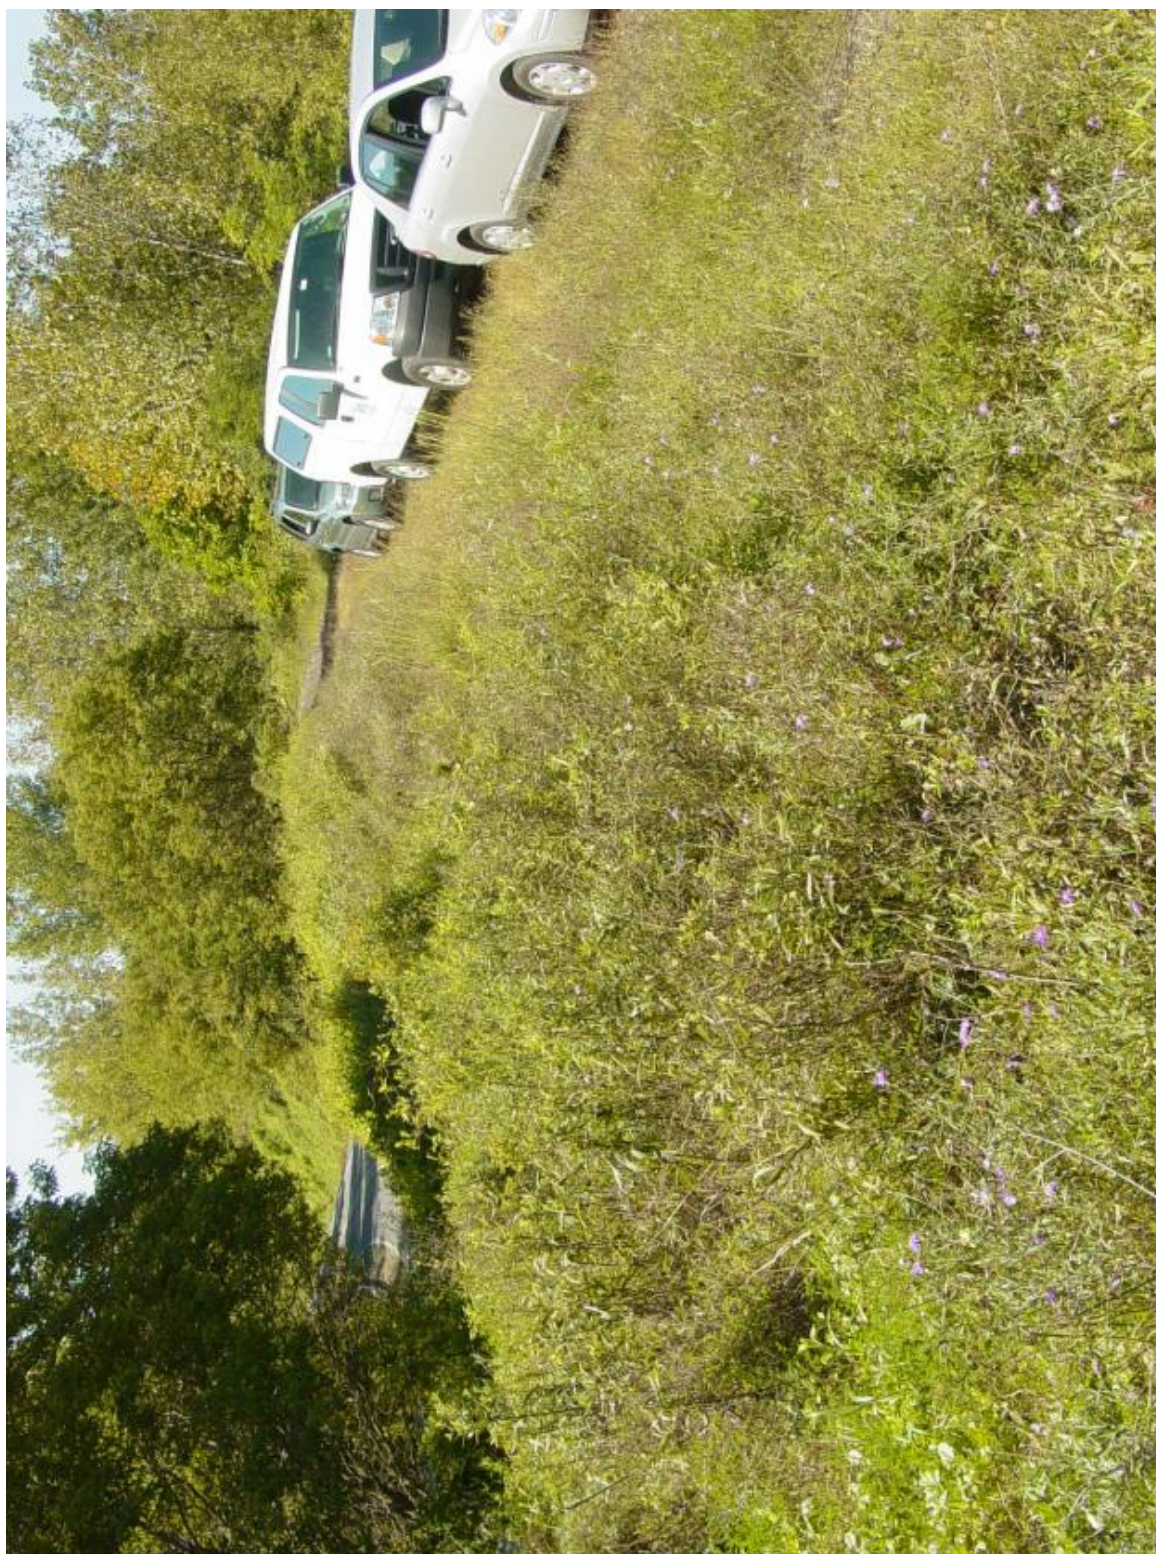
Photo BI-2: Ash Basin No. 1 Crest and Outside Slope of East Embankment North End - Viewed South.

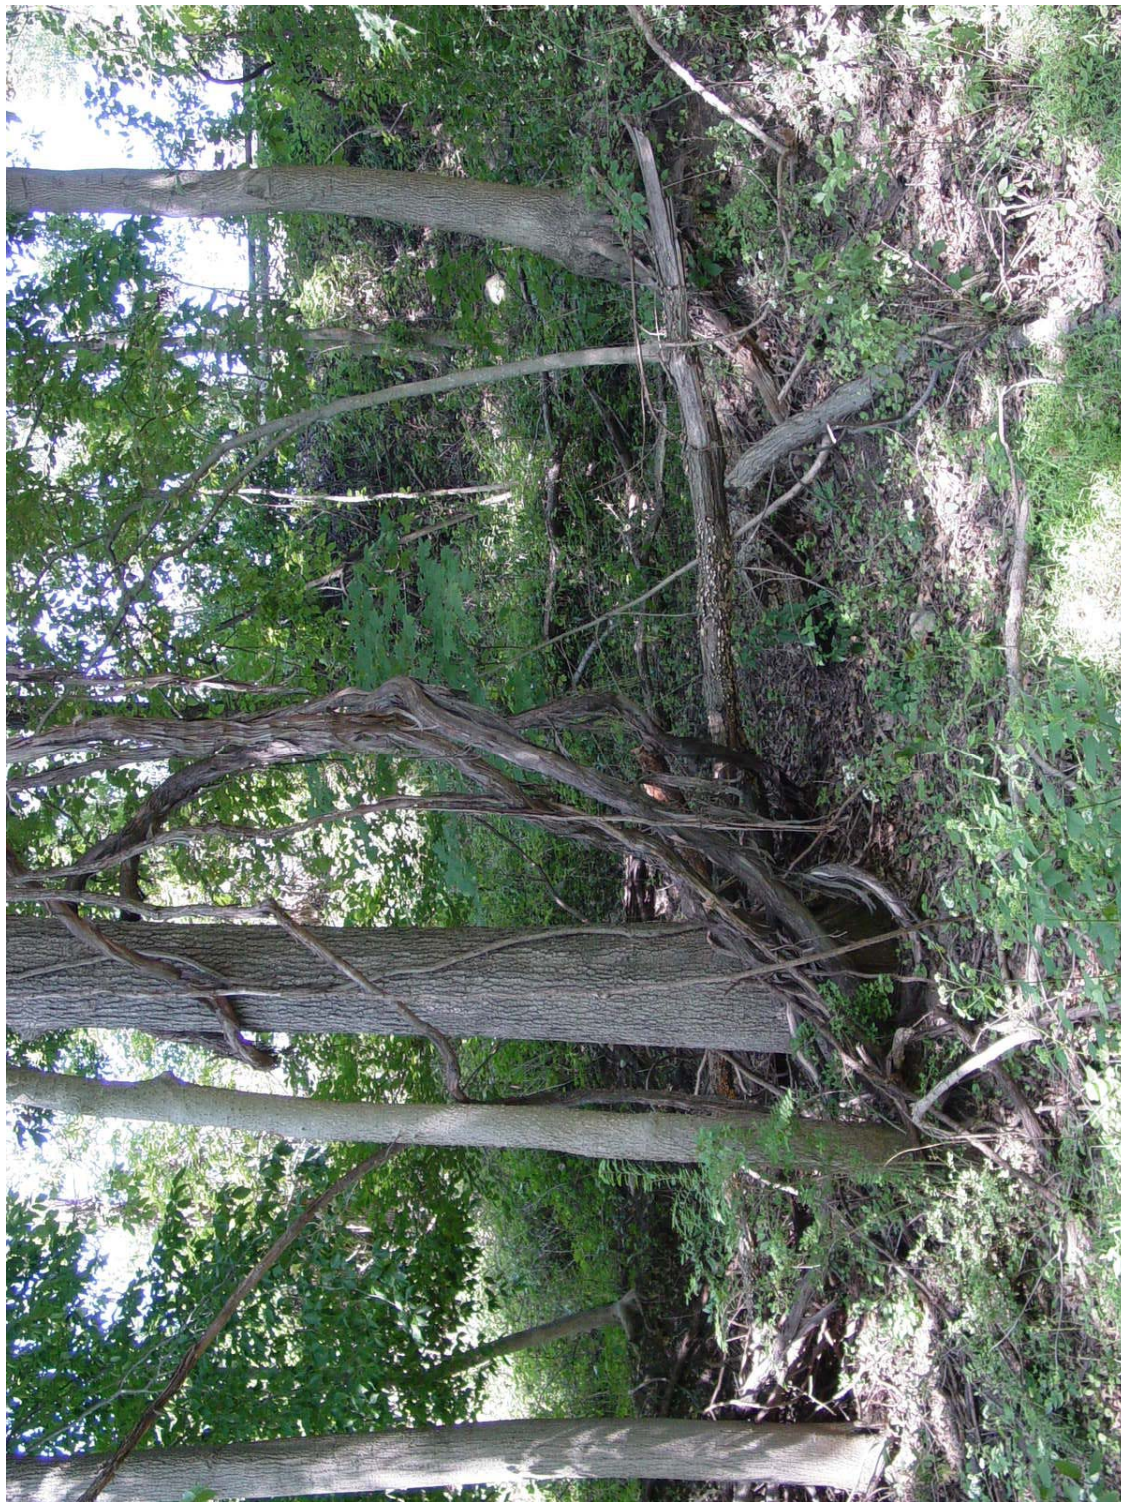
Photo BI-4: Ash Basin No. 1 Outside Toe of Embankment Below Paved Access Road outside Southeast Corner of Basin  
Near where Outlet Pipe Passes Through Embankment- Viewed West.

Ash Basin No. 1 Dam – None appear warranted at this time, other than maintaining vegetation on the crest and outside slope and visual monitoring of the shallow depression at the outside toe of the embankment at the southeast corner as recommended in Subsection 1.2.6, below.

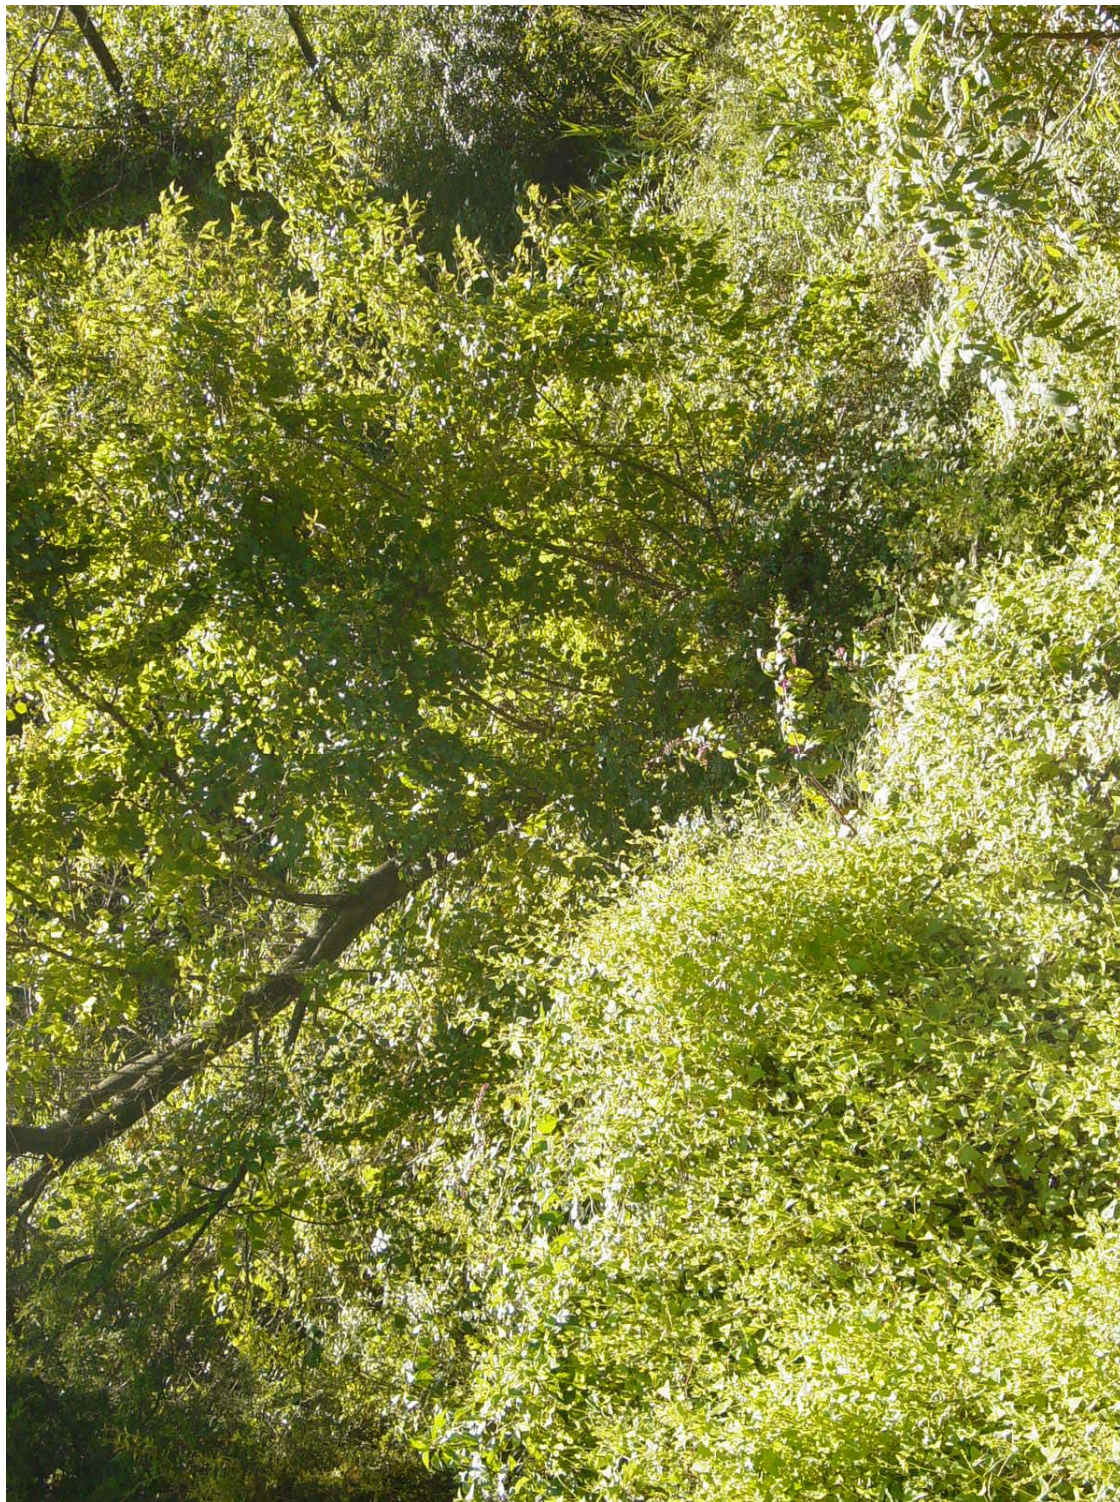
Photo BI-8: Ash Basin No. 1 View of Tree Growth and other Vegetation in Lower Southern Part of Basin Just Downstream of West Part of Main Cross Dike – Viewed East.

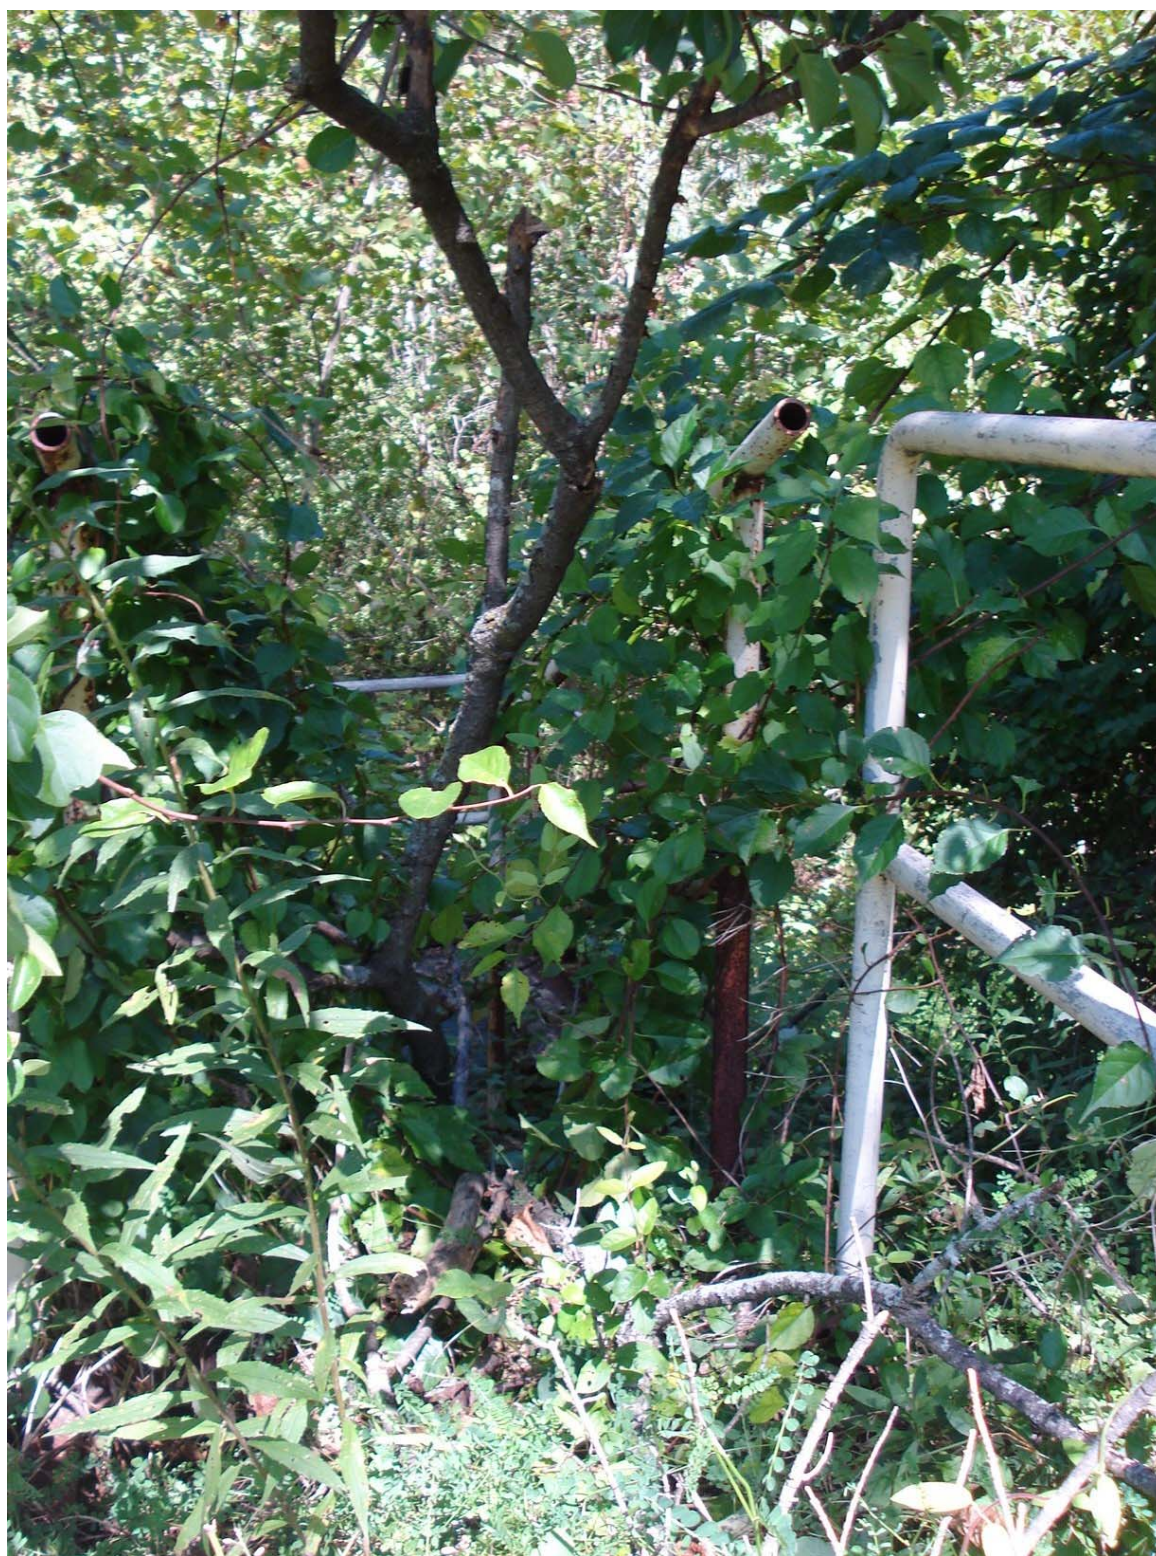
Photo BL-11: Ash Basin No. 1 Overgrown Footbridge to Outlet Standpipe inside Southeast Corner of Basin - Viewed West.

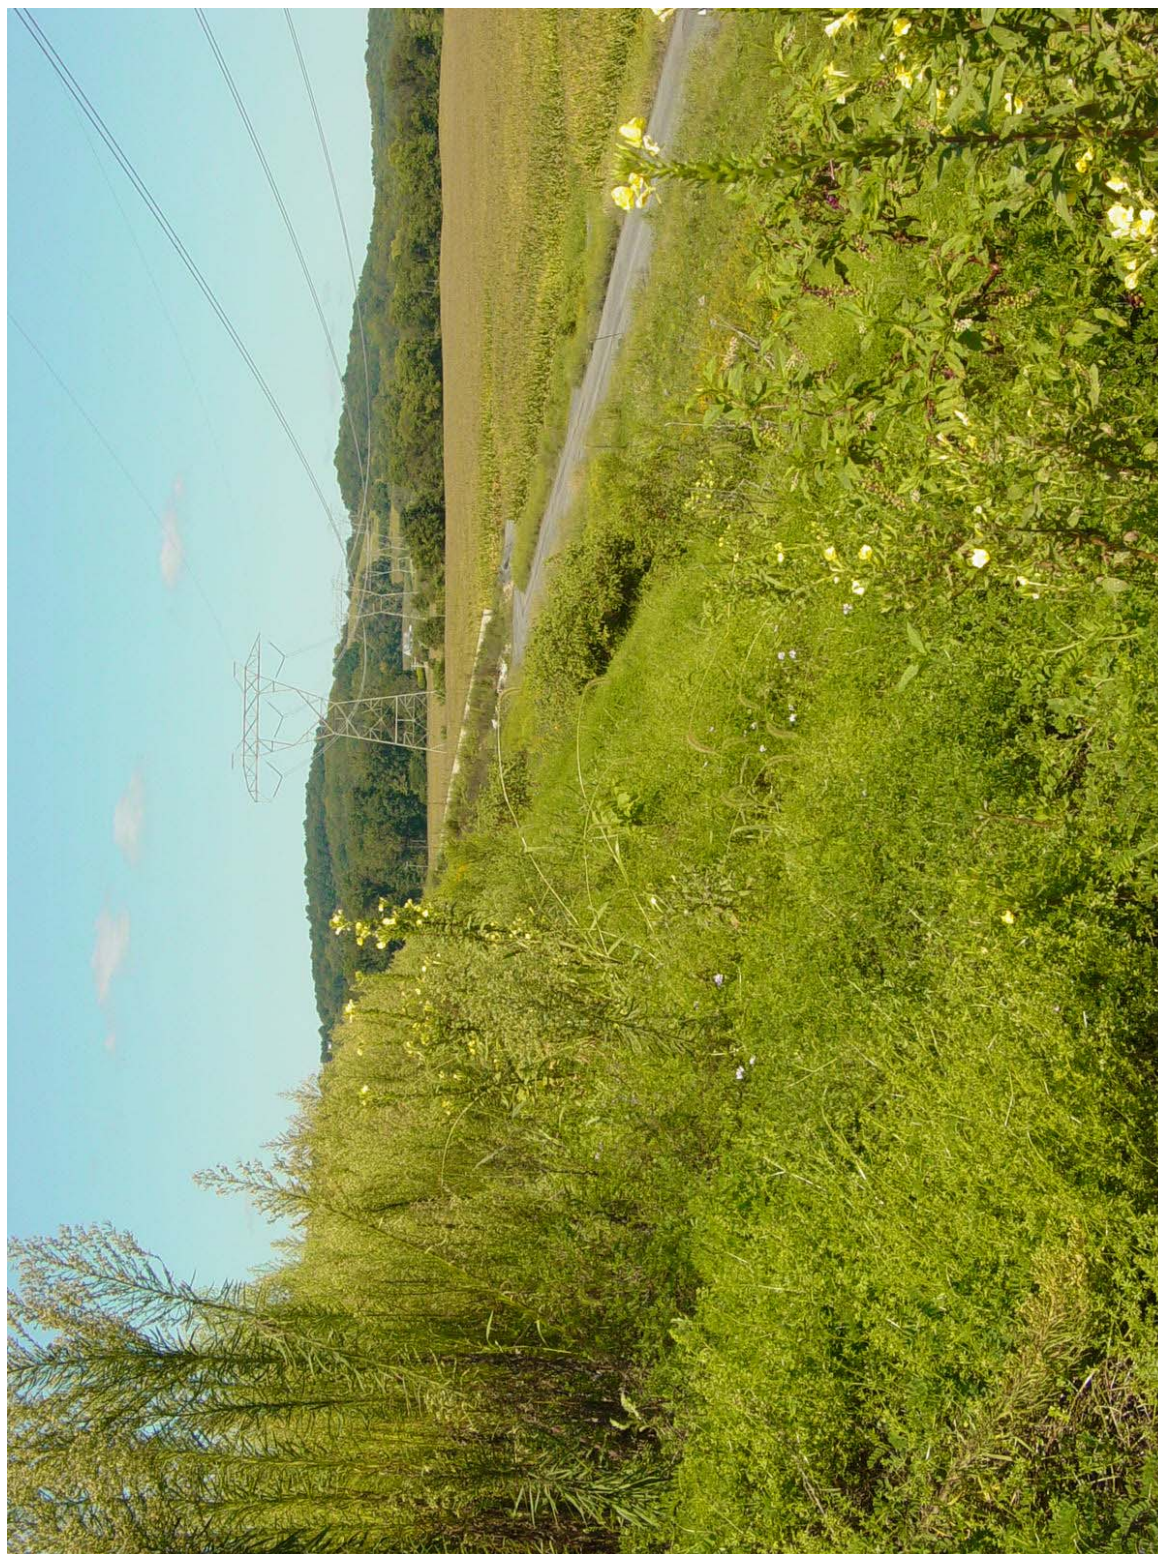
Photo B4-B: Ash Basin No. 4 Outside Slope of North Embankment – Viewed Northwest.

Ash Basin No. 4 Dam - It is recommended that the outside slope be mowed at a frequency of 3 times per year: one time each during spring, summer, and fall. PPL's quarterly inspections and the annual inspection by the independent consultant should be coordinated with the mowing schedule. On the basis of observations made by an outside consultant in June 2009, it is recommended that a burrowing animal control program be implemented. It appears that the animals should be trapped and moved to a different location or eradicated. It is recommended that the control program be implemented within a time frame of 1 year. Filling of their burrows apparently is not effective and only encourages the animals to make new burrows. The post-closure maintenance program should also include repair of eroded areas that may develop on the outside slope or final closure cap. If the decant tower and outlet pipe are to remain open and functional after closure, it is recommended that these structures be maintained or repaired as needed, based on the results of routine inspections.

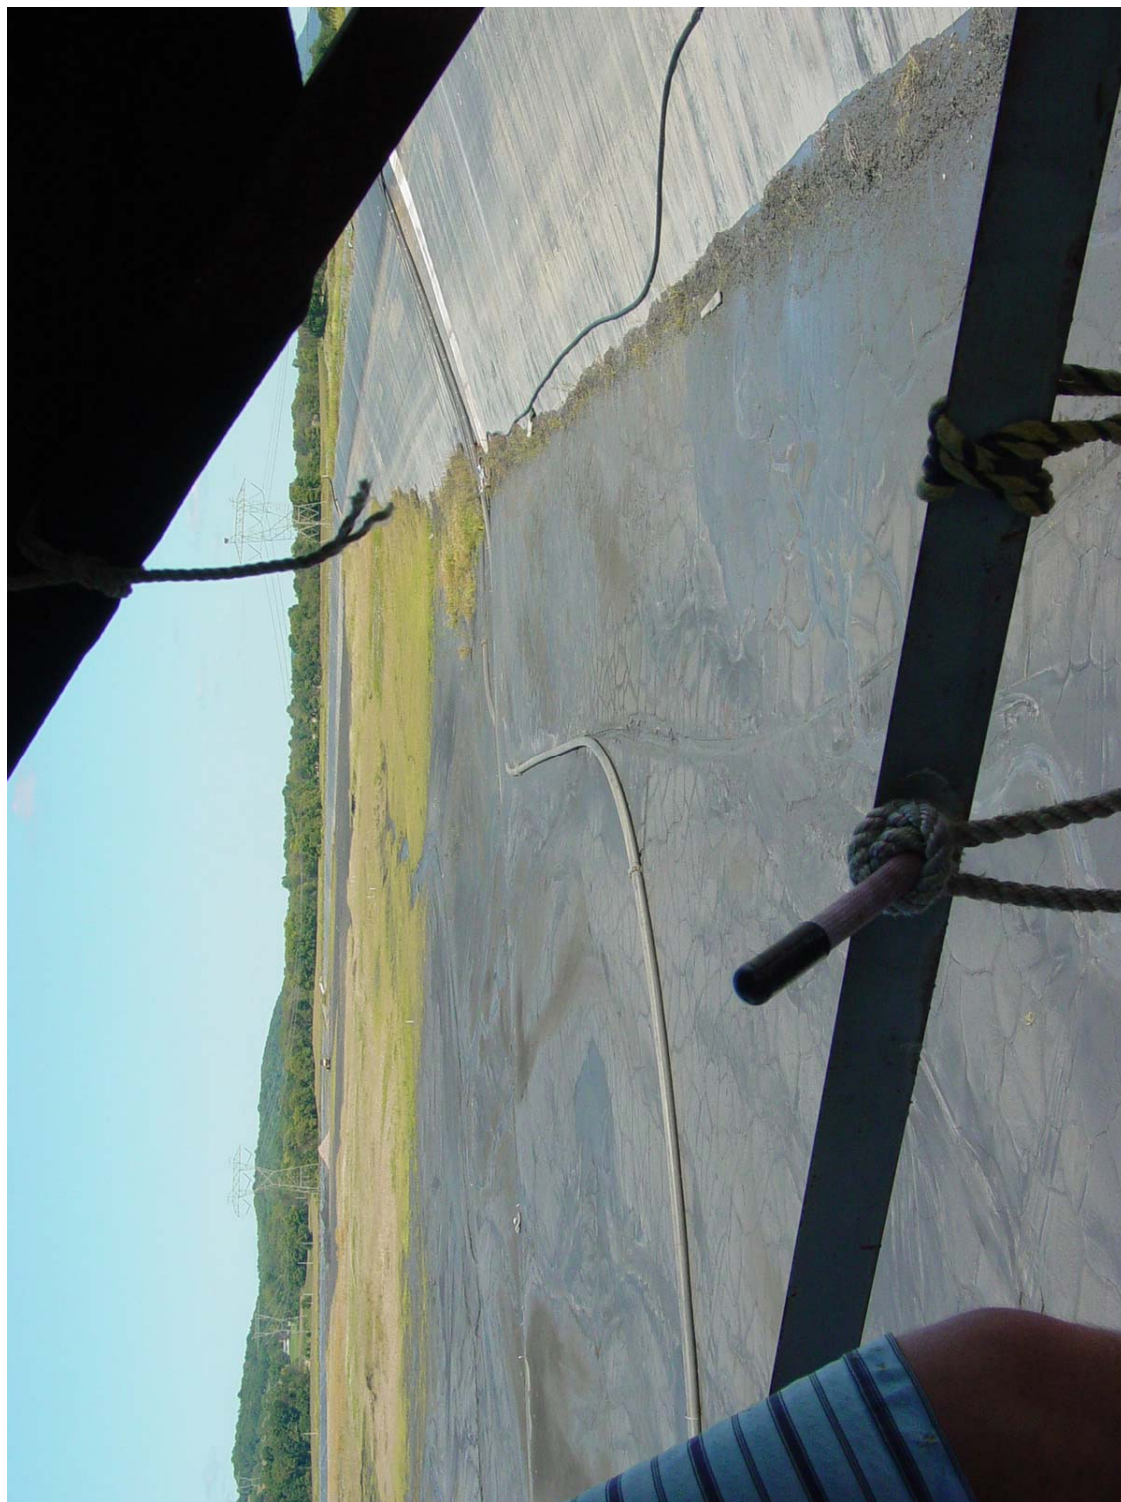
Photo B4-9: Ash Basin No. 4 Inside Slope of East Embankment and View of Ash Surface in Basin– Viewed North from Top of Decant Tower – Note Vertical Wrinkles in Liner (Commonly Occurs Throughout).

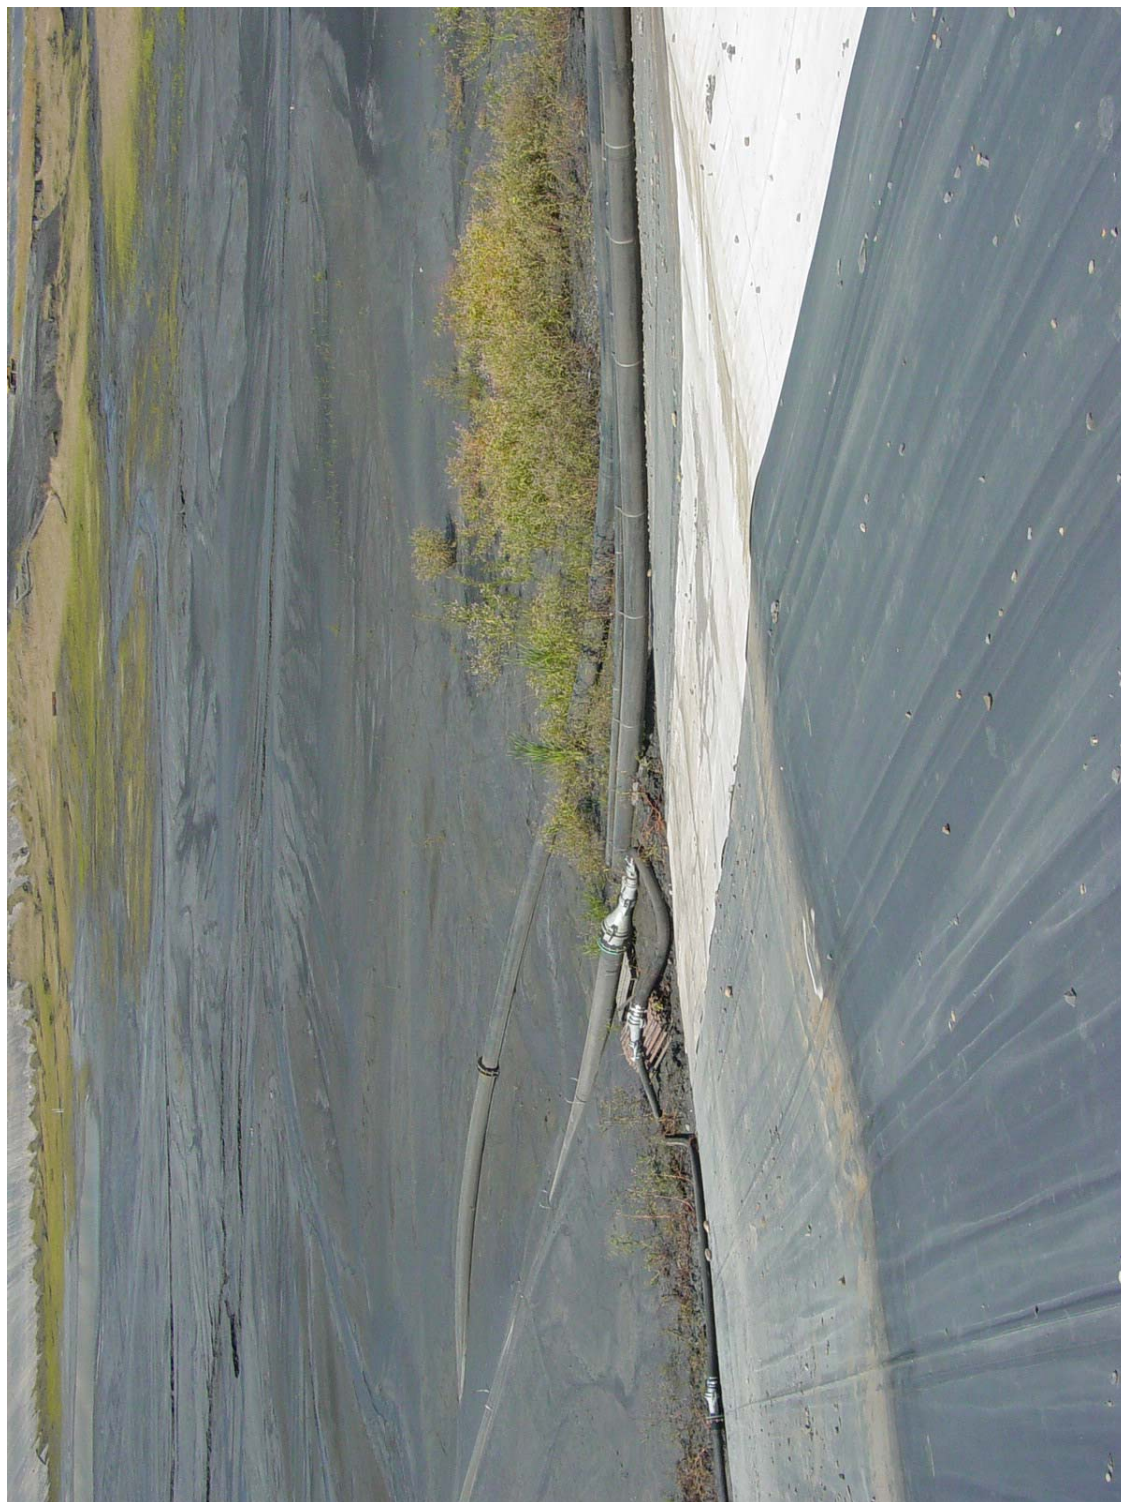
Photo B4-ID: Ash Basin No. 4 View of Slight Linear Bulge Under Liner along Former Operating Water Level on Inside Slope of East Embankment Approximately 430' North of Decant Tower Footbridge.

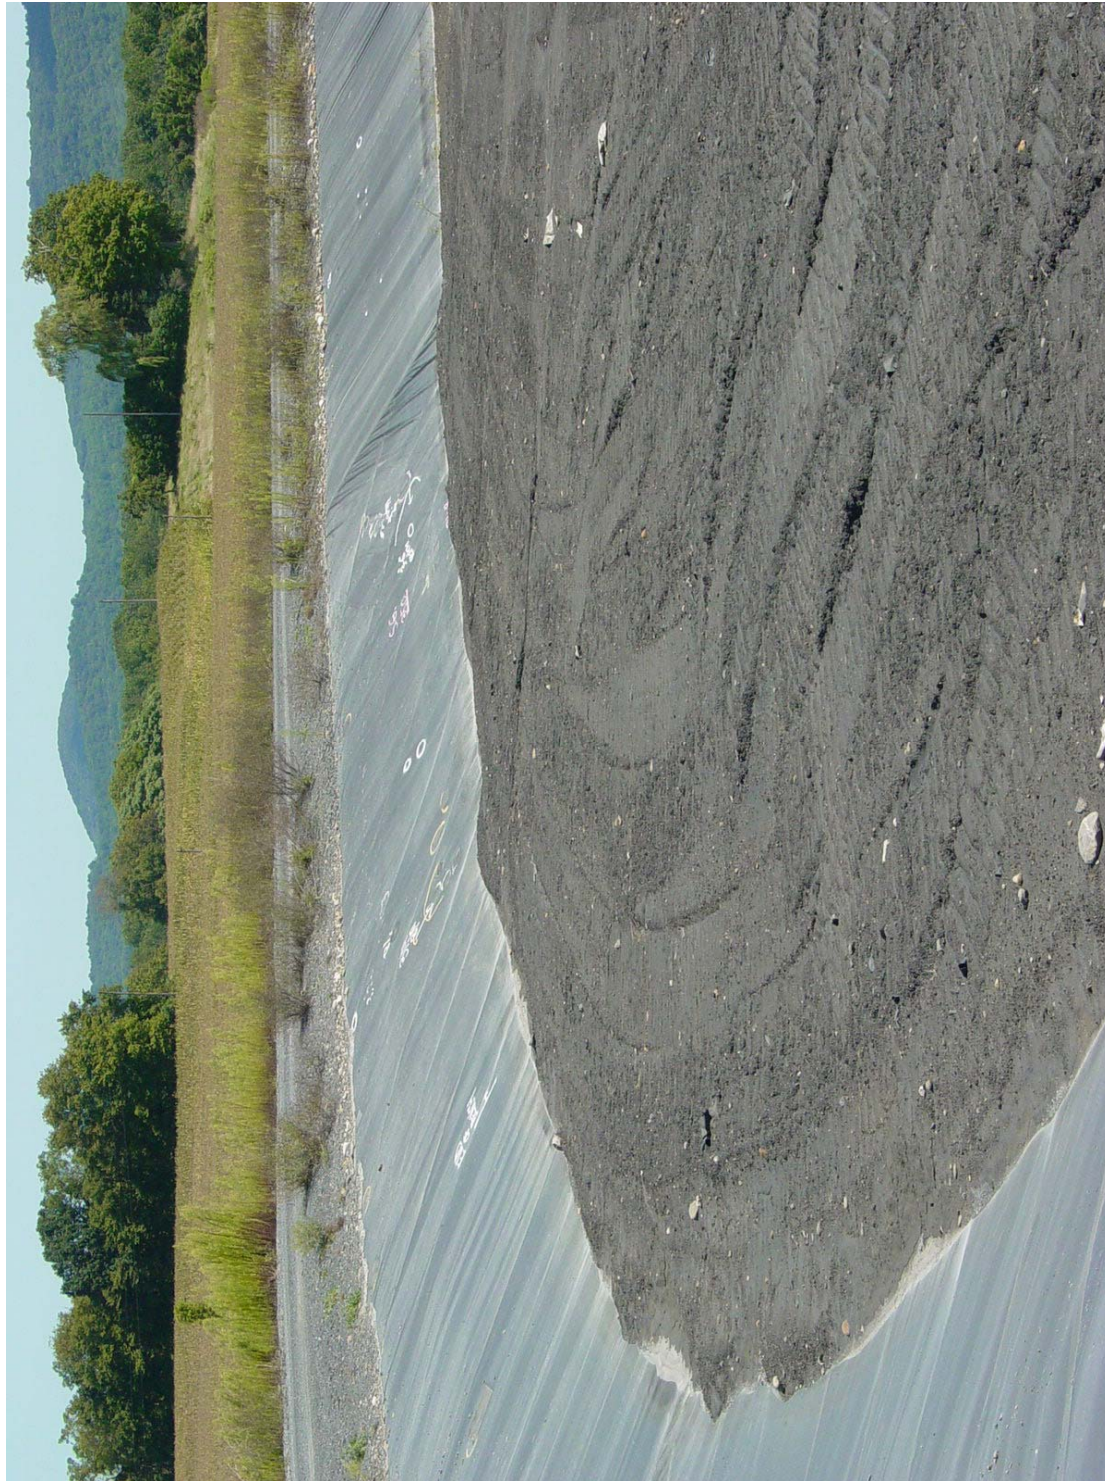
Photo B4-12: Ash Basin No. 4 Inside Slope of North Embankment at Northwest Corner – Note Highest Point of Ash in the Basin Spread in Place by Dozer in Preparation for Closure; White Marks on Liner from PPL Inspection Indicating Holes and Defects to be Patched.

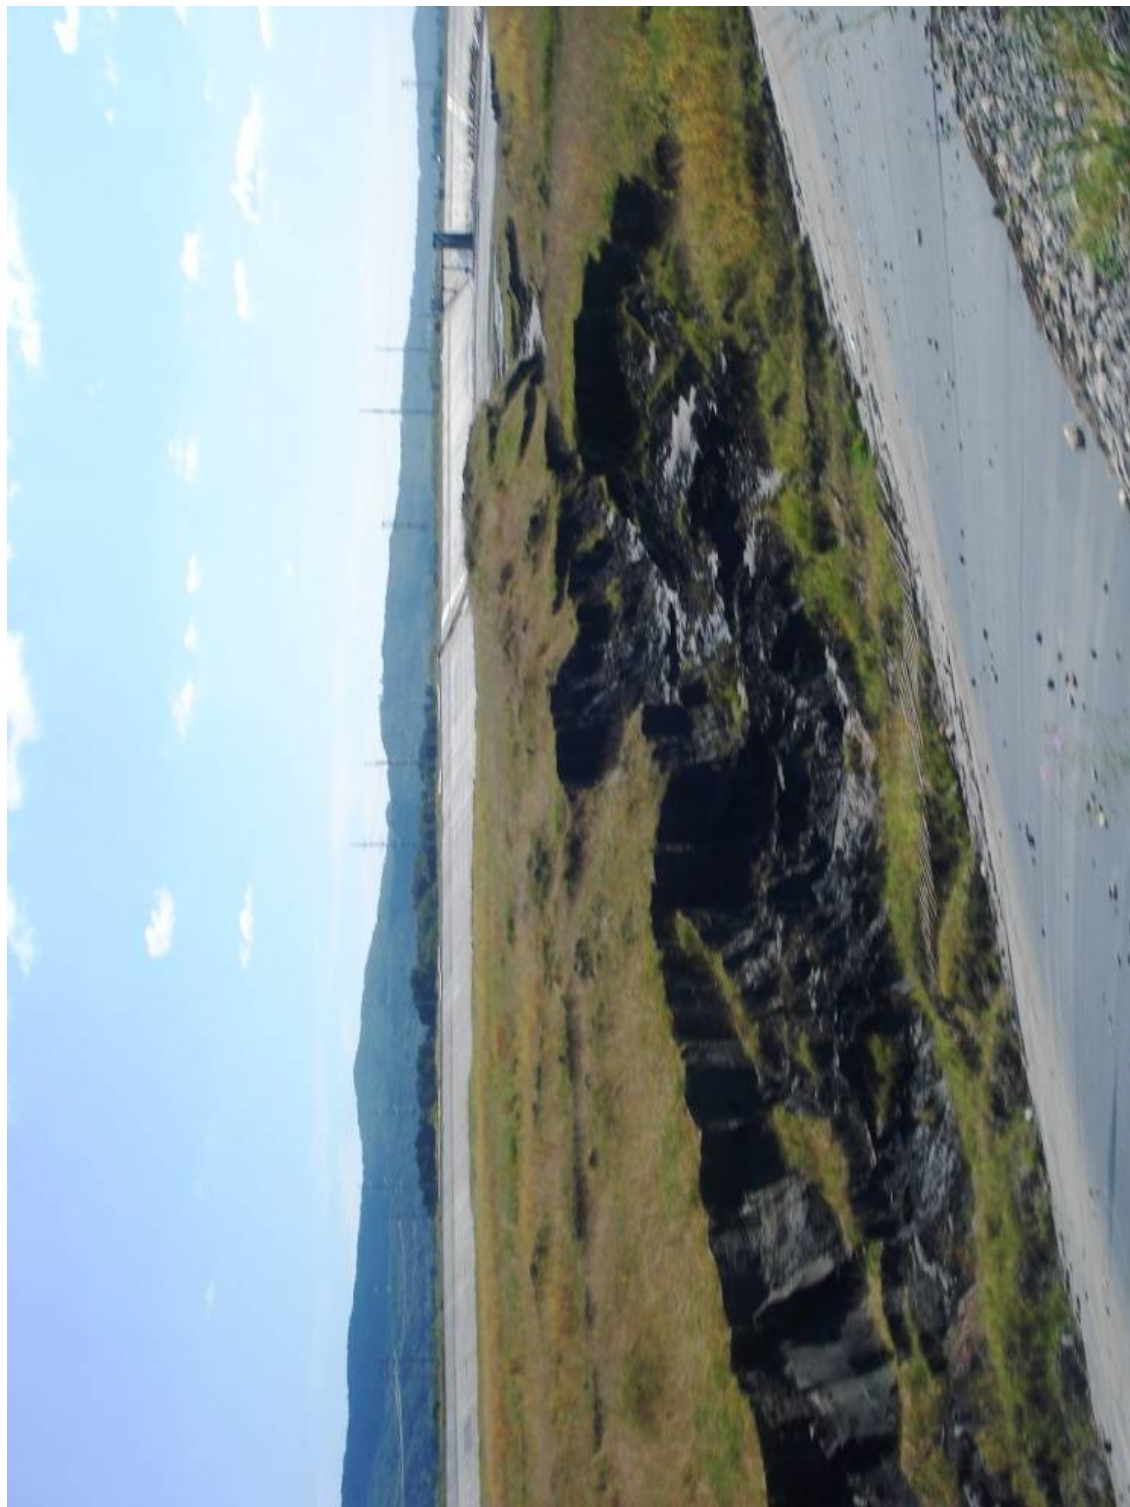
Photo B4-14: Ash Basin No. 4 View of Swale Cut Through Ash to Allow Drainage from West Part of Basin – Note Sloughing and Erosion of the Side Slopes of the Swale.

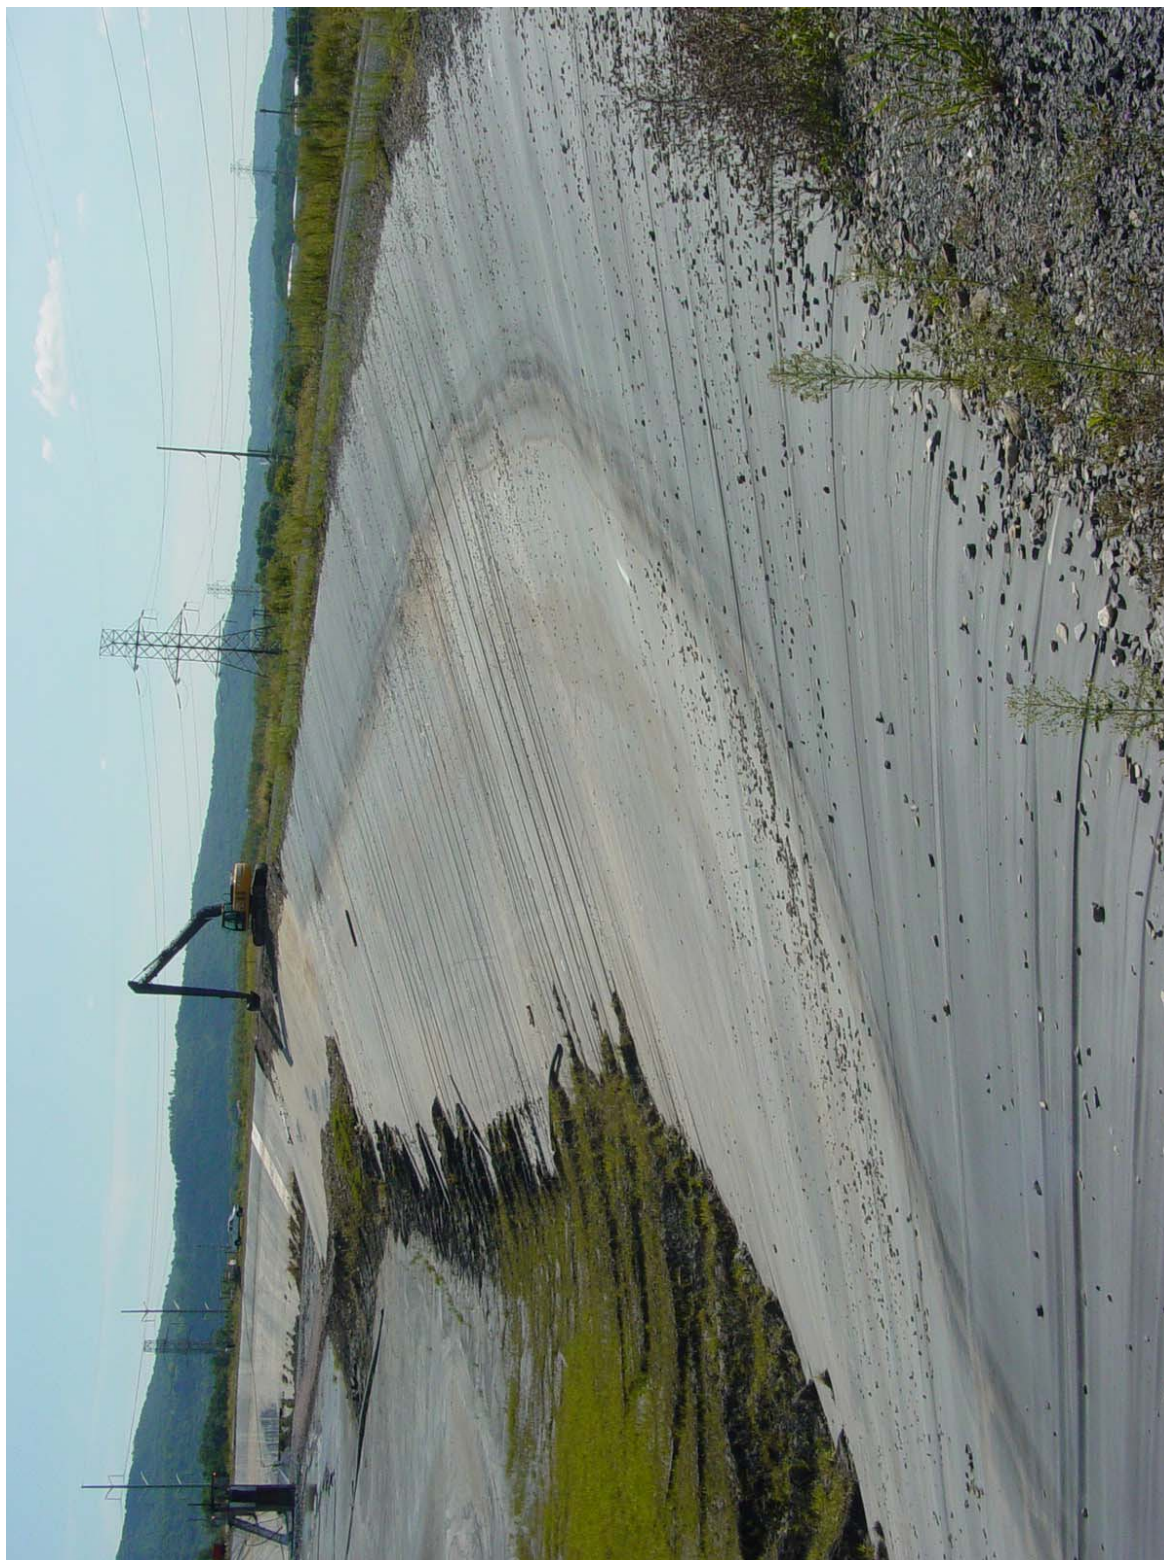
Photo B4-15: Ash Basin No. 4 Inside Slope of South Embankment – Viewed Southeast – Note Vertical Wrinkles.

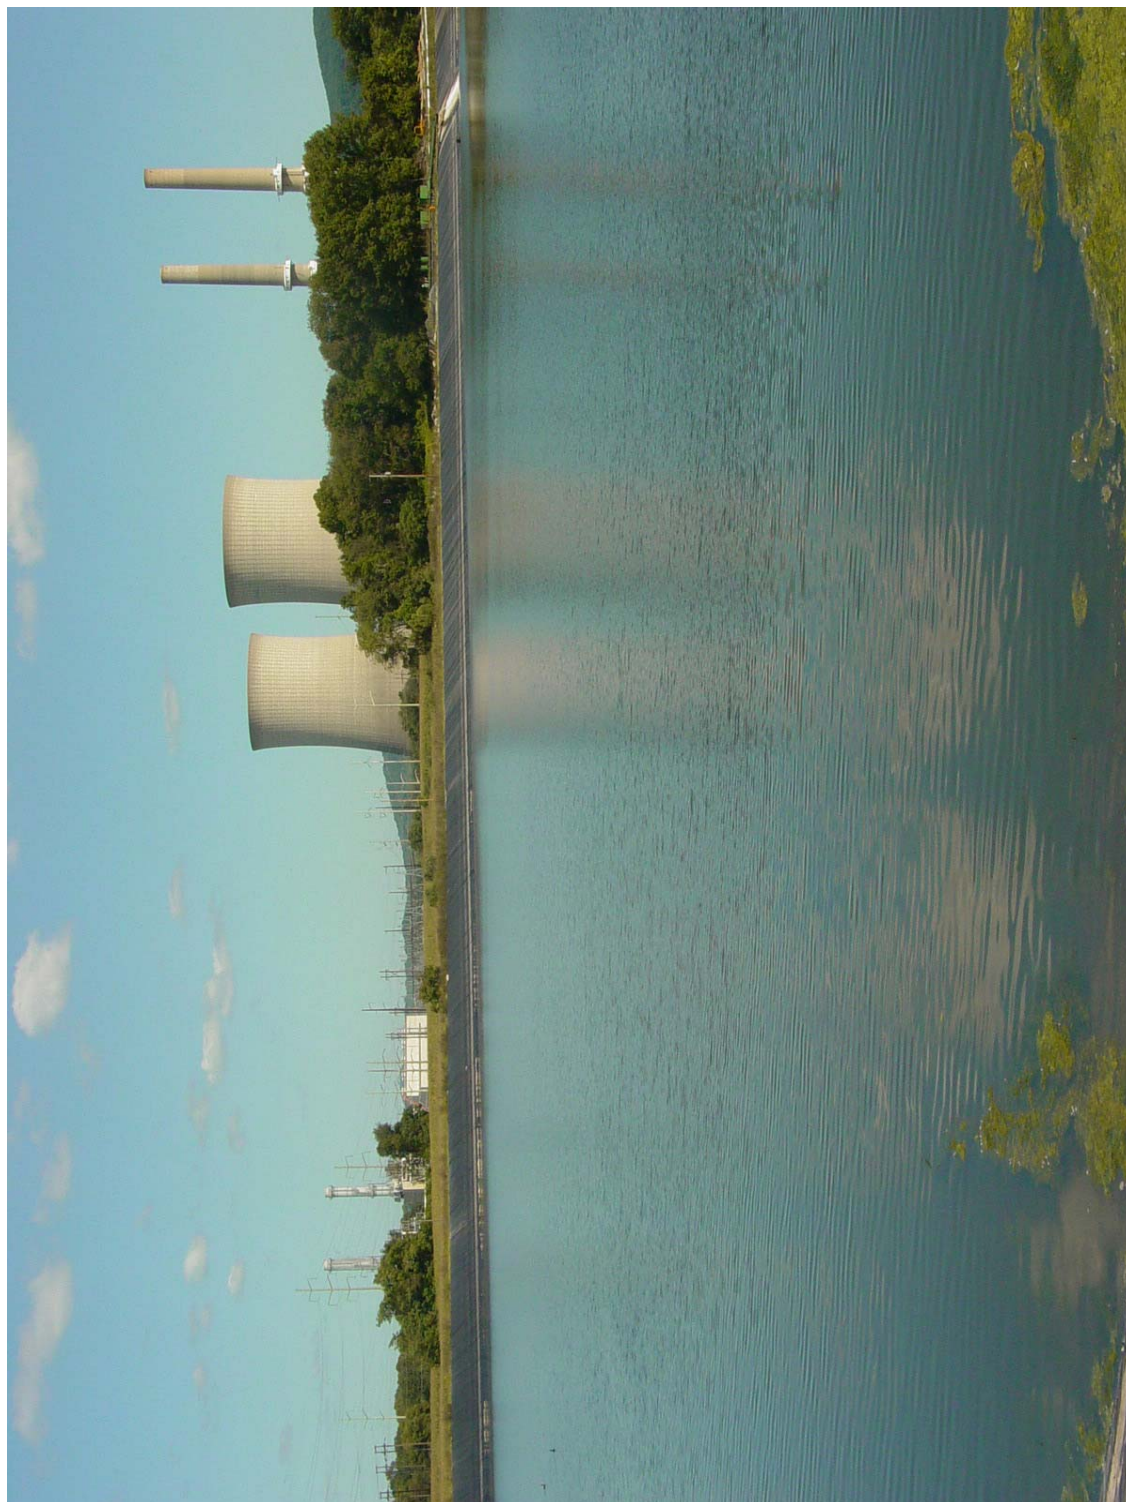
Photo 1-1: Industrial Waste Treatment Basin (WTB) General View across Basin toward North Incised Slope – Viewed Northeast – Note Some Algae on Surface of Water.

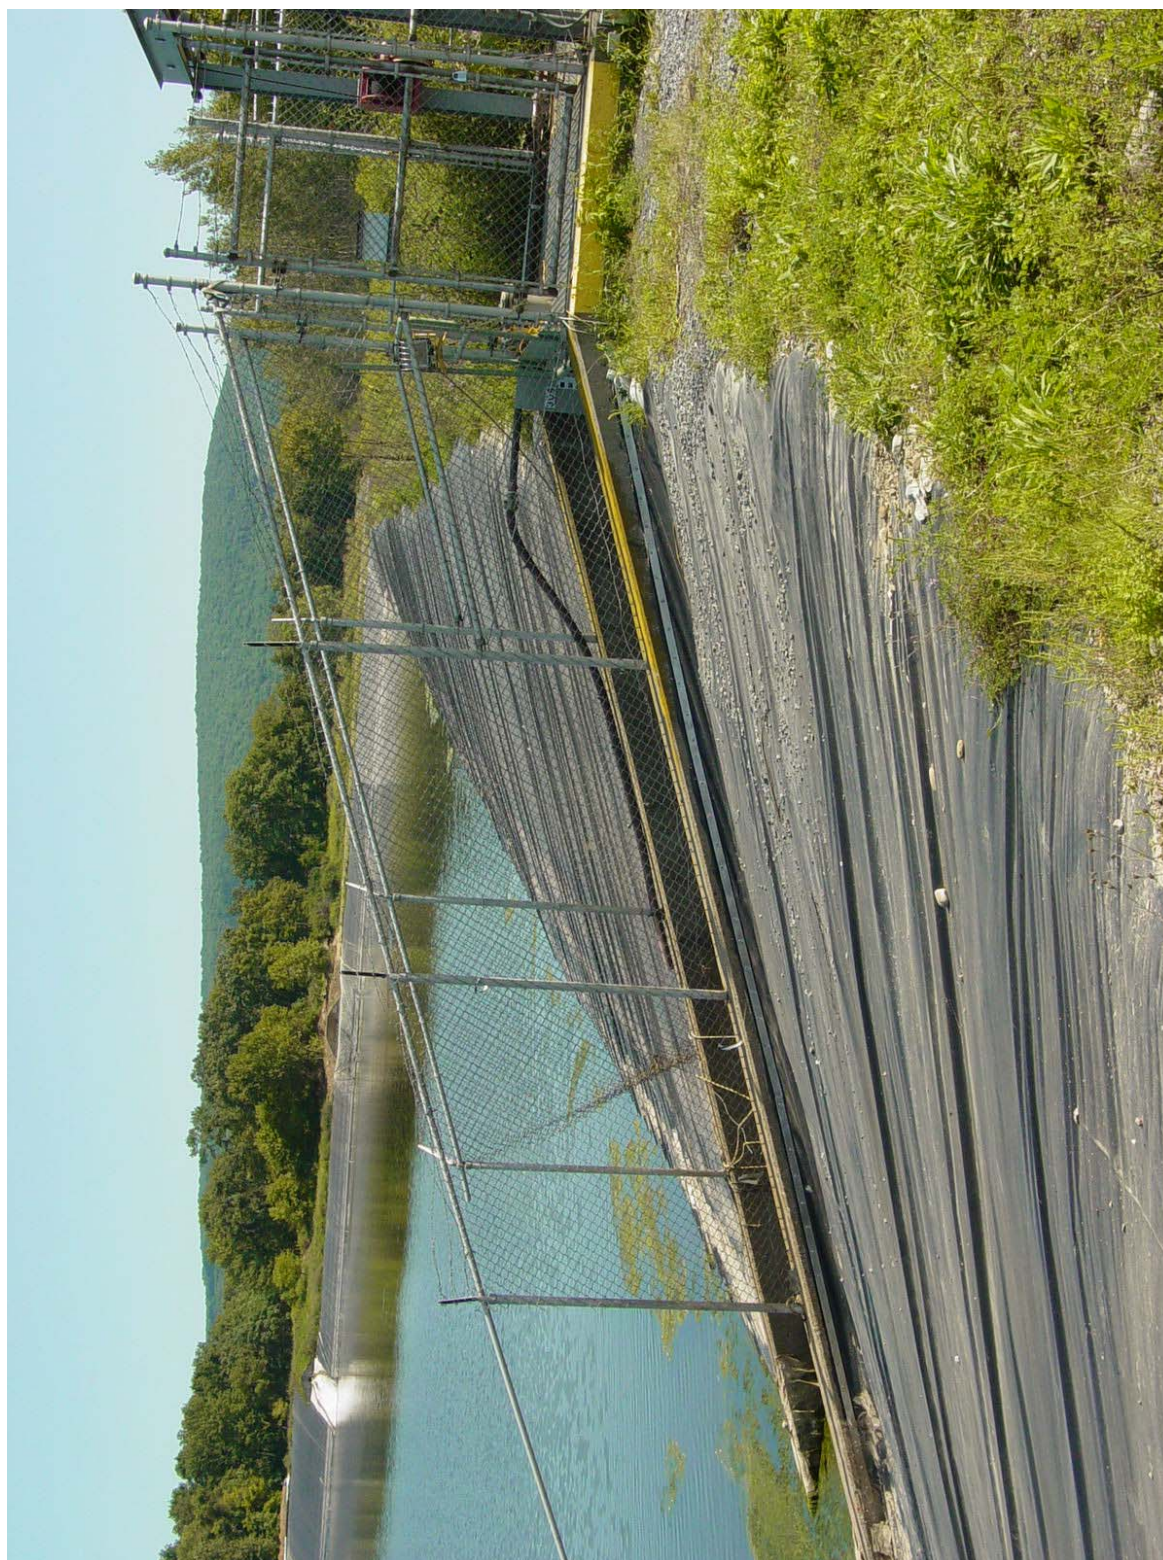
Photo I-2: IWTB South Incised Slope with Outlet Structure in Foreground – Viewed East – Note Vertical Wrinkles in Liner.
