**Coal Combustion Waste Impoundment  
Dam Assessment Report**

***Martins Creek Steam Electric Station  
PPL Generation  
Bangor, Pennsylvania***

**Project # 0-381  
Assessment of Dam Safety  
Coal Combustion Surface Impoundments  
for the REAC Program**

**September 2009**

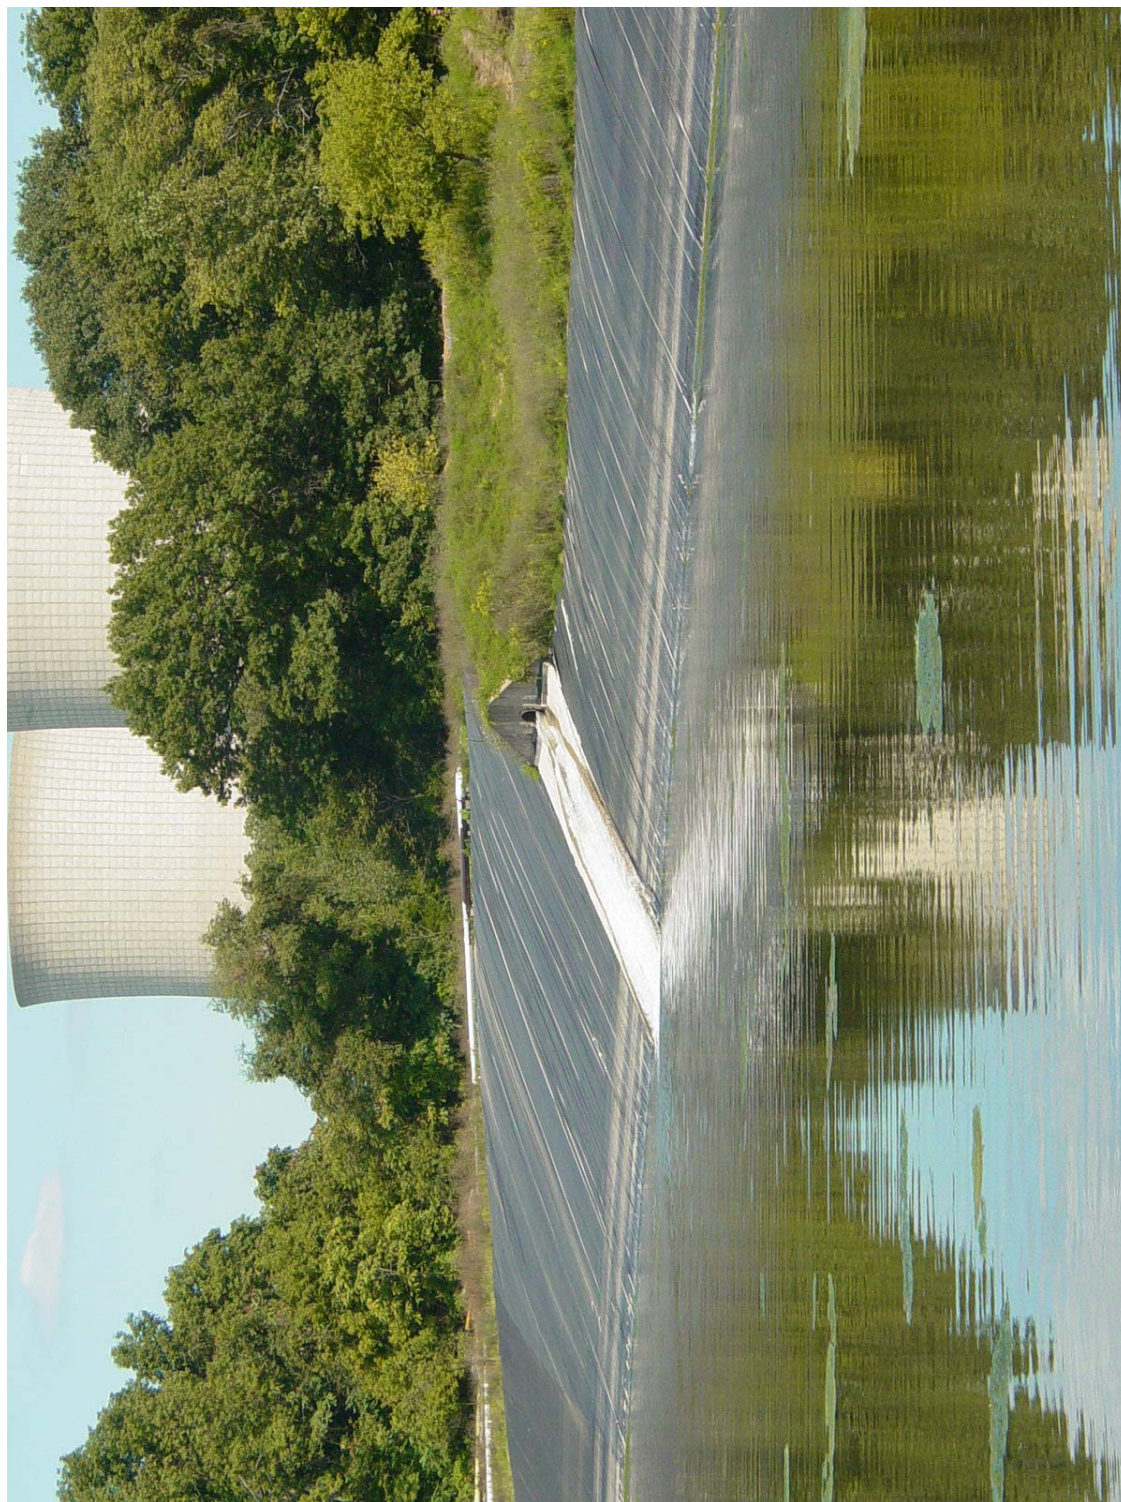
Photo I-3: IWTB East Incised Slope and Cooling Tower Blow-down Discharge into Basin – Viewed Northeast– Note Liner Extends Higher on North Half to Cover former Sinkhole Area in Shallow Rock.

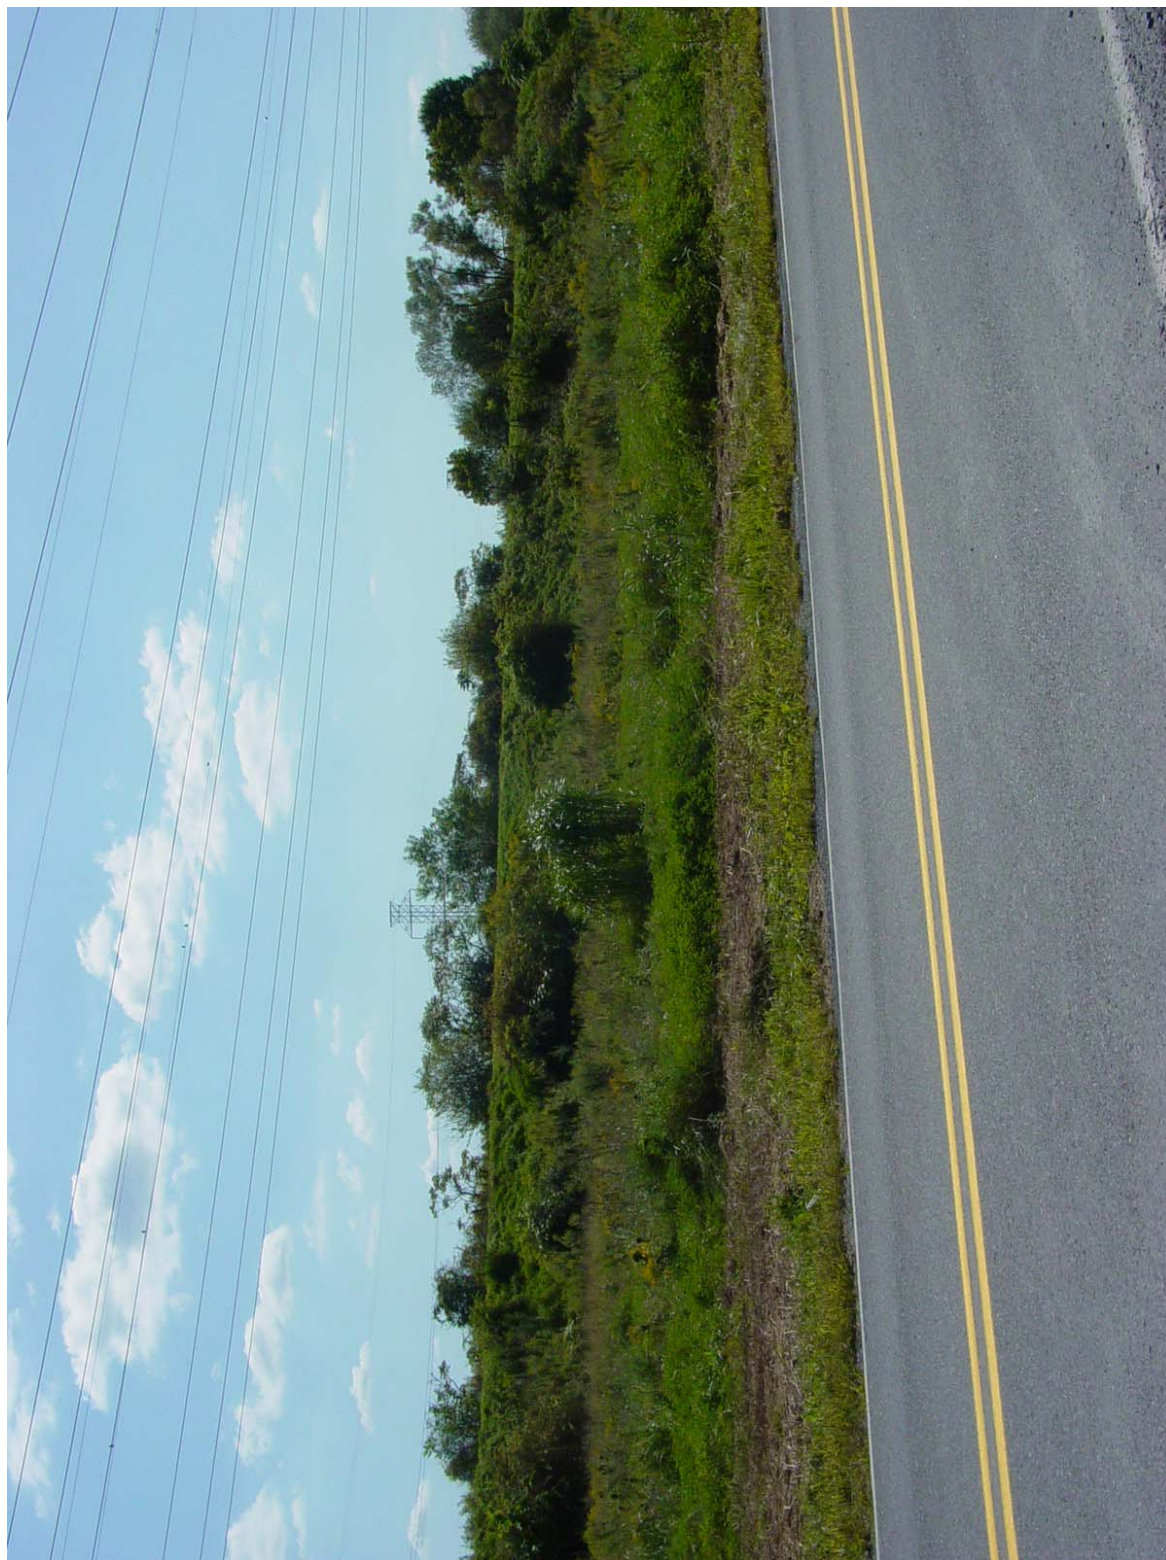
Partial views of the outside slopes of the west embankment and east embankment of the closed Ash Basin No. 3 are shown in Photos B3-1 and B3-2, respectively. As shown, the slopes have a thick cover of herbaceous vegetation; the west slope also has tall bushes.

Photo B3-1: Ash Basin No. 3 View of Outside Slope of West Embankment of the Closed Basin– Viewed Southeast.

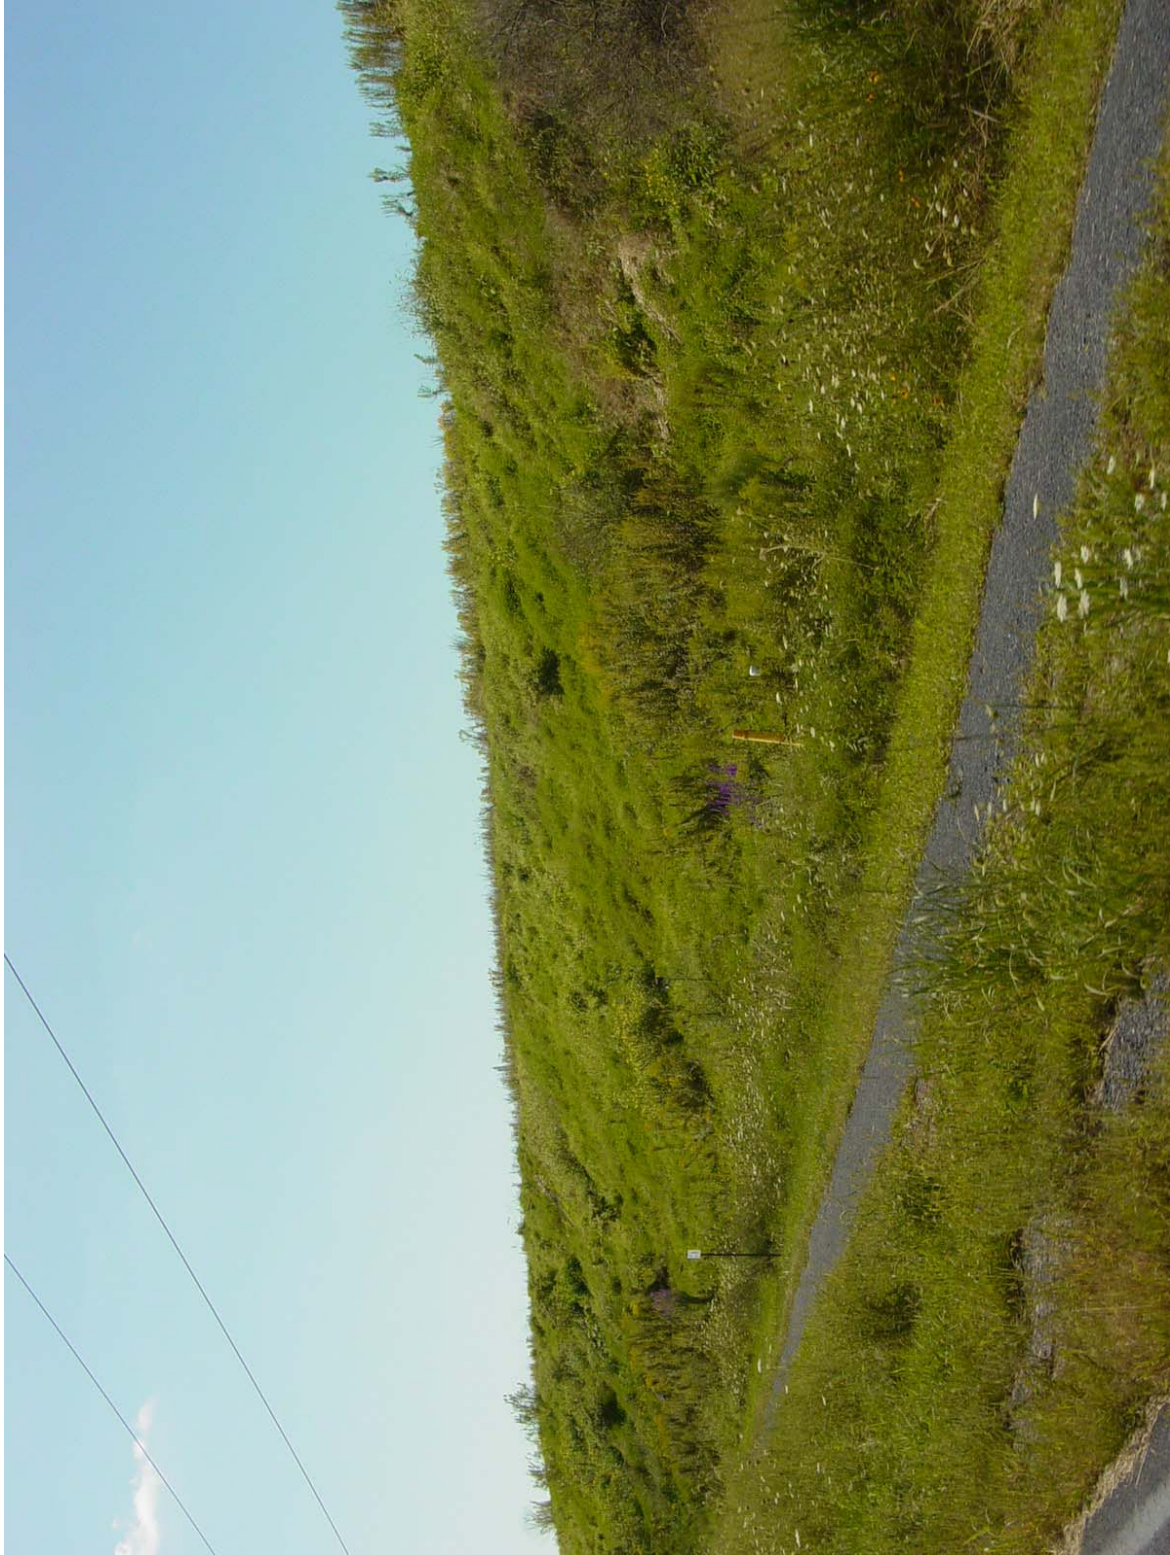
Photo B3-2: Ash Basin No. 3 View of Outside Slope of East Embankment of the Closed Basin- Viewed Southwest.
