**Coal Combustion Waste Impoundment  
Dam Assessment Report**

***Martins Creek Steam Electric Station  
PPL Generation  
Bangor, Pennsylvania***

**Project # 0-381  
Assessment of Dam Safety  
Coal Combustion Surface Impoundments  
for the REAC Program**

**September 2009  
Revised December 9, 2009**

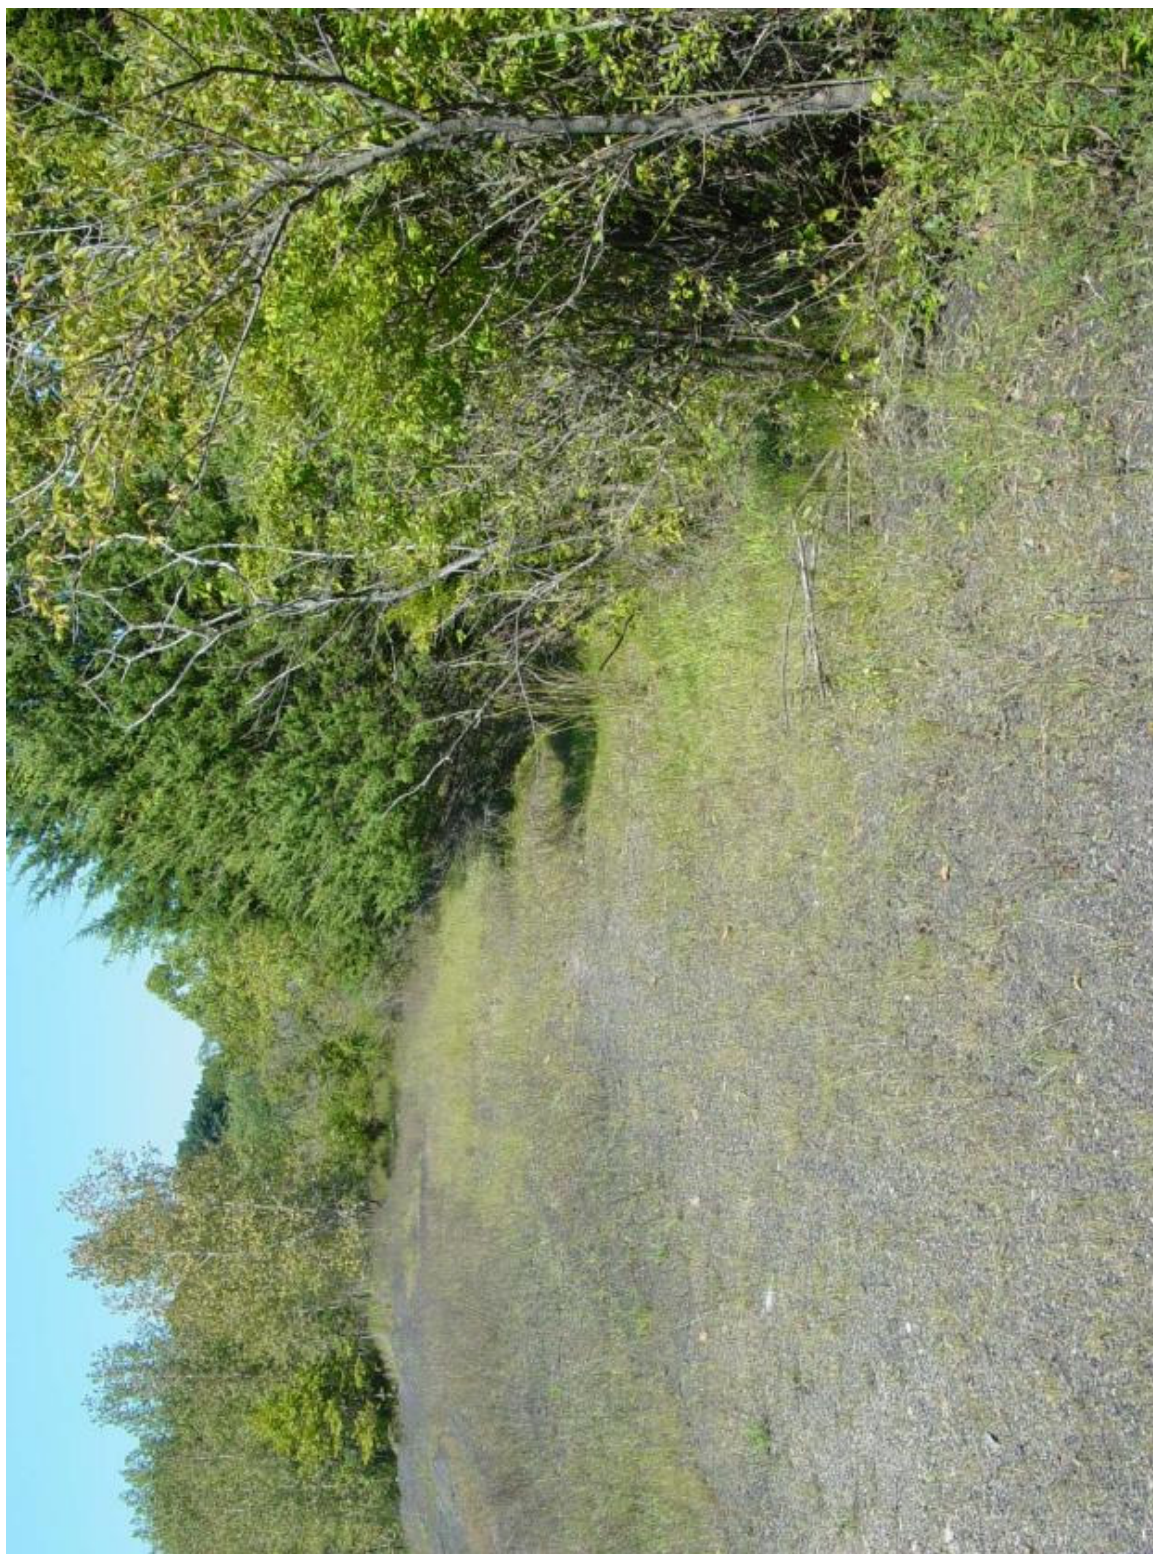
Photo BI-1: Ash Basin No. 1 Crest of North Embankment – Viewed West.

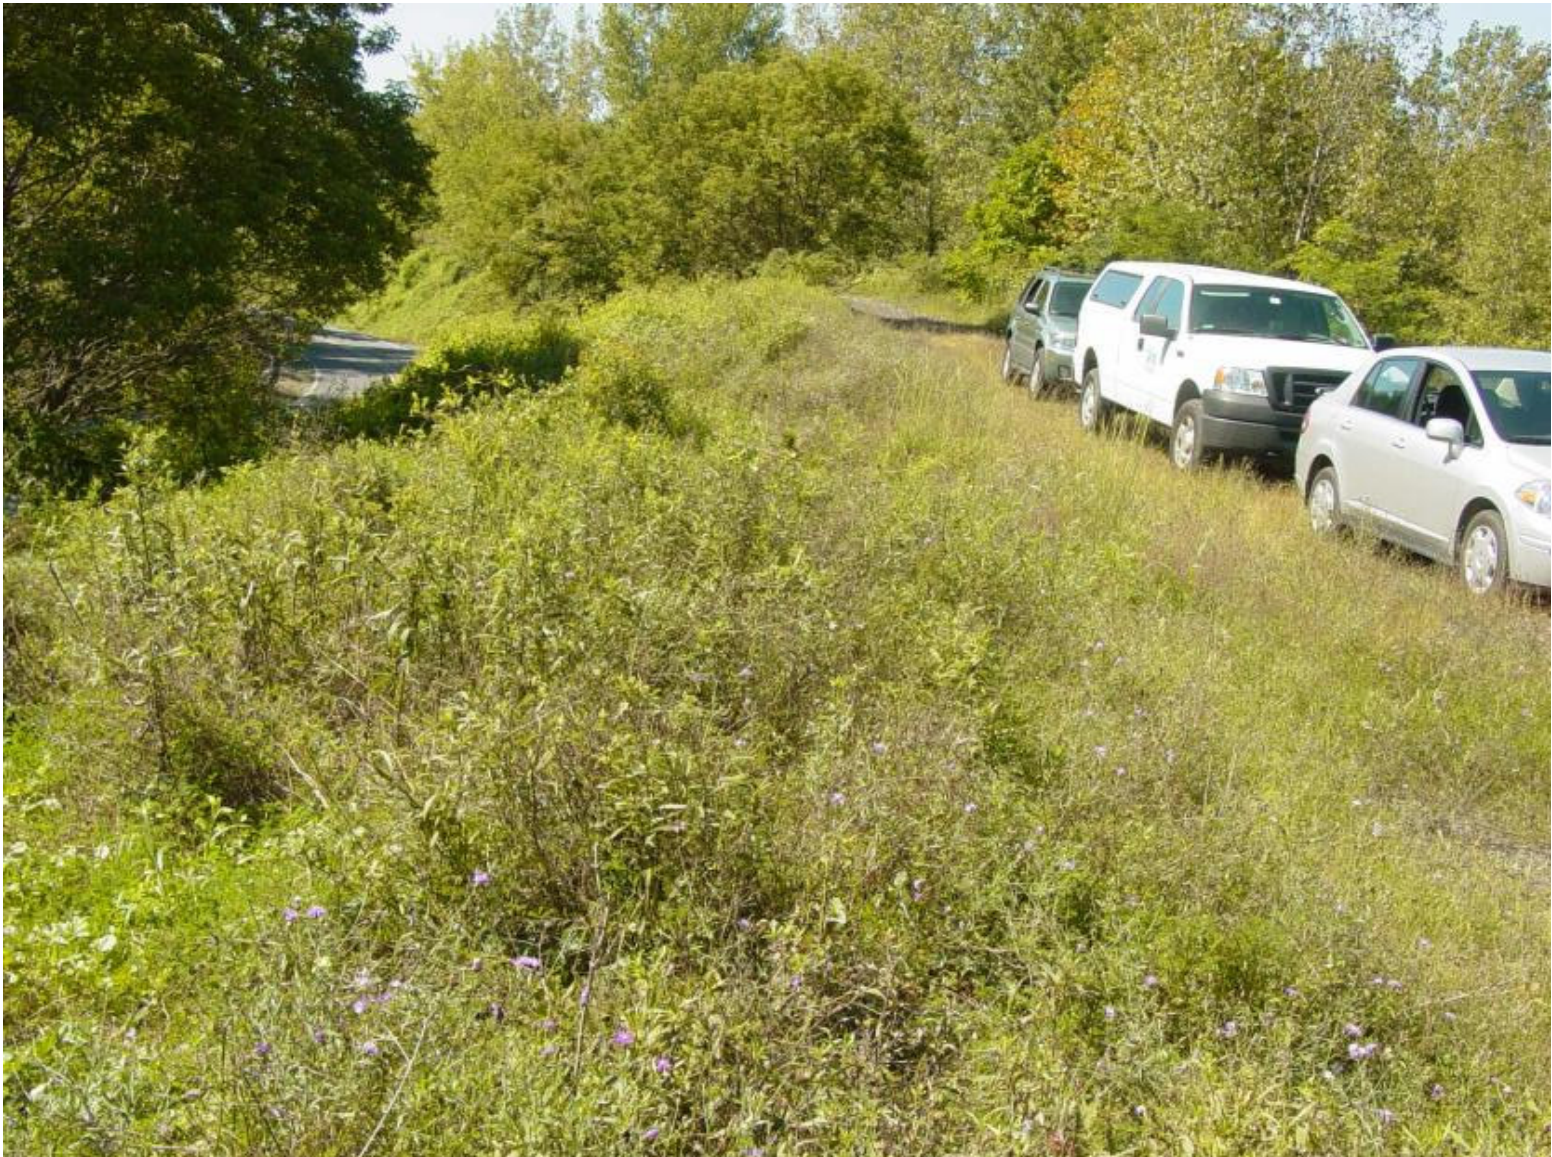
Photo B1-2: Ash Basin No. 1 Crest and Outside Slope of East Embankment North End - Viewed South.

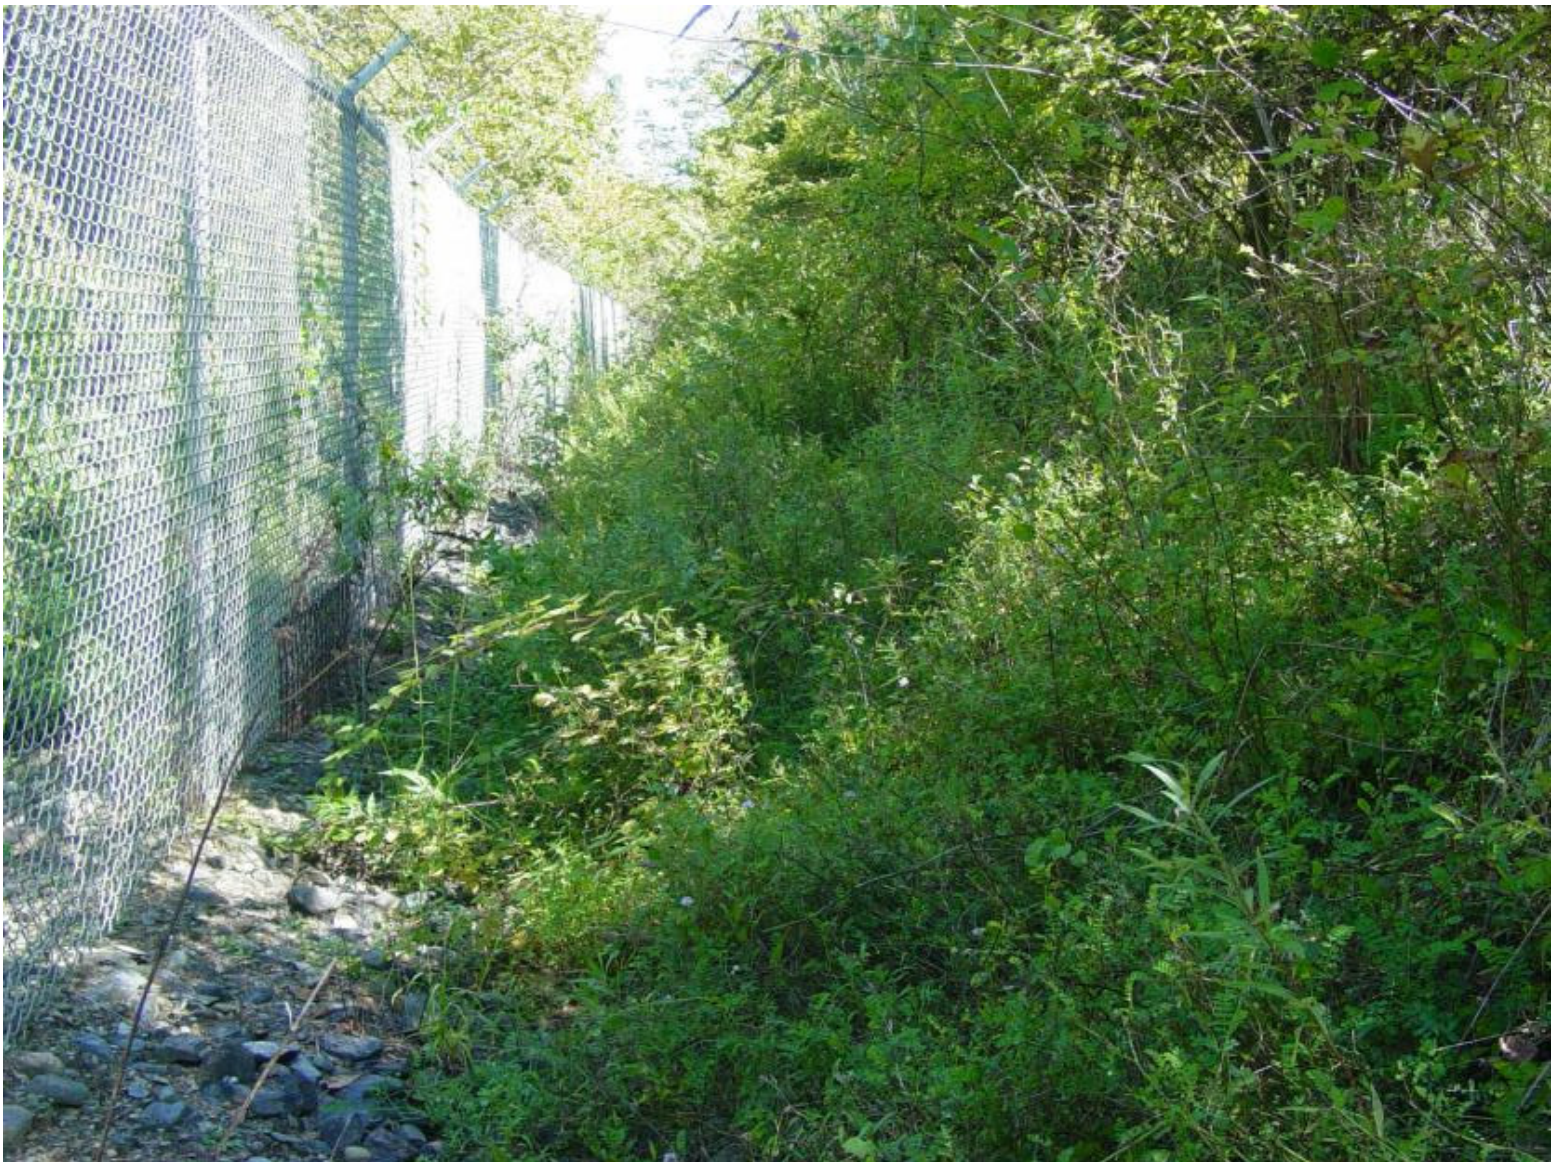
Photo BI-3: Ash Basin No. 1 Outside Slope of West Embankment at West End of Main Cross Dike End - Viewed North.

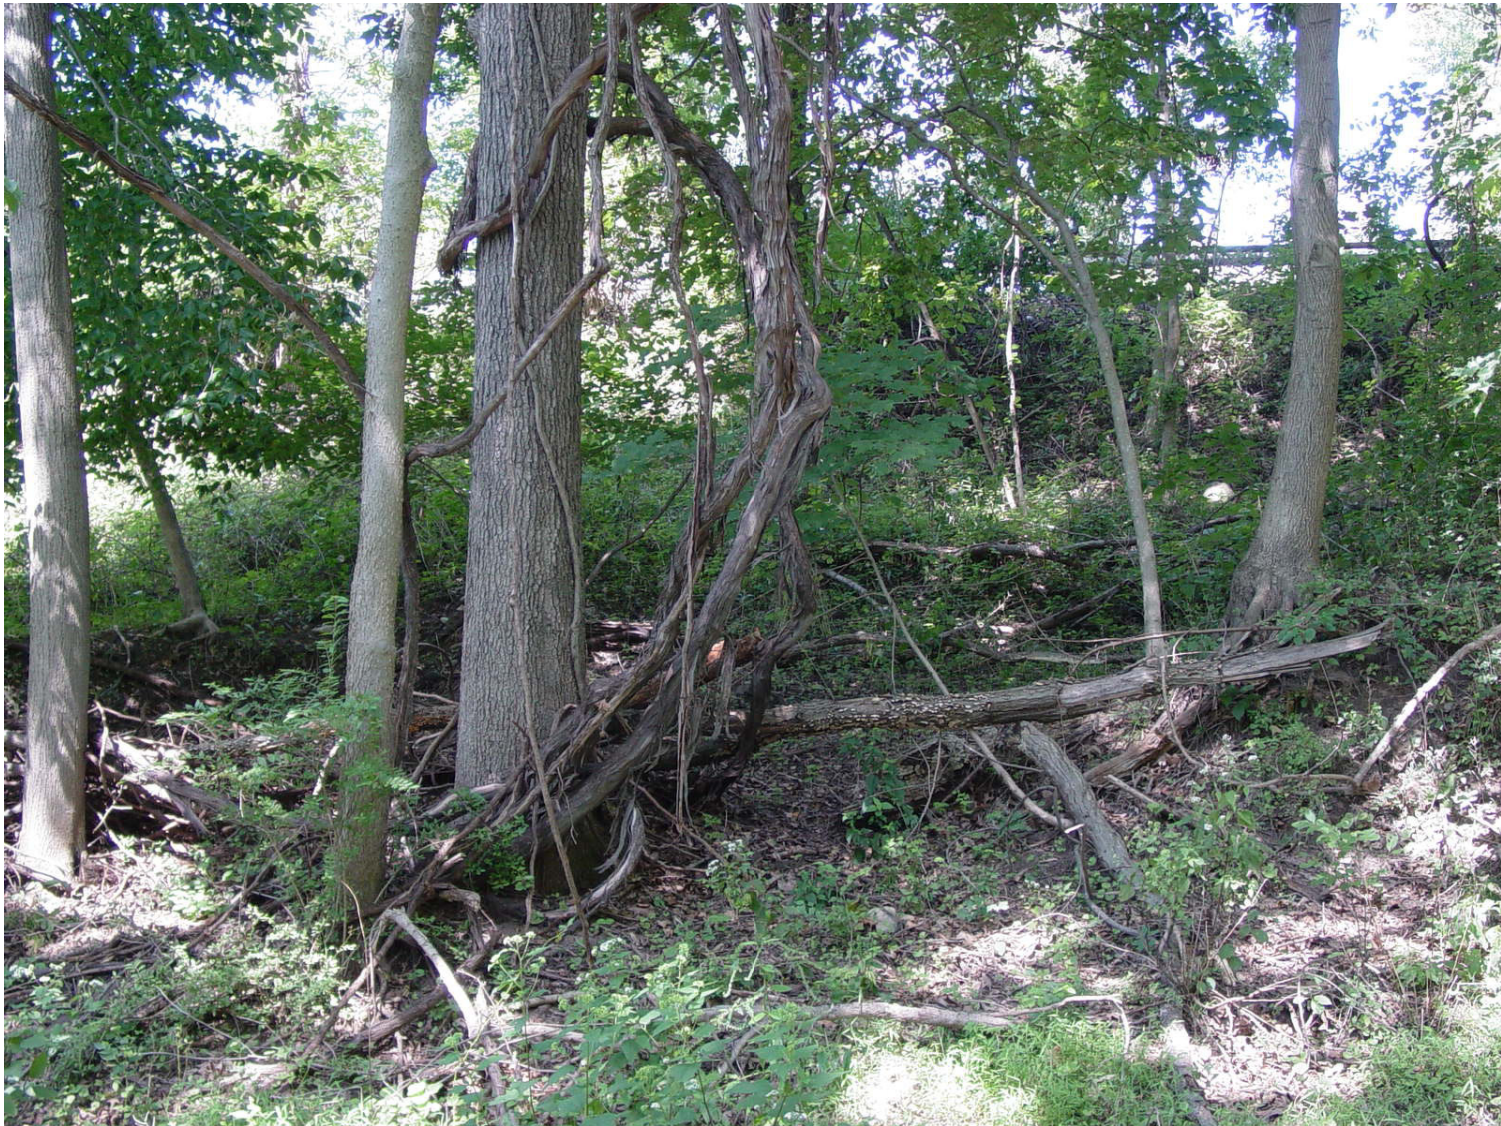
Ash Basin No. 1 Dam – The dam appeared sound. The visible parts of the embankment dam and outlet structure were observed to have no signs of overstress, significant settlement, shear failure, or other signs of instability, although visual observations were severely hampered by the presence of thick vegetation. No seepage was observed, but the basin had no water in it at the time of the site visit. However, the basin does not normally impound water, since it is no longer actively used for disposal of CCW. A shallow depression or wallowed-out area at the outside toe of the roadway embankment next to

Photo BI-4: Ash Basin No. 1 Outside Toe of Embankment Below Paved Access Road outside Southeast Corner of Basin  
Near where Outlet Pipe Passes Through Embankment- Viewed West.

Ash Basin No. 1 Dam – None appear warranted at this time, other than maintaining vegetation on the crest and outside slope and visual monitoring of the shallow depression at the outside toe of the embankment at the southeast corner as recommended in Subsection 1.2.6, below.

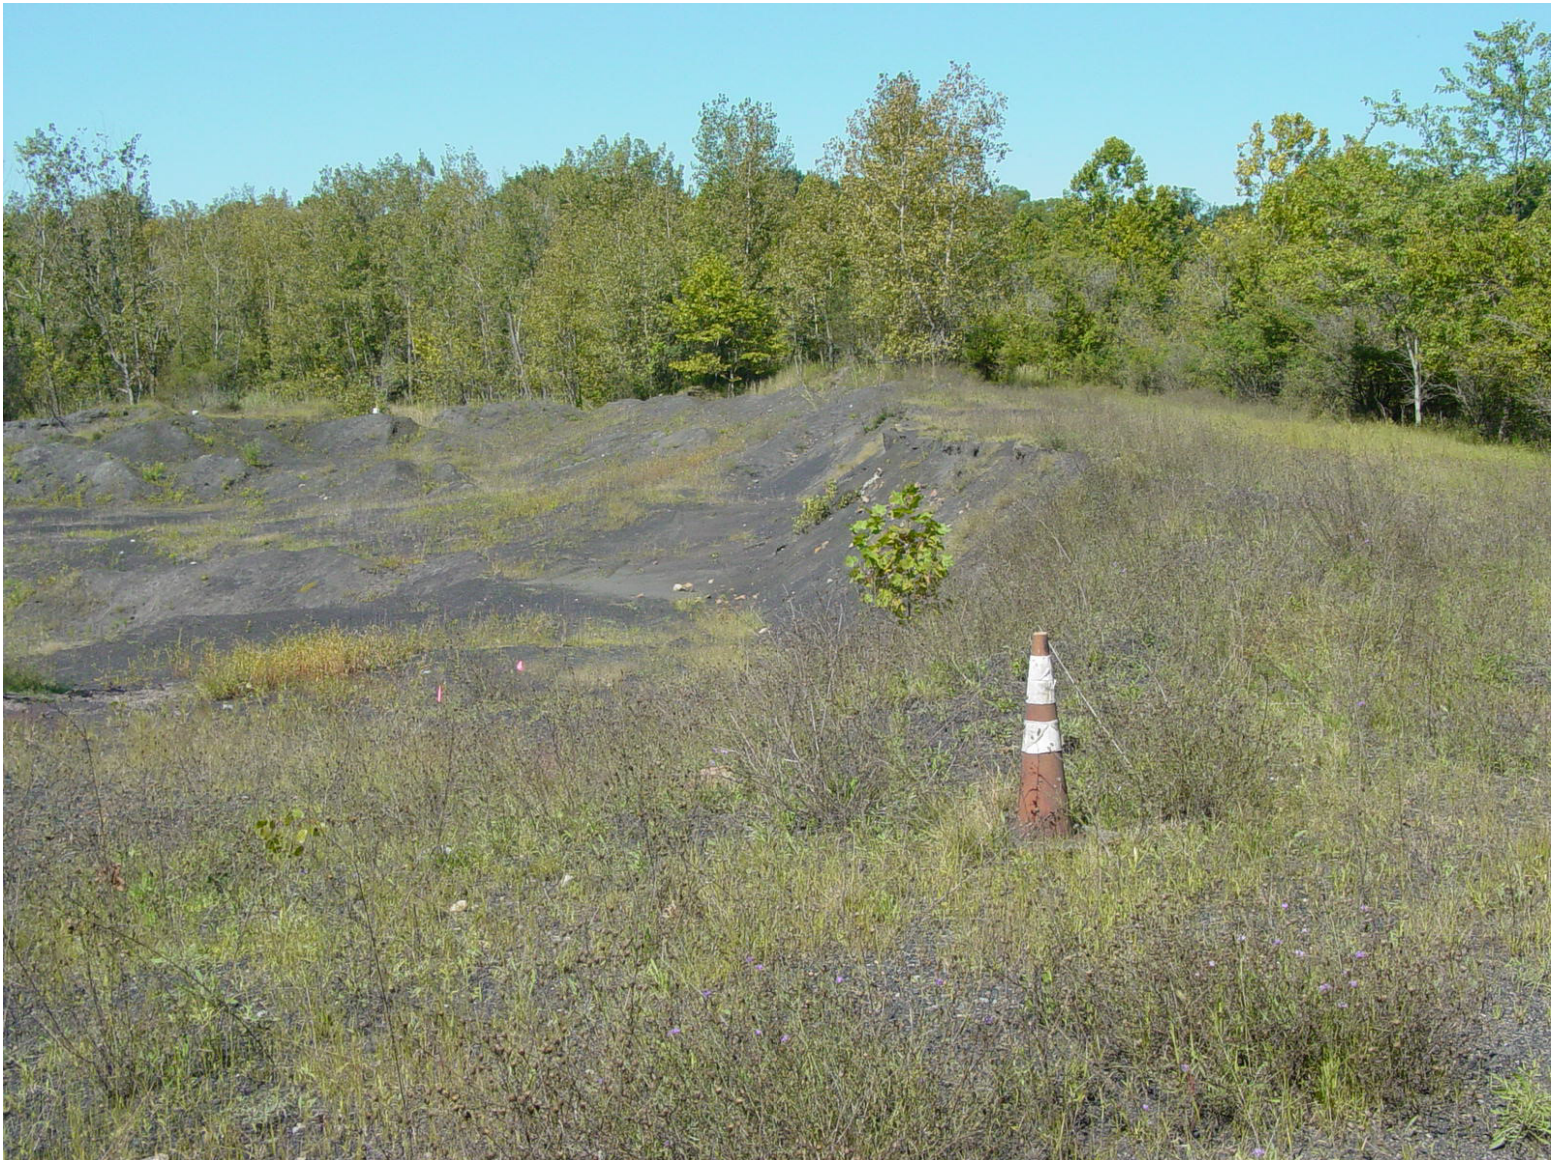
Photo BI-5: Ash Basin No. 1 North End Area where Bottom Ash Formerly was Sluiced into Basin – Viewed West.

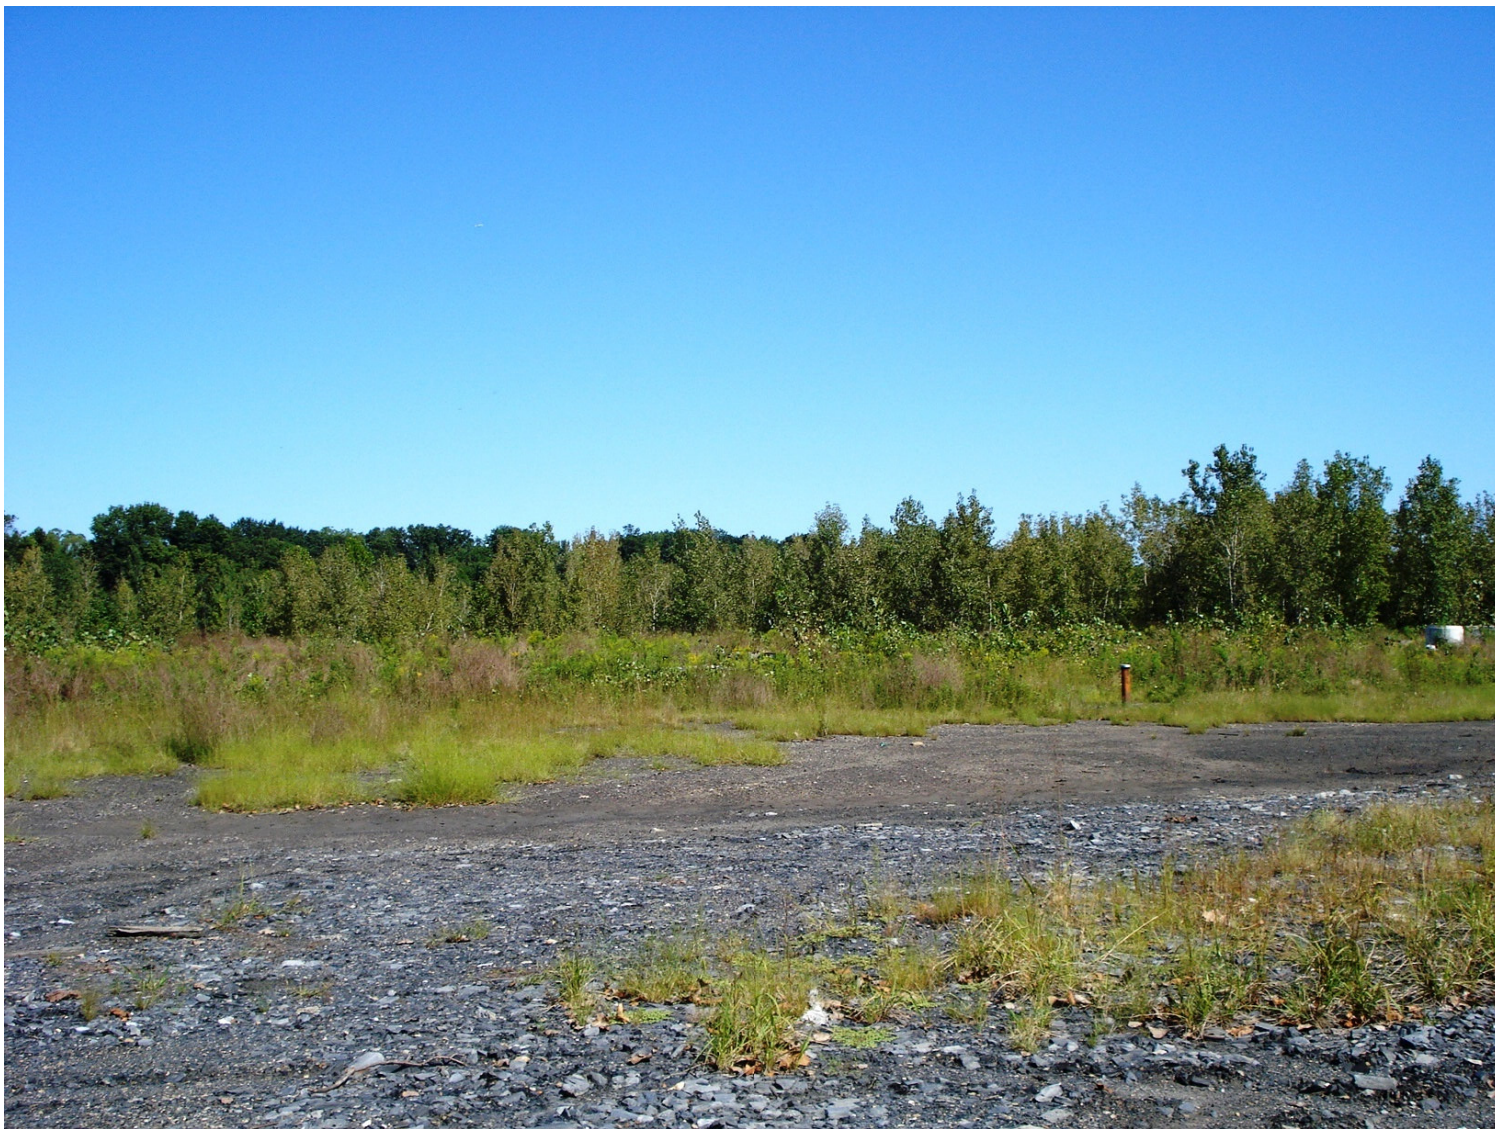
Photo B1-6: Ash Basin No. 1 Central Area North of Main Cross Dike where Dredged Material from Delaware River was Pumped into Basin during Clean-up Operations after 2005 Release from Basin No. 4- Viewed West.

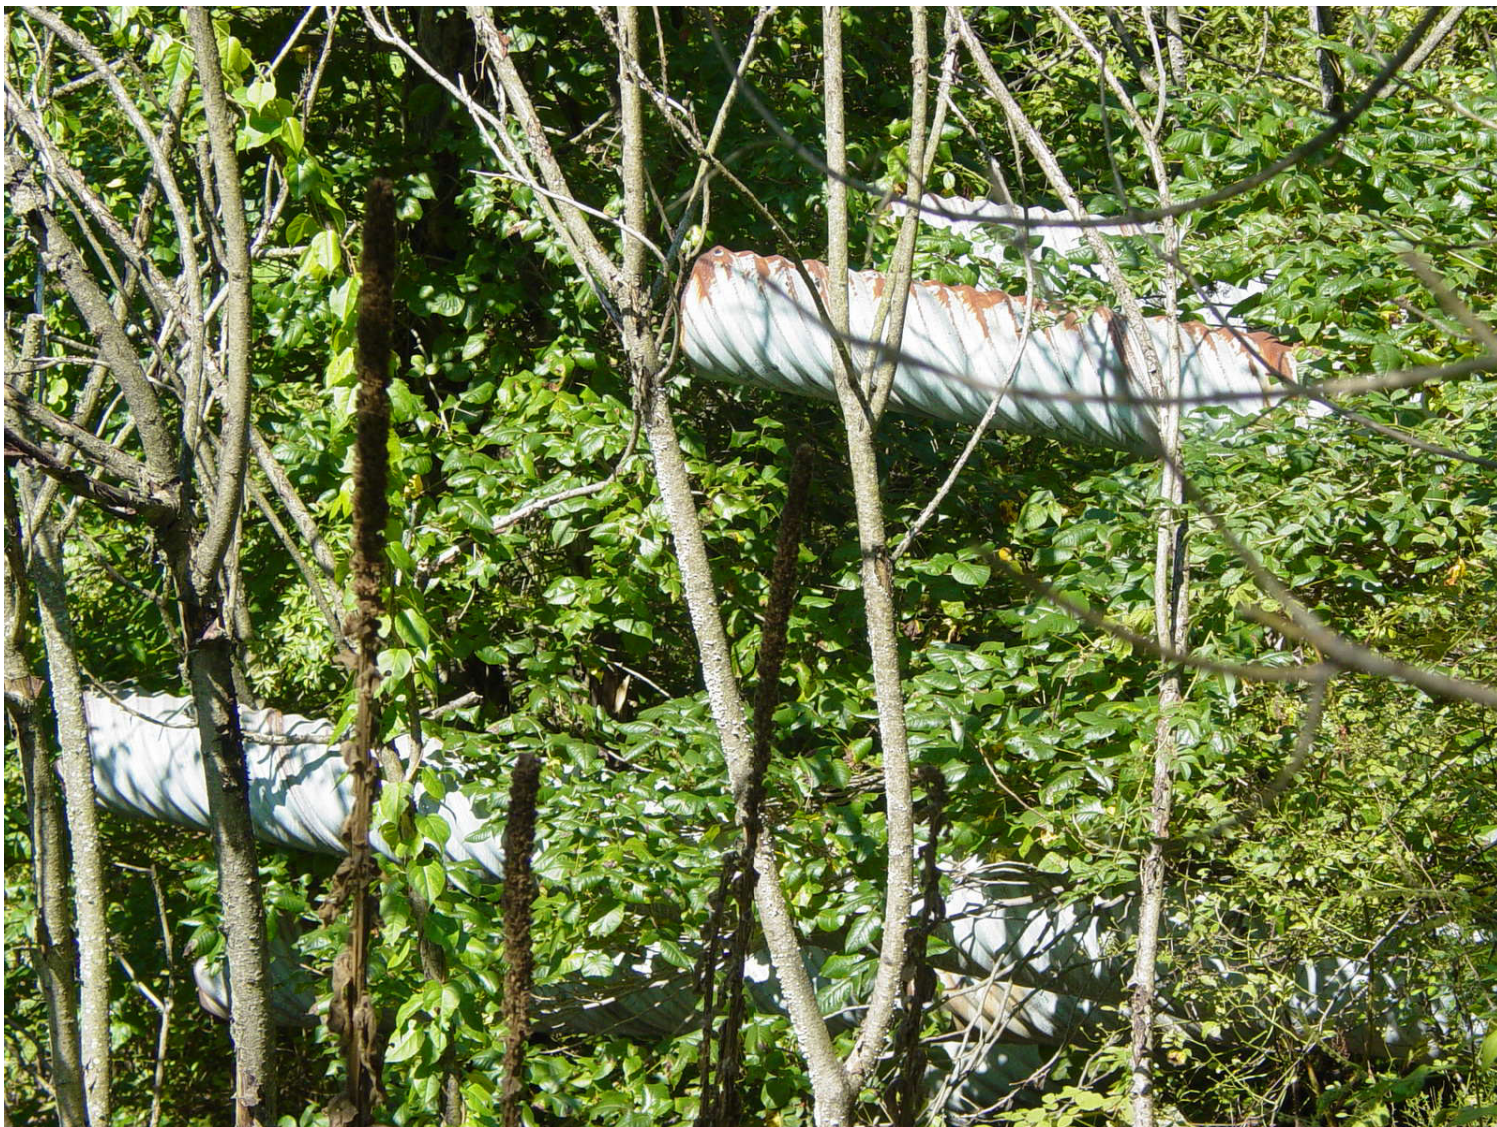
Photo BI-7: Ash Basin No. 1 View of Discharge End of 12" CMP Drains through Main Cross Dike that Divides the Higher Northern Two-Thirds of the Basin from the Lower Southern One-Third.

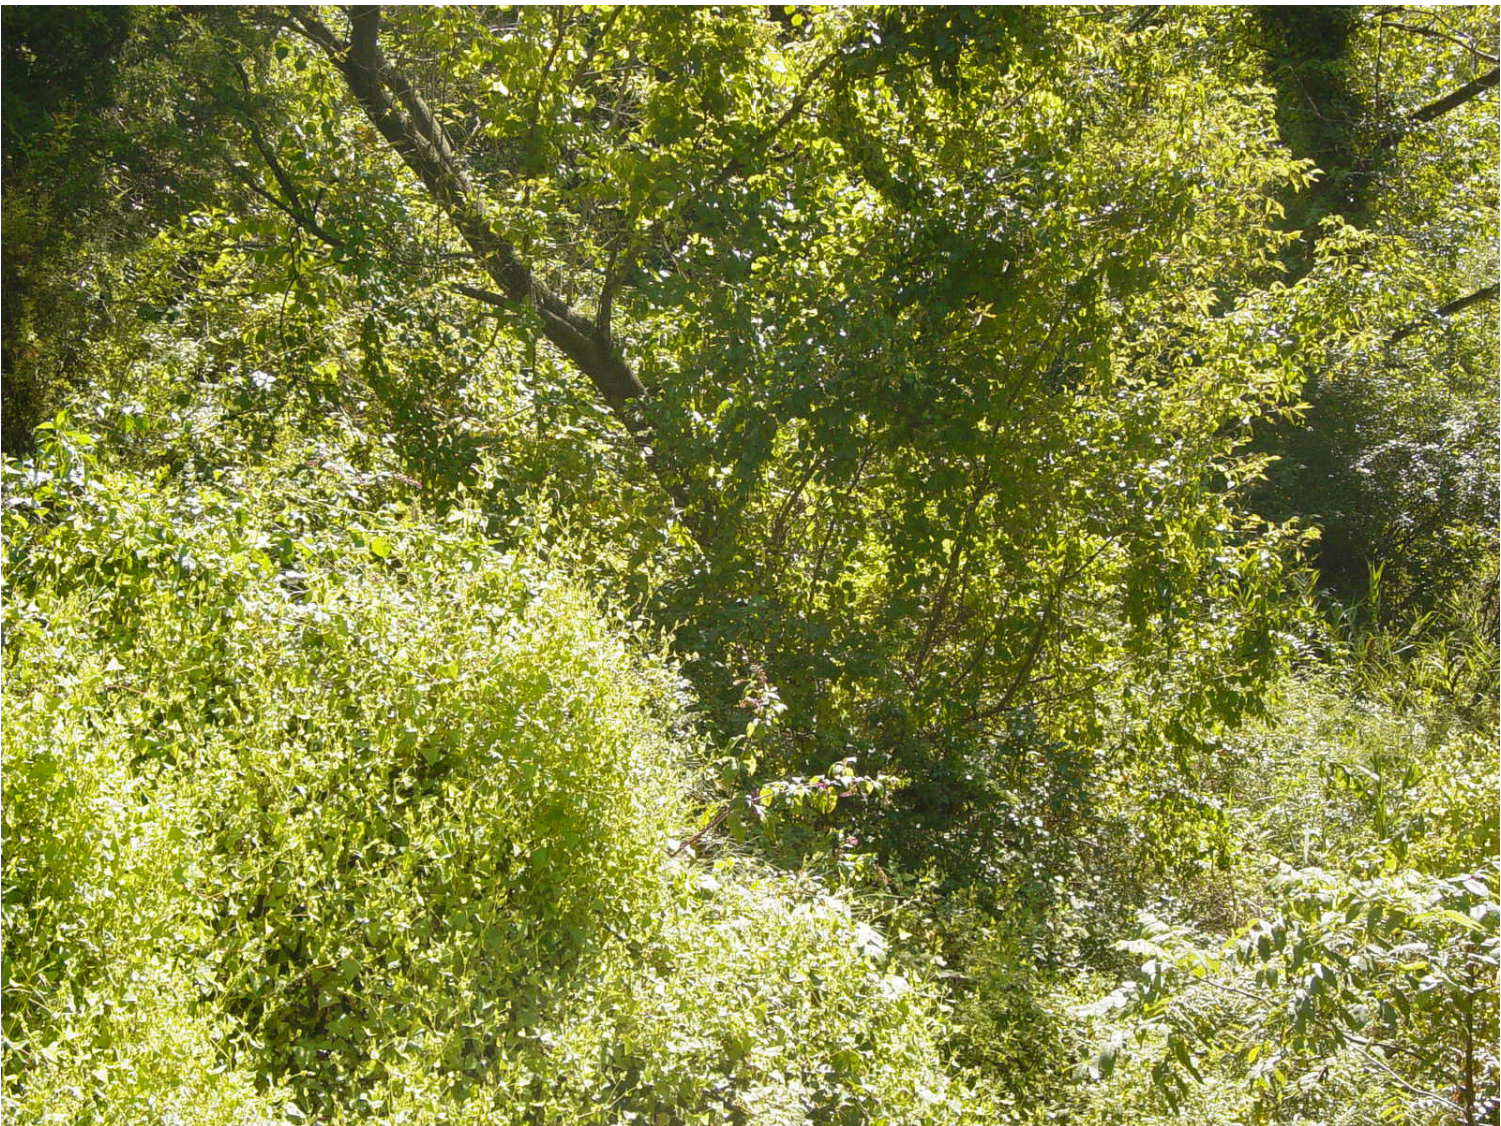
Photo BI-8: Ash Basin No. 1 View of Tree Growth and other Vegetation in Lower Southern Part of Basin Just Downstream of West Part of Main Cross Dike – Viewed East.

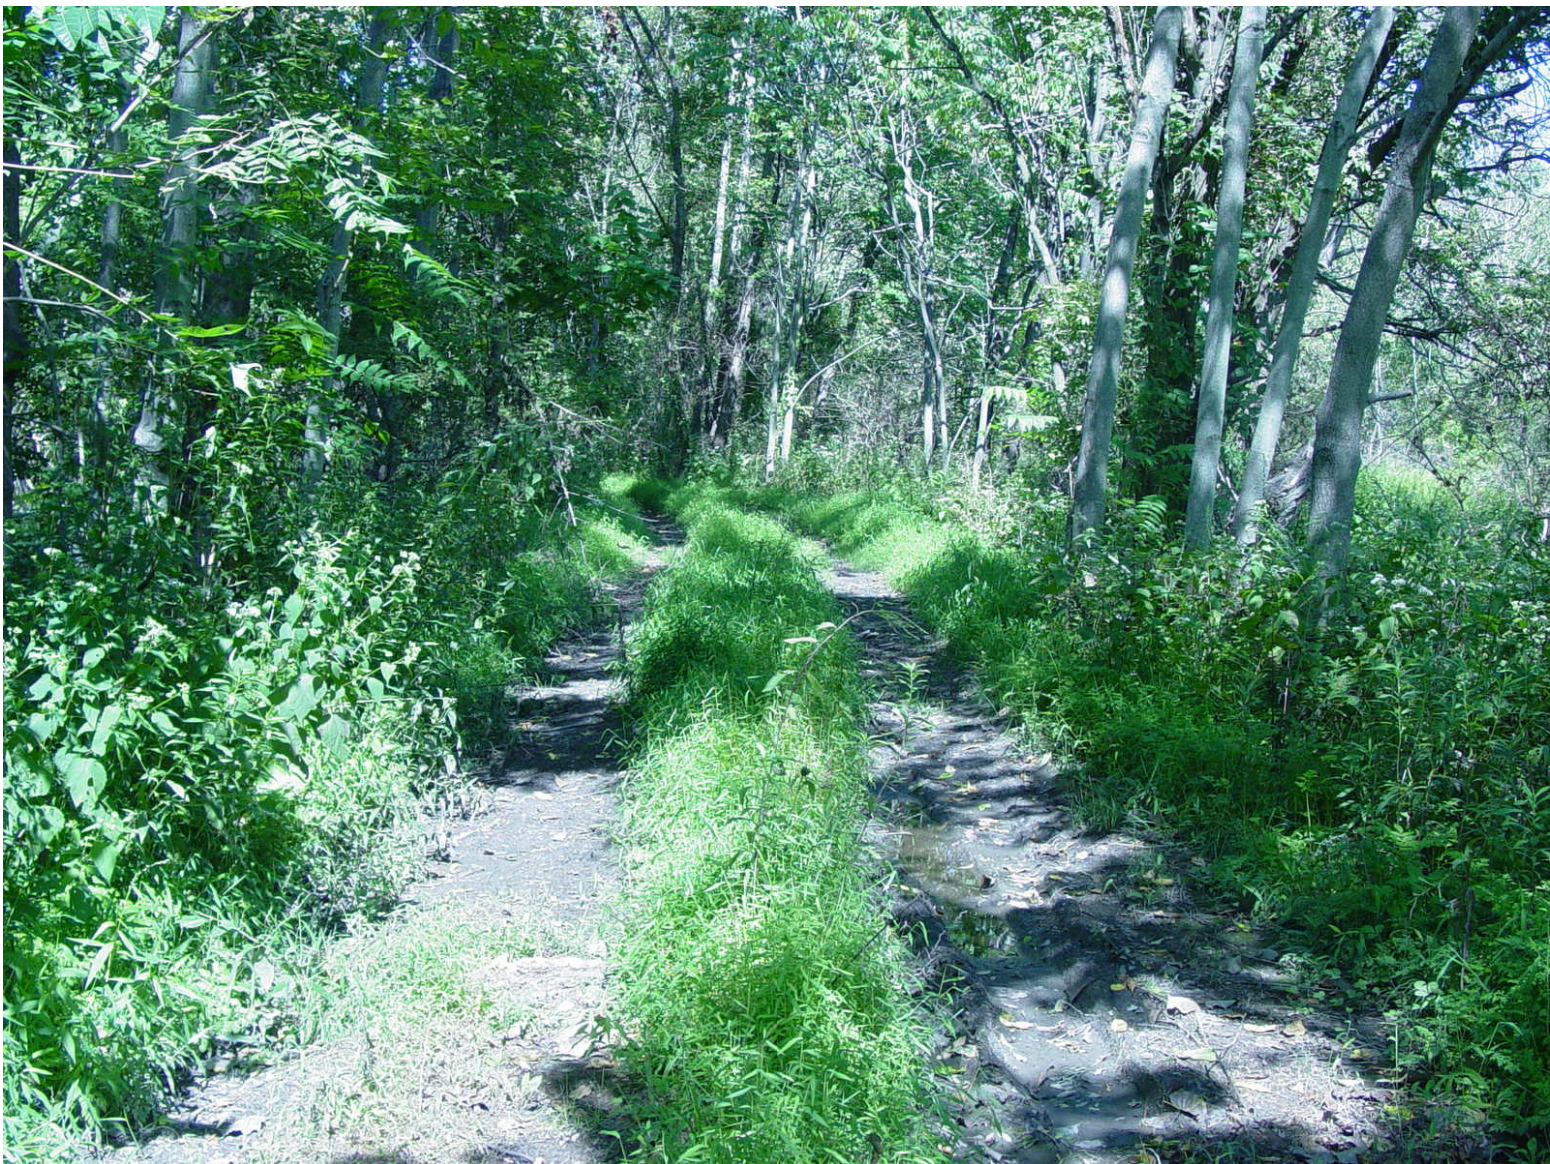
Photo BI-9: Ash Basin No. 1 Top of Small Cross Dike in Lower Southern Part of Basin - Viewed West.

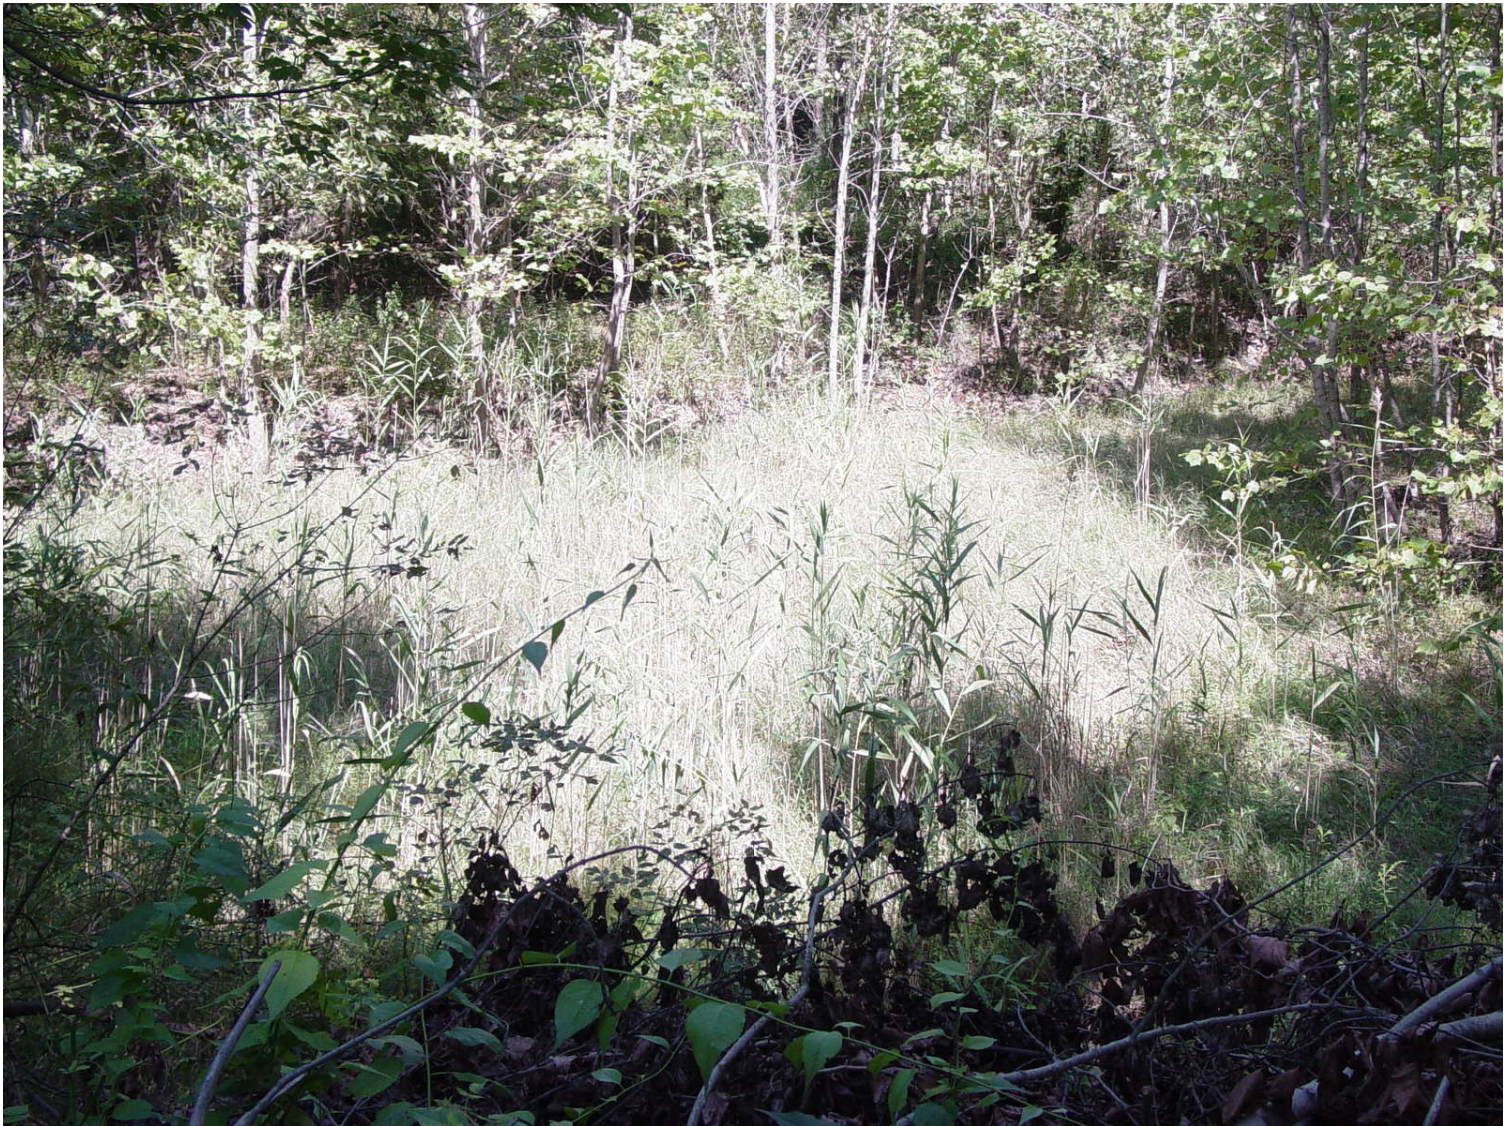
Photo BI-10: Ash Basin No. 1 Relatively Open Low Area within Lower Southern Part of Basin Just Upstream of Drain Pipe Through Small Cross Dike- Viewed Northwest.

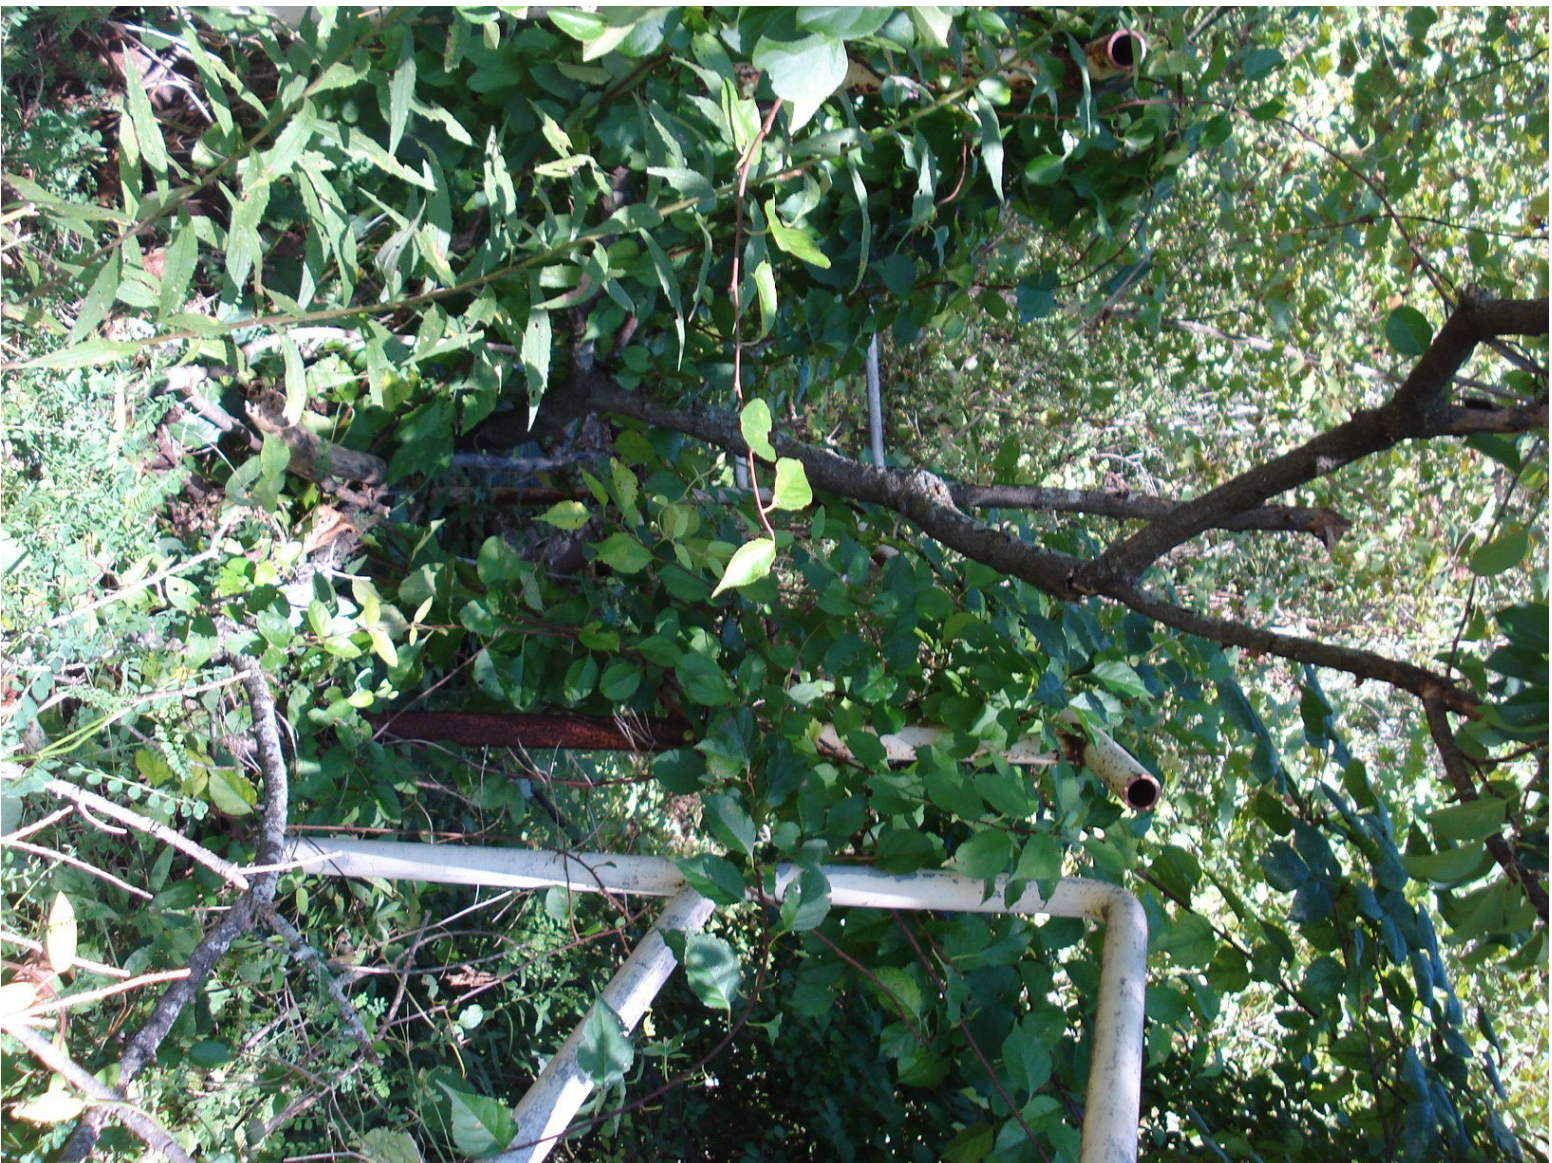
Photo BI-II: Ash Basin No. 1 Overgrown Footbridge to Outlet Standpipe inside Southeast Corner of Basin - Viewed West.

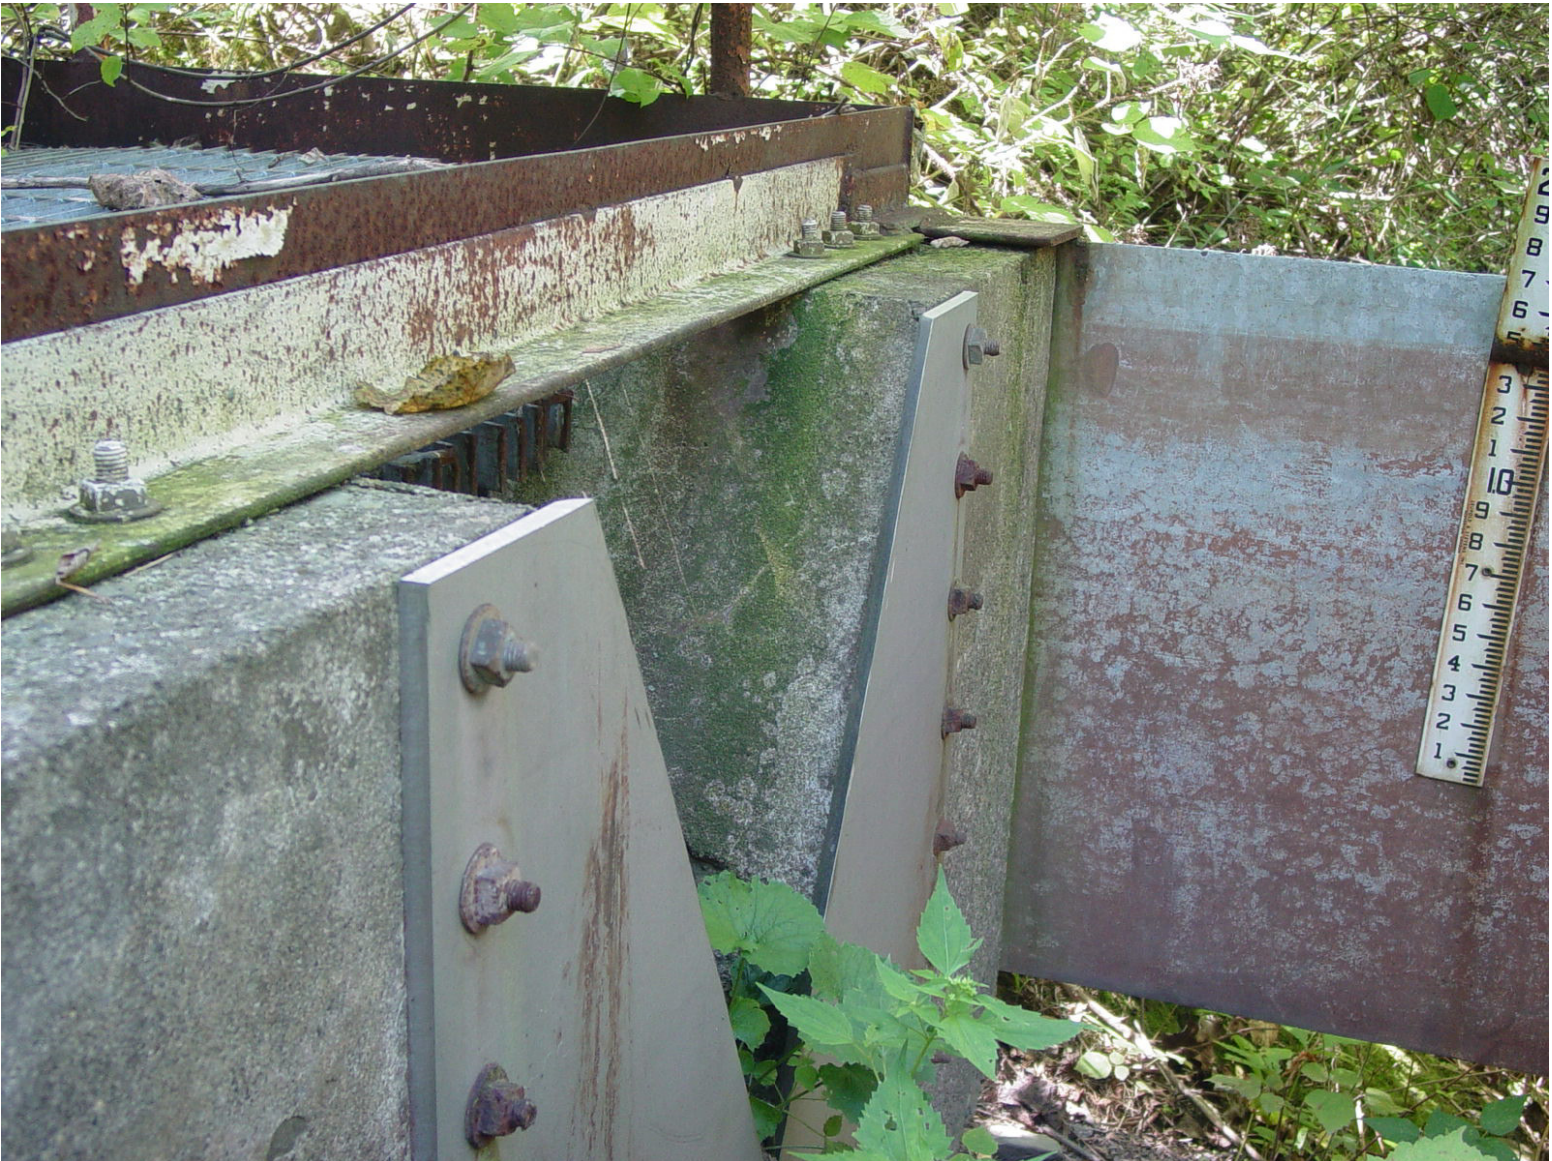
Photo BI-12: Ash Basin No. 1 V-Notch Weir at Top West Side of 4-foot Diameter RCP Outlet Standpipe.
