**Coal Combustion Waste Impoundment  
Dam Assessment Report**

***Martins Creek Steam Electric Station  
PPL Generation  
Bangor, Pennsylvania***

**Project # 0-381  
Assessment of Dam Safety  
Coal Combustion Surface Impoundments  
for the REAC Program**

**September 2009  
Revised December 9, 2009**

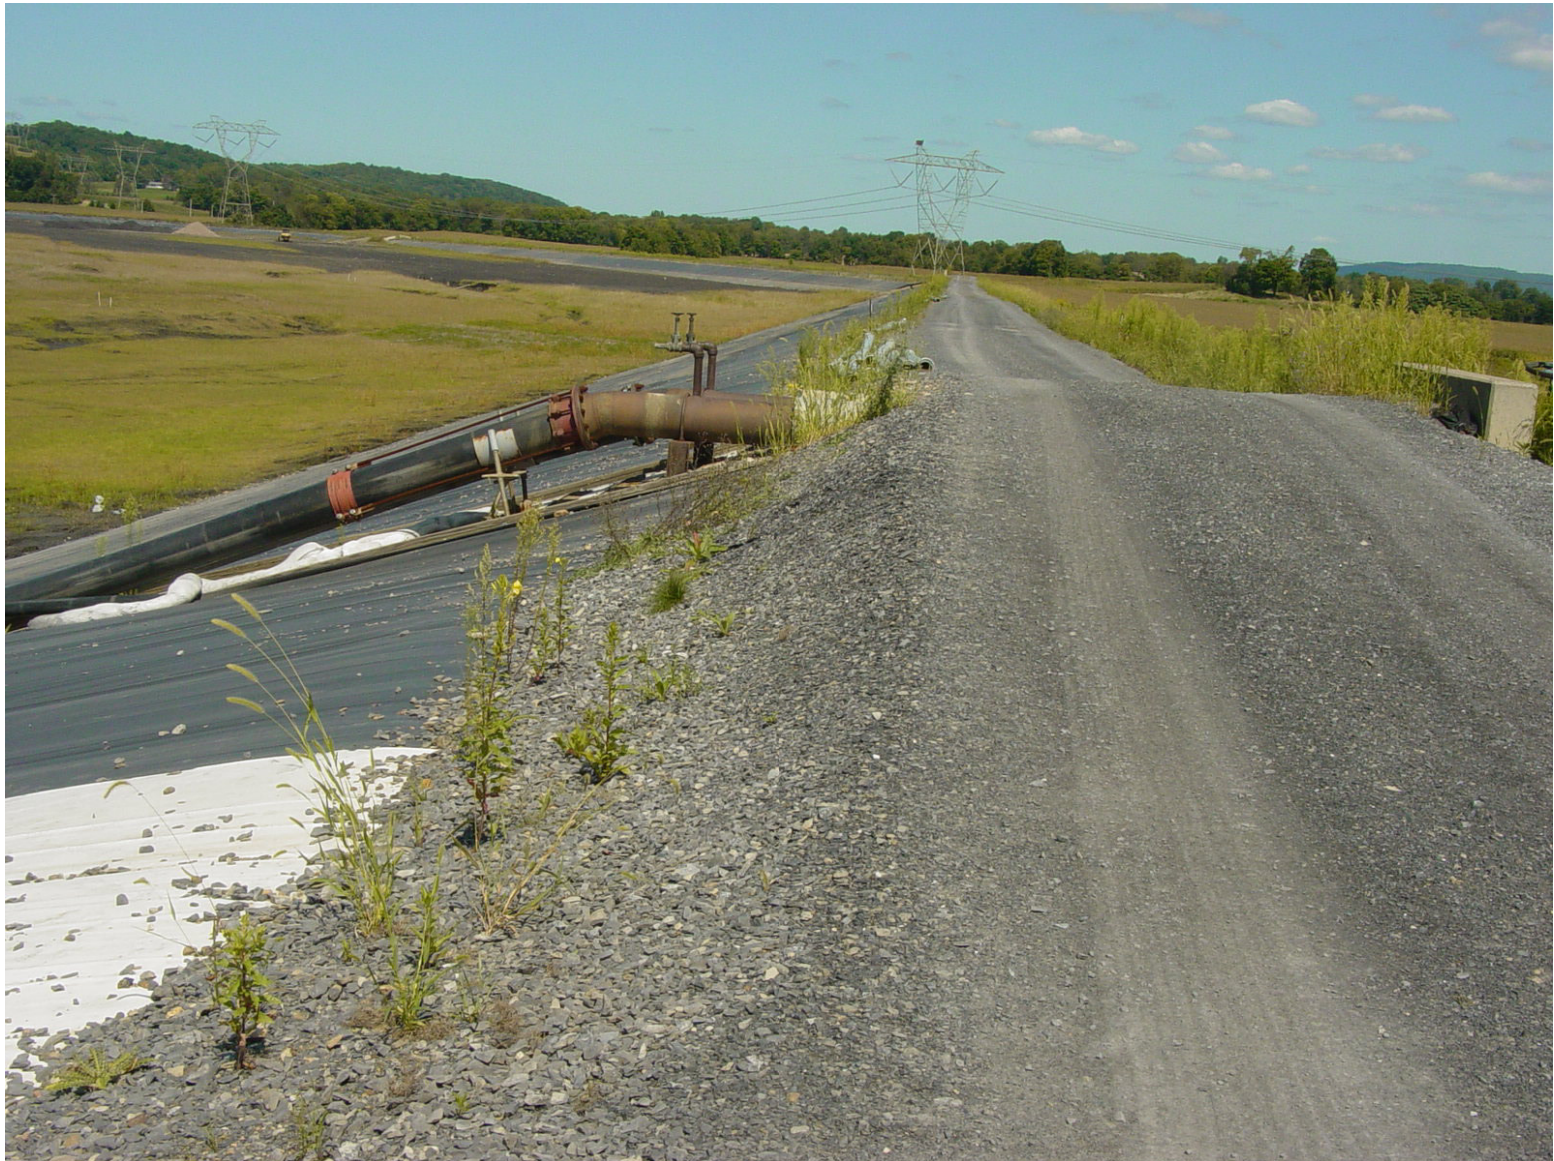
Photo B4-1: Ash Basin No. 4 Crest of East Embankment – Viewed North.

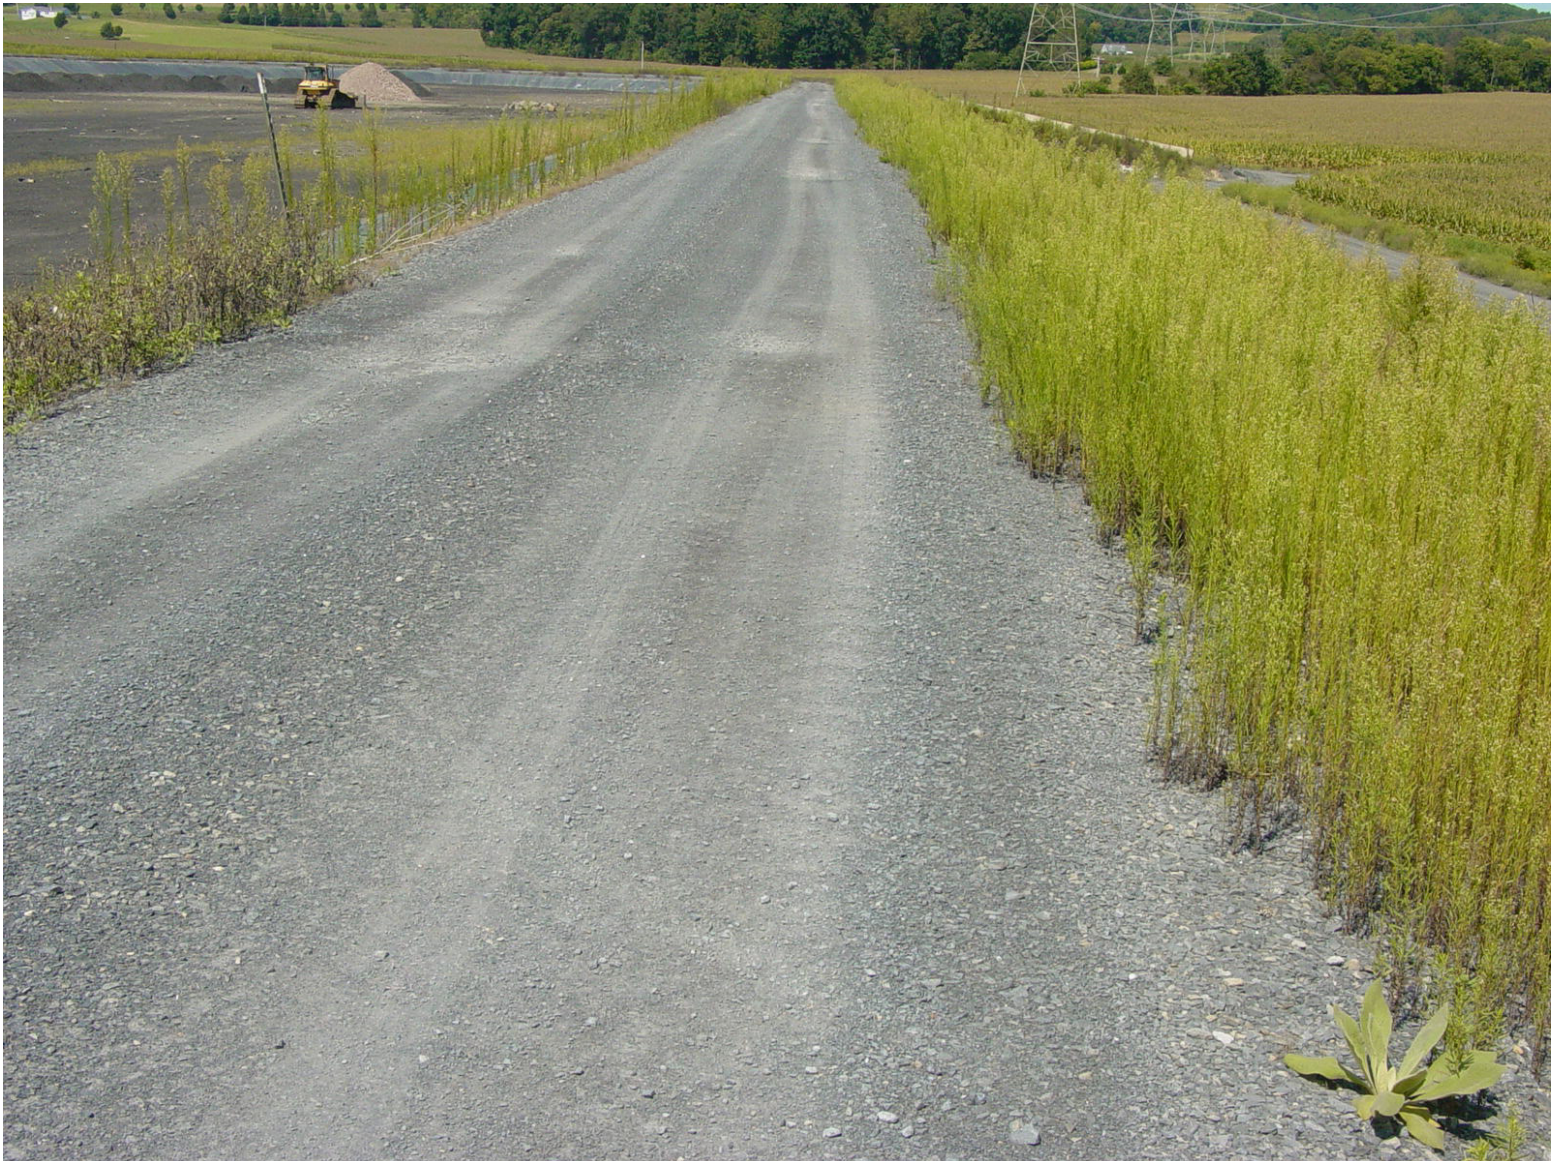
Photo B4-2: Ash Basin No. 4 Crest of North Embankment – Viewed Northwest.

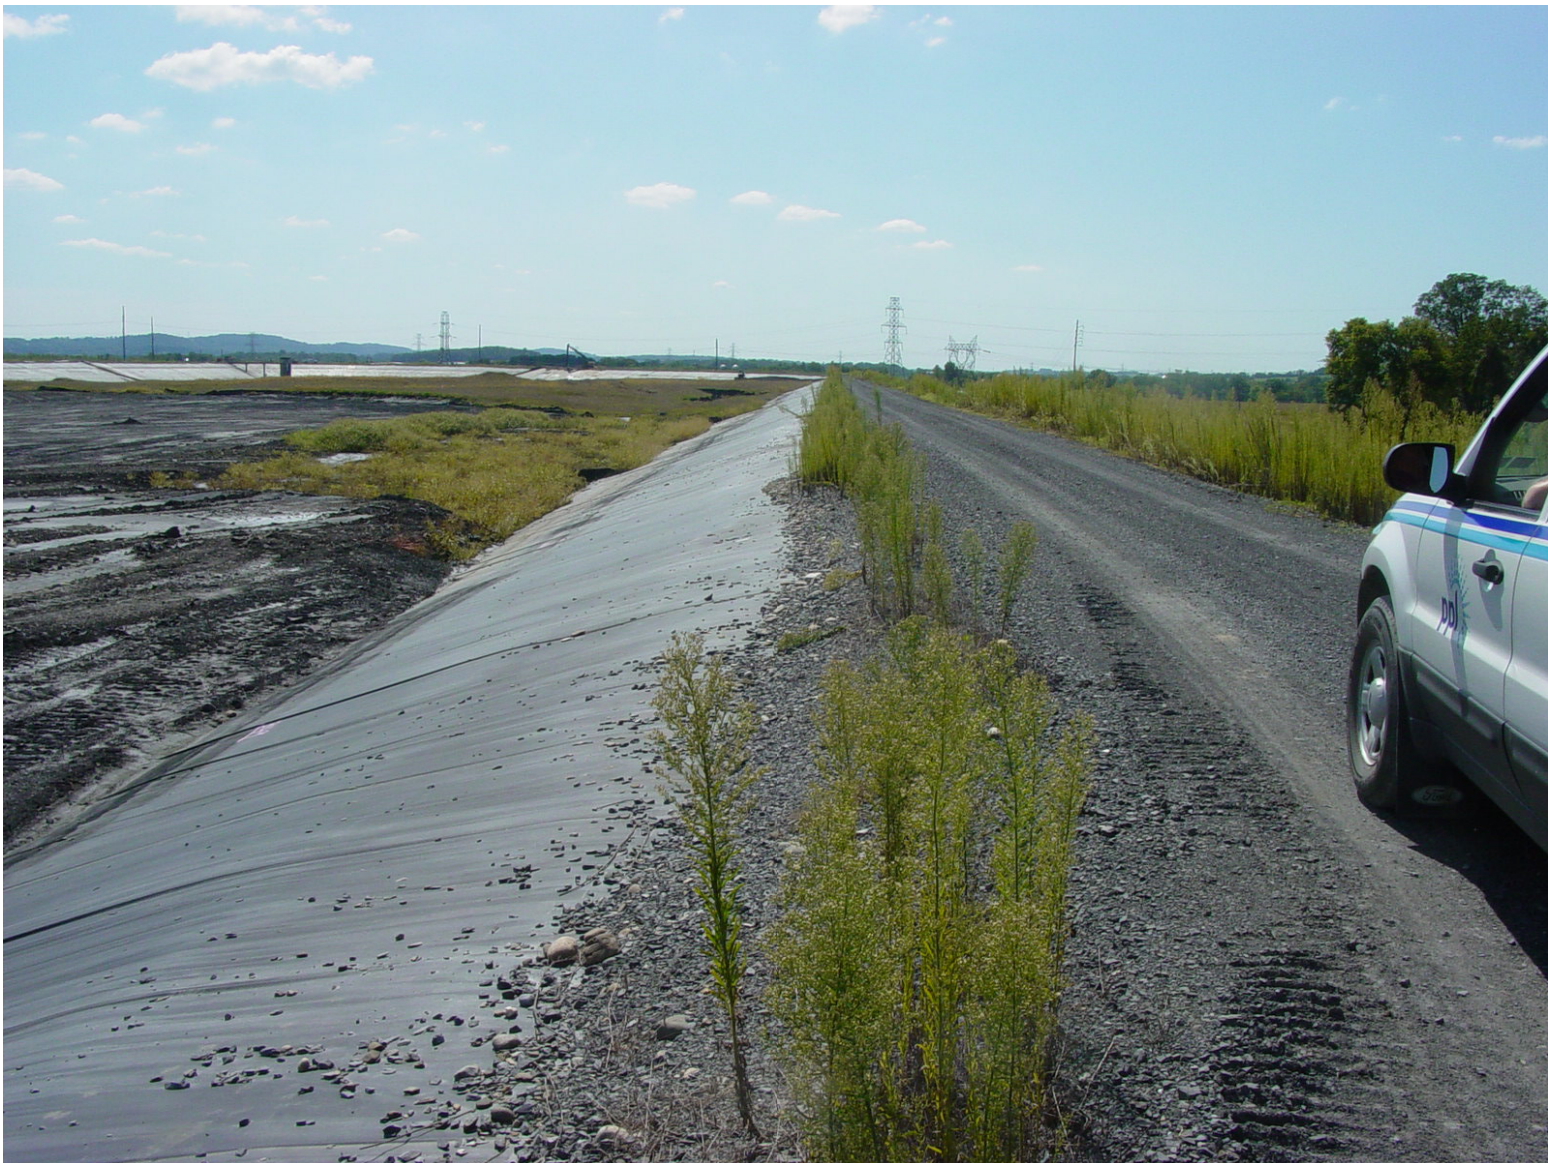
Photo B4-3: Ash Basin No. 4 Crest and Inside Slope of West Embankment – Viewed South.

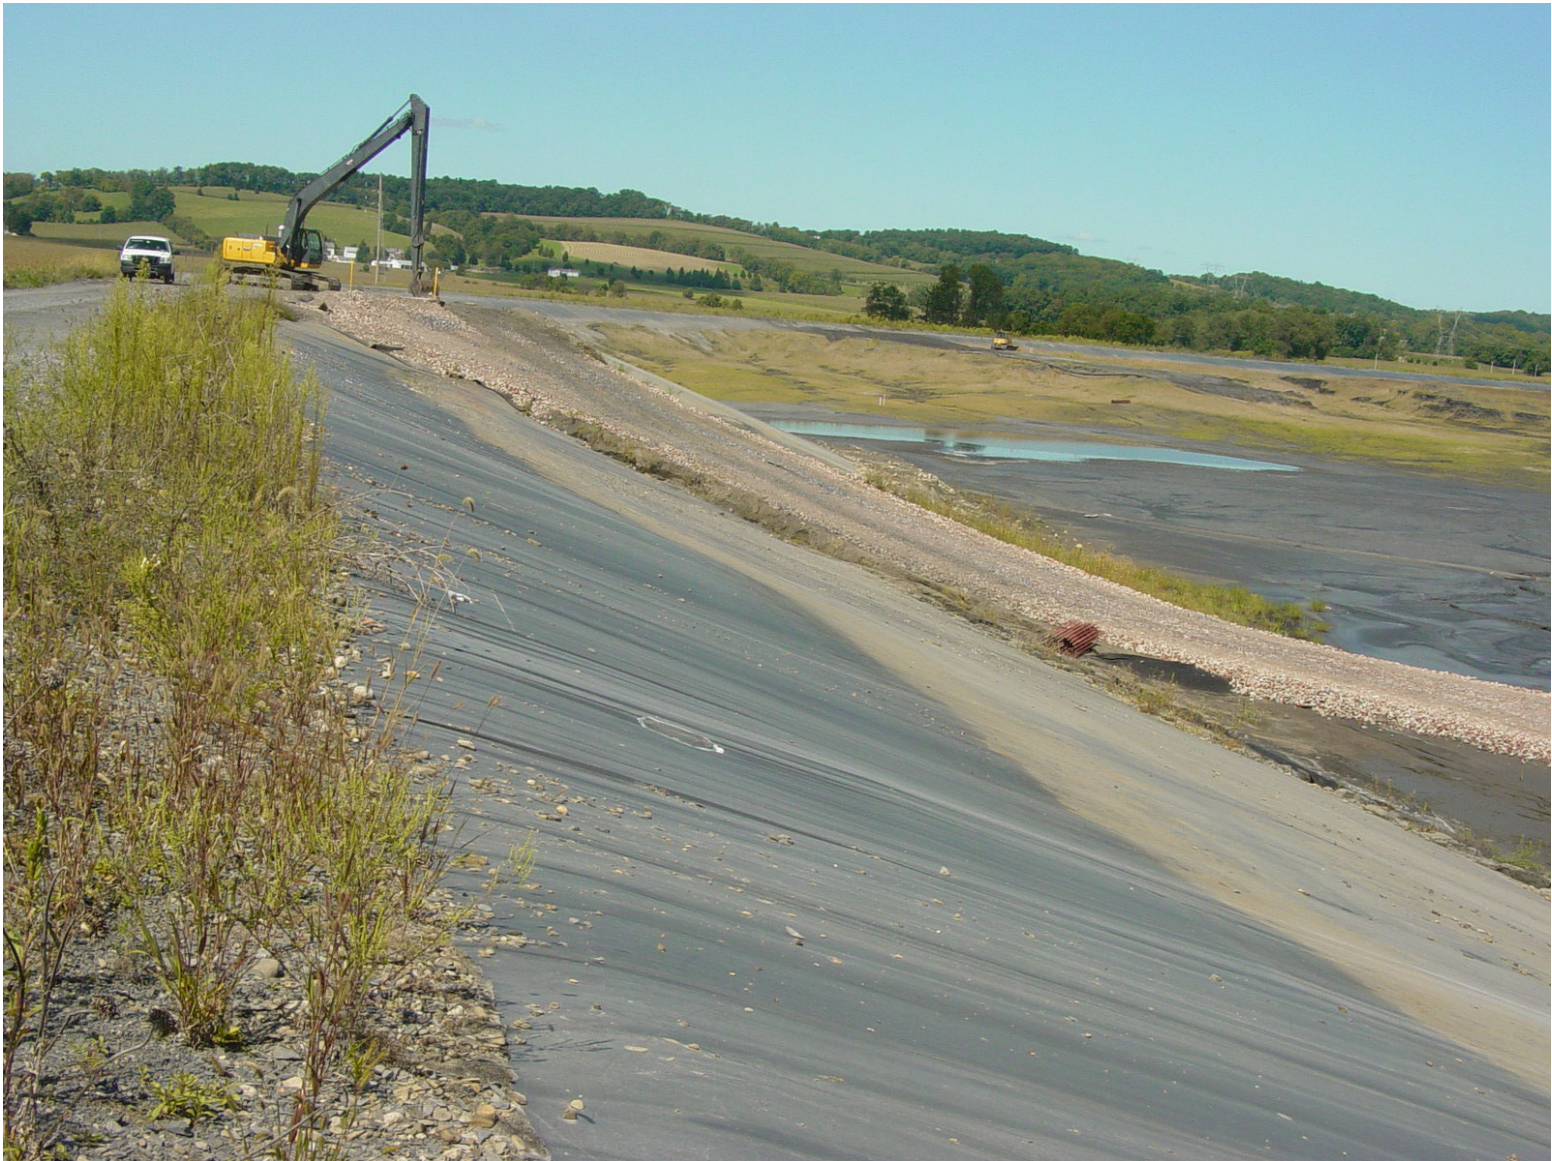
Photo B4-4: Ash Basin No. 4 Crest and Inside Slope of South Embankment – Viewed Northwest.

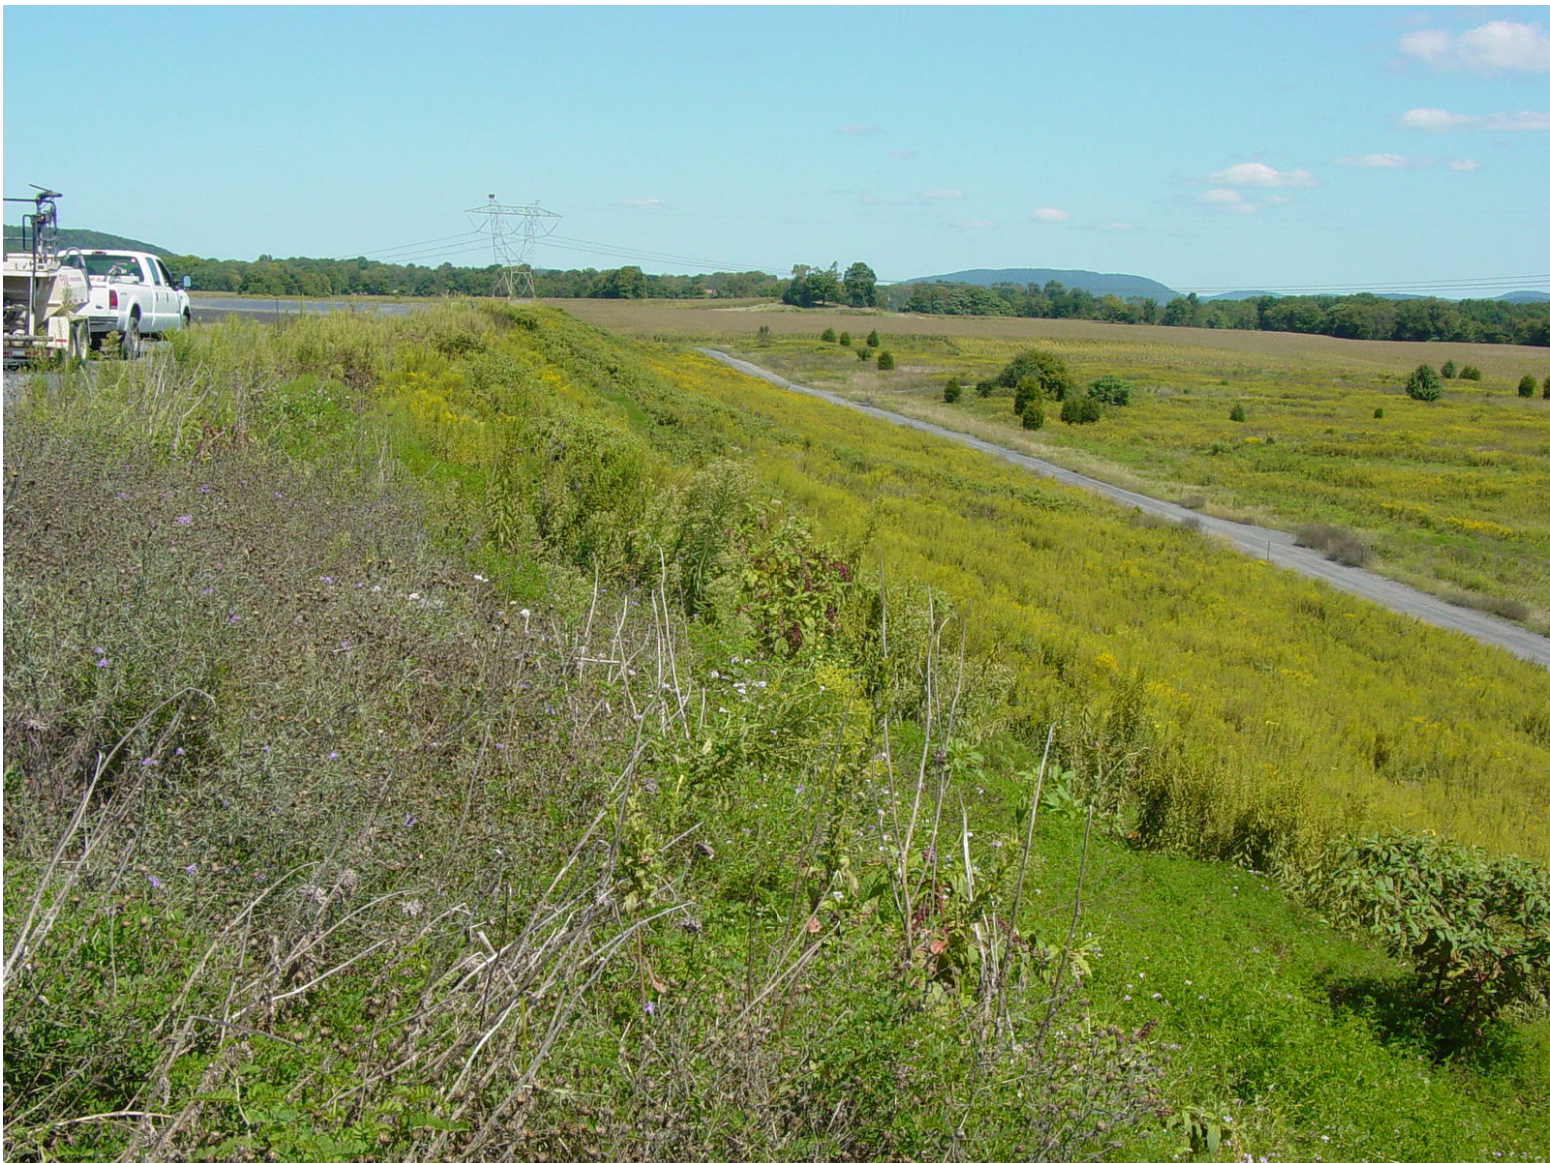
Photo B4-5: Ash Basin No. 4 Outside Slope of East Embankment – Viewed North.

Ash Basin No. 4 Dam - It is recommended that the outside slope be mowed at a frequency of 3 times per year: one time each during spring, summer, and fall. PPL's quarterly inspections and the annual inspection by the independent consultant should be coordinated with the mowing schedule. On the basis of observations made by an outside consultant in June 2009, it is recommended that a burrowing animal control program be implemented. It appears that the animals should be trapped and moved to a different location or eradicated. It is recommended that the control program be implemented within a time frame of one year. Filling of their burrows apparently is not effective and only encourages the animals to make new burrows. The post-closure maintenance program should also include repair of eroded areas that may develop on the outside slope or final closure cap. If the decant tower and outlet pipe are to remain open and functional after closure, it is recommended that these structures be maintained or repaired as needed, based on the results of routine inspections.

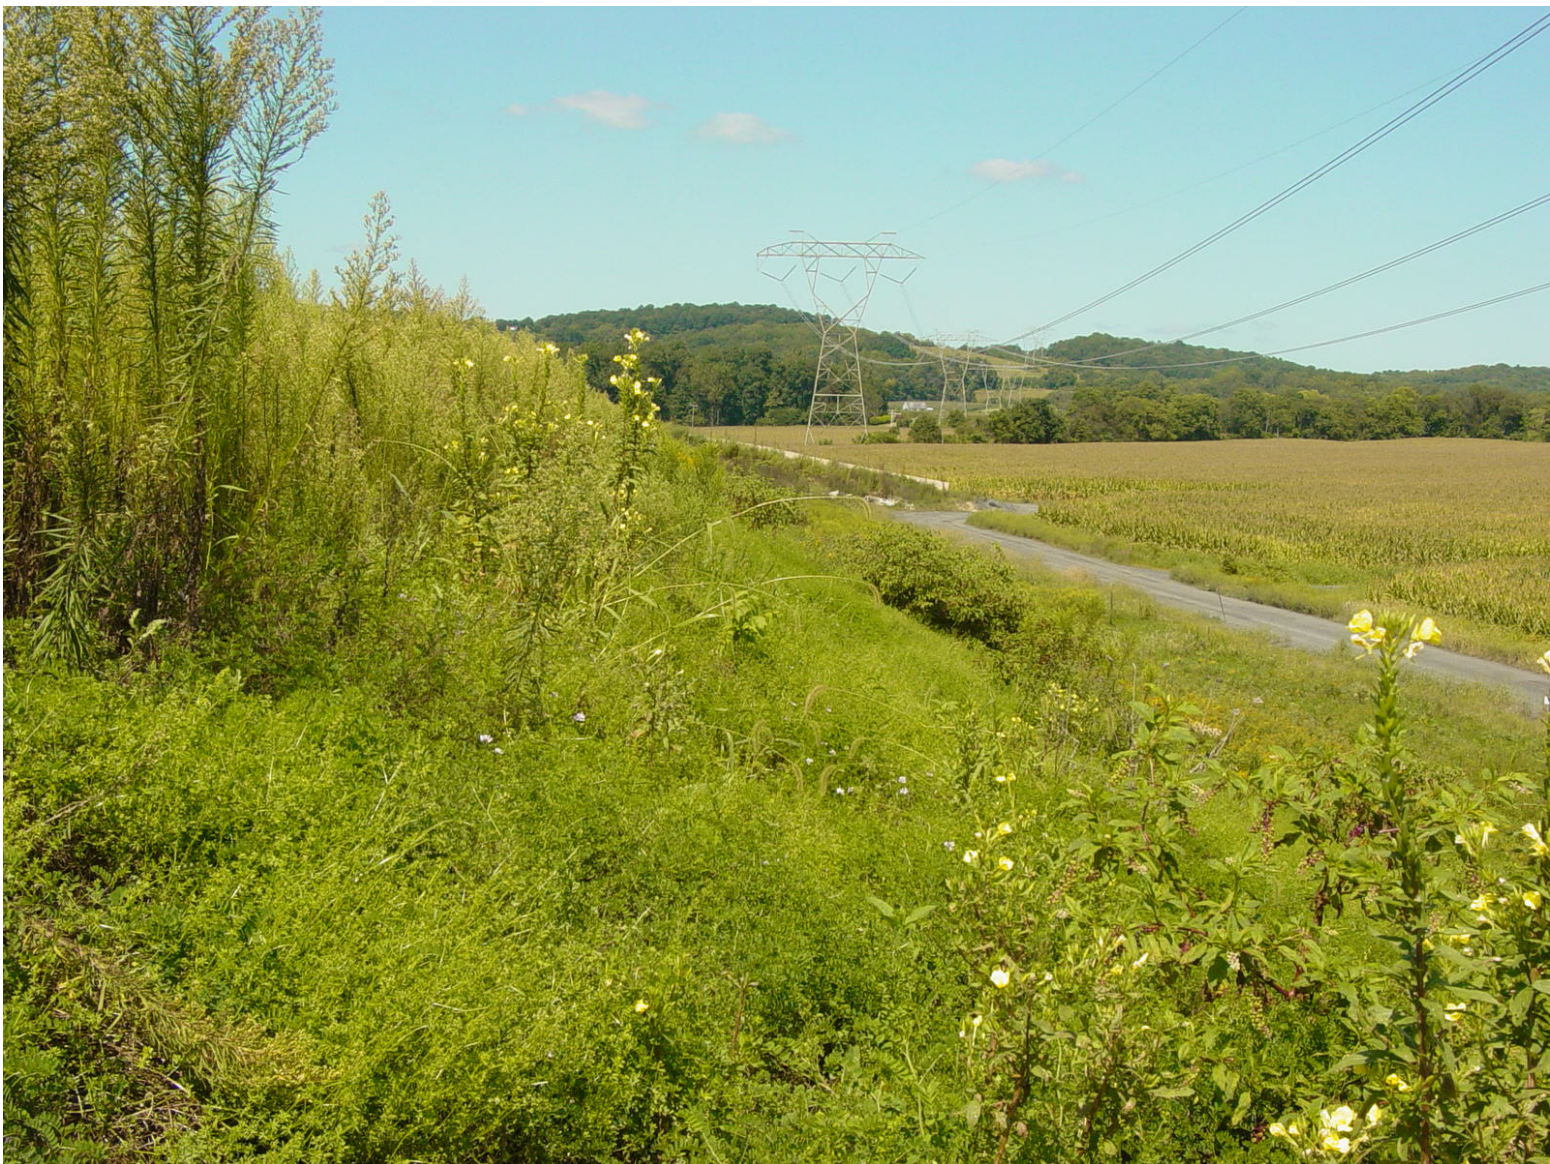
Photo B4-6: Ash Basin No. 4 Outside Slope of North Embankment – Viewed Northwest.

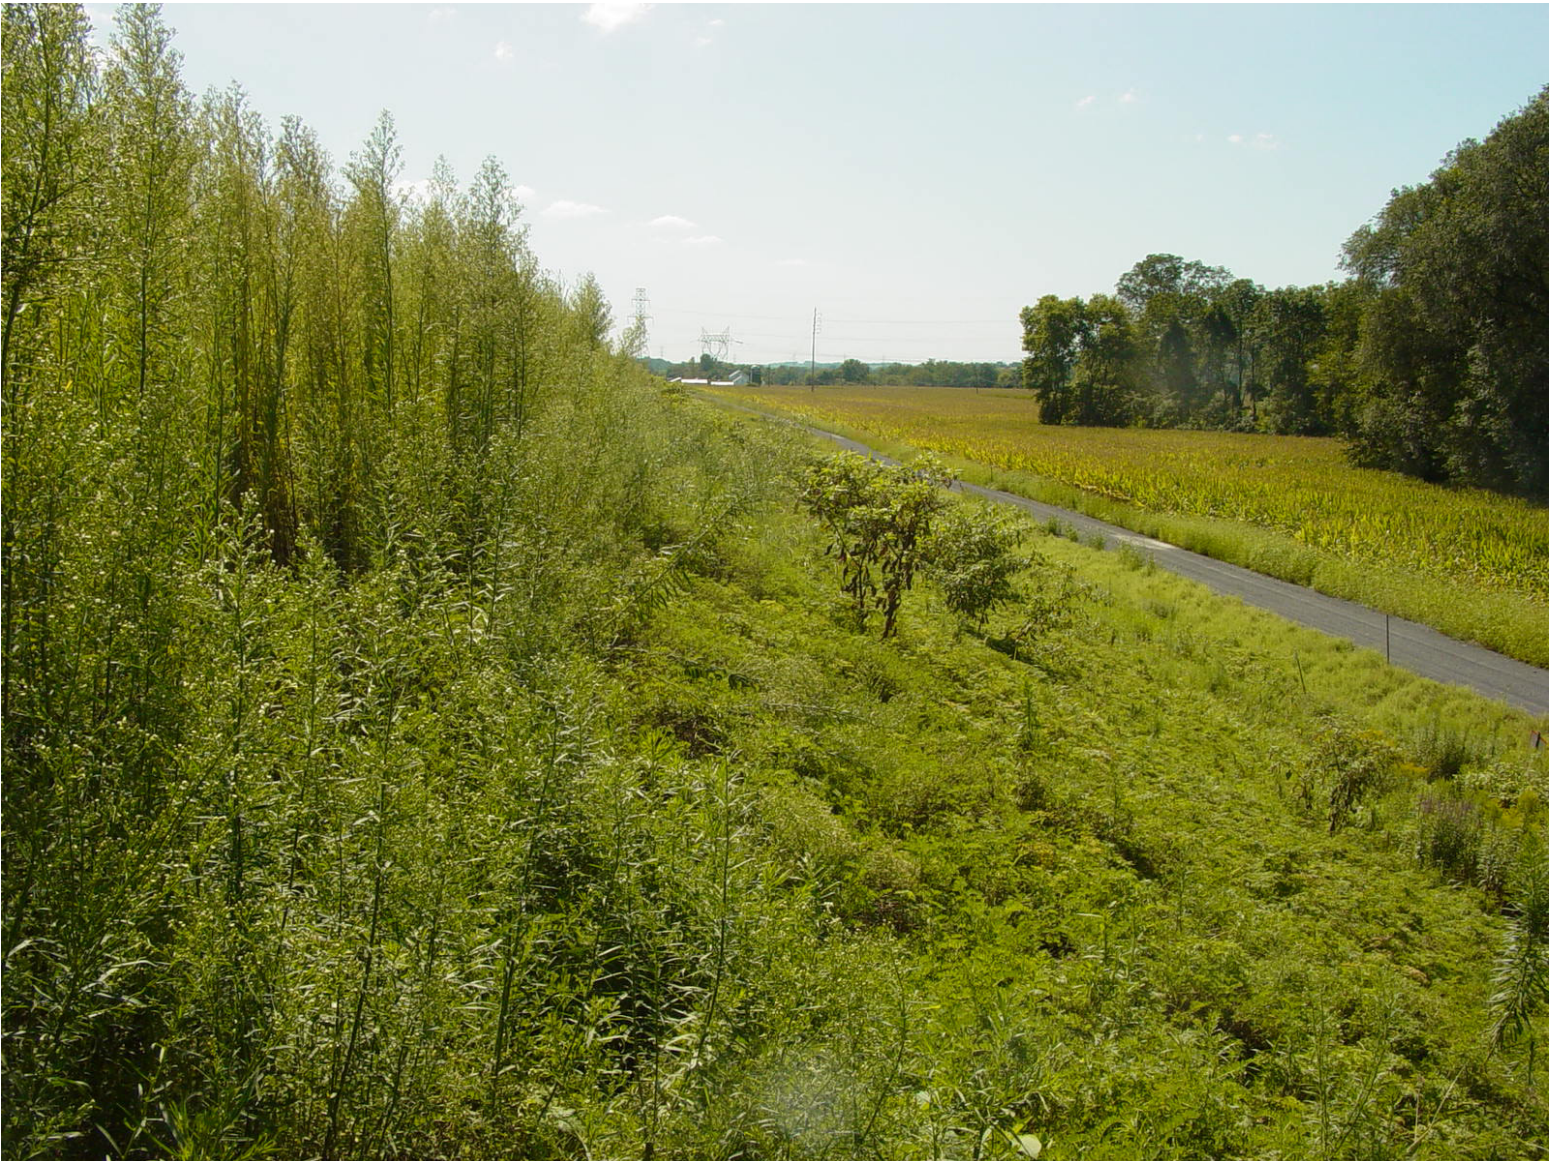
Photo B4-7: Ash Basin No. 4 Outside Slope of West Embankment – Viewed South.

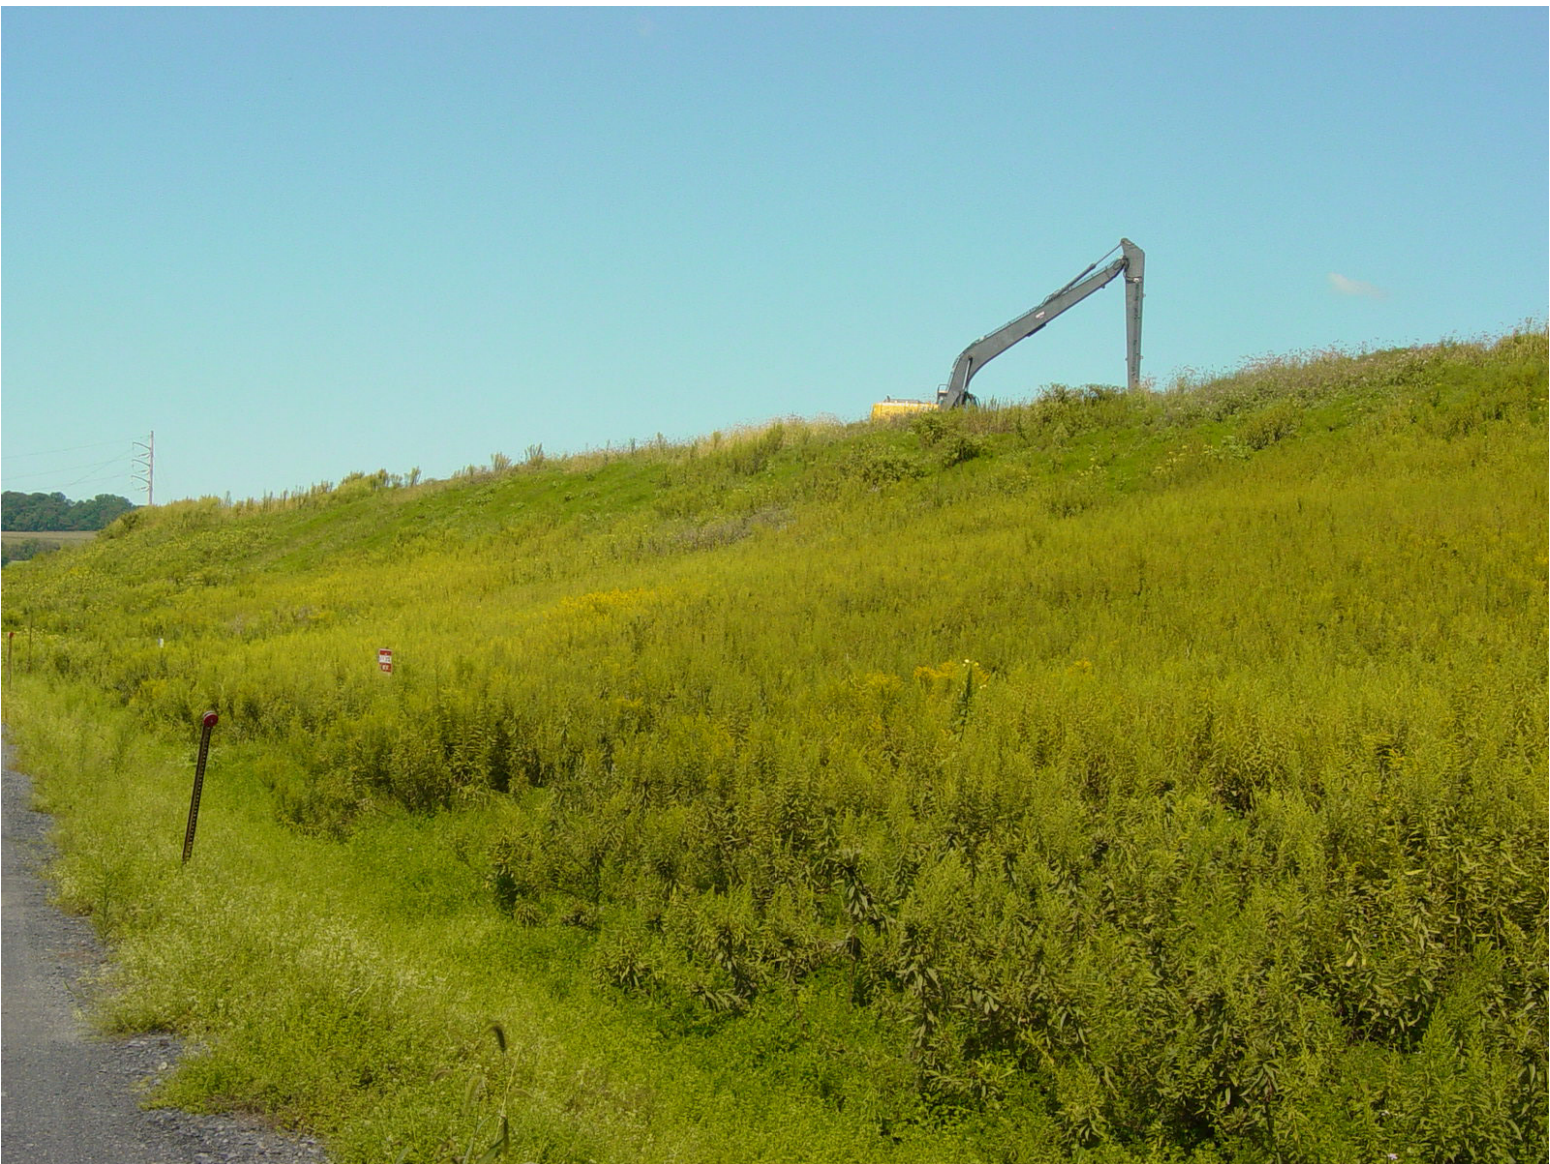
Photo B4-8: Ash Basin No. 4 Outside Slope of South Embankment – Viewed Northwest.

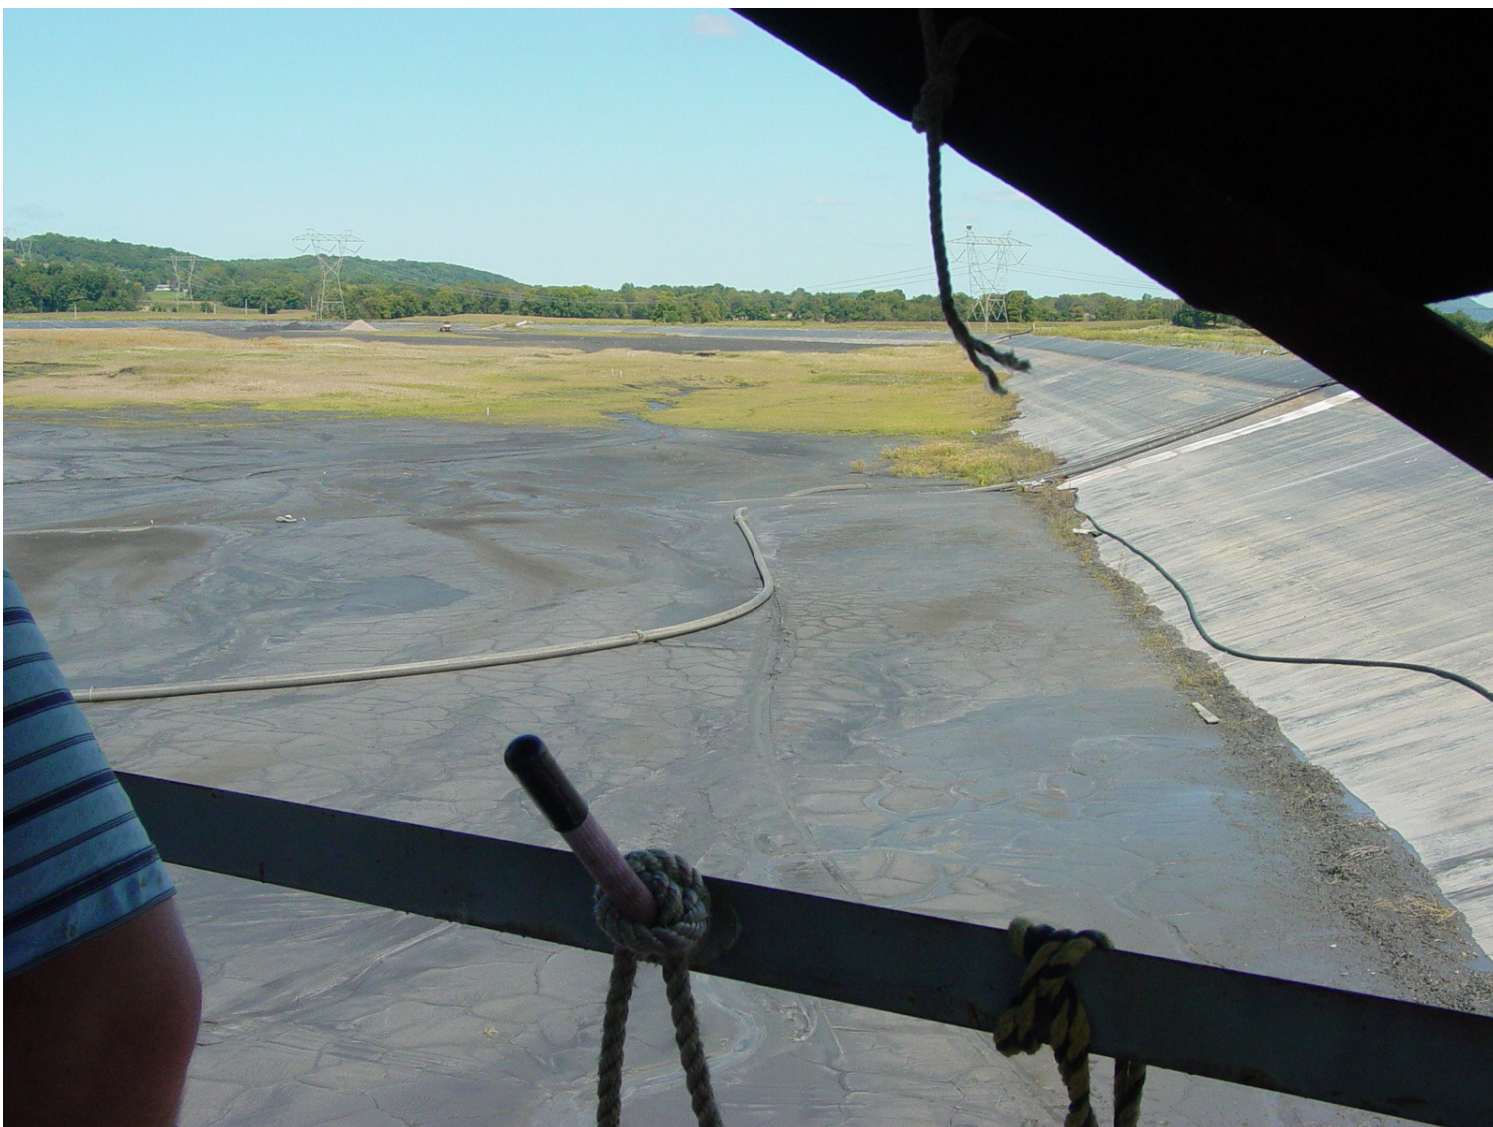
Photo B4-9: Ash Basin No. 4 Inside Slope of East Embankment and View of Ash Surface in Basin- Viewed North from Top of Decant Tower - Note Vertical Wrinkles in Liner (Commonly Occurs Throughout).

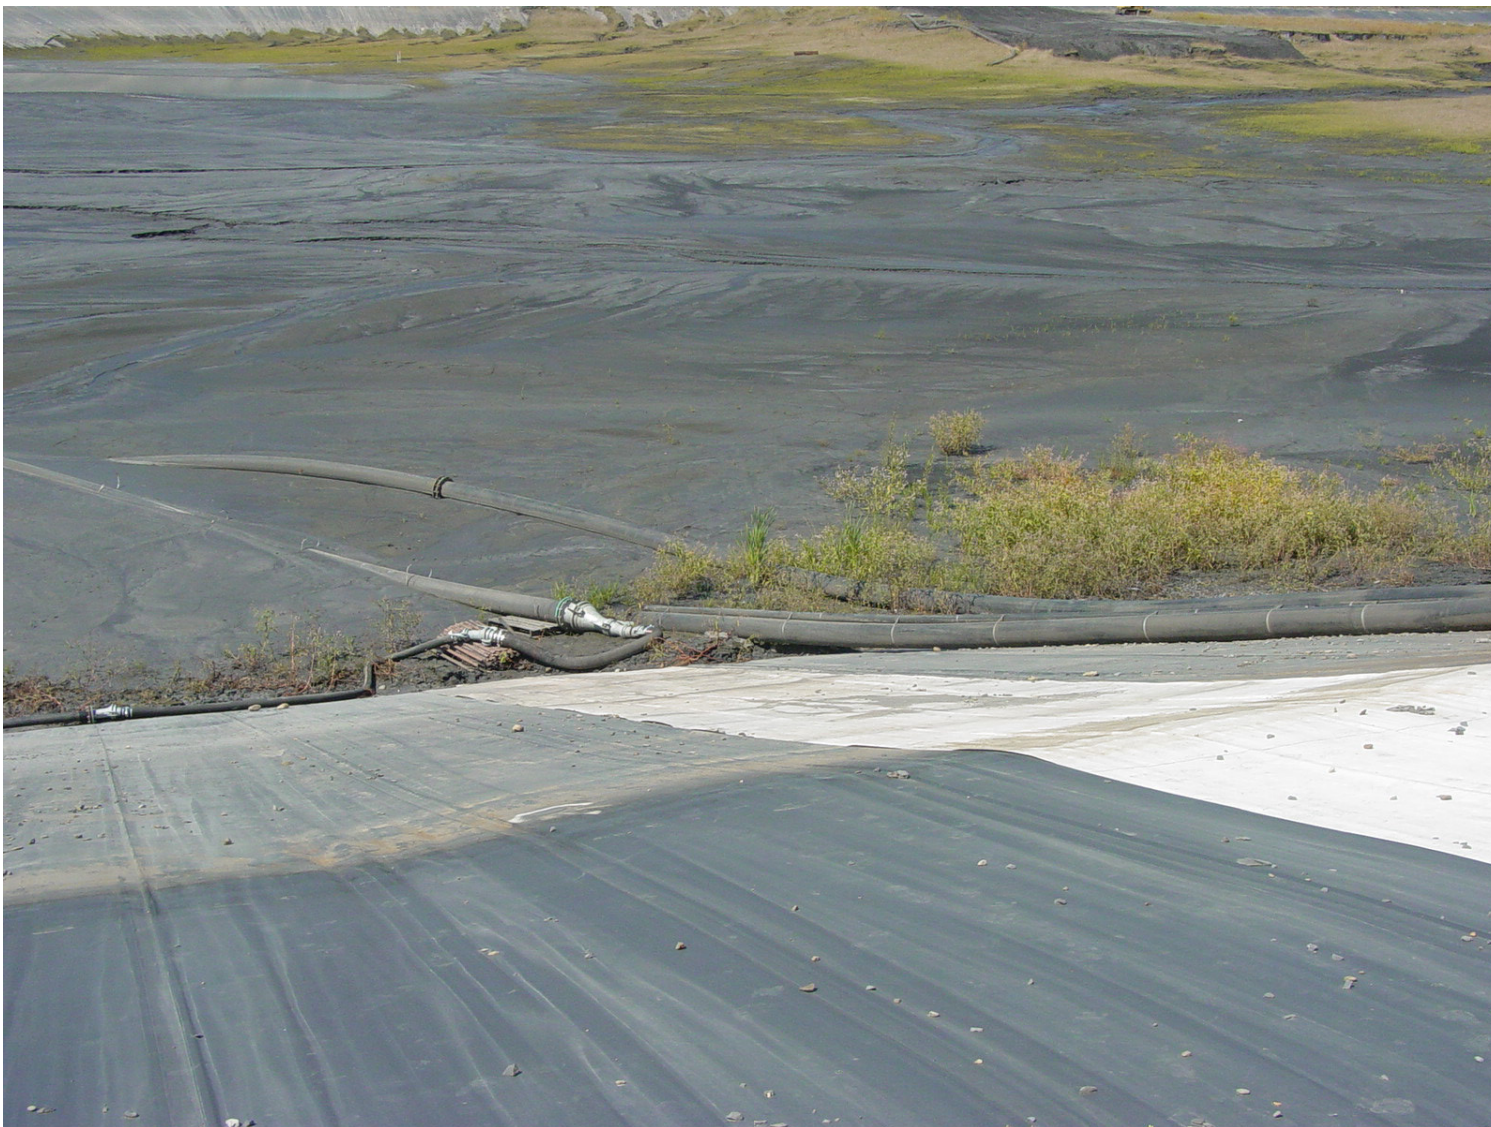
Photo B4-10: Ash Basin No. 4 View of Slight Linear Bulge Under Liner along Former Operating Water Level on Inside Slope of East Embankment Approximately 430' North of Decant Tower Footbridge.

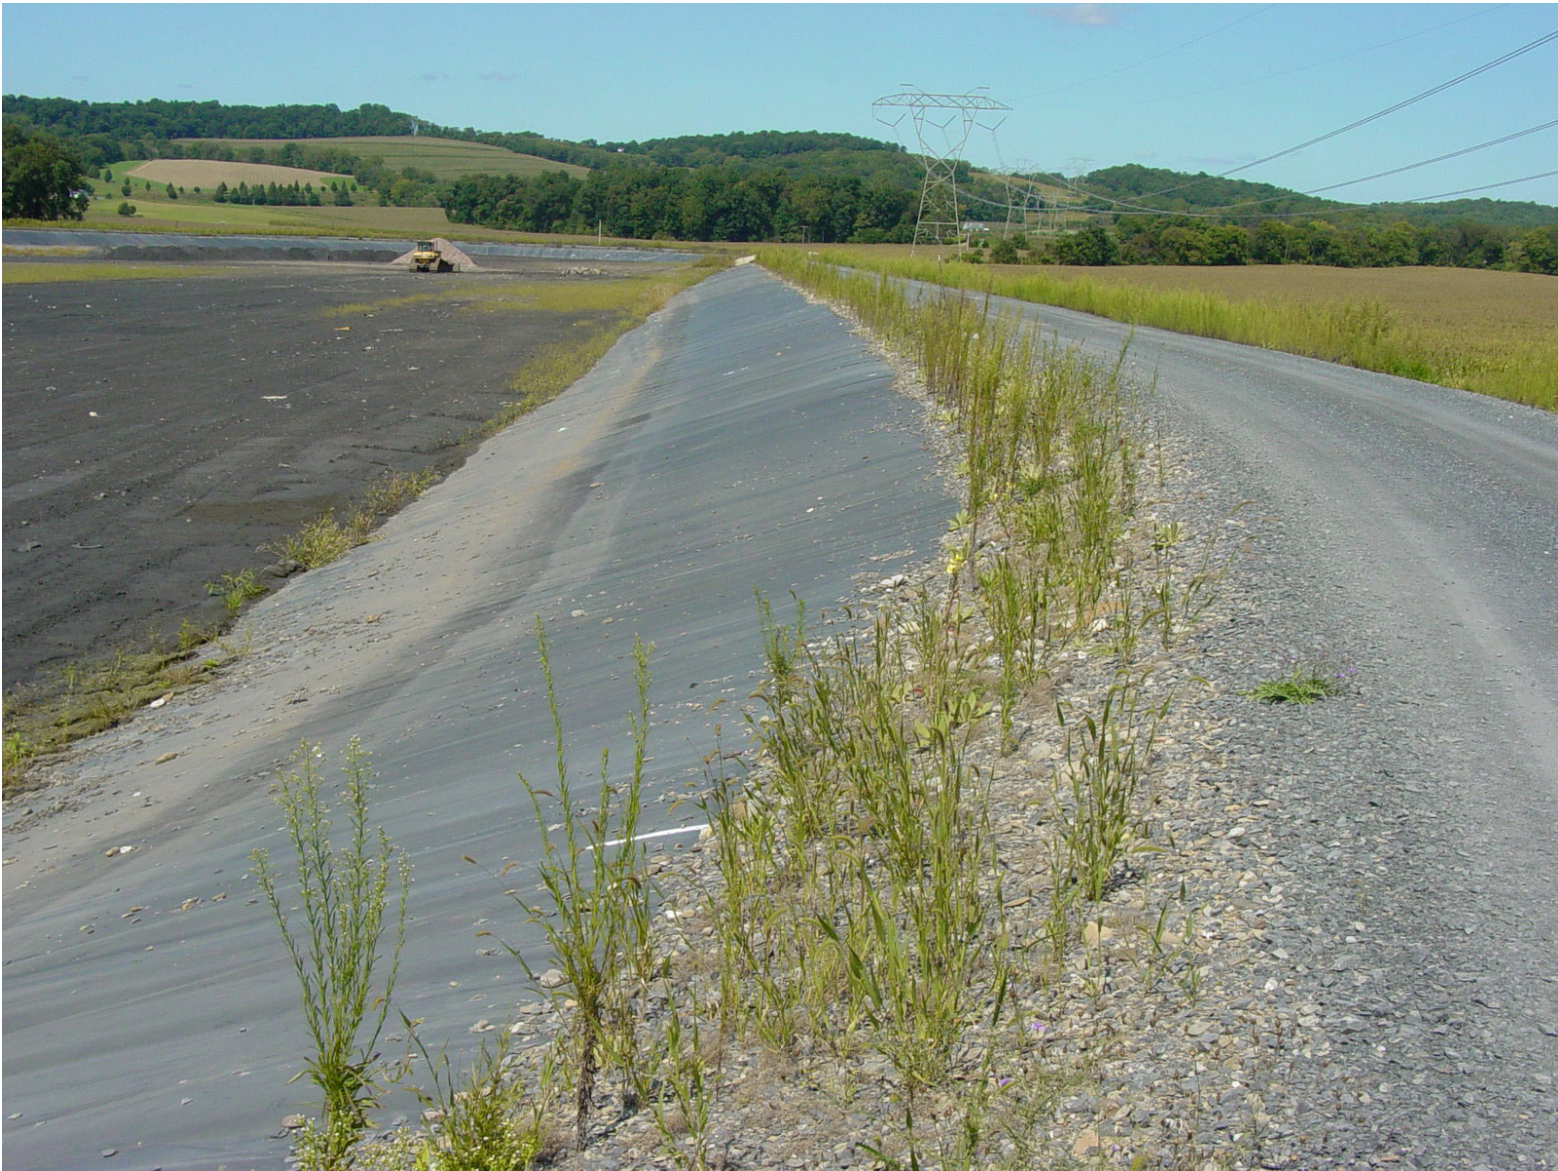
Photo B4-II: Ash Basin No. 4 Inside Slope of North Embankment – Viewed Northwest.

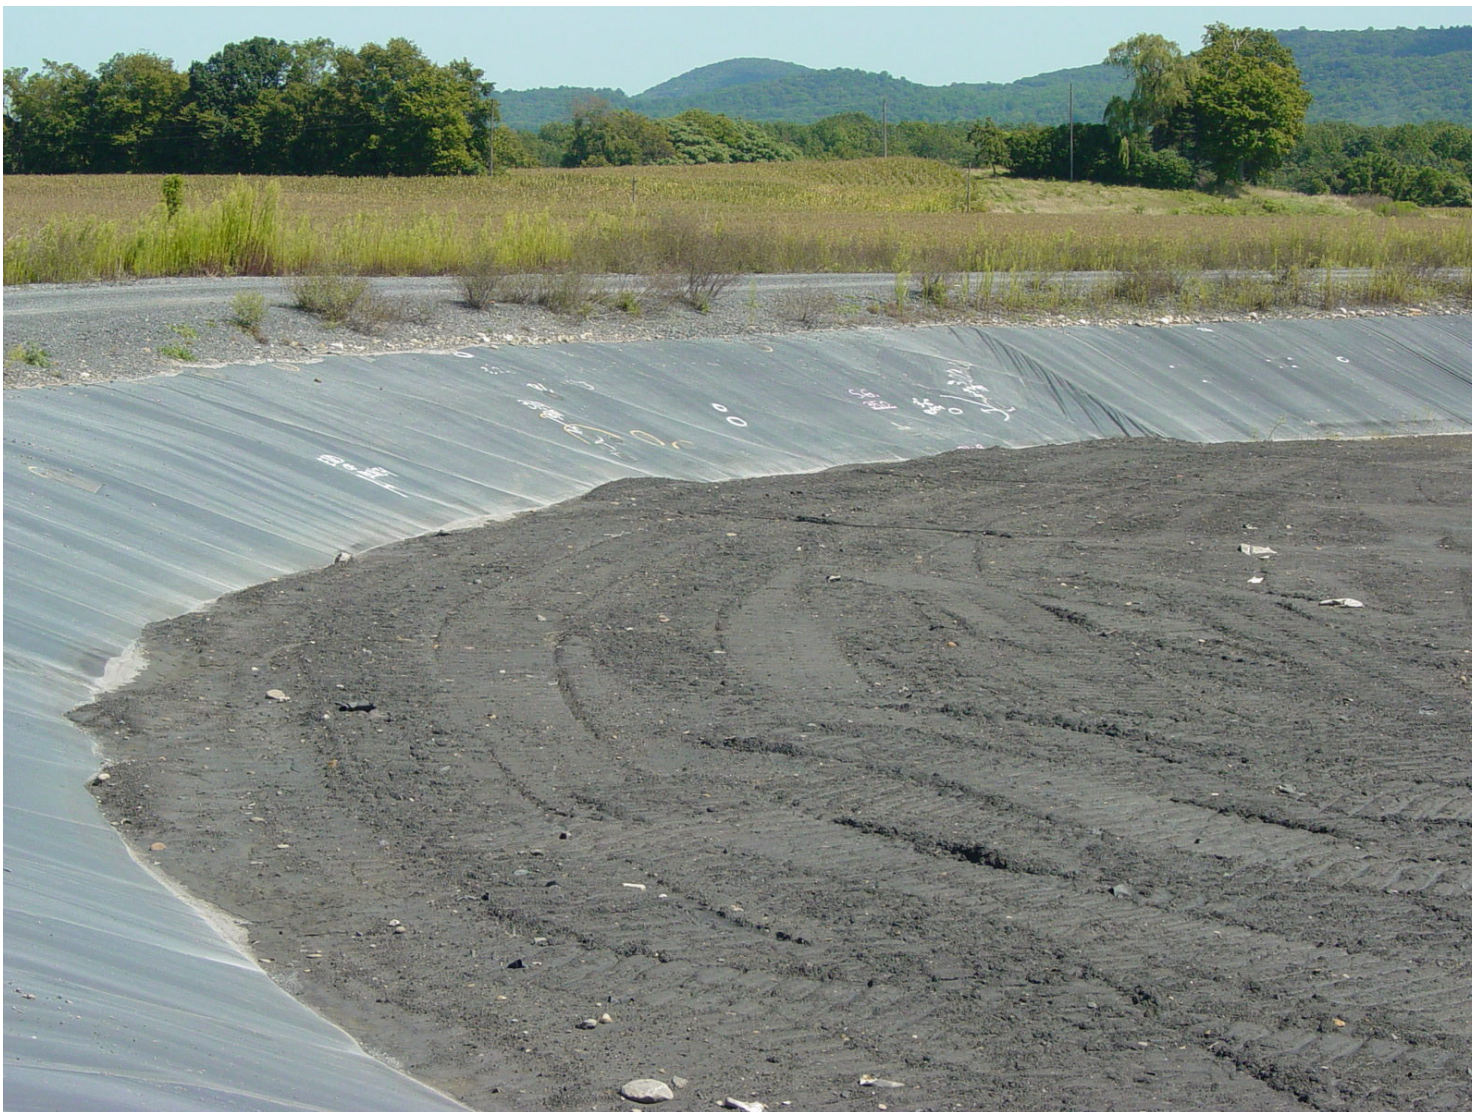
Photo B4-12: Ash Basin No. 4 Inside Slope of North Embankment at Northwest Corner – Note Highest Point of Ash in the Basin Spread in Place by Dozer in Preparation for Closure; White Marks on Liner from PPL Inspection Indicating Holes and Defects to be Patched.
