**Coal Combustion Waste Impoundment  
Dam Assessment Report**

***Martins Creek Steam Electric Station  
PPL Generation  
Bangor, Pennsylvania***

**Project # 0-381  
Assessment of Dam Safety  
Coal Combustion Surface Impoundments  
for the REAC Program**

**September 2009  
Revised December 9, 2009**

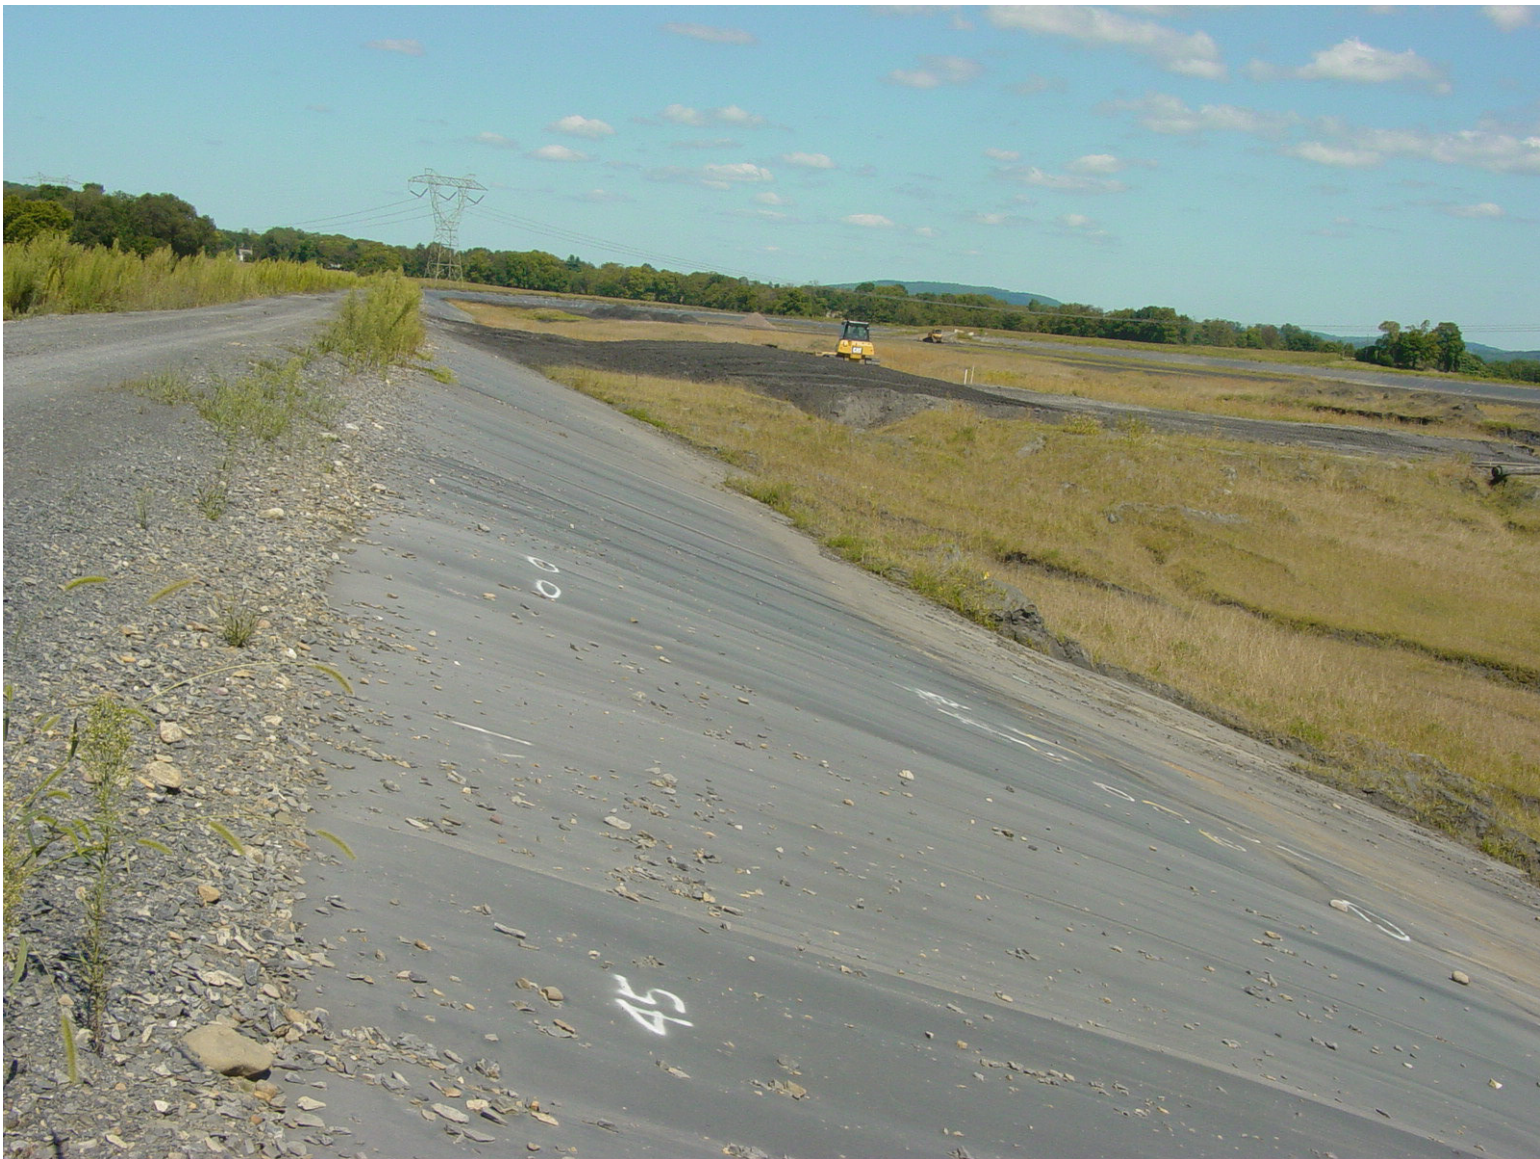
Photo B4-13: Ash Basin No. 4 Inside Slope of West Embankment – Viewed North.

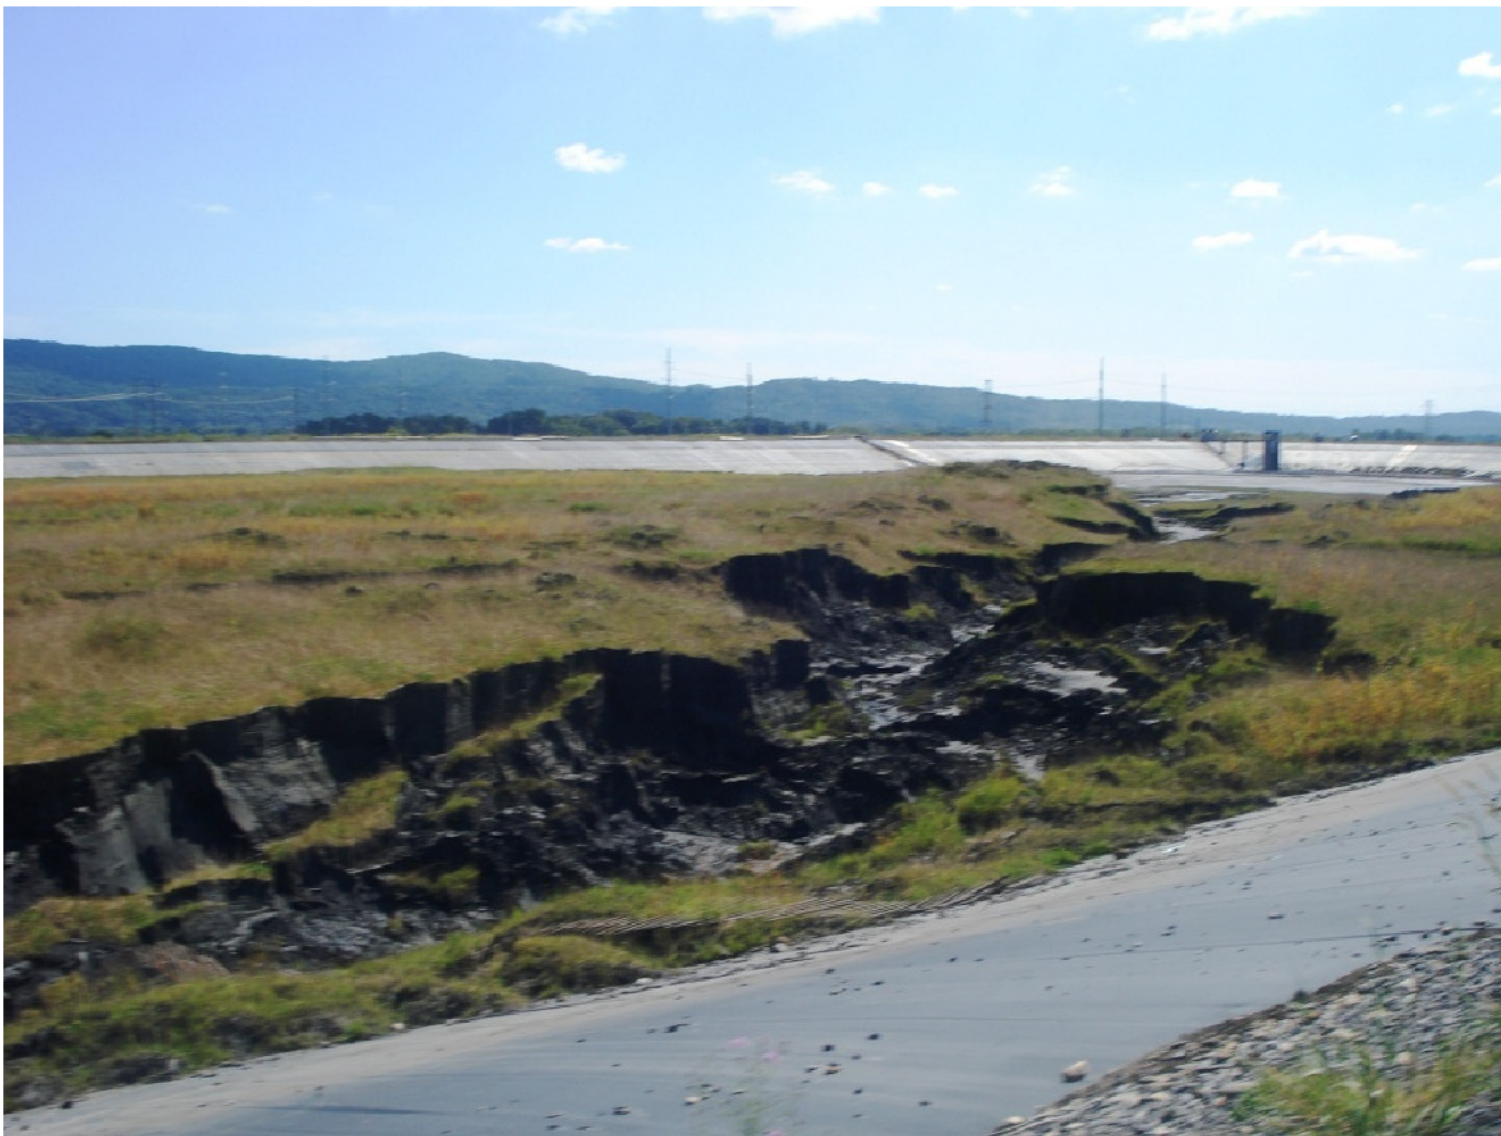
Photo B4-14: Ash Basin No. 4 View of Swale Cut Through Ash to Allow Drainage from West Part of Basin – Note Sloughing and Erosion of the Side Slopes of the Swale.

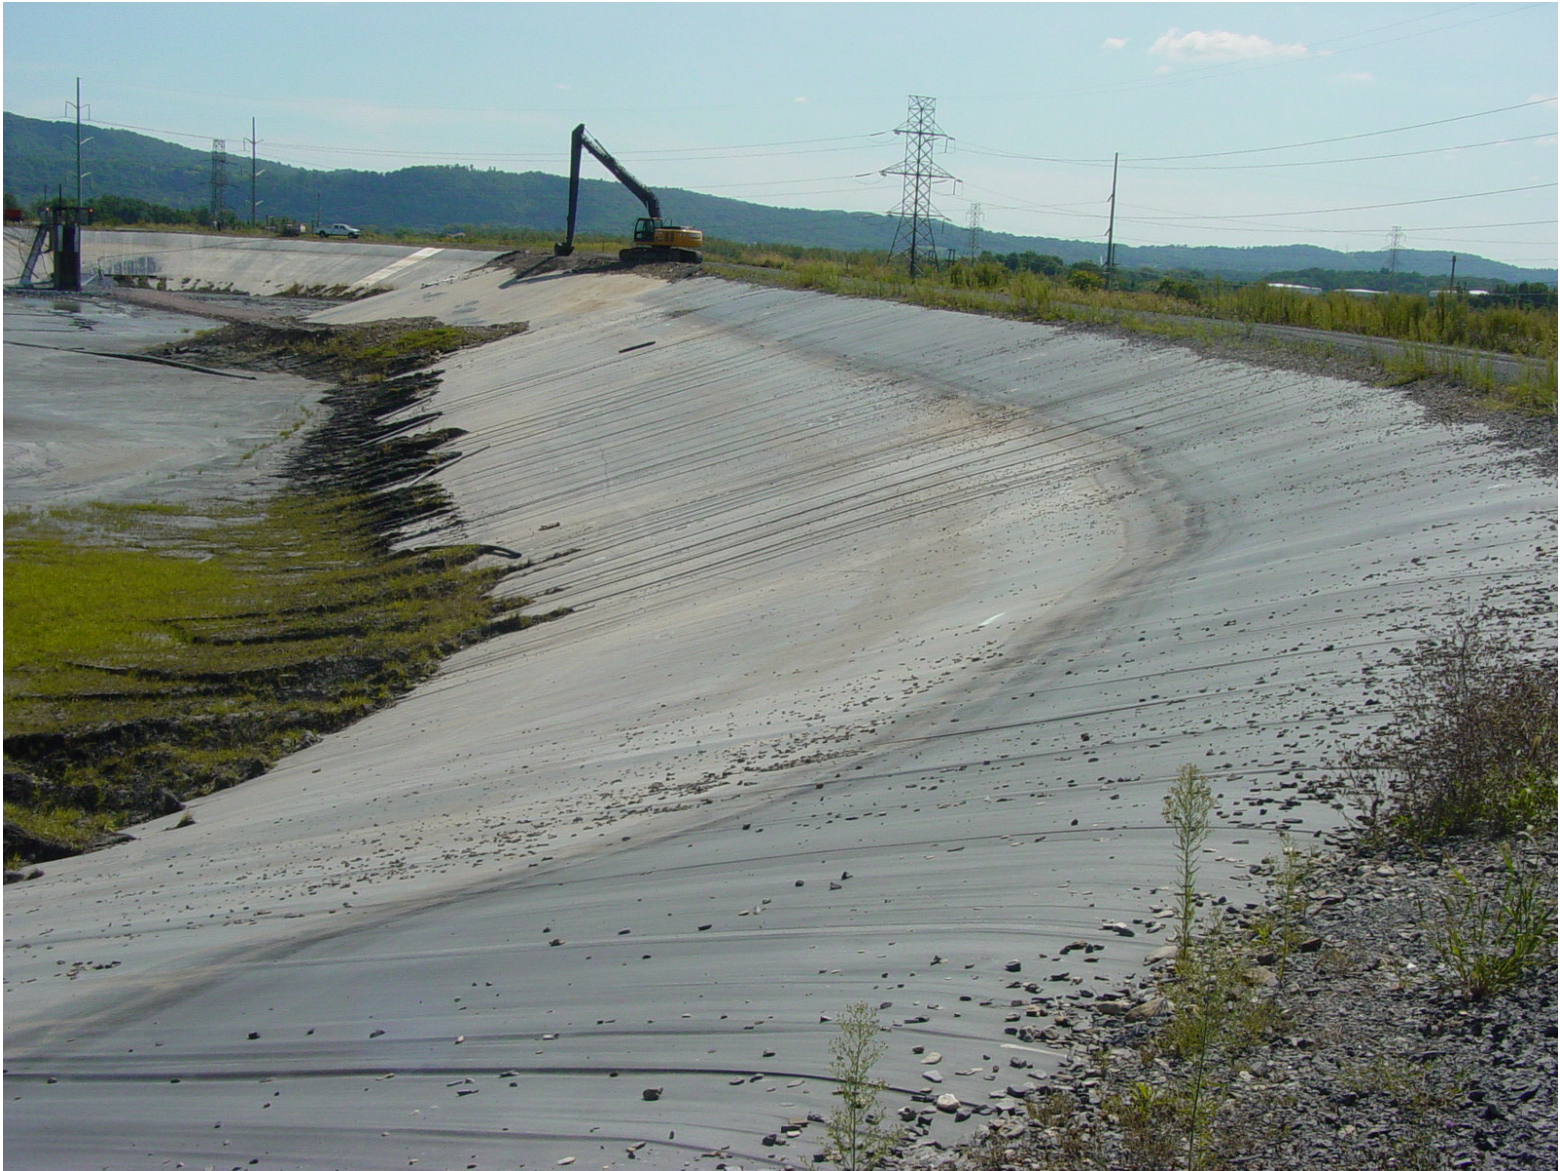
Photo B4-15: Ash Basin No. 4 Inside Slope of South Embankment – Viewed Southeast – Note Vertical Wrinkles.

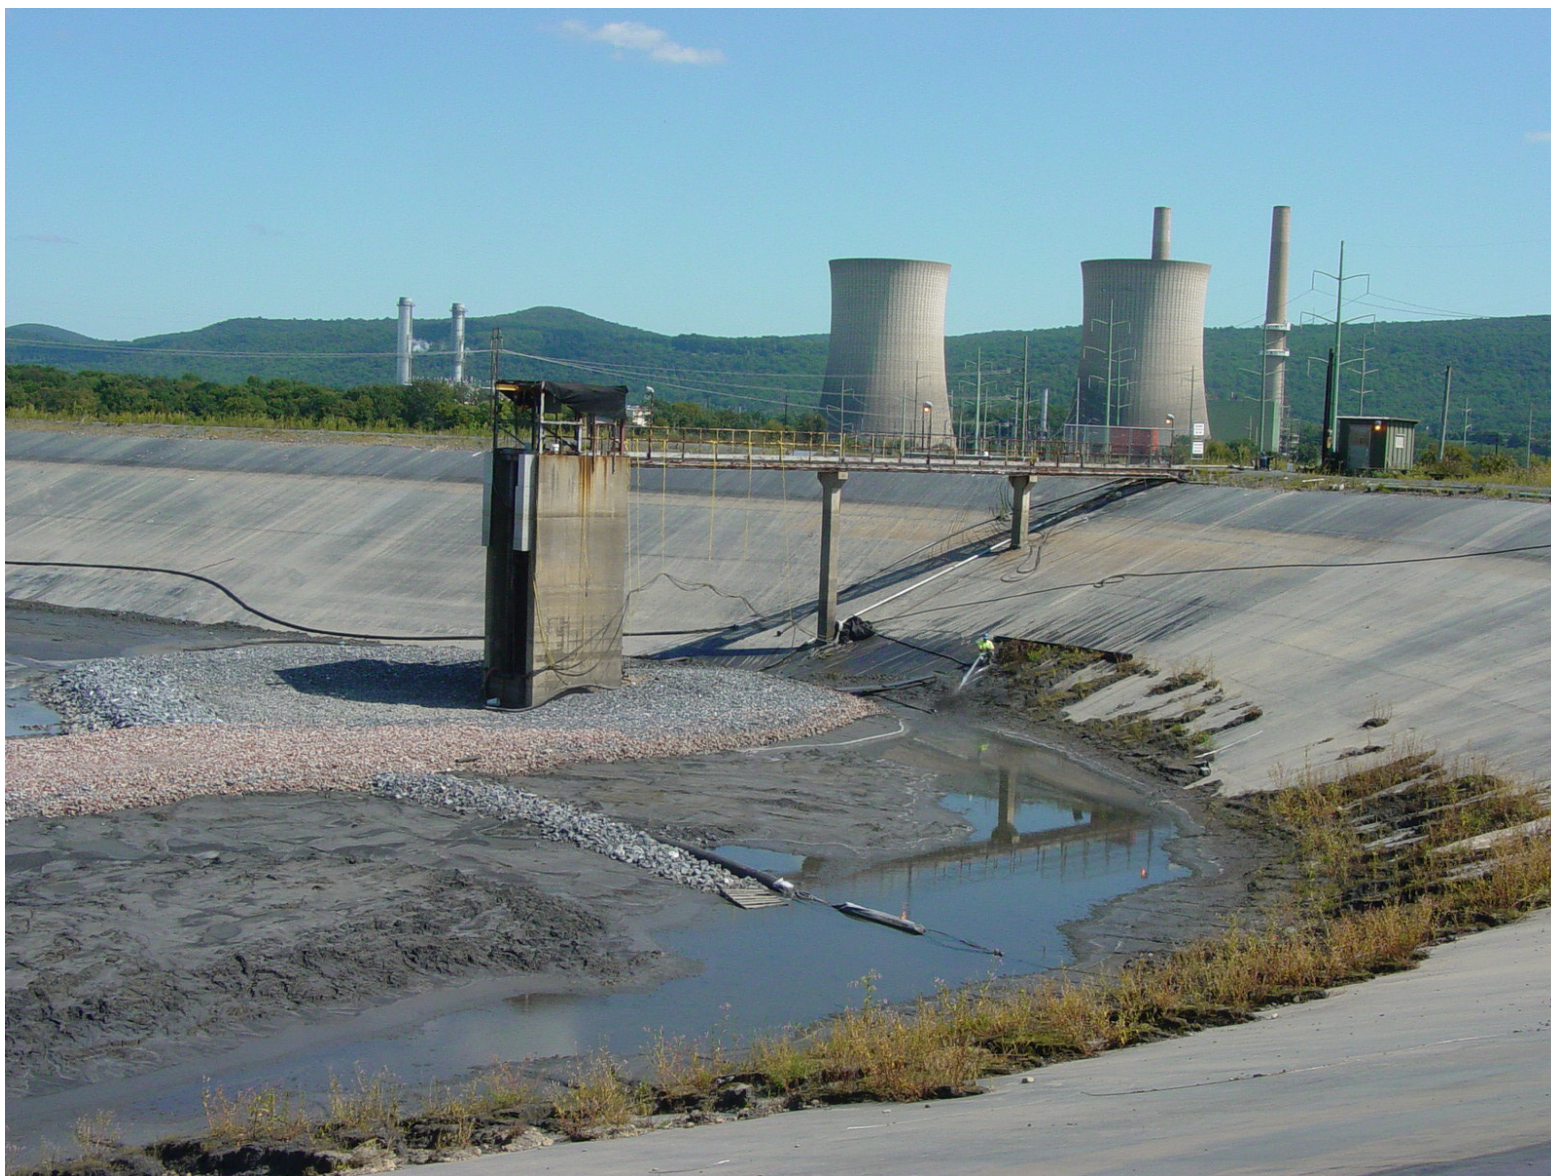
Photo B4-16: Ash Basin No. 4 View of South and West Sides of Decant Tower – Viewed Northeast Note Crushed Stone Filter Around Base of Tower.

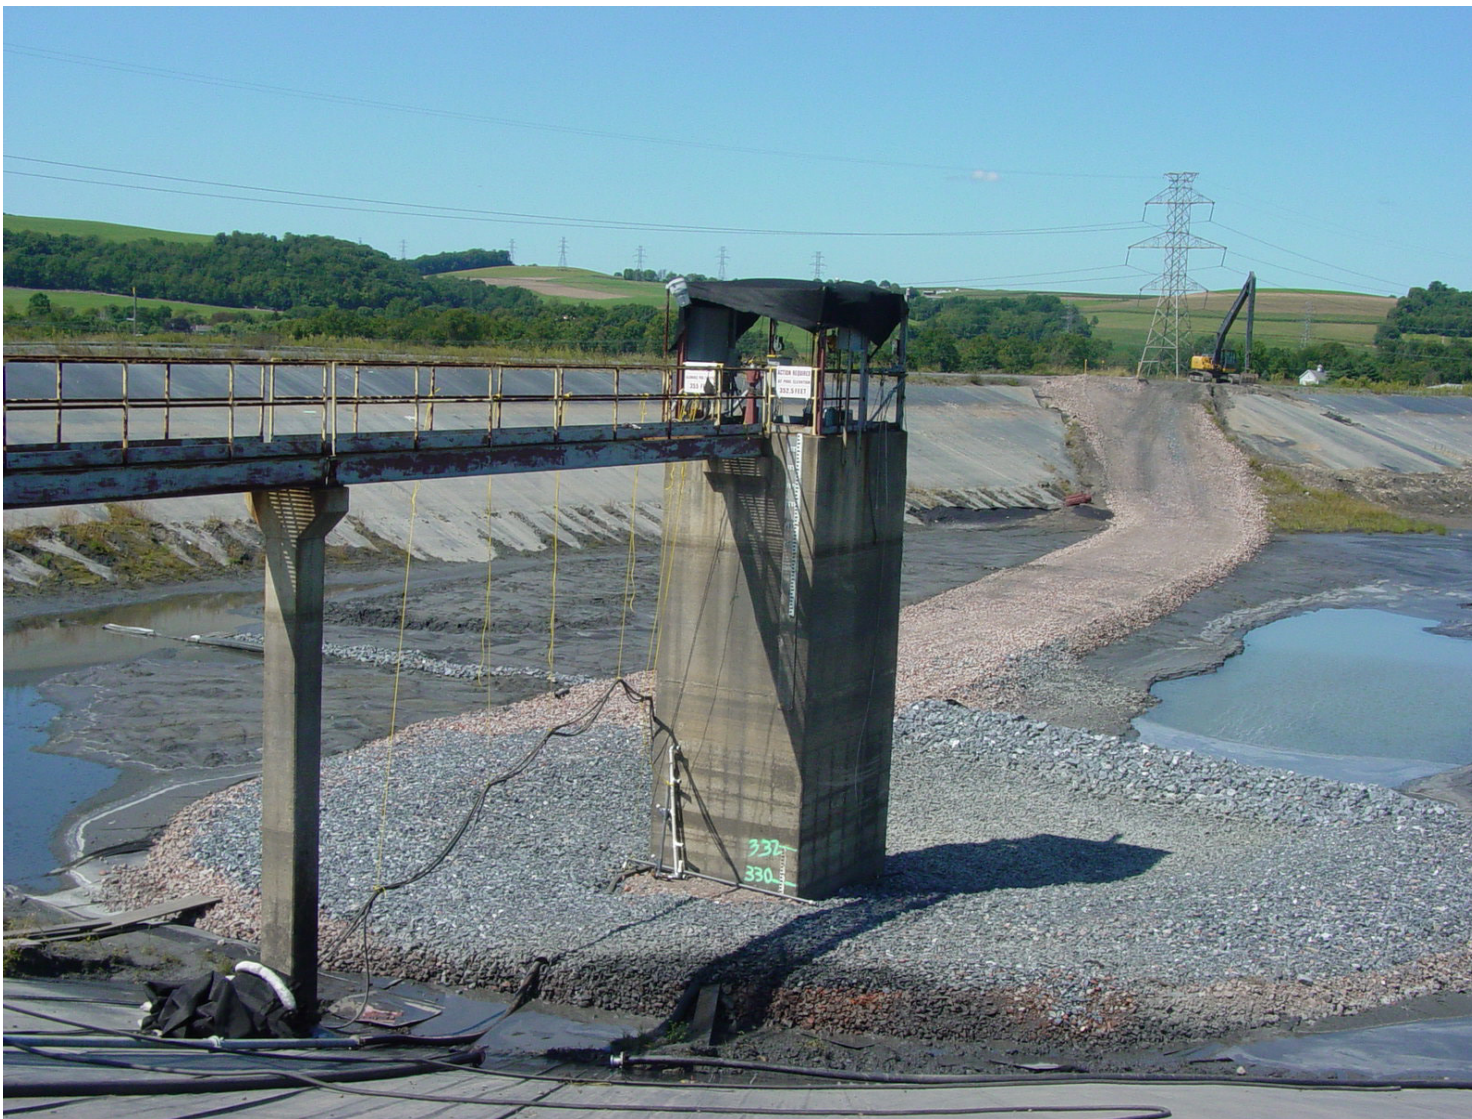
Photo B4-17: Ash Basin No. 4 View of East and North Sides of Decant Tower – Viewed Southwest Note Crushed Brick Access Causeway to Filter Around Base of Tower (Brick from Demolition of Smoke Stacks).

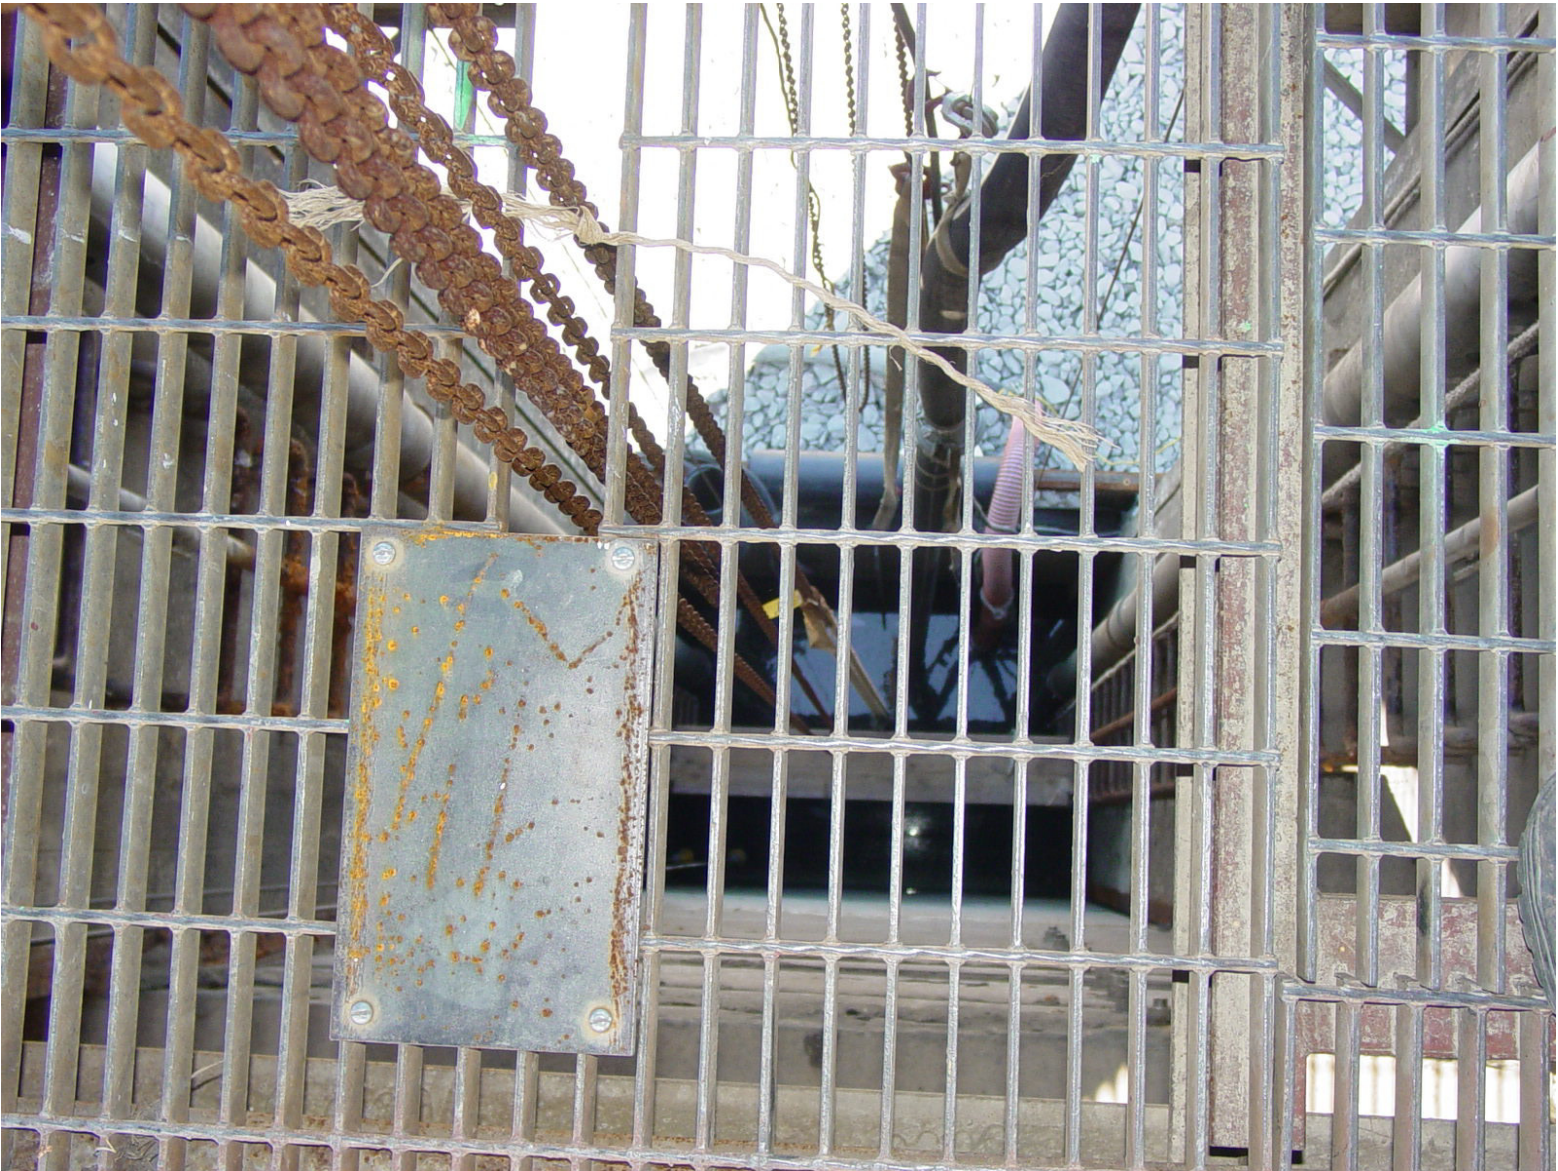
Photo B4-18: Ash Basin No. 4 View Through Top Grate into Outer Chamber of Decant Tower.

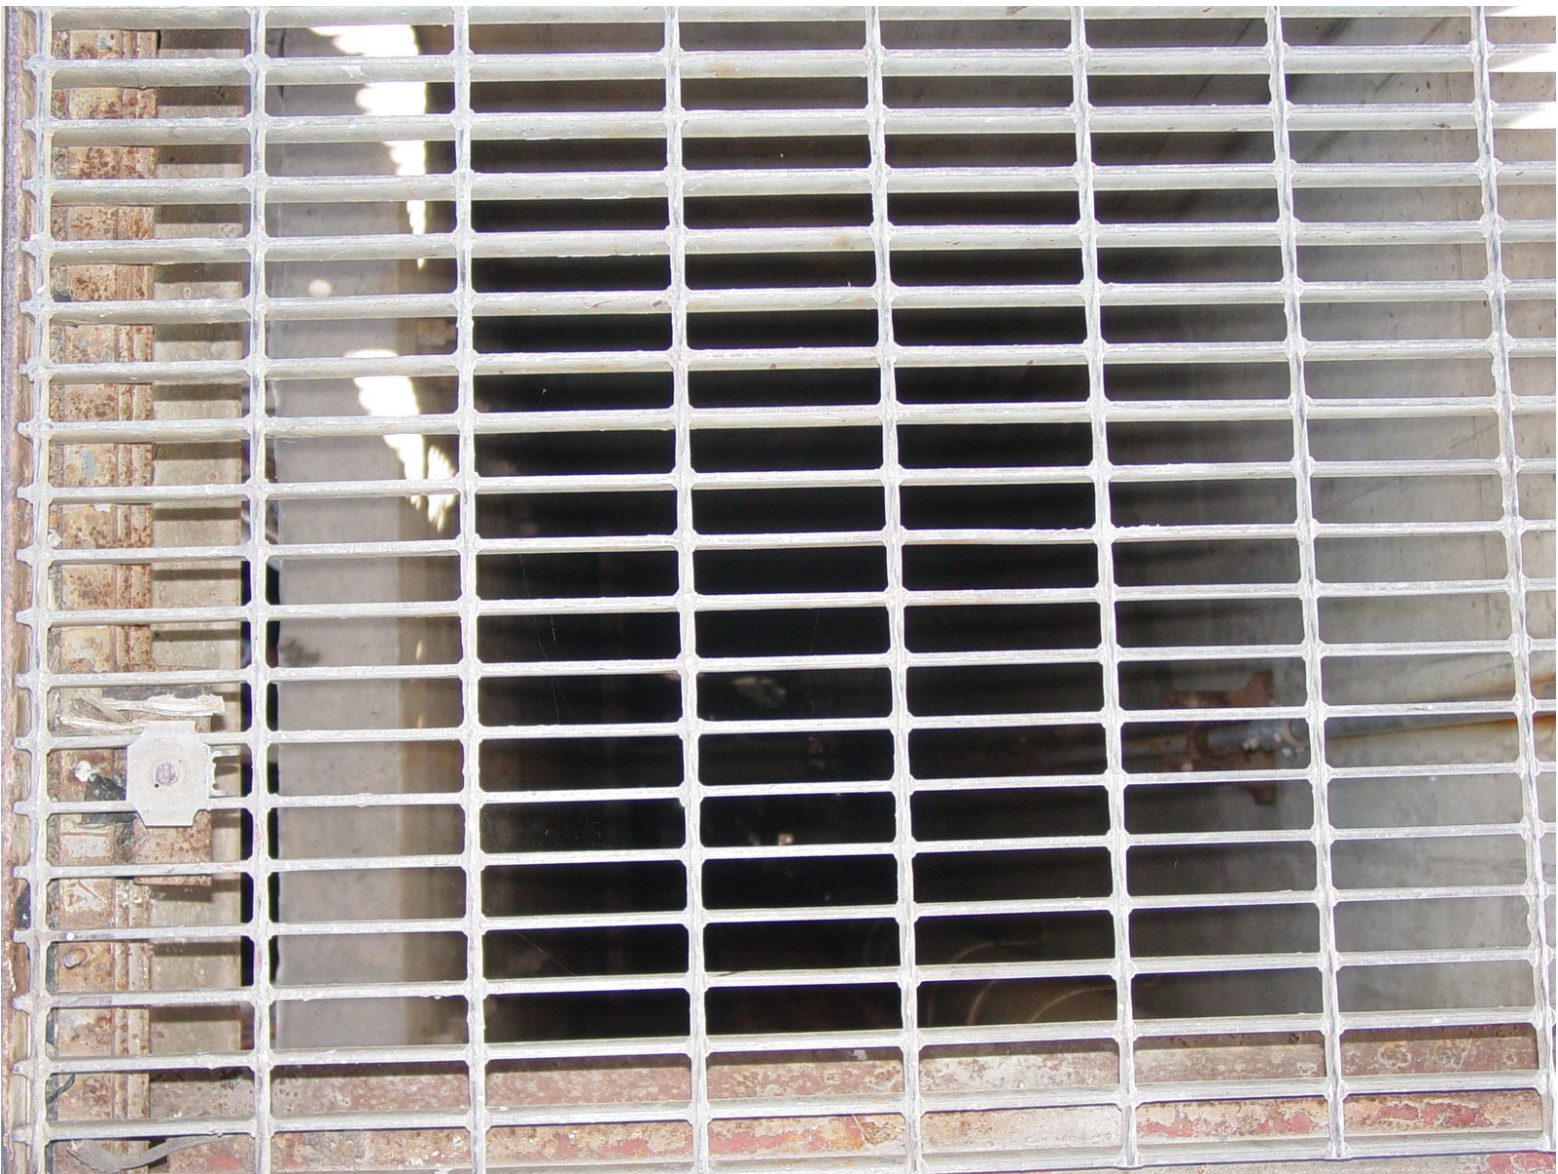
Photo B4-19: Ash Basin No. 4 View Through Top Grate into Inner Chamber of Decant Tower (Behind Concrete Stop Logs).

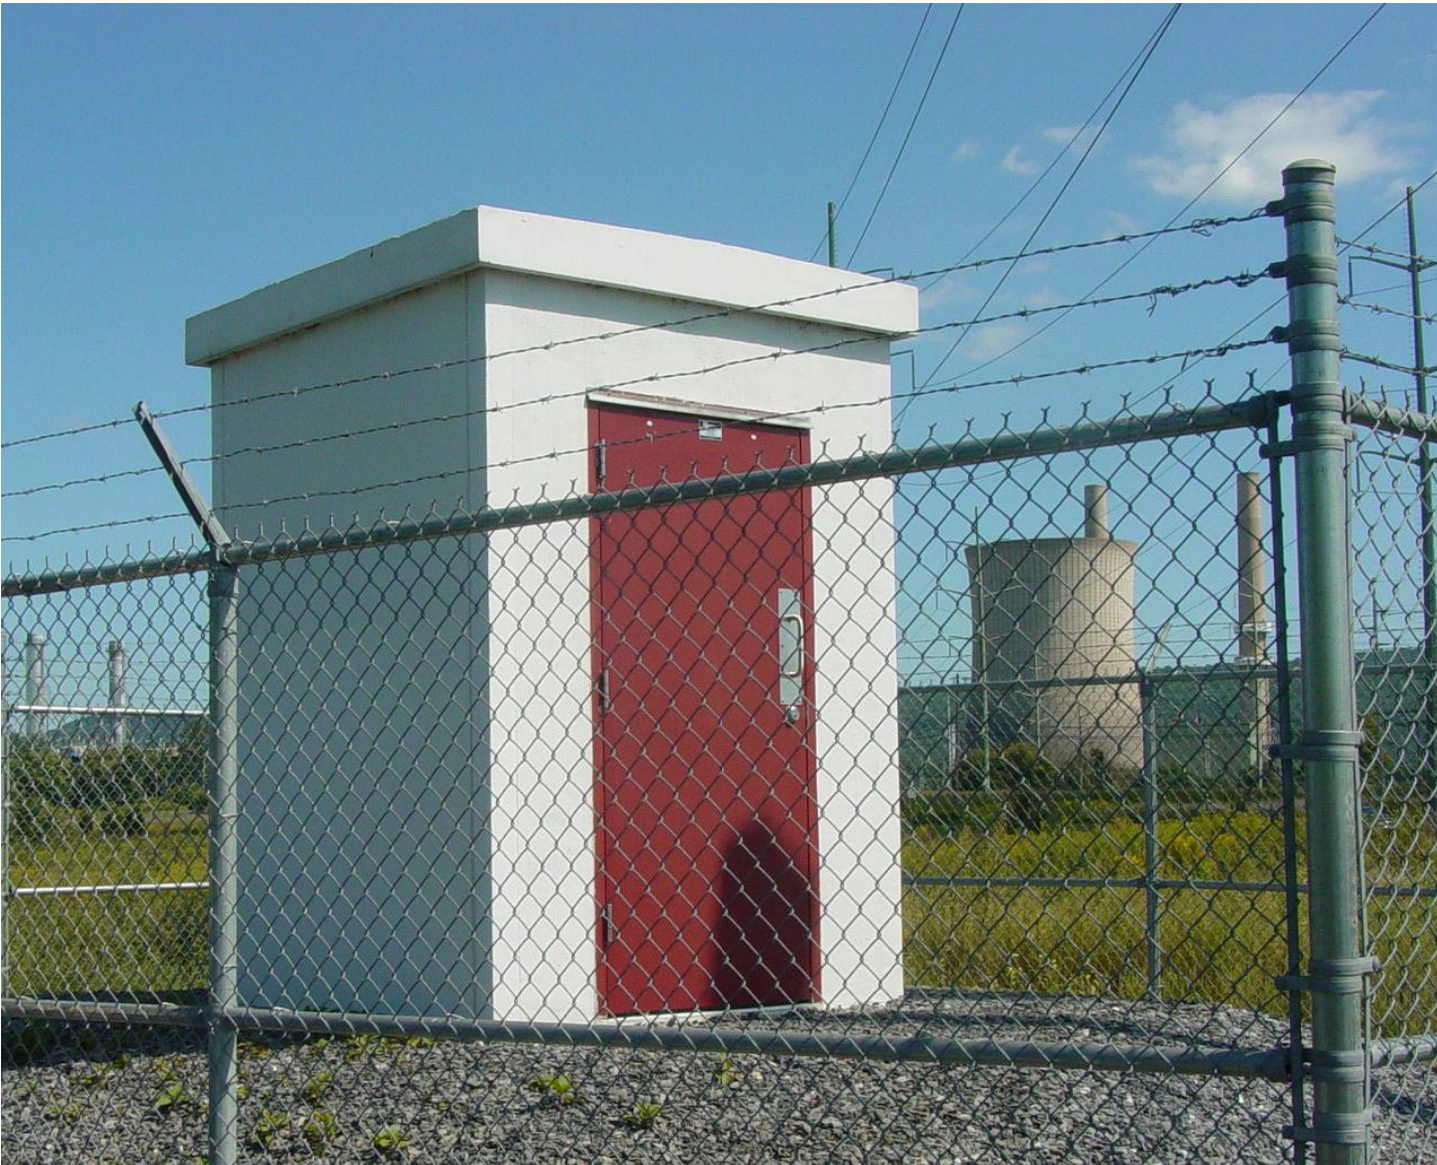
Photo B4-20: Ash Basin No. 4 View of Building Housing Operator for New Gate Valve in Underlying Concrete Vault.

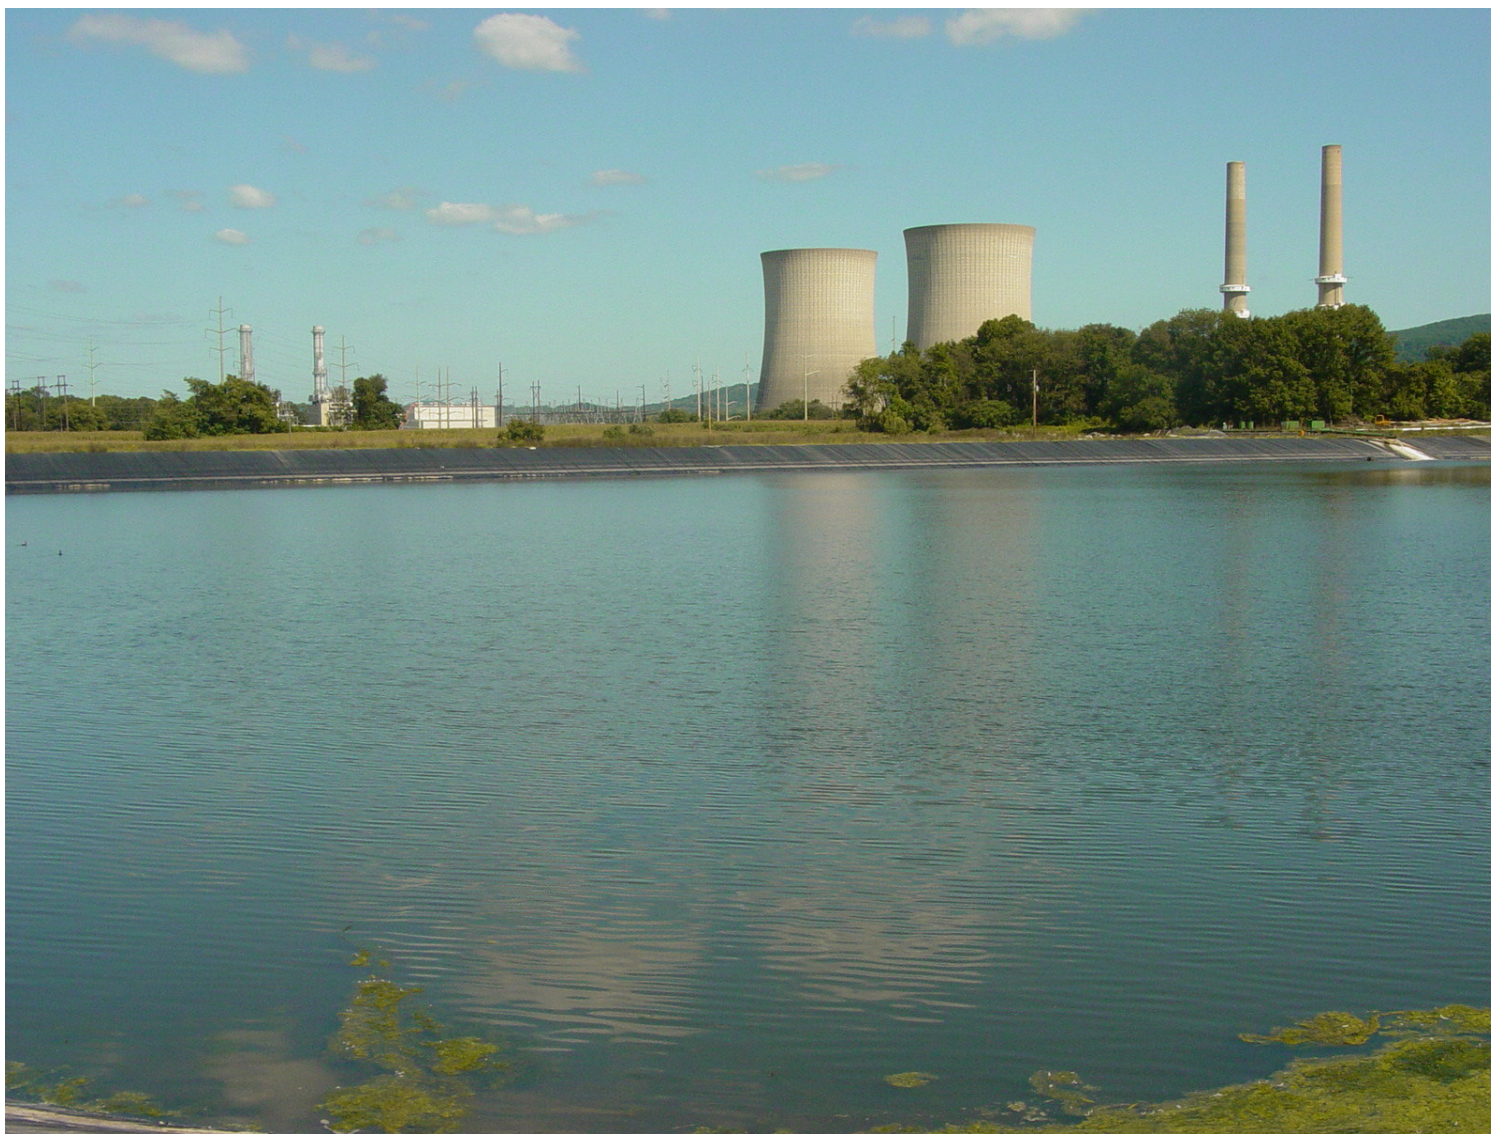
Photo I-1: Industrial Waste Treatment Basin (IWTB) General View across Basin toward North Incised Slope- Viewed Northeast - Note Some Algae on Surface of Water.

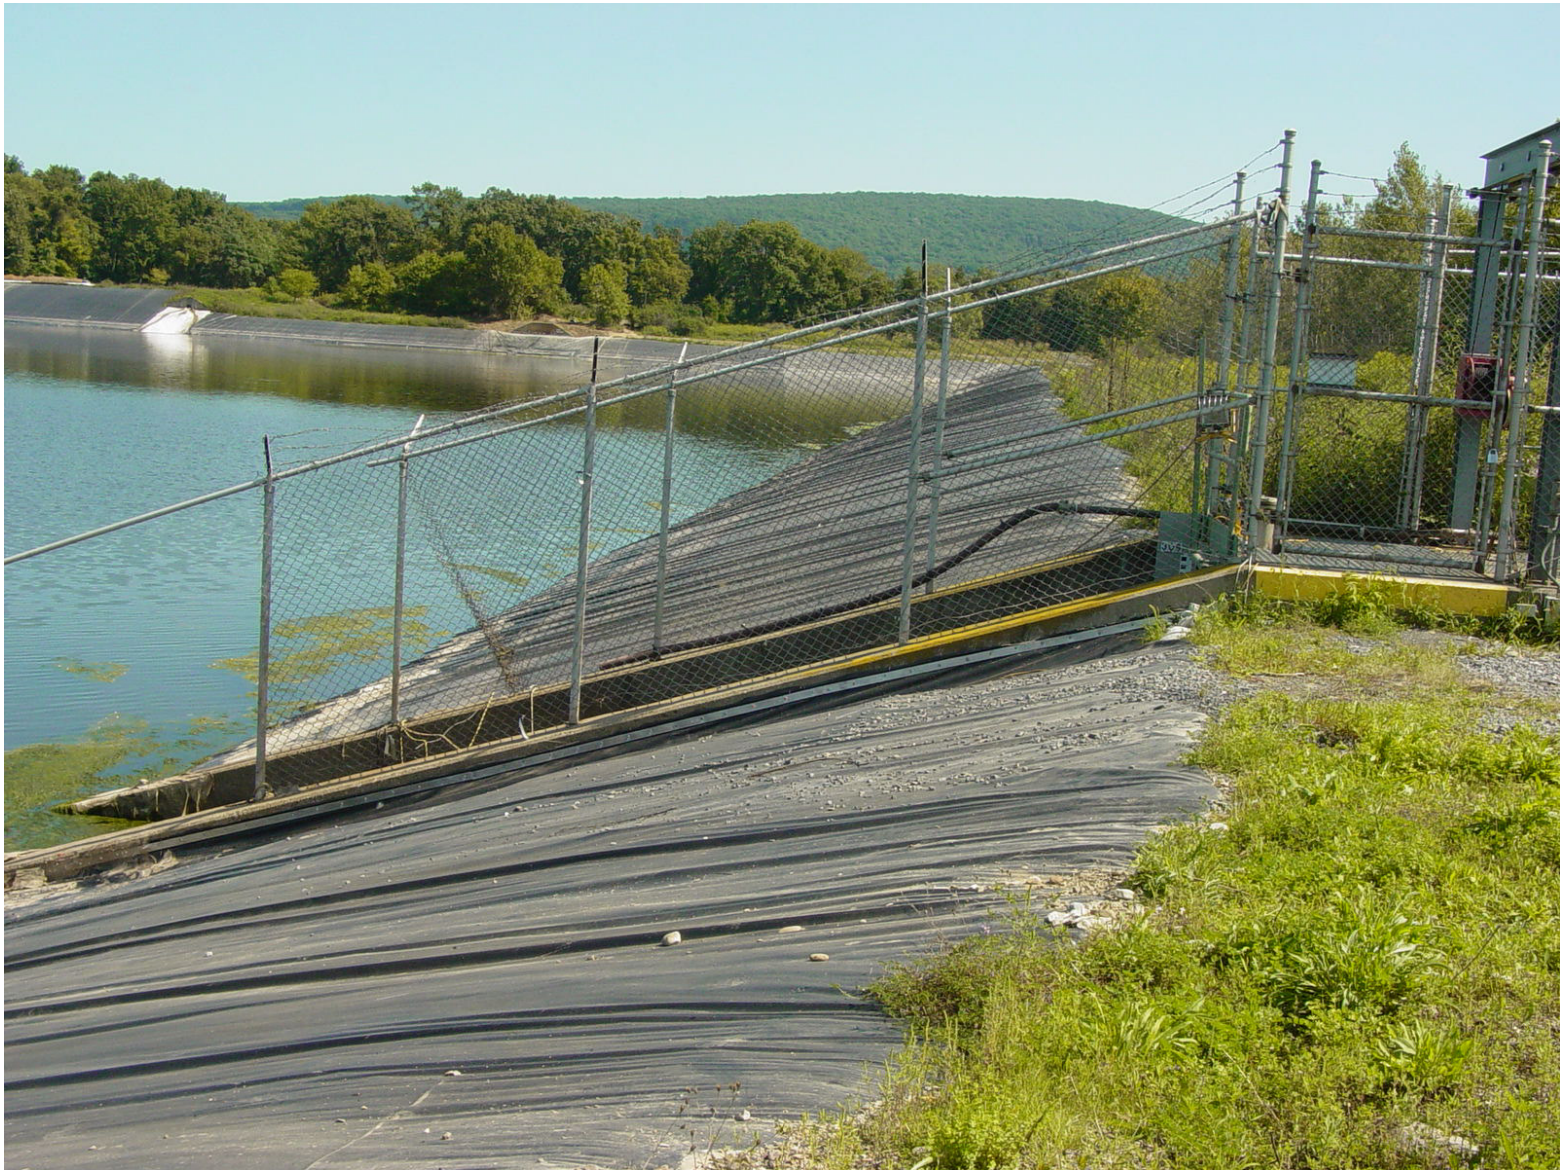
Photo I-2: IWTB South Incised Slope with Outlet Structure in Foreground – Viewed East – Note Vertical Wrinkles in Liner.

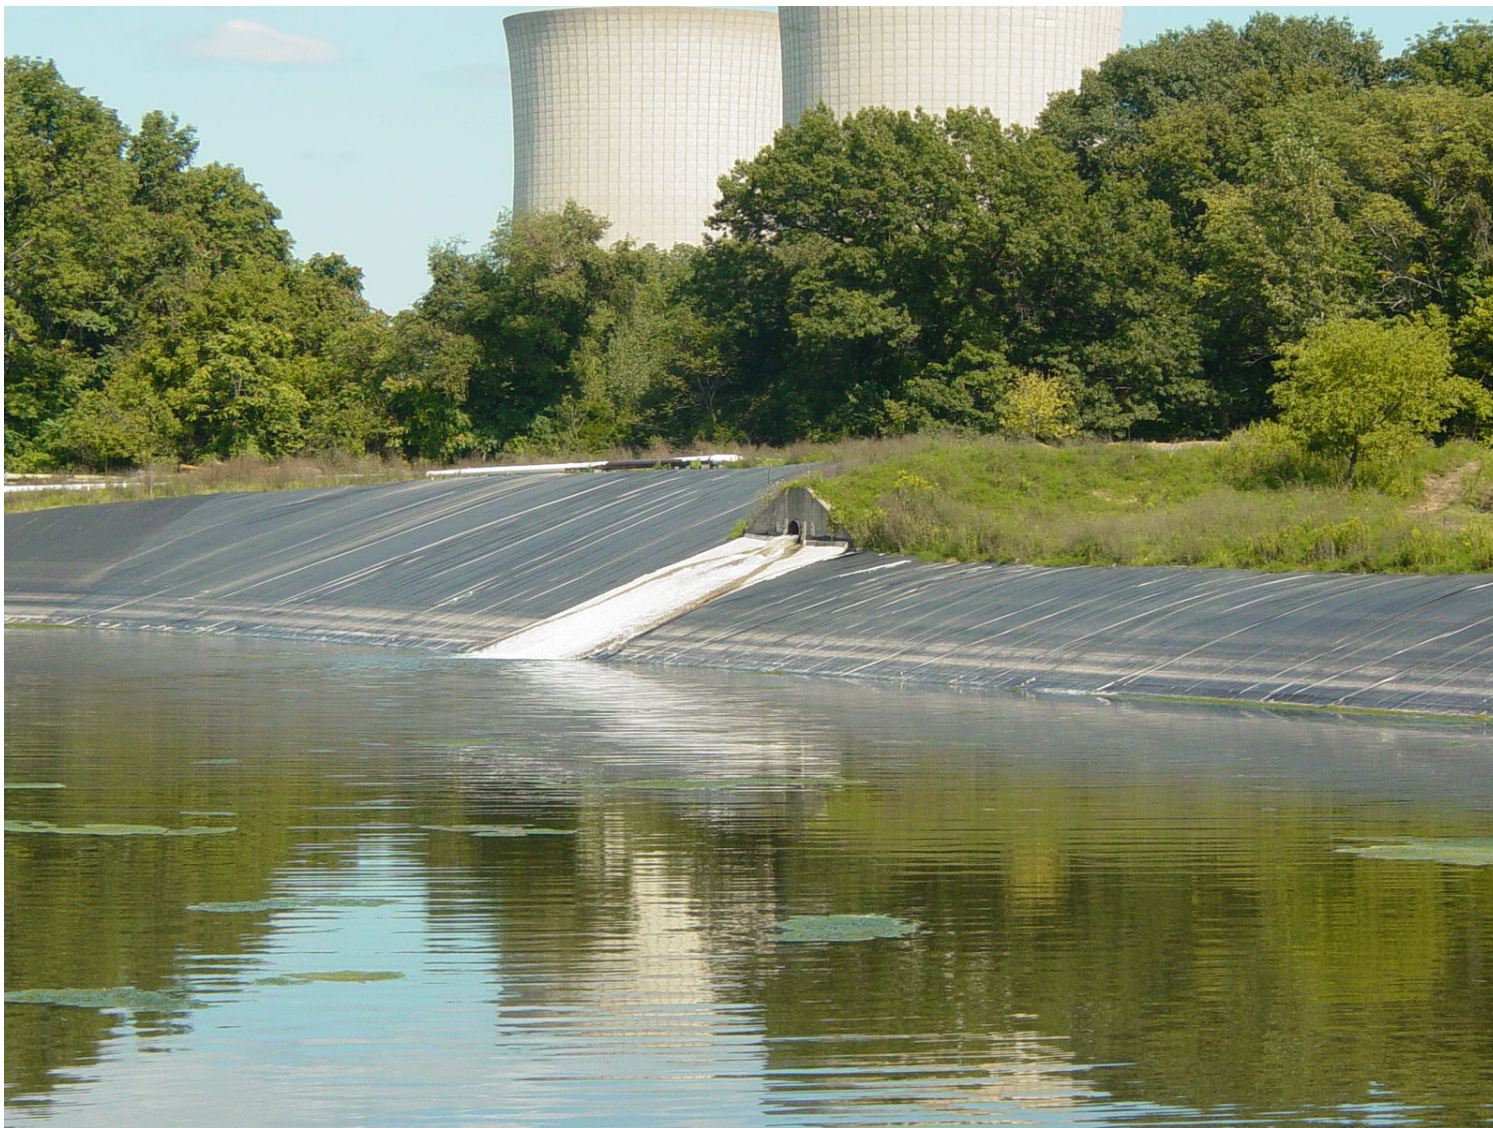
Photo I-3: IWTB East Incised Slope and Cooling Tower Blow-down Discharge into Basin - Viewed Northeast- Note Liner Extends Higher on North Half to Cover former Sinkhole Area in Shallow Rock.

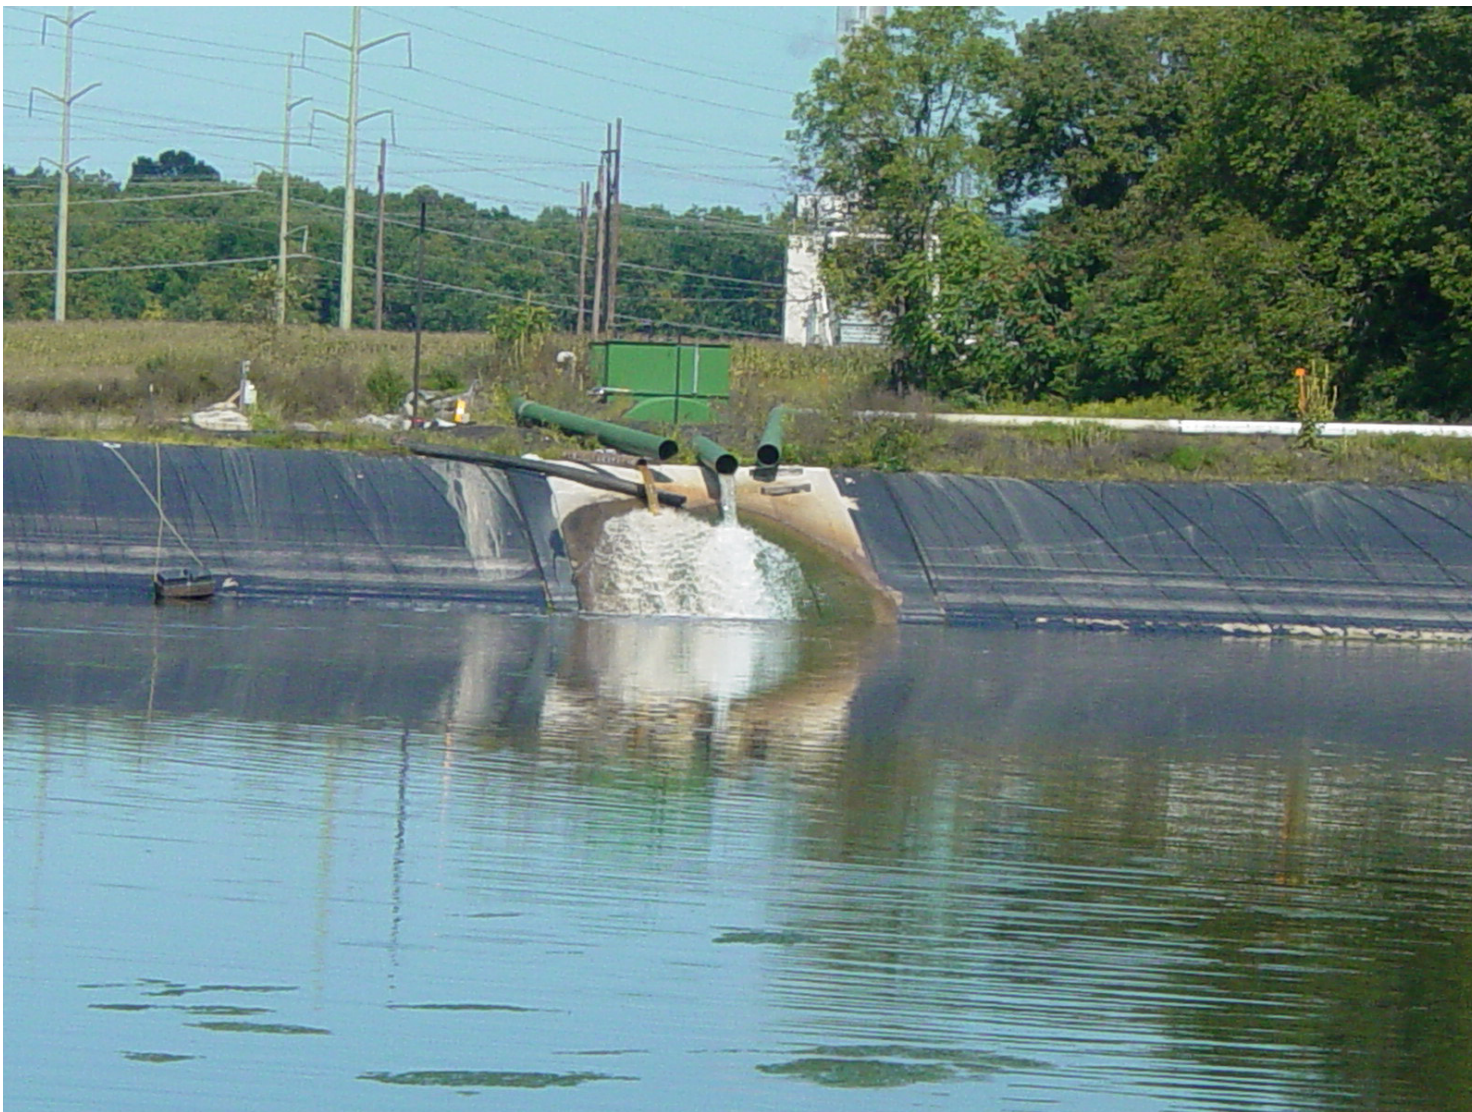
Photo I-4: IWTB North Incised Slope and Plant Drainage Discharge into Basin- Viewed North - Drainage Comes from both Martins Creek Power Plant via Oil/Water Separator (Green Fiberglass Pipes) and Lower Mt. Bethel Power Plant (Brown Fiberglass Pipe); Drainage also Comes from Ash Basin No. 4 (Black HDPE Pipe).

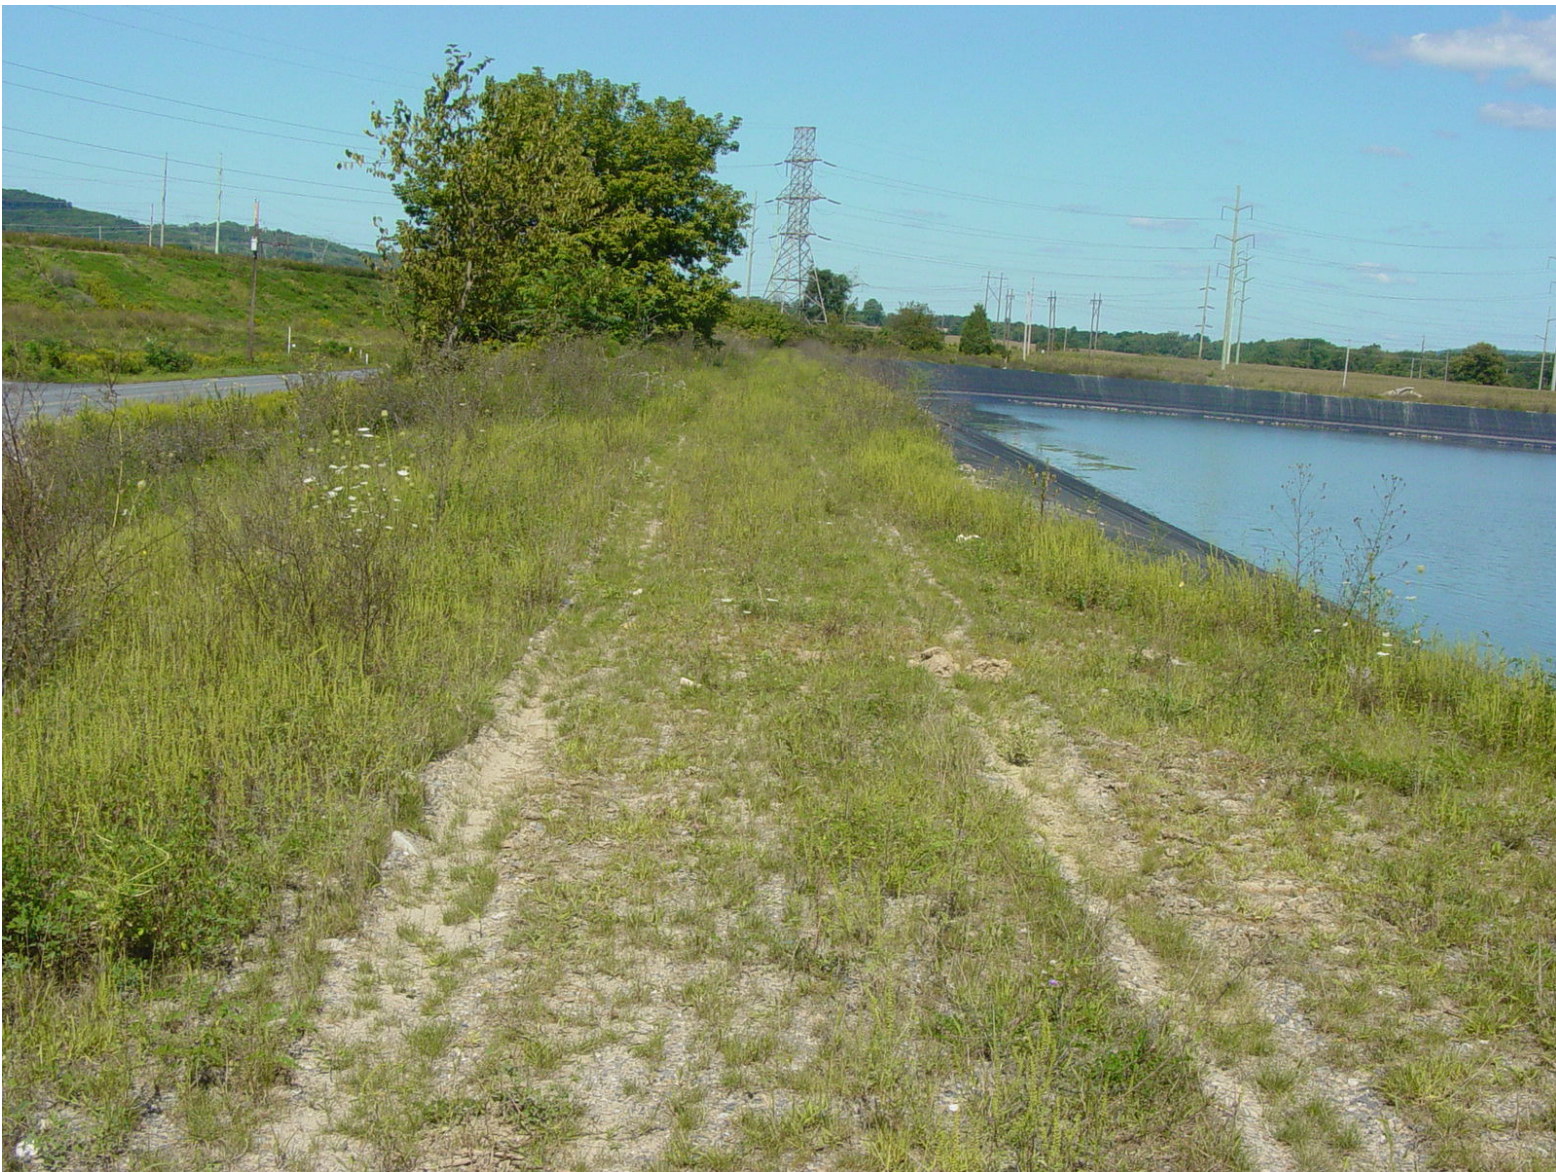
Photo I-5: IWTB Top of Earth Embankment Dam across South End of Basin- Viewed North.
