**Coal Combustion Waste Impoundment  
Dam Assessment Report**

***Martins Creek Steam Electric Station  
PPL Generation  
Bangor, Pennsylvania***

**Project # 0-381  
Assessment of Dam Safety  
Coal Combustion Surface Impoundments  
for the REAC Program**

**September 2009  
Revised December 9, 2009**

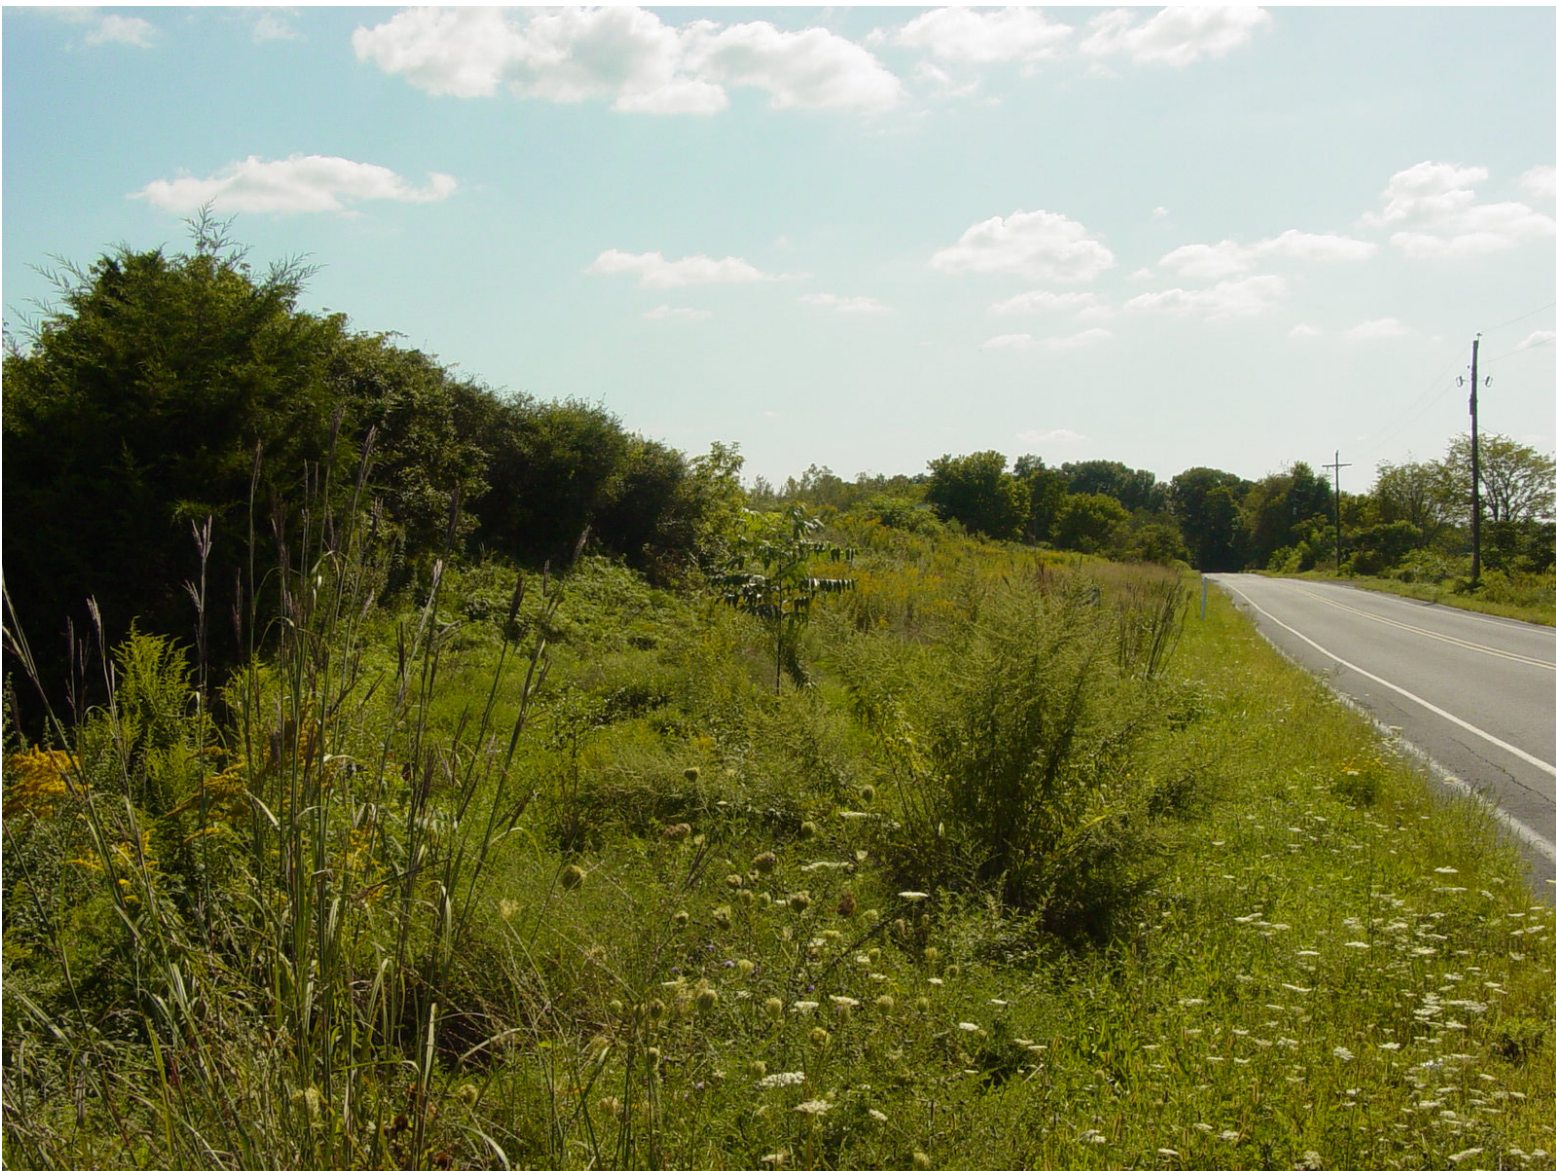
Photo I-6: IWTB Outside Slope of Earth Embankment Dam across South End of Basin- Viewed South.

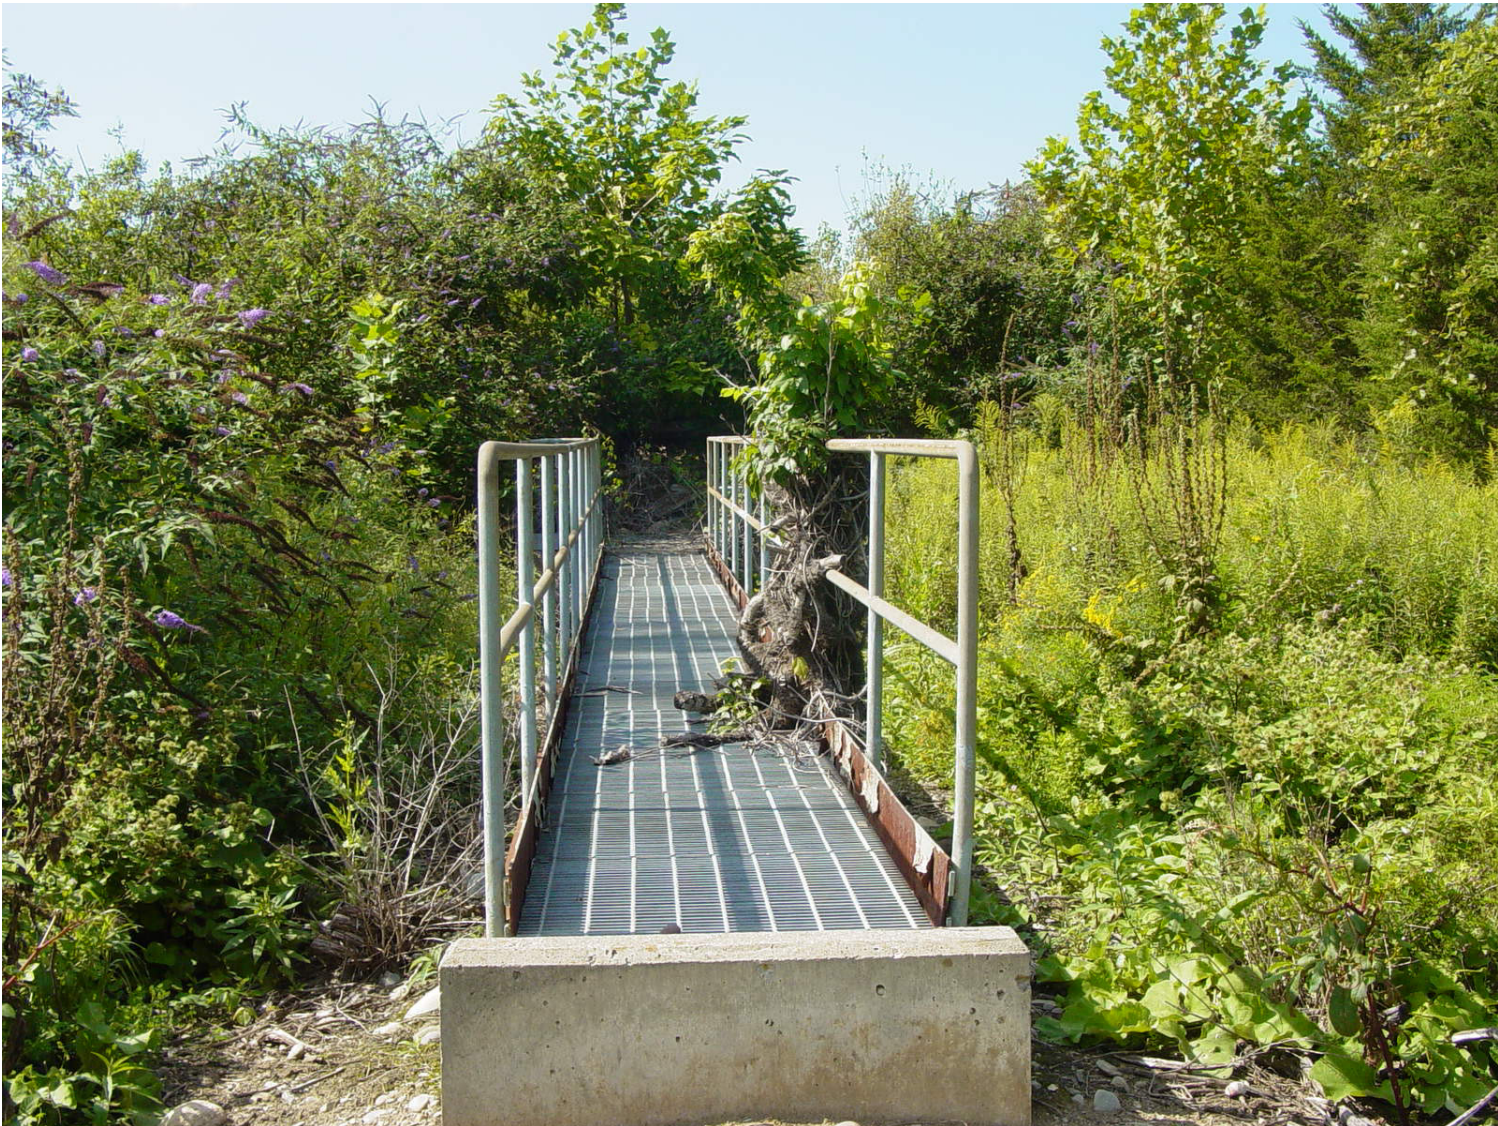
Photo B2-1: View of former Footbridge to North Decant Tower at Ash Basin No. 2 – Viewed West – Note Dense Vegetation on the Soil Cover over the Closed Basin.

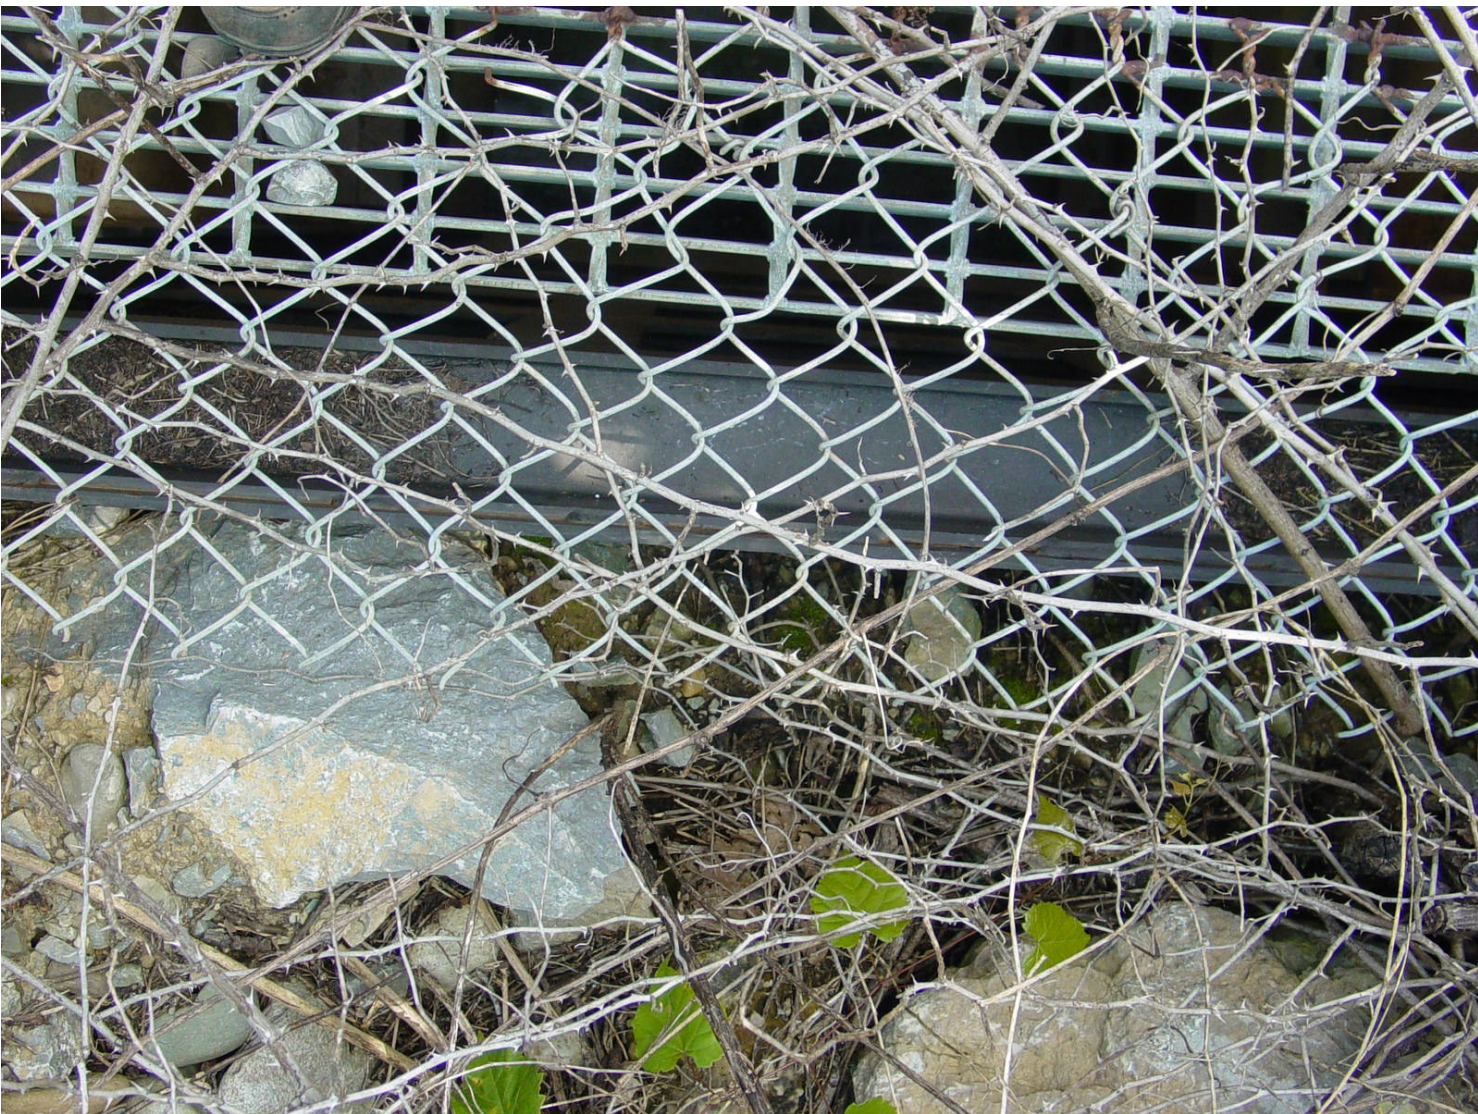
Photo B2-2: View of Top of Reinforced Steel Plate Bulkhead that Seals off the Wood Stop Log Side of the North Decant Tower at Ash Basin No. 2 – This and Two other Drainage Towers at the Closed Basin No. 2 are used for Drainage from the IWTB to the

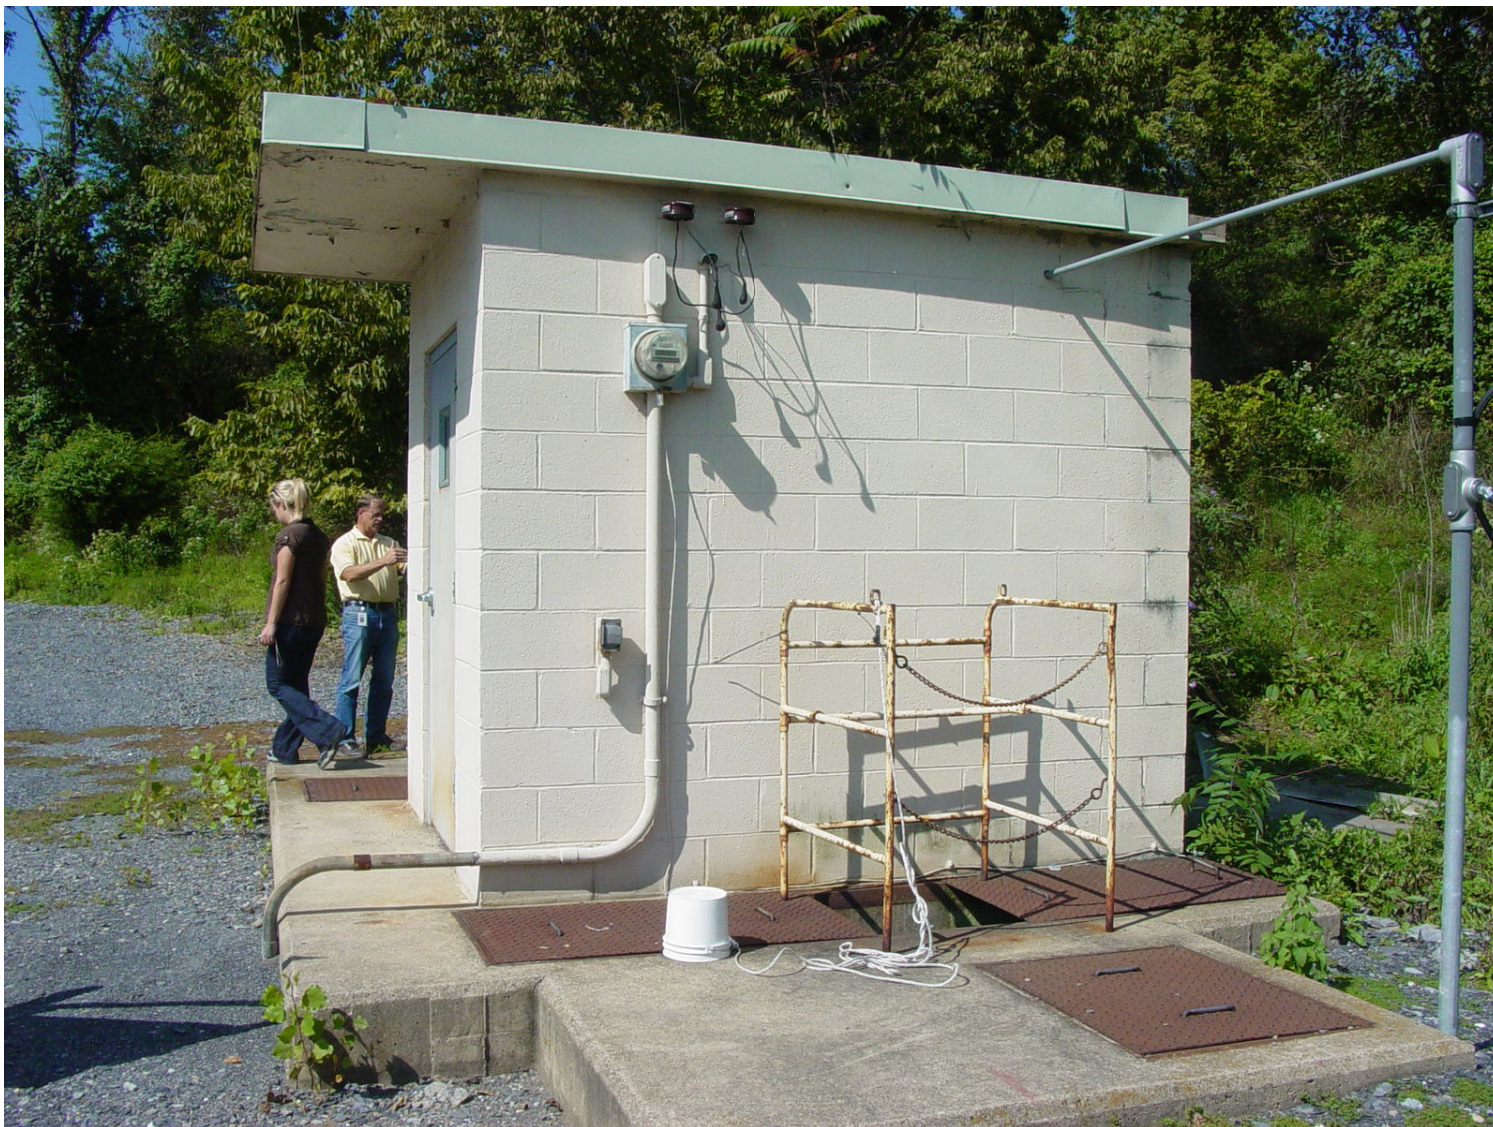
Photo B2-3: View of NPDES Monitoring Control Building at Combining Structure, which is a Below-grade Concrete Basin with Outflow Weir for Measuring Total Discharge from the Plant; Steel Plates Cover Top of the Basin for Safety- Note Bucket for Grabbing Water

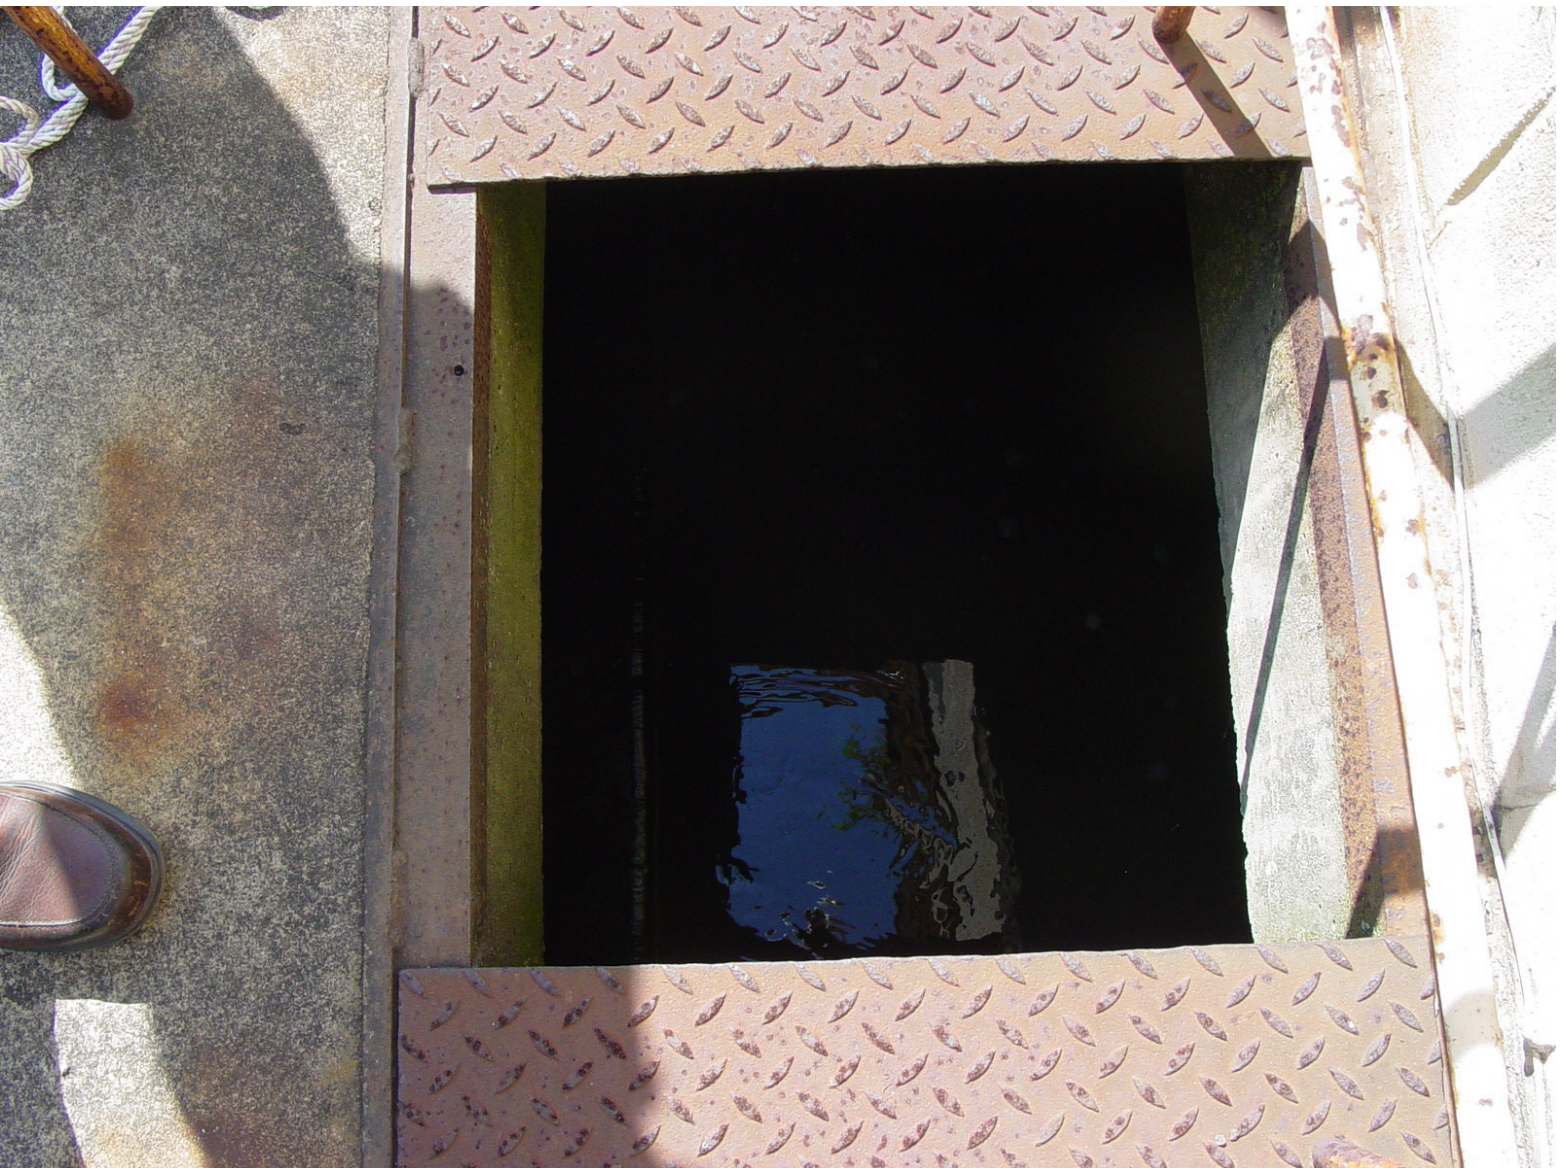
Photo B2-4: View Inside Combining Structure Basin at location of Weir

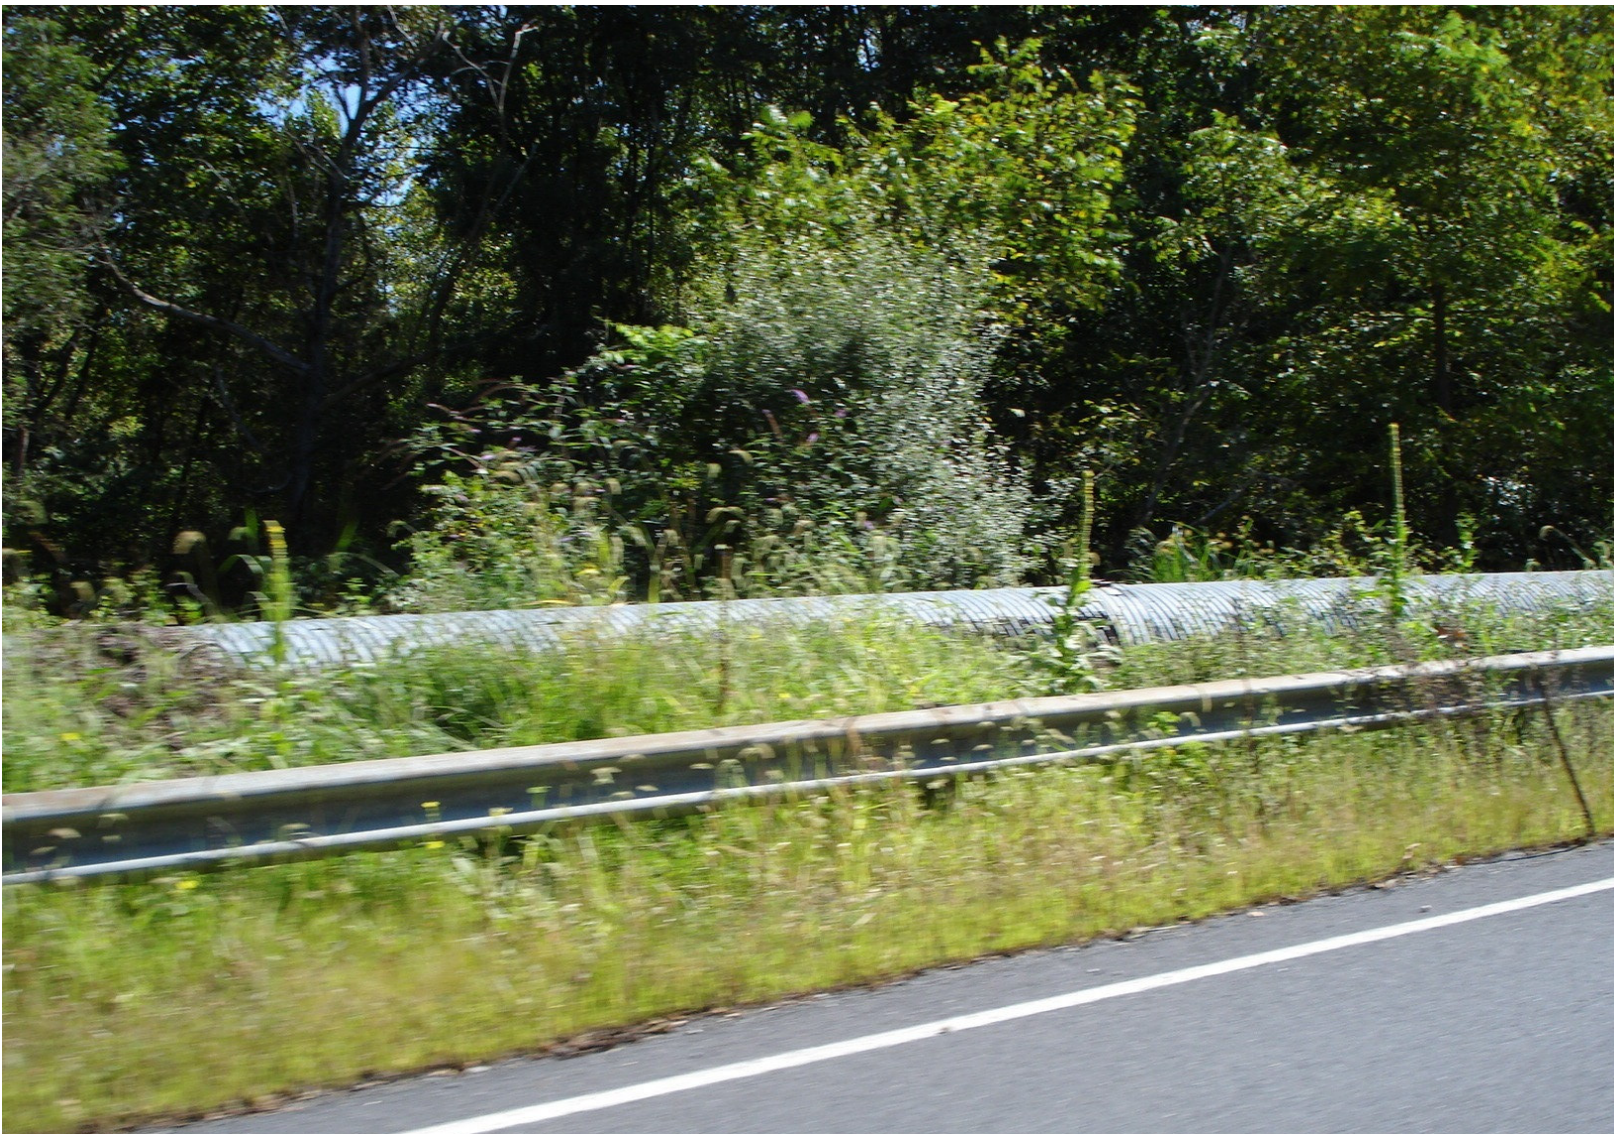
Photo B2-5: View of Above Ground 42" CMP Discharge Line from Combining Structure to Outfall Near the Delaware River.

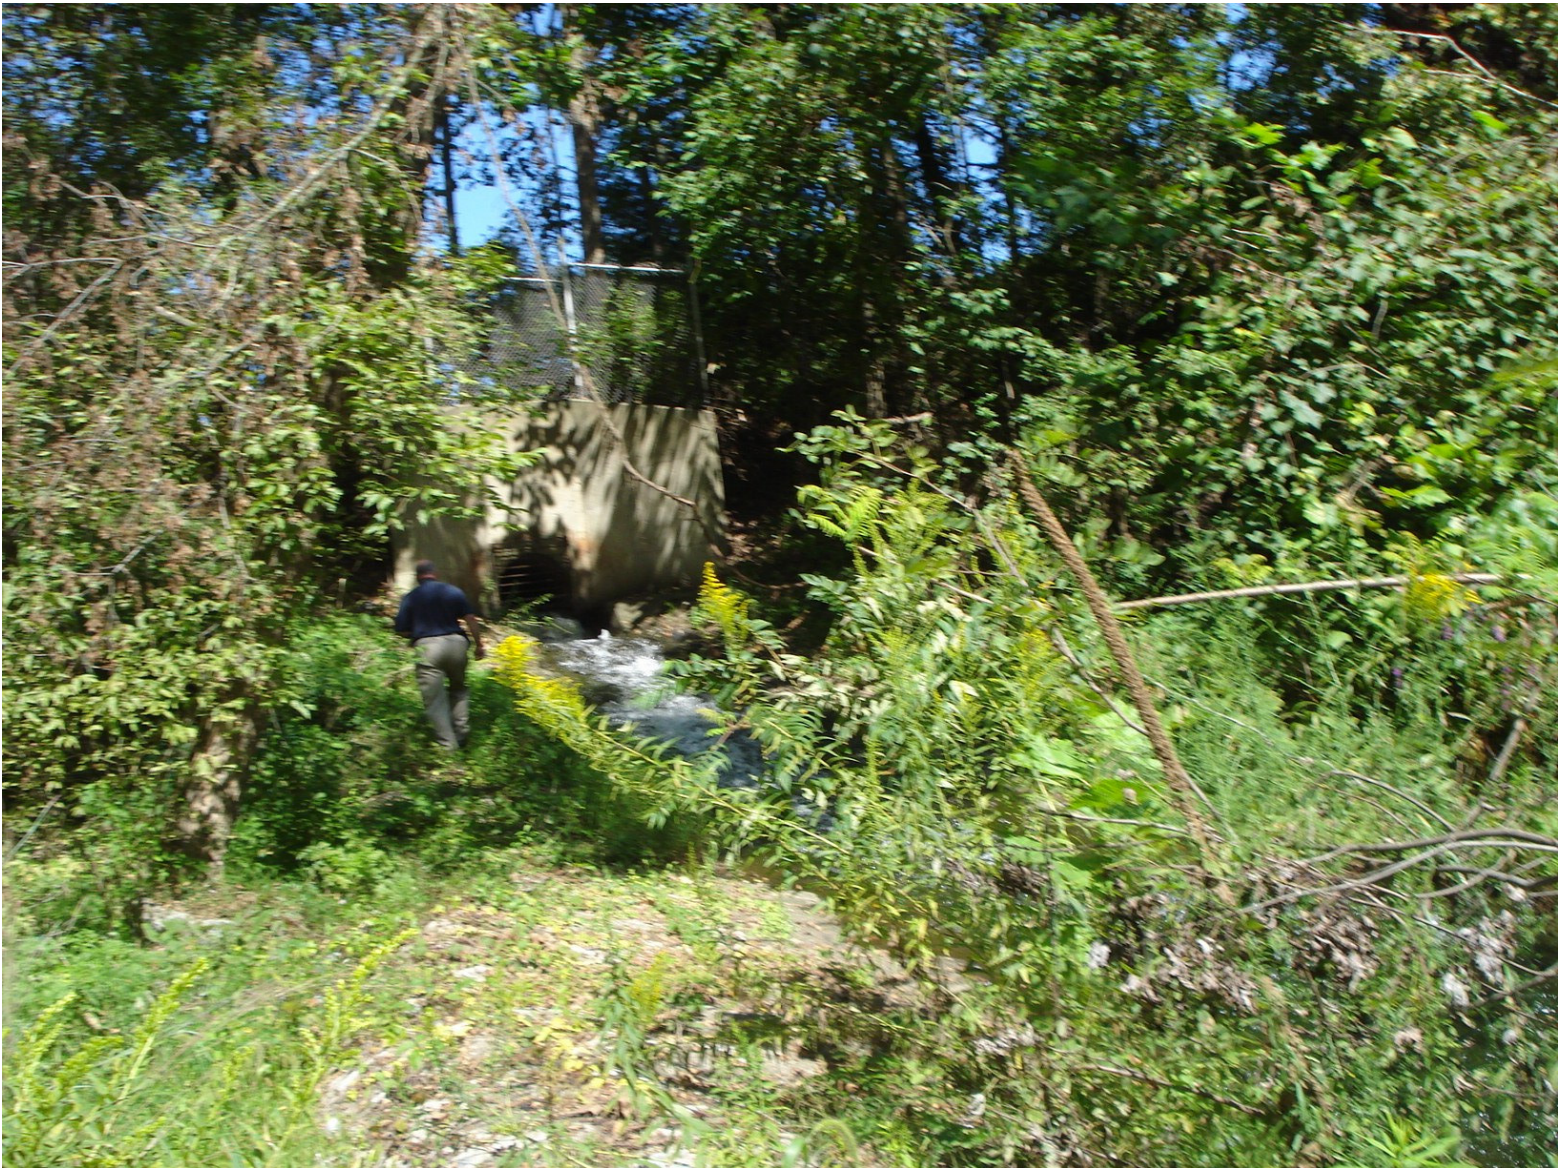
Photo B2-6: View of Outfall of 42" CMP Discharge Line into Grouted Riprap Channel to the Delaware River.

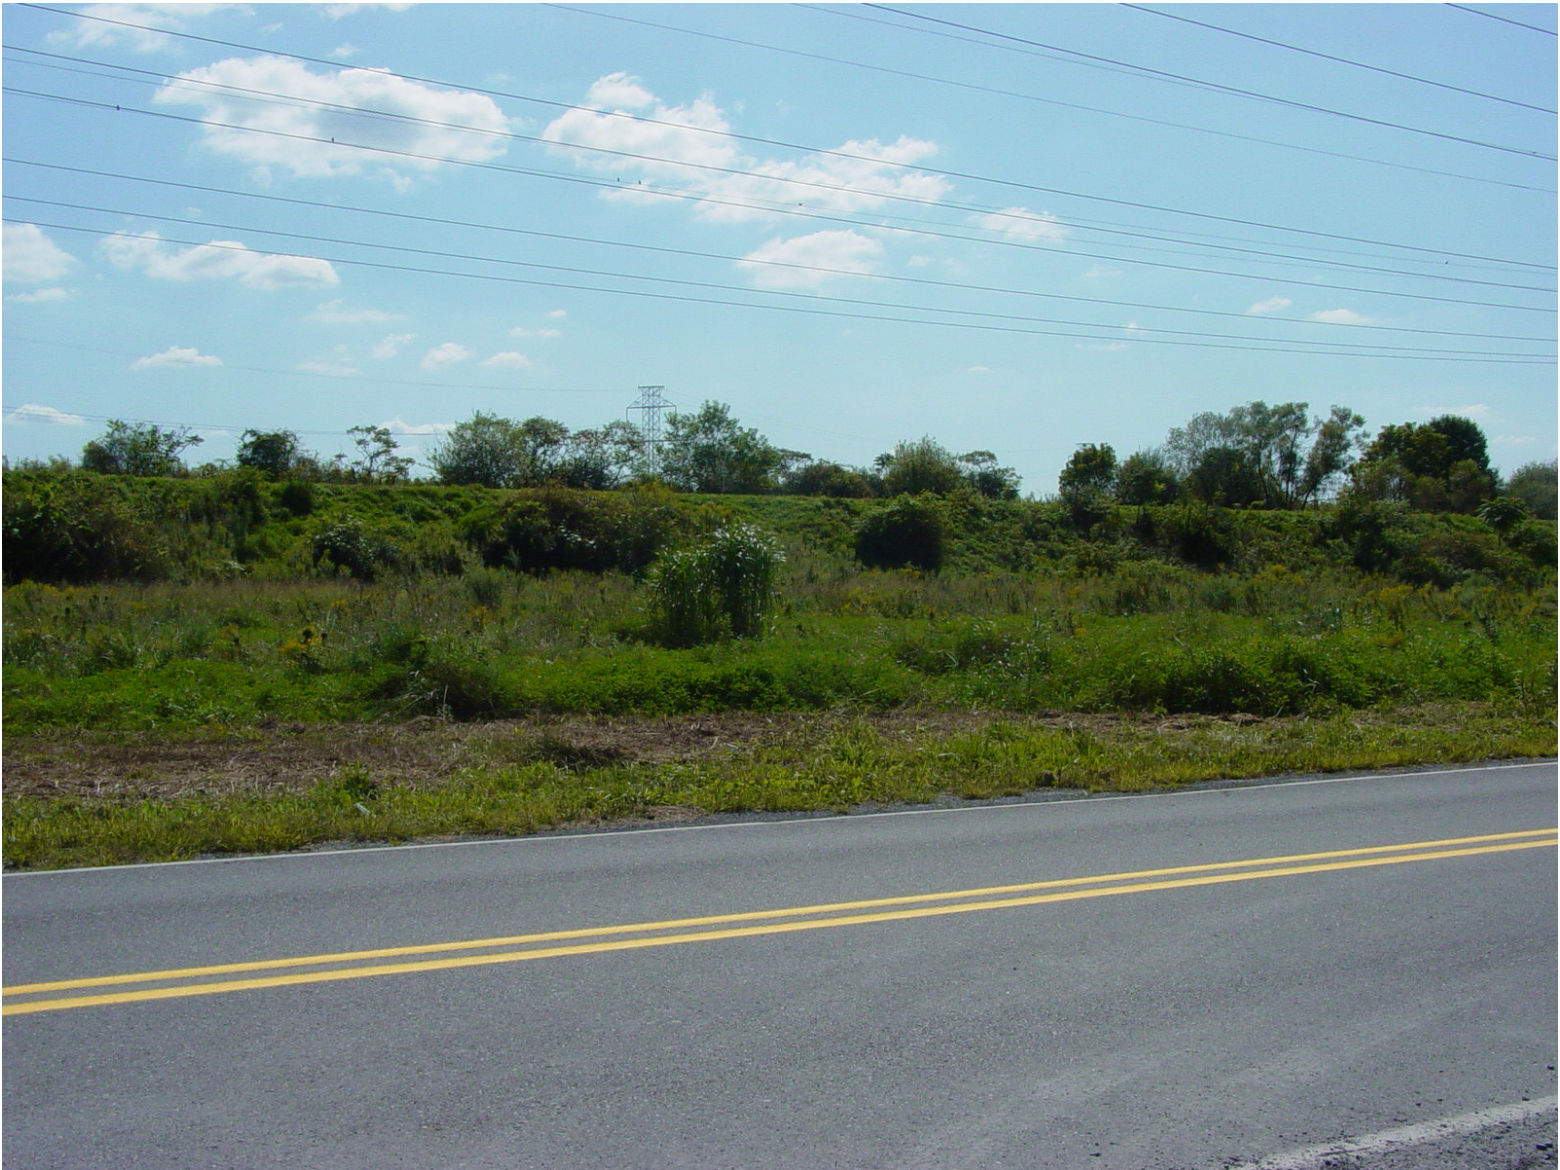
Partial views of the outside slopes of the west embankment and east embankment of the closed Ash Basin No. 3 are shown in Photos B3-1 and B3-2, respectively. As shown, the slopes have a thick cover of herbaceous vegetation; the west slope also has tall bushes.

Photo B3-1: Ash Basin No. 3 View of Outside Slope of West Embankment of the Closed Basin- Viewed Southeast.

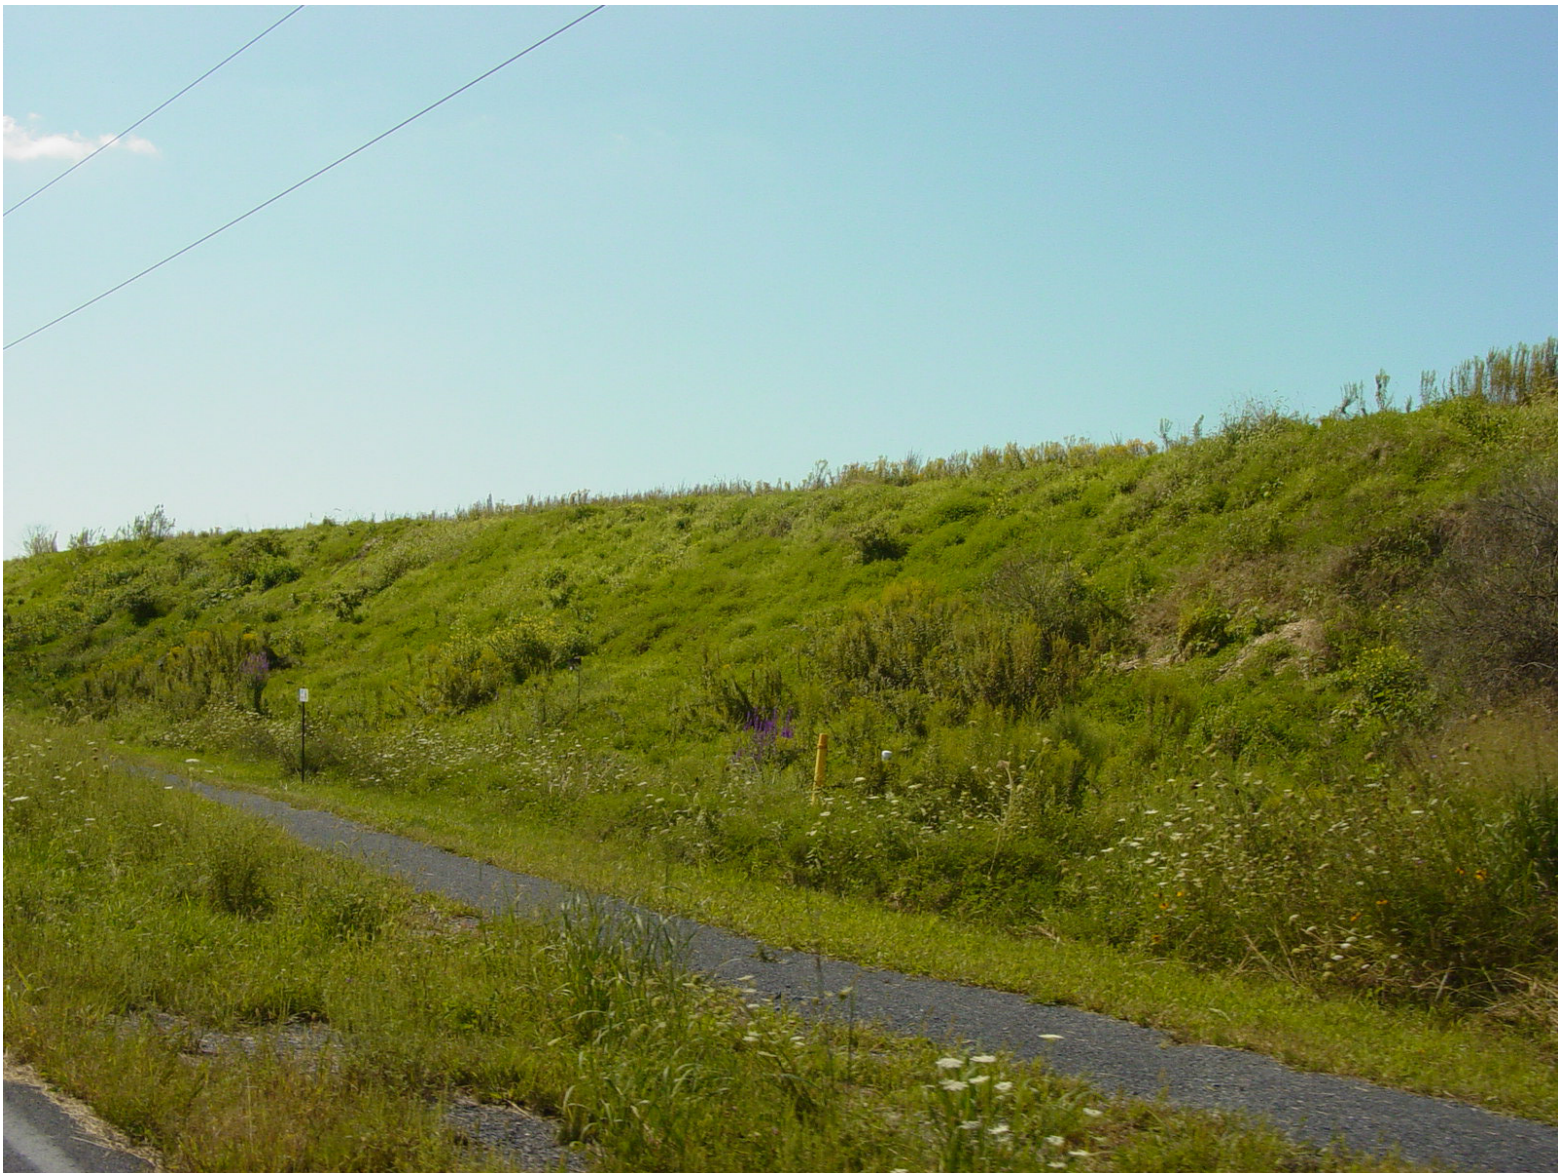
Photo B3-2: Ash Basin No. 3 View of Outside Slope of East Embankment of the Closed Basin– Viewed Southwest.
