Martins Creek Power Plant Regional Map Showing the Management Unit(s) in Relationship to Critical Infrastructure (Photo Locations of Documents A1.3-A1.10)

***DEP comment # 6: PPL asserts that certain portions of the basin are susceptible to leaching dissolved selenium when ash remains saturated for a period of time. Please provide estimates of the amount of continuous precipitation that could result in the saturation of fly ash within the basin and the increase in water level within the aquifer beneath the basin such that it contacts the ash and affects groundwater.***

**Martins Creek SES Ash Basin #4 Release**  
Martins Creek SES Site Layout

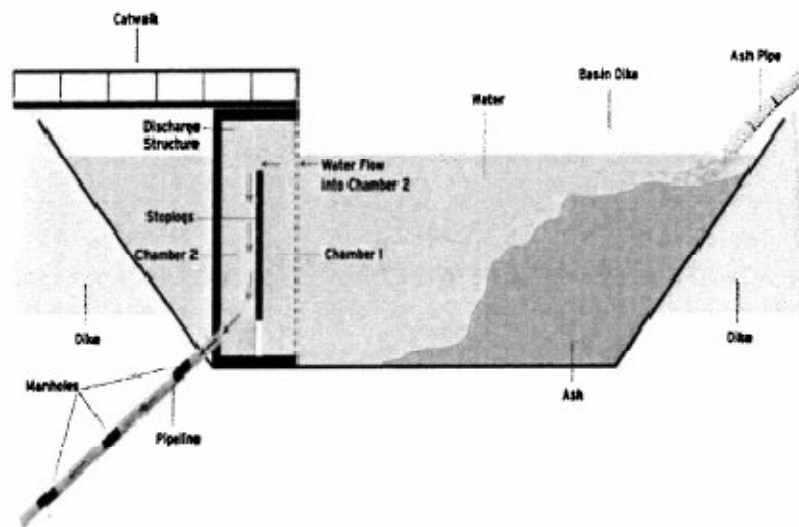
**Martins Creek SES Ash Basin #4 Release  
Normal Flow in Ash Basin #4**

During normal operation, a mixture of coal ash and water is pumped into the ash basin from the Martins Creek plant. The ash settles to the bottom, and the clear water runs over a wooden wall made up of stop logs, which resemble railroad ties. The clear water is then discharged to the river through a 1 ¼ mile pipeline under the terms of PPL's permit from the Pennsylvania Department of Environmental Protection.

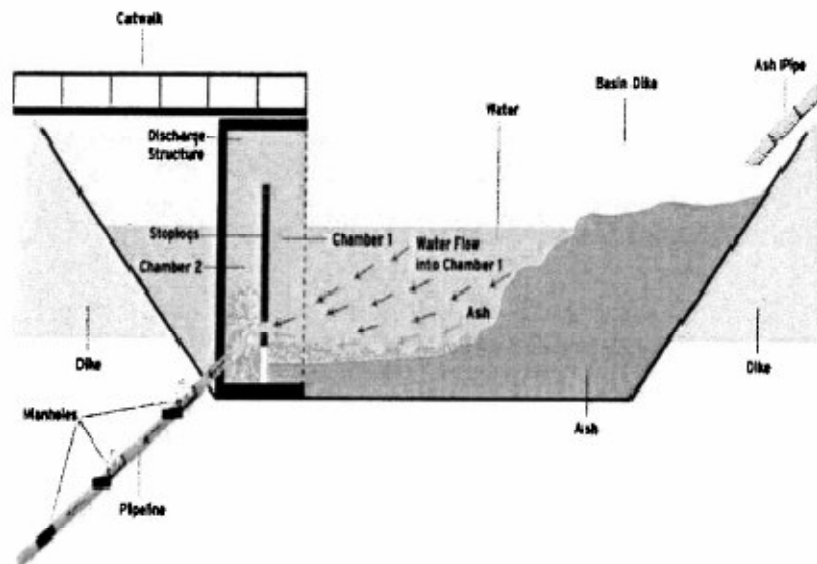
### Martins Creek SES Ash Basin #4 Release Flow in Ash Basin #4 When the Stop Log Failed

When the stop log failed near the bottom of the discharge structure, water and eventually ash flowed to the river through the discharge pipeline. The pressure lifted manhole covers along the pipeline, allowing the ash and water to spill out onto roads and fields on plant property.

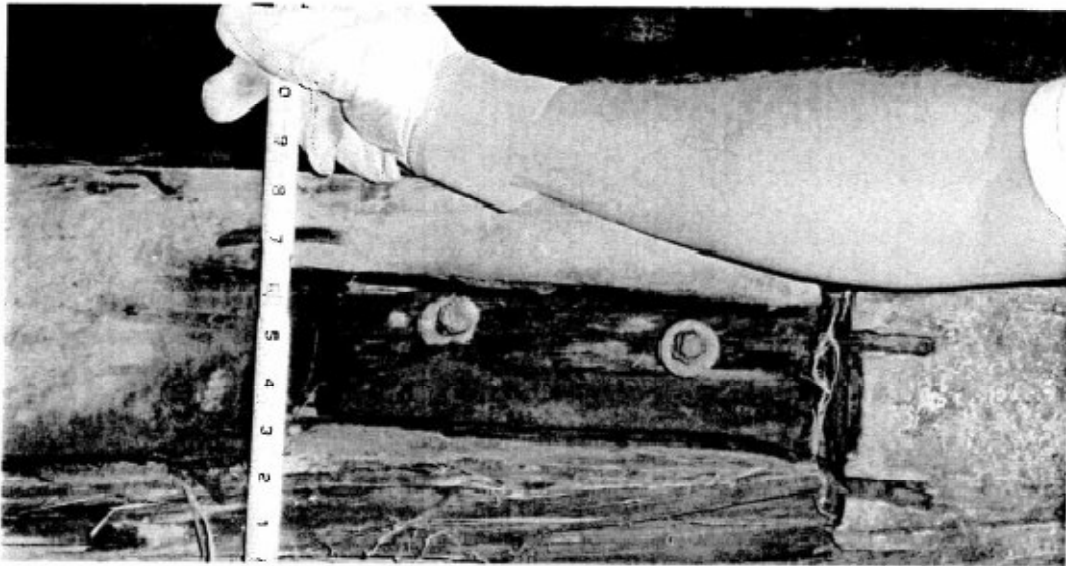
**Martins Creek SES Ash Basin #4 Release**  
PHOTO OF PORTION OF FAILED STOP LOG # 2  
(Evidence of over-cuts in handle cutout)
