# ASSESSMENT OF DAM SAFETY OF COAL COMBUSTION SURFACE IMPOUNDMENTS – DRAFT REPORT

**Prairie Power, Inc.  
Pearl Power Plant  
Pearl, Illinois**

Prepared for  
*United States Environmental  
Protection Agency  
Washington, D.C.*

October, 2012  
Revision 1, January 2014

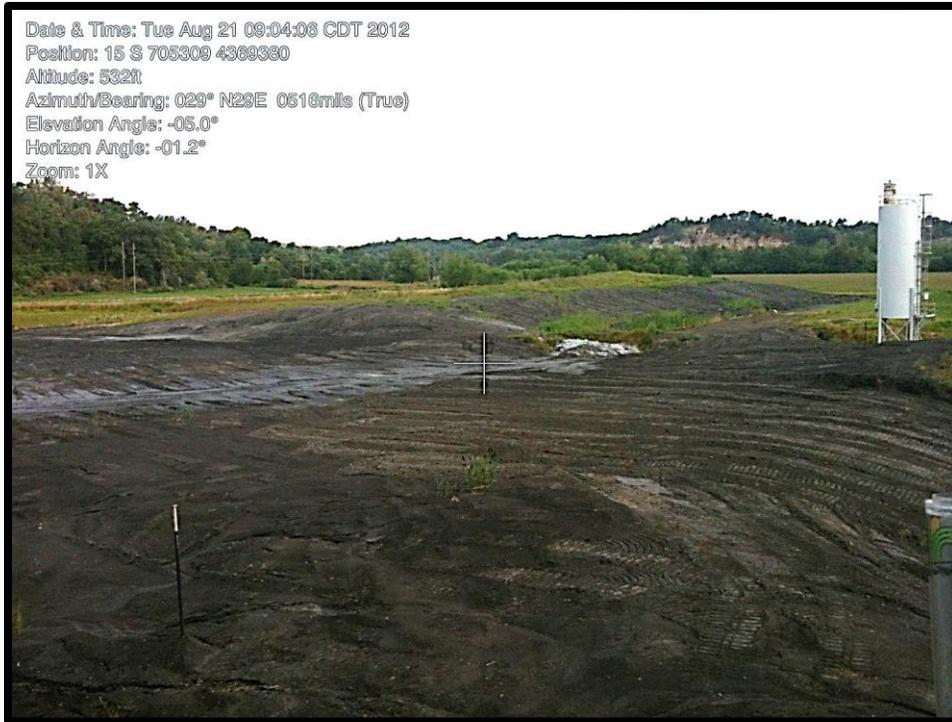
Visual observations of the surface of the impoundment surface indicated the eastern half of this area was filled and stockpiled with fly ash. The ash was dry at the surface, and stockpiled into a long, narrow pile aligned in a north-south direction. The height of the ash pile varied from a low visually estimated to be 3 to 5 feet below the embankment crest, to a high of about 15 to 20 feet above the embankment crest (**Photograph 5.1**).

**Photograph 5.1 - Dry Ash Covering Southeast Corner of Pond, with Ash Pile in Background Looking Northwest**

Based on a visual projection of the horizontal alignment of the east embankment (where it was exposed at the north end of the site), fly ash covered the embankment and extended beyond the exterior toe of the east embankment eastern boundary of the impoundment to the coal overhead conveyor to the east.

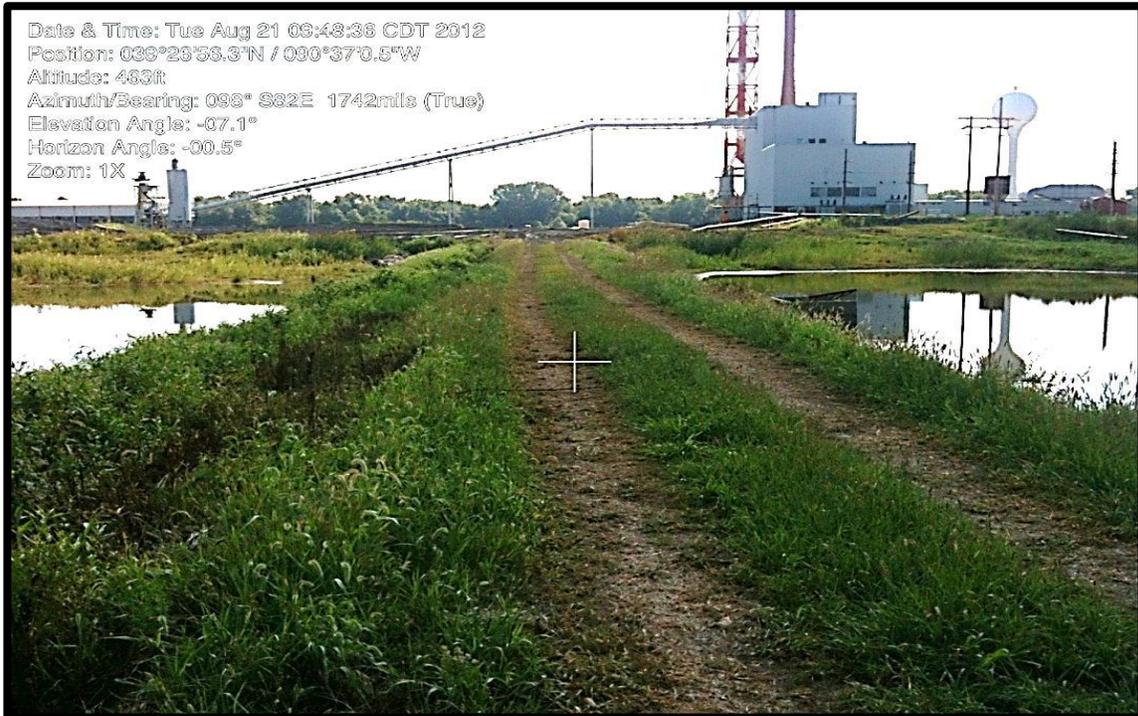
The crests of the embankments of the CCW impoundment (where they could clearly be seen) appeared to be nearly level and have a generally consistent width of 10 to 15 feet, with no evidence of prior breaches or overtopping erosion (**Photograph 5.2**). Some areas of the crest were grass-covered (up to about 10 inches in height). The surface of the west embankment was covered by State Highway 100, and the southern portion of the east embankment was covered by fly ash.

Photograph 5.2 - Crest of South Embankment Looking East – Ash Pond on Left Side of Photograph

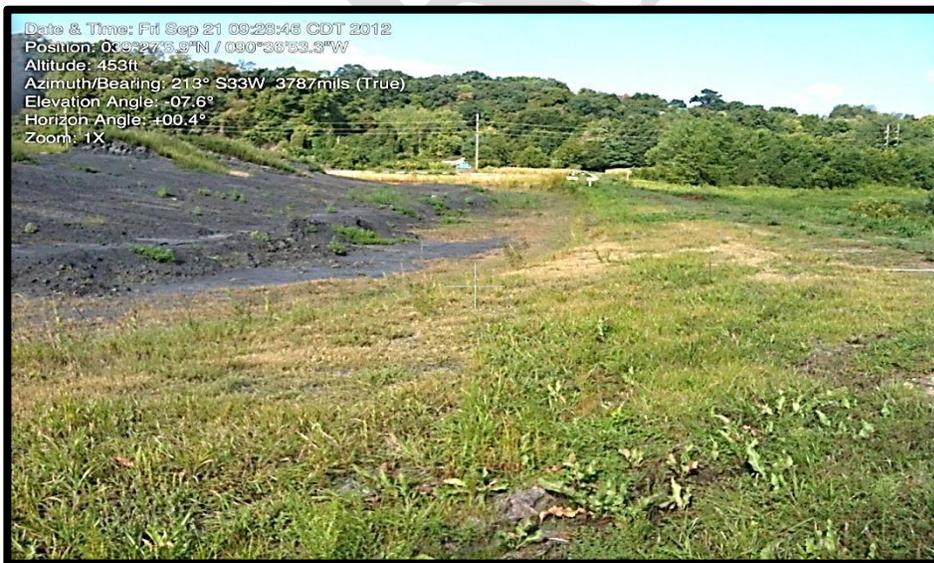
The interior slopes of the embankments were generally in fair condition (**Photographs 5.3 and 5.4**). The inclination of these slopes were approximately 4H:1V (horizontal: vertical) or flatter. Most of the interior slopes were covered with thick grass-like vegetation up to 3 feet high on the north, south, and east embankments. The west embankment contained much denser vegetation up to 5 feet high.

Photograph 5.3 - North Embankment Interior Slope Looking West

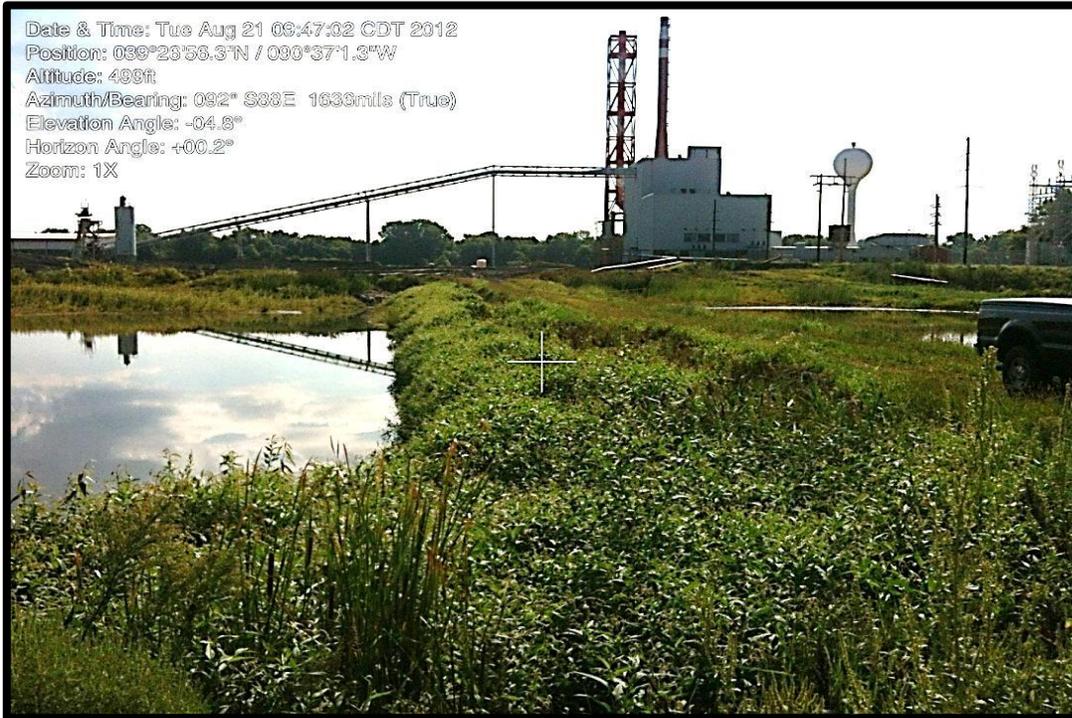
Photograph 5.4 - Interior Slope of South Embankment Looking East

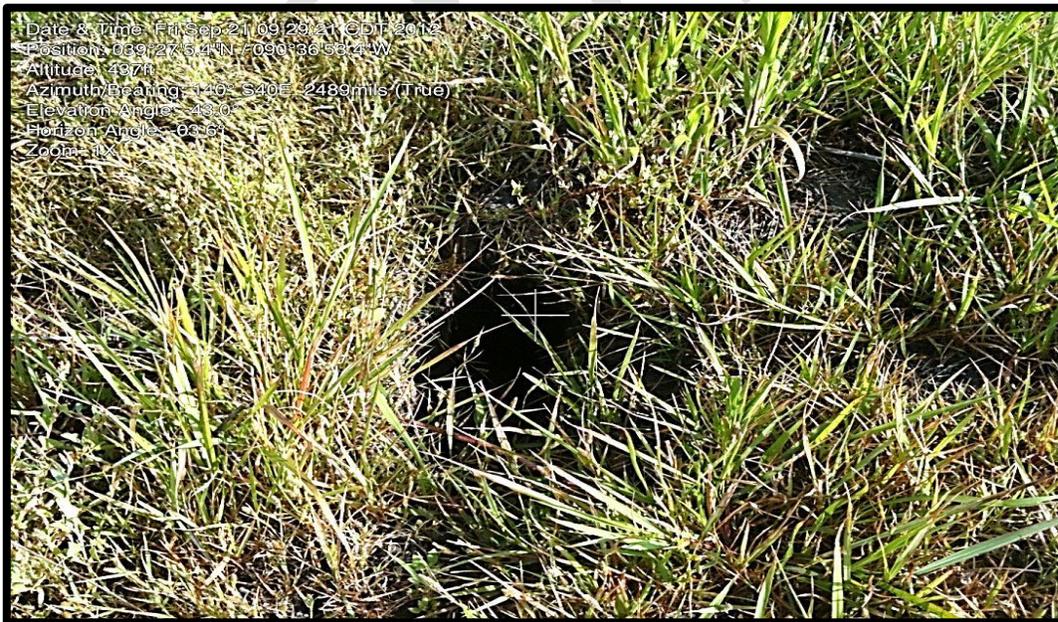
Visual observations of the interior slope of the east embankment towards the north end detected what appeared to be an animal burrow about 8 inches in diameter (**Photograph 5.5**).

Photograph 5.5 - Animal Burrow on Interior Slope of East Embankment

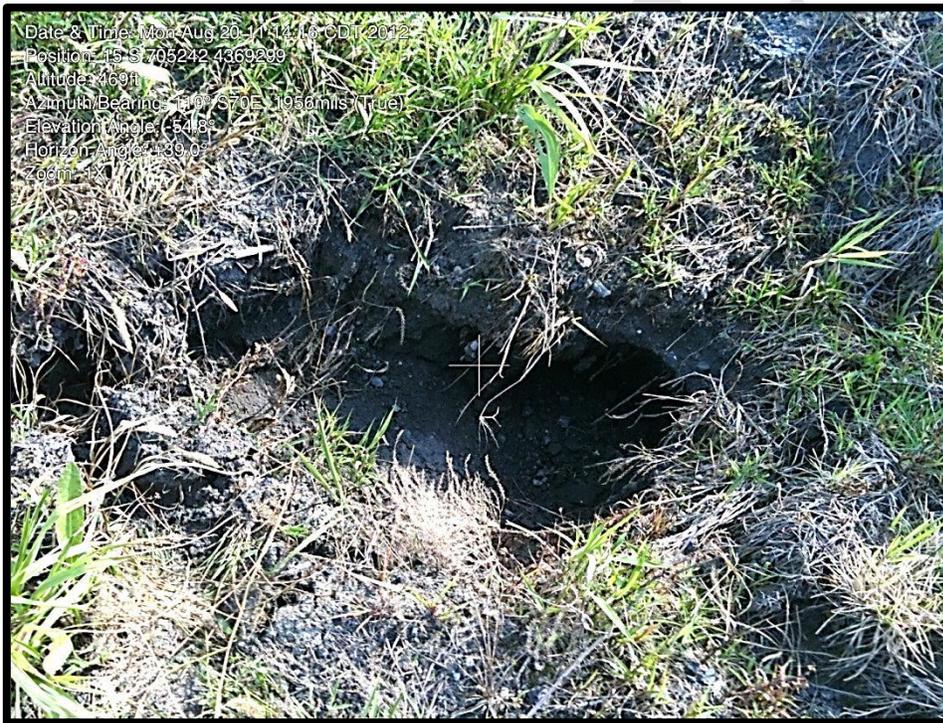
Other visual observations of the interior slopes consisted of an apparent shallow erosion feature on the south embankment near the mid-point of this side of the impoundment, (**Photograph 5.6**), and on the interior slope of the west embankment toward the north end of the west side (**Photograph 5.7**).

Photograph 5.6 - Erosion Feature on Interior Slope of South Embankment

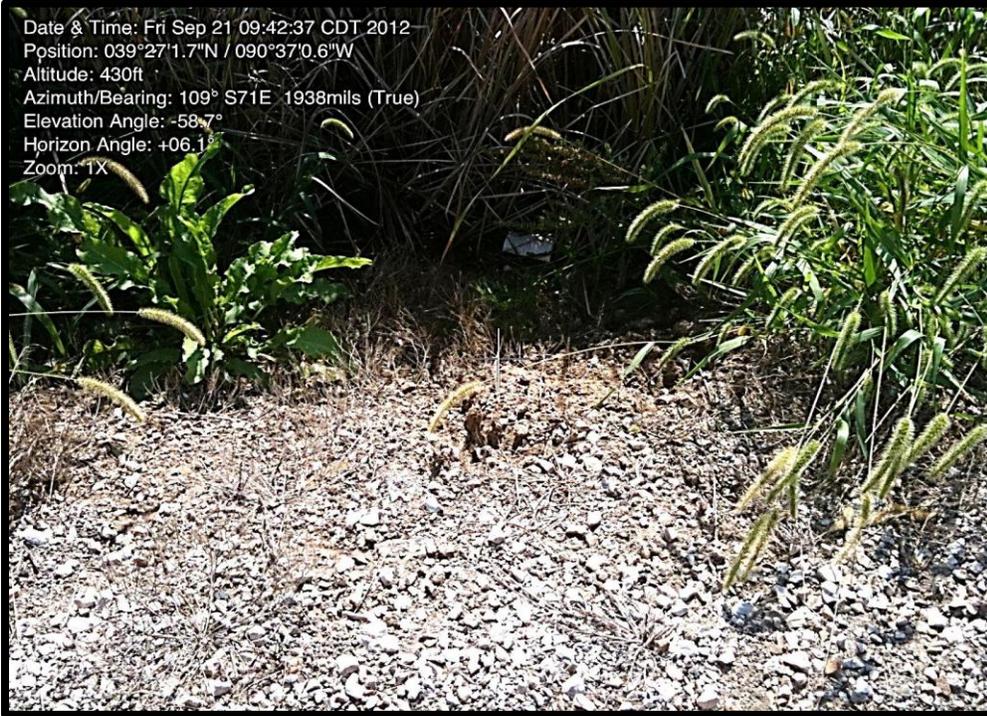
Photograph 5.7 - Erosion Feature on West Embankment along Highway 100

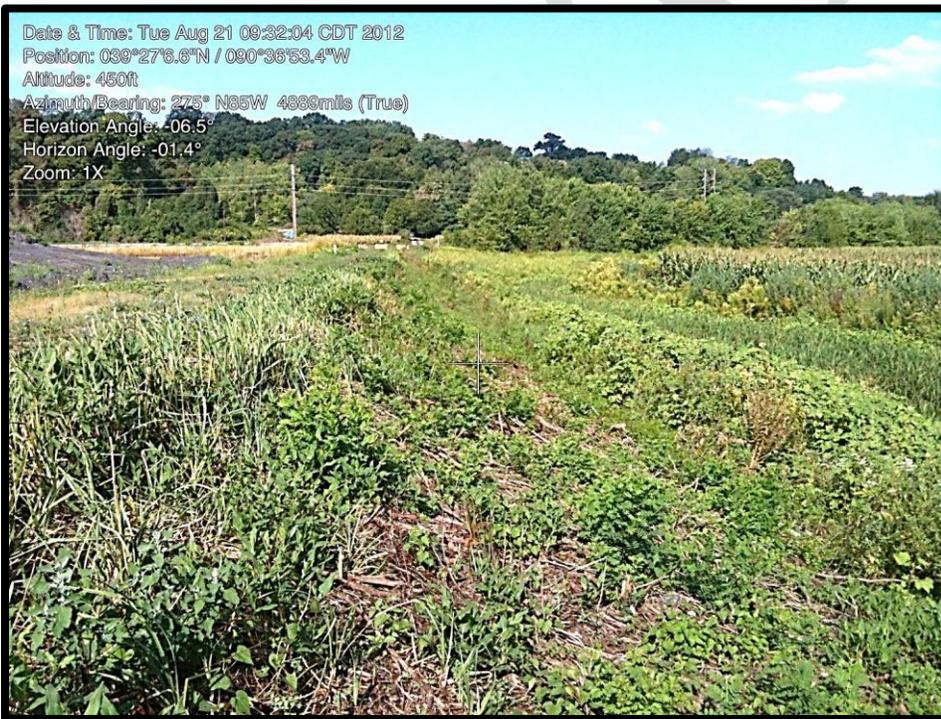
The exterior slopes and toe of the embankments generally appeared to be in fair condition. The inclination of exterior slopes were approximately 4H:1V or flatter. Most slopes were grass covered. The grass ranged in height from about 6 to 18 inches (**Photograph 5.8**). The PR indicated that the outer slopes are mowed at least once or twice a year.

Photograph 5.8- Vegetation on Exterior Slope at Southeast Corner of Pond

- Regular mowing and trimming of vegetation on the crest, exterior slopes (including the toe of the slope), and exposed interior slopes (above the water level) of the embankments with the intention of facilitating conditions for inspection of the embankments;

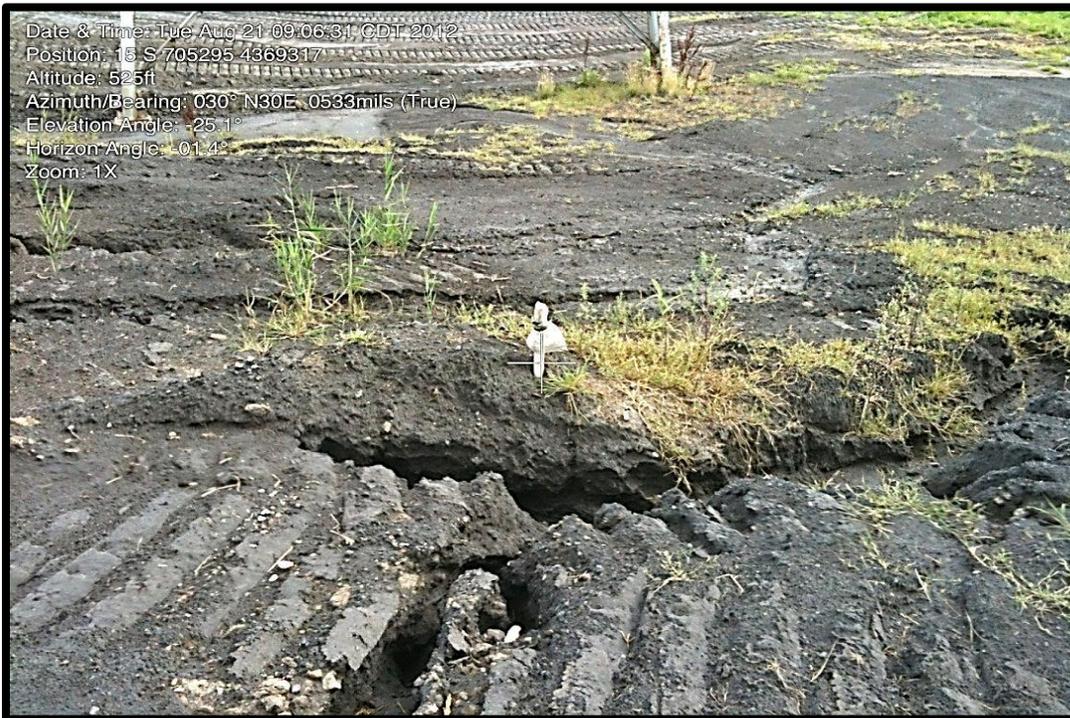
No evidence of animal burrows, cracks, or erosion was observed on the exterior slopes of the impoundment. No evidence of seepage was observed along the exterior slopes, including the toe of the slope where seepage is more-likely to occur. There was dried ash covering the southern portion of the east embankment (**Photographs 5.1**), preventing visual assessment of this area. Several small erosion rills were observed on the exterior slope of the southeast embankment perimeter (**See Photograph 5.9**).

**Photograph 5.9- Erosion Rills on Exterior Slope at Southeast Corner of Pond**

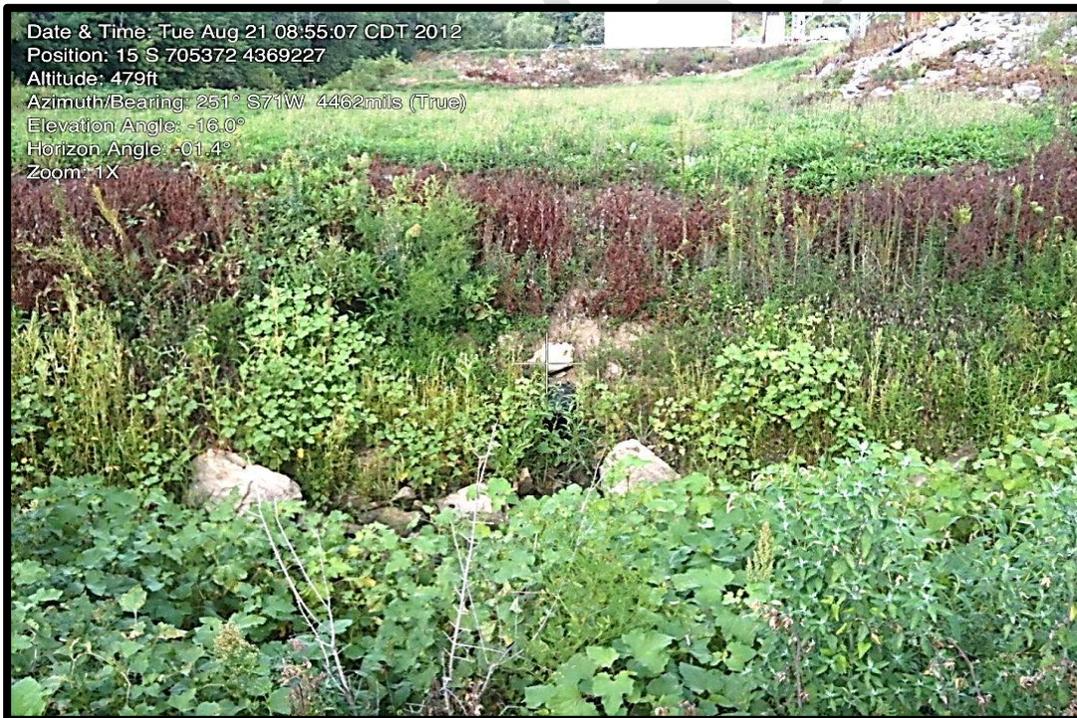
Photograph 5.11 - Pond Discharge Outlet to Illinois River

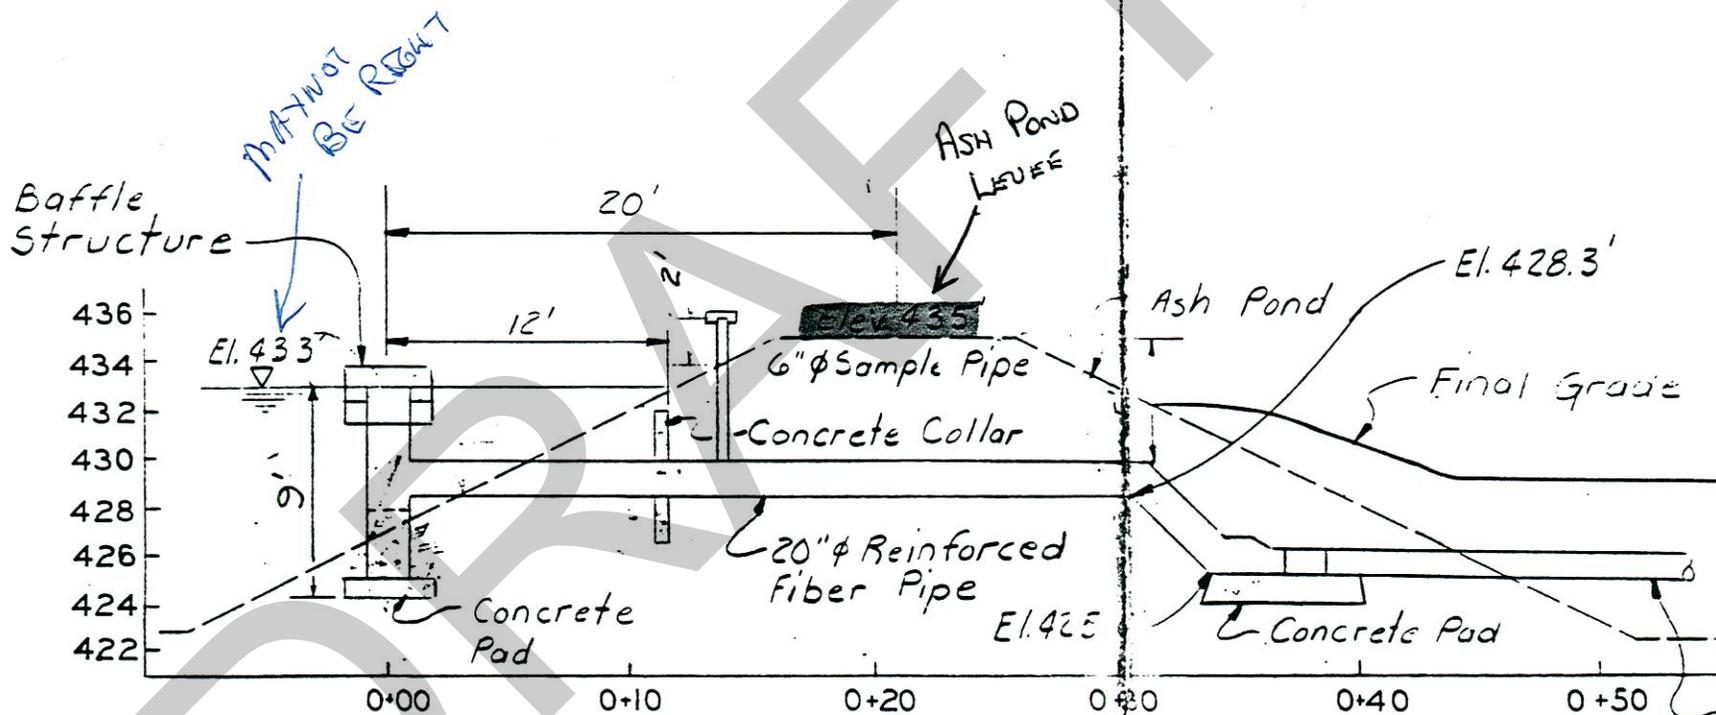
PROPOSED ASH POND DISCHARGE PIPING THROUGH DIKE

The PR also provided a drawing showing an ash pond discharge pipe that penetrates through the east embankment of the Ash Pond at a depth of approximately 6.7 feet. The PR indicated that the pipe elevation shown on the drawing may not reflect the as-built condition. The PR did confirm that the pipe shown on the drawing is 20 inches in diameter and serves as an outlet pipe for the impoundment, transporting water by gravity flow from the Ash Pond to the Illinois River. The inlet and outlet of this pipe could clearly be seen during our walk of the property. The drawing is attached in **Appendix C**.

PIPE MAY BE AT THIS ELEVATION BUT DO NOT COUNT ON IT.

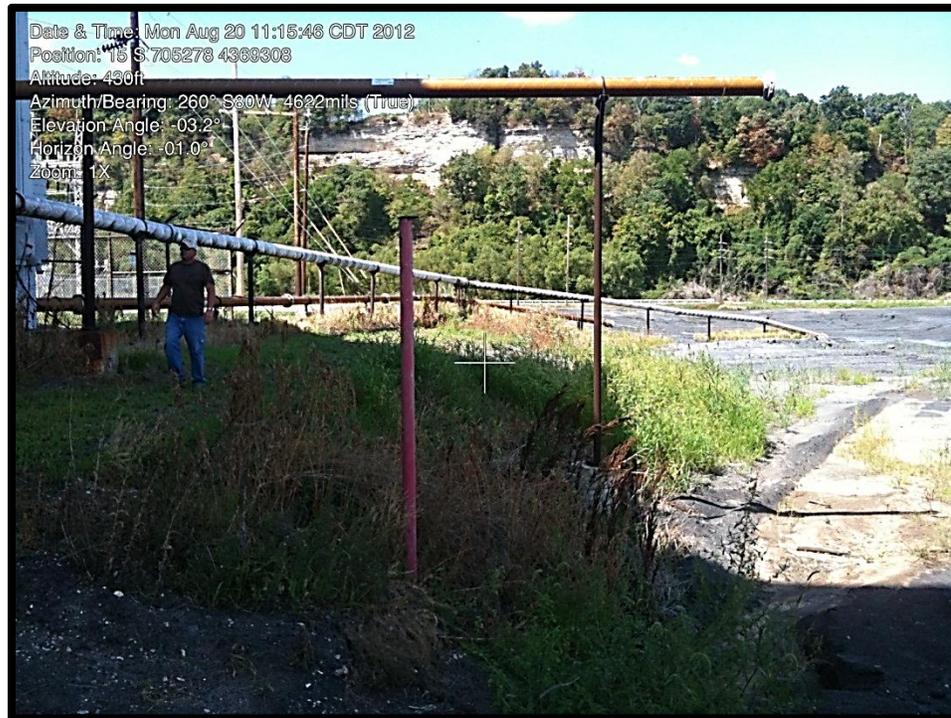
**Photograph D.1. Interior Slope of South Embankment Showing Inlet Piping Looking West**

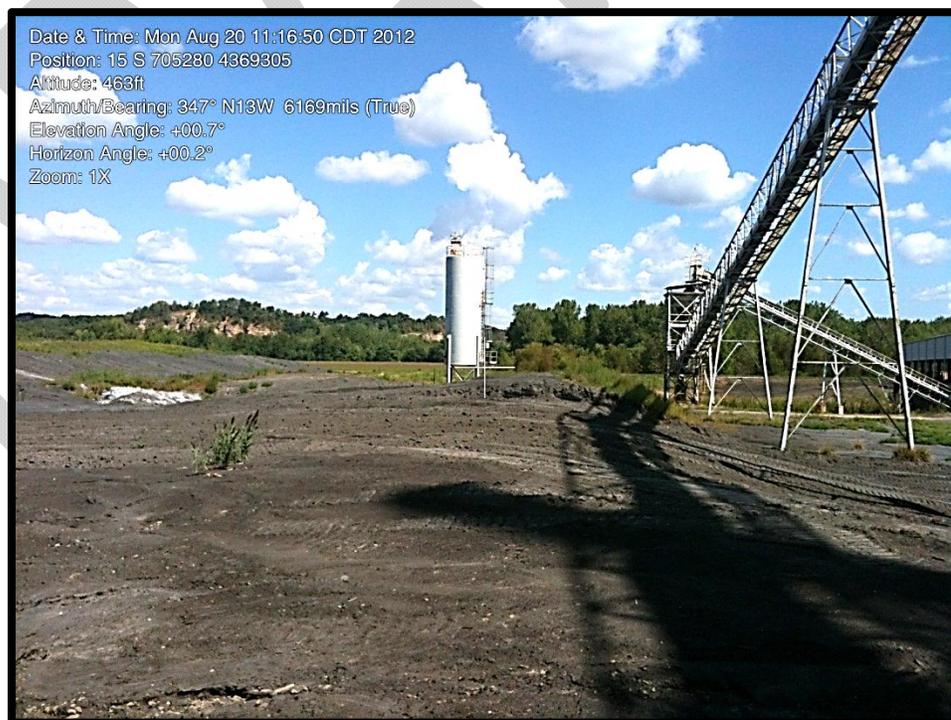
**Photograph D.2. Crest of East Embankment Covered by Dry Ash Looking North**

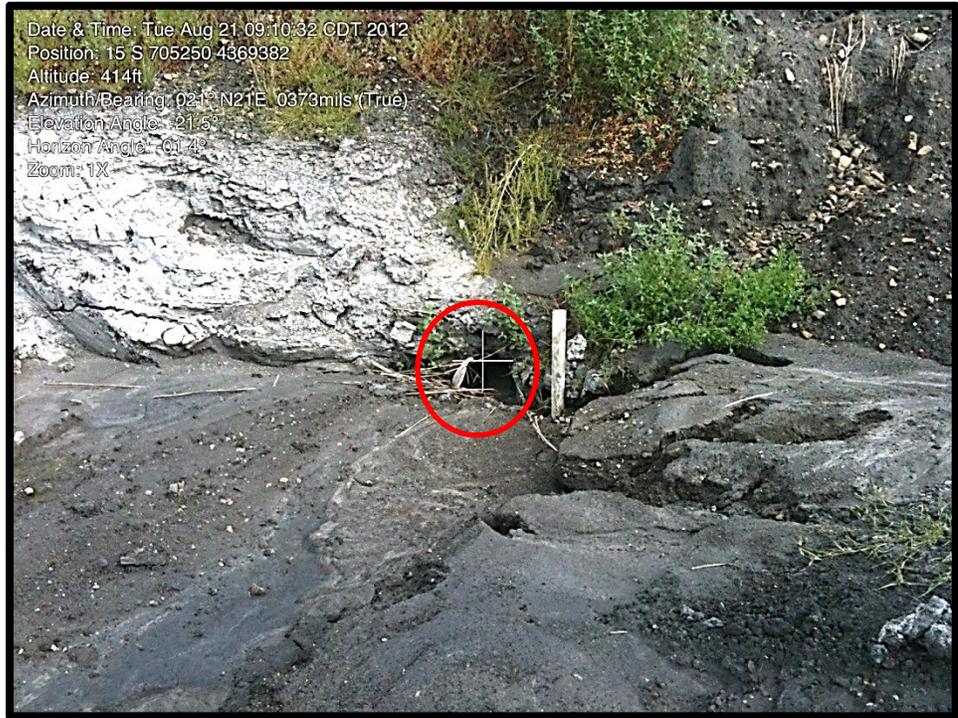
Photograph D.5. Unidentified Pipe Inlet to Pond

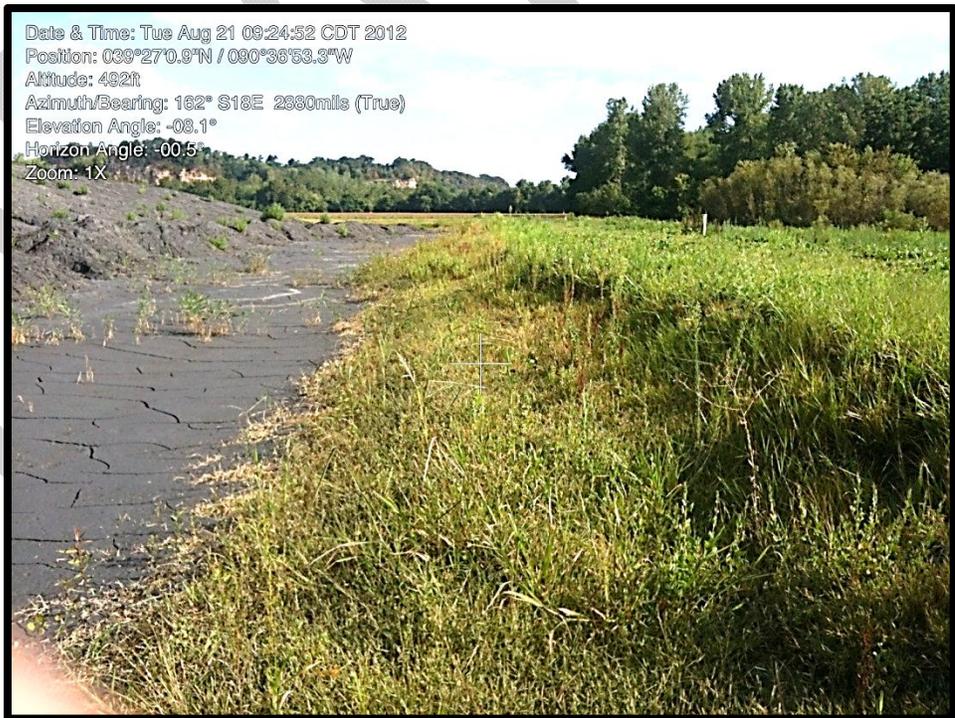
**Photograph D.8. Interior Slope of East Embankment Looking North with Portion of Ash Pile on Left Side of Photo**
