# ASSESSMENT OF DAM SAFETY OF COAL COMBUSTION SURFACE IMPOUNDMENTS – FINAL REPORT

**Prairie Power, Inc.  
Pearl Power Plant  
Pearl, Illinois**

March, 2014  
Revised May 2014

CDM Smith Project No.:  
93083.1801.044.SIT.PEARL

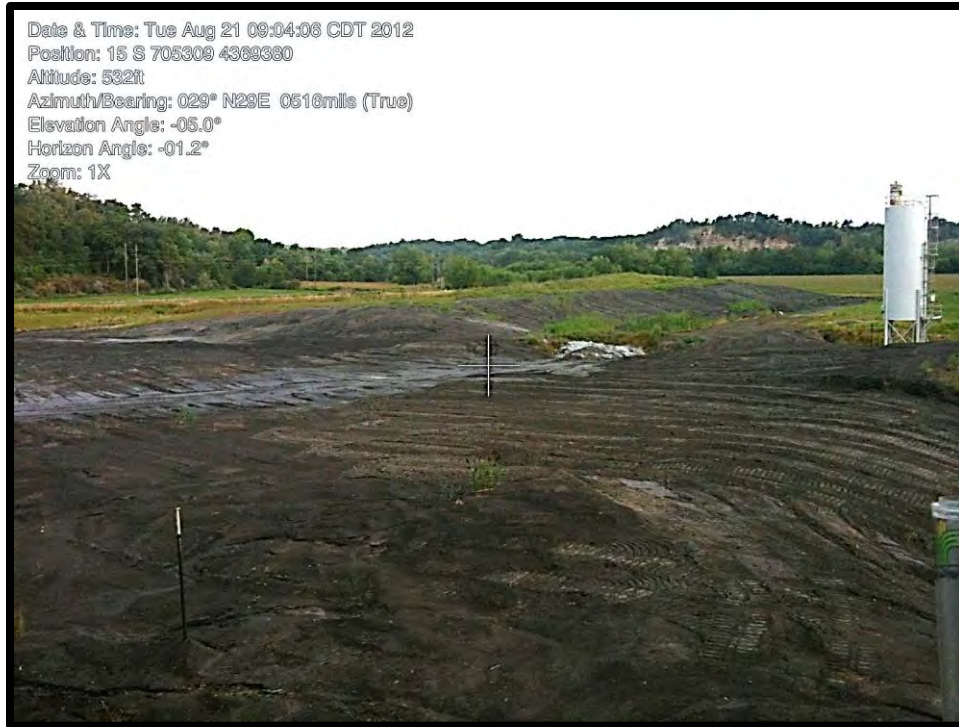
Visual observations of the surface of the impoundment surface indicated the eastern half of this area was filled and stockpiled with fly ash. The ash was dry at the surface, and stockpiled into a long, narrow pile aligned in a north-south direction. The height of the ash pile varied from a low visually estimated to be 3 to 5 feet below the embankment crest, to a high of about 15 to 20 feet above the embankment crest (**Photograph 5.1**).

**Photograph 5.1 - Dry Ash Covering Southeast Corner of Pond, with Ash Pile in Background Looking Northwest**

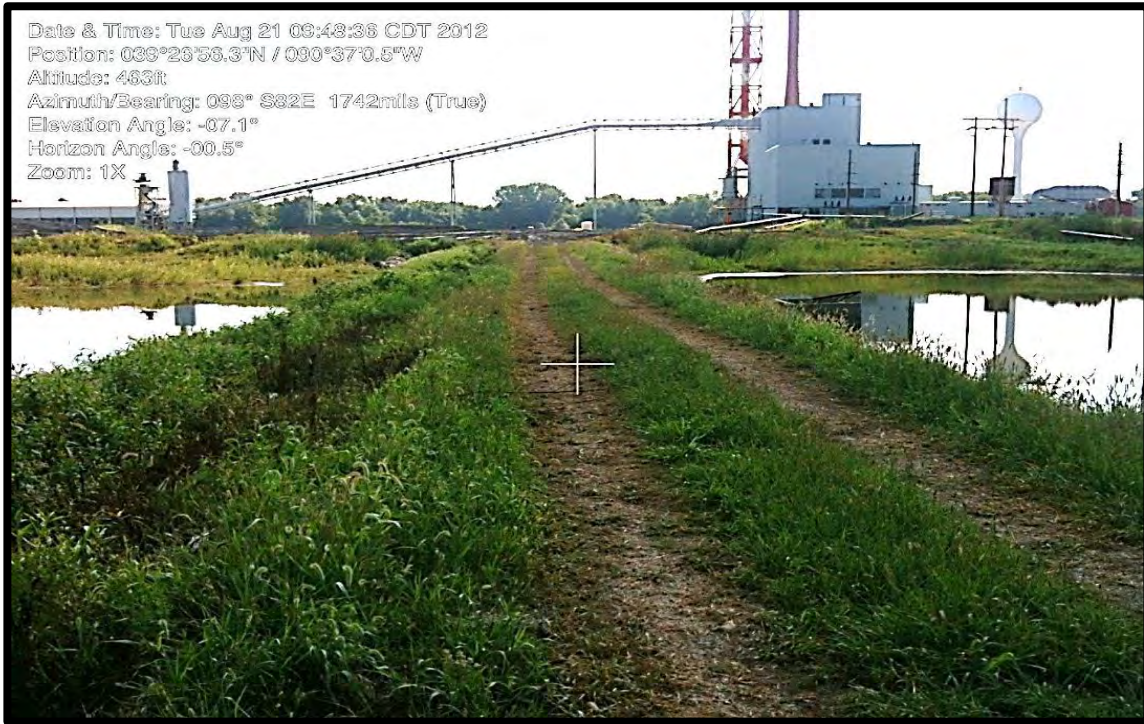
The crests of the embankments of the CCW impoundment (where they could clearly be seen) appeared to be nearly level and have a generally consistent width of 10 to 15 feet, with no evidence of prior breaches or overtopping erosion (**Photograph 5.2**). Some areas of the crest were grass-covered (up to about 10 inches in height). The surface of the west embankment was covered by State Highway 100, and the southern portion of the east embankment was covered by fly ash.

**Photograph 5.2 - Crest of South Embankment Looking East – Ash Pond on Left Side of Photograph**

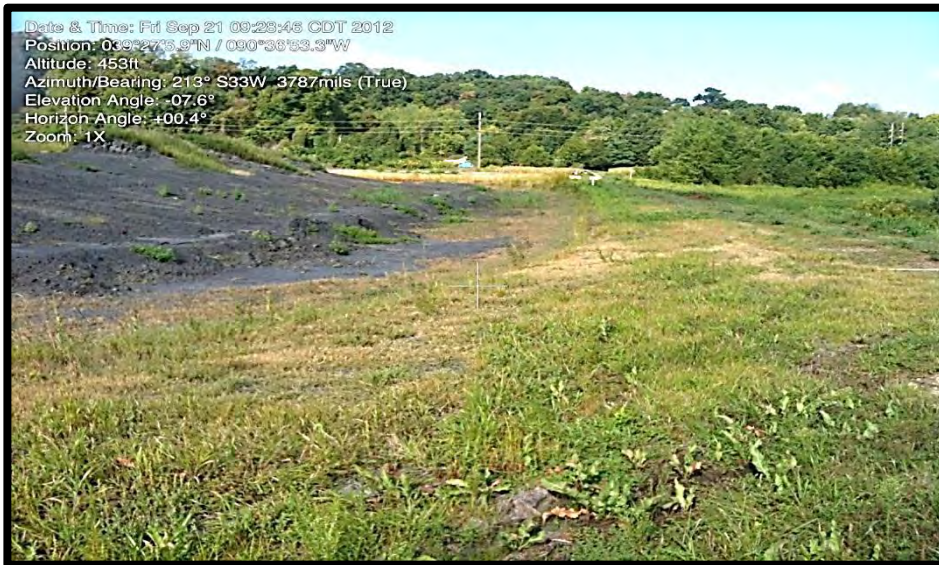
The interior slopes of the embankments were generally in fair condition (**Photographs 5.3 and 5.4**). The inclination of these slopes were approximately 4H:1V (horizontal: vertical) or flatter. Most of the interior slopes were covered with thick grass-like vegetation up to 3 feet high on the north, south, and east embankments. The west embankment contained much denser vegetation up to 5 feet high.

**Photograph 5.3 - North Embankment Interior Slope Looking West**

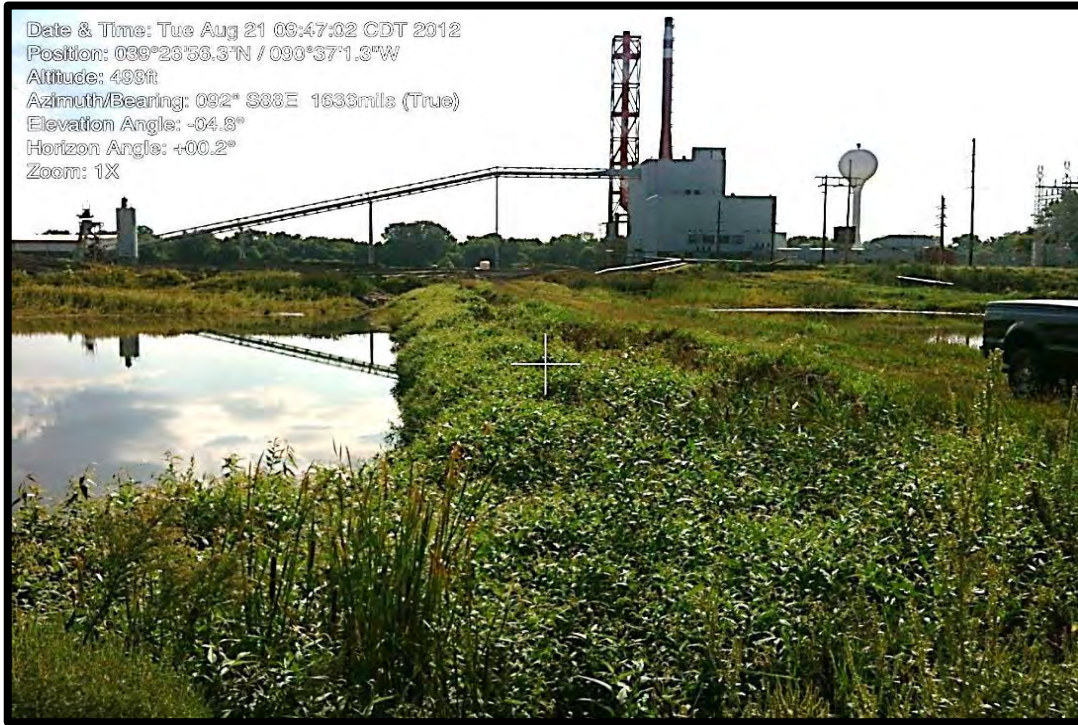
**Photograph 5.4 - Interior Slope of South Embankment Looking East**

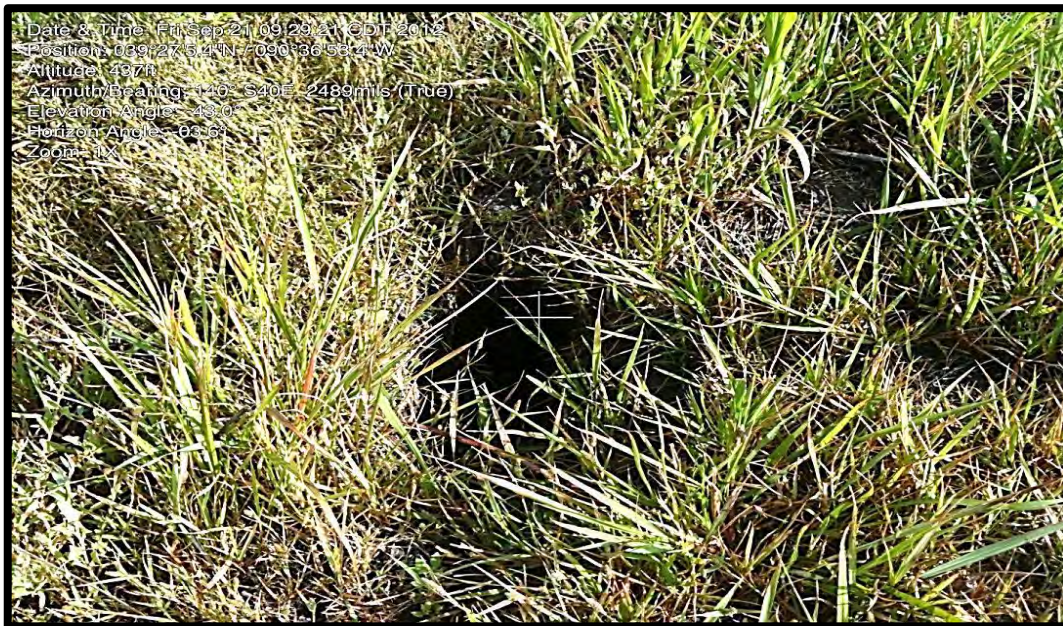
Visual observations of the interior slope of the east embankment towards the north end detected what appeared to be an animal burrow about 8 inches in diameter (**Photograph 5.5**).

**Photograph 5.5 - Animal Burrow on Interior Slope of East Embankment**

Other maintenance issues consisted of evidence of small erosion features on the interior slopes of the west and south embankments, and an animal burrow on the interior slope of the east embankment. Based on visual observations of the mechanical systems of the impoundment, maintenance of the outlet structure appeared inadequate. The outfall portion of the gravity-flow pipe was broken off and the outlet discharge is covered by overgrown vegetation.

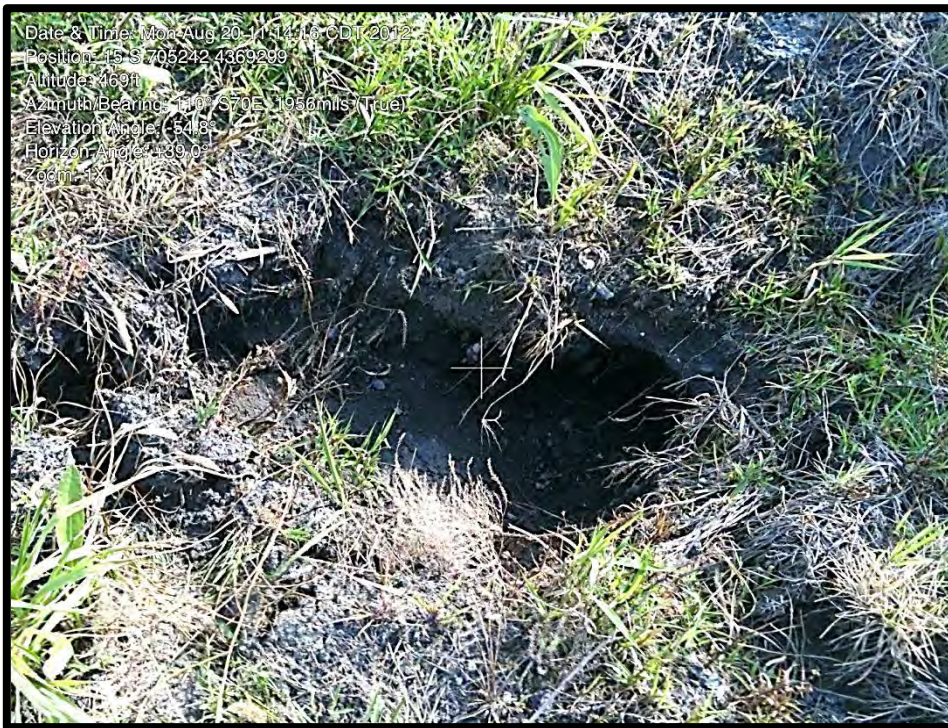
Other visual observations of the interior slopes consisted of an apparent shallow erosion feature on the south embankment near the mid-point of this side of the impoundment, (**Photograph 5.6**), and on the interior slope of the west embankment toward the north end of the west side (**Photograph 5.7**).

**Photograph 5.6 - Erosion Feature on Interior Slope of South Embankment**

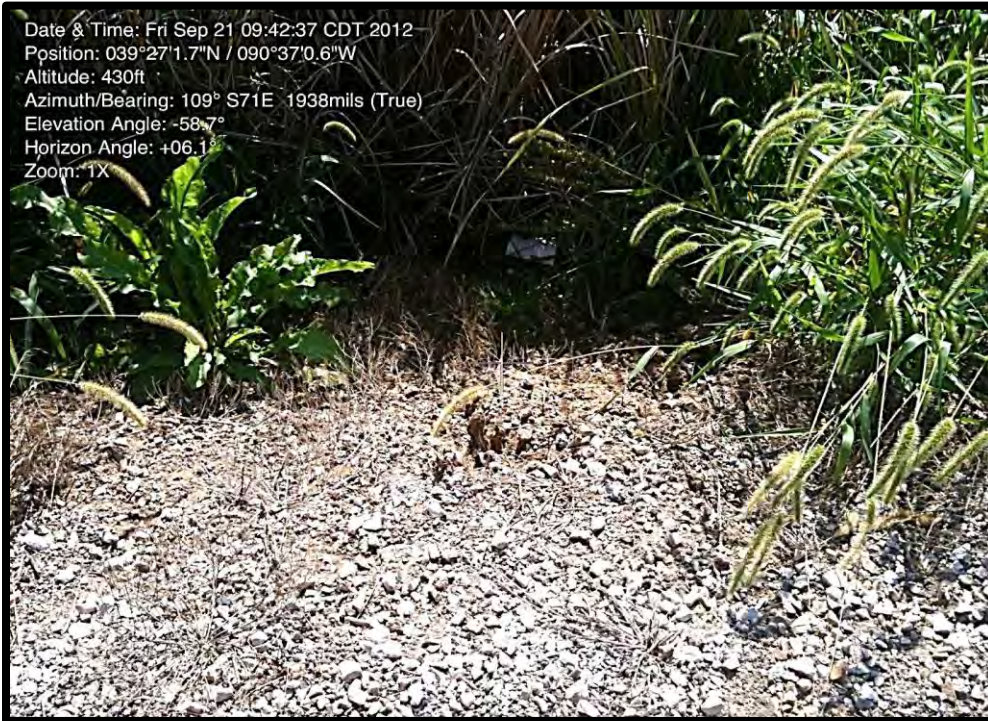
Photograph 5.7 - Erosion Feature on West Embankment along Highway 100

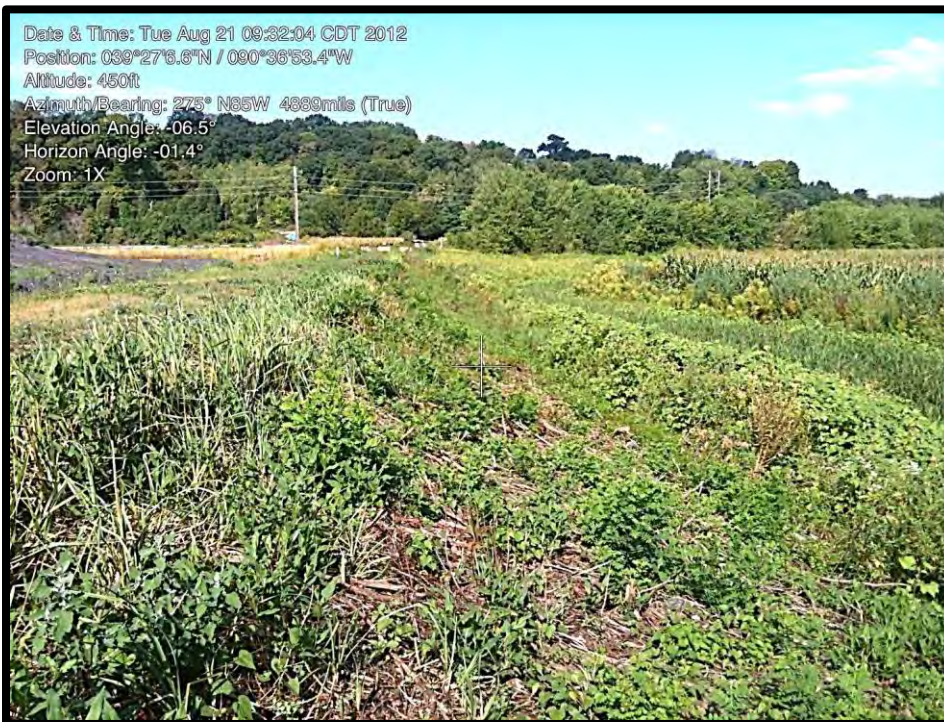
Photograph 5.8- Vegetation on Exterior Slope at Southeast Corner of Pond

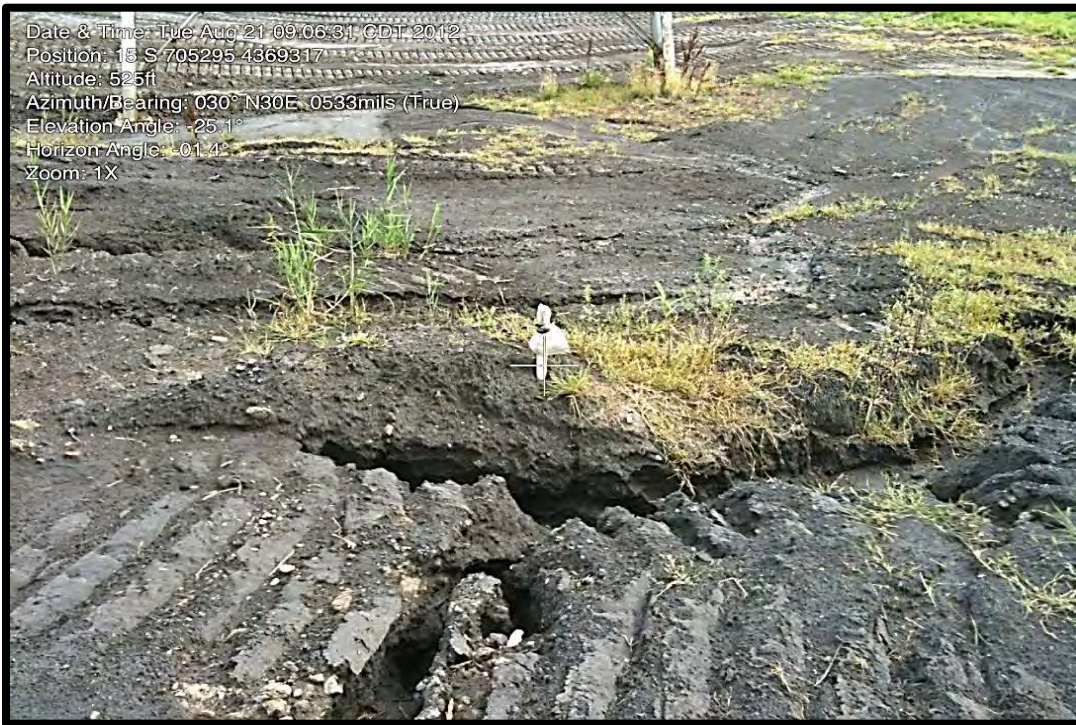
No evidence of animal burrows, cracks, or erosion was observed on the exterior slopes of the impoundment. No evidence of seepage was observed along the exterior slopes, including the toe of the slope where seepage is more-likely to occur. There was dried ash covering the southern portion of the east embankment (**Photographs 5.1**), preventing visual assessment of this area. Several small erosion rills were observed on the exterior slope of the southeast embankment perimeter (**See Photograph 5.9**).

**Photograph 5.9- Erosion Rills on Exterior Slope at Southeast Corner of Pond**

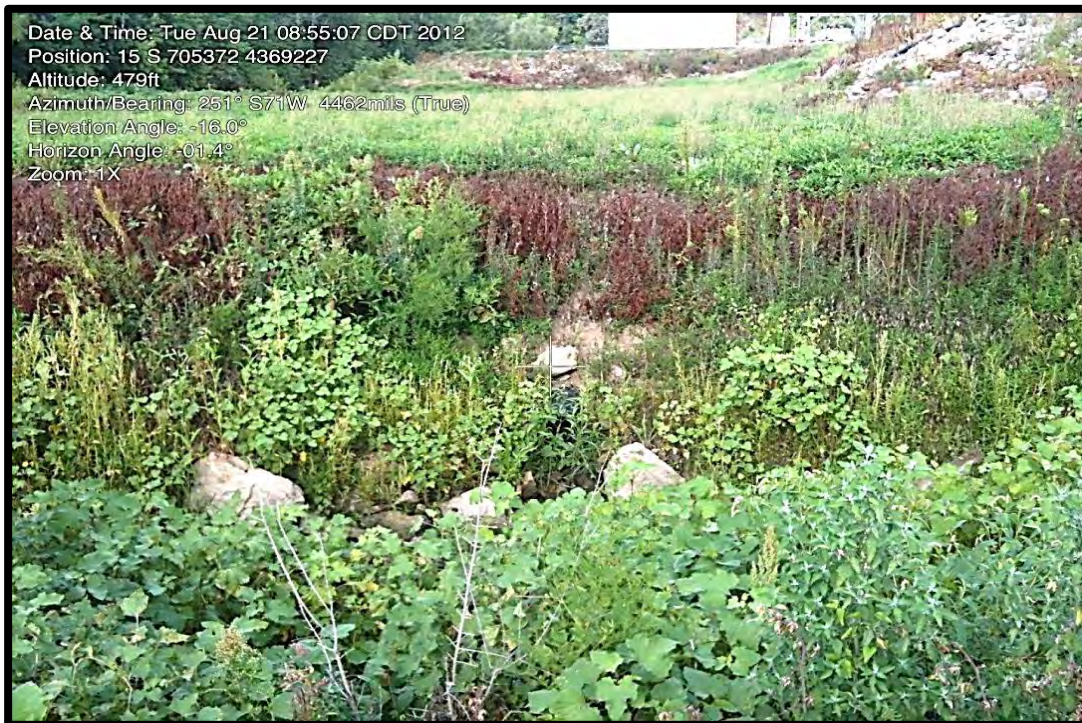
**Photograph 5.11 - Pond Discharge Outlet to Illinois River**

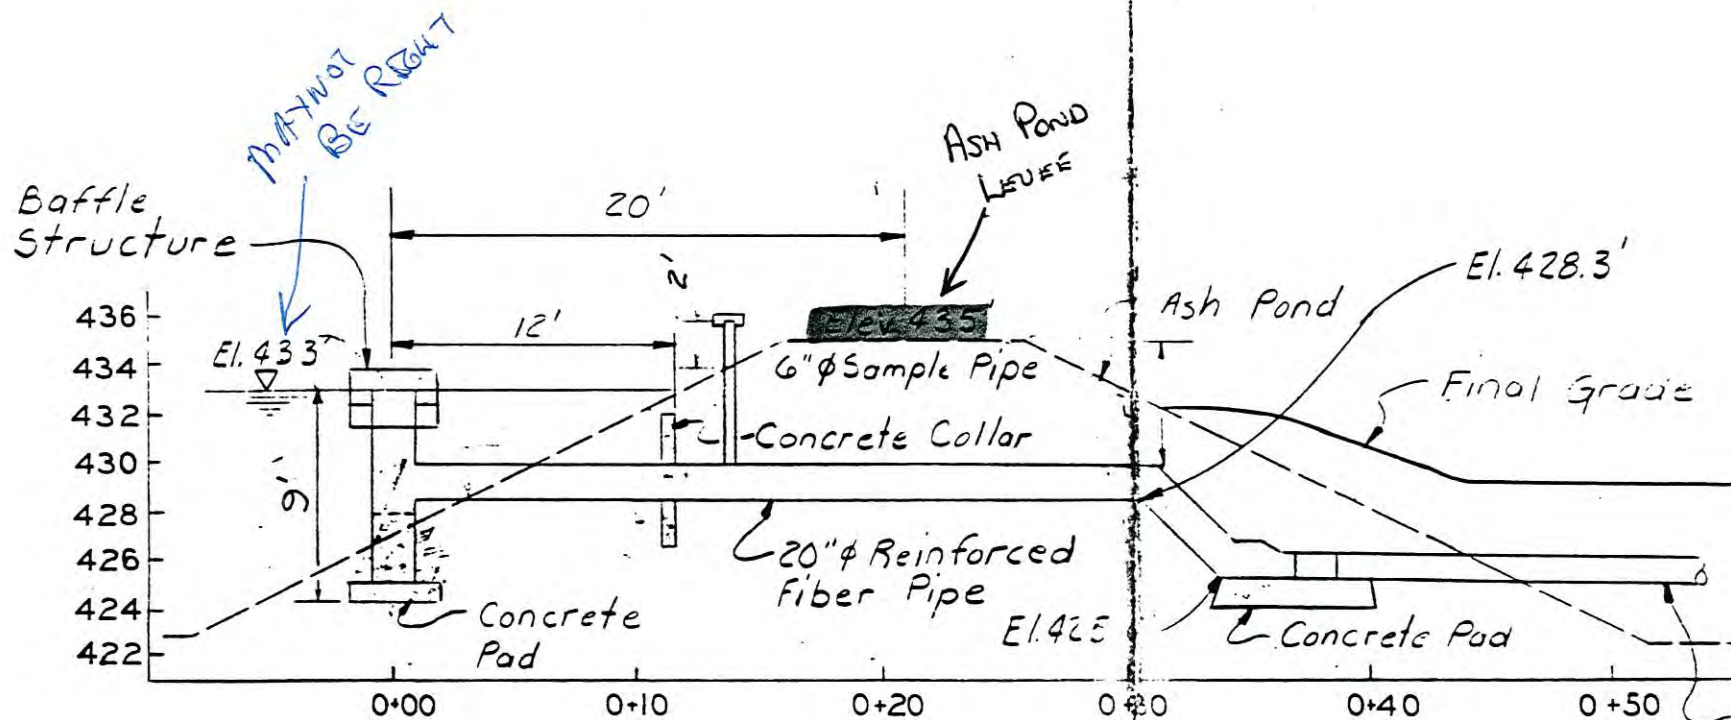
PROPOSED ASH POND DISCHARGE PIPING THROUGH DIKE

PIPE MAY BE AT THIS  
ELEVATION BUT DO NOT COUNT ON IT.

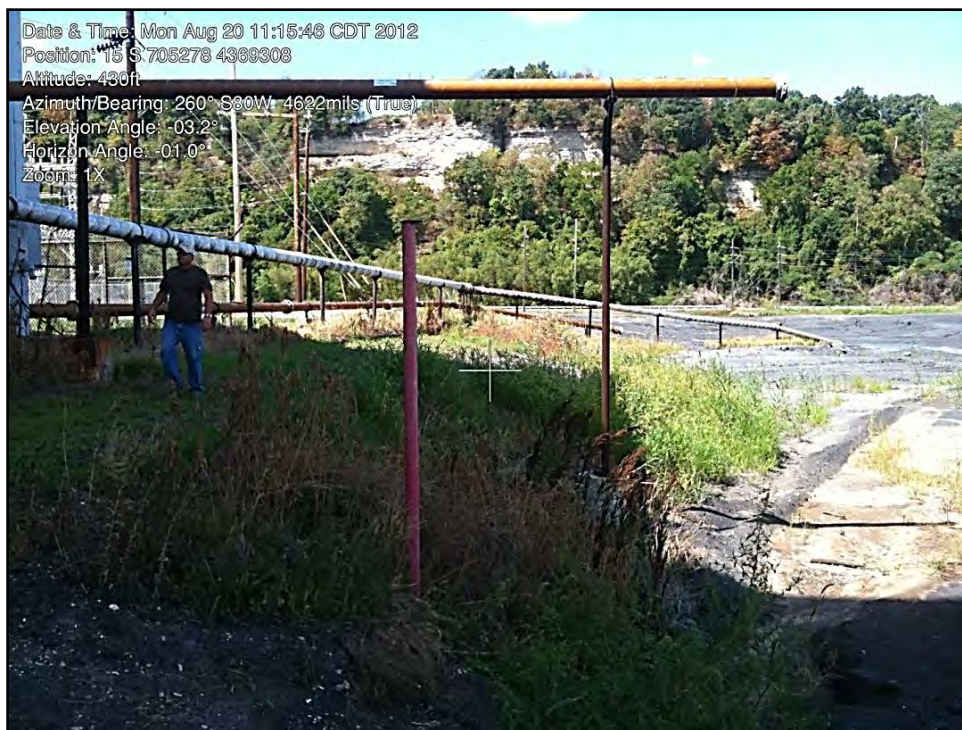
Photograph D.1. Interior Slope of South Embankment Showing Inlet Piping Looking West

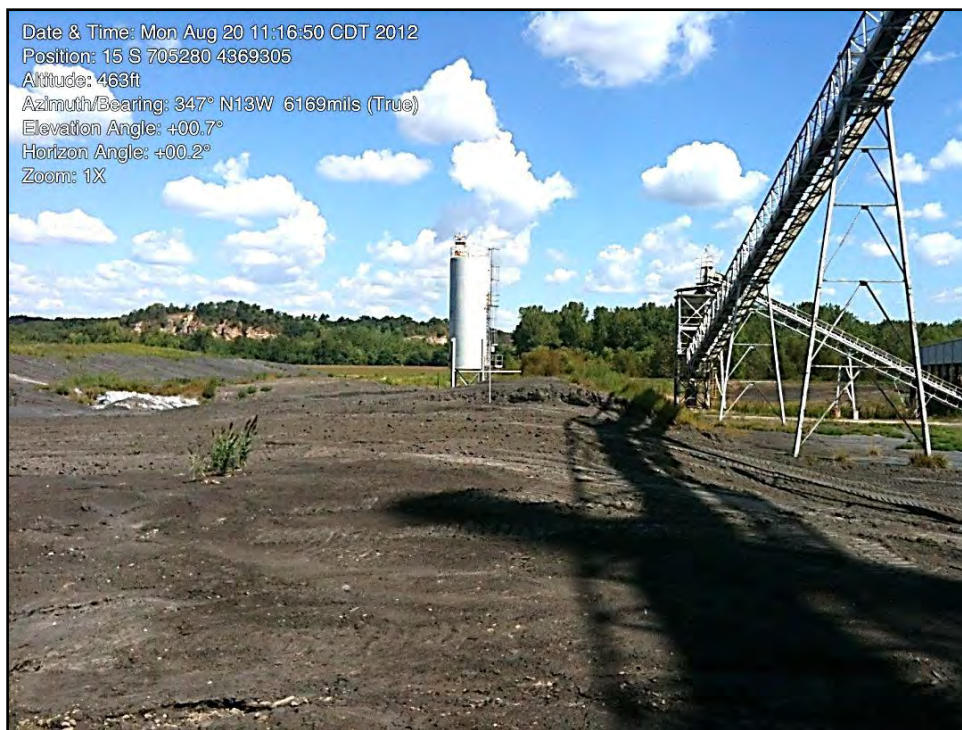
Photograph D.2. Crest of East Embankment Covered by Dry Ash Looking North

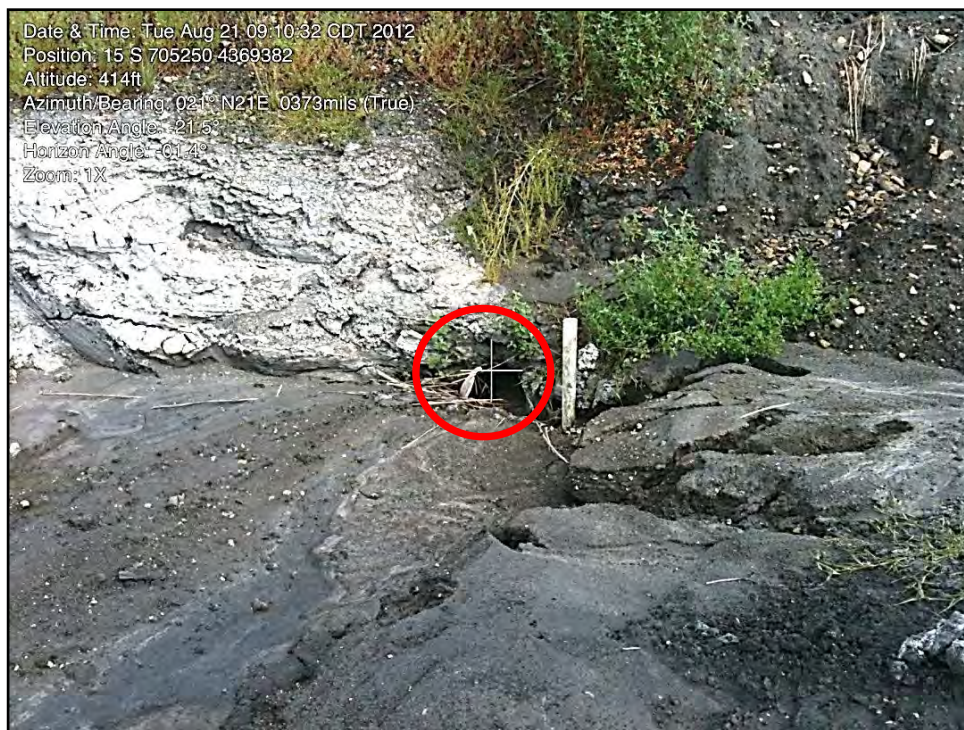
Photograph D.5. Unidentified Pipe Inlet to Pond
