# **Assessment of Dam Safety of Coal Combustion Surface Impoundments**

**PowerSouth Energy Cooperative**

**Charles R. Lowman Power Plant**

**March 30, 2011**

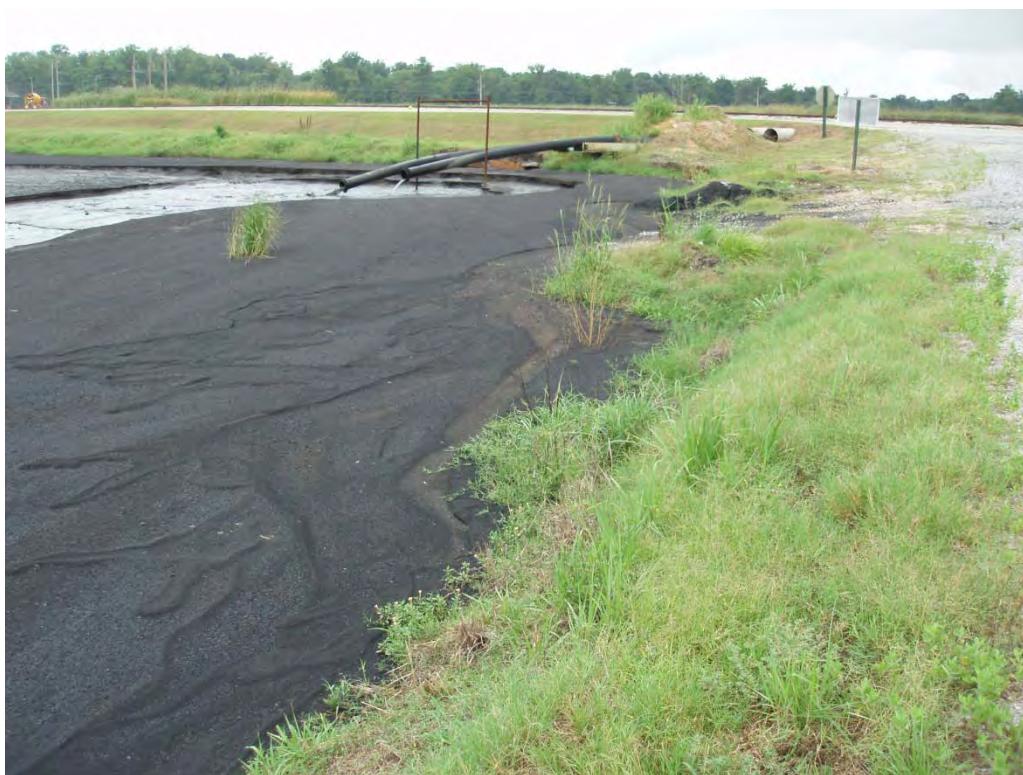
**Photo No. 2: #1 Bottom Ash Pond – North embankment interior slope, looking west. Looking at sluice line discharge from Units 2 & 3.**

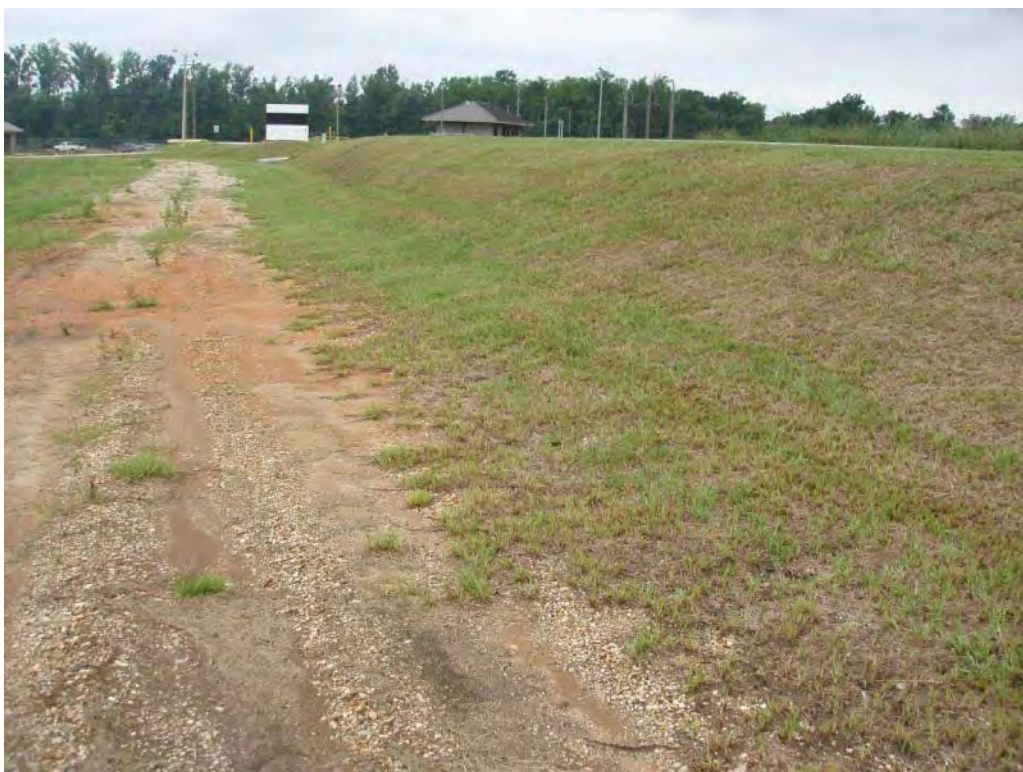
**Photo No. 8: #1 Bottom Ash Pond – West embankment crest, looking south. Plant access road embankment on right.**

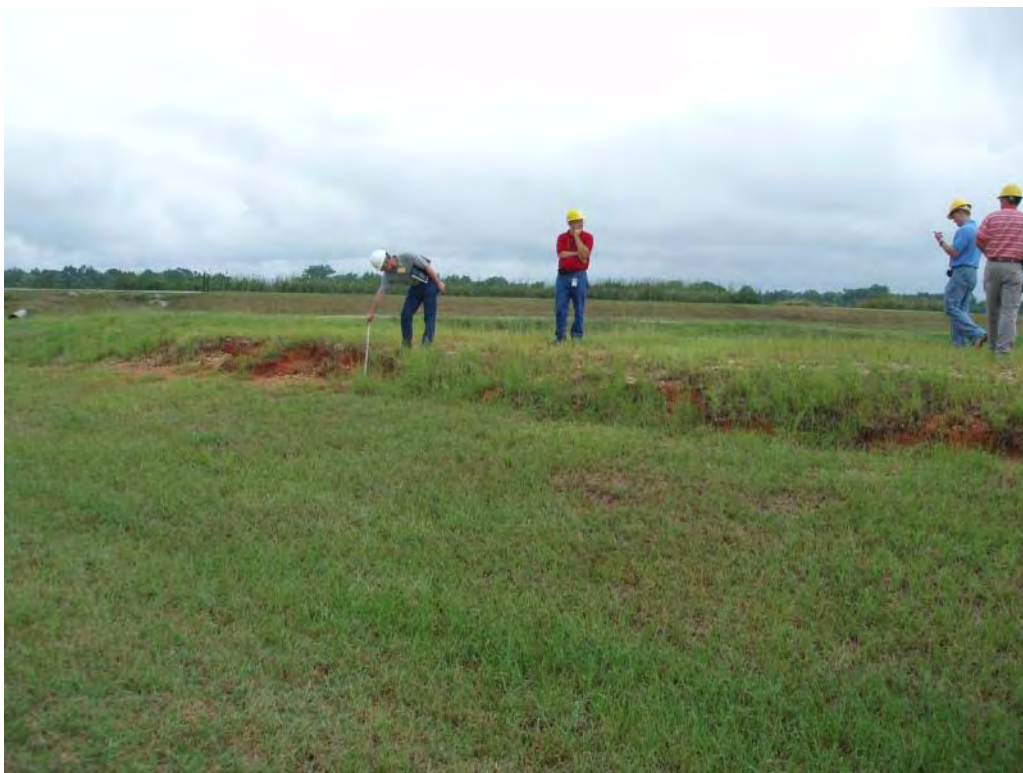
**Photo No. 14: #1 Bottom Ash Pond – South embankment exterior slope, looking north. Note surface erosion.**

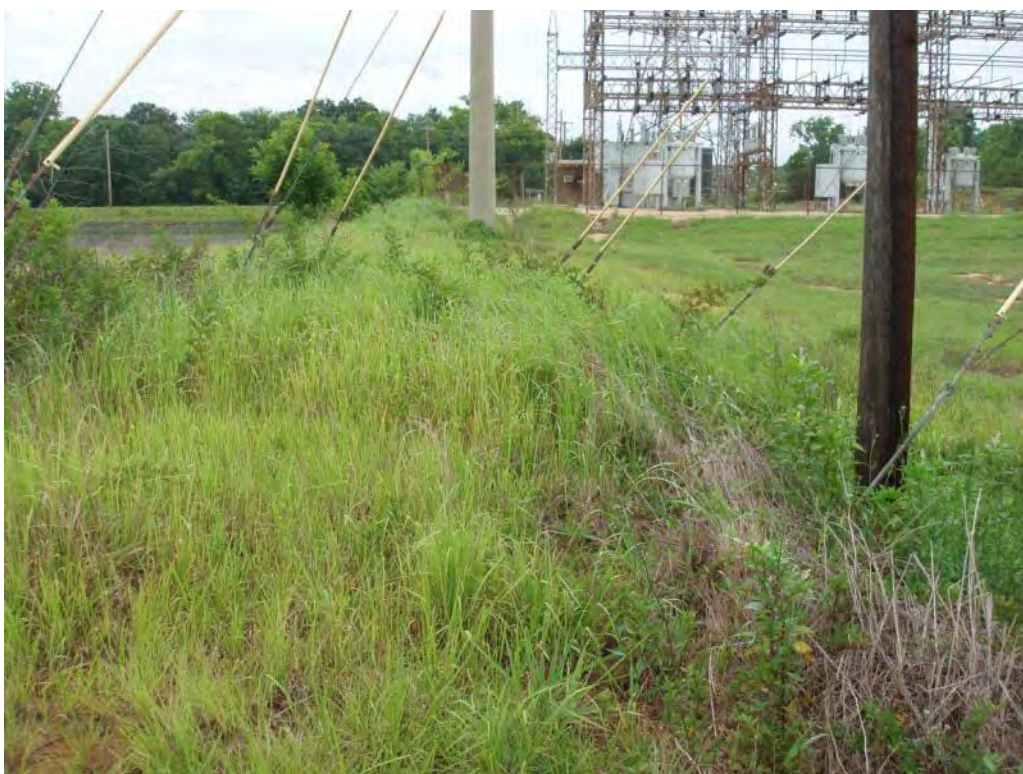
**Photo No. 20: #1 Bottom Ash Pond – South embankment crest, looking east. Note substation in background.**

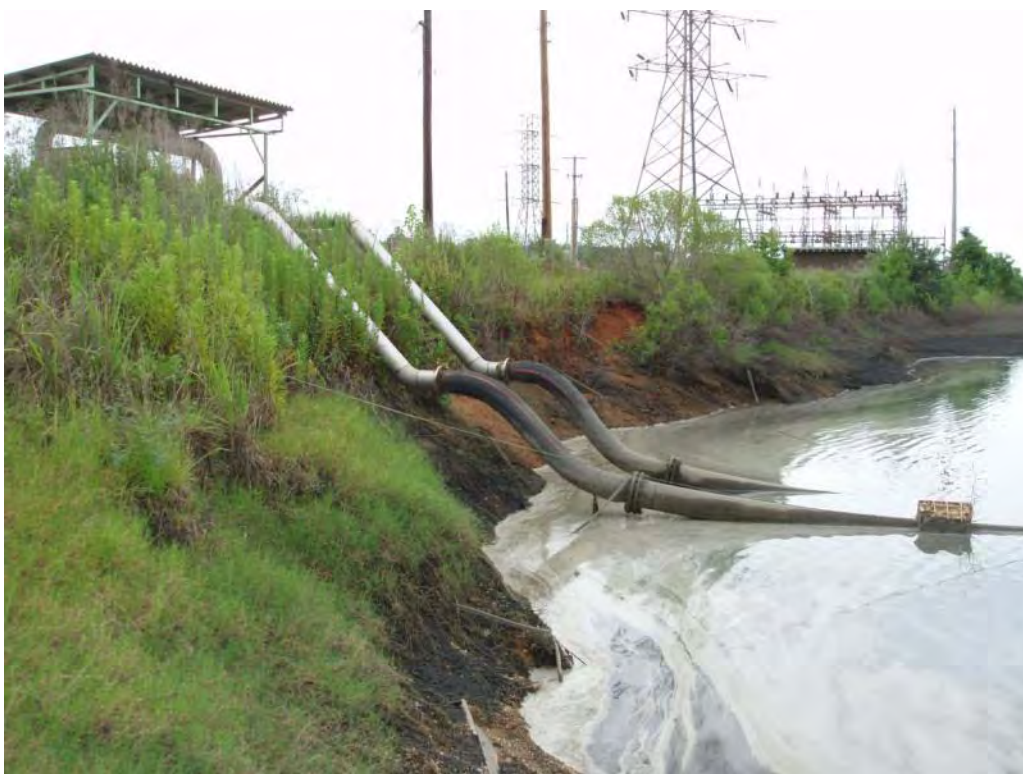
The outlet pipes in the #1 Bottom Ash Pond appear to be in good condition. Two 10-inch-diameter pipes, located at the southwestern end of the pond, intake water that is pumped to the #2/#3 Bottom Ash Pond through one 14-inch-diameter HDPE pipe (Photographs 23 and 24). No unusual movement was observed around the pumps or piping.

**Photo No. 24: #1 Bottom Ash Pond – South embankment interior slope, looking southwest.  
Looking at outlet pipes.**

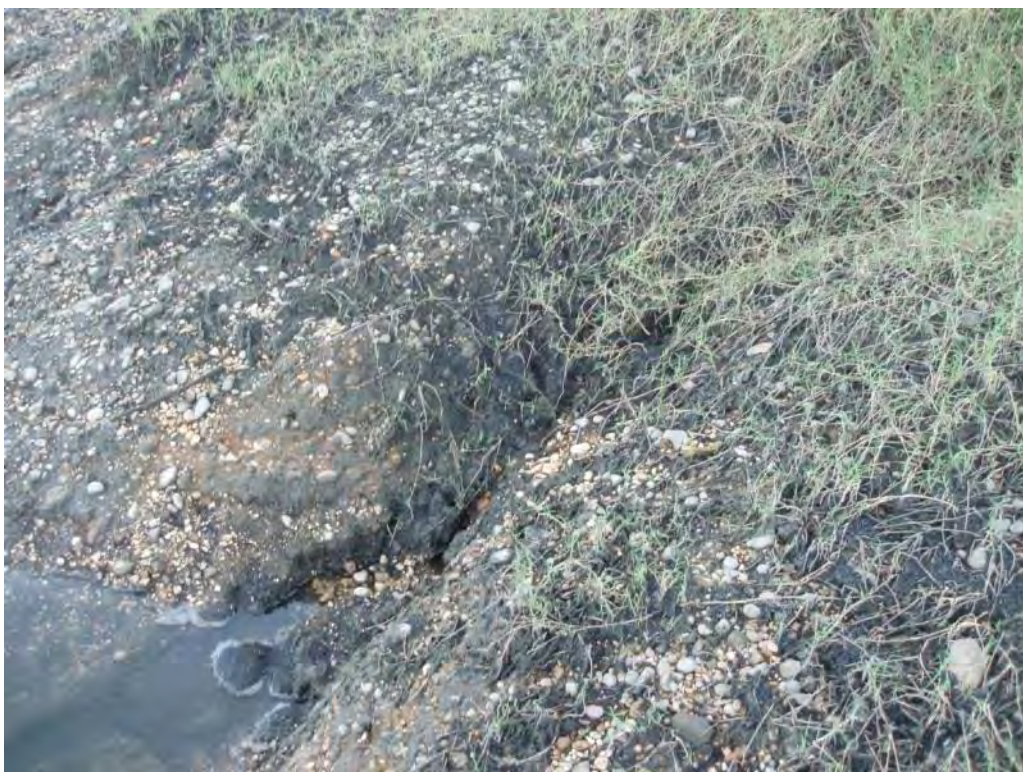
A section of the interior slope of the south embankment has been excavated and remains open, apparently to facilitate the repair of the discharge pipe (Photograph 19). Erosion features, including minor sloughing and erosion rills, were observed on portions of the interior slopes (Photographs 22, 24, 25, 28, 31, 47, and 48).

**Photo No. 28: #1 Bottom Ash Pond – East embankment interior slope. Looking at erosion rills.**

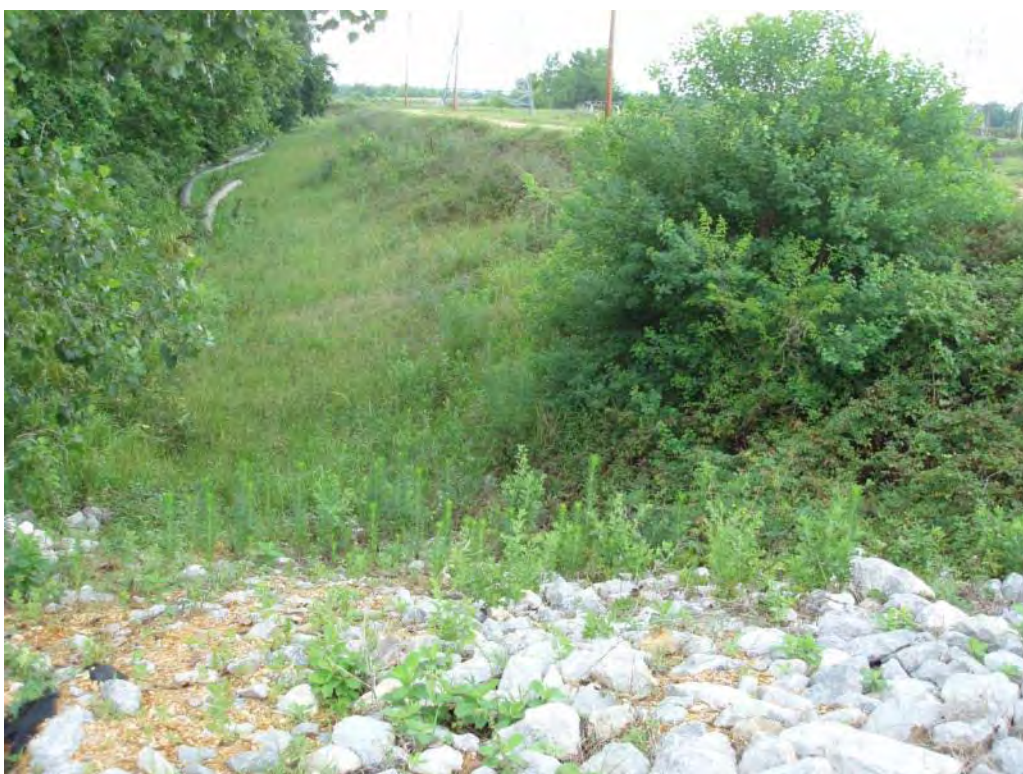
**Photo No. 32: #1 Bottom Ash Pond – East embankment exterior slope, looking south.**

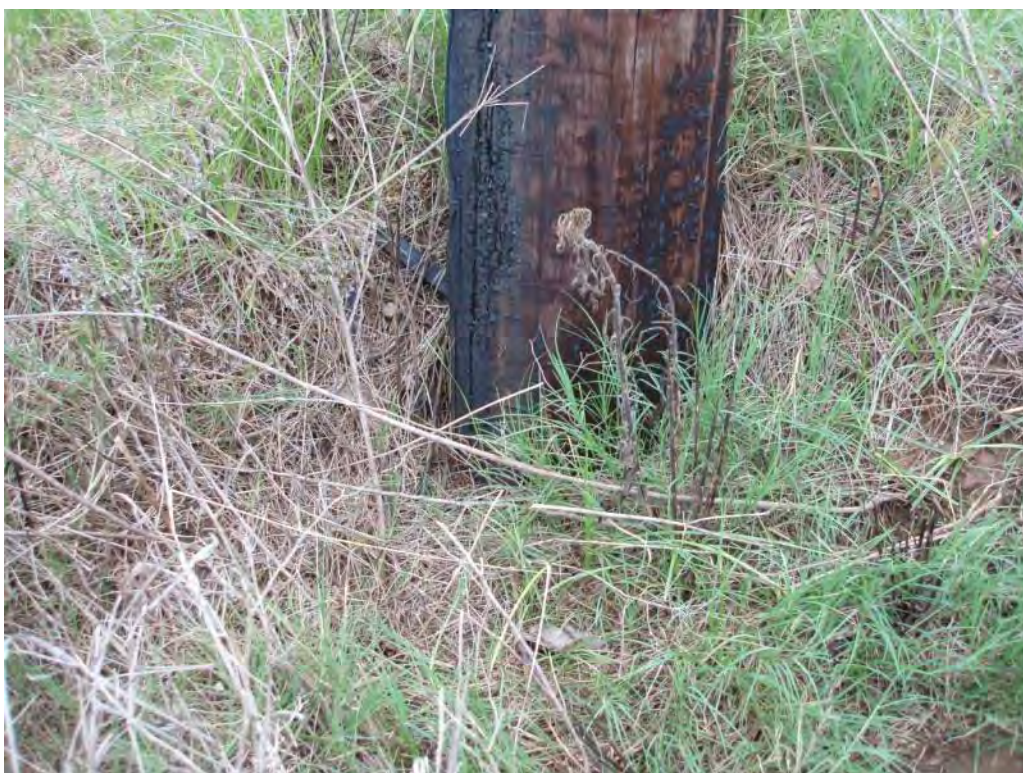
**Photo No. 38: #1 Bottom Ash Pond – East embankment interior slope. Looking at eroded or missing soils near utility pole.**

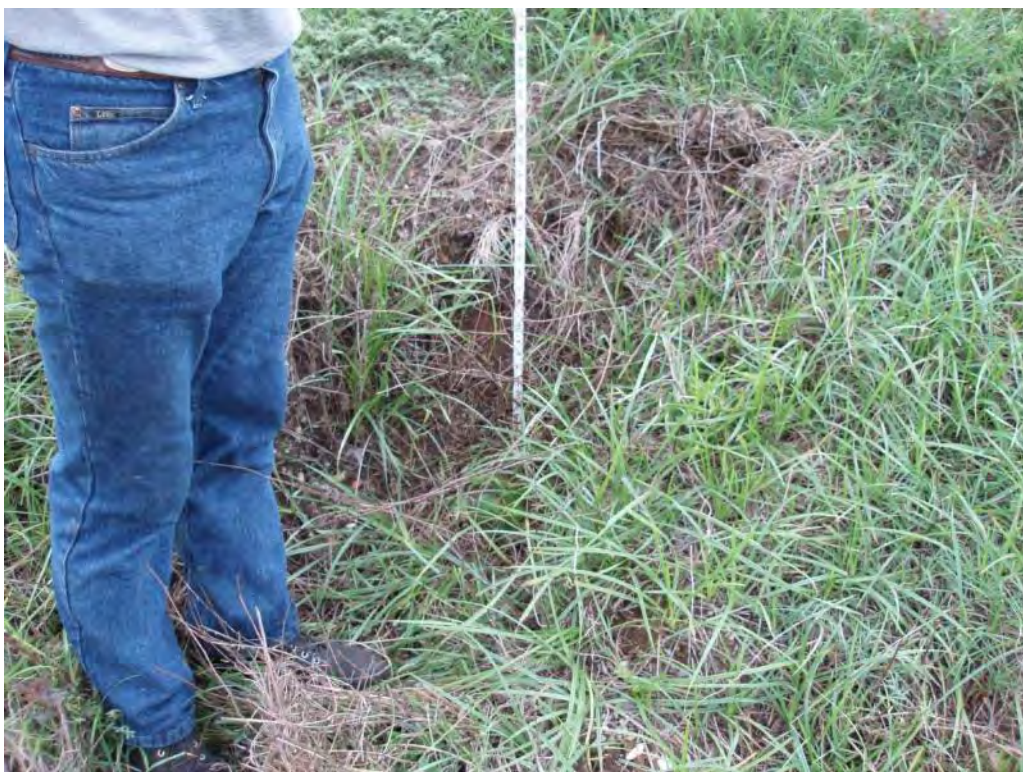
**Photo No. 44: #1 Bottom Ash Pond - North embankment interior slope. Looking at surface erosion/erosion rill.**

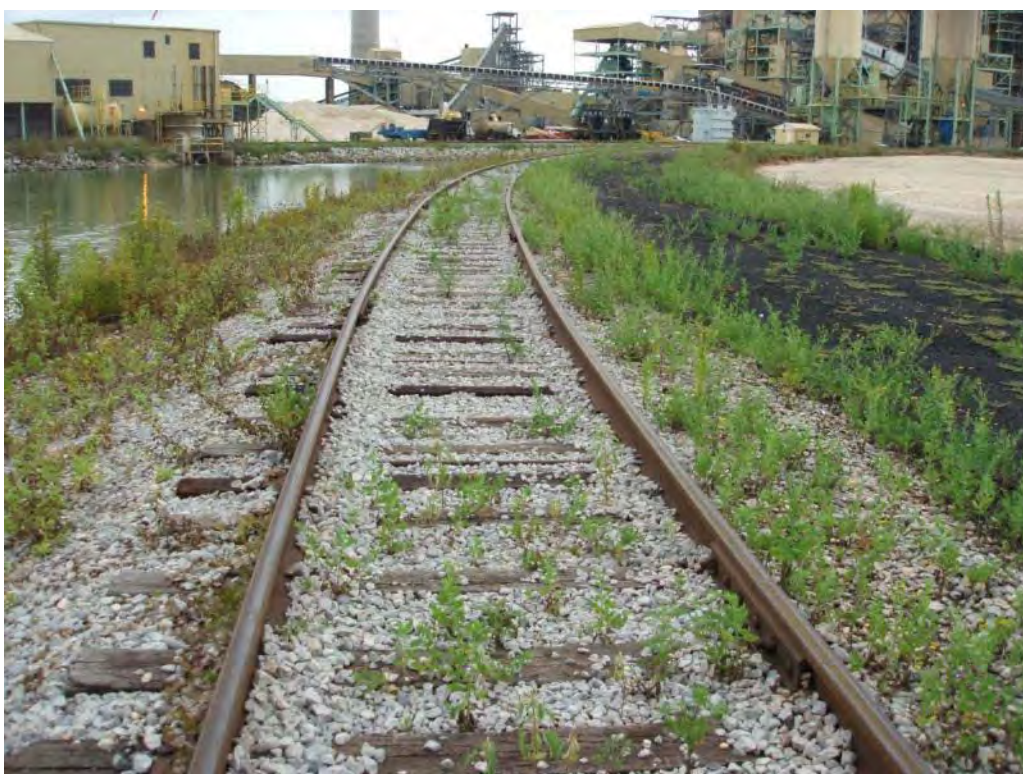
The crest appears to be in good condition (Photographs 60 and 127). The average crest width is approximately 20 feet, except at the east embankment that is incised, extending to the generating facility. A PSEC-owned railroad spur runs along the north and west embankment crests that are covered with a layer of crushed stone railway ballast (Photograph 71 and 94). The south and east embankment crests are paved and subject to vehicle traffic (Photographs 85 and 133). No depressions, ruts, or evidence of settlement were observed on the crests.

**Photo No. 60: Process Waste Pond – South embankment crest, looking east.**

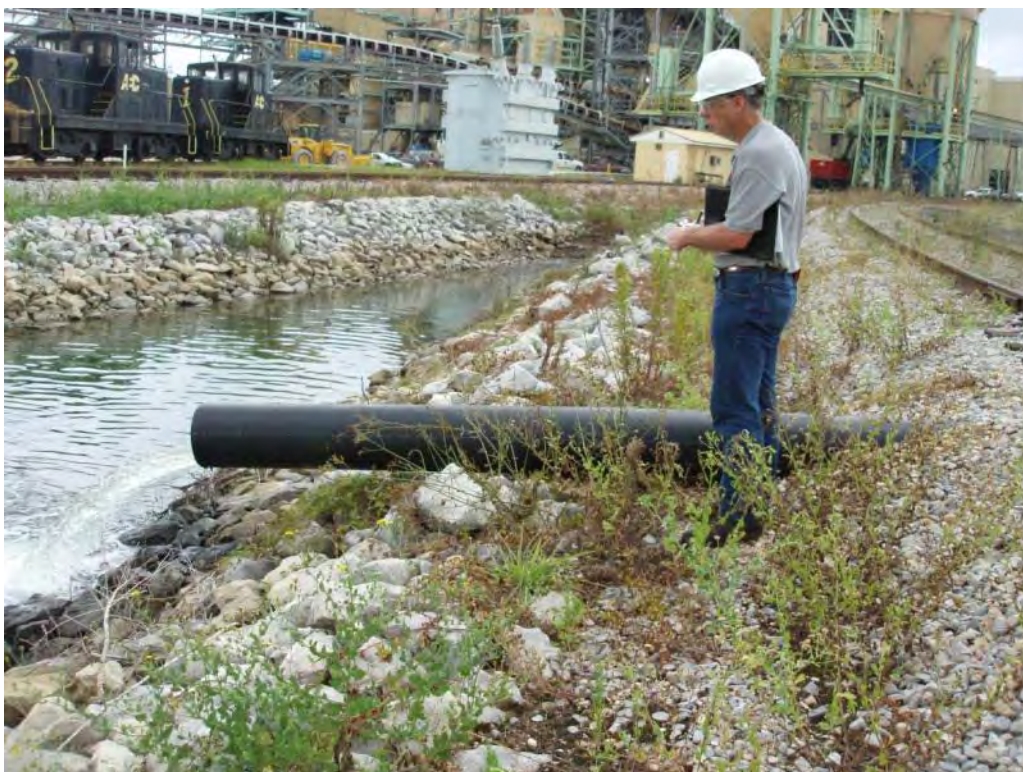
**Photo No. 62: Process Waste Pond – South embankment interior slope, looking east. Looking at discharge outfall from pump station.**

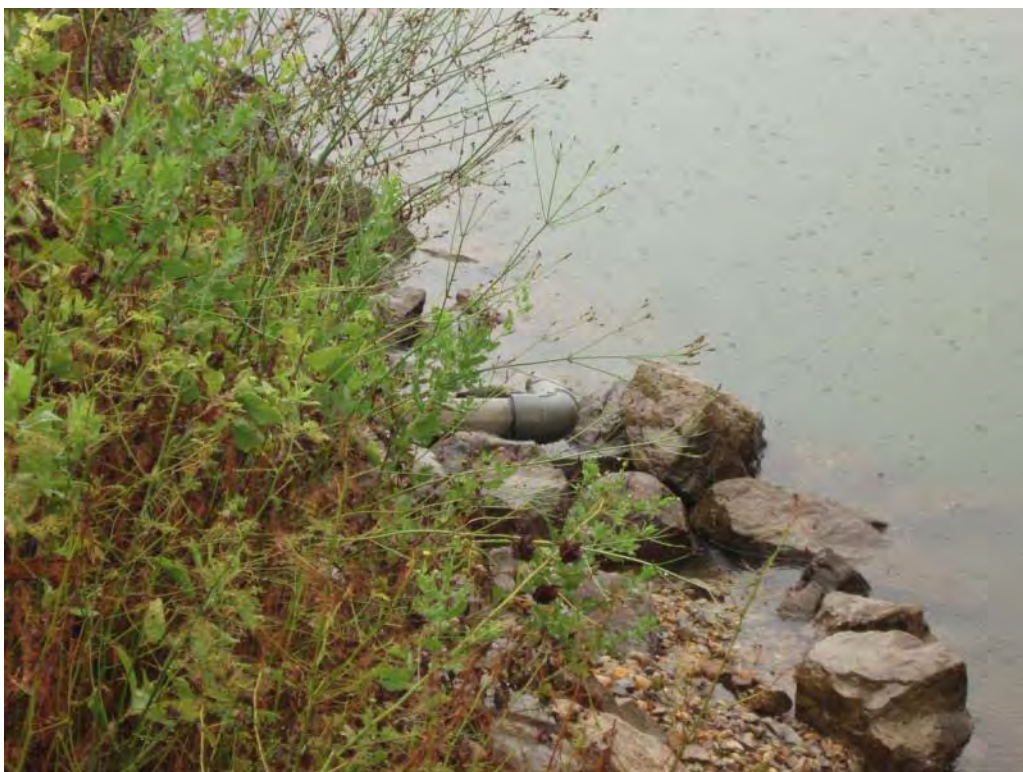
**Photo No. 68: Process Waste Pond – North embankment interior slope. Looking at capped pipe (unknown origin).**

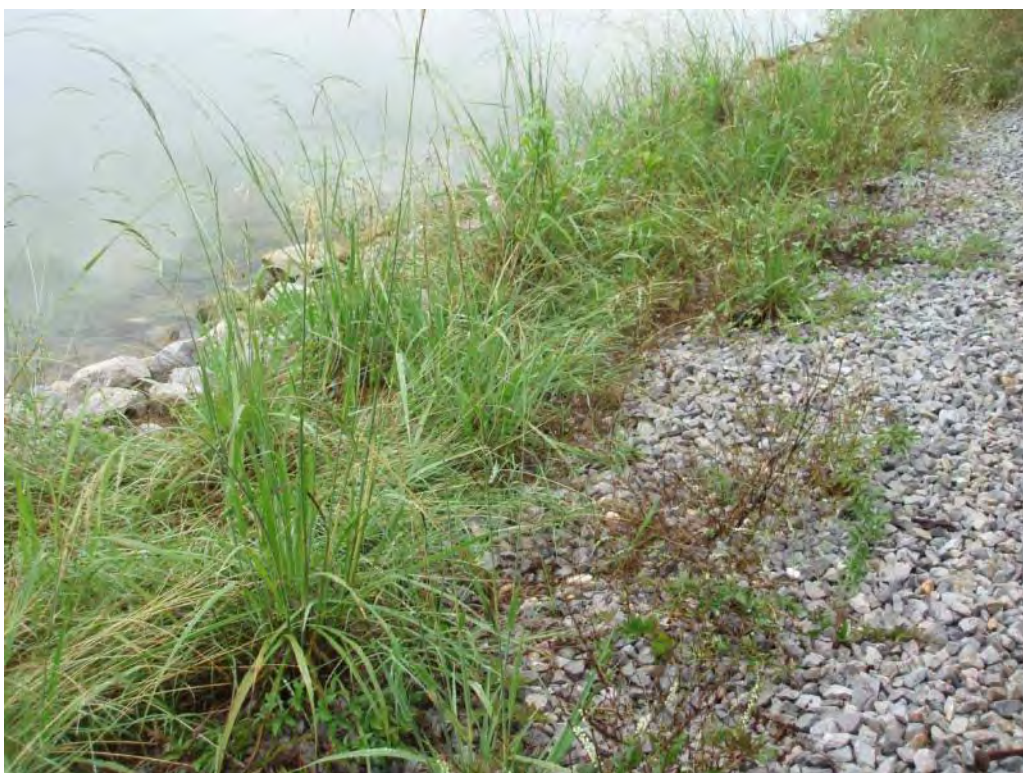
**Photo No. 72: Scrubber Waste Pond – West embankment interior slope. Looking at vegetation on slope.**

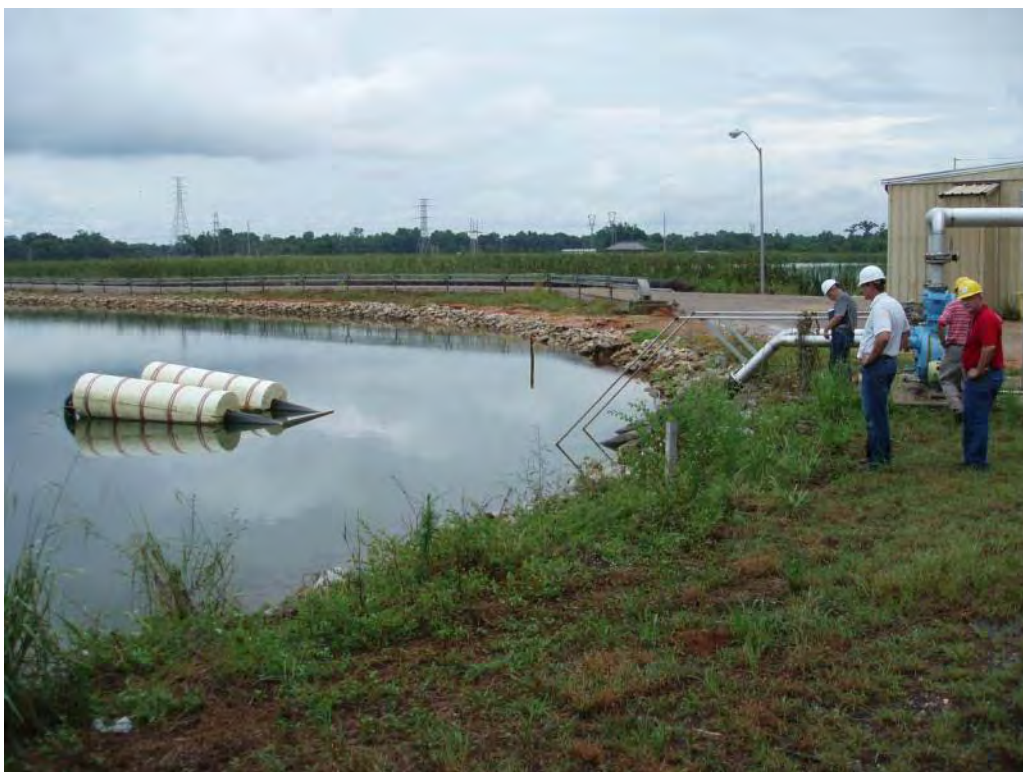
**Photo No. 74: Scrubber Waste Pond – West embankment interior slope, looking southeast. Looking at intake piping and pump station.**

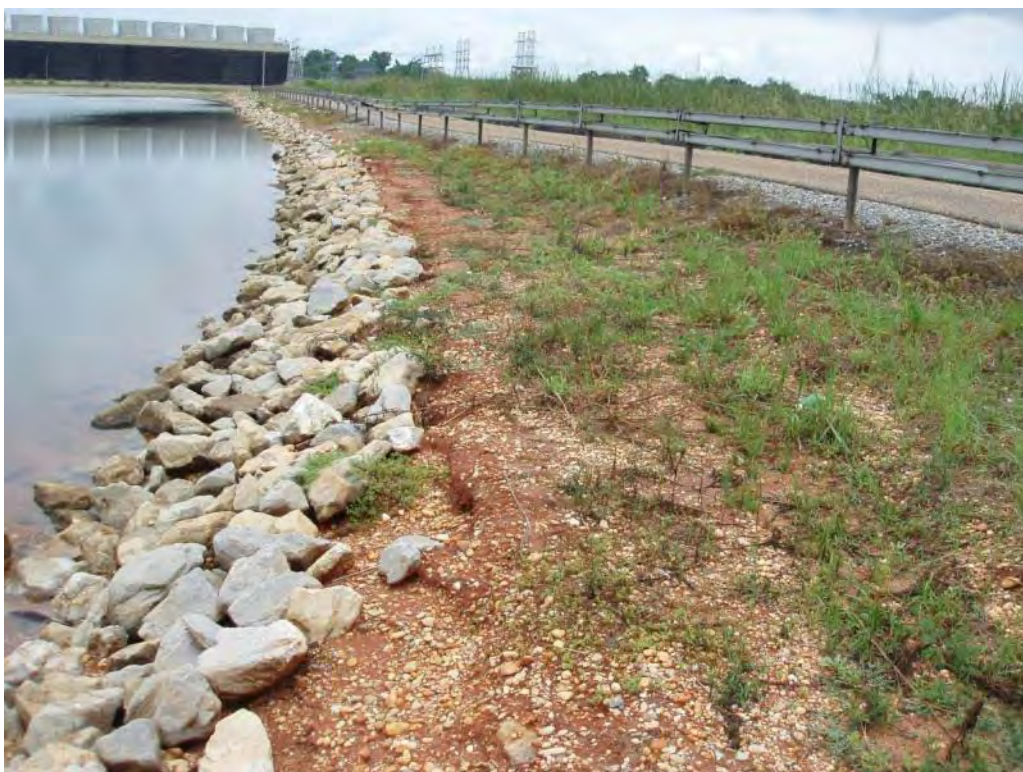
Surface erosion features were observed on the exterior slopes of the north embankment that is a divider embankment with the adjacent pond (Photographs 76 and 81). Spongy soils, sloughing, and voids were observed along the length of the south embankment in the location of a buried pipeline (Photograph 77). PSEC reported that the pipeline was installed in 2009 by excavating into the embankment slope. The excavation was backfilled, and riprap was replaced at the completion of the work. Also observed was missing riprap, voids within the riprap, and vegetation

**Photo No. 76: Scrubber Waste Pond – South (divider) embankment interior slope, looking east. Note surface erosion and settlement above riprap.**

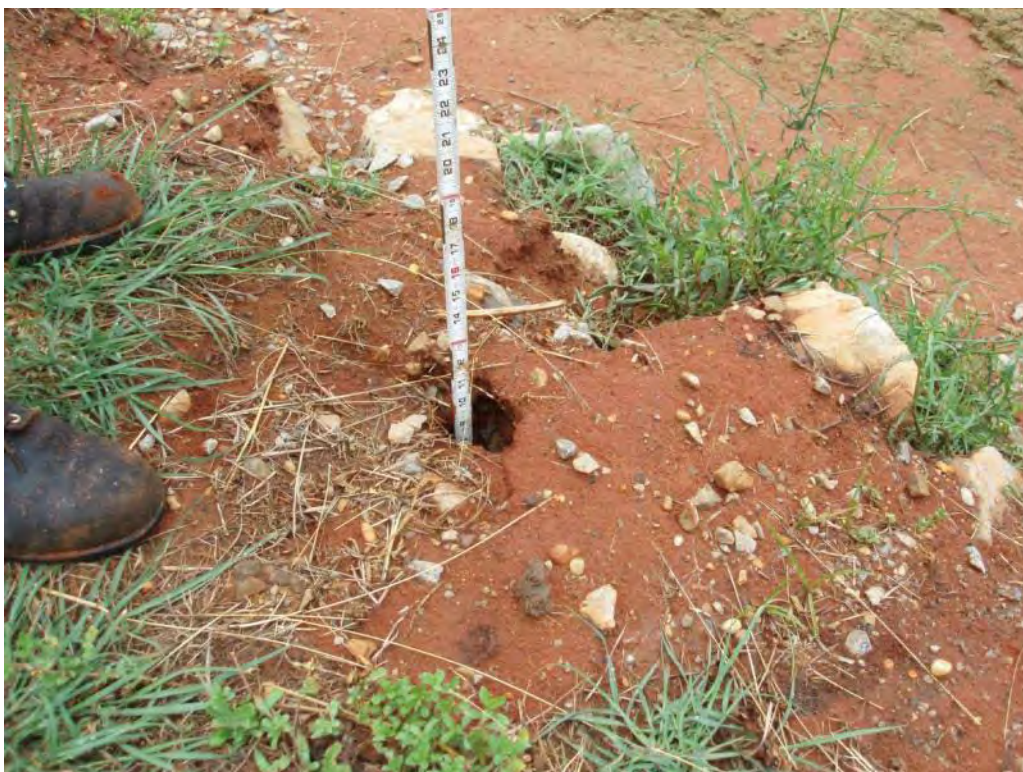
Also observed on the south and east embankments were areas where riprap coverage was less than 50 percent, voids within the riprap, and vegetation growing within the riprap (Photographs 80, 81, 84, and 89).

**Photo No. 80: Scrubber Waste Pond – South embankment exterior slope. Looking at 10-inch-deep void in soils.**

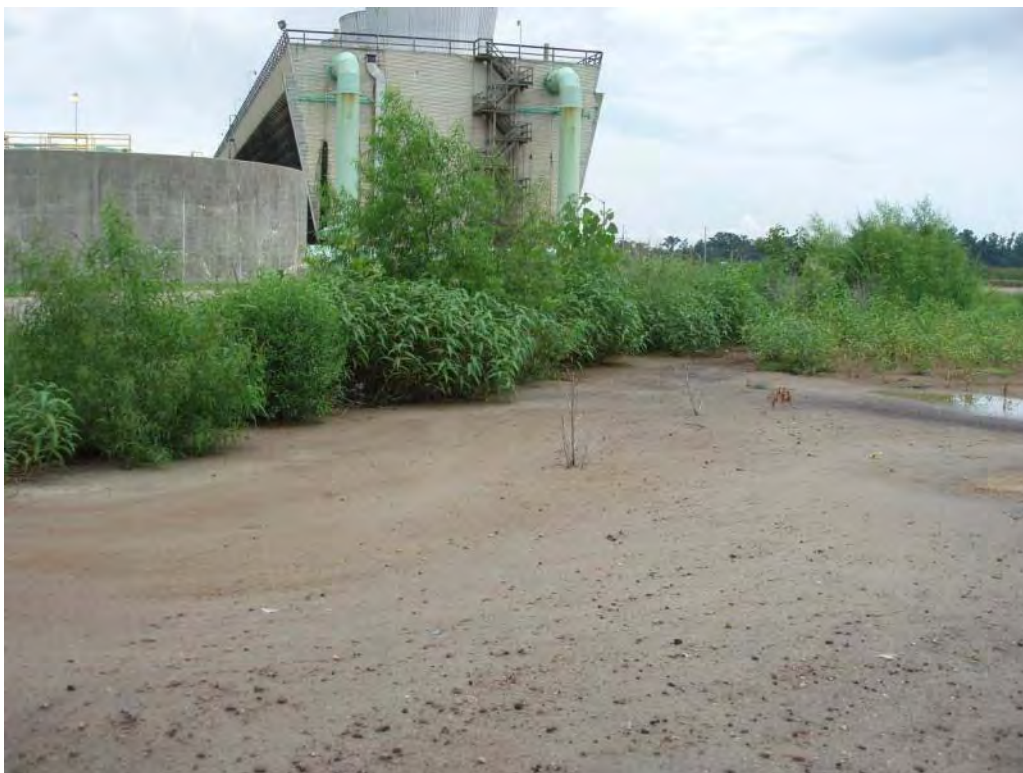
**Photo No. 90: Scrubber Waste Pond – East embankment interior slope, looking southeast.  
Looking at ash product and vegetation on slope.**

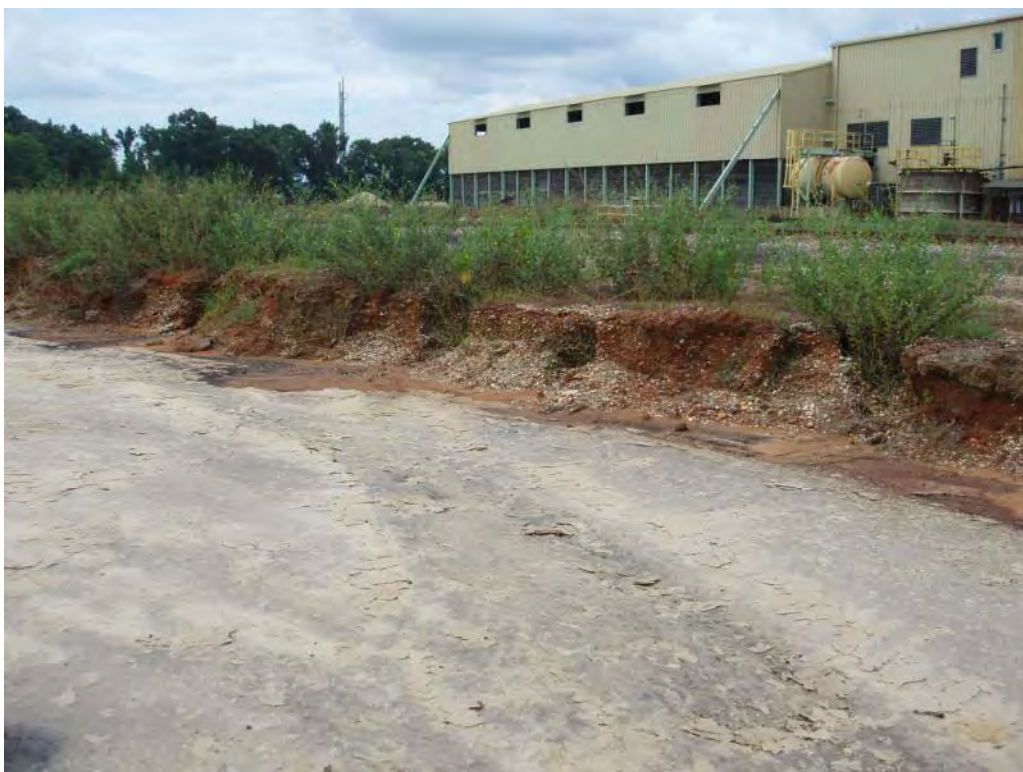
**Photo No. 98: Scrubber Waste Pond – North embankment interior slope, looking northwest. Looking at erosion rills in fill material.**

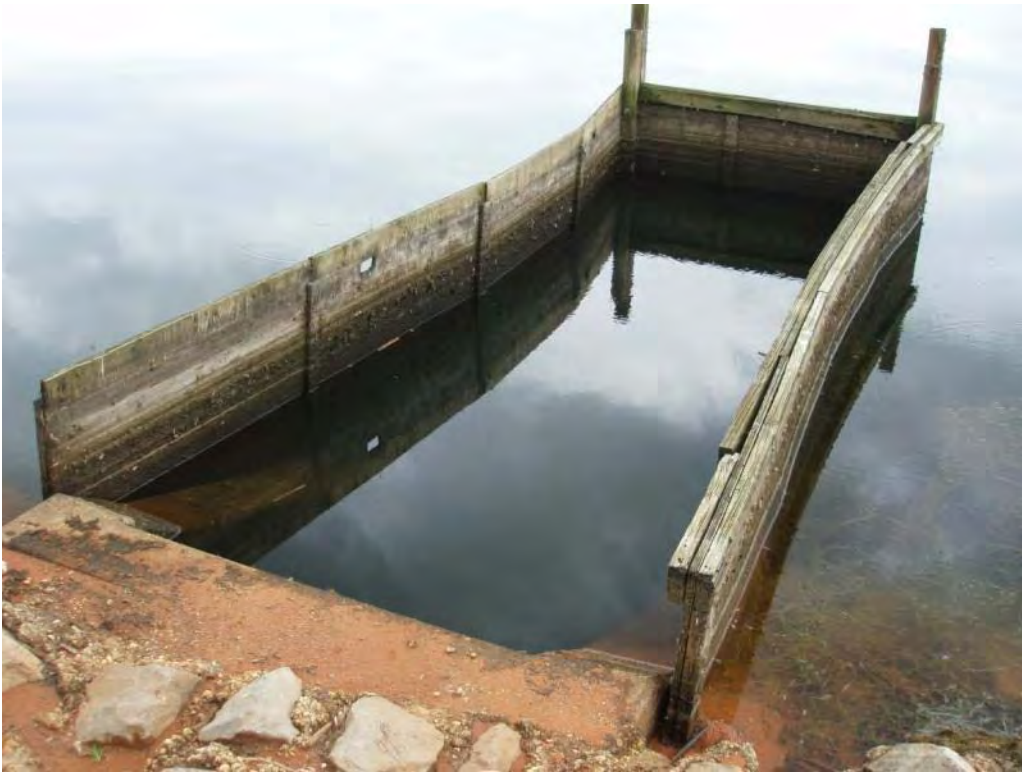
The outlet pipe in the #2/#3 Bottom Ash Pond was kept free of debris by a wood-framed structure and was submerged at the time of the assessment (Photograph 103). Based on drawings provided by PSEC, a 36-inch-diameter cast or ductile iron pipe, with invert elevation El. 35.5, is the intake for the pump house located on the crest at the northwest corner of the pond. From the limited view, the outlet appeared to be free of debris. No unusual movement was observed around the pipe penetrations.

**Photo No. 103: #2/#3 Bottom Ash Pond – North embankment interior slope. Looking at outlet structure.**

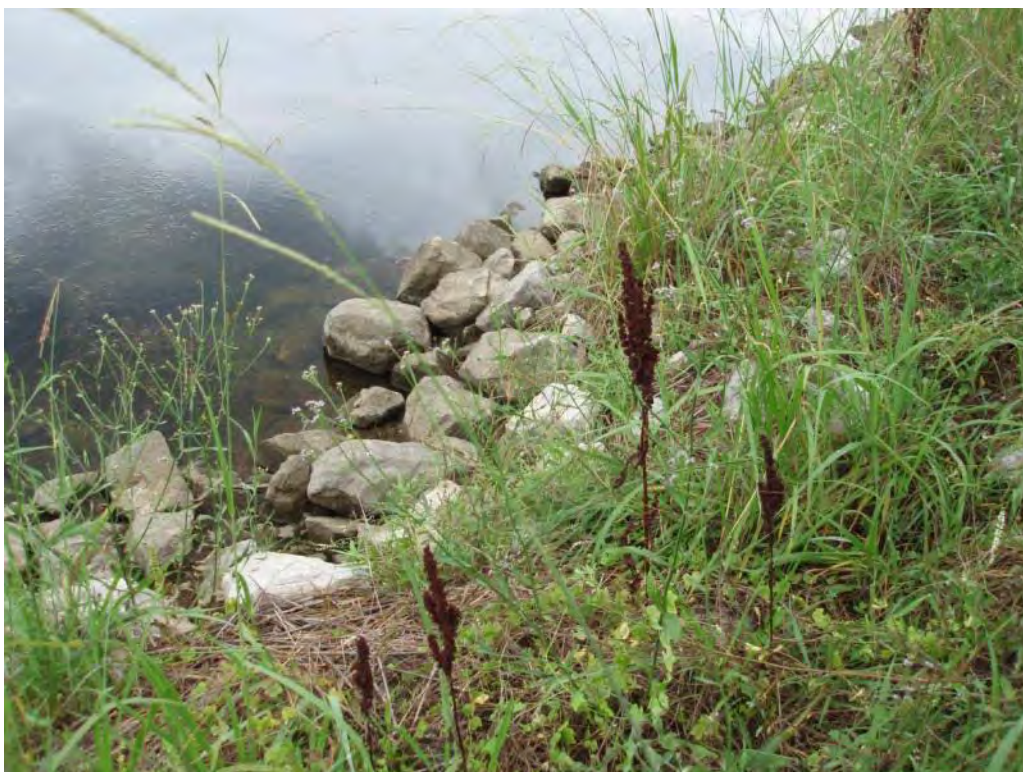
**Photo No. 106: #2/#3 Bottom Ash Pond – West embankment interior slope. Looking at erosion of riprap.**

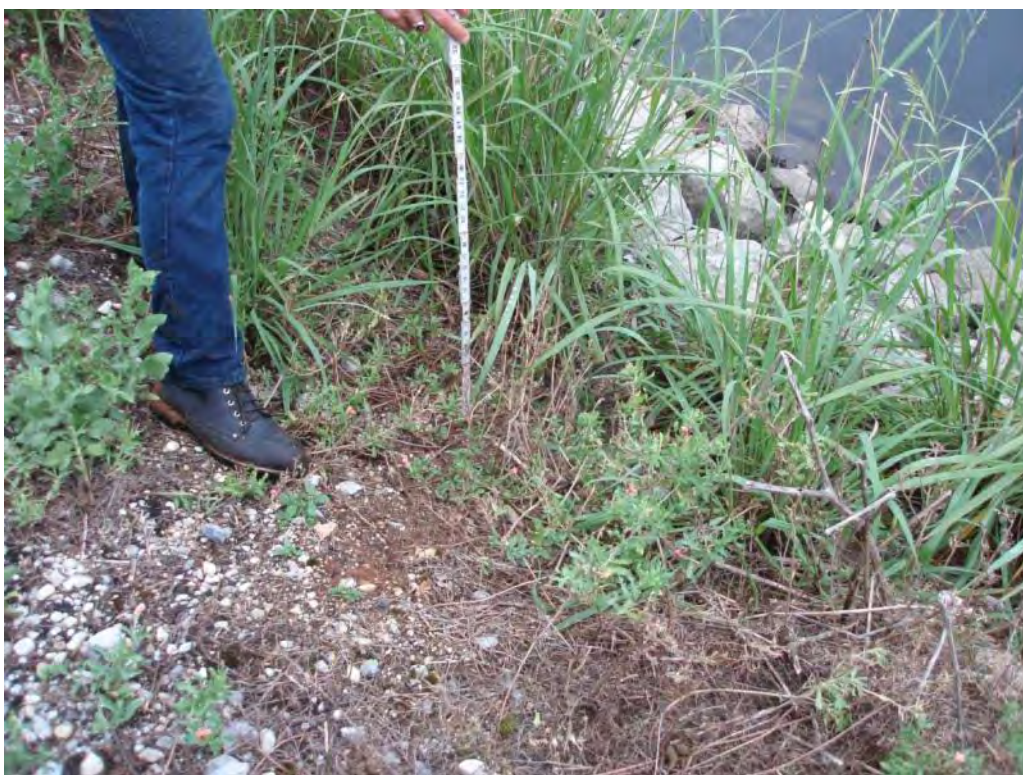
Locations of erosion due to missing riprap, vegetation growing within riprap, and possible localized settlement were observed at various locations on the interior slopes (Photographs 108, 114, 129 and 132).

**Photo No. 108: #2/#3 Bottom Ash Pond – West embankment interior slope. Looking at surface erosion and possible localized settlement.**

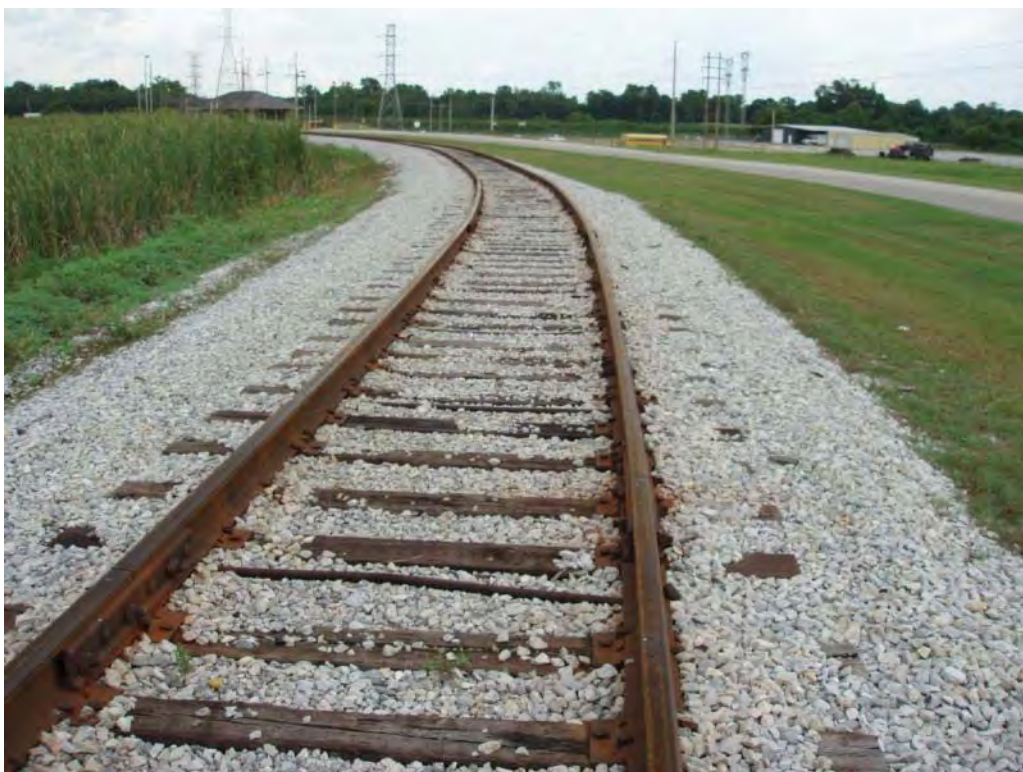
The crest appears to be in good condition (Photographs 110 and 130). The average crest width is approximately 20 feet, except at the east embankment, where the crest is approximately 30 feet wide. A Norfolk Southern railroad spur is located on the west, south, and east embankment crests that are covered with crushed stone railroad ballast (Photographs 110 and 118). The north embankment crest is covered with asphalt paving and subject to vehicle traffic (Photograph 133). No depressions, ruts, or evidence of settlement were observed on the crests (Photographs 110, 118, and 130).

**Photo No. 110: #2/#3 Bottom Ash Pond – South embankment crest, looking east.**

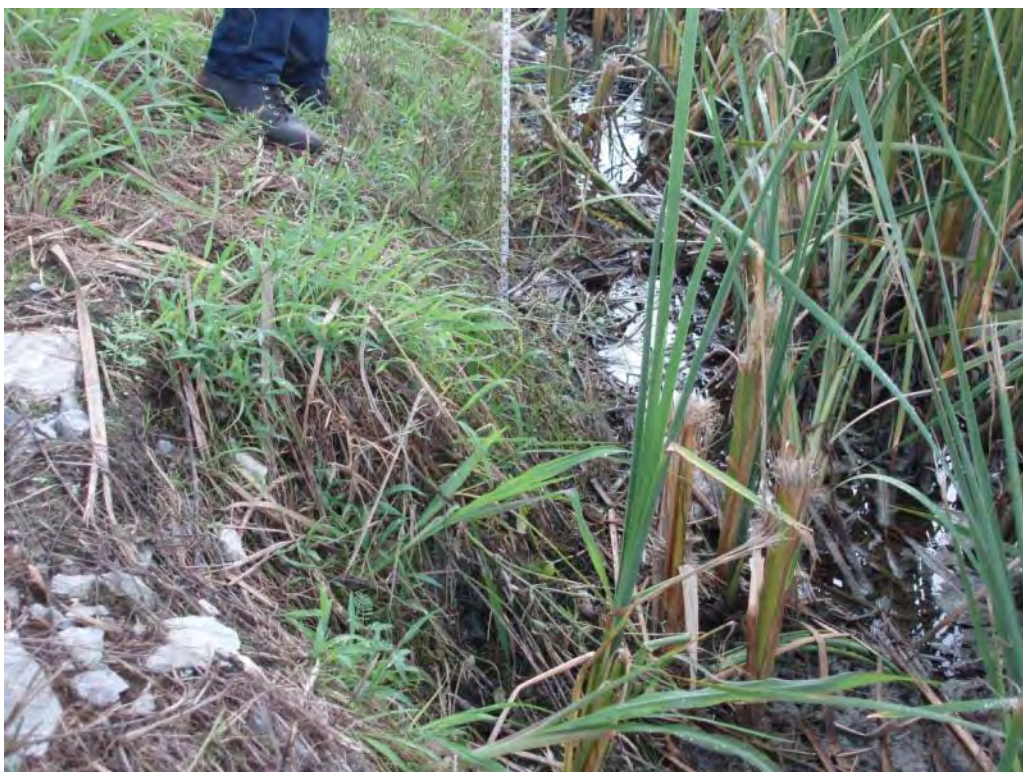
**Photo No. 114: #2/#3 Bottom Ash Pond – South embankment interior slope, looking southwest. Looking at erosion and missing riprap.**

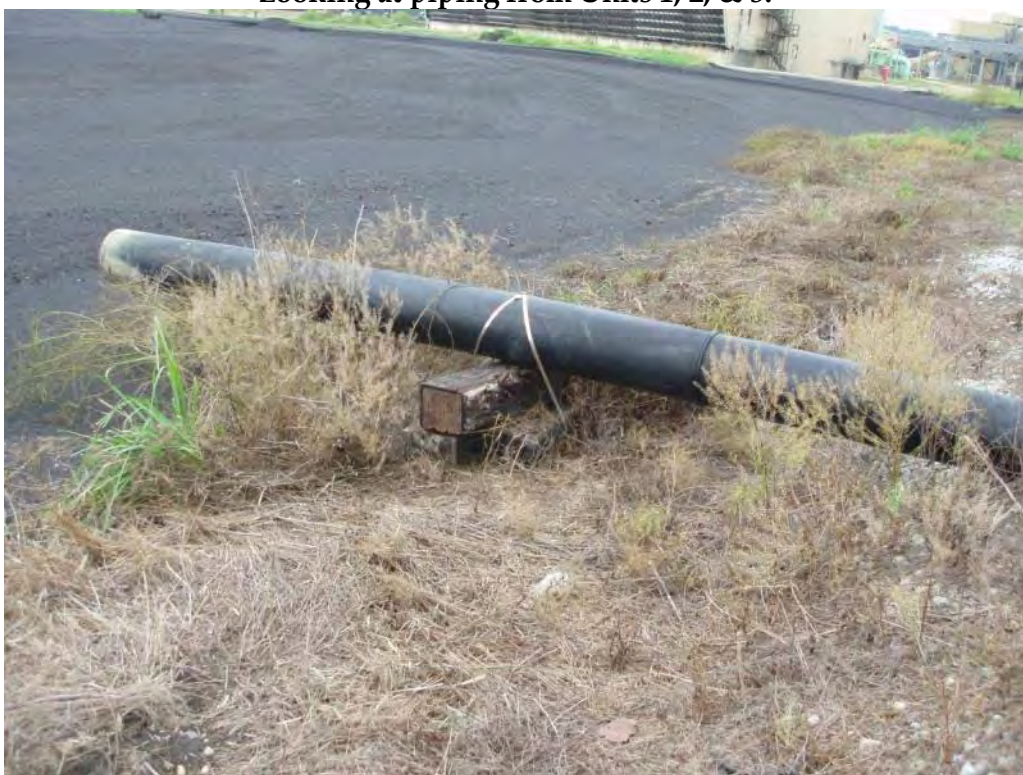
**Photo No. 120: #2/#3 Bottom Ash Pond – East embankment interior slope. Looking at inactive discharge pipe from Units 1, 2, & 3. Note sluice lines were configured for discharge of Units 1, 2 & 3 CCW to #1 Bottom Ash Pond.**

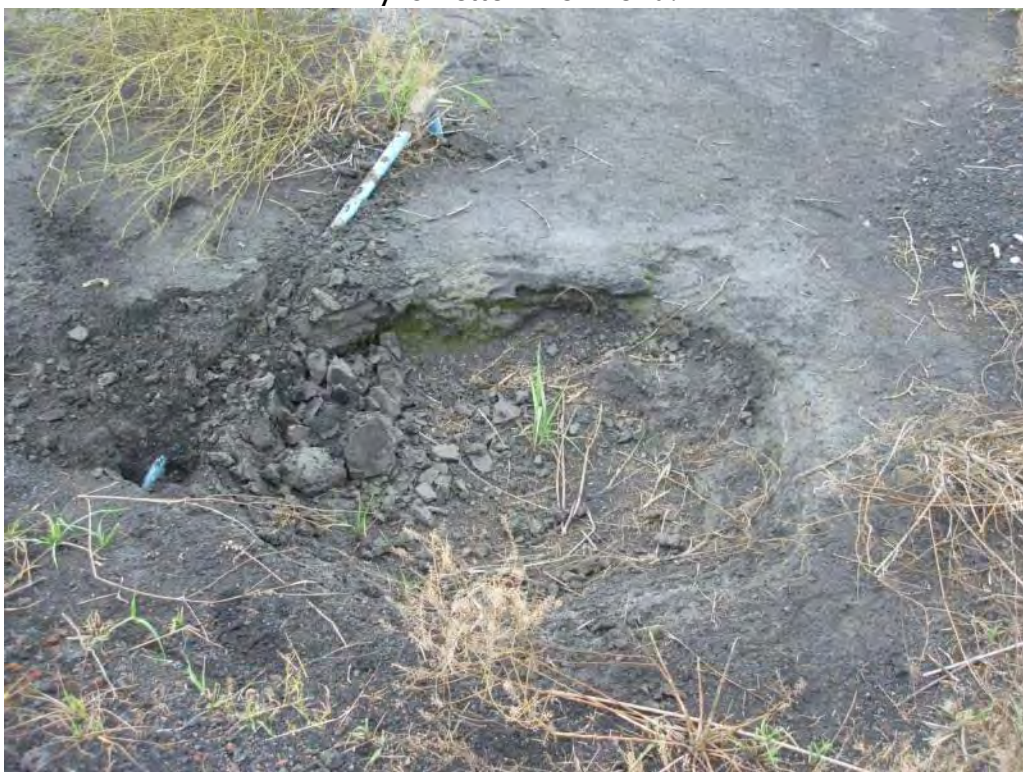
**Photo No. 124: #2/#3 Bottom Ash Pond - East embankment interior slope. Looking at abandoned electrical line.**

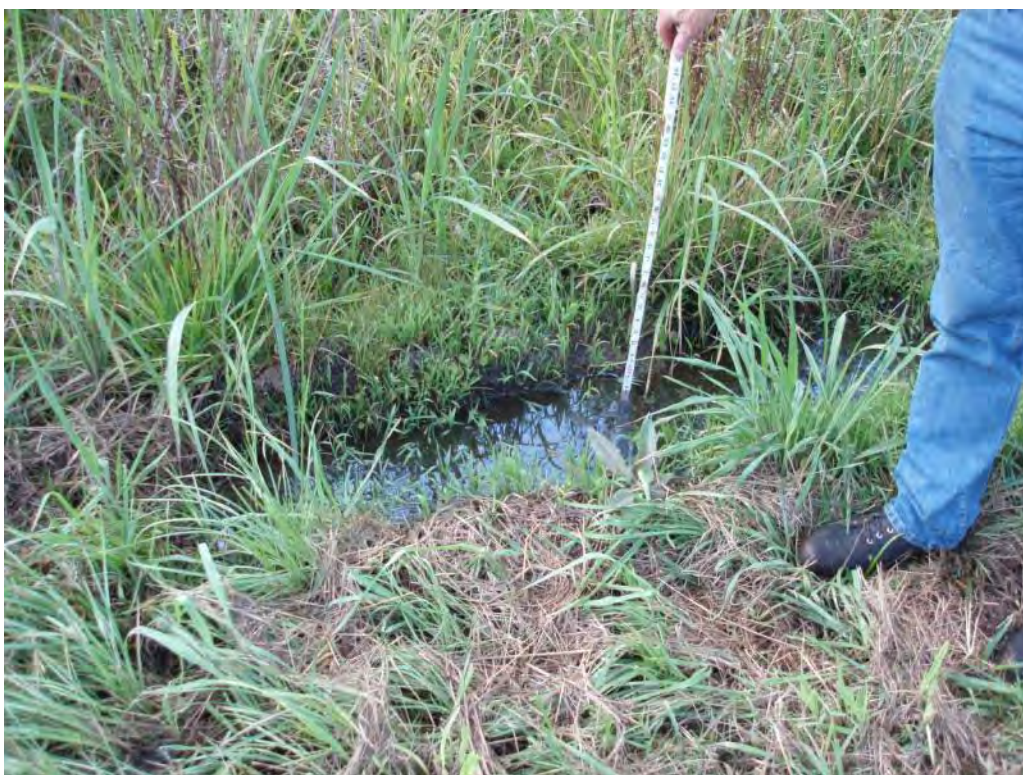
**Photo No. 138: #2/#3 Bottom Ash Pond – West embankment exterior slope. Looking at area of possible seepage.**

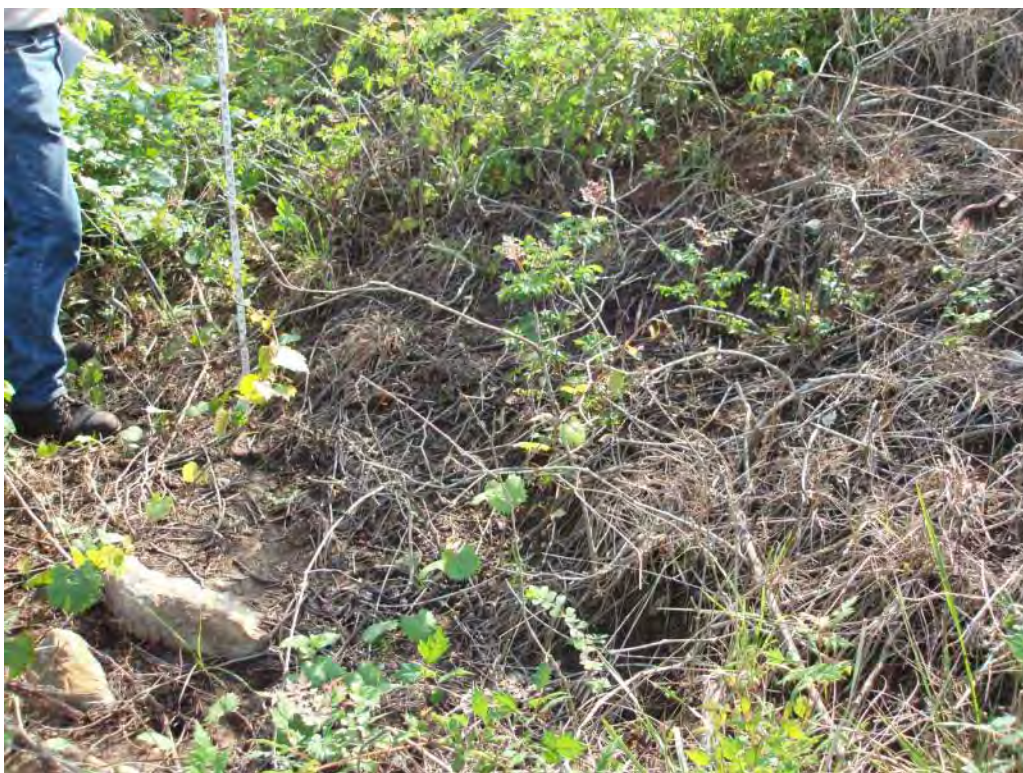
Minor surface erosion, sloughing, and scarps, as well as several animal burrow holes, were observed on the exterior slope of the west embankment within the dense vegetation (Photographs 153, 149, and 150).

**Photo No. 149: Scrubber Waste Pond – West embankment exterior slope. Looking at surface erosion.**
